## status report

#### Audi A5 Sportback 2.0 TDI quattro

| Vehicle identification number | <b>WAUZZZ8T7GA028458</b> | mileage read: | <b>110850 km</b> |

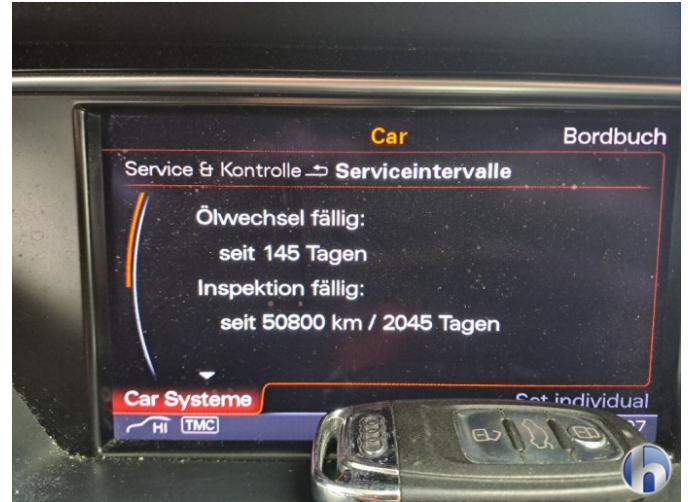
| component | Damage | Rep kind |
|---|---|---|
| 2. Wartung | Due | Replace |

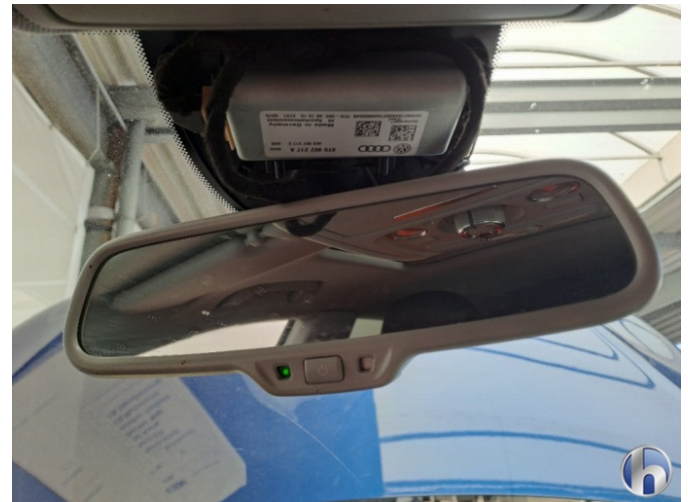
| component | Damage | Rep kind |
|---|---|---|
| 3. Abdeckung Spiegel innen | Breakage | Replace |

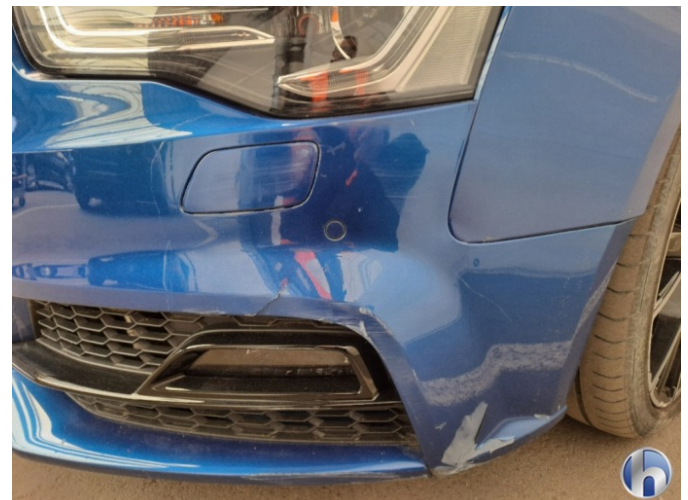
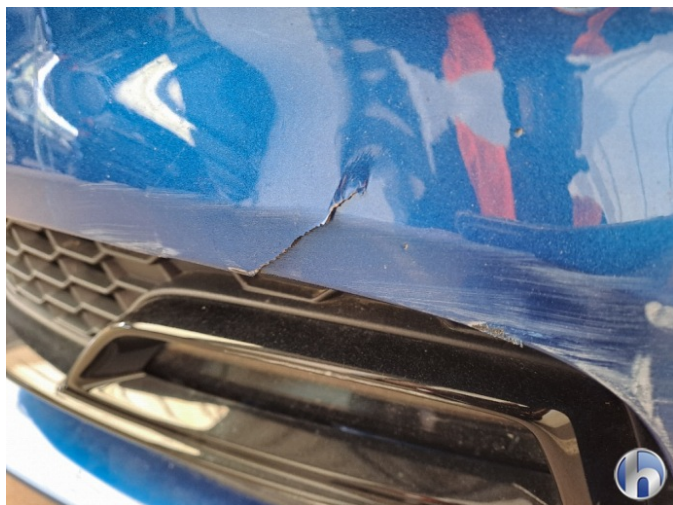
| component | Damage | Rep kind |
|---|---|---|
| 4. Front bumper | Crack | Replace |

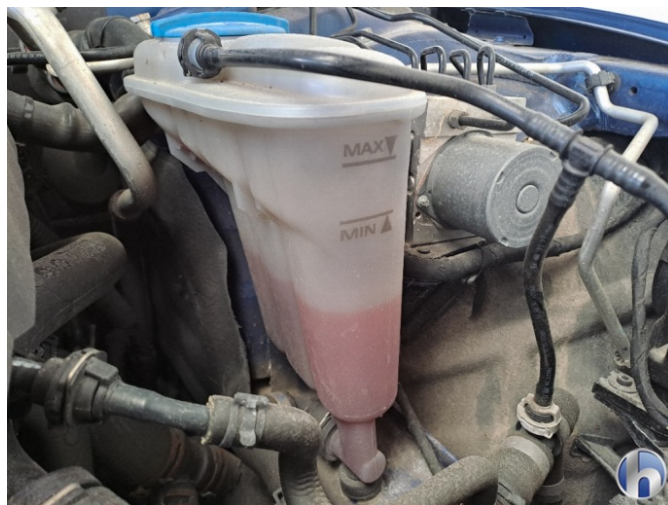
| component | Damage | Rep kind |
|---|---|---|
| 5. Kühlmittelbehälter | Missing | Carry out a fault diagnosis |

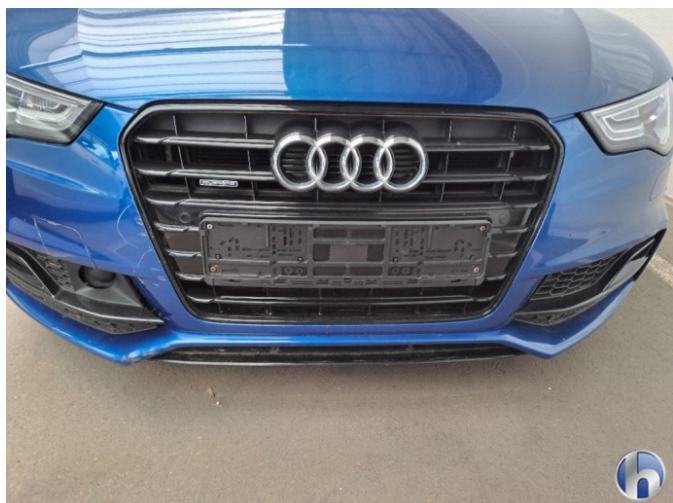
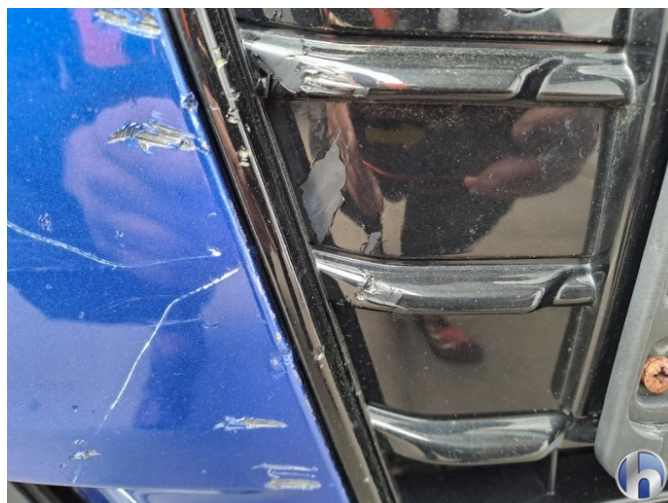
| component | Damage | Rep kind |
|---|---|---|
| 6. Front grille top | Scratch(es) | Replace |

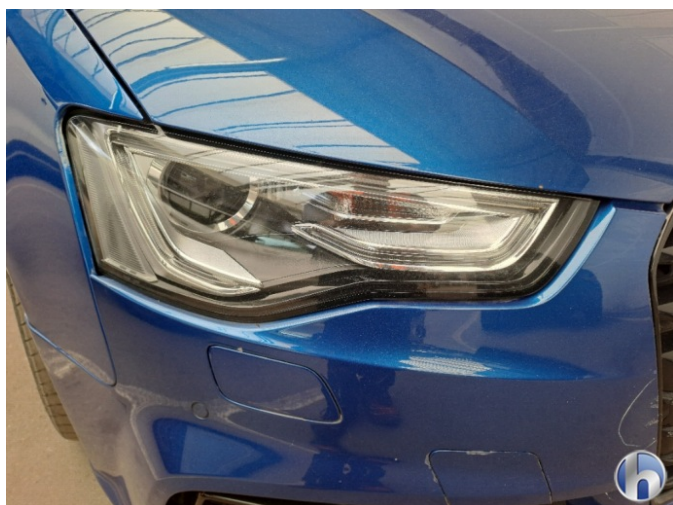
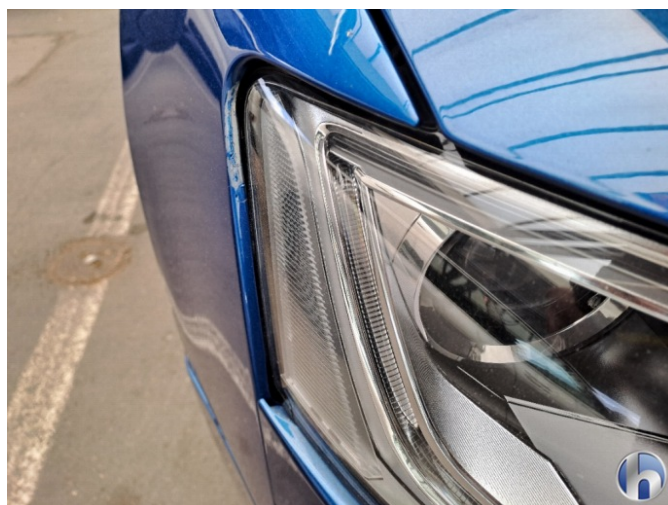
| component | Damage | Rep kind |
|---|---|---|
| 7. Halogen headlights - right | Increase in play | Replace |

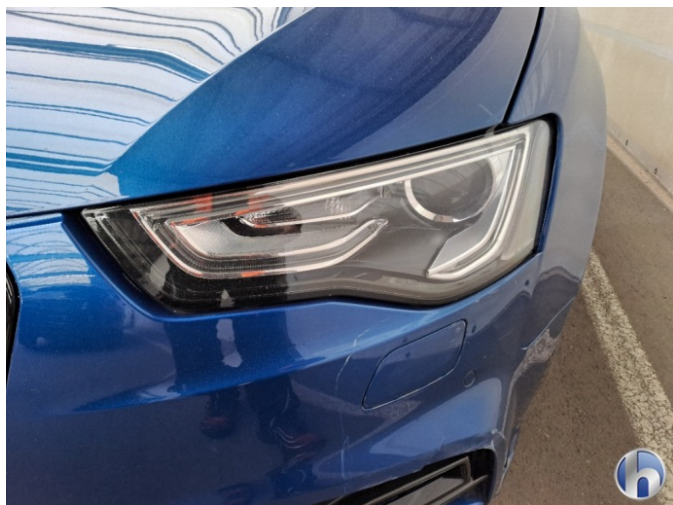
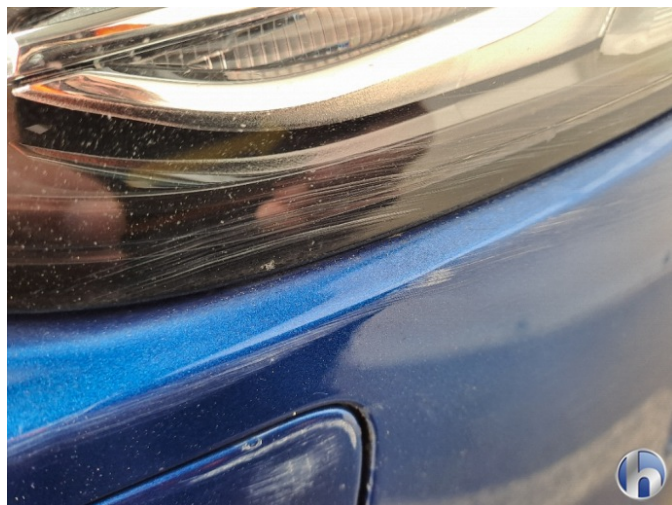
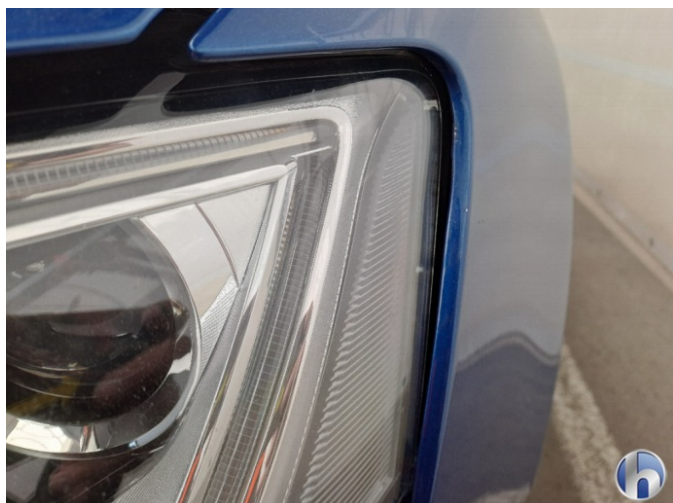
| component | Damage | Rep kind |
|---|---|---|
| 8. Halogen headlights - left | Scratch(es) | Replace |

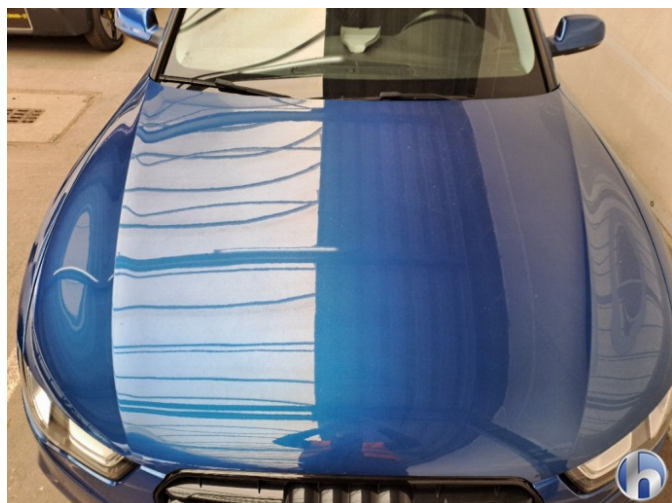
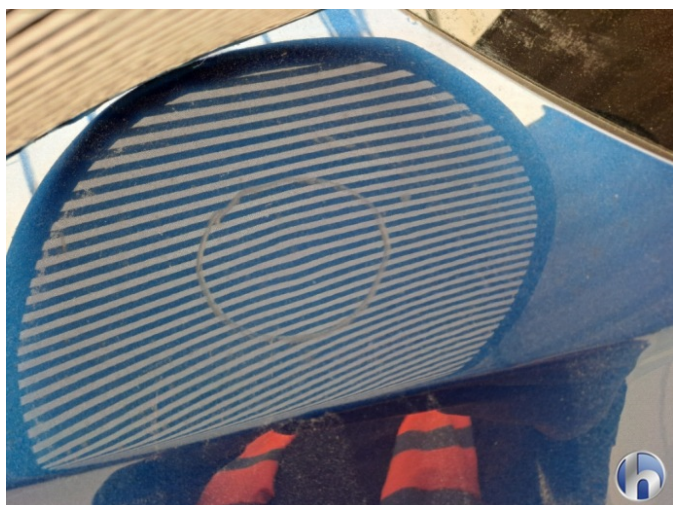
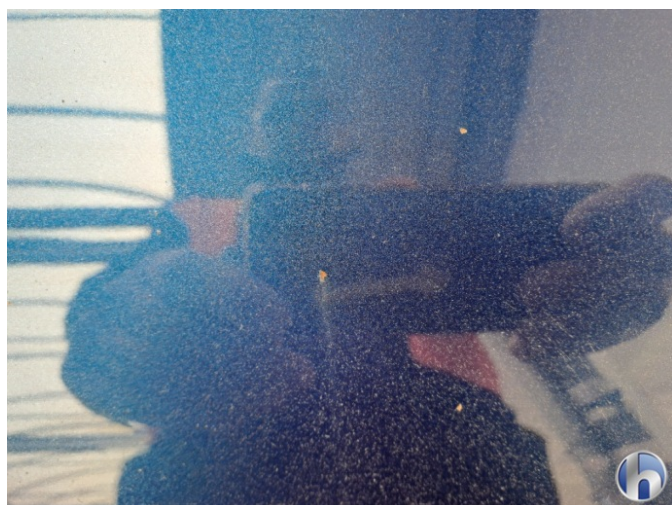
| component | Damage | Rep kind |
|---|---|---|
| 9. hood | | Smart repair |

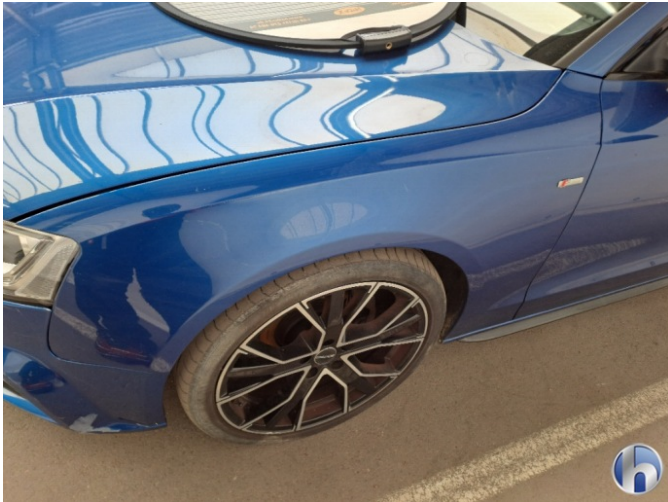
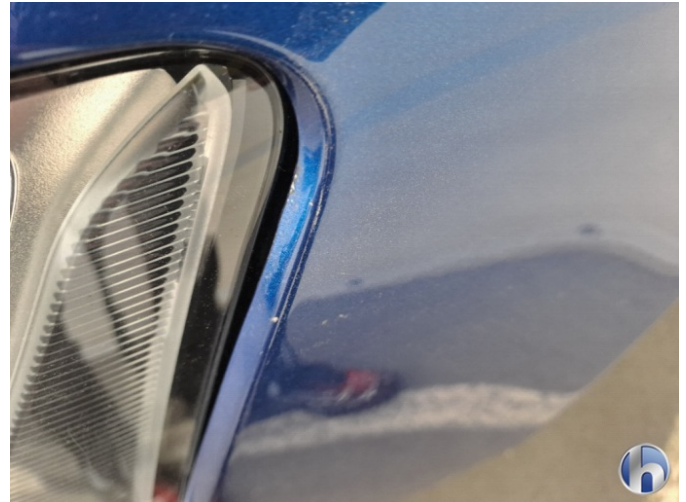
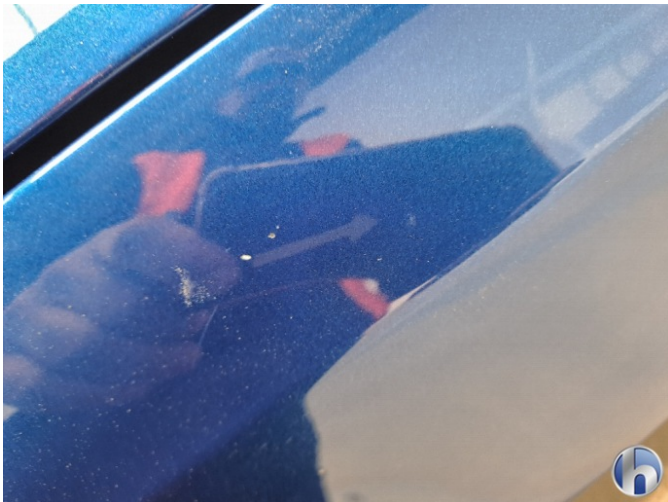
| component | Damage | Rep kind |
|---|---|---|
| 10. Front fender - left | Scratch(es) | Smart repair |

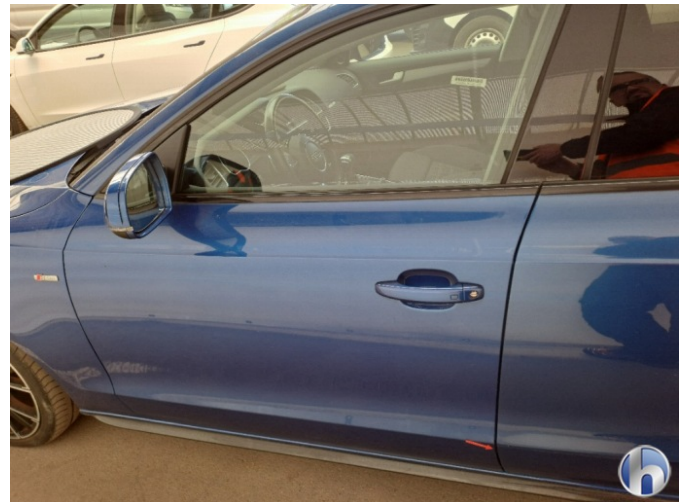
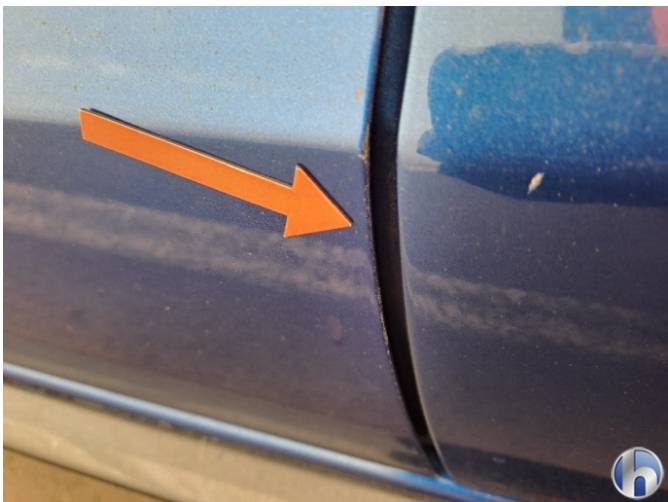
| component | Damage | Rep kind |
|---|---|---|
| 11. Front door - left | Scratch(es) | Smart repair |

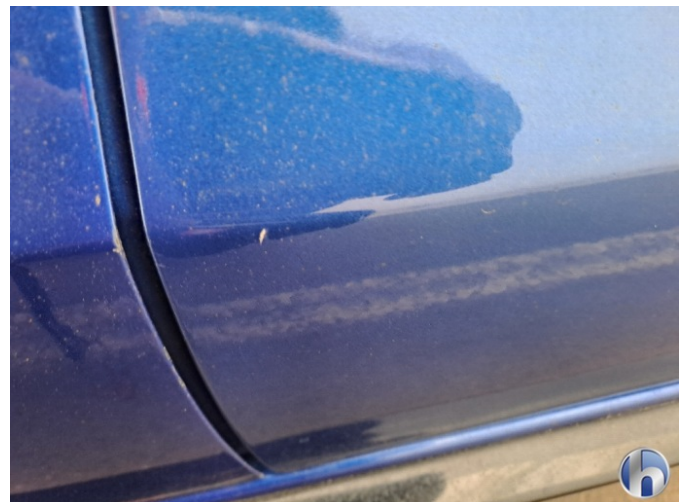
| component | Damage | Rep kind |
|---|---|---|
| 12. Rear door - left | Scratch(es) | Smart repair |

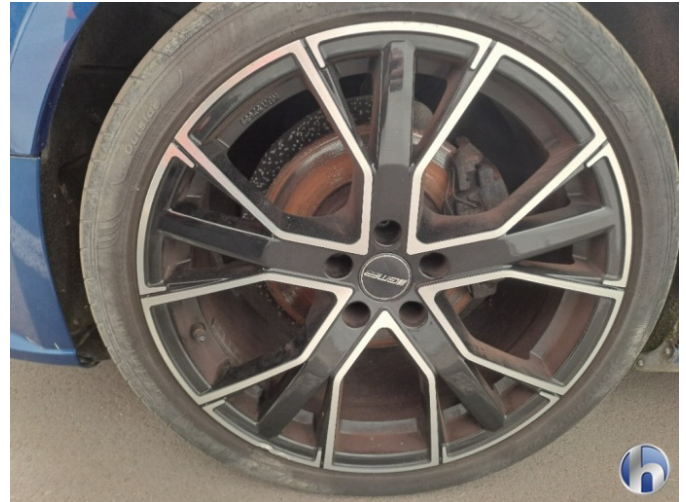
| component | Damage | Rep kind |
|---|---|---|
| 13. Felge vorn links | Scratch(es) | Replace |

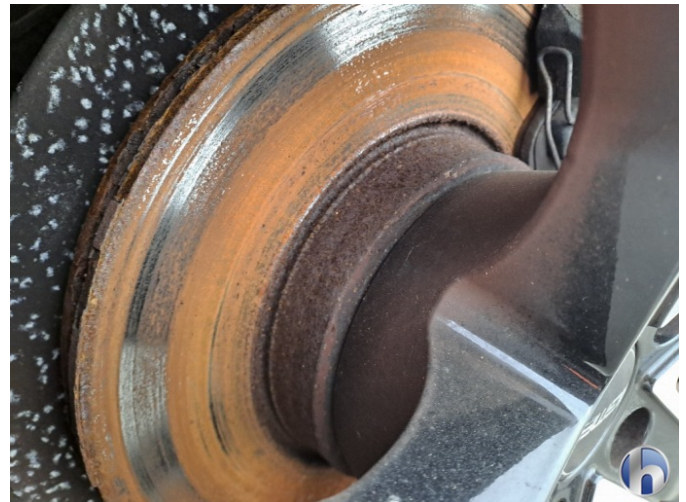
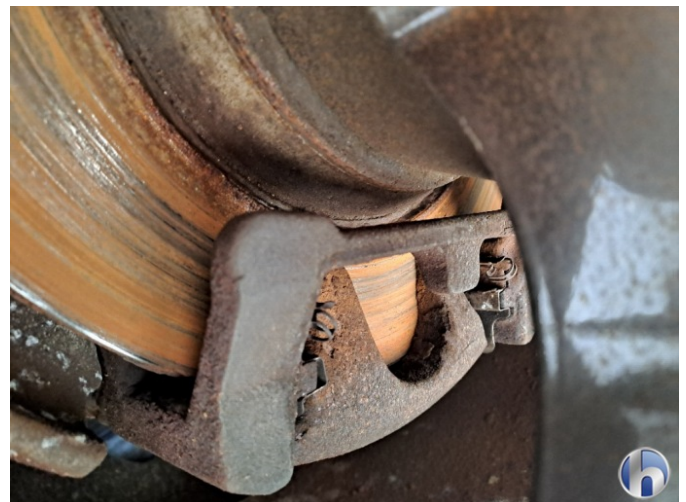
| General examination | |
|---|---|
| <b>Note Road Safe:</b> | Partikelfilter fehler,Bremse Hinten links fehlt Belag |

| component | Damage | Rep kind |
|---|---|---|
| 14. Bremse Komplett Hinten fehlt der Belag | Due | Replace |

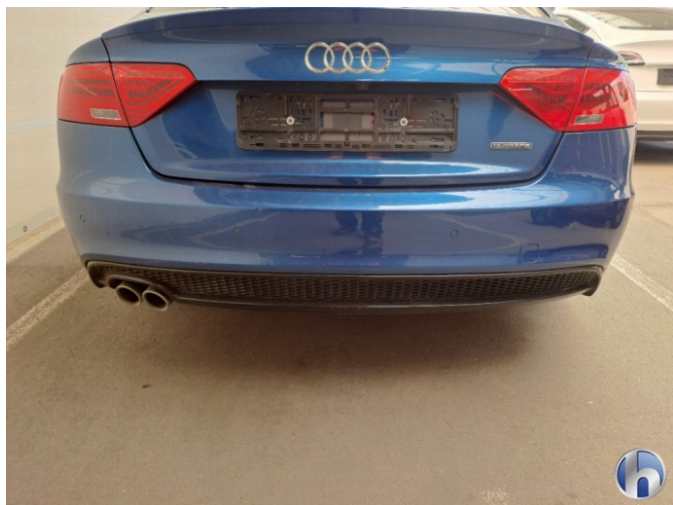
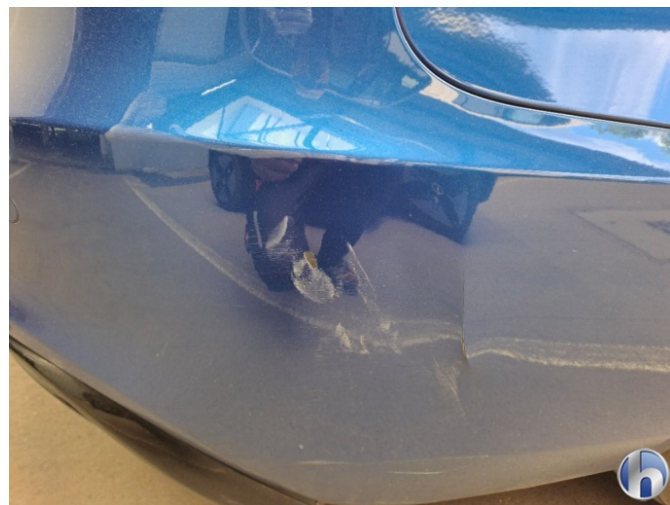
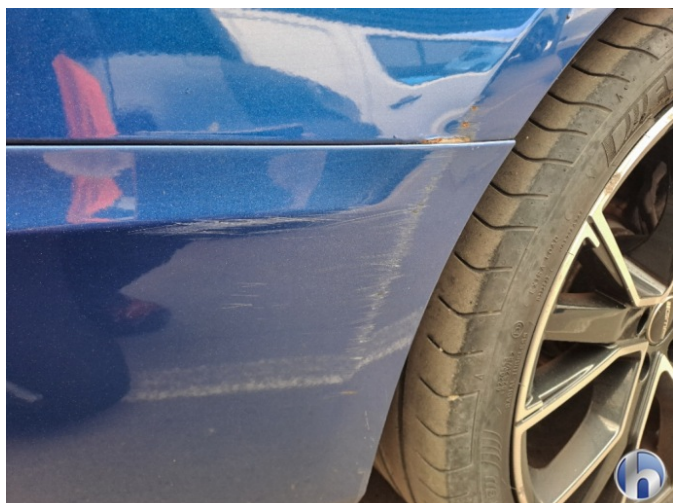
| component | Damage | Rep kind |
|---|---|---|
| 15. Rear bumper | Crack | Replace |

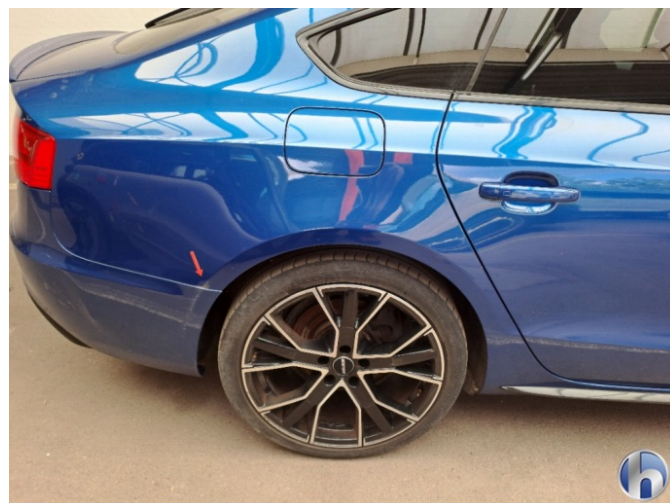
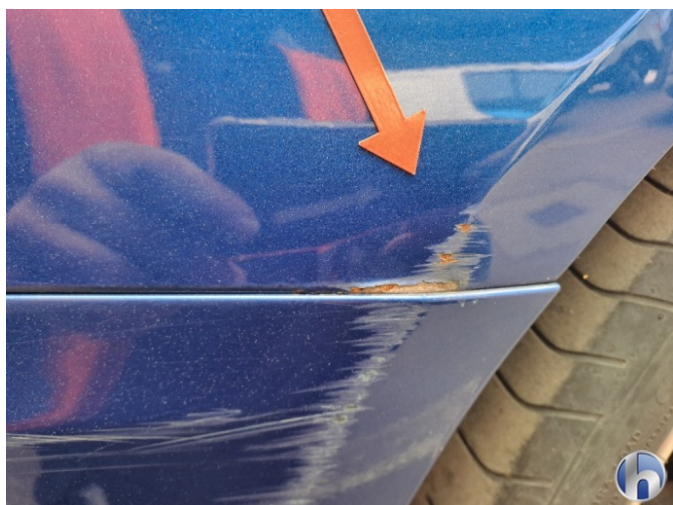
| component | Damage | Rep kind |
|---|---|---|
| 16. Sidewall - Rear - right | Scratch(es) | Refurbish and paint |

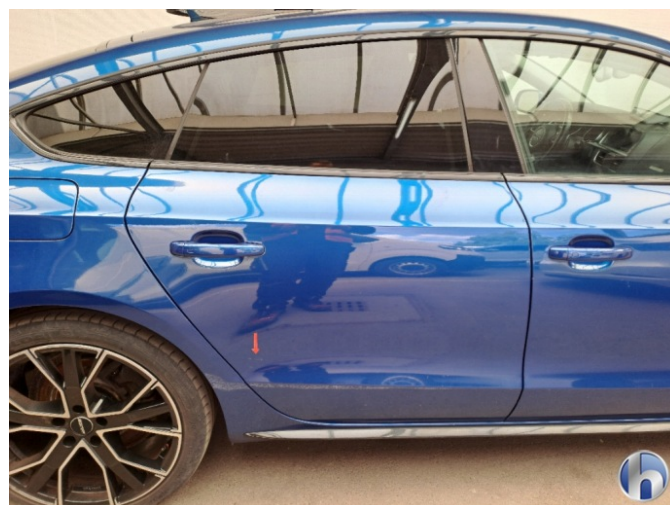
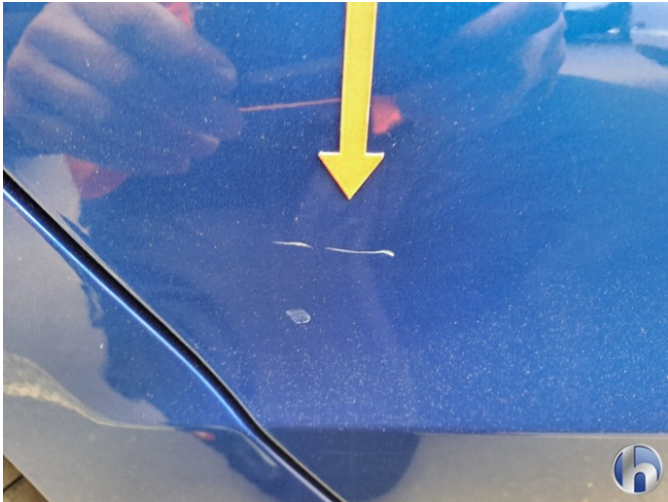
| component | Damage | Rep kind |
|---|---|---|
| 17. Door Rear - right | Scratch(es) | Paint |

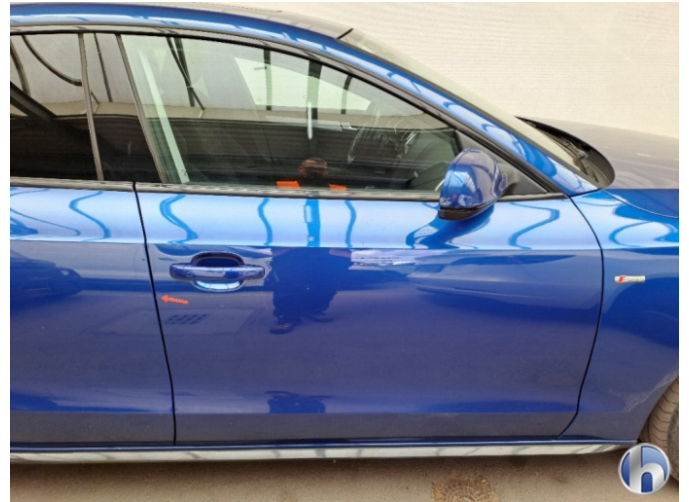
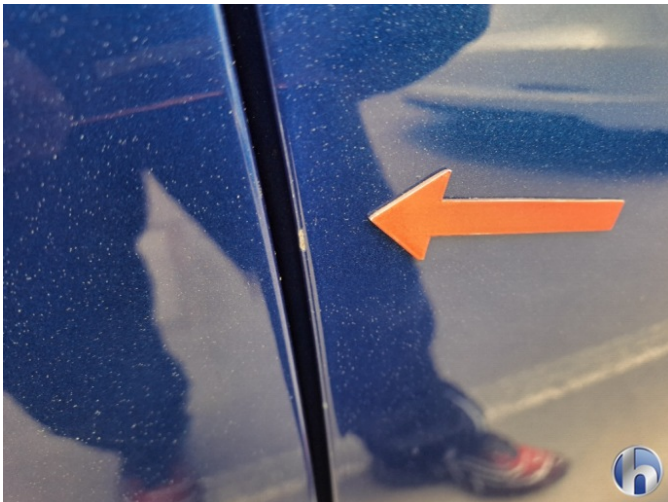
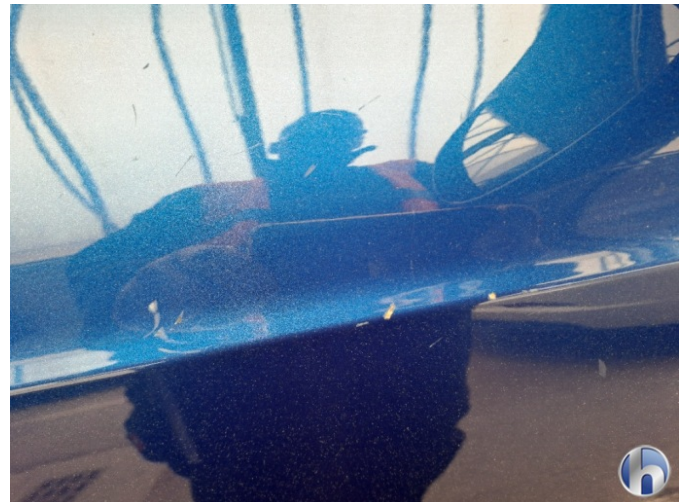
| component | Damage | Rep kind |
|---|---|---|
| 18. Front door - right | Scratch(es) | Paint |

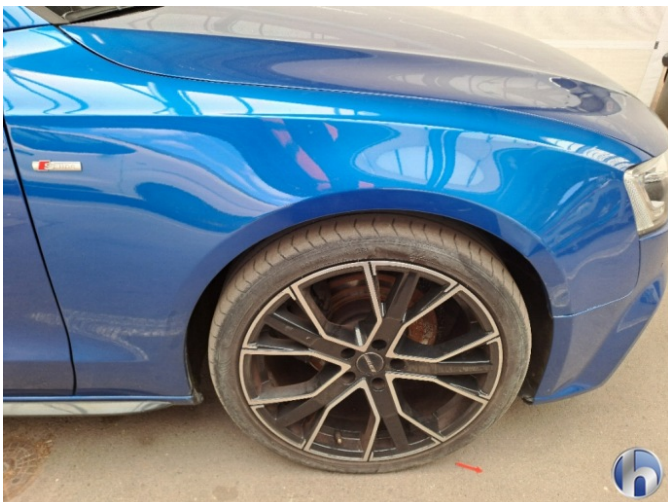
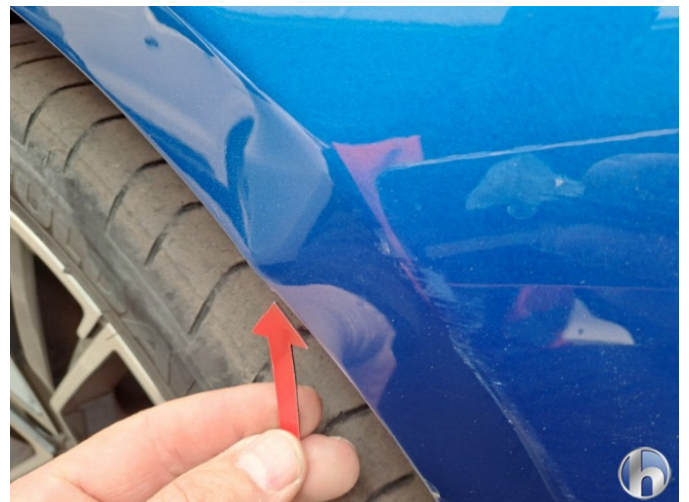
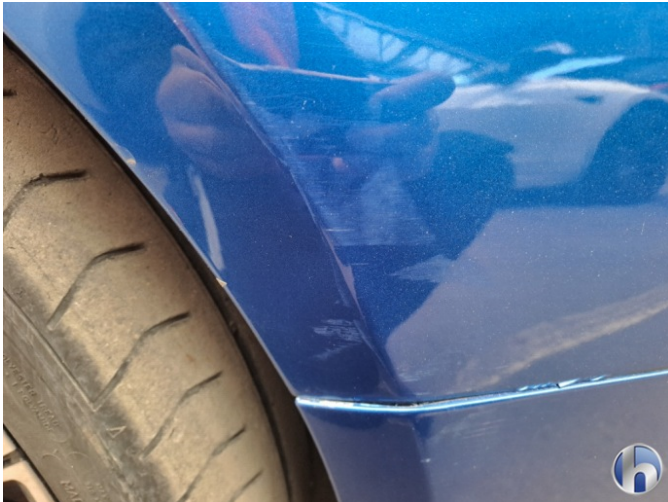
| component | Damage | Rep kind |
|---|---|---|
| 19. Front fender - right | Deformed | Refurbish and paint |

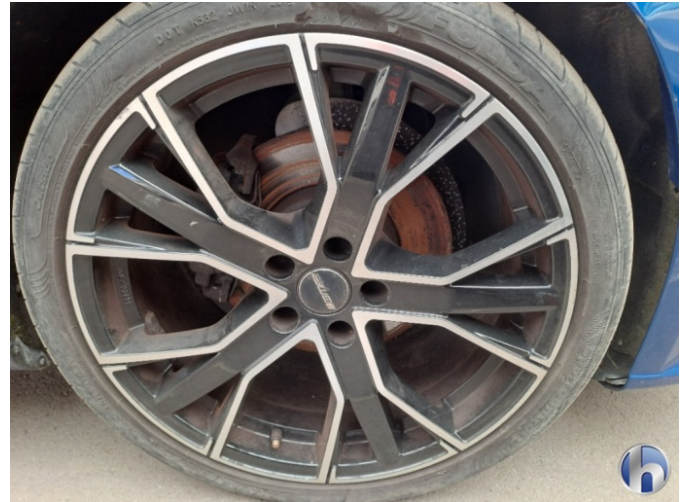
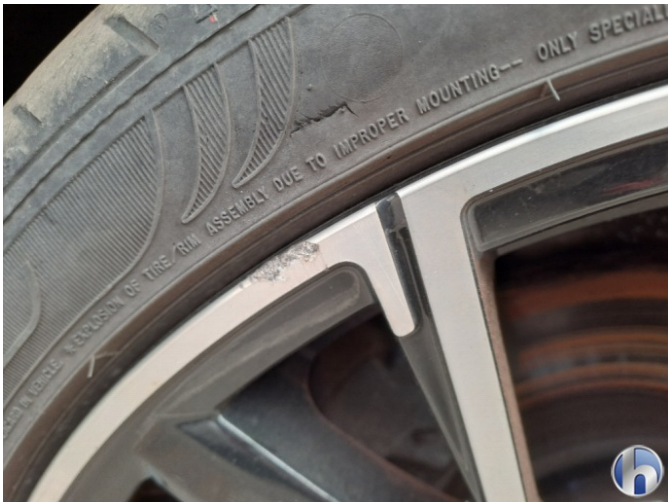
| component | Damage | Rep kind |
|---|---|---|
| 20. Felge vorn rechts | Scratch(es) | Replace |

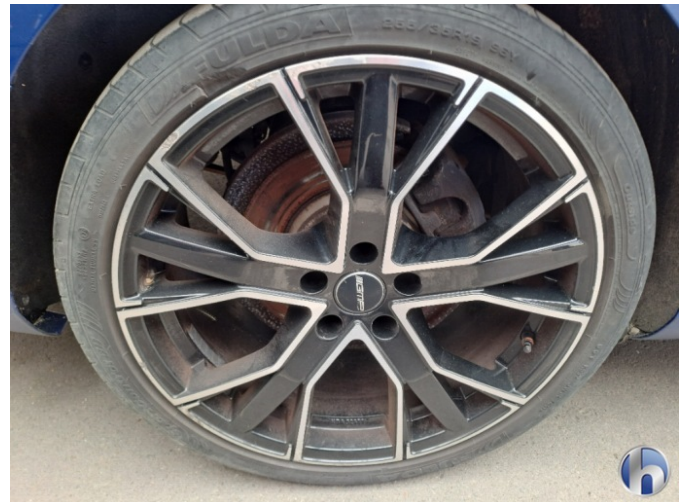
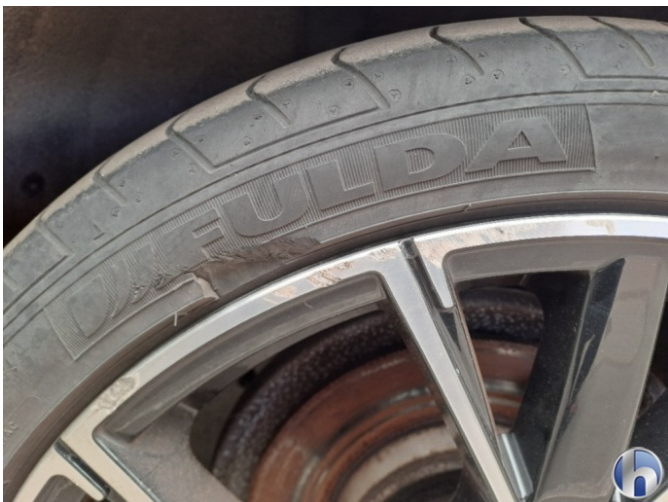
| component | Damage | Rep kind |
|---|---|---|
| 21. Felge Hinten rechts | Scratch(es) | Replace |

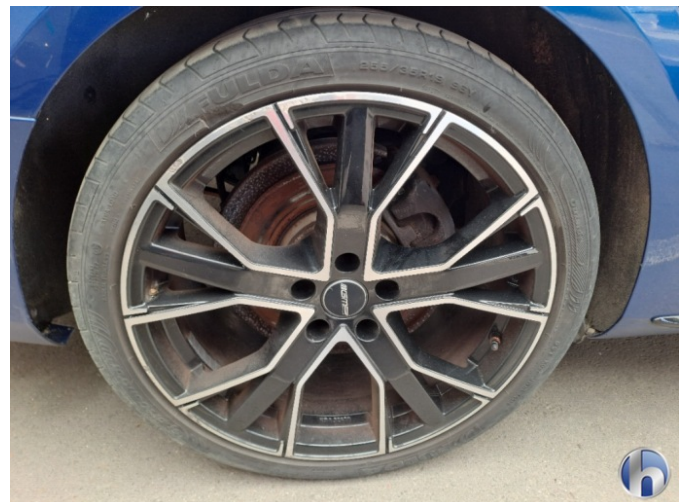
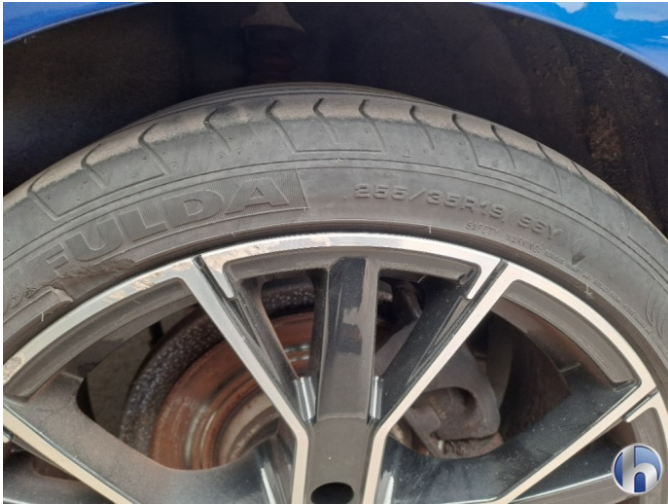
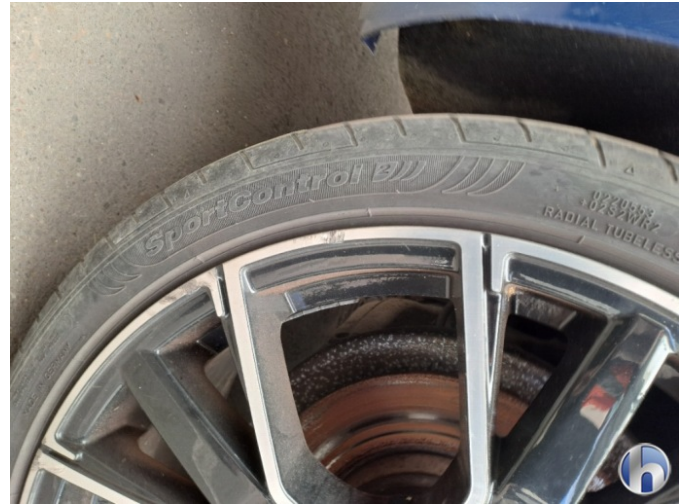
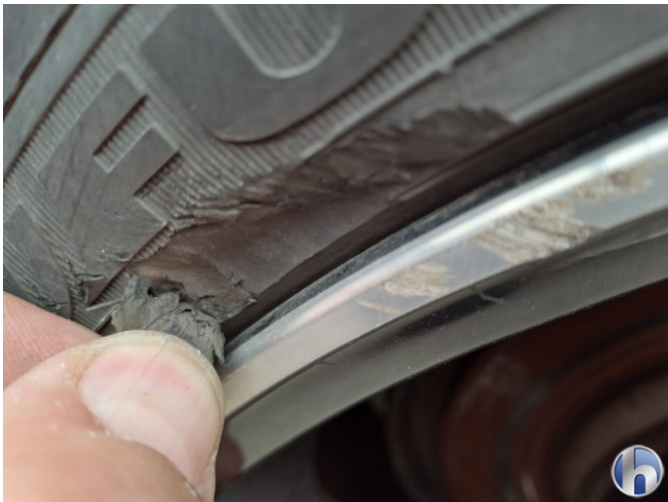
| component | Damage | Rep kind |
|---|---|---|
| 22. Reifen Hinten rechts | Damaged | Replace |

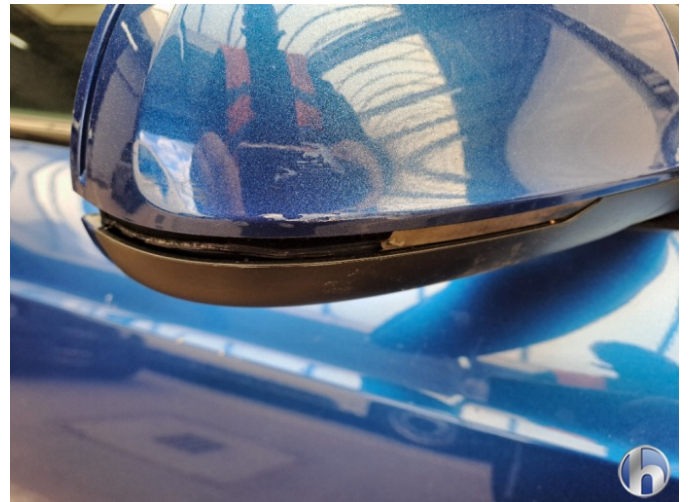
| component | Damage | Rep kind |
|---|---|---|
| 23. Blinker Led vorn rechts | Breakage | Replace |

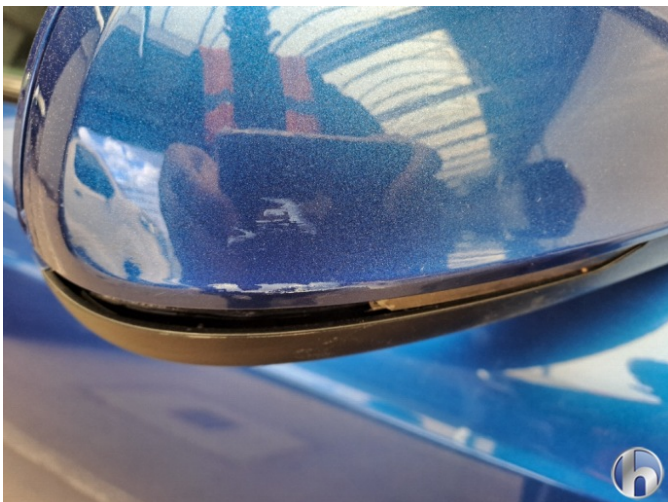
| component | Damage | Rep kind |
|---|---|---|
| 24. Spiegelkappe rechts | Scratch(es) | Smart repair |

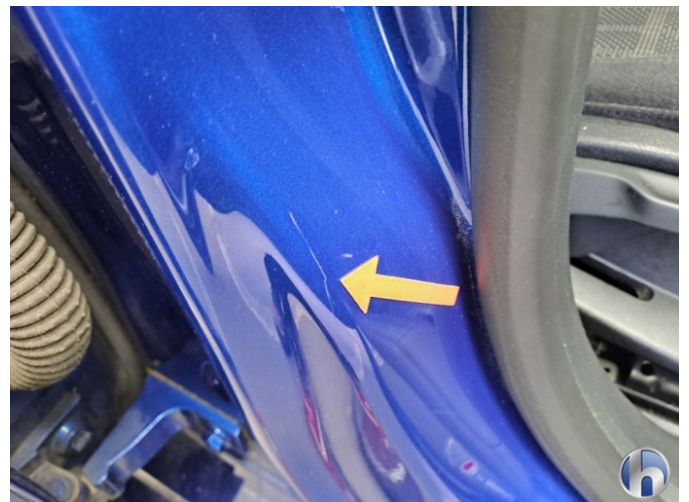
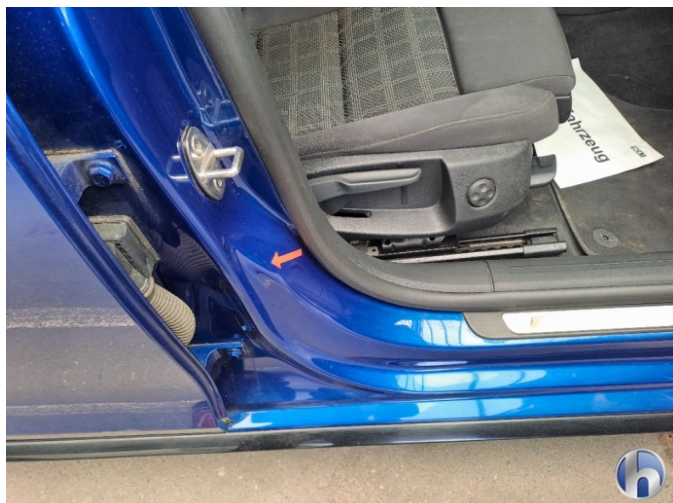
| component | Damage | Rep kind |
|---|---|---|
| 26. Türeinstieg Vorne rechts | Scratch(es) | Smart repair |

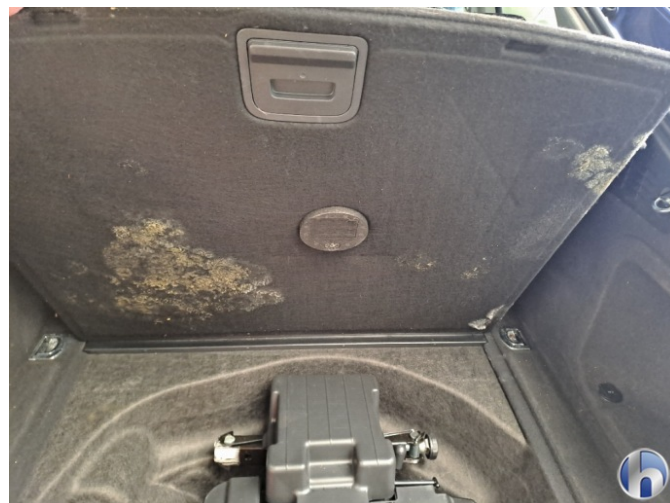
| component | Damage | Rep kind |
|---|---|---|
| 27. Innenraum | Formation of mould | |

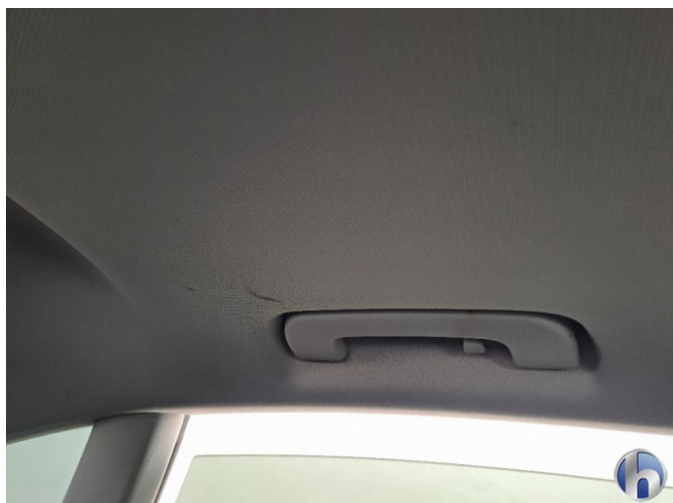
| component | Damage | Rep kind |
|---|---|---|
| 28. Dachhimmel | Dirty | |

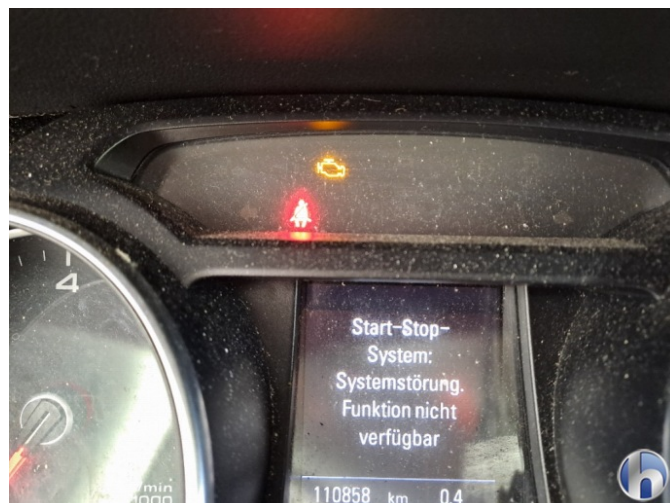
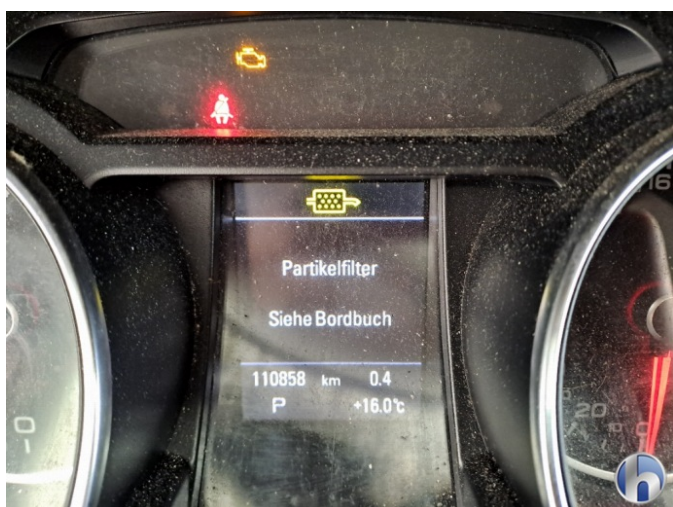
| component | Damage | Rep kind |
|---|---|---|
| 29. Motor | Error message | Carry out a fault diagnosis |
