## status report

#### Audi A5 Coupe 2.7 TDI

| Vehicle identification number | <b>WAUZZZ8T98A027197</b> | mileage read: | <b>189234 km</b> |
| First Registration / construction year: | <b>25.01.2008 / 2007</b> | Visit Date / place of birth: | <b>05.06.2025 Neuss</b> |

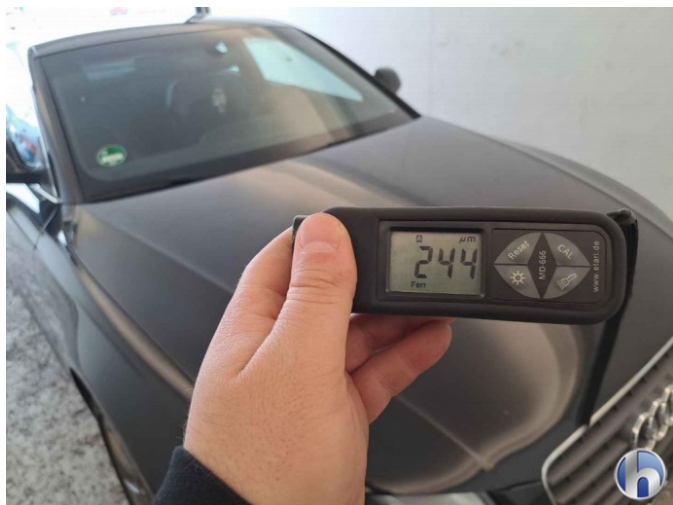
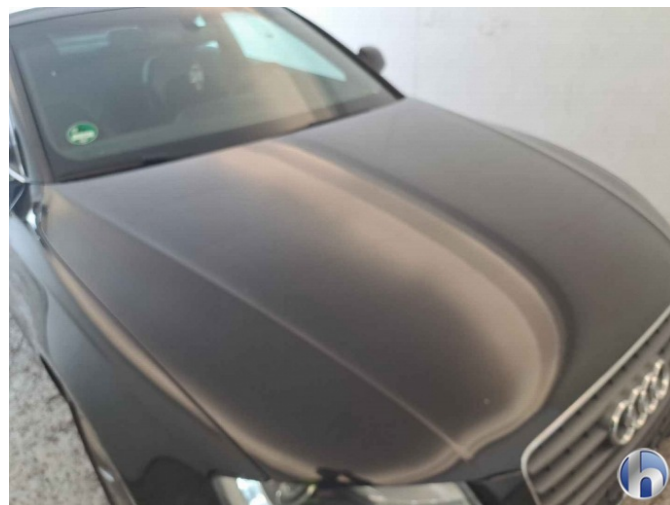
| component | Damage | Rep kind |
|---|---|---|
| 1. hood | Subsequently painted | acceptable |

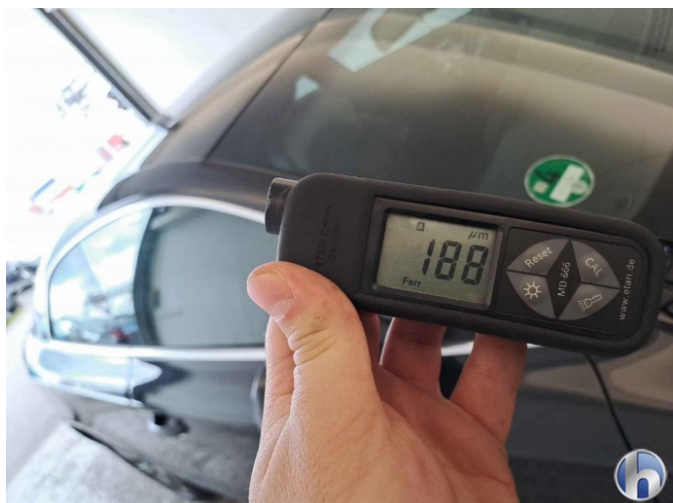
| component | Damage | Rep kind |
|---|---|---|
| 2. A-pillar Front - right | Subsequently painted | acceptable |

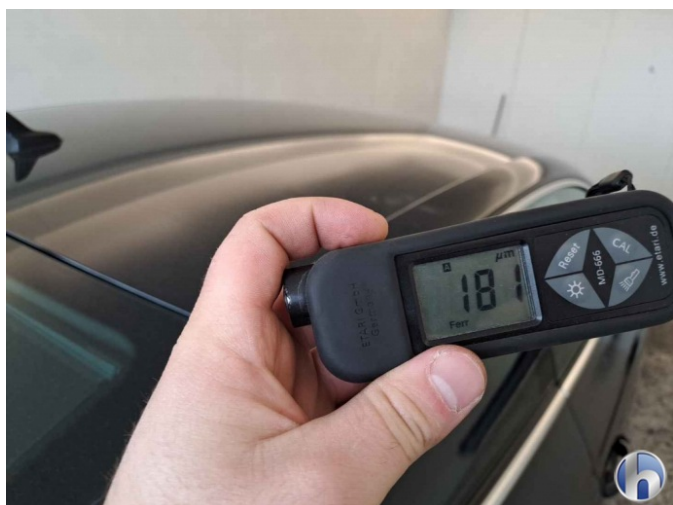
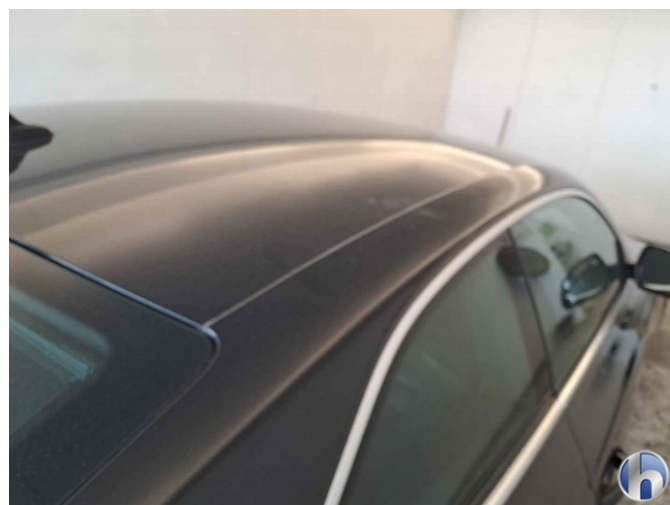
| component | Damage | Rep kind |
|---|---|---|
| 3. Roof frame - right | Subsequently painted | acceptable |

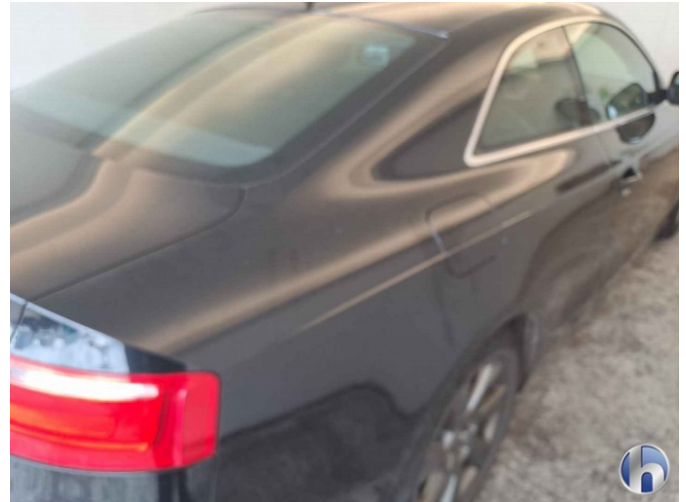
| component | Damage | Rep kind |
|---|---|---|
| 4. Sidewall - Rear - right | Subsequently painted | acceptable |

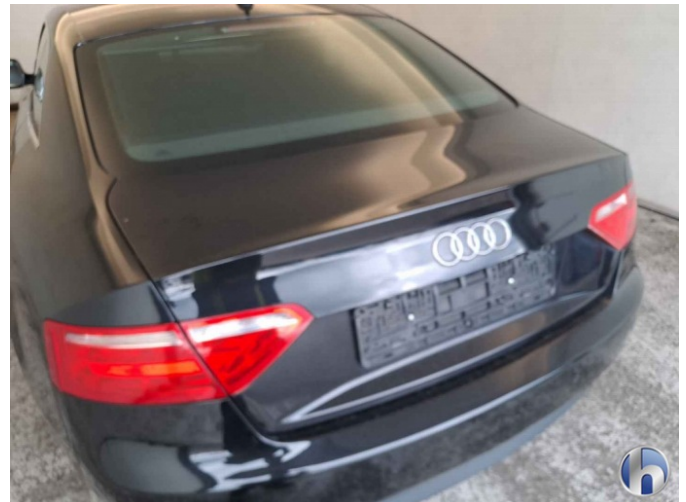
| component | Damage | Rep kind |
|---|---|---|
| 5. tailgate | Subsequently painted | acceptable |

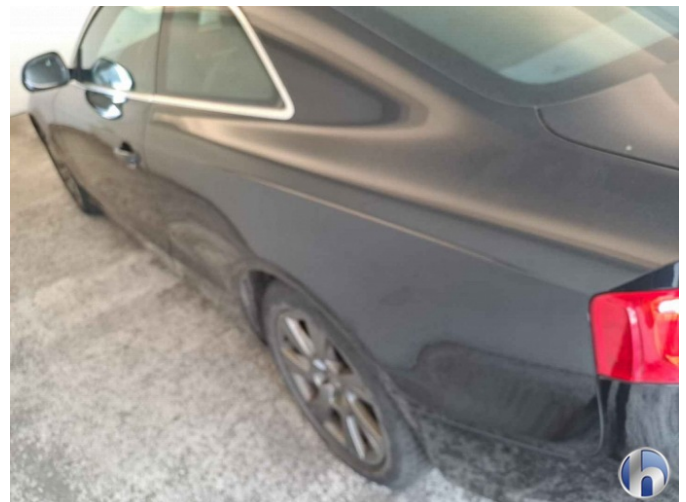
| component | Damage | Rep kind |
|---|---|---|
| 6. Sidewall - Rear - Left | Subsequently painted | acceptable |

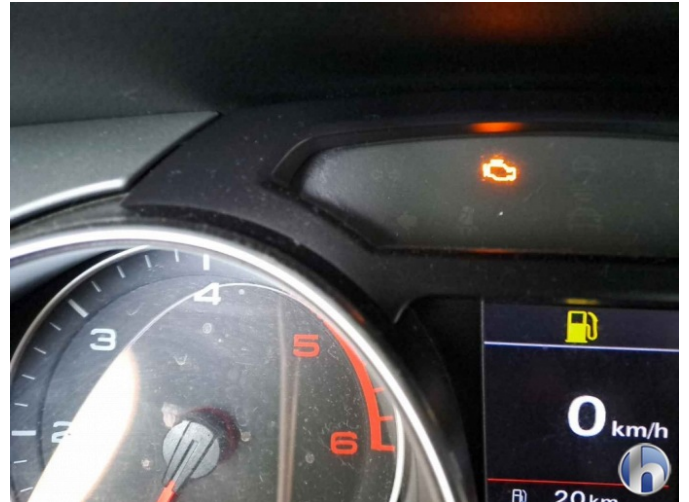
| component | Damage | Rep kind |
|---|---|---|
| 10. Malfunction Indicator Lamp | Error message | Carry out a fault diagnosis |

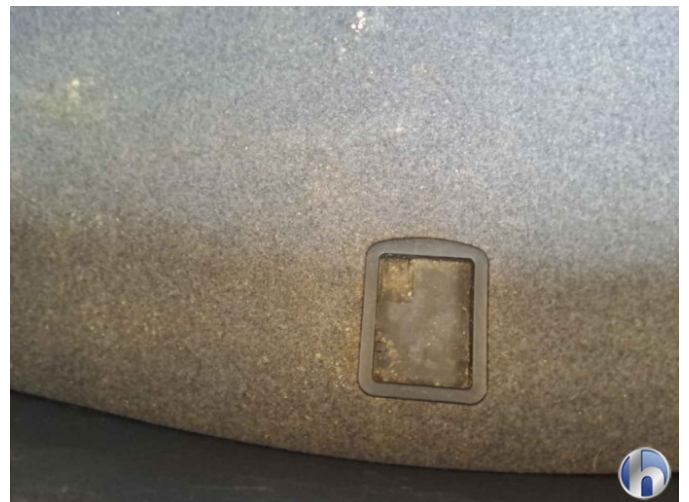
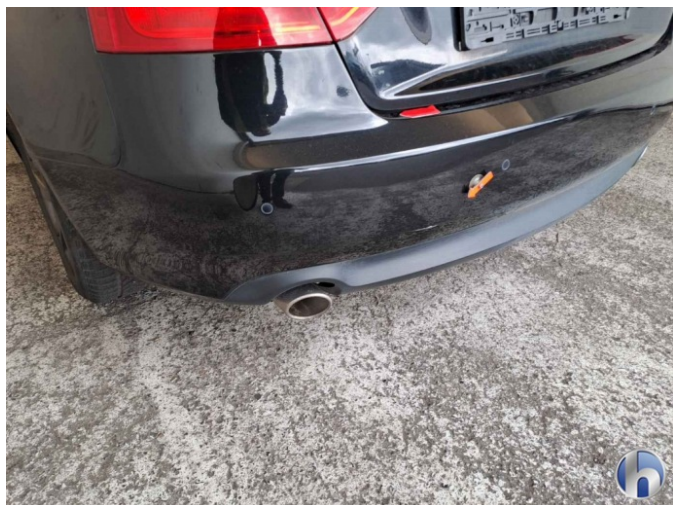
| component | Damage | Rep kind |
|---|---|---|
| 13. Trunk Flooring | Damaged | Replace |

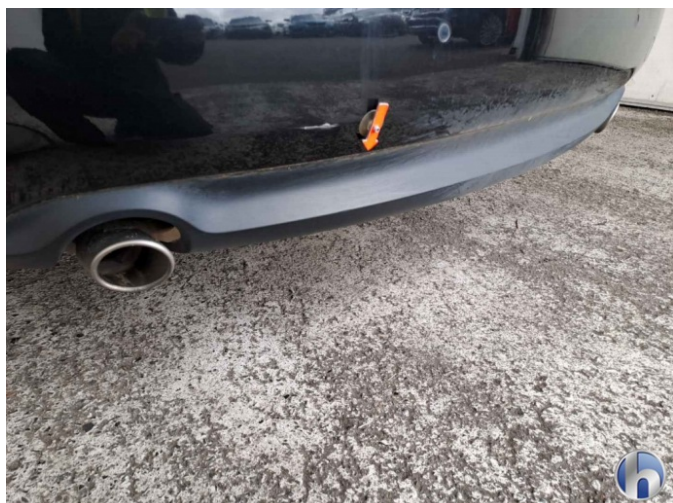
| component | Damage | Rep kind |
|---|---|---|
| 14. Rear bumper | Damaged | Replace |

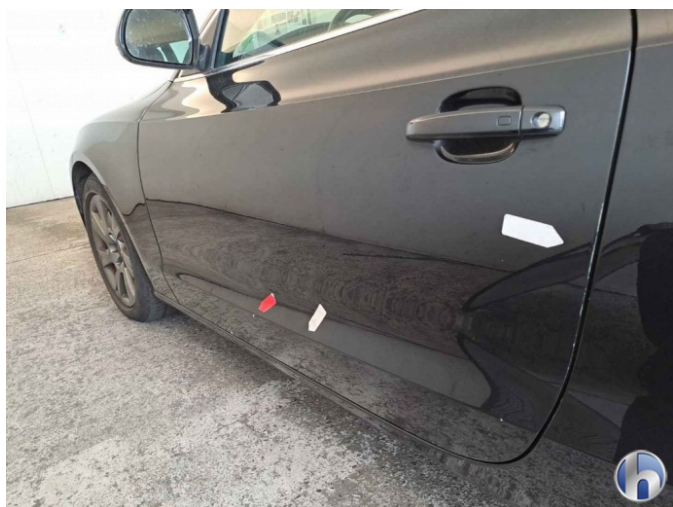
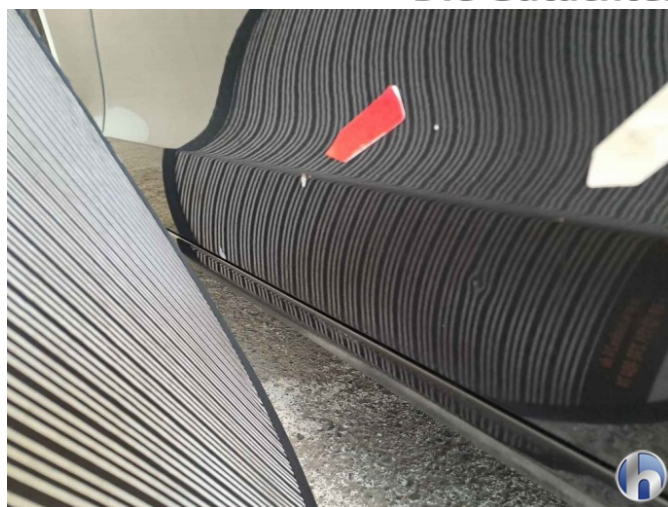
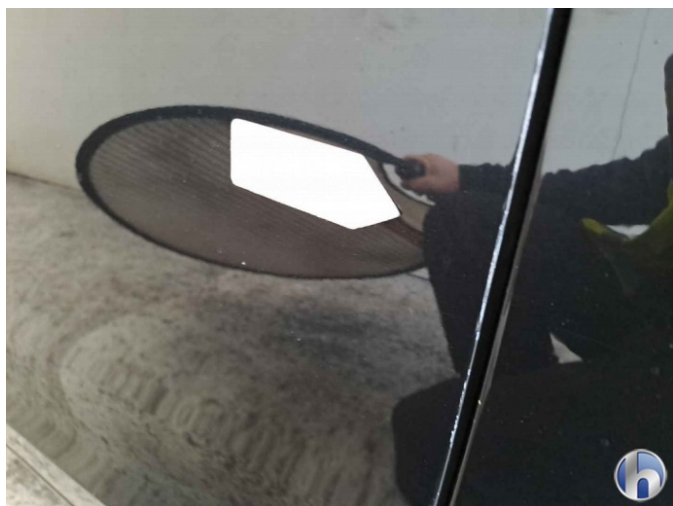
| component | Damage | Rep kind |
|---|---|---|
| 19. Front door - left | Damaged | Refurbish and paint |

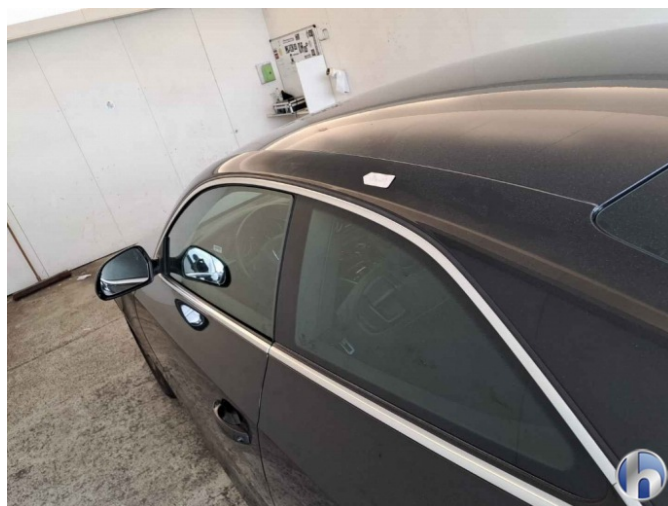
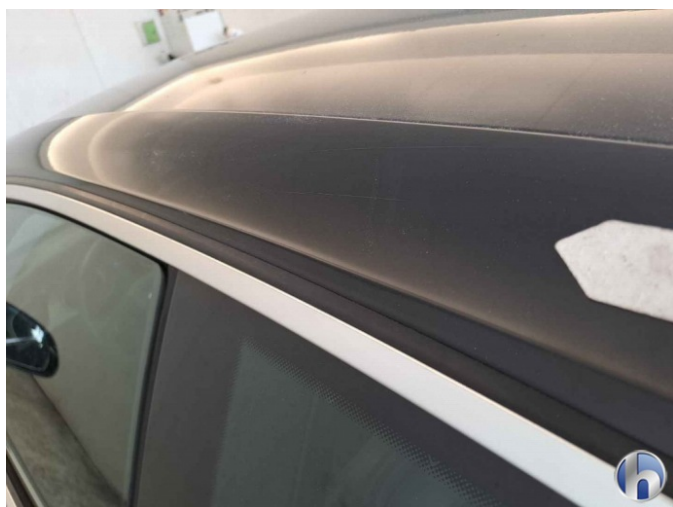
| component | Damage | Rep kind |
|---|---|---|
| 20. Roof frame - left | Scratch(es) | Paint |

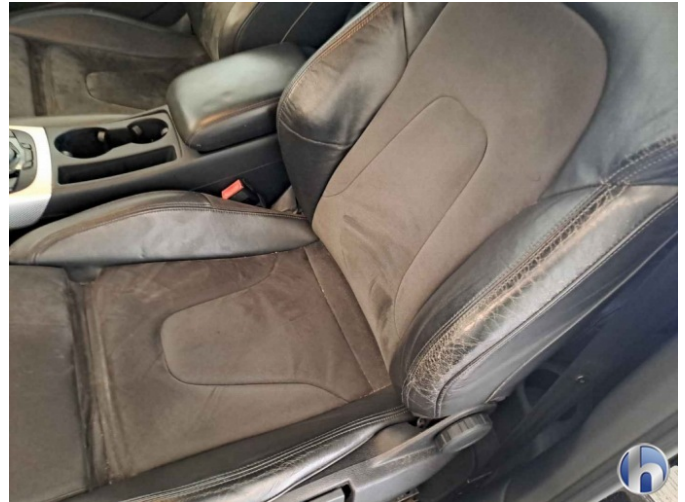
| component | Damage | Rep kind |
|---|---|---|
| 21. Sitz - Vorne - Links: Kissen (Leder-Alcantara) | Damaged | Replace |

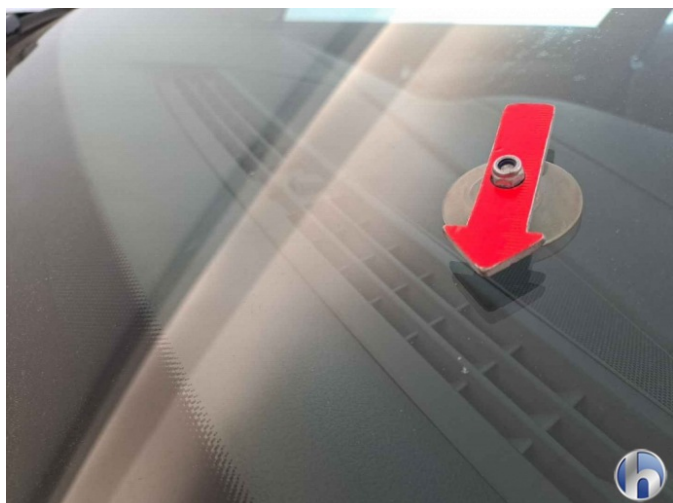
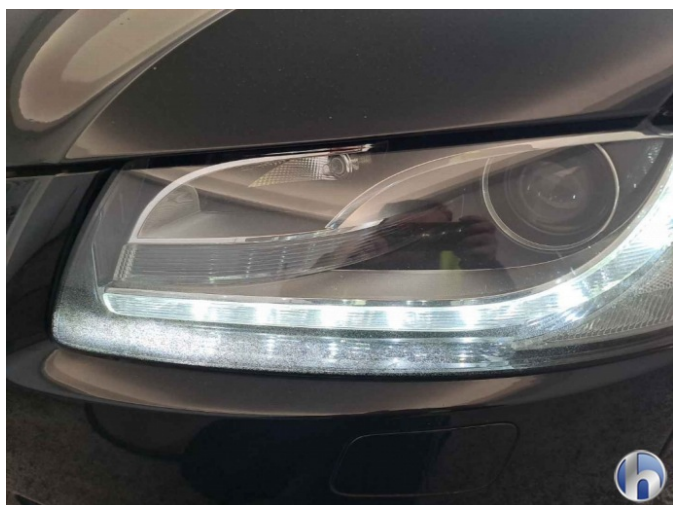
| component | Damage | Rep kind |
|---|---|---|
| 25. Windshield | Chipping from stones in field of view | Replace |

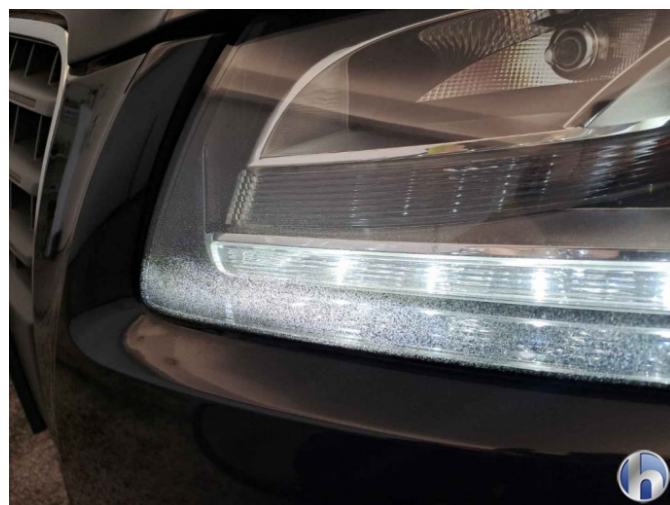
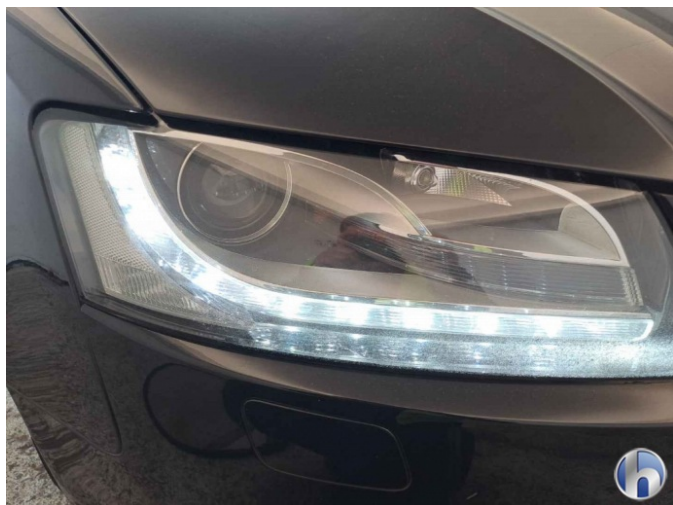
| component | Damage | Rep kind |
|---|---|---|
| 26. Scheinwerfer - Links | Damaged | Replace |

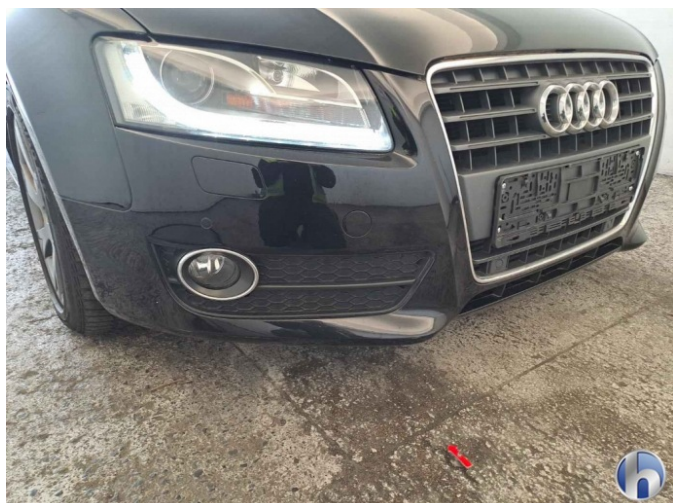
| component | Damage | Rep kind |
|---|---|---|
| 27. Scheinwerfer - Rechts | Damaged | Replace |

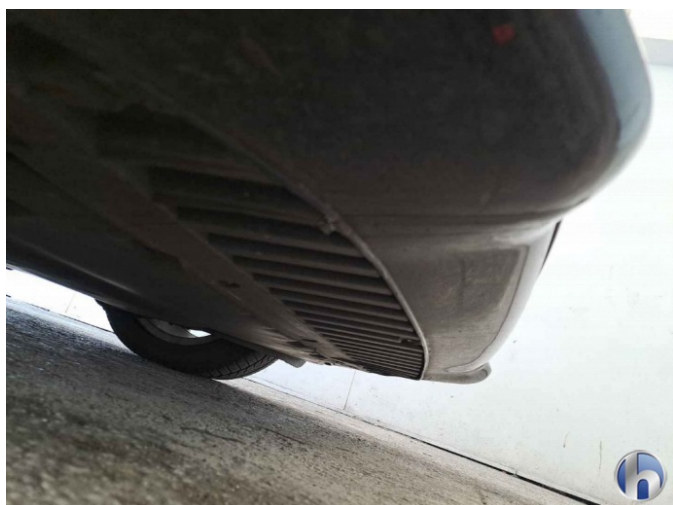
| component | Damage | Rep kind |
|---|---|---|
| 28. Front bumper | Damaged | Replace |

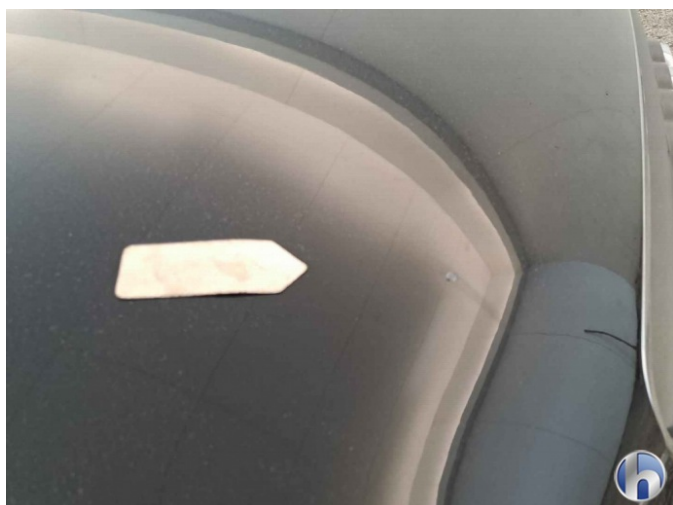
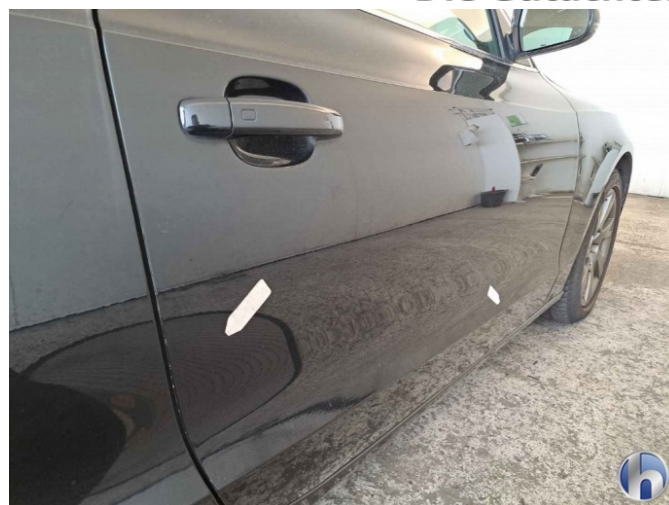
| component | Damage | Rep kind |
|---|---|---|
| 29. hood | chipped paint | Paint |

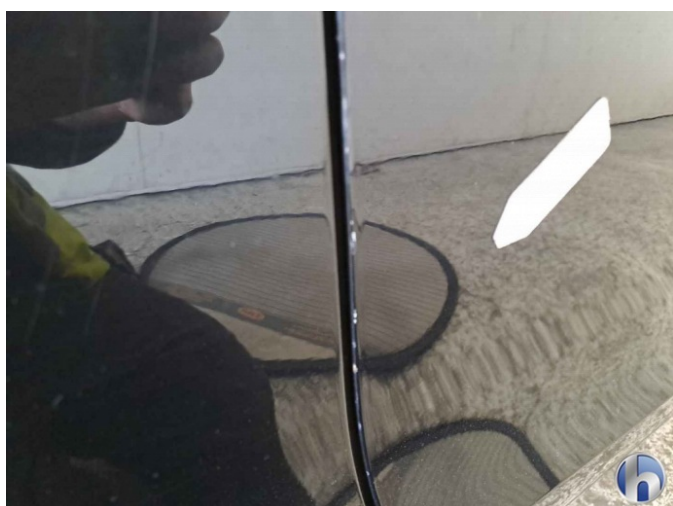
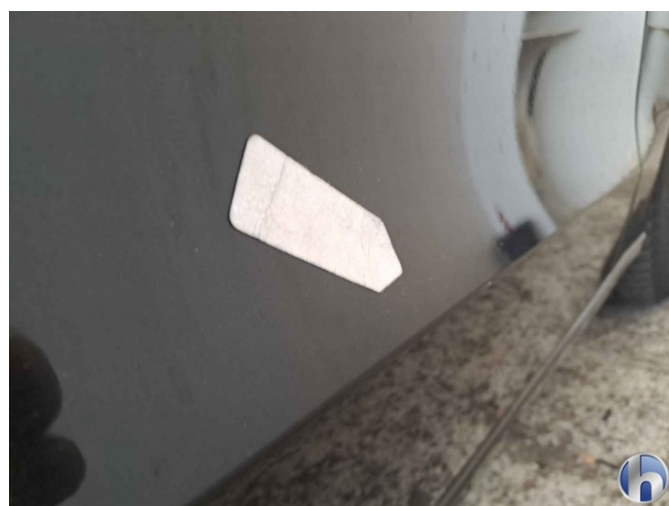
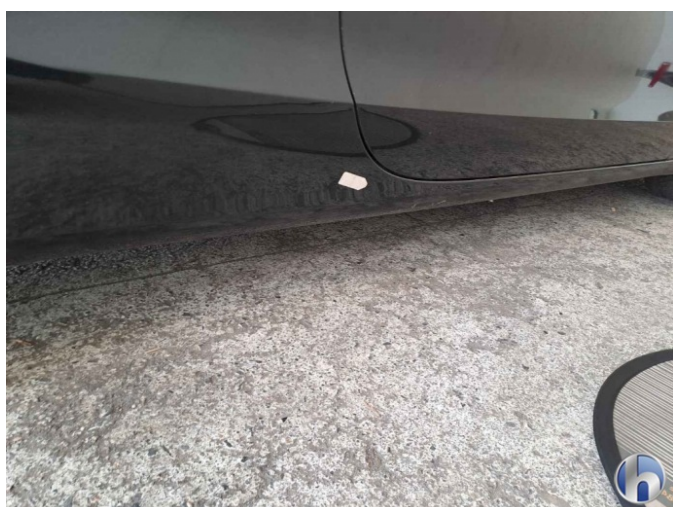
| component | Damage | Rep kind |
|---|---|---|
| 30. Front door - right | Scratch(es) | Paint |

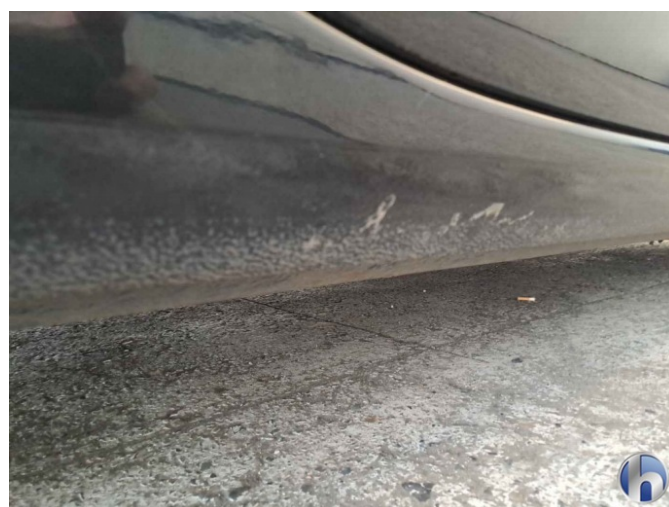
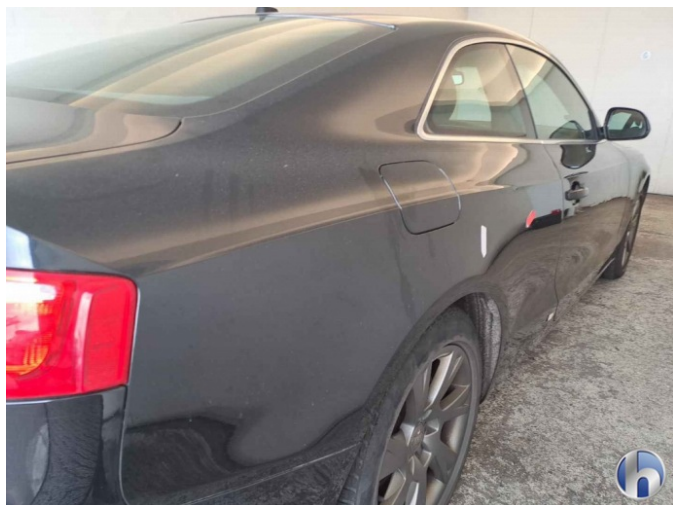
| component | Damage | Rep kind |
|---|---|---|
| 31. side skirt - left | Damaged | Paint |

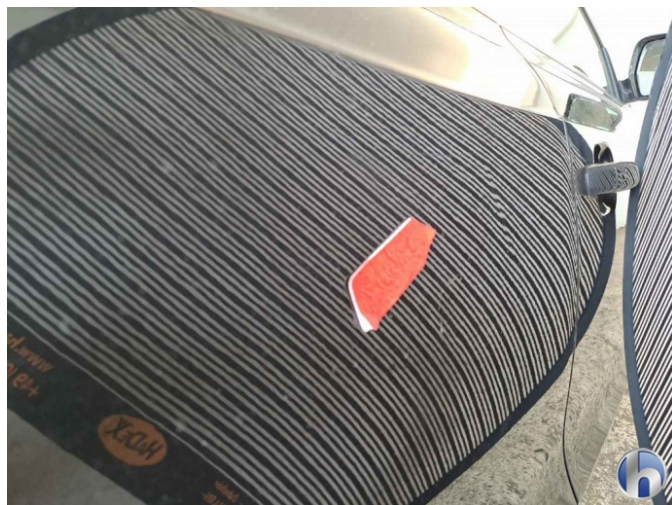
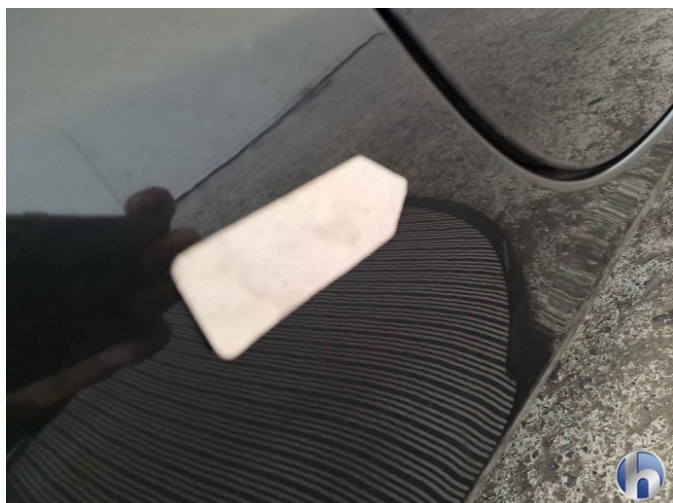
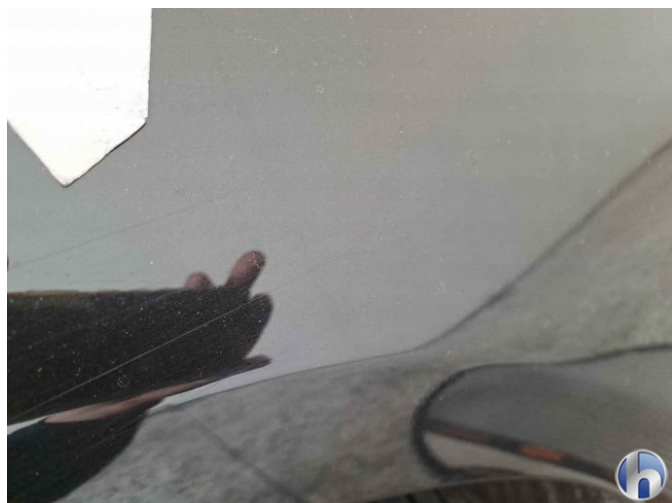
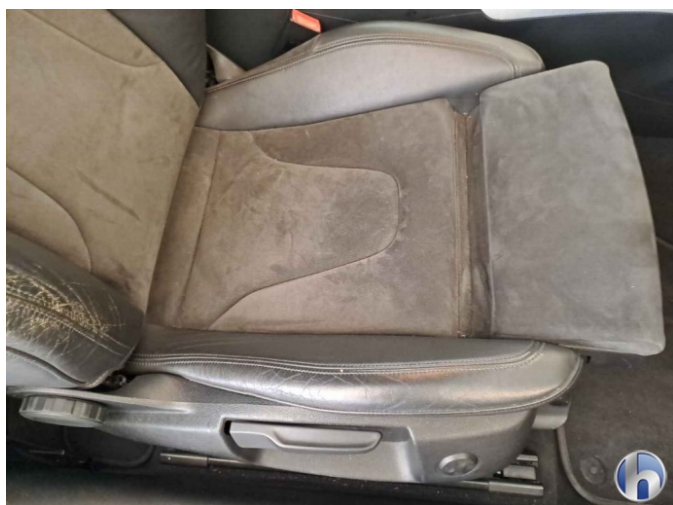
| component | Damage | Rep kind |
|---|---|---|
| 32. Sidewall - Rear - right | Damaged | Refurbish and paint |

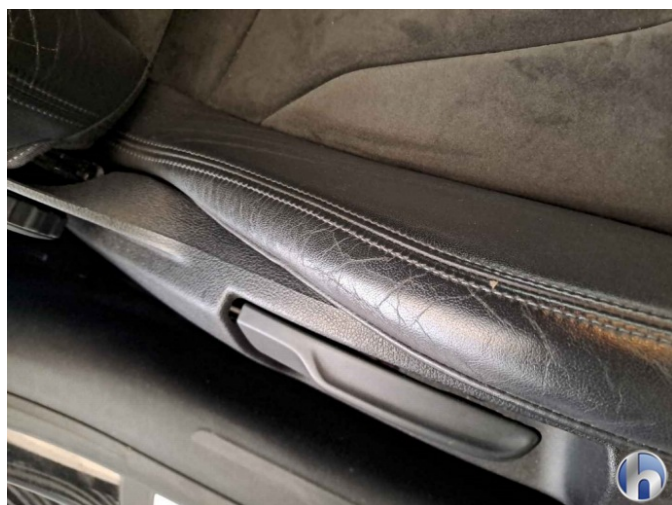
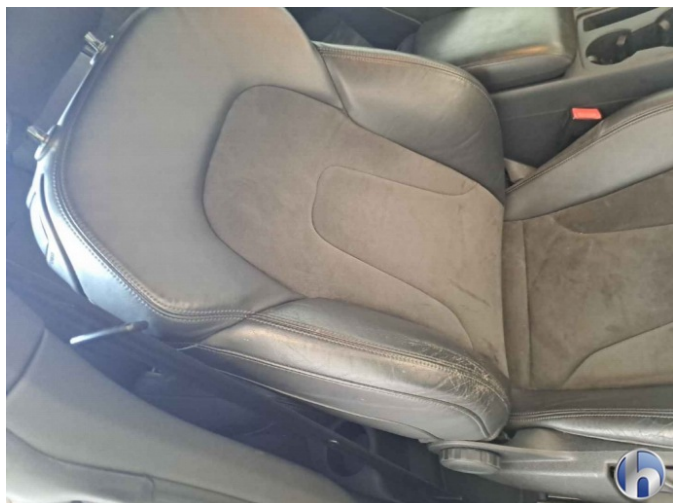
| component | Damage | Rep kind |
|---|---|---|
| 33. Sitz - Vorne - Rechts: Kissen (Leder-Alcantara) | Damaged | Replace |

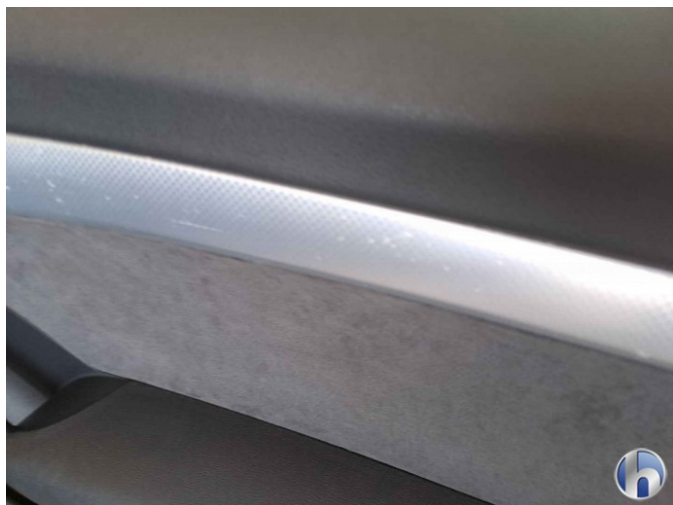
39. Trim Front - right

| 39. | Trim Front - right | Scratch(es) | Replace |

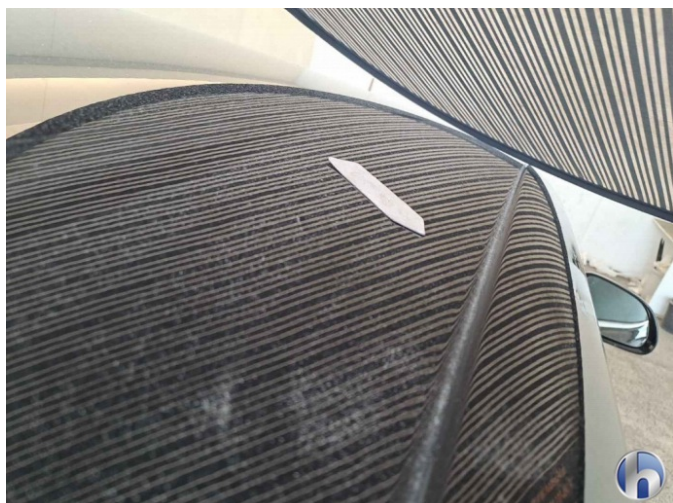
40. roof

| 40. | roof | Deformed | Refurbish and paint |

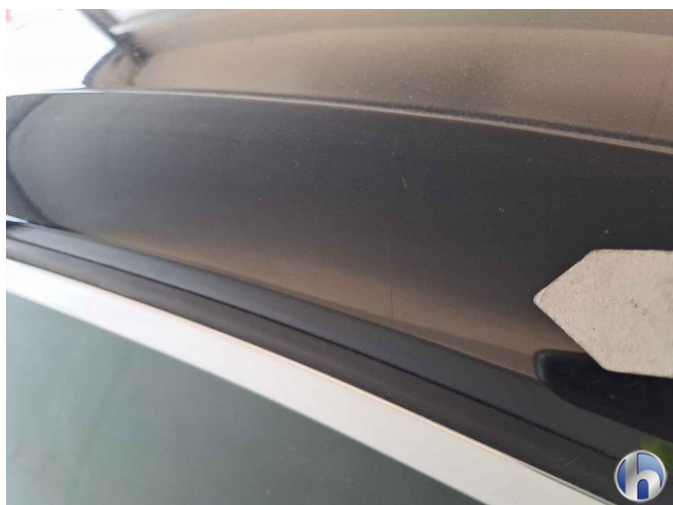
41. Roof frame - right

| 41. | Roof frame - right | Damaged | Refurbish and paint |

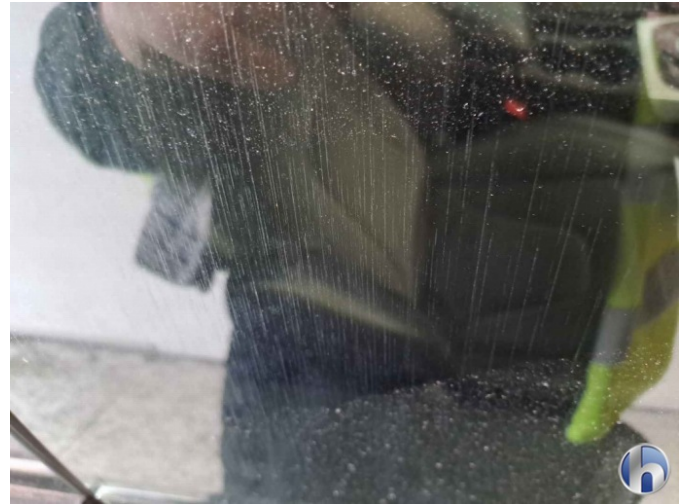
42. Side window - Rear - right

| 42. | Side window - Rear - right | Scratch(es) | Replace |

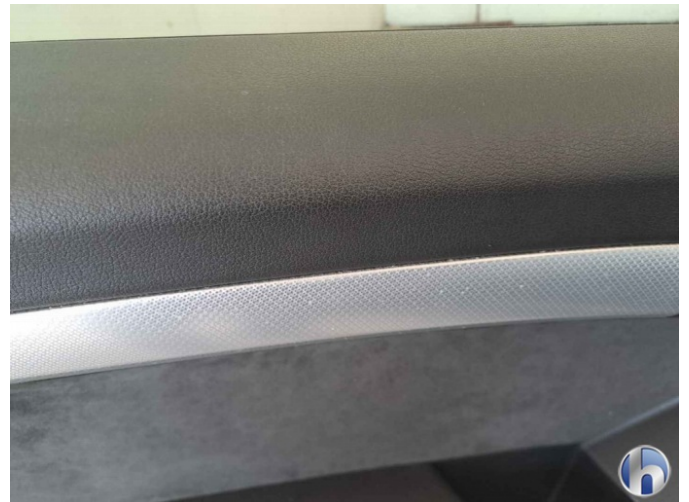
43. Trim Front - Left

| 43. | Trim Front - Left | Scratch(es) | Replace |

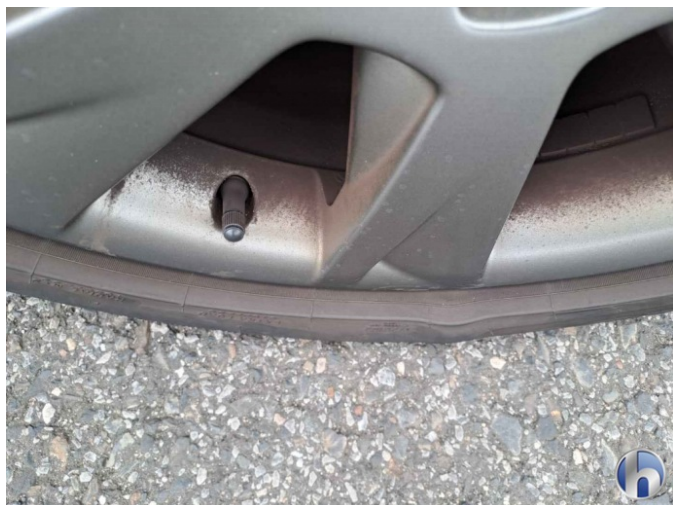
48. tire front - right

| General examination | |
|---|---|
| <b>Note Road Safe:</b> | Reifen beschädigt. |

| 48. | tire front - right | Damaged | Replace |
