AUDI A3

A3 1.4 TFSI Limousine

Inspection Report Summary

Customer	BCA Online	Report Number	P20251001095833
Inspection Date / Place	2025-10-01 / BCA Neuss	Cosmetic Grade	4

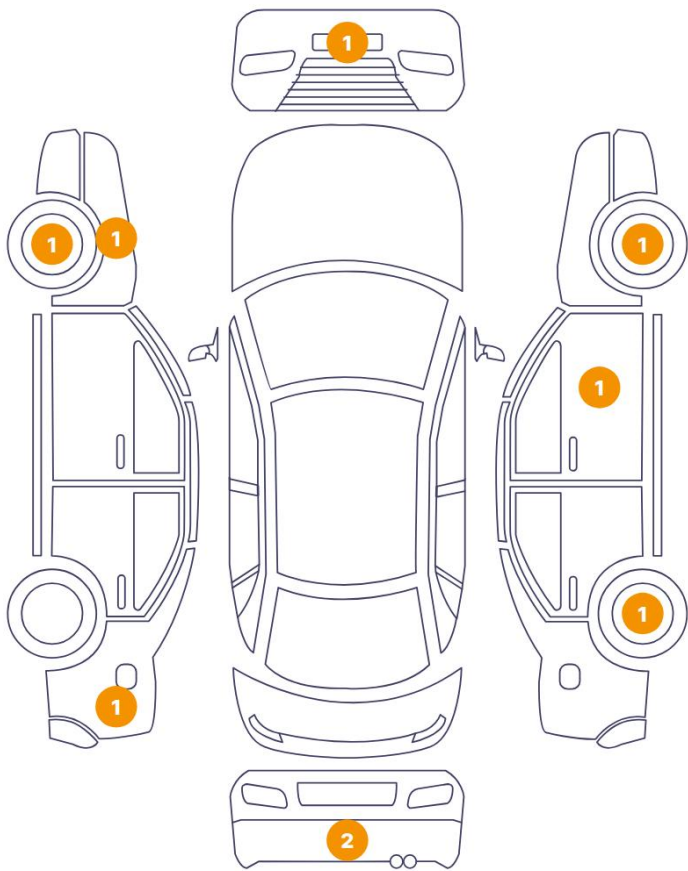
9 Schäden

Component		Damage	Comments
1	Fender / Front Left	Paint / Poor Previous Repair	
2	Rim / Front Left	Out of Bodywork / Scratch	
3	Fender / Back Left	Bodywork / Dent / Dent	
4	Bumper / Back	Paint / Scratch / Scuff	
5	Bumper / Back	Paint / Scratch / Scuff	
6	Rim / Back Right	Out of Bodywork / Scratch	
7	Door / Front Right	Bodywork / Dent / Dent	
8	Rim / Front Right	Out of Bodywork / Scratch	
9	Bumper / Front	Bodywork / Breakage / Crack

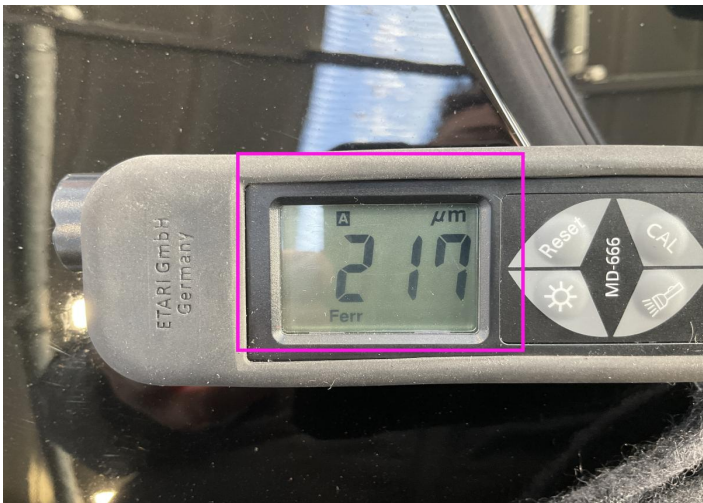
1. Fender / Front Left
Paint / Poor Previous Repair -

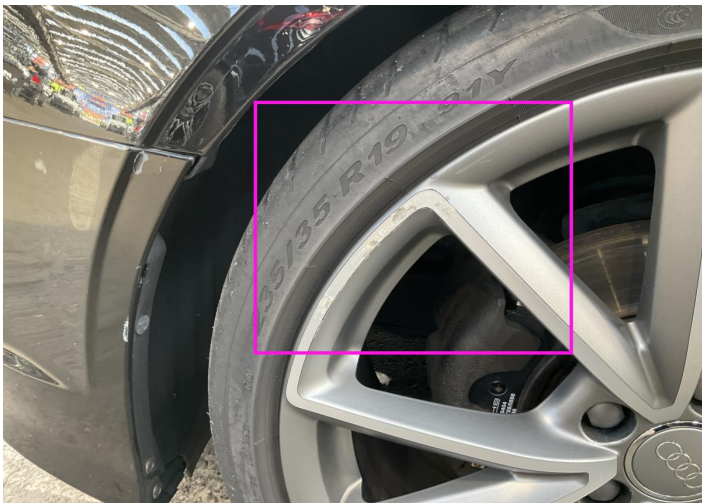
2. Rim / Front Left
Out of Bodywork / Scratch -

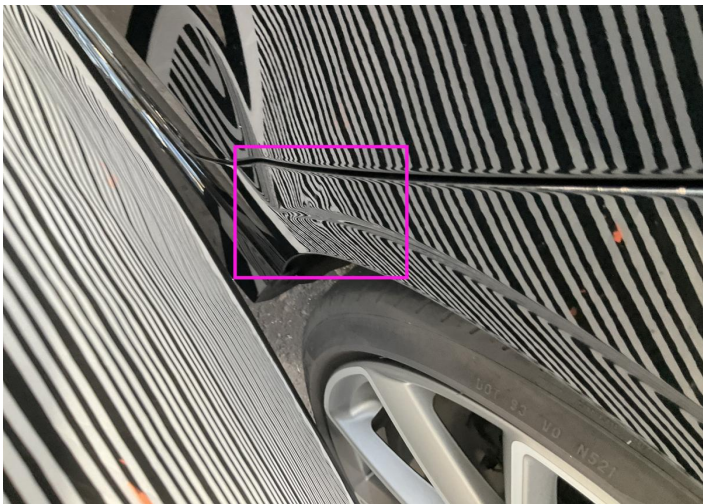
3. Fender / Back Left
Bodywork / Dent / Dent -

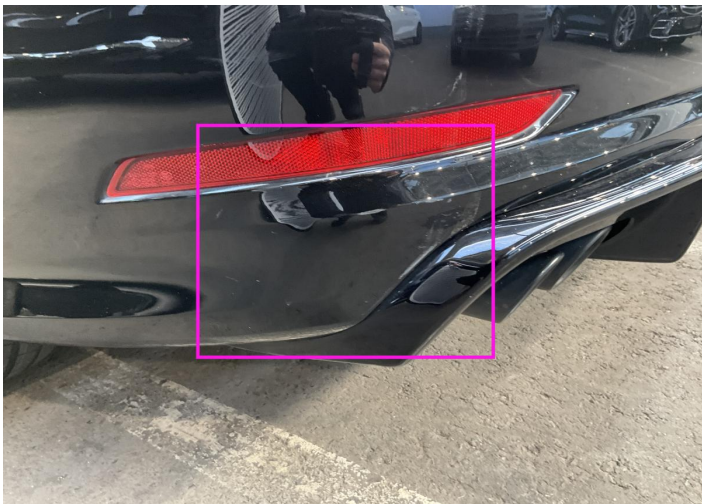
4. Bumper / Back
Paint / Scratch / Scuff -

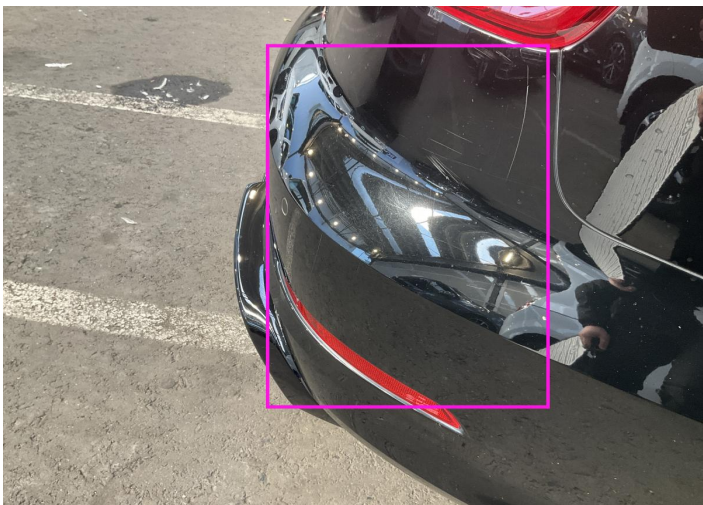
5. Bumper / Back
Paint / Scratch / Scuff -

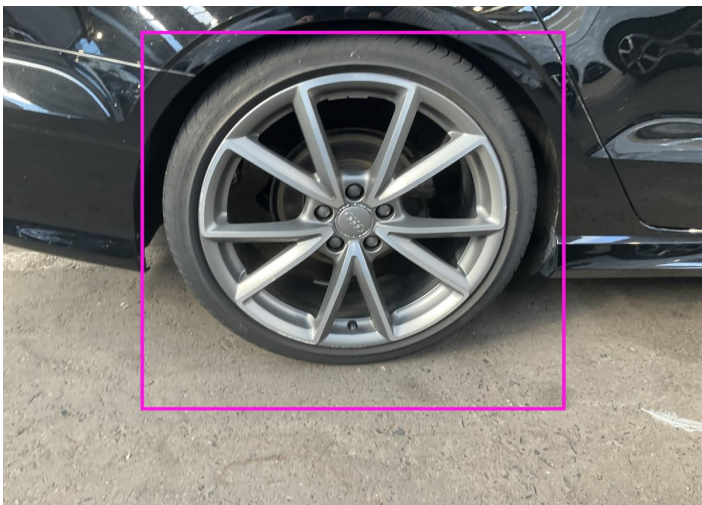
6. Rim / Back Right
Out of Bodywork / Scratch -

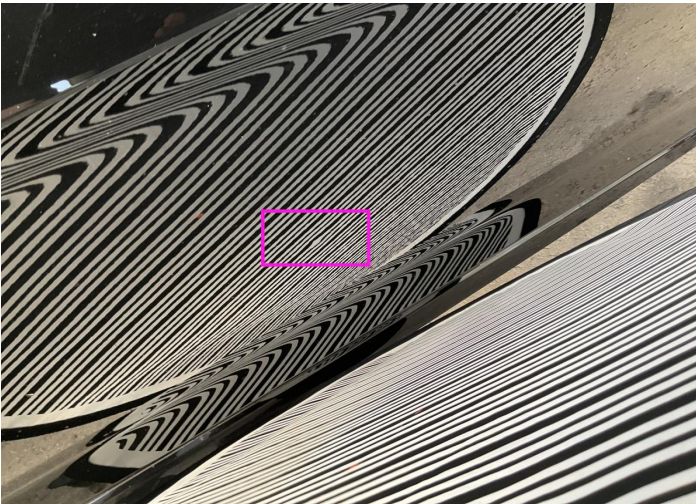
7. Door / Front Right
Bodywork / Dent / Dent -

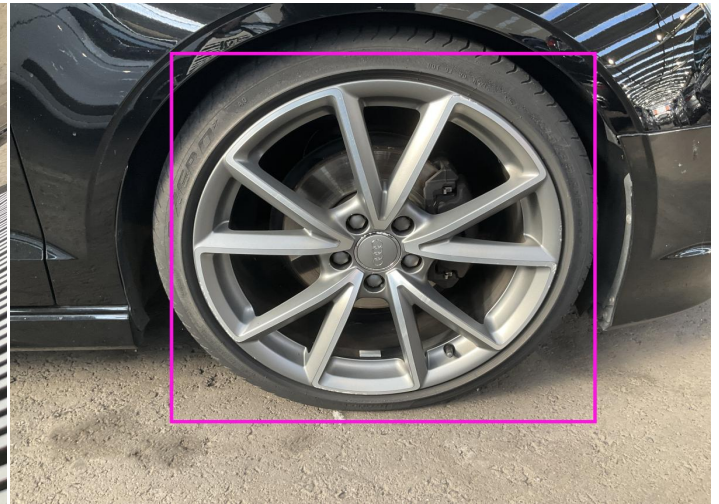
8. Rim / Front Right
Out of Bodywork / Scratch -

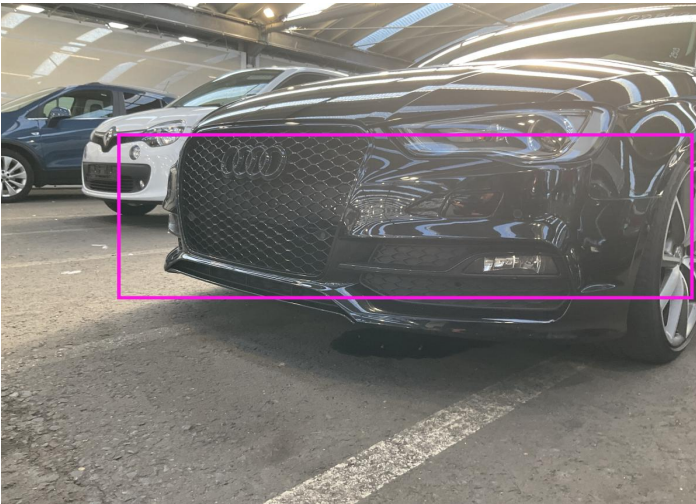
9. Bumper / Front
Bodywork / Breakage / Crack -
