AUDI A6 A6 Avant 50 TFSI e quattro S tronic

VIN NO WAUZZZF25NN019855 Registration Number 25NN019855

Inspection Report Summary

Customer	BCA Online	Report Number	P20250730142001
Inspection Date / Place	2025-07-30 / BCA Oberndorf	Cosmetic Grade	2

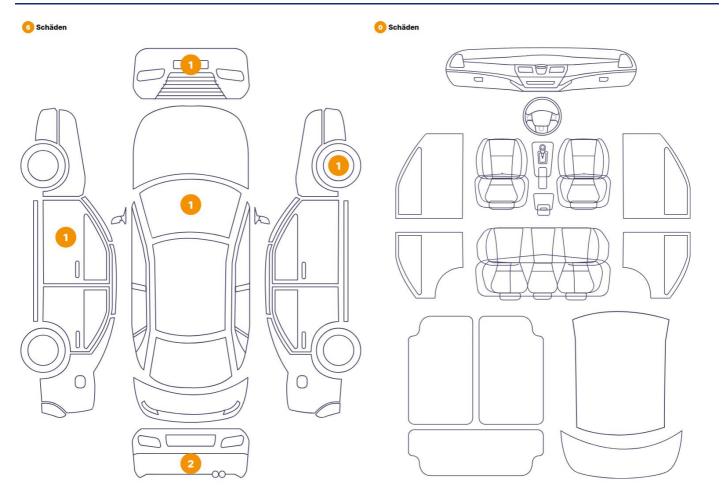
Component	Damage	Comments
1	Windshield / Front	Glass Break / Impact	
2	Bumper / Front	Paint / Scratch / Scuff	
3	Mirror / Front Left	Paint / Scratch / Line	
4	Bumper / Back	Paint / Scratch / Scuff	
5	Corner Bumper / Back Right	Paint / Scratch / Line	
6	Rim / Front Right	Paint / Stone Chip

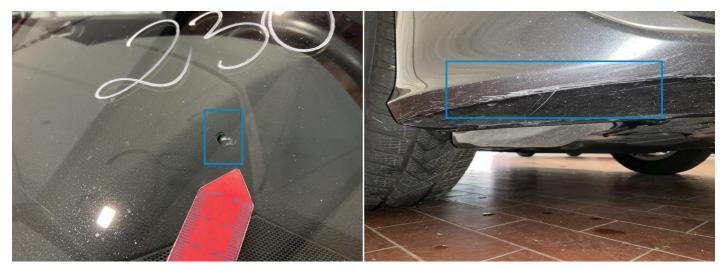
1. Windshield / Front Glass Break / Impact -

2. Bumper / Front Paint / Scratch / Scuff -

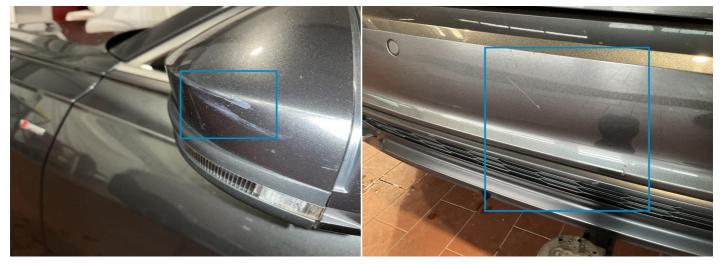
3. Mirror / Front Left Paint / Scratch / Line -

4. Bumper / Back Paint / Scratch / Scuff -

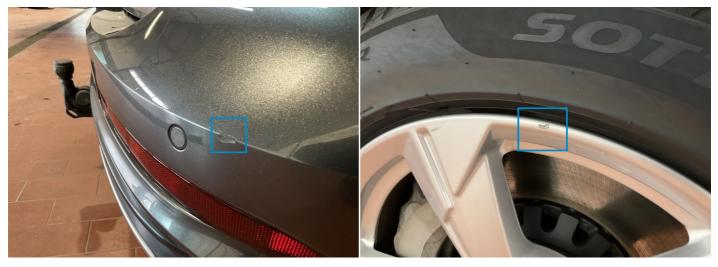
5. Corner Bumper / Back Right Paint / Scratch / Line -

6. Rim / Front Right Paint / Stone Chip -
