AUDI A6  
A6 Avant 50 TDI quattro tiptronic

VIN NO WAUZZZF28NN043079  
Registration Number 28NN043079

Inspection Report Summary

Customer	BCA Online	Report Number	P20250922105720
Inspection Date / Place	2025-09-22 / BCA Neuss	Cosmetic Grade	2

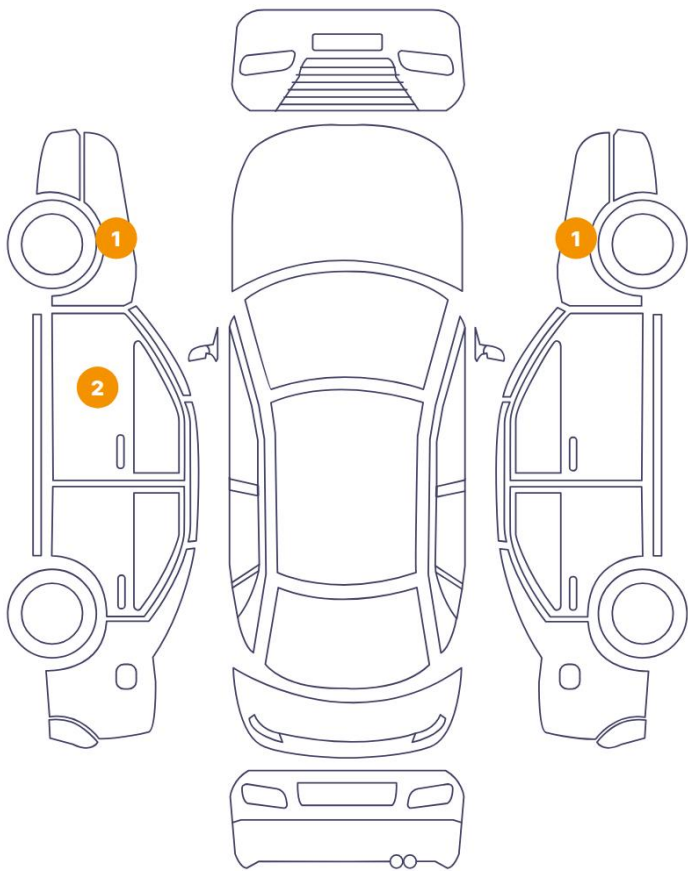
4 Schäden

Component	Damage	Comments
1 Fender / Front Left	Paint / Poor Previous Repair	
2 Fender / Front Right	Paint / Poor Previous Repair	
3 Door / Front Left	Bodywork / Dent / Dent	
4 Door Handle / Front Left	Paint / Scratch / Scuff	
5 Panel Filling / Front Left	Interior / Scratched	
6 Center Console	Interior / Scratched

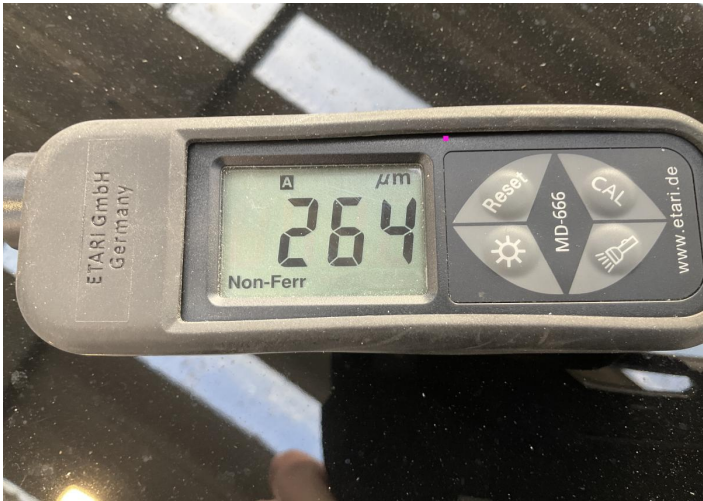
1. Fender / Front Left  
Paint / Poor Previous Repair -

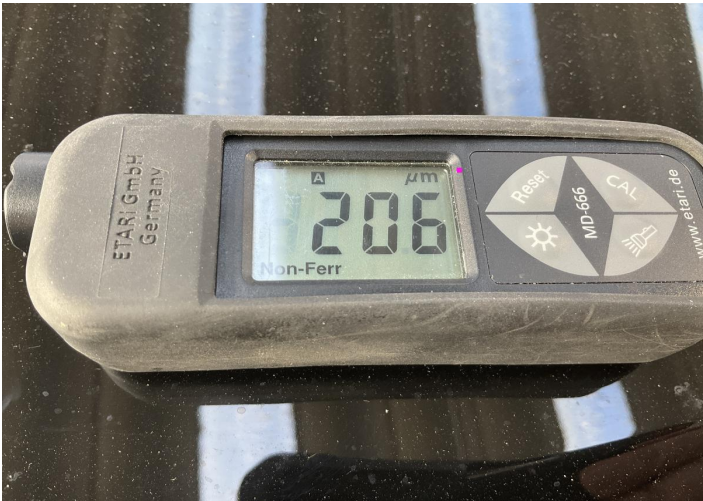
2. Fender / Front Right  
Paint / Poor Previous Repair -

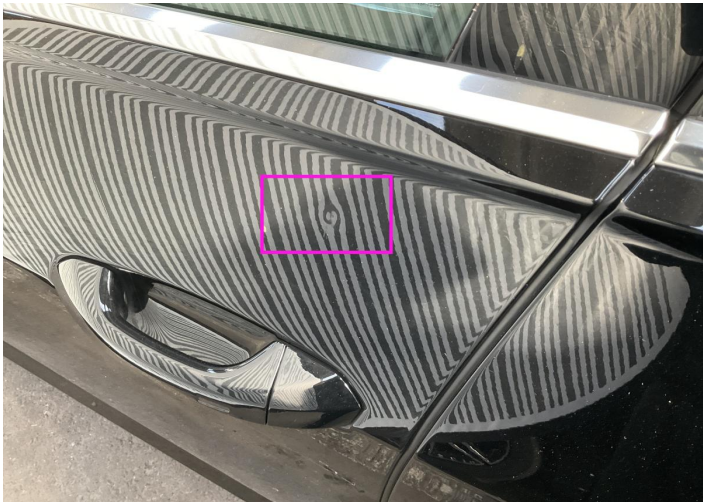
3. Door / Front Left  
Bodywork / Dent / Dent -

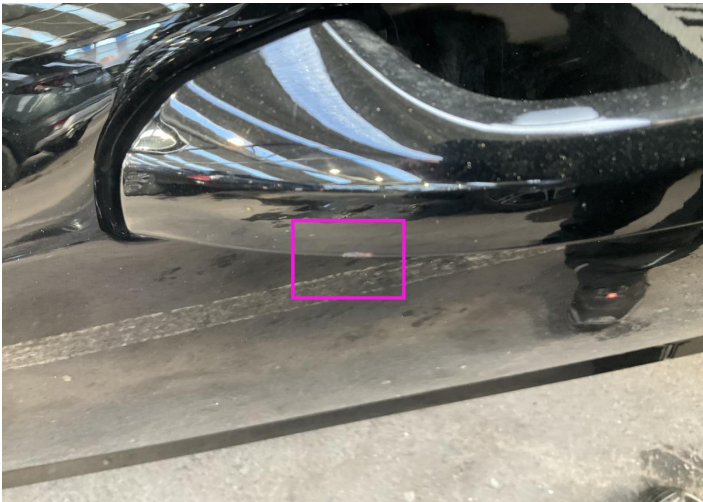
4. Door Handle / Front Left  
Paint / Scratch / Scuff -

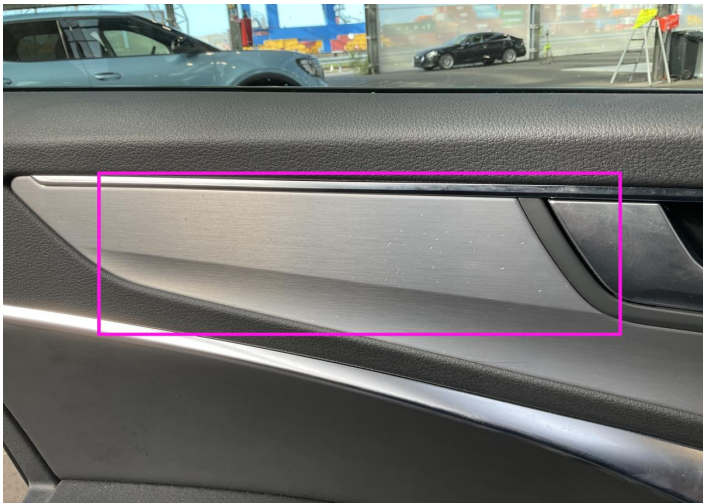
5. Panel Filling / Front Left  
Interior / Scratched -

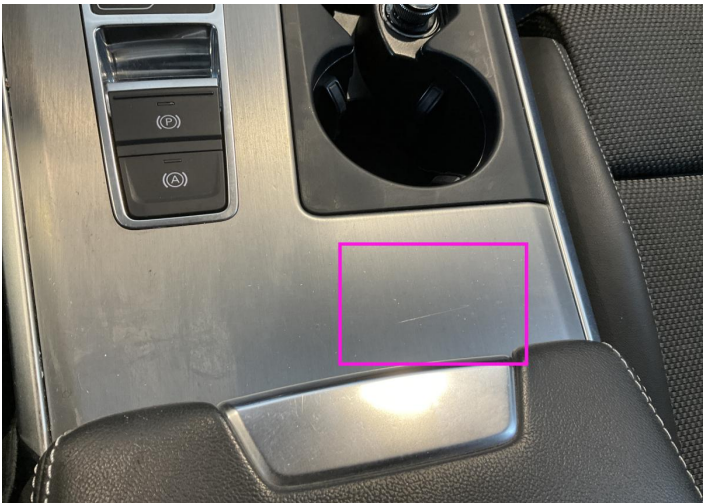
6. Center Console  
Interior / Scratched -
