## status report

**customer:** Bank 11, Neuss  
**contract number:** 902025030  
**reference:**

#### Audi A4 Avant quattro sport

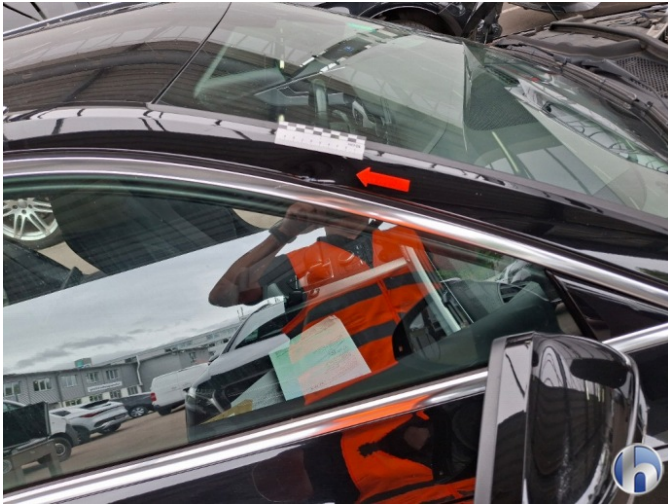
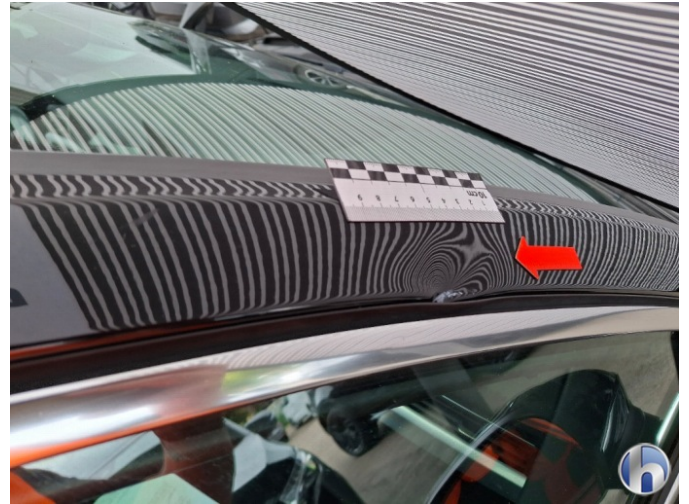
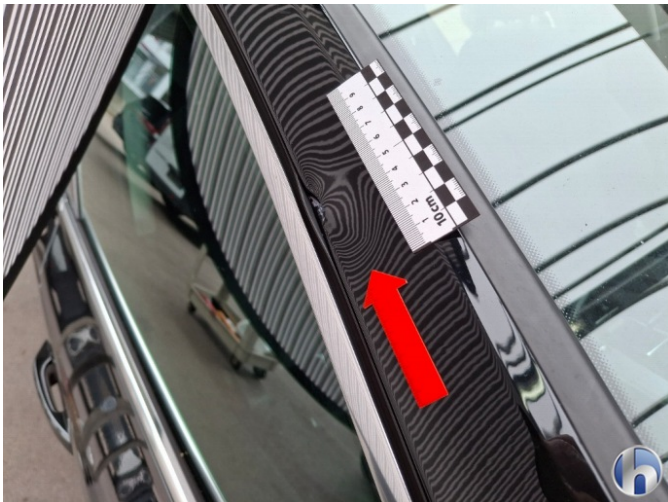
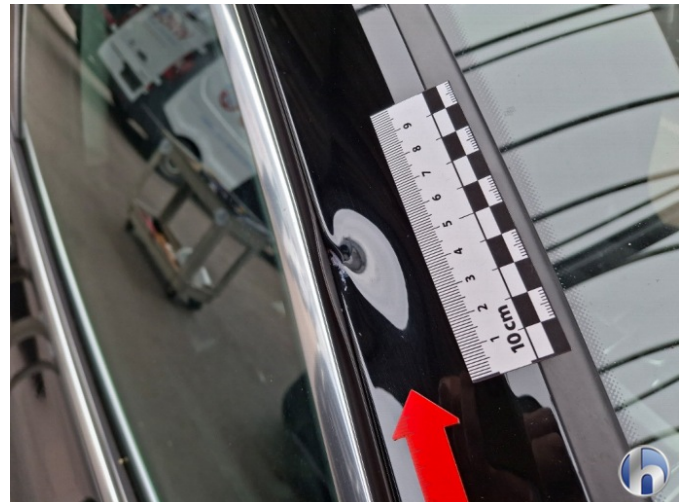
1. A-pillar Front - right

At the unrepaired vehicle accident damage were observed on visual examination on the body skin .

| | component | Damage | Rep kind |
|---|---|---|---|
| 1. | A-pillar Front - right | Accident damage | Refurbish and paint |

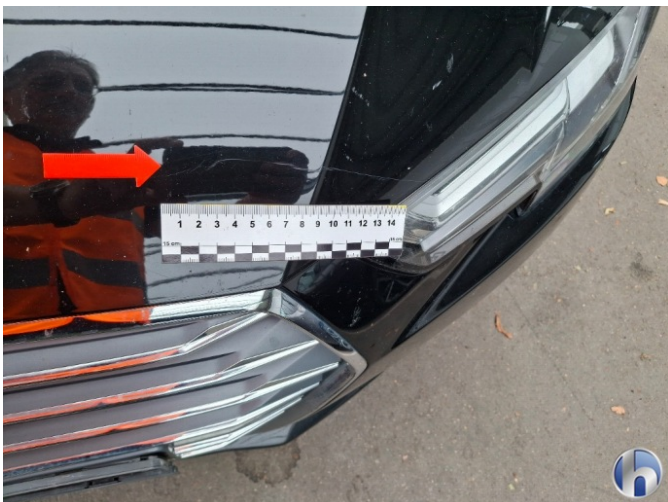
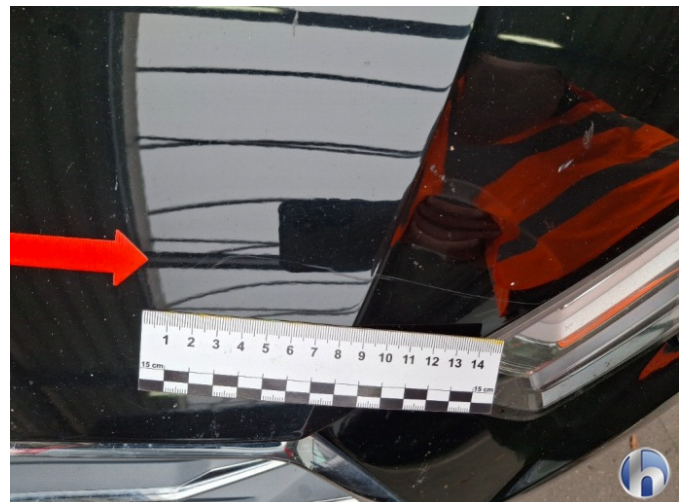
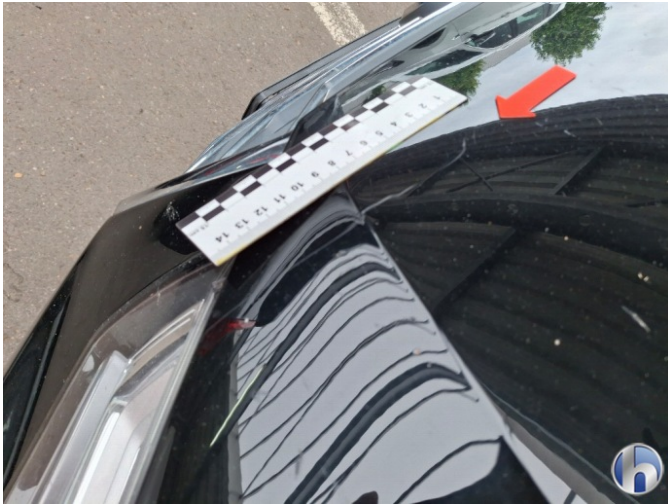
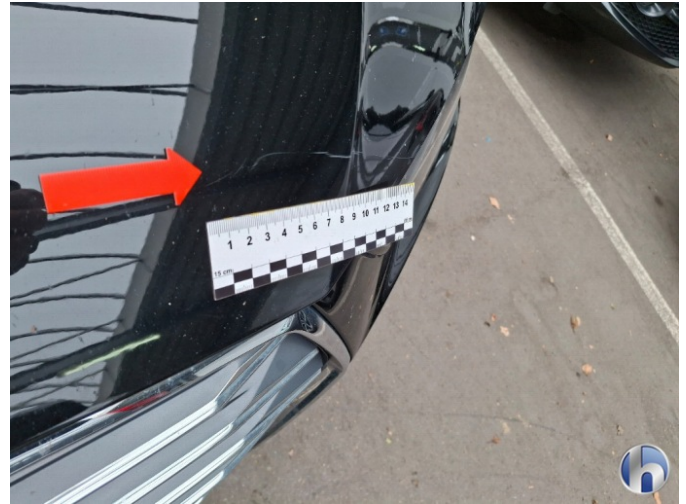
2. hood

| | component | Damage | Rep kind |
|---|---|---|---|
| 2. | hood | Scratch(es) | Paint |

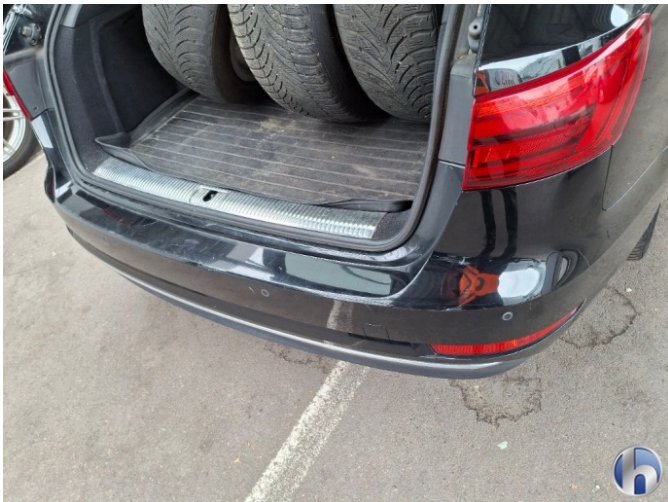
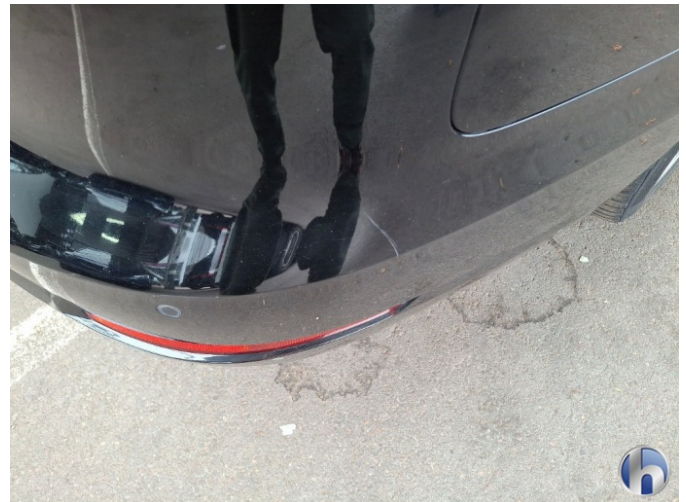
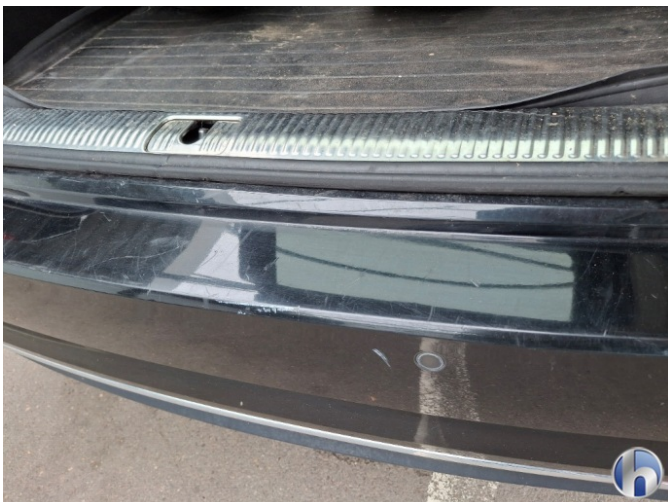
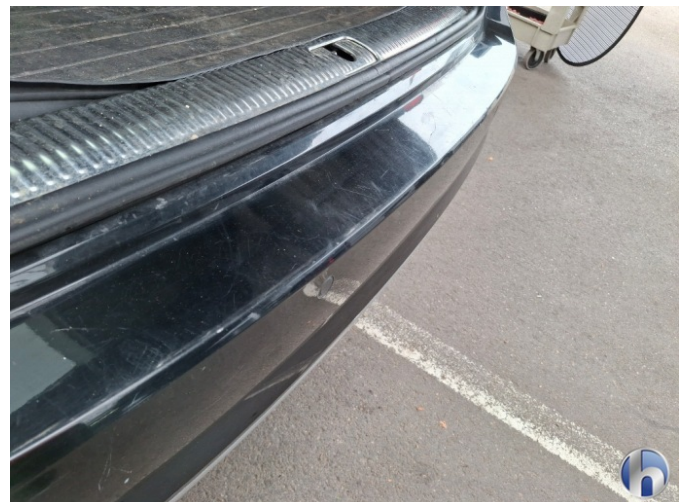
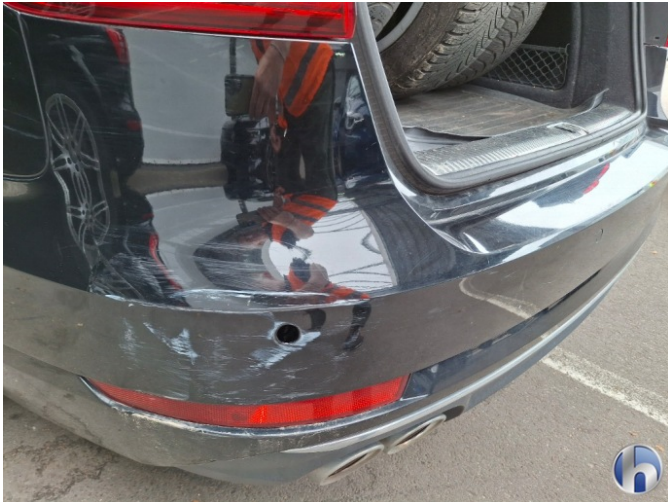
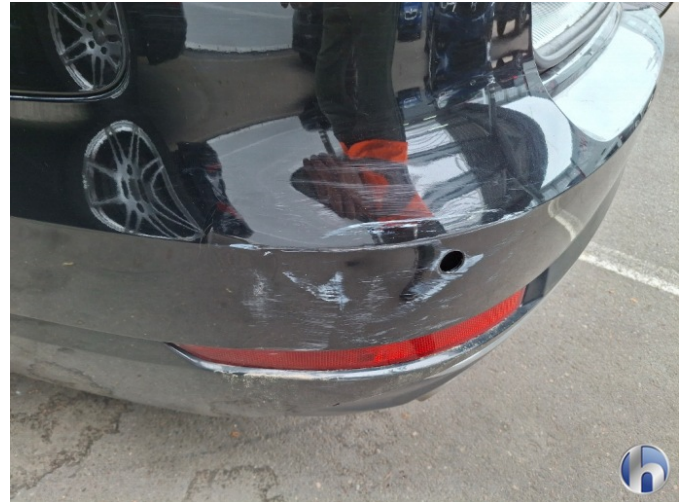
3. Rear bumper

| | component | Damage | Rep kind |
|---|---|---|---|
| 3. | Rear bumper | Scratch(es) | Paint |

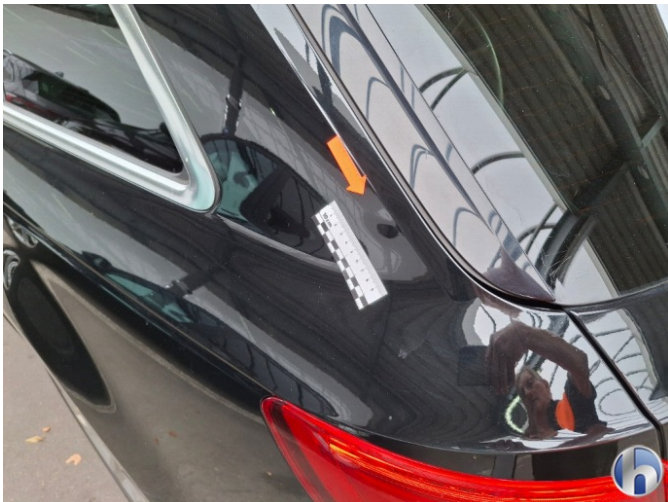
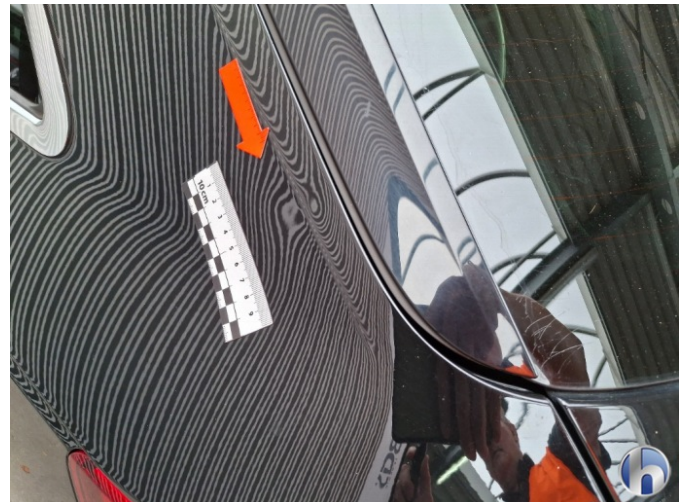
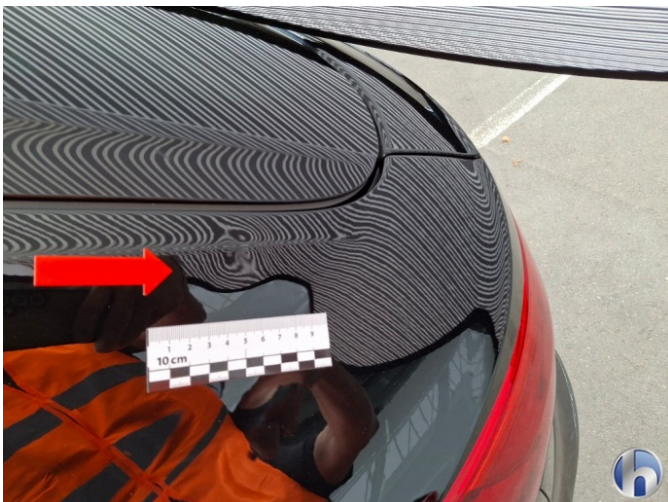
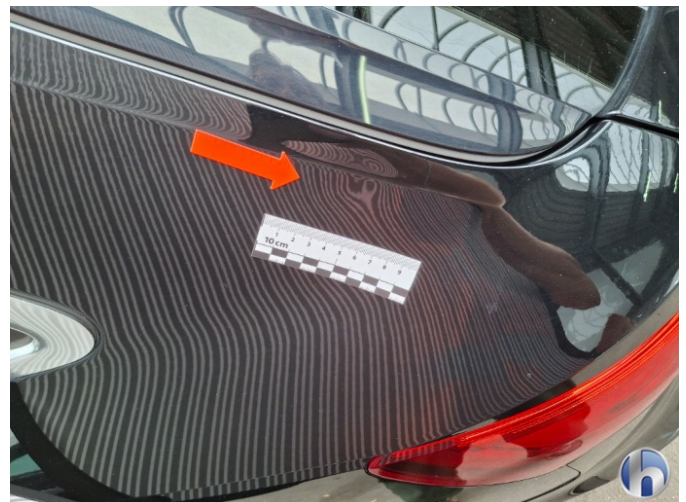
4. Sidewall - Rear - Left

| | component | Damage | Rep kind |
|---|---|---|---|
| 4. | Sidewall - Rear - Left | Delle | Smart repair |
