## status report

#### Audi A4 Avant basis

| Vehicle identification number | <b>WAUZZZF4XJA127374</b> | mileage read: | <b>210796 km</b> |

Hüsges GmbH  
Gießerallee 23  
47877 Willich  
Tel.: 02154 / 9534 0  
E-Mail: gutachten@huesges-group.eu

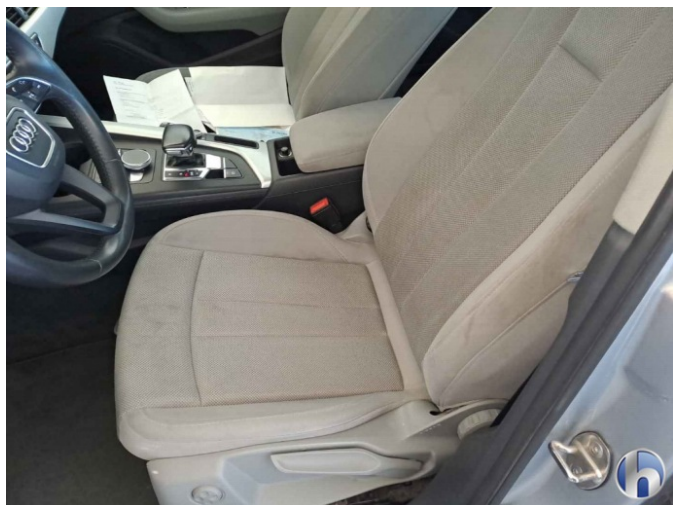
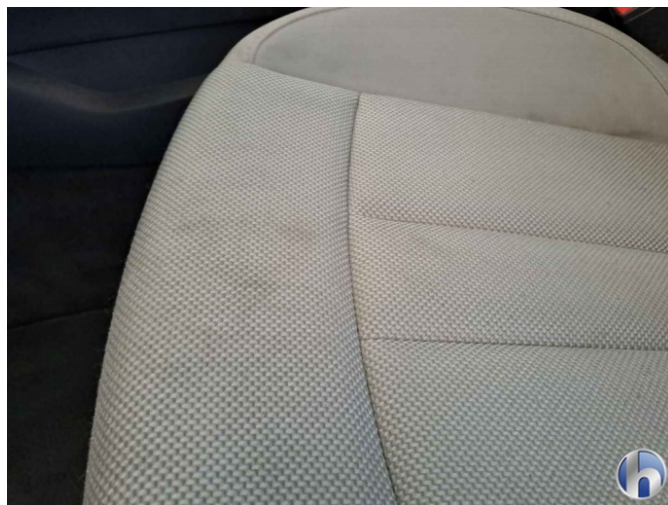
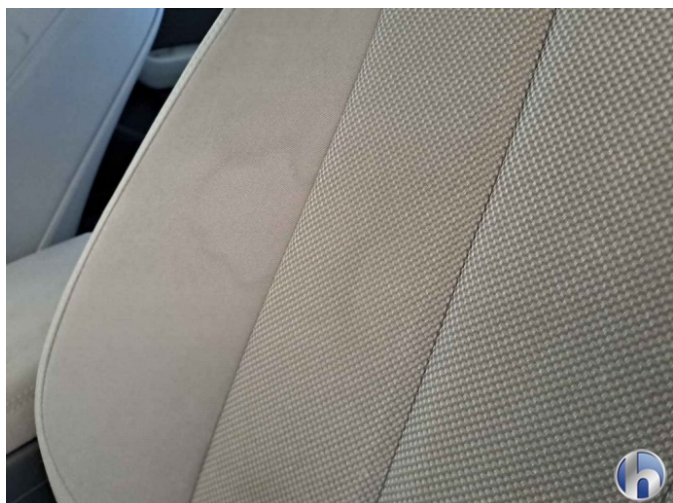
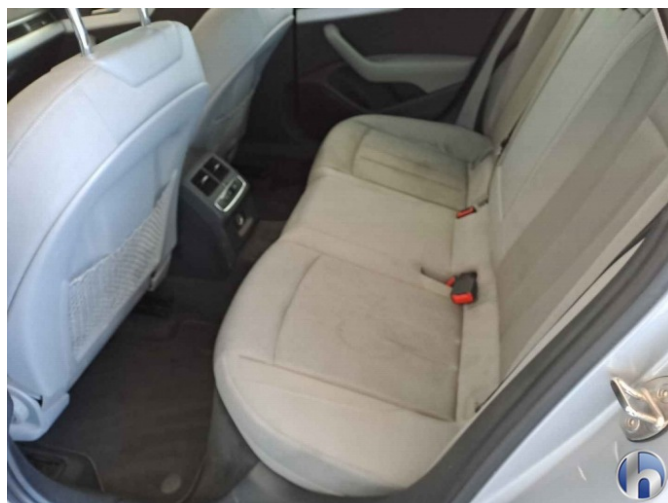
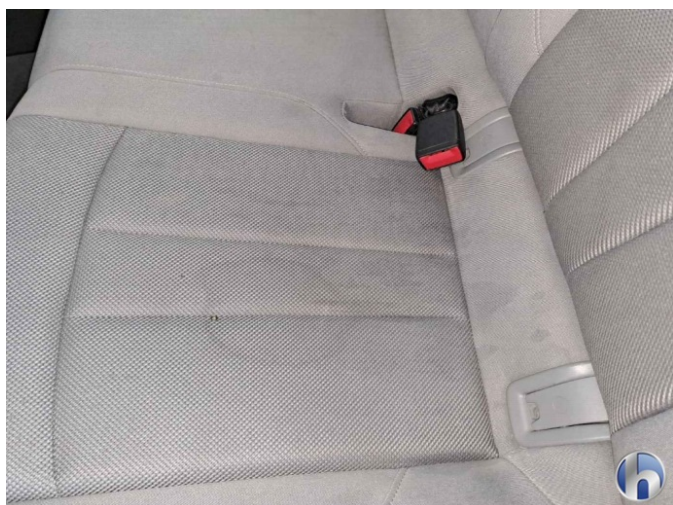
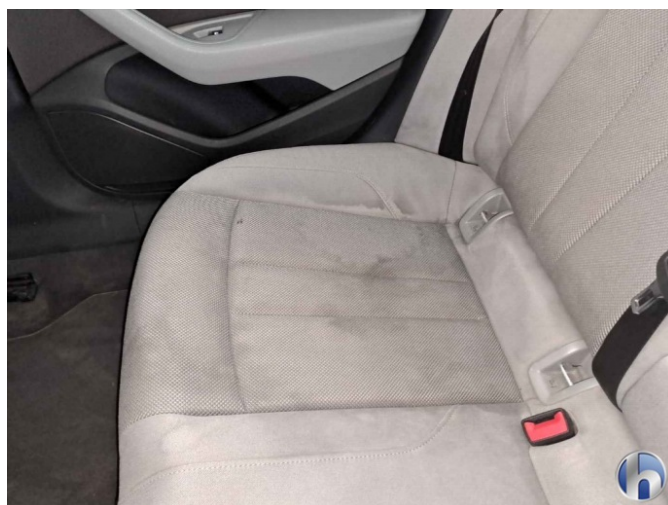
| component | Damage | Rep kind |
|---|---|---|
| 1. | Dirty | |

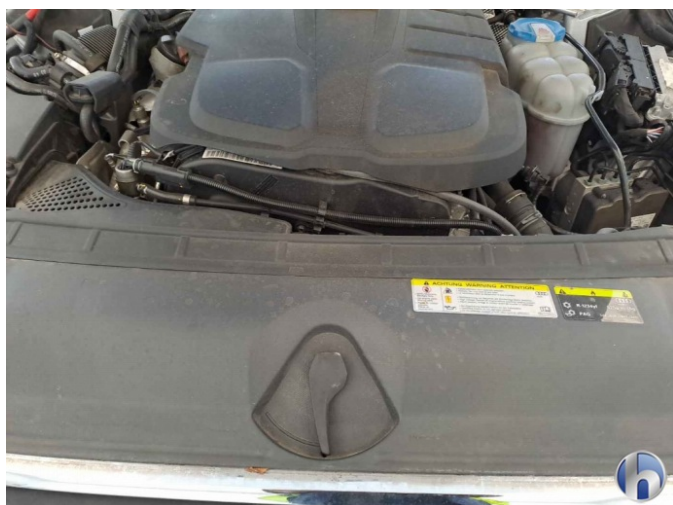
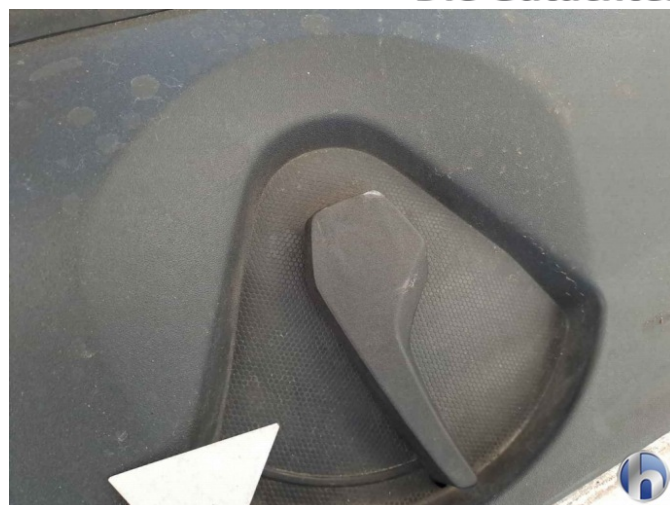
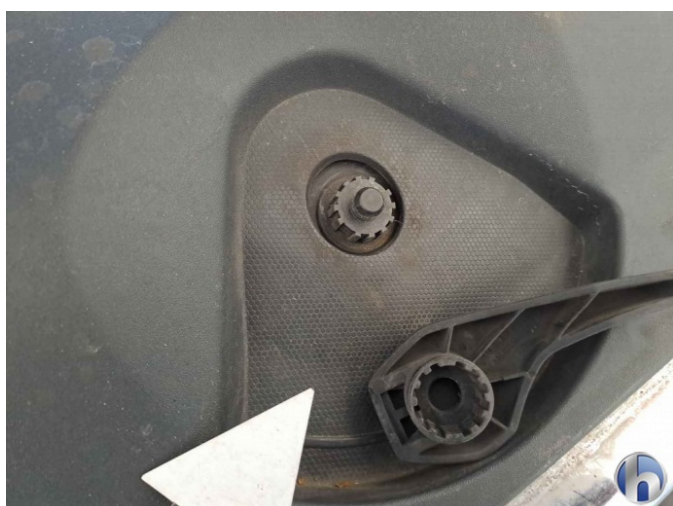
| component | Damage | Rep kind |
|---|---|---|
| 2. | Not okay | Replace |

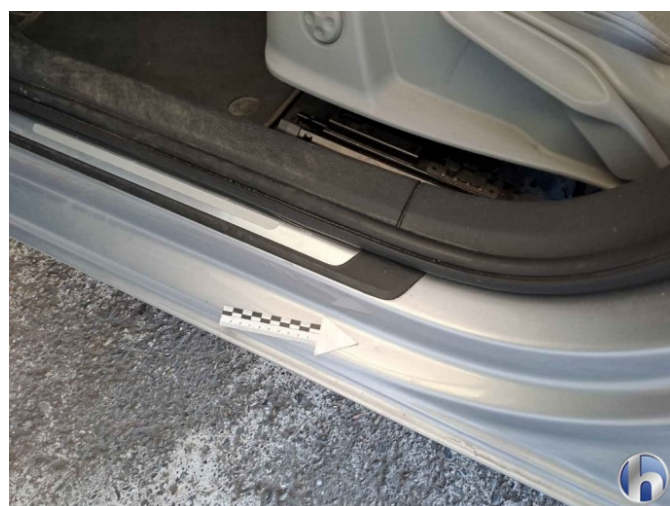
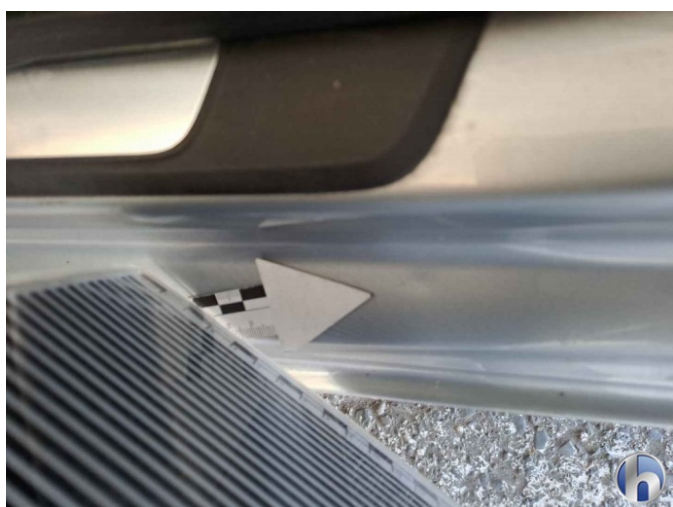
| component | Damage | Rep kind |
|---|---|---|
| 3. Türeinstieg Vorne - Links | Delle | Smart repair |

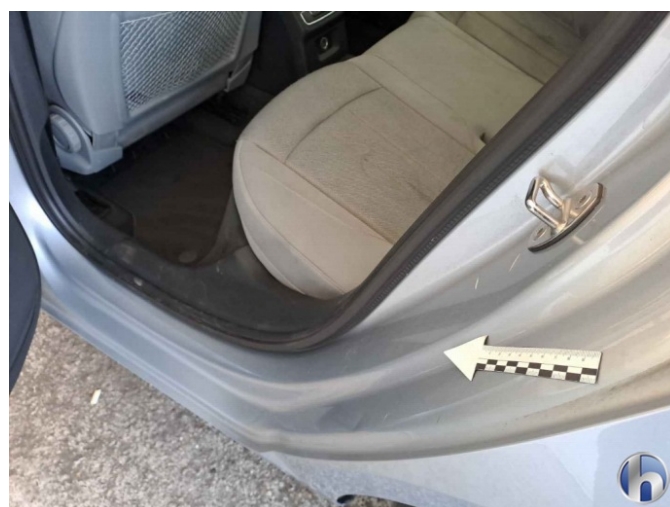
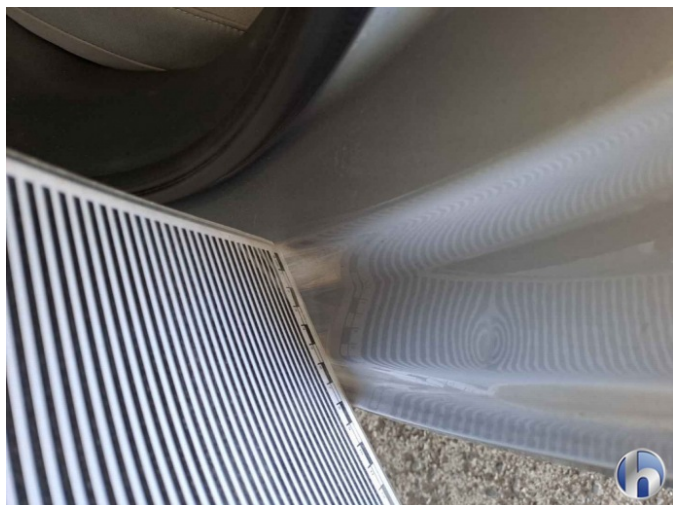
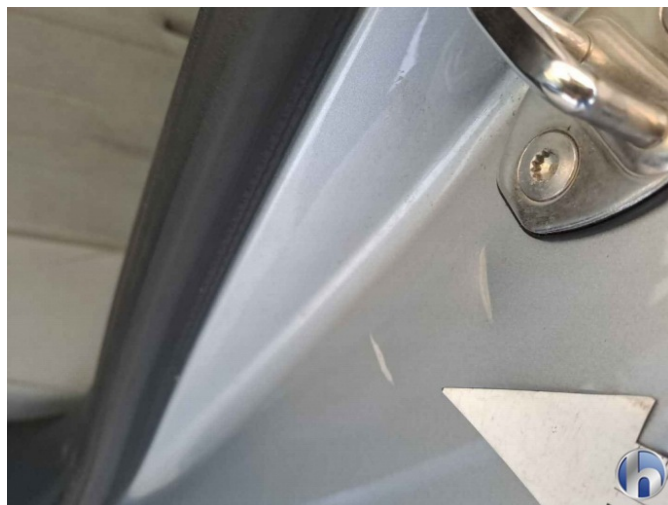
| component | Damage | Rep kind |
|---|---|---|
| 4. Türeinstieg Hinten - Links | Damaged | Refurbish and paint |

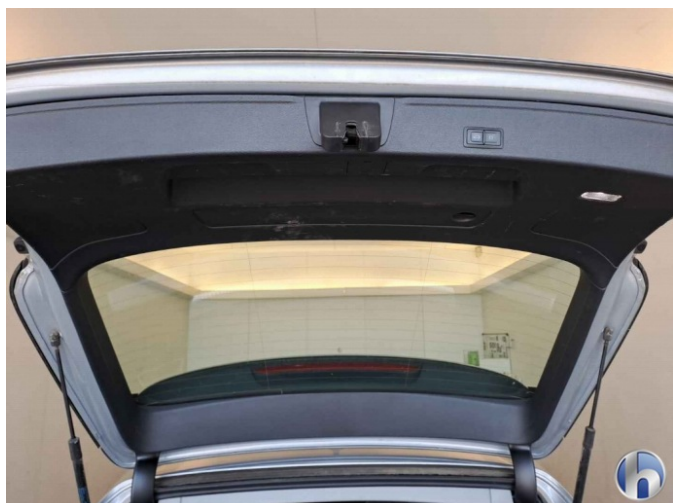
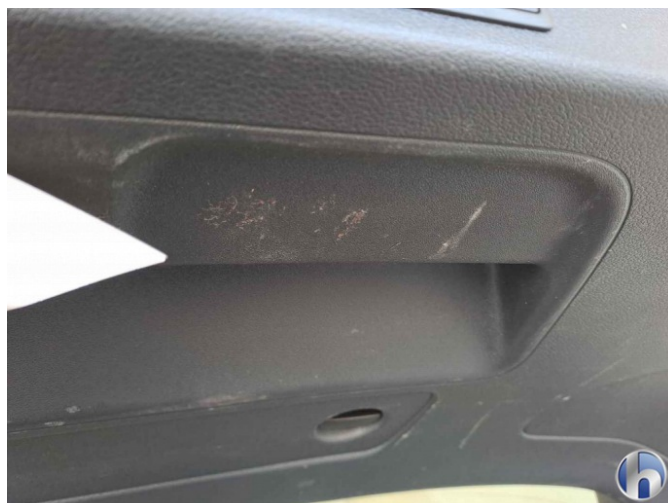
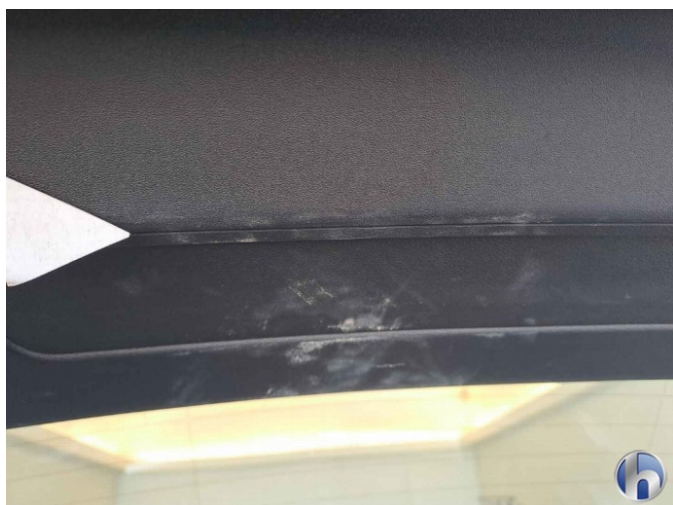
| component | Damage | Rep kind |
|---|---|---|
| 5. Heckdeckelverkleidung | Scratch(es) | Replace |

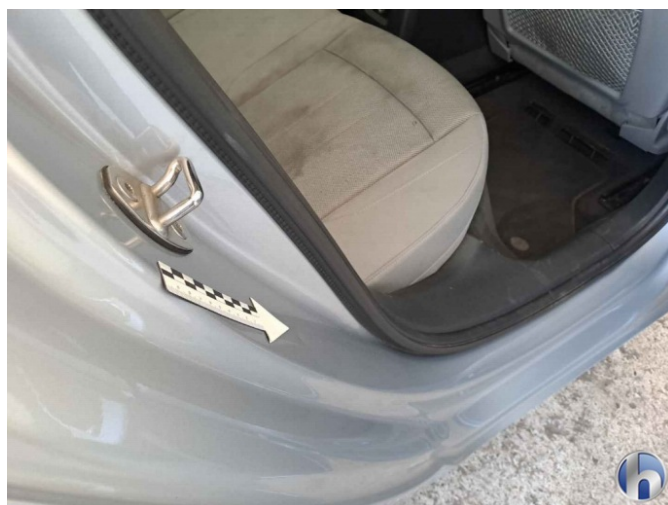
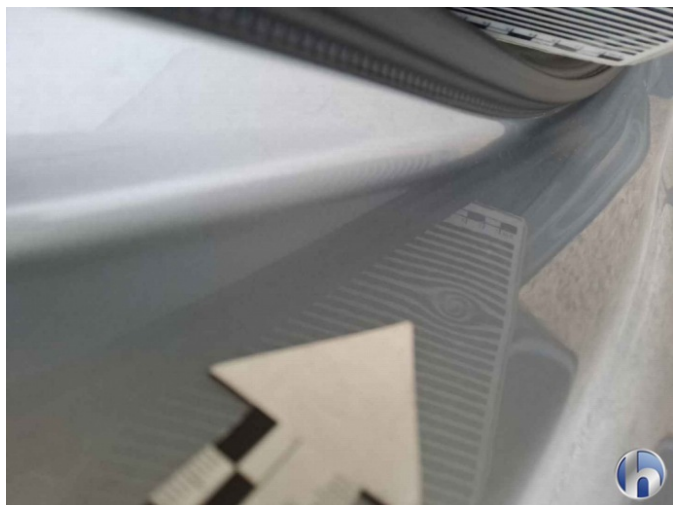
| component | Damage | Rep kind |
|---|---|---|
| 6. Türeinstieg Hinten - Rechts | | Refurbish and paint |

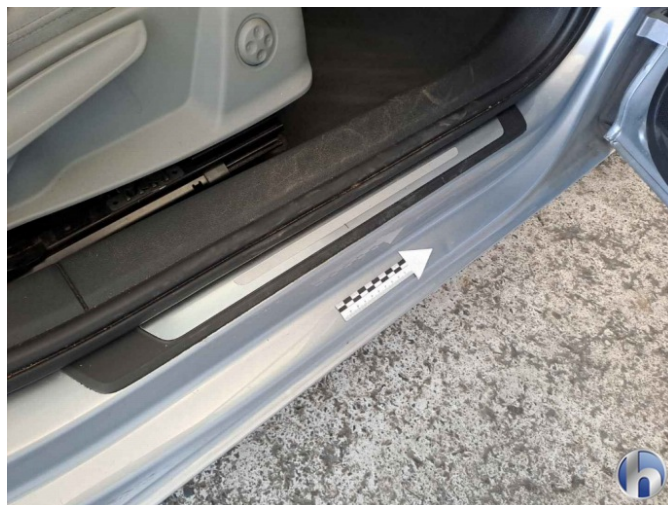
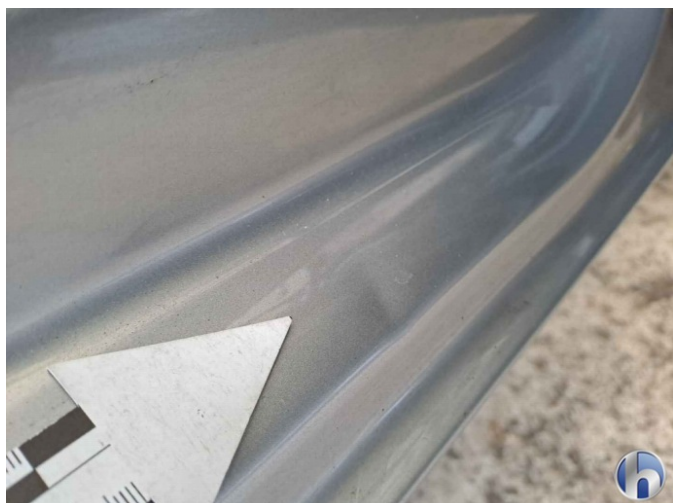
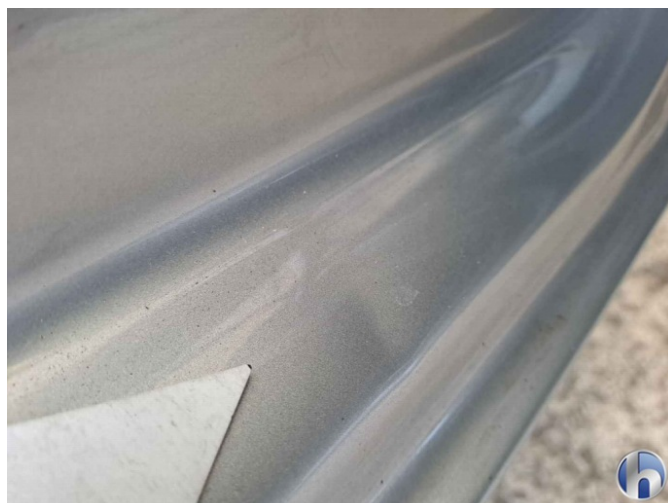
| component | Damage | Rep kind |
|---|---|---|
| 7. Türeinstieg Vorne - Rechts | | Refurbish and paint |

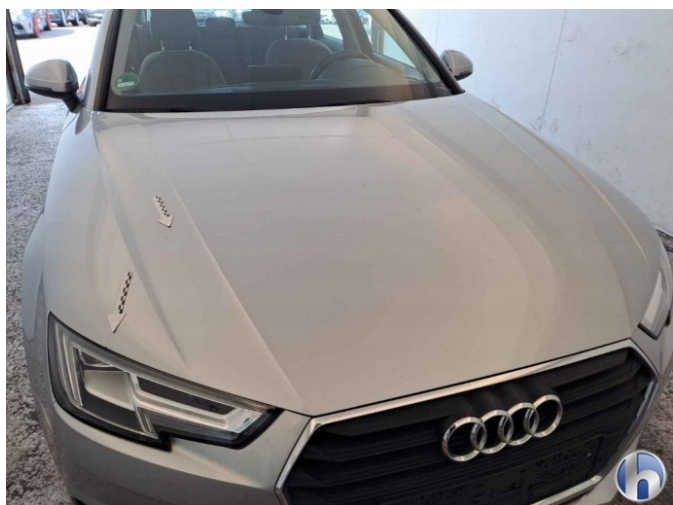
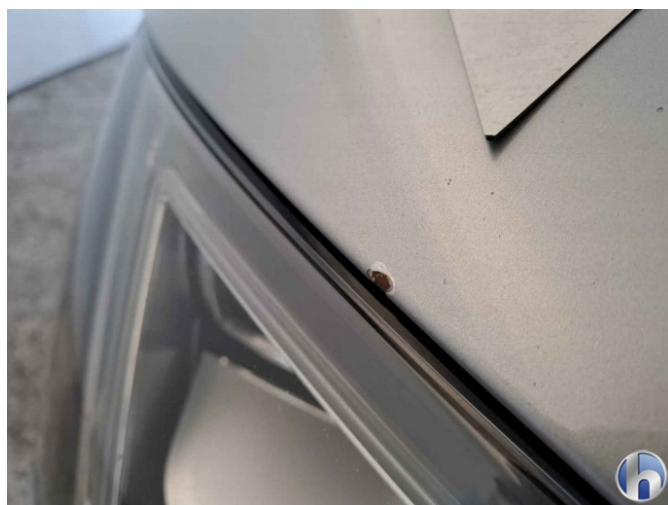
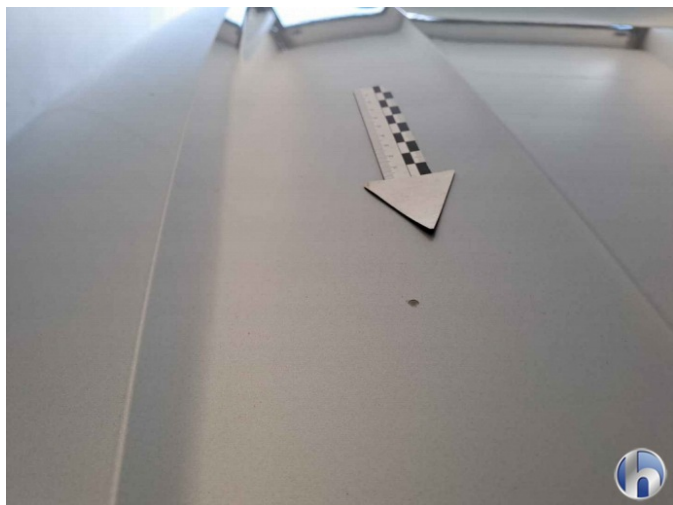
| component | Damage | Rep kind |
|---|---|---|
| 8. hood | Rust | Paint |

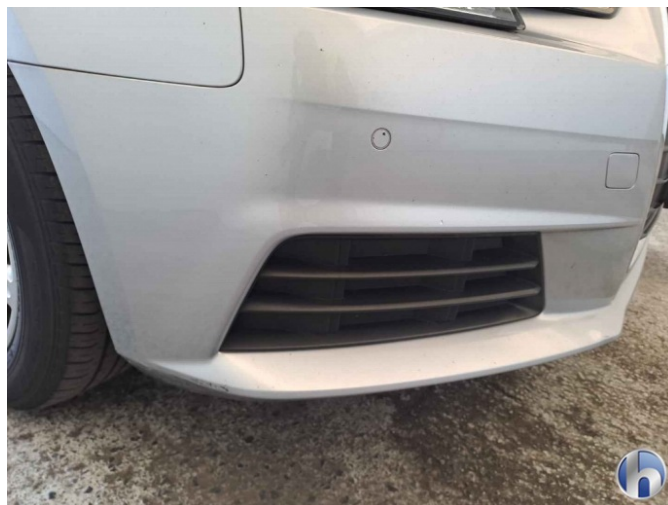
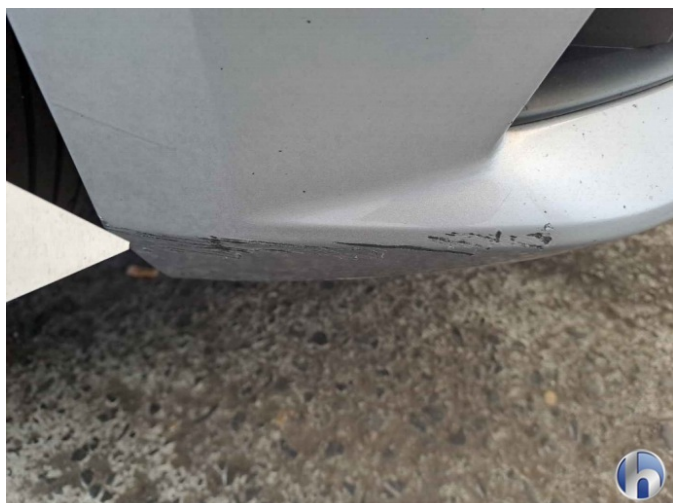
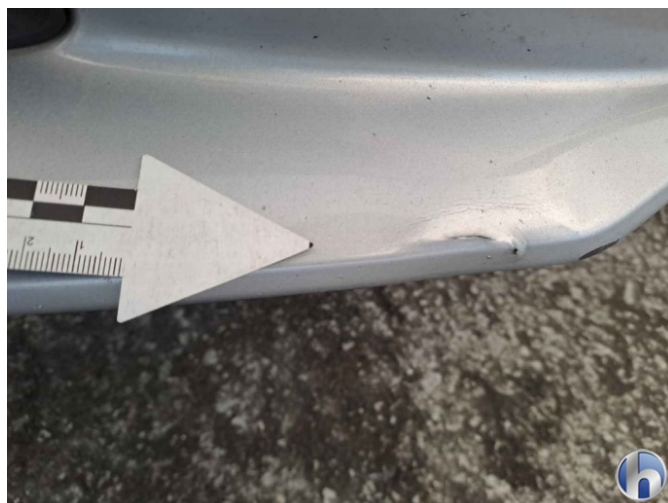
| component | Damage | Rep kind |
|---|---|---|
| 9. Front bumper | Damaged | Replace |

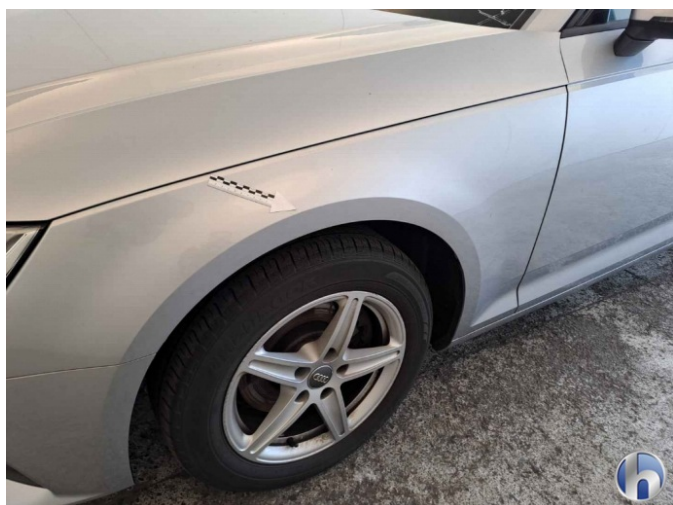
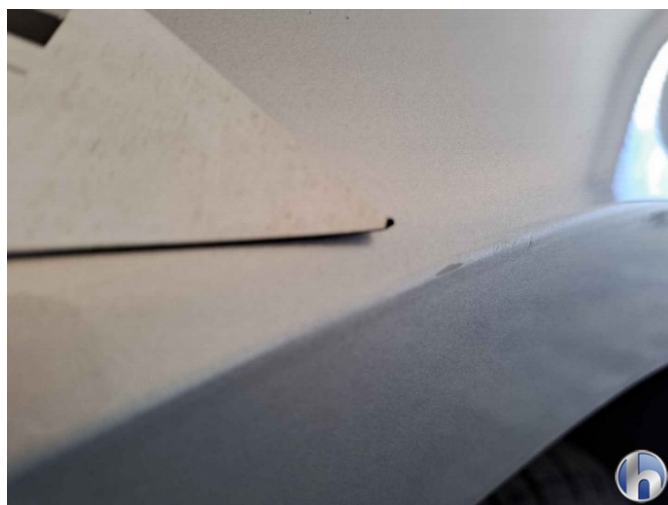
| component | Damage | Rep kind |
|---|---|---|
| 10. Front fender - left | Scratch(es) | Smart repair |

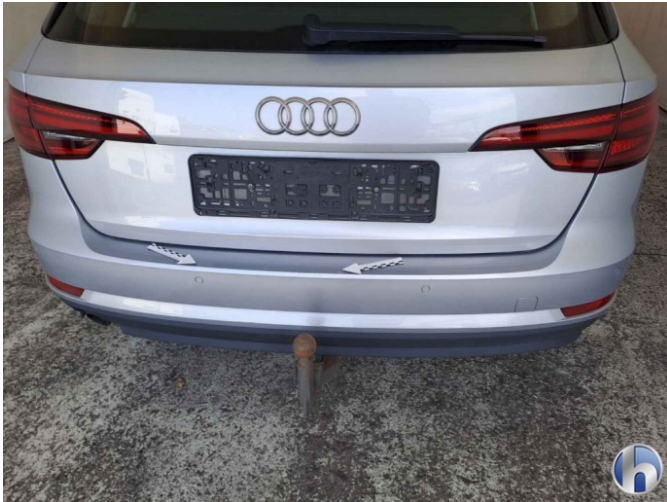
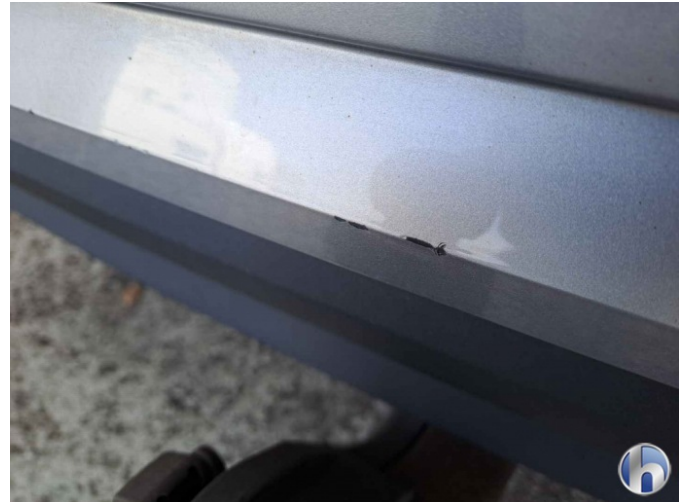
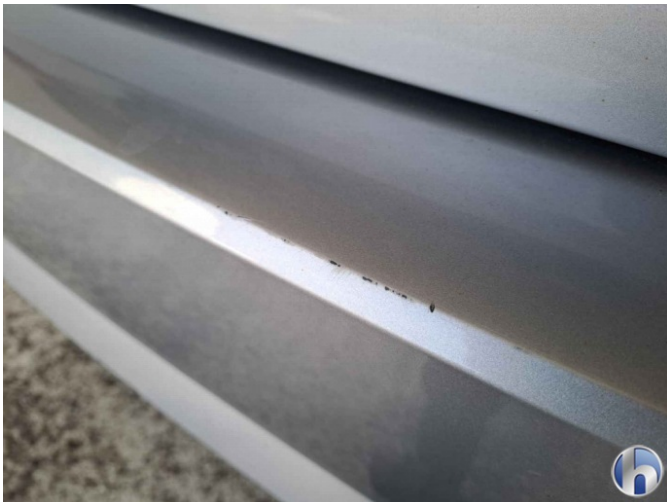
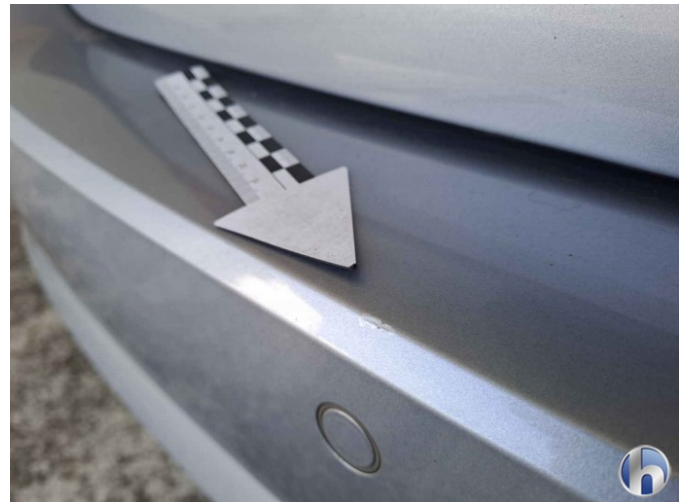
| component | Damage | Rep kind |
|---|---|---|
| 11. Rear bumper | Scratch(es) | Paint |

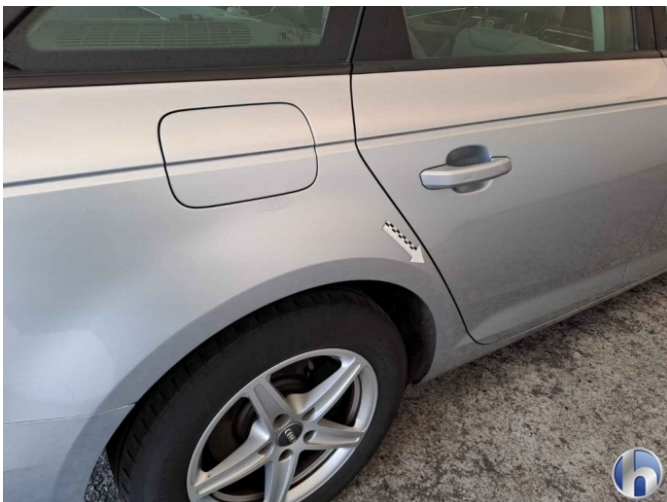
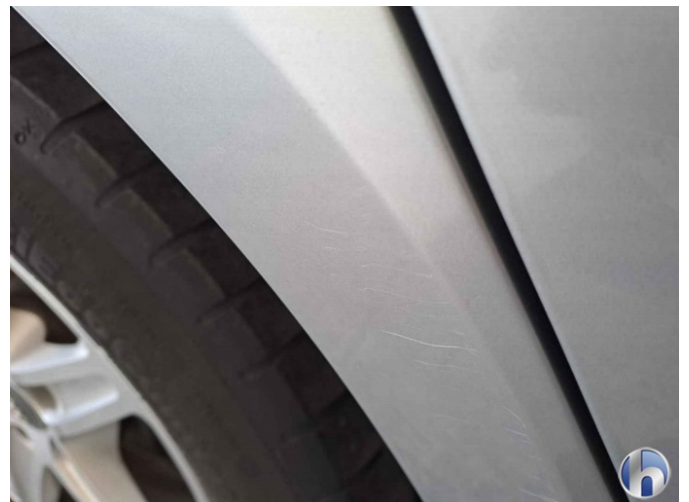
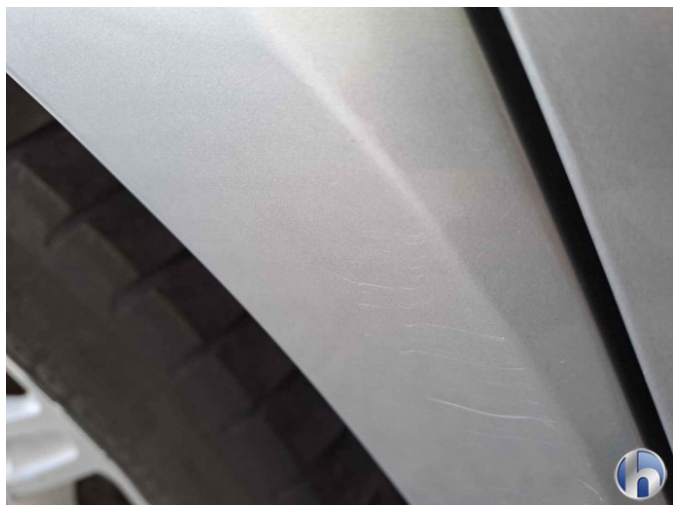
| component | Damage | Rep kind |
|---|---|---|
| 12. Sidewall - Rear - right | Scratch(es) | Smart repair |
