## status report

| <b>customer:</b> | <b>BCA Autoauktionen GmbH</b> |

| vehicle data | | | |
|---|---|---|---|
| <b>Audi Q5 50 TDI quattro S line</b> | | | |
| Vehicle identification number | <b>WAUZZZFY2P2045029</b> | mileage read: | <b>32543 km</b> |

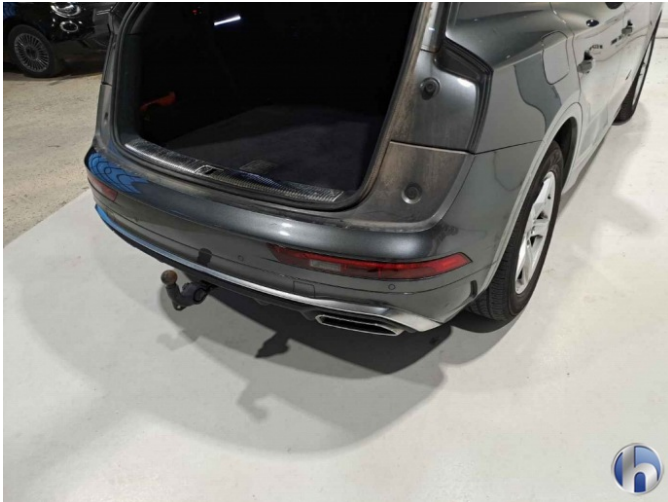
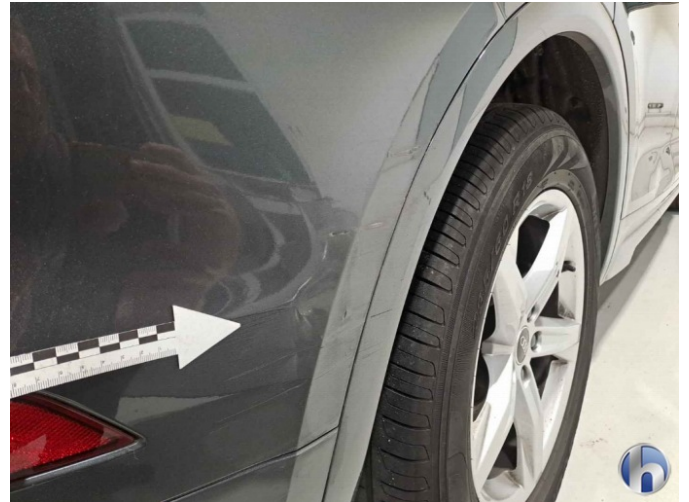
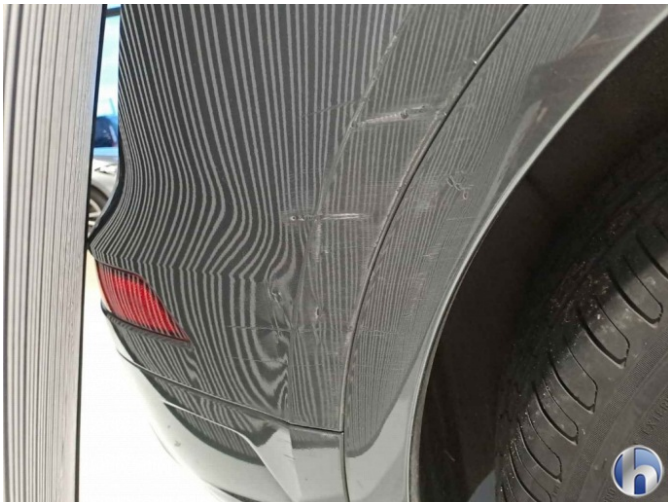
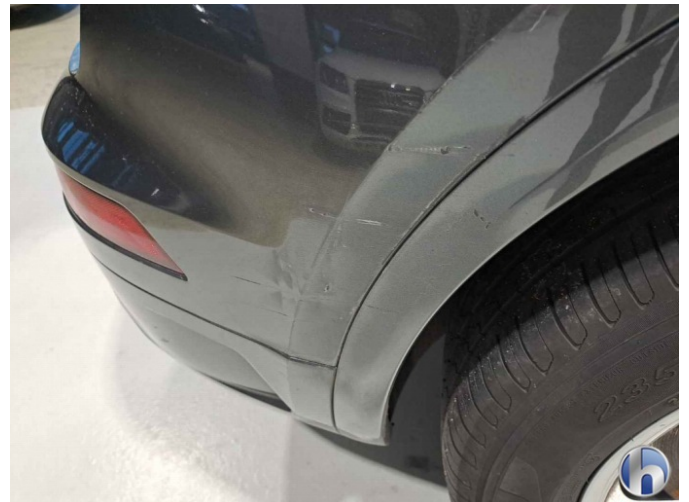
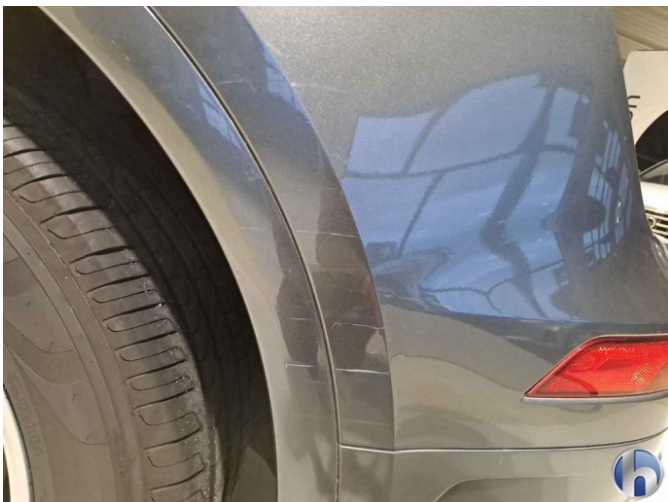
| Performed testing technology | |
|---|---|
| <b>reference:</b> | *Unfallschaden Stoßfänger Hinten, Kotflügel VL, Tür HR Schaden und Kosten Erweiterung möglich<br>Fahrzeug hat Alter und Laufleistungs bedingte Gebrauchsspuren innen und außen. |

| component | Damage | Rep kind |
|---|---|---|
| 3. Rear bumper | Damaged | Replace |

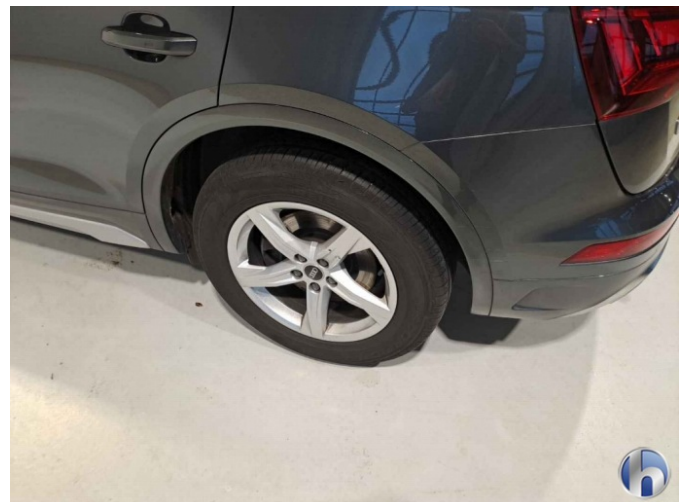
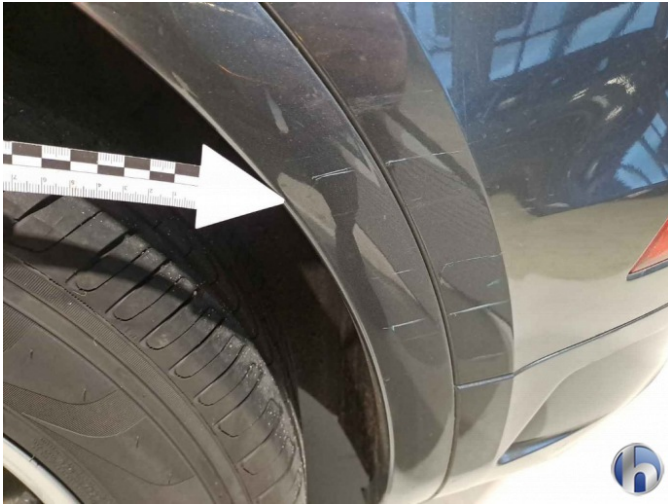
| component | Damage | Rep kind |
|---|---|---|
| 4. | Scrape | Smart repair |

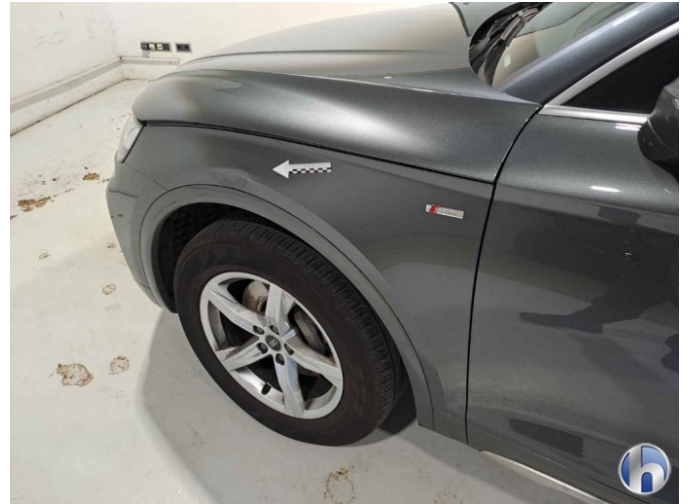
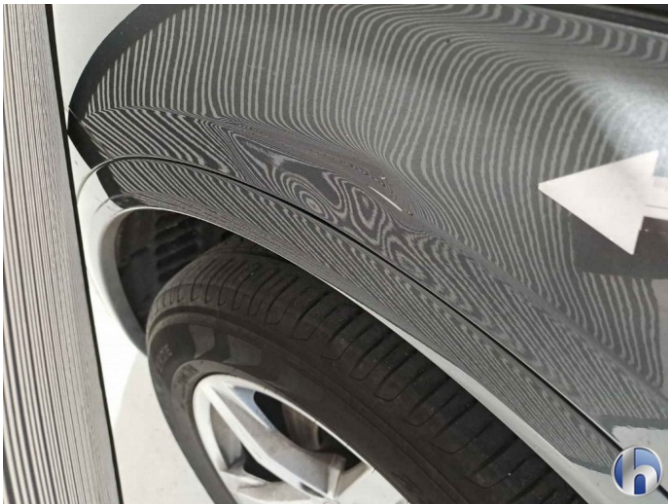
| component | Damage | Rep kind |
|---|---|---|
| 5. Front fender - left | Deformed | Refurbish and paint |

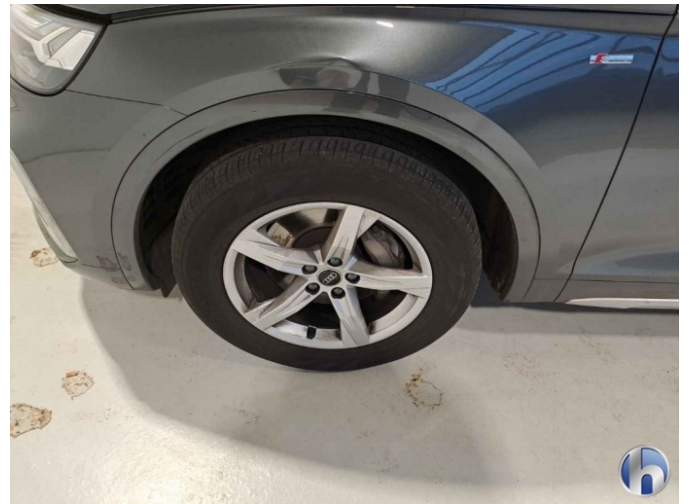
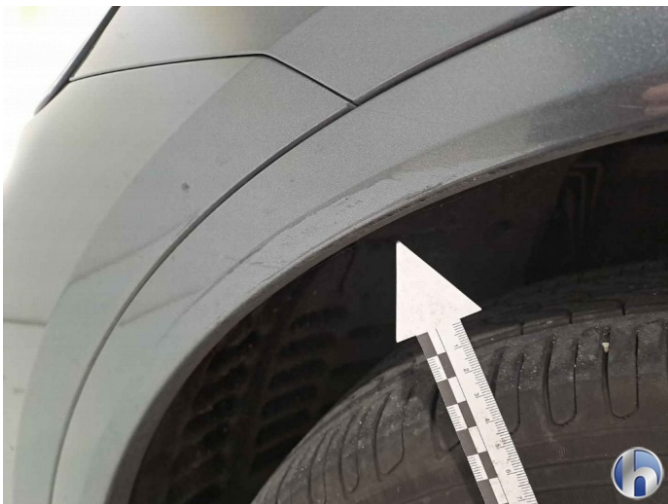
| component | Damage | Rep kind |
|---|---|---|
| 6. | Scrape | Smart repair |

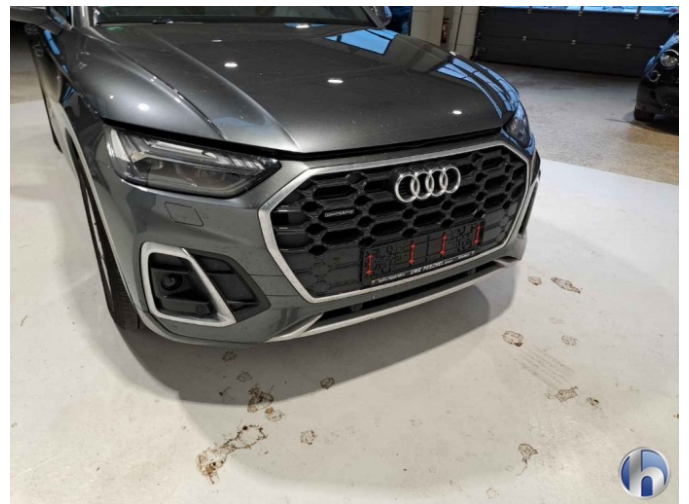
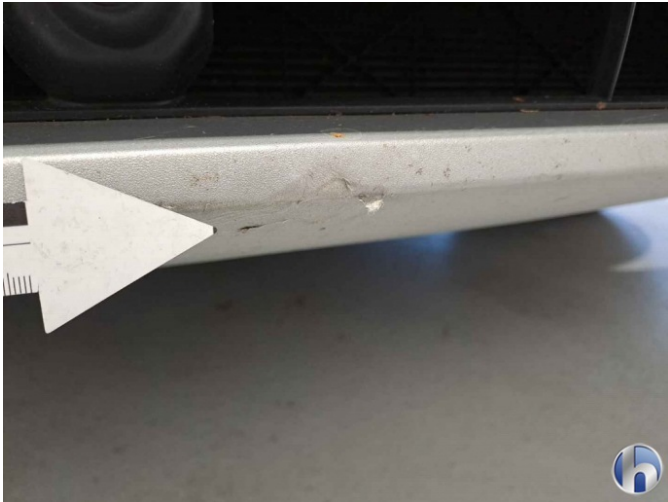
| component | Damage | Rep kind |
|---|---|---|
| 7. Front bumper | Damaged | Replace |

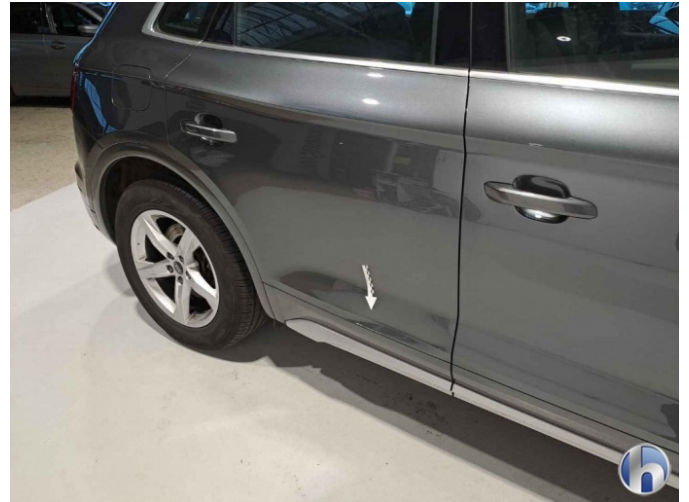
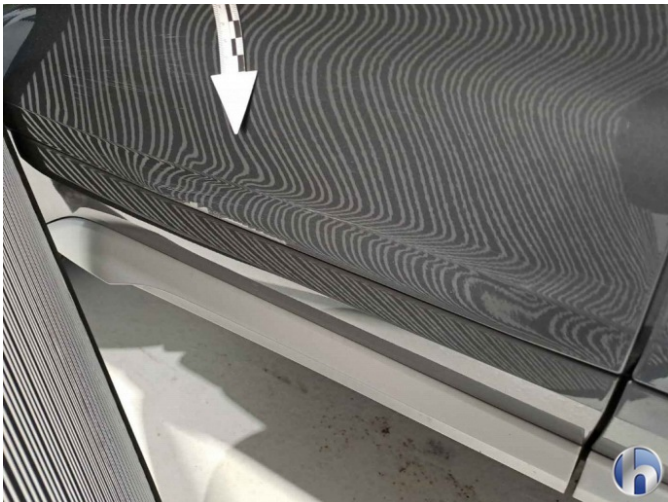
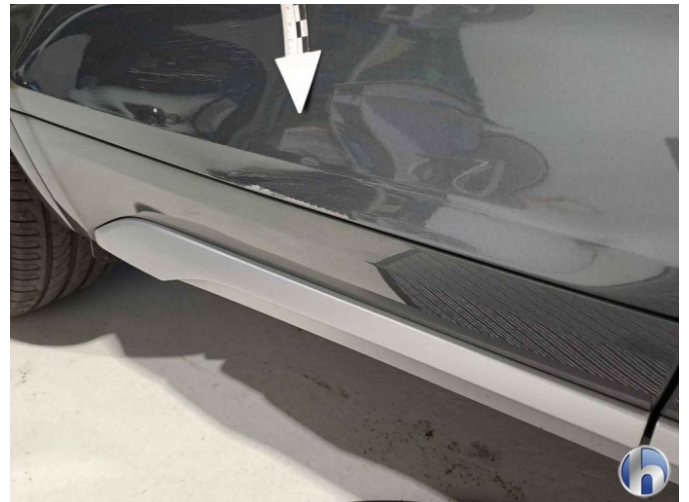
| component | Damage | Rep kind |
|---|---|---|
| 8. Door Rear - right | Deformed | Refurbish and paint |

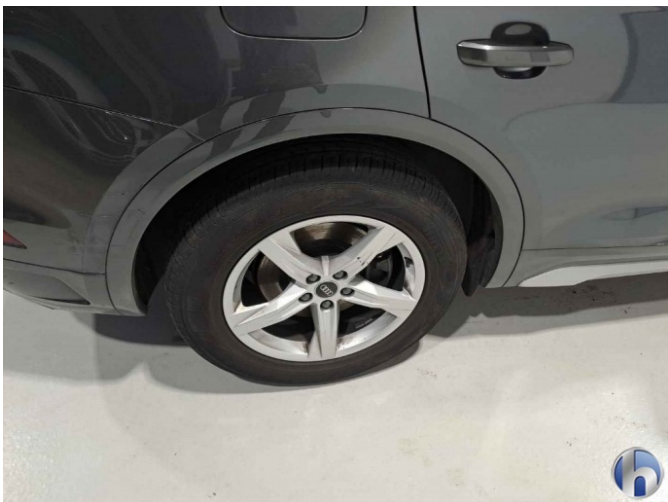
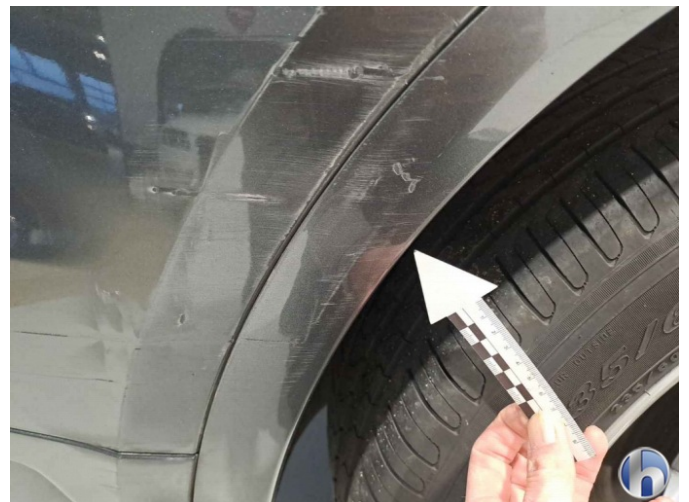
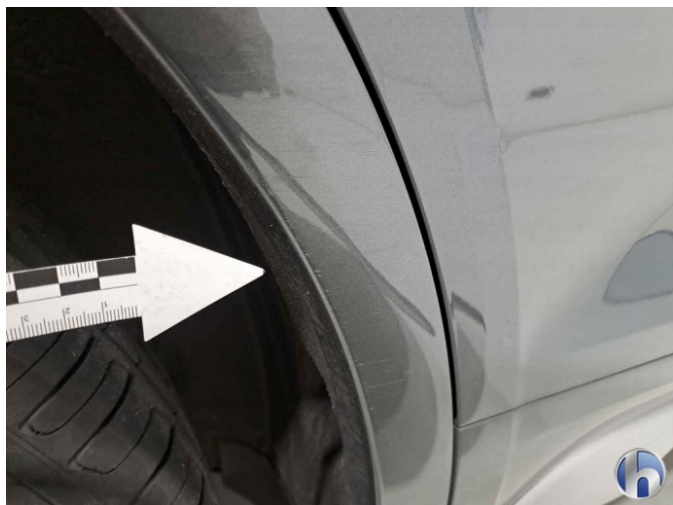
| component | Damage | Rep kind |
|---|---|---|
| 9. | Scrape | Smart repair |

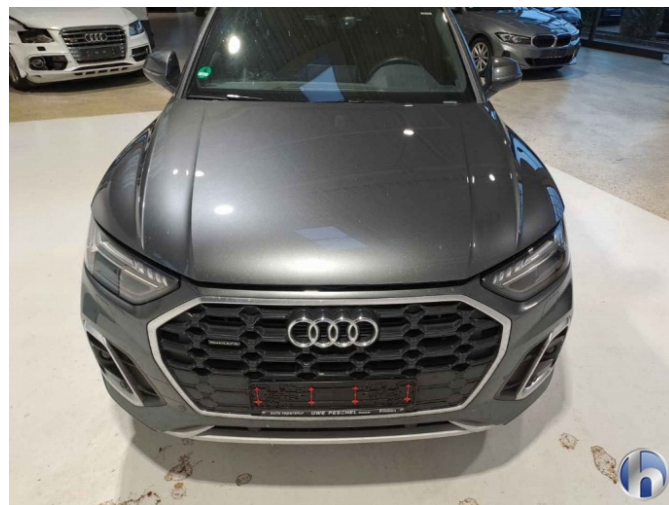
| component | Damage | Rep kind |
|---|---|---|
| 10. exterior body | Surface scratch(es) | |

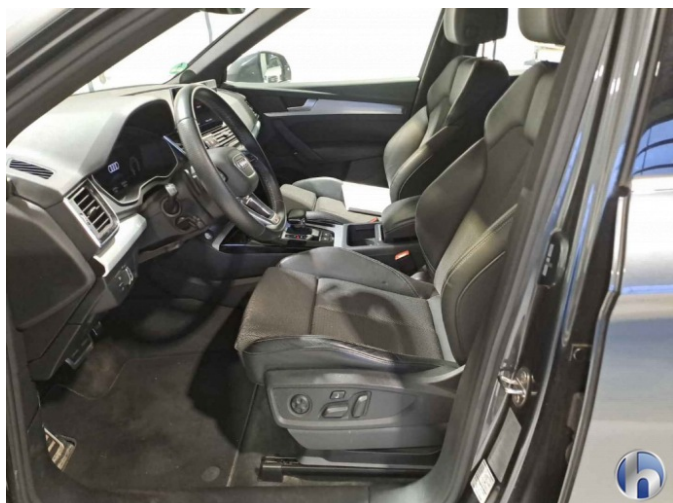
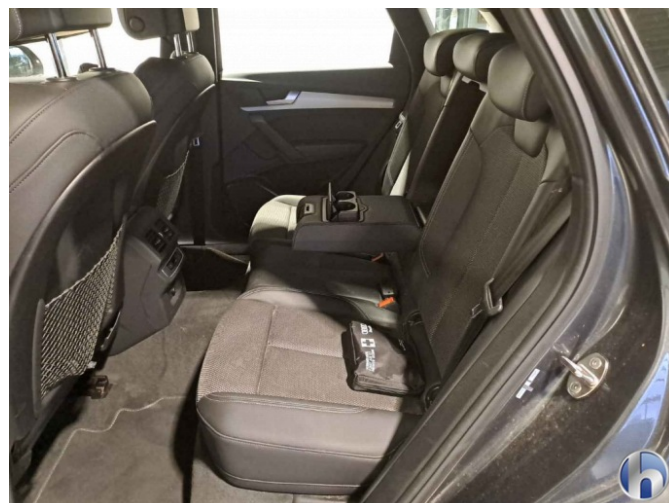
| component | Damage | Rep kind |
|---|---|---|
| 11. | Wear and tear | acceptable |

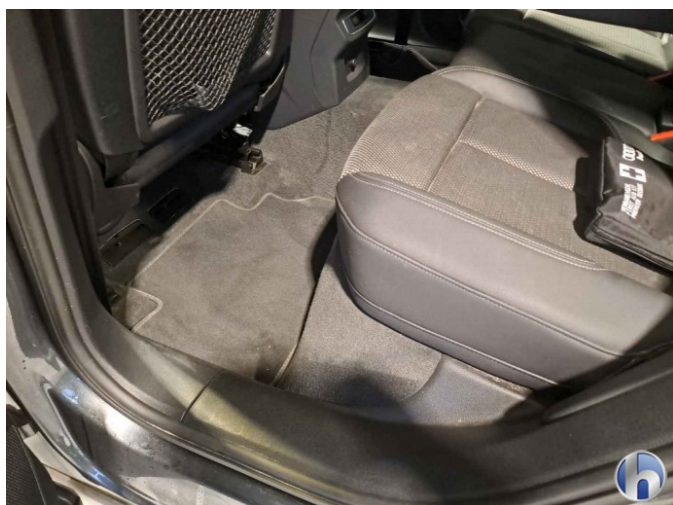
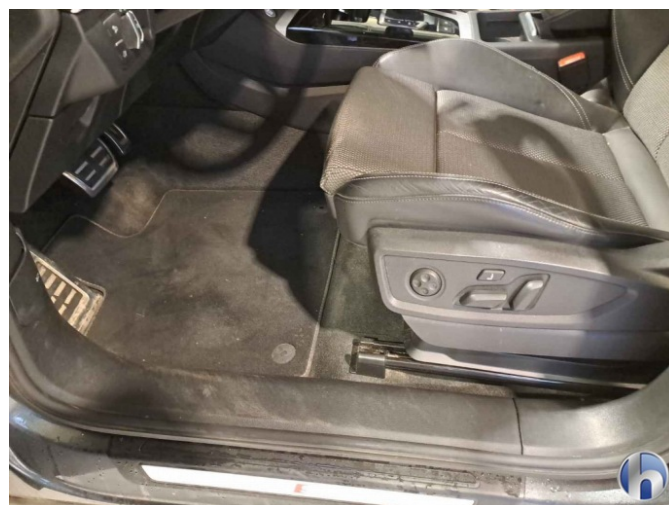
| component | Damage | Rep kind |
|---|---|---|
| 12. | Dirty | |

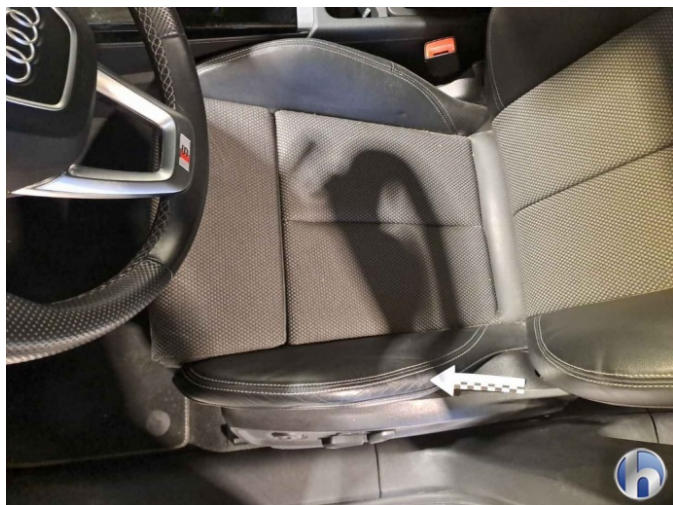
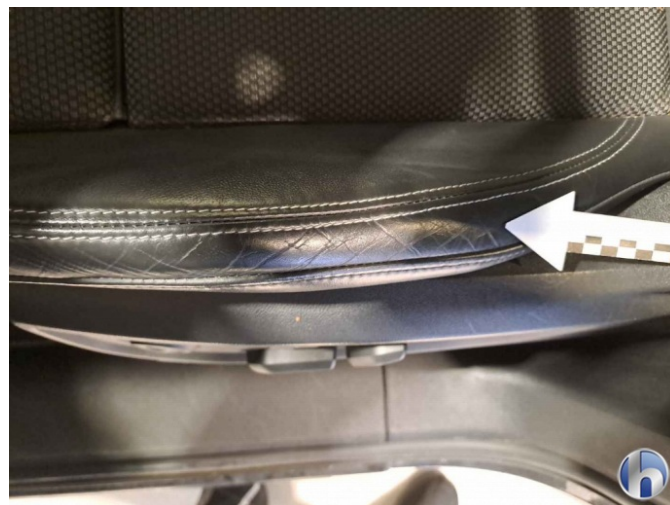
| component | Damage | Rep kind |
|---|---|---|
| 14. | Damaged | Replace |

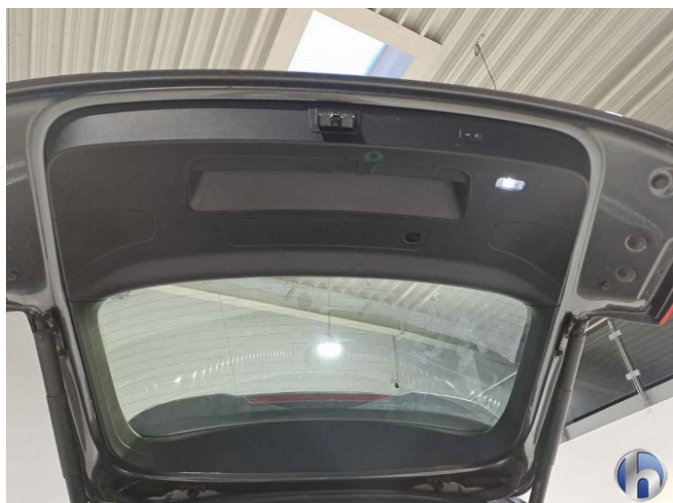
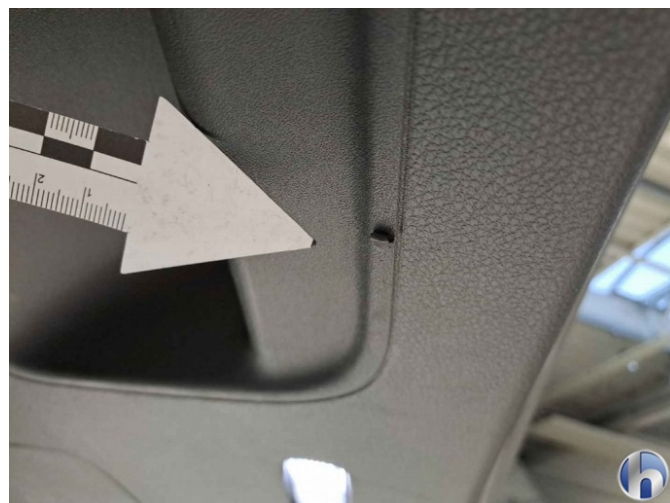
| component | Damage | Rep kind |
|---|---|---|
| 15. tailgate trim | Scrape | Replace |
