Expertise

Protocol number: 40971467  
Order No. / Reference: 24997064  
Inspection date: 8 Aug 2025

Manufacturer: Audi	Model: A3 30 TFSI Limousine
VIN: WAUZZZGY5NA063848

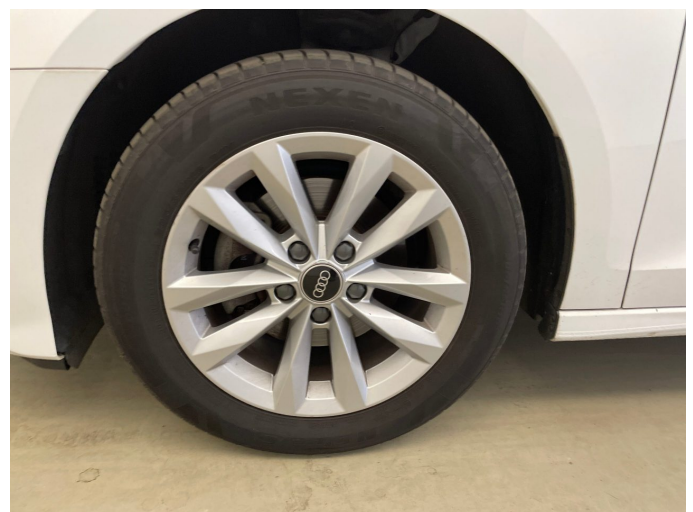
Figure 12: Mounted tyres

#	Tyre size	Type of tyre	Manufacturer	Tread depth
1)	205/55 R16 91V	Summer tyres on Light alloy	Nexen	4mm / 4mm
2)	205/55 R16 91V	Summer tyres on Light alloy	Nexen	4mm / 4mm

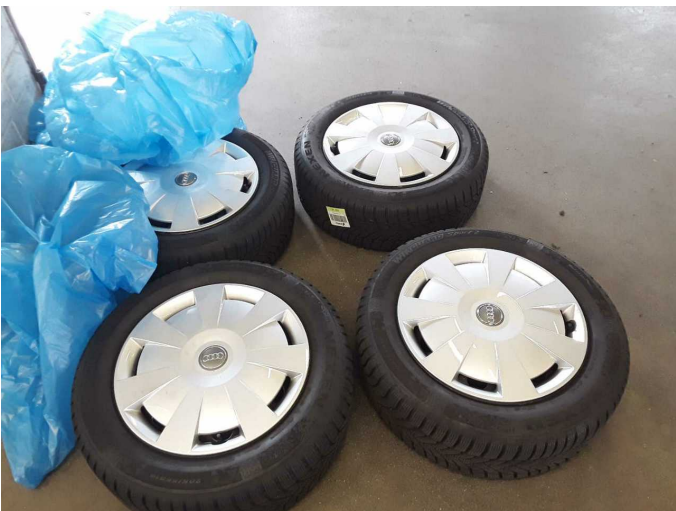
Figure 17: Additional tyres

#	Tyre size	Type of tyre	Manufacturer	Tread depth
1)	205/55 R16 91H	Winter tyres on Steel rim with wheel cover	Nexen	6mm / 6mm
2)	205/55 R16 91H	Winter tyres on Steel rim with wheel cover	Nexen	6mm / 6mm

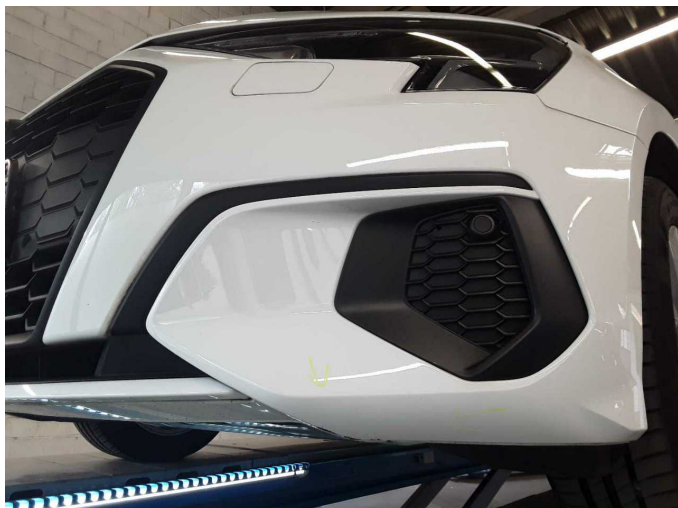
No.	Component group	Description
1	Front bumper	Front bumper - Scratched - Paint

**Damage 1:** Front bumper: Front bumper - Scratched - Paint

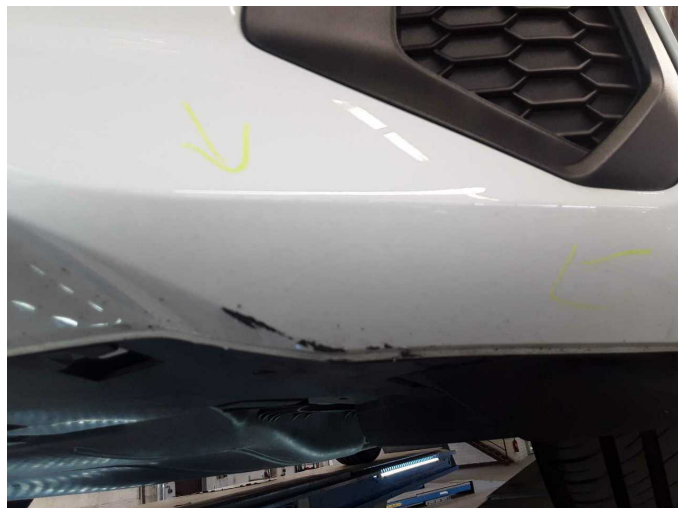
**Damage 1:** Front bumper: Front bumper - Scratched - Paint
