BMW 2er Active Tourer 218d Active Tourer Aut.

Inspection Report Summary

Customer	BCA Online	Report Number	P20250903085150
Inspection Date / Place	2025-09-03 / BCA Oberndorf	Cosmetic Grade	2

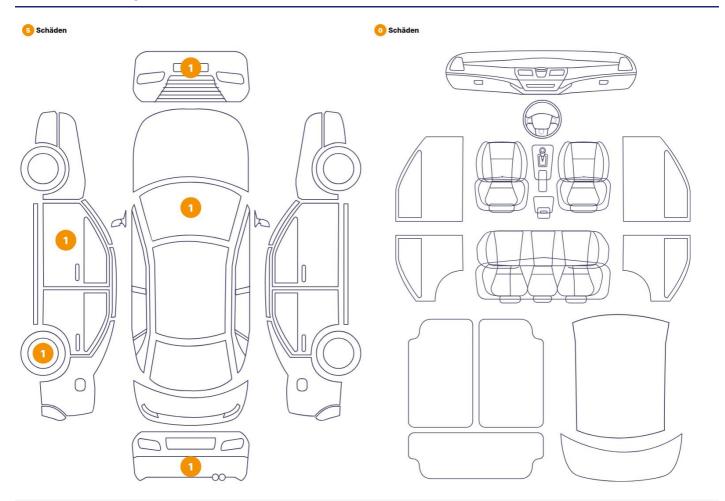
Component	Damage	Comments
1	Windshield / Front	Glass Break / Impact	
2	Bumper / Front	Paint / Scratch / Scuff	
3	Mirror / Front Left	Paint / Scratch / Scuff	
4	Rim / Back Left	Out of Bodywork / Scratch	
5	Bumper / Back	Paint / Scratch / Scuff

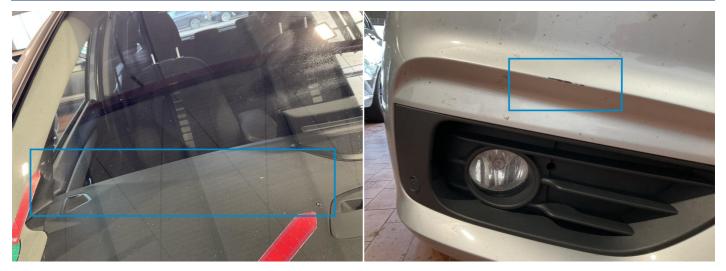
1. Windshield / Front Glass Break / Impact -

2. Bumper / Front Paint / Scratch / Scuff -

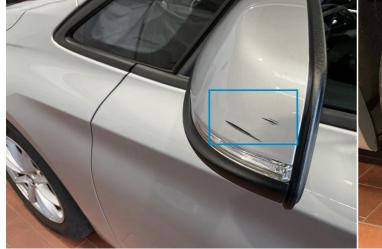
3. Mirror / Front Left Paint / Scratch / Scuff -

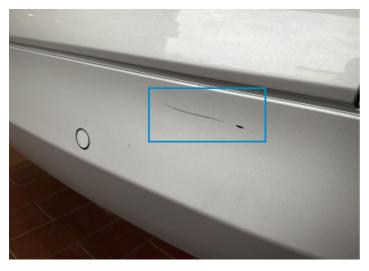
5. Bumper / Back Paint / Scratch / Scuff -
