BMW 1er

116i

Inspection Report Summary

P20251007140905

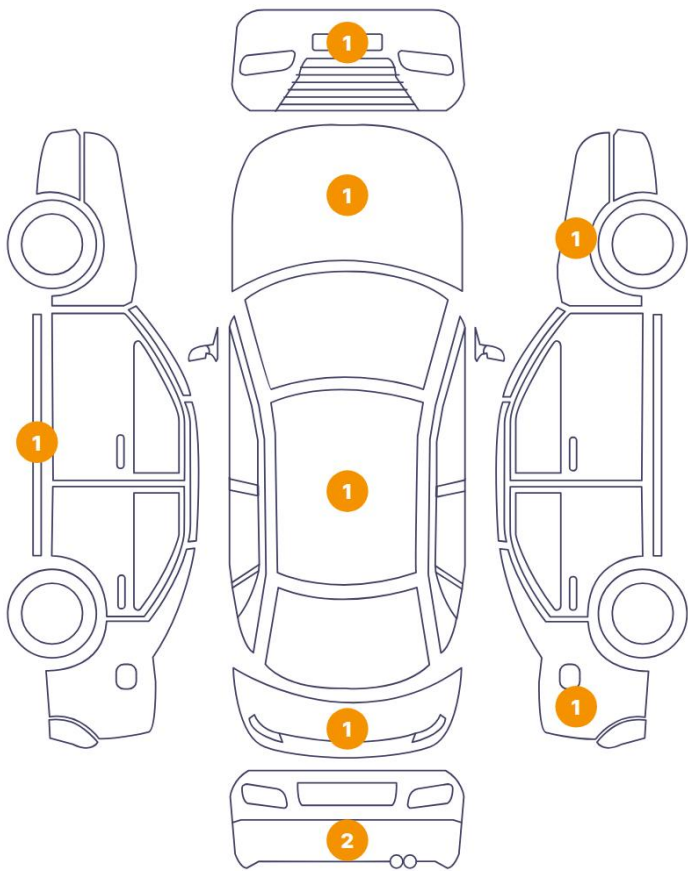
9 Schäden

Component	Damage	Comments
1 Hood	Bodywork / Dent / Hail Area	
2 Roof	Bodywork / Dent / Hail Area	
3 Bumper / Front	Paint / Scratch / Scuff	
4 Rocker Panel / Center Left	Paint / Scratch / Scuff	
5 Bumper / Back	Bodywork / Dent / Dent	
6 Fender / Back Right	Paint / Poor Previous Repair	
7 Bumper / Back	Paint / Scratch / Scuff	
8 Tailgate	Bodywork / Dent / Dent	
9 Fender / Front Right	Paint / Poor Previous Repair

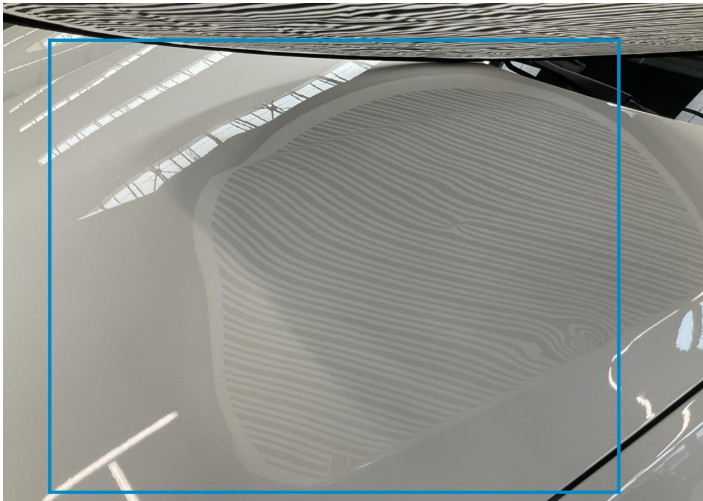
1. Hood
Bodywork / Dent / Hail Area -

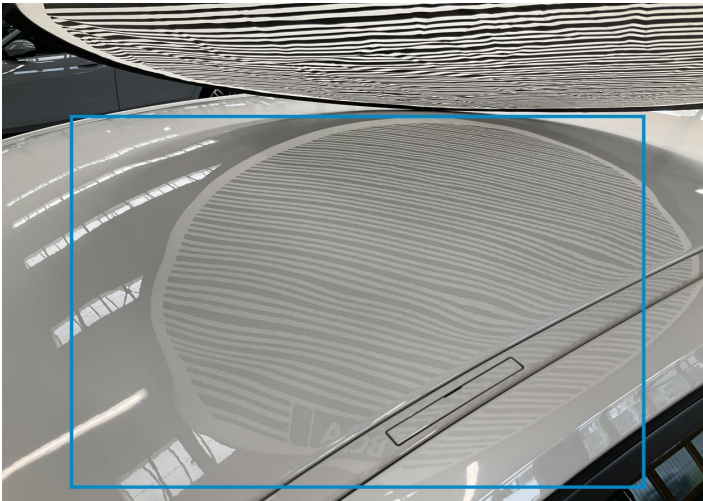
2. Roof
Bodywork / Dent / Hail Area -

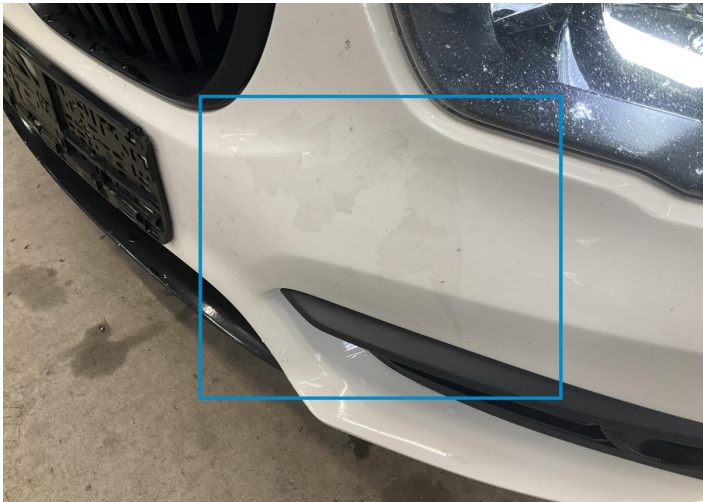
3. Bumper / Front
Paint / Scratch / Scuff -

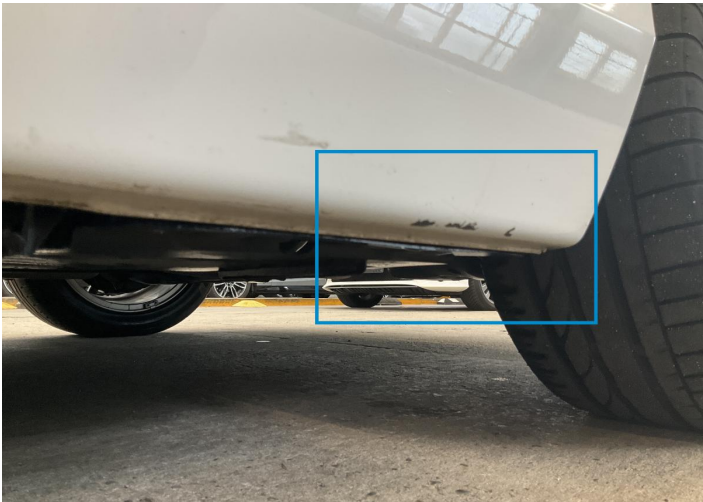
4. Rocker Panel / Center Left
Paint / Scratch / Scuff -

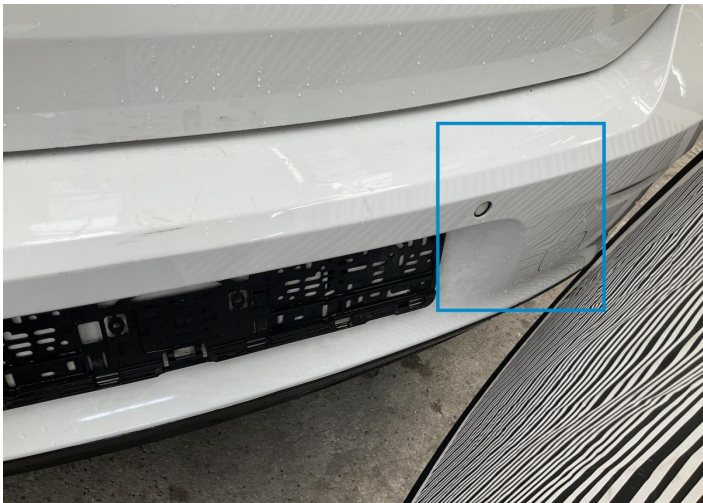
5. Bumper / Back
Bodywork / Dent / Dent -

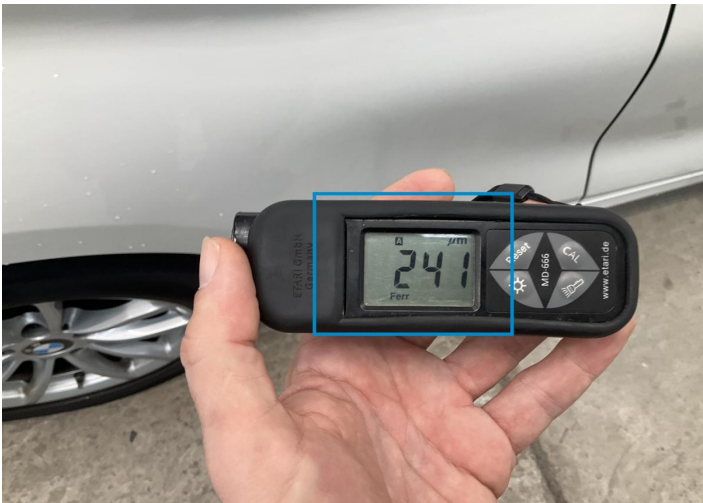
6. Fender / Back Right
Paint / Poor Previous Repair -

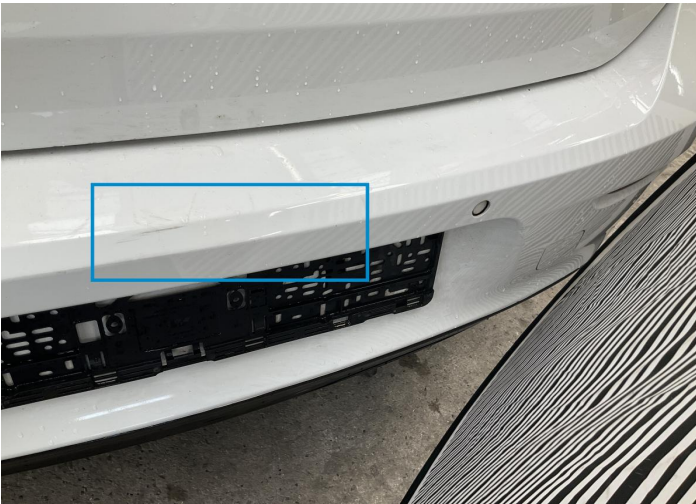
7. Bumper / Back
Paint / Scratch / Scuff -

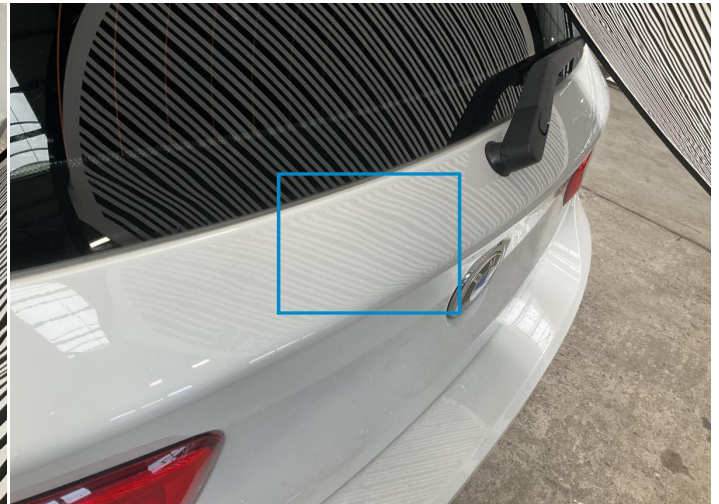
8. Tailgate
Bodywork / Dent / Dent -

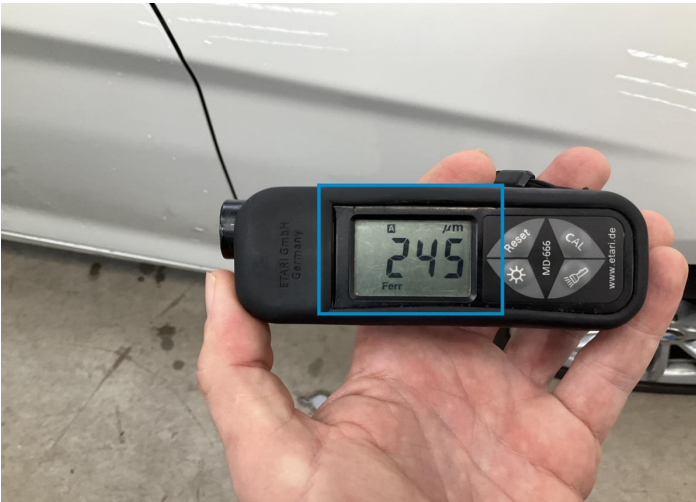
9. Fender / Front Right
Paint / Poor Previous Repair -
