## status report

| <b>customer:</b> | <b>Bank 11, Neuss</b> |

| vehicle data | | | |
|---|---|---|---|
| <b>BMW Baureihe X1 sDrive 18 i</b> | | | |
| Vehicle identification number | <b>WBA31AA0903M88505</b> | mileage read: | <b>89953 km</b> |

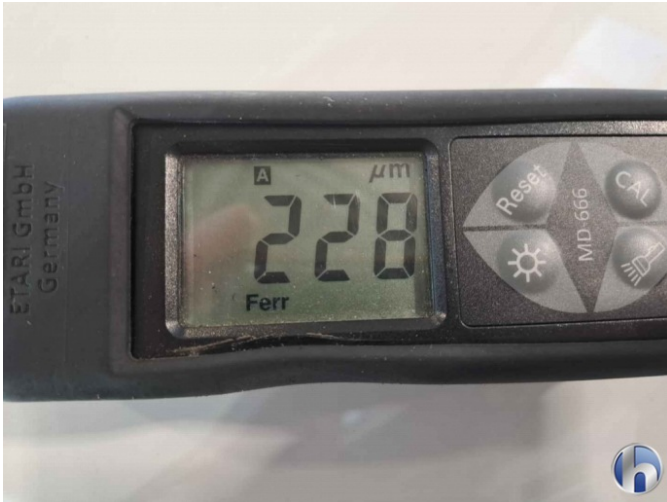
| component | Damage | Rep kind |
|---|---|---|
| 1. Sidewall - Rear - right | Subsequently painted | acceptable |

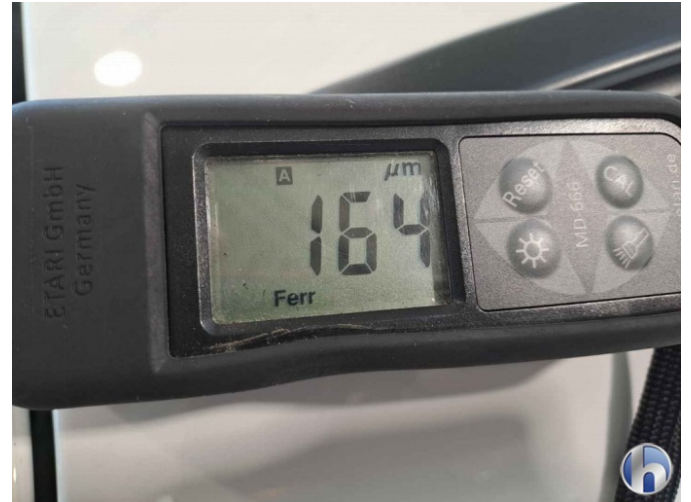
| component | Damage | Rep kind |
|---|---|---|
| 2. Roof frame - right | Subsequently painted | acceptable |

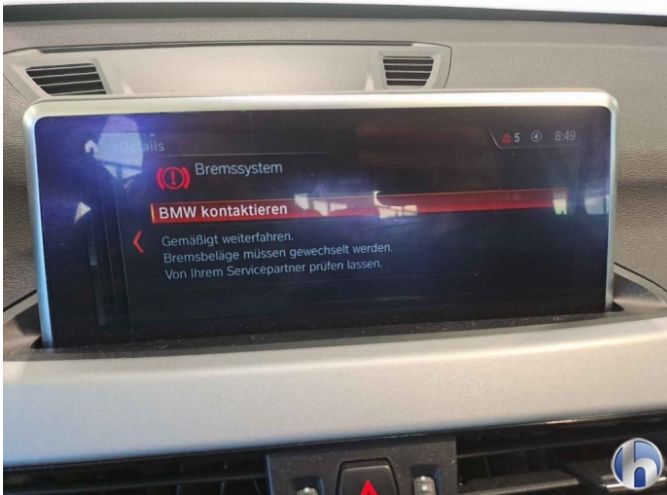
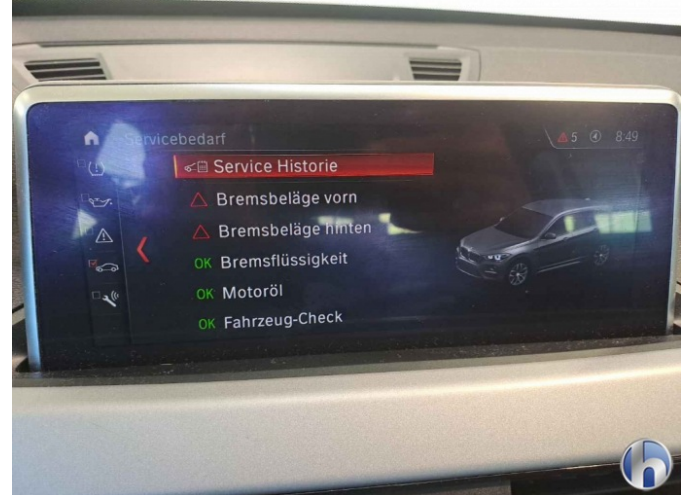
| <b>Note Road Safe:</b> | Bremsanlage Fehlermeldung, Motor Klappergeräusche |

| component | Damage | Rep kind |
|---|---|---|
| 4. brake system | Error message | Carry out a fault diagnosis |

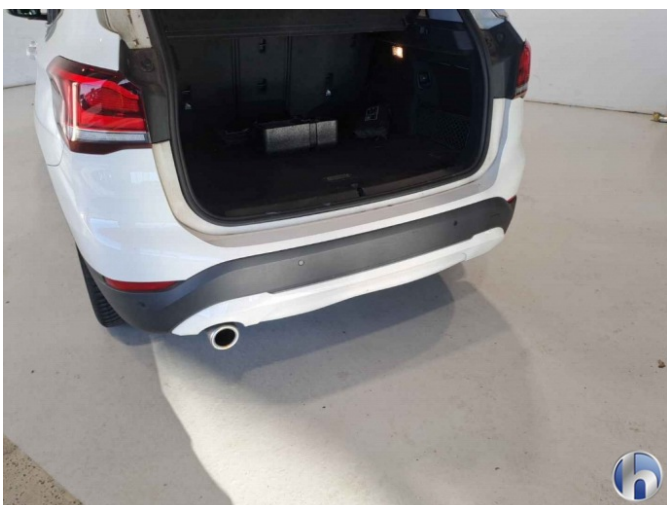
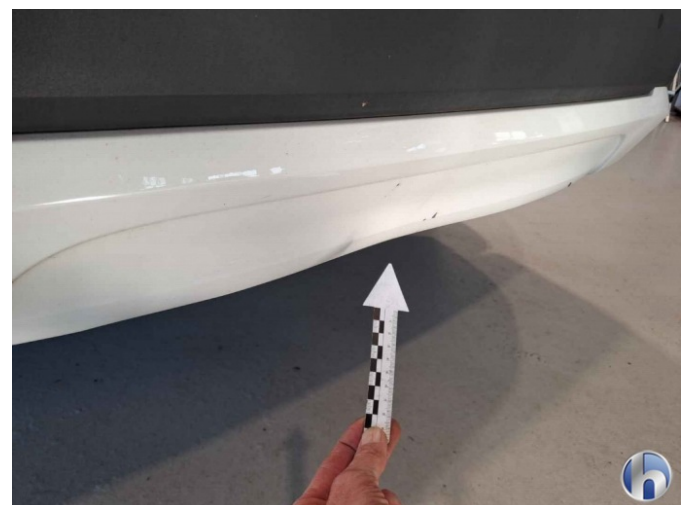
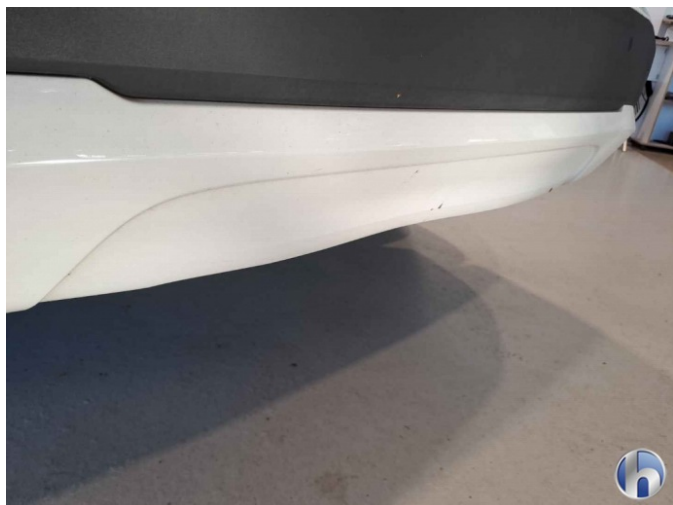
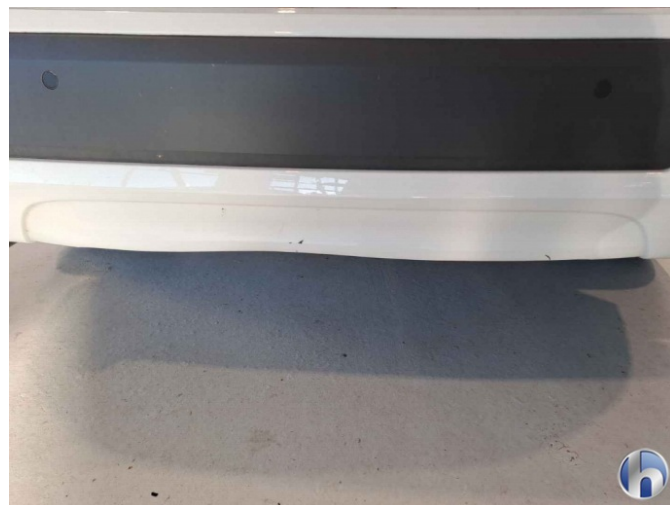
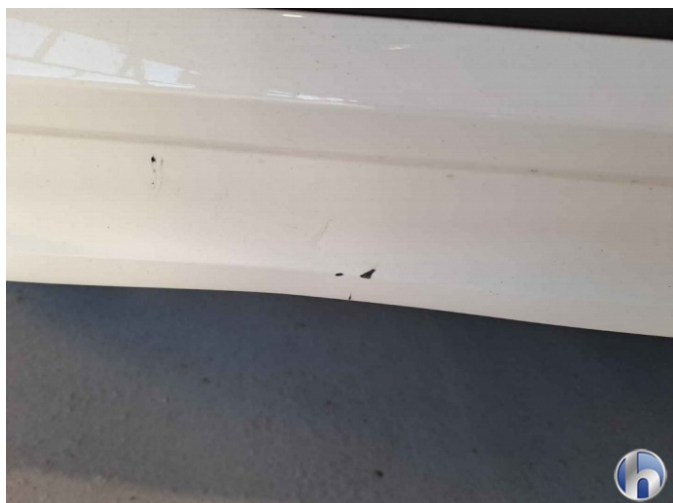
| component | Damage | Rep kind |
|---|---|---|
| 5. Rear bumper | Damaged | Replace |

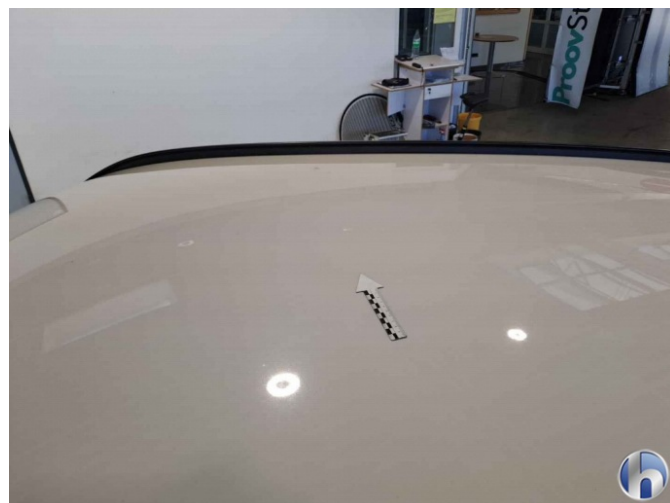
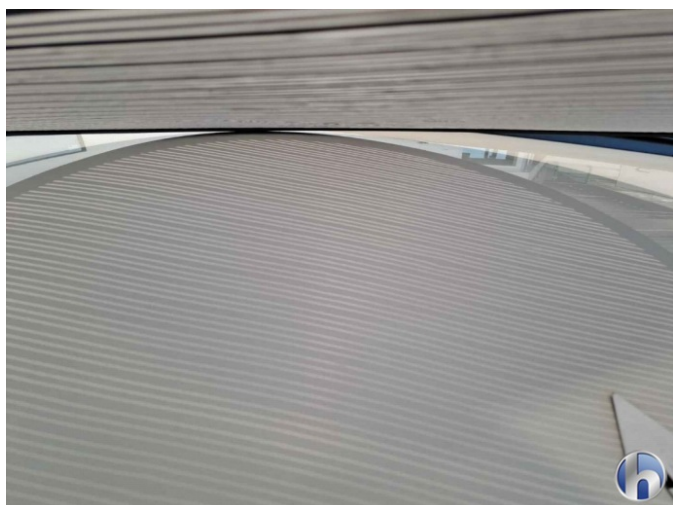
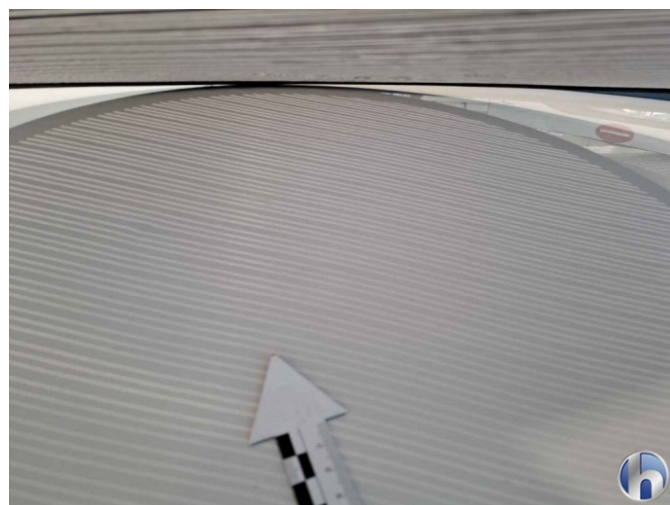
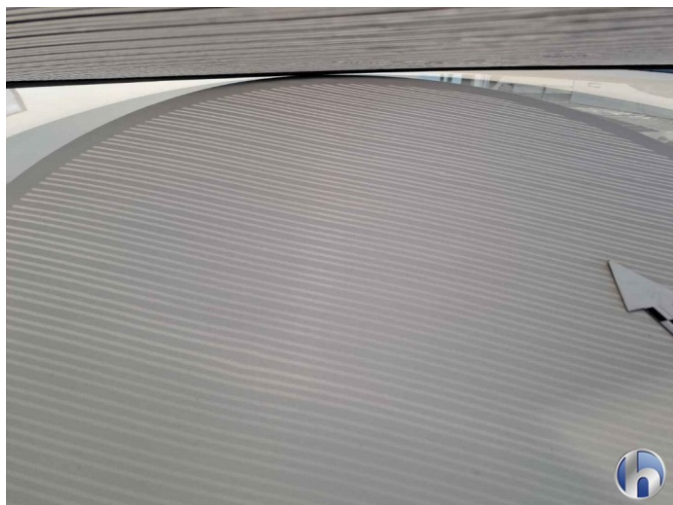
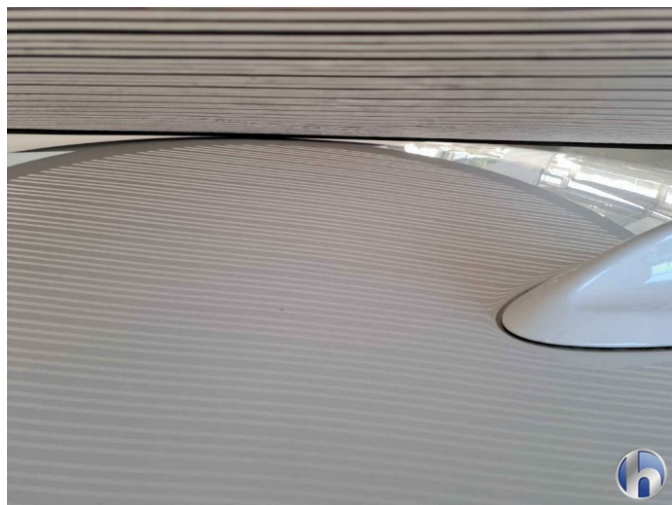
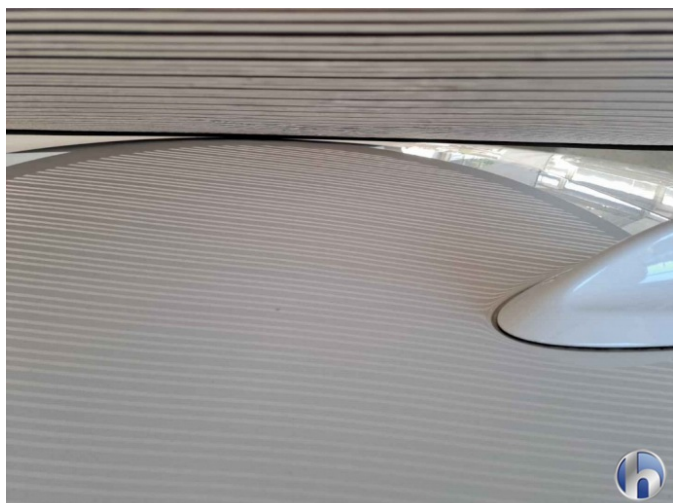
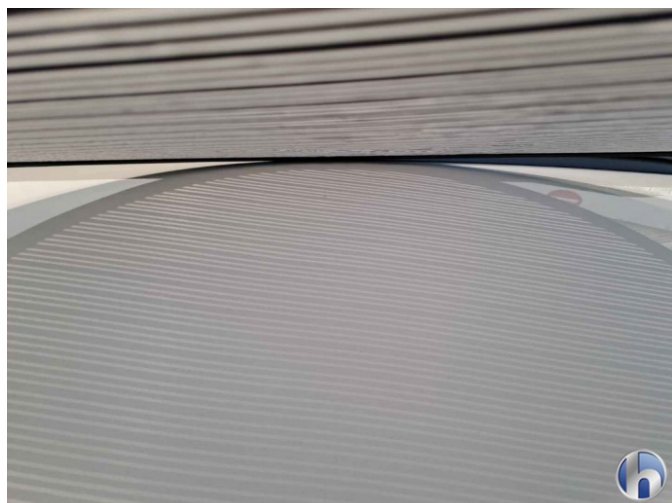
| component | Damage | Rep kind |
|---|---|---|
| 6. roof | Dented | Smart repair |

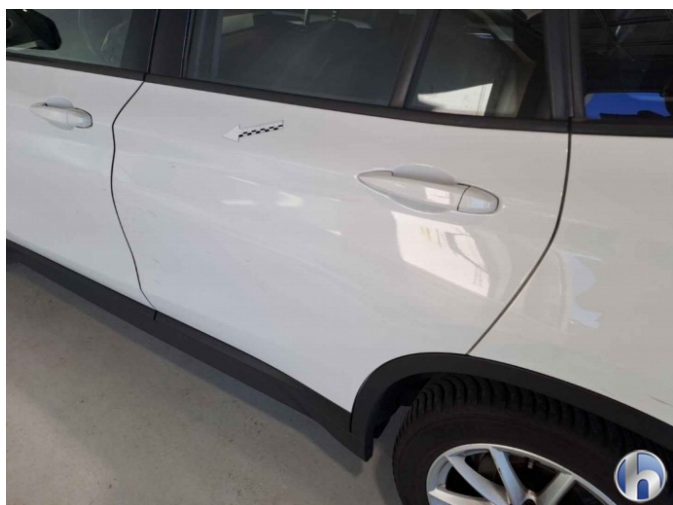
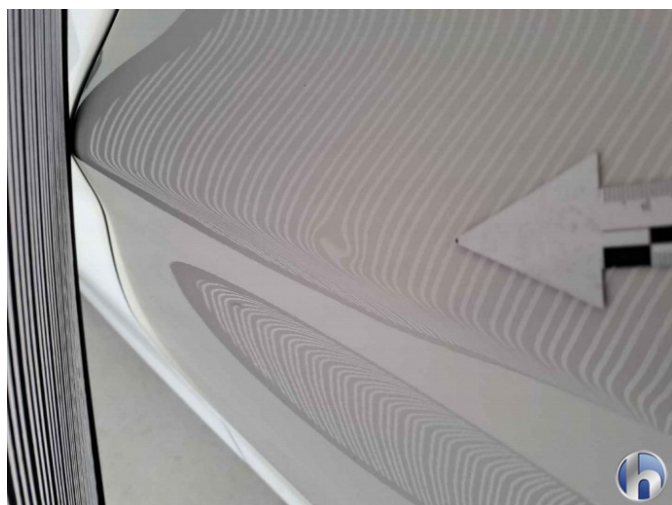
| component | Damage | Rep kind |
|---|---|---|
| 7. Rear door - left | Deformed (slightly) | Refurbish and paint |

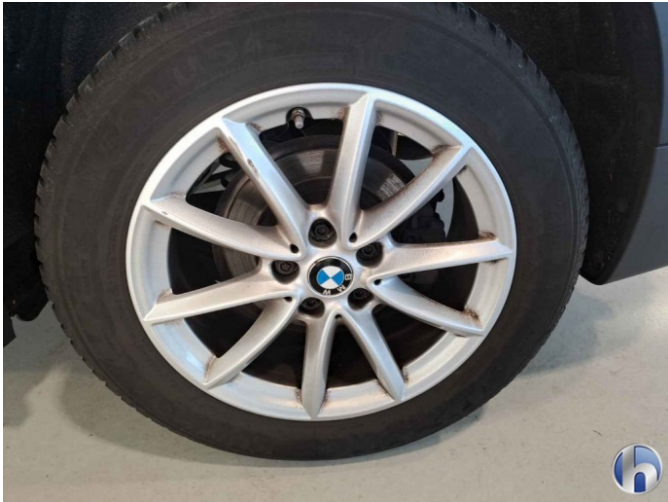
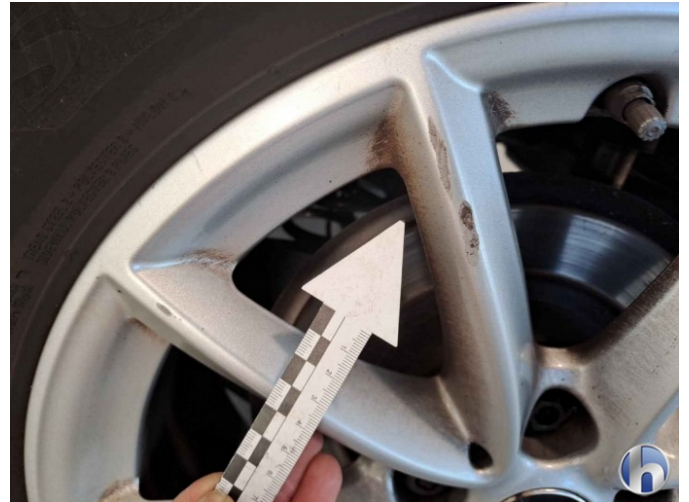
| component | Damage | Rep kind |
|---|---|---|
| 8. Rim rear - left | Damaged | Paint |

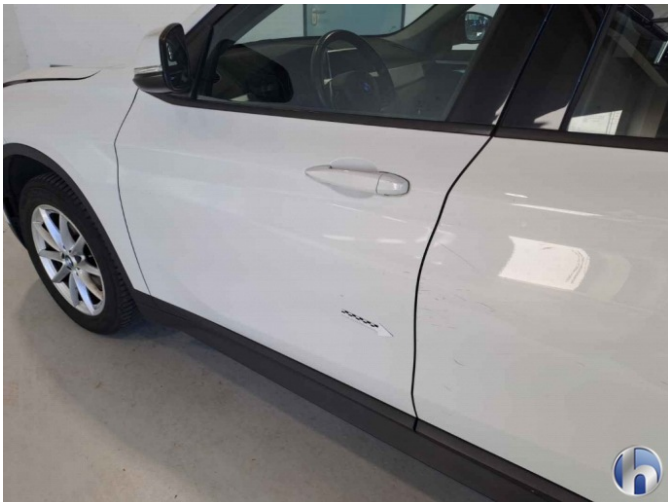
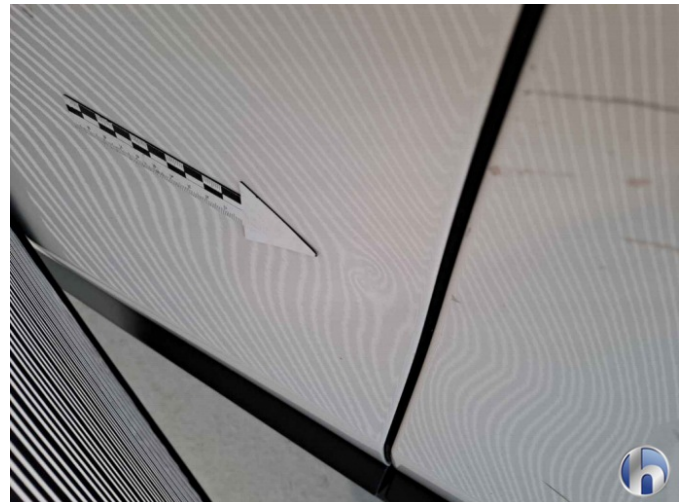
| component | Damage | Rep kind |
|---|---|---|
| 9. Front door - left | Deformed (slightly) | Refurbish and paint |

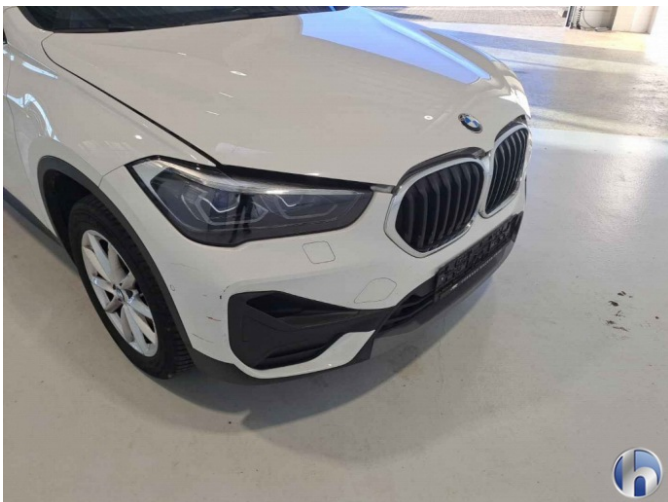
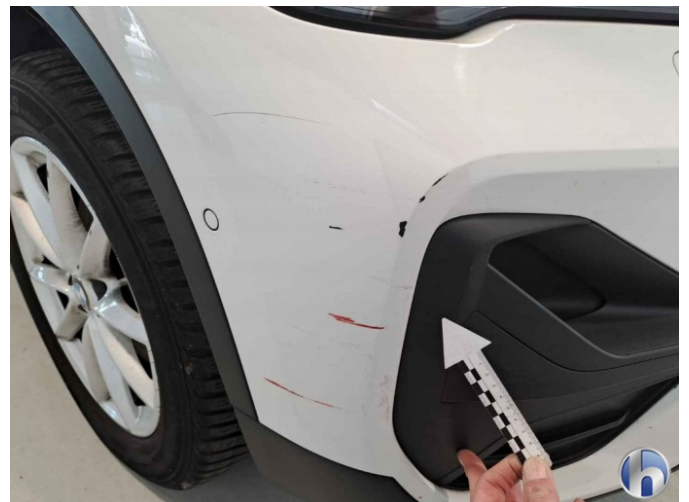
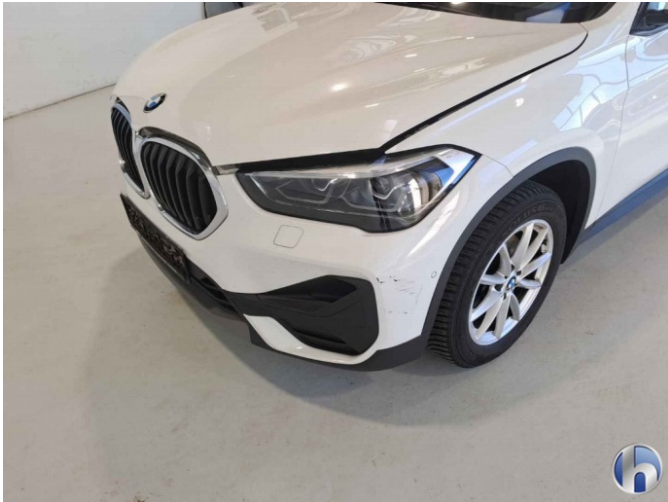
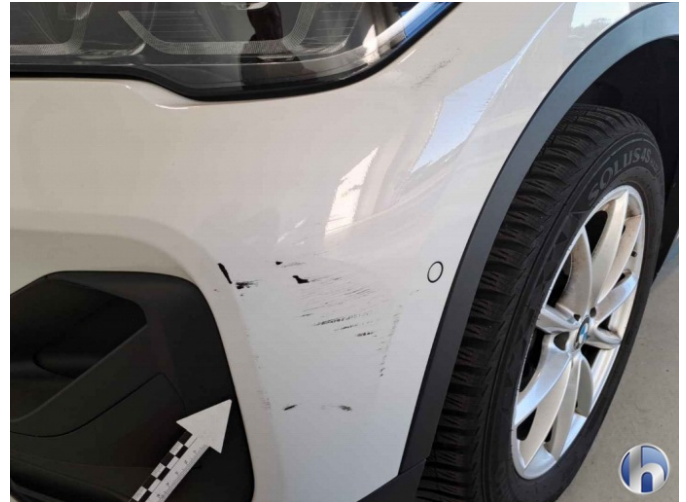
| component | Damage | Rep kind |
|---|---|---|
| 10. Front bumper | Scrape | Paint |

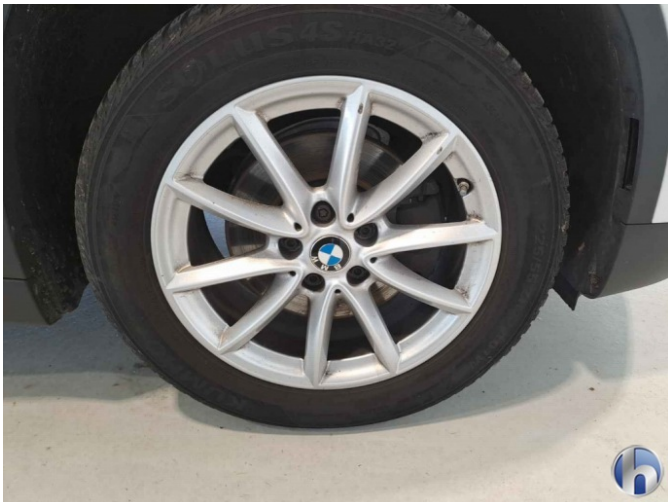
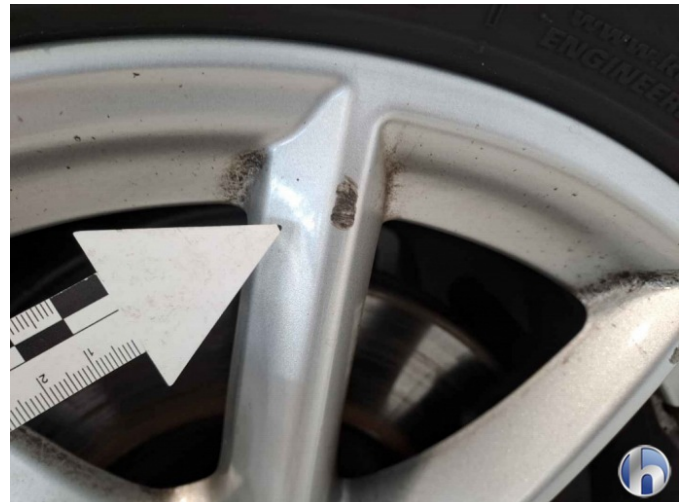
| component | Damage | Rep kind |
|---|---|---|
| 11. Rim front - right | Damaged | Paint |

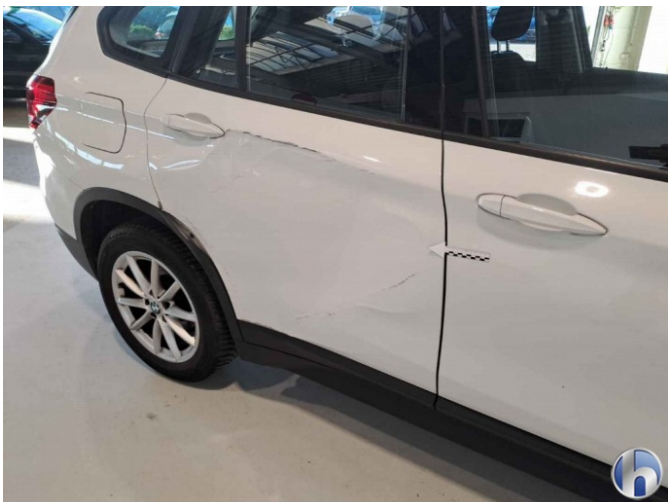
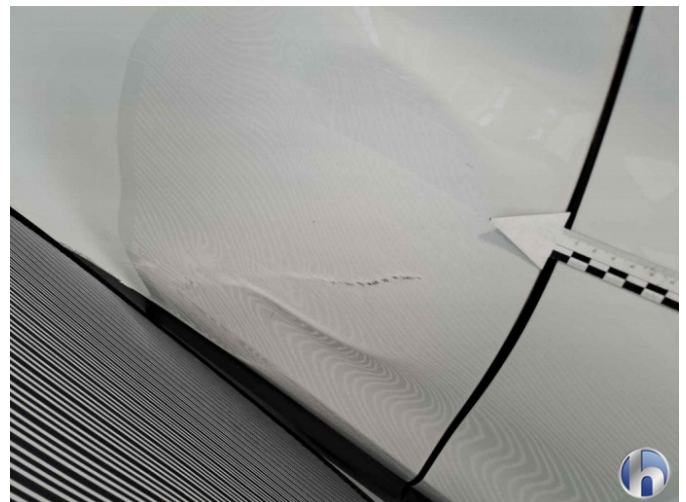
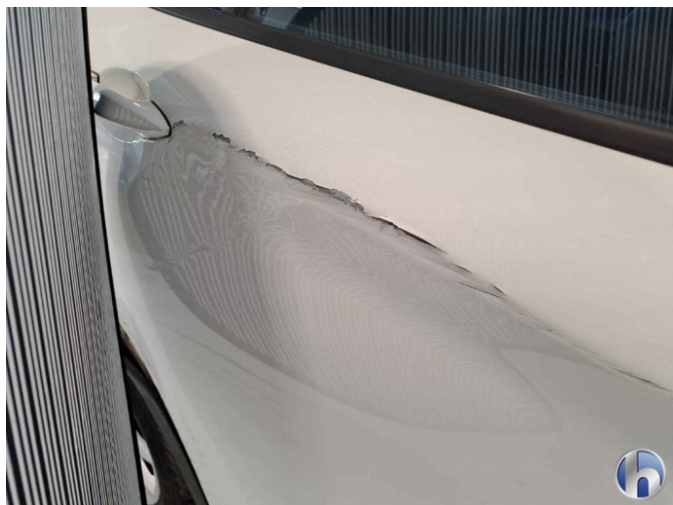
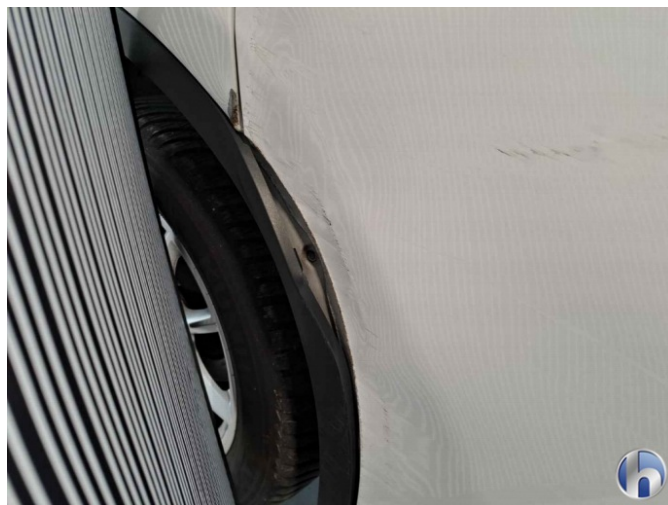
| <b>reference:</b> | Tür und Seitenteil HR. Fahrzeug mit bestehenden Unfallschaden, zur Schadensermittlung wurden keine Demontagearbeiten durchgeführt, verborgen gebliebene Schäden können nicht ausgeschlossen werden. Unfallschaden Kosten wurden überschlägig Kalkuliert, Kostenerweiterung möglich. |

| component | Damage | Rep kind |
|---|---|---|
| 12. Door Rear - right | Accident damage | Replace |

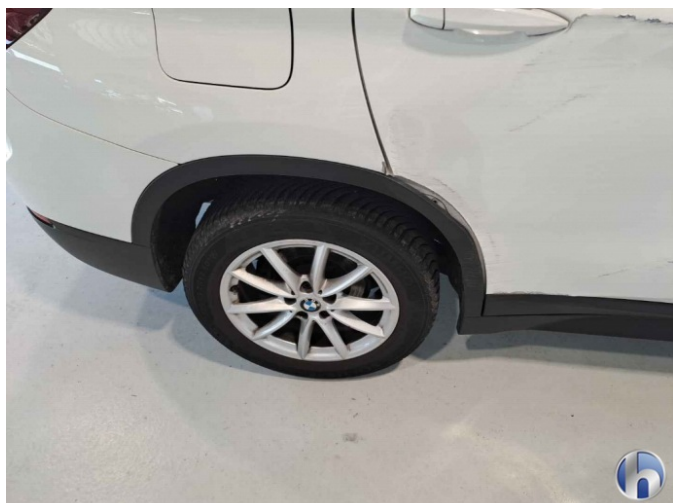
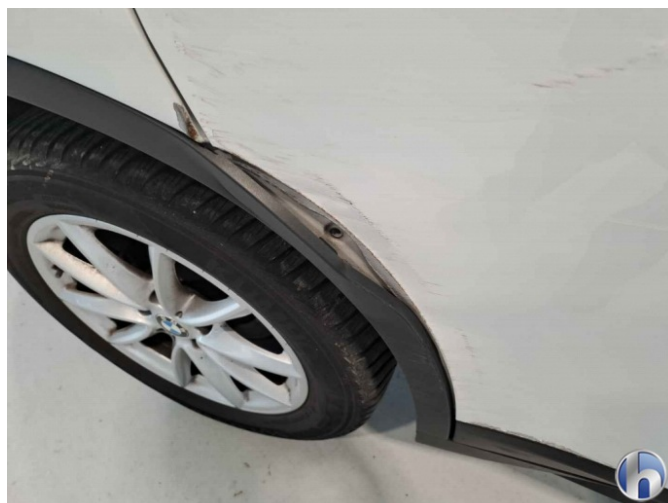
| component | Damage | Rep kind |
|---|---|---|
| 13. | Accident damage | Replace |

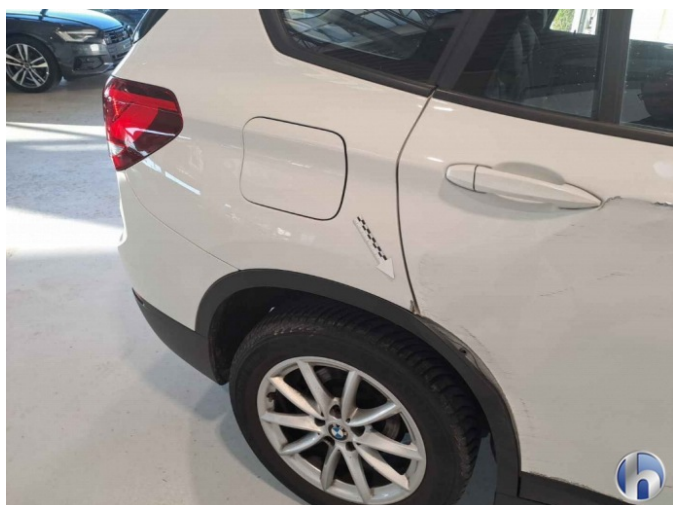
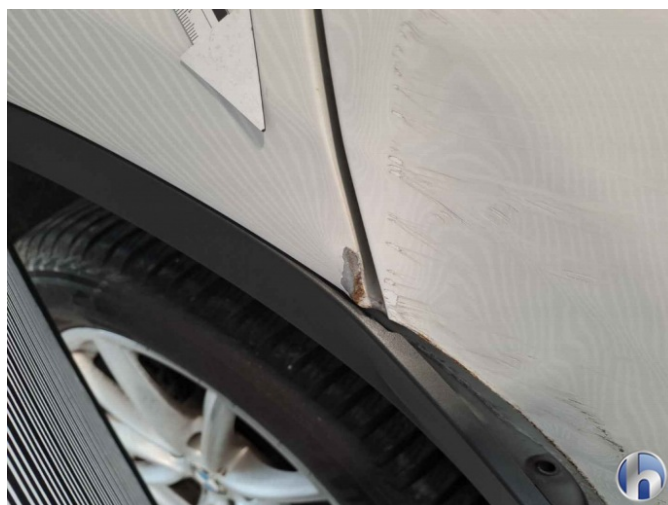
| component | Damage | Rep kind |
|---|---|---|
| 14. Sidewall - Rear - right | Accident damage | Refurbish and paint |

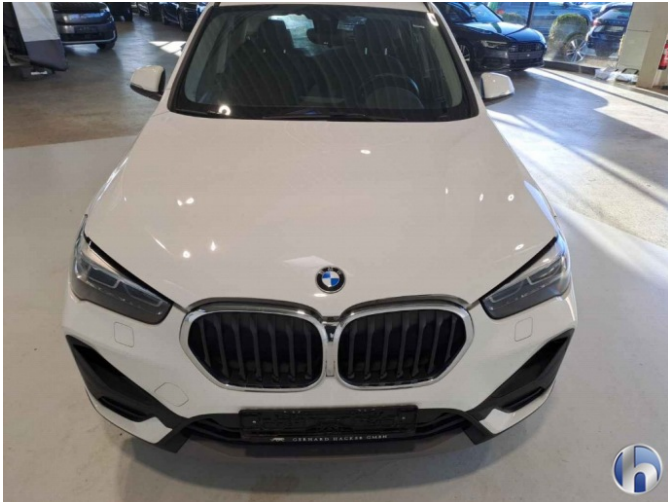
| component | Damage | Rep kind |
|---|---|---|
| 15. exterior body | Surface scratch(es) | |

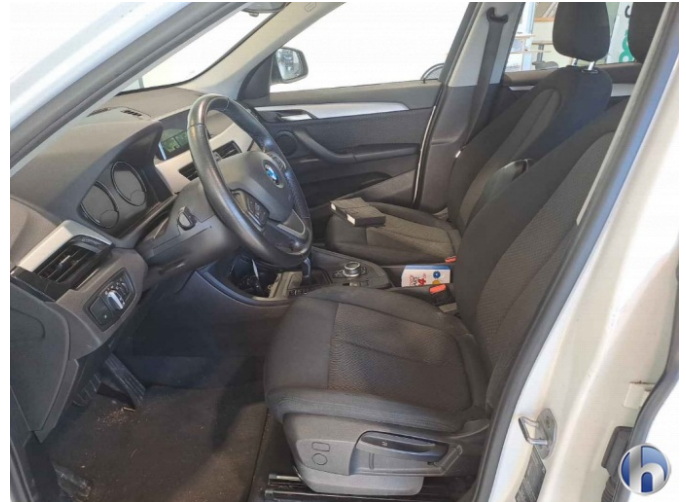
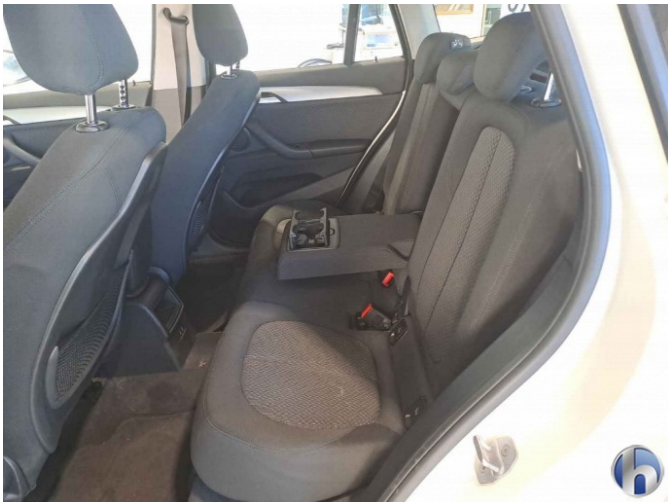
| component | Damage | Rep kind |
|---|---|---|
| 16. | Wear and tear | acceptable |

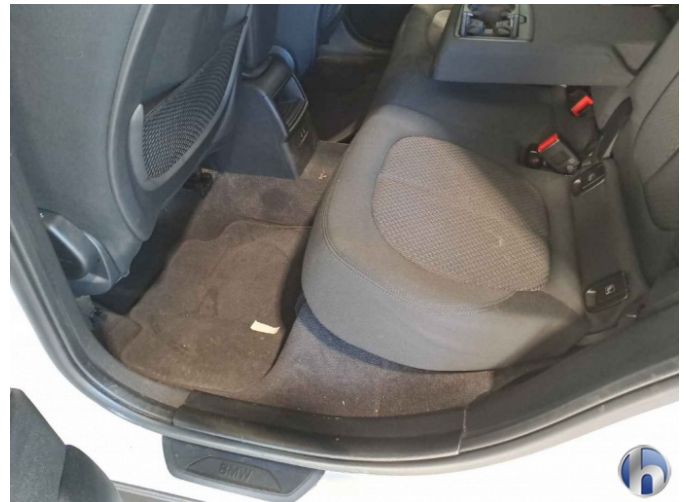
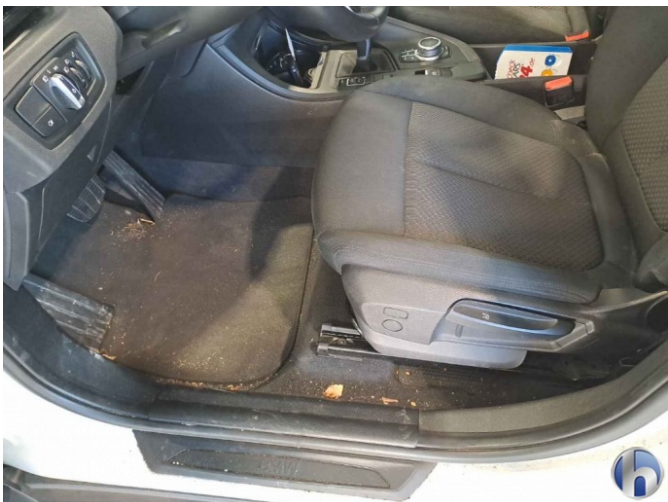
| component | Damage | Rep kind |
|---|---|---|
| 17. | Dirty | |

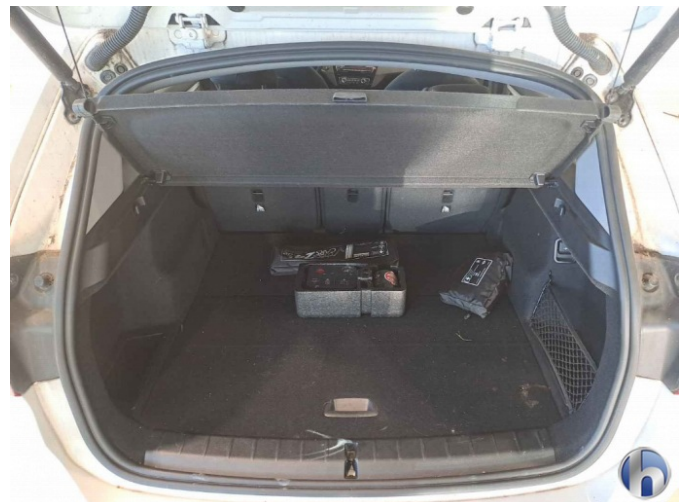
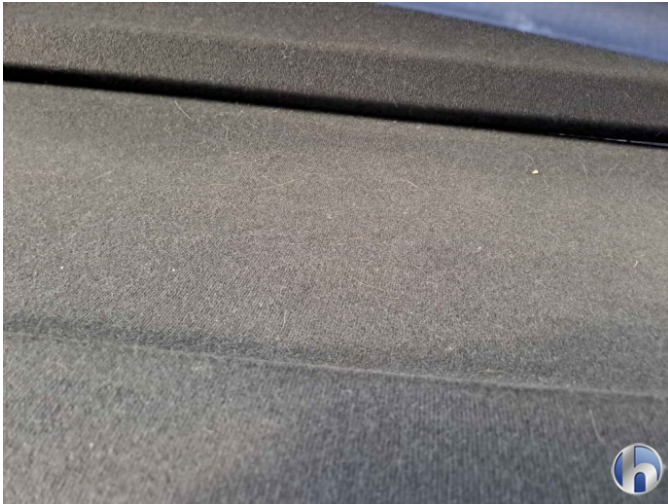
| component | Damage | Rep kind |
|---|---|---|
| 19. | Dirty (animal hair) | |

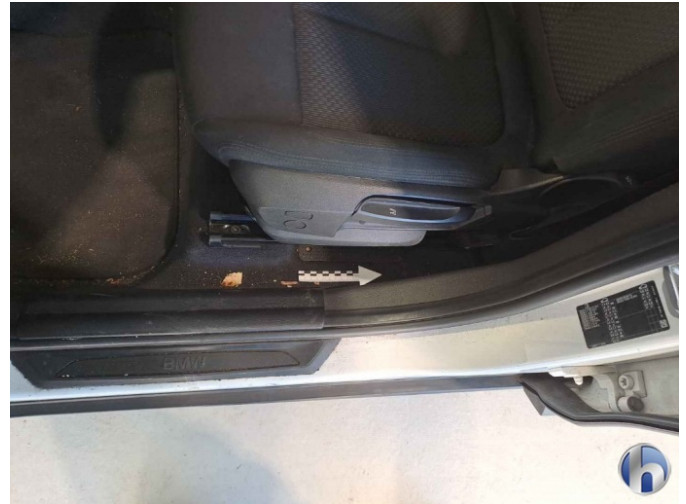
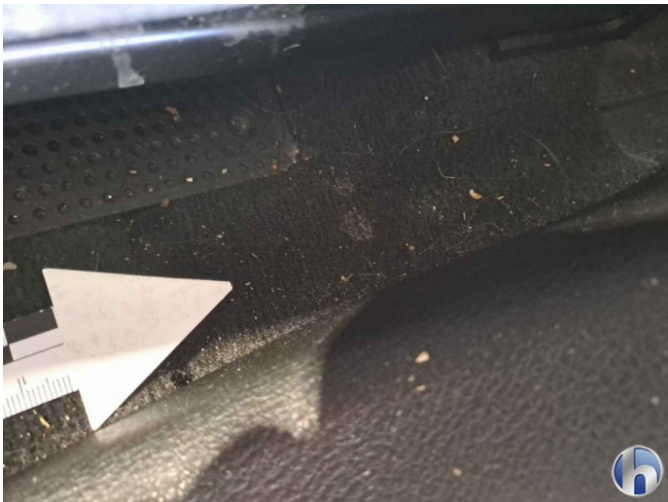
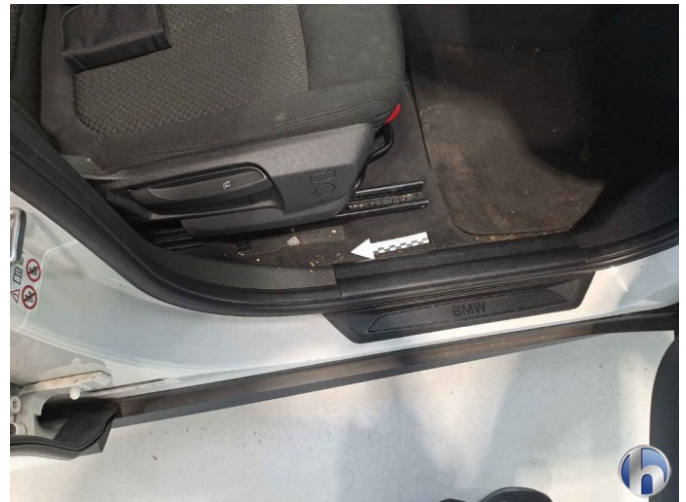
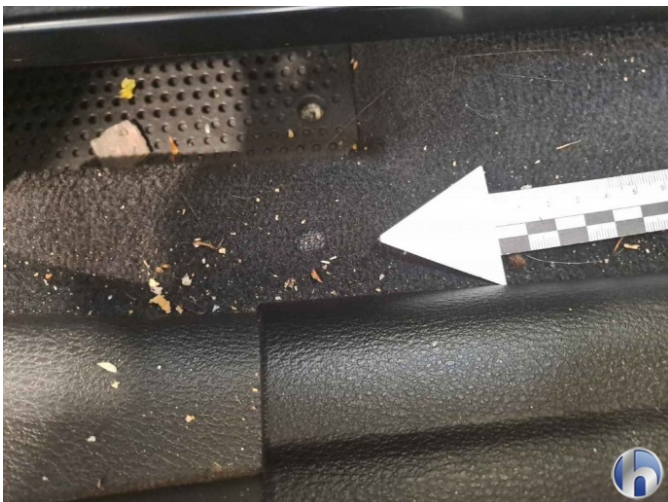
| component | Damage | Rep kind |
|---|---|---|
| 20. flooring | Burn hole | Replace |

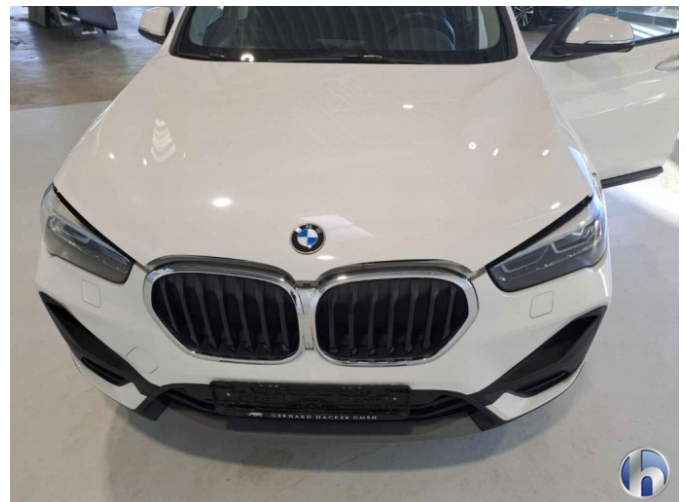
| component | Damage | Rep kind |
|---|---|---|
| 21. hood | Not open | Carry out a fault diagnosis |

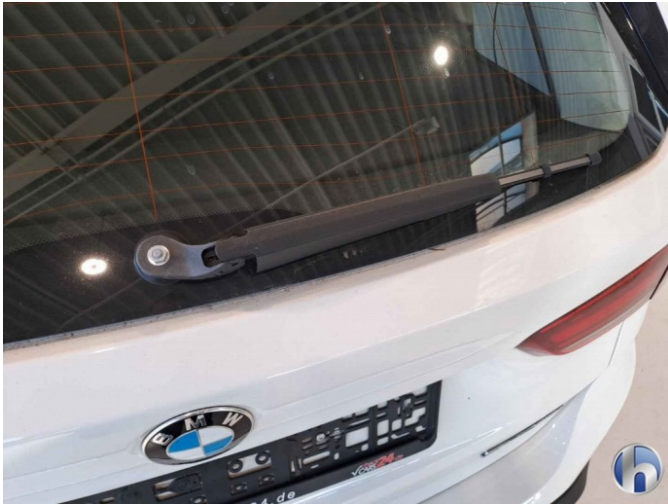
| component | Damage | Rep kind |
|---|---|---|
| 22. Kappe Heckwischer | Missing | Replace |
