status report

customer: BCA Autoauktionen GmbH

BMW Baureihe 3 Touring 316 i

Vehicle identification number	WBA3G11010KR69269	mileage read:	158969 km
First Registration / construction year:	07.07.2015 / 2015	Visit Date / place of birth:	02.09.2025 Hoppegarten
Bodywork:	cars	Re - import:	no
Body type:	station wagon	KBA no. :	0005//BOY
Fuel / emission class:	gasoline / € 6	transmission type:	automatic
Displacement / power:	1598 ccm / 100 kW (136 PS)	Engine:	rear-wheel drive
paint:	MINERALGRAU METALLIC	Number of previous owners:	3
Doors / seats:	5 / 5	number keys:	2
Next HU / AU:	- / -	cushion type:	substance
Service book available:	digital	Interior Color:	black
smoking vehicle:	yes	Last service km / on the:	78744 / 28.02.2020
Vehicle roadworthy:	yes	Vehicle roadworthy:	yes
Submitted vehicle	Eg II (veh - letter)	state outside:	3 - Average
documents:			
visit condition:	-	condition inside:	3 - Average
state general:	3 - Average

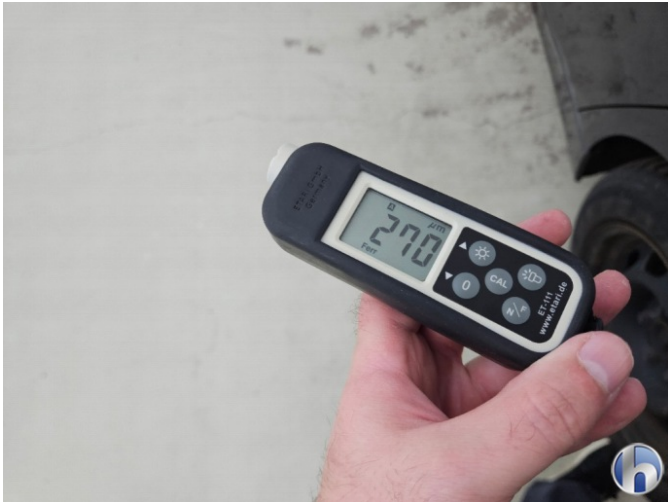
component	Damage	Rep kind
1. roof	Subsequently painted	acceptable
2. Rear door - left	Subsequently painted	acceptable
3. Front door - left	Subsequently painted	acceptable
4. Front fender - left	Subsequently painted	acceptable
5. hood	Subsequently painted	acceptable
6. Front fender - right	Subsequently painted	acceptable
7. maintenance	Due	Replace
8.	Not available	acceptable
9. Front bumper	Scrape	Paint
10. Front fender - left	Execution defect	Paint
11. Front fender - left	Wear and tear	acceptable
12.	Dirty
