## status report

#### BMW Baureihe 3 Gran Turismo 330 d xDrive

| Vehicle identification number | <b>WBA3Z51000D398573</b> | mileage read: | <b>206985 km</b> |

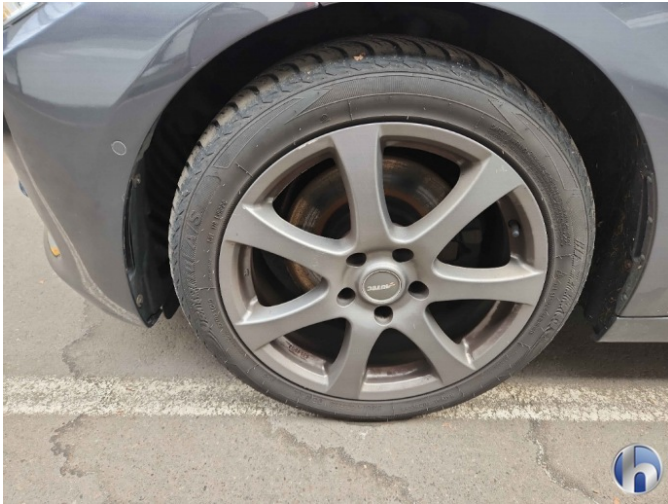
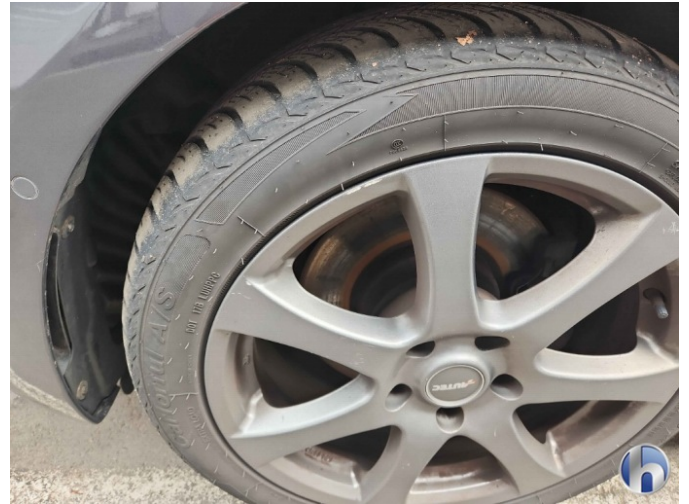
| | component | Damage | Rep kind |
|---|---|---|---|
| 1. | Rim front - left | Scratch(es) | Paint |

1. Rim front - left

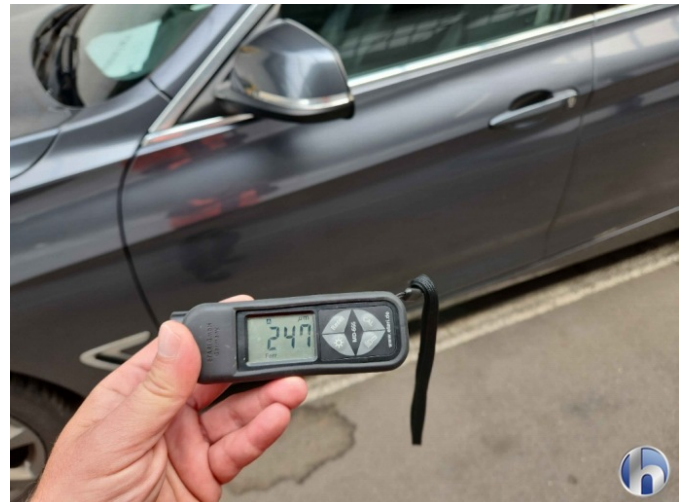
| | component | Damage | Rep kind |
|---|---|---|---|
| 2. | Front door - left | Execution defect | Refurbish and paint |

2. Front door - left

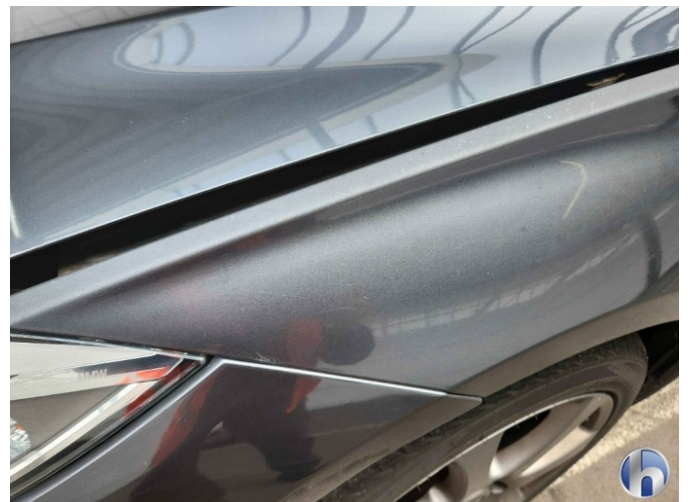
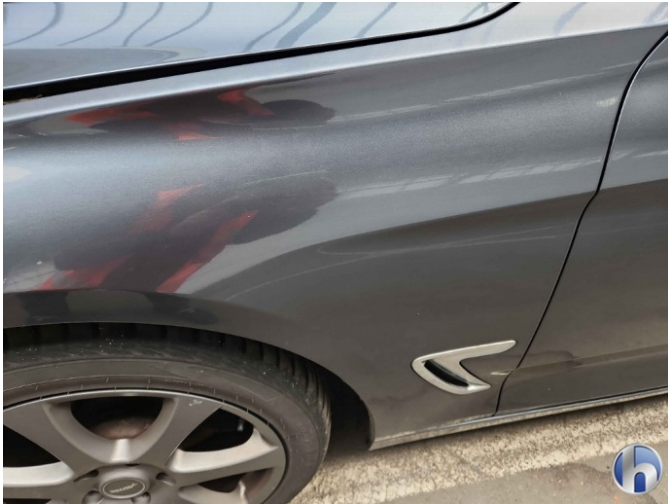
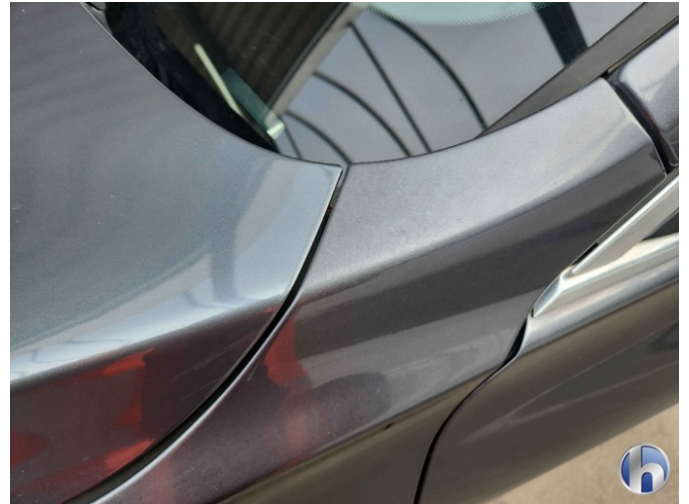
| | component | Damage | Rep kind |
|---|---|---|---|
| 3. | Front fender - left | Execution defect | Refurbish and paint |

3. Front fender - left

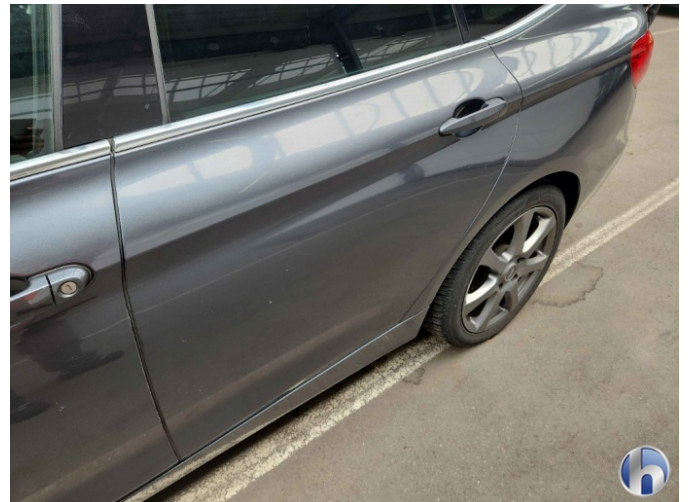
| | component | Damage | Rep kind |
|---|---|---|---|
| 4. | Rear door - left | Execution defect | Paint |

4. Rear door - left

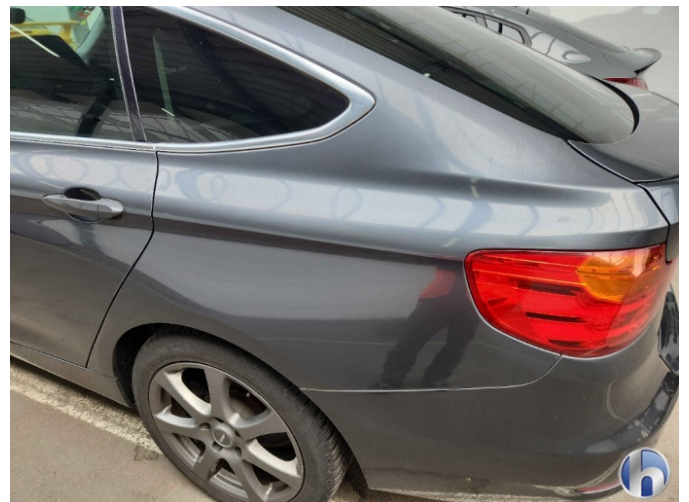
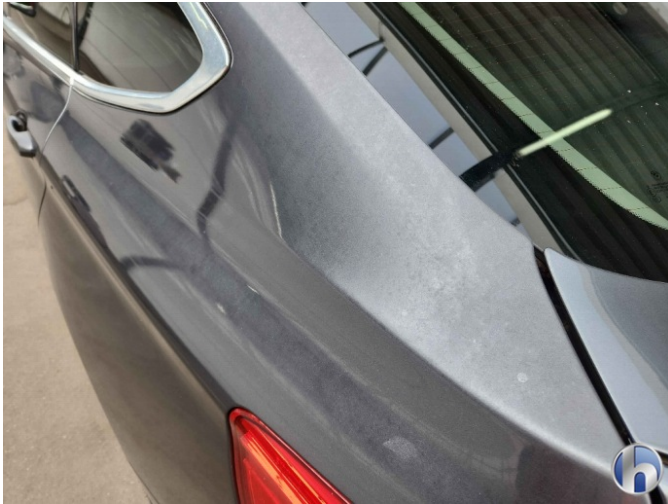
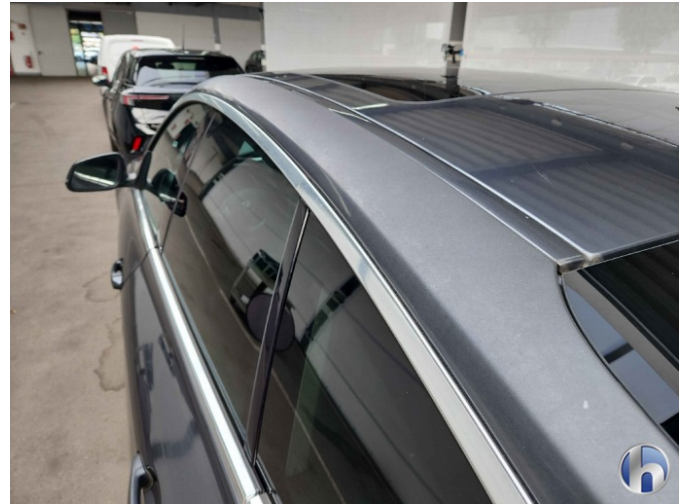
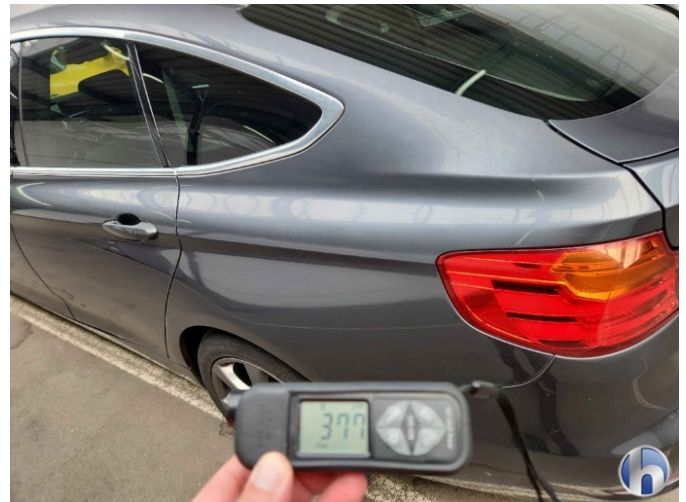
| | component | Damage | Rep kind |
|---|---|---|---|
| 5. | Sidewall - Rear - Left | Execution defect | Refurbish and paint |

5. Sidewall - Rear - Left

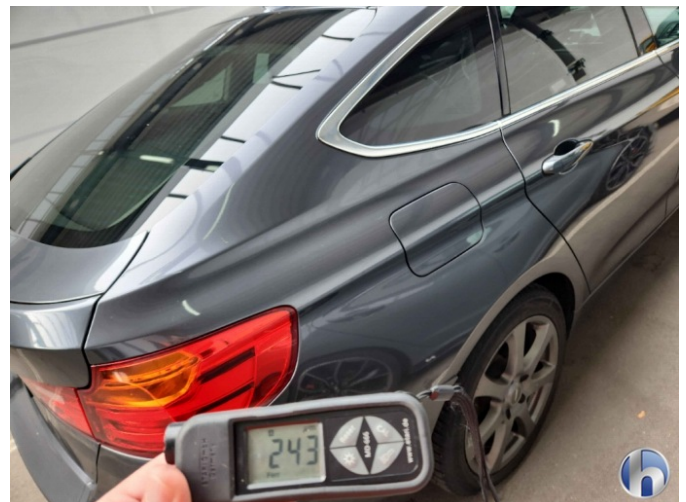
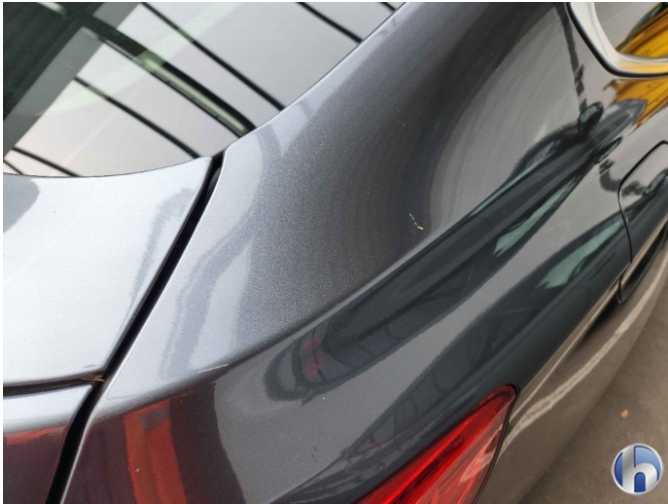
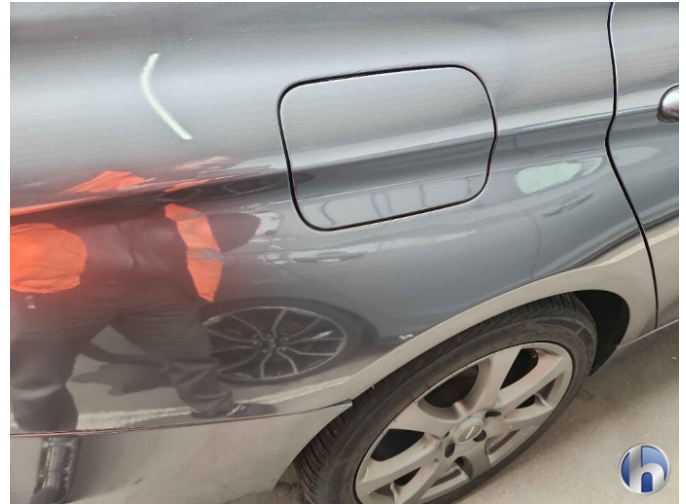
| | component | Damage | Rep kind |
|---|---|---|---|
| 6. | Sidewall - Rear - right | Execution defect | Refurbish and paint |

6. Sidewall - Rear - right

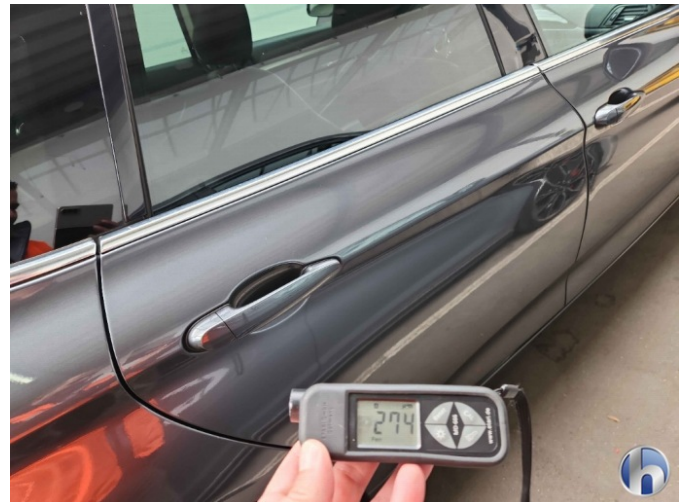
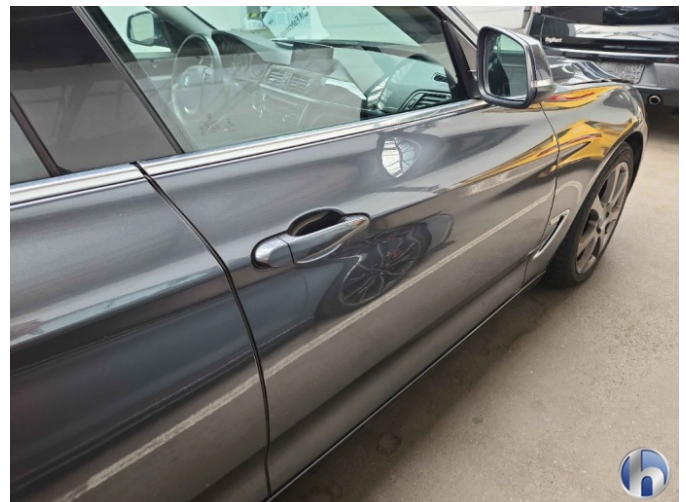
| | component | Damage | Rep kind |
|---|---|---|---|
| 7. | Door Rear - right | Execution defect | Refurbish and paint |

7. Door Rear - right

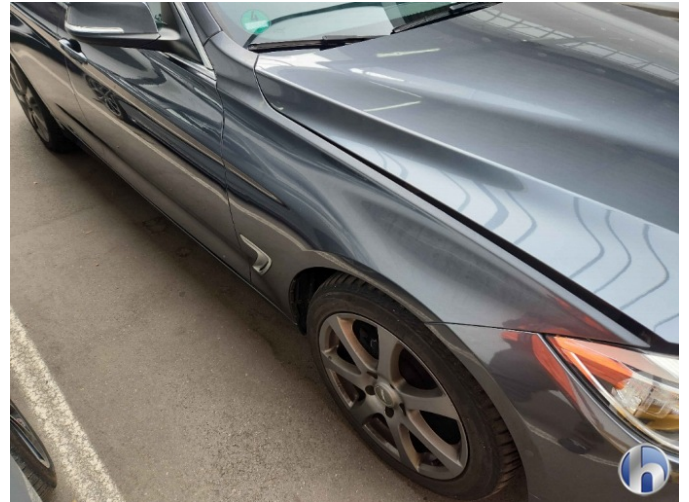
| | component | Damage | Rep kind |
|---|---|---|---|
| 8. | Front door - right | Execution defect | Refurbish and paint |

8. Front door - right

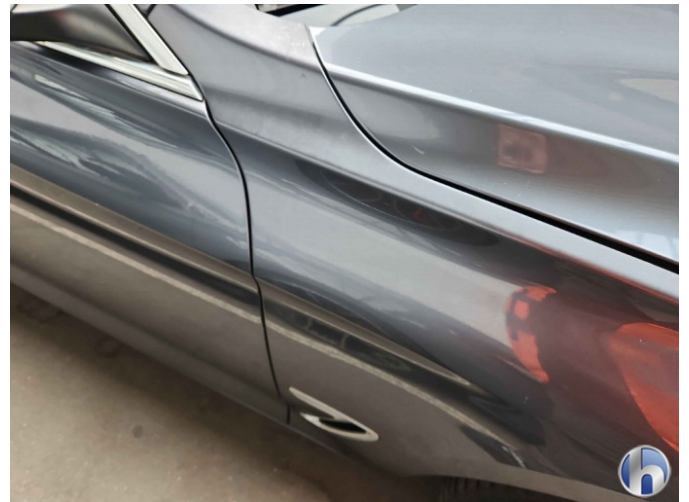
| | component | Damage | Rep kind |
|---|---|---|---|
| 9. | Front fender - right | Execution defect | Refurbish and paint |

9. Front fender - right

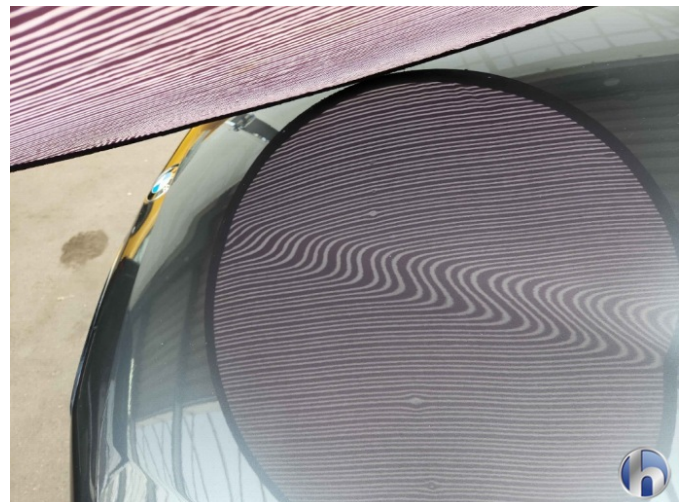
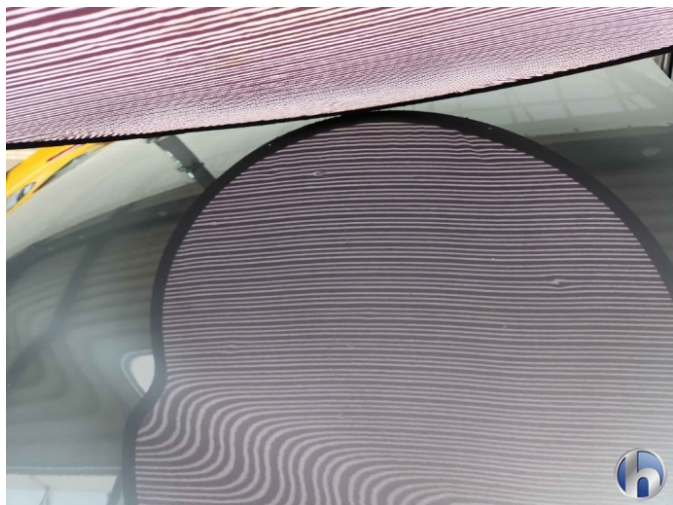
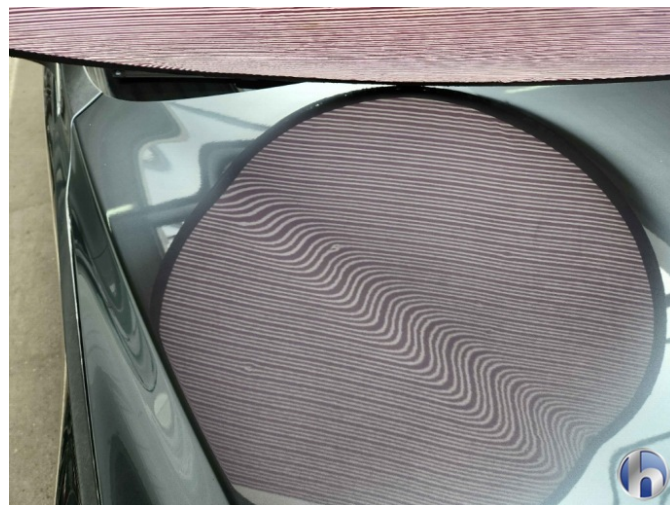
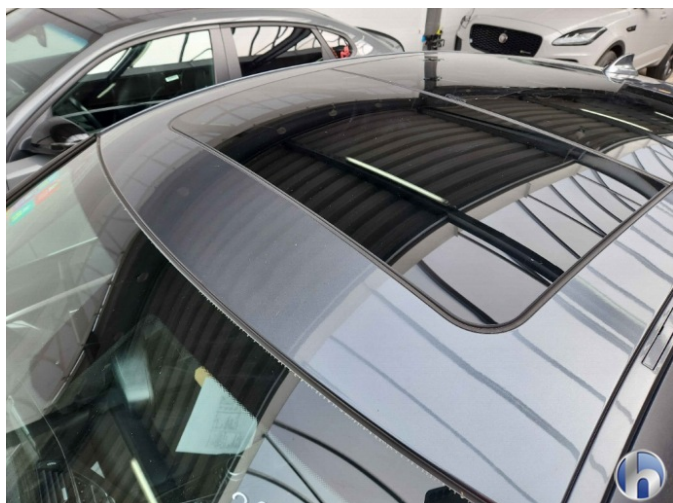
| | component | Damage | Rep kind |
|---|---|---|---|
| 10. | hood | Hail damage | Refurbish and paint |

10. hood

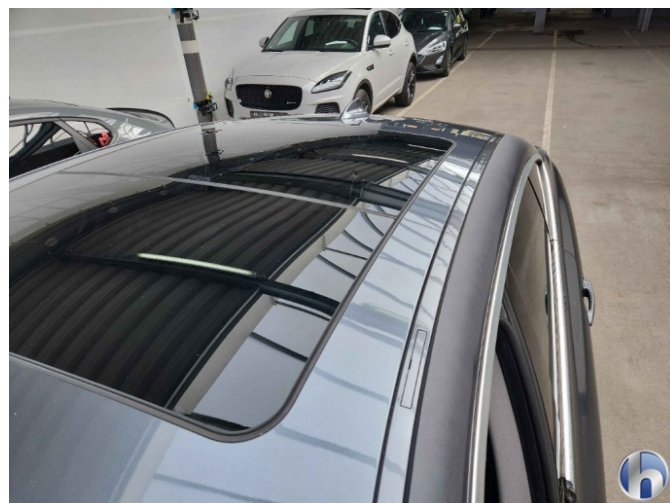
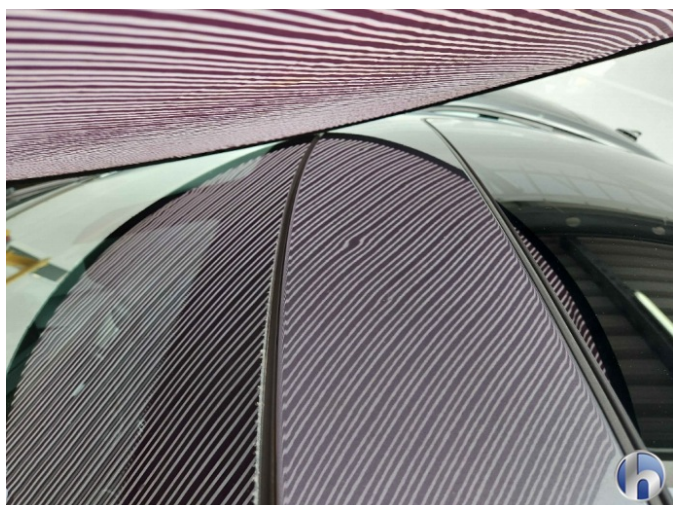
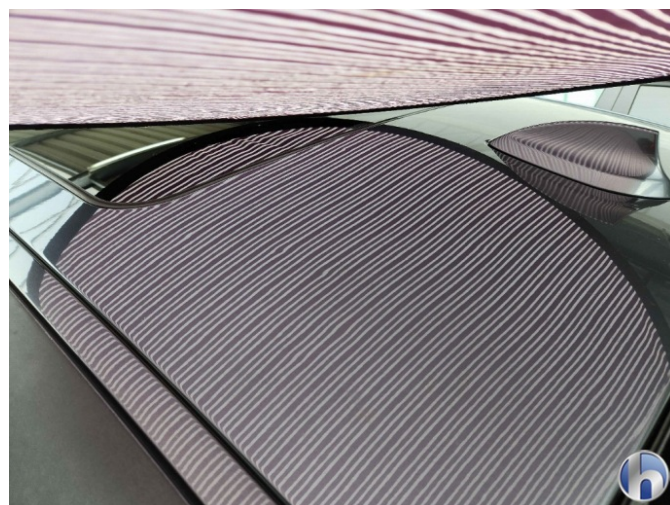
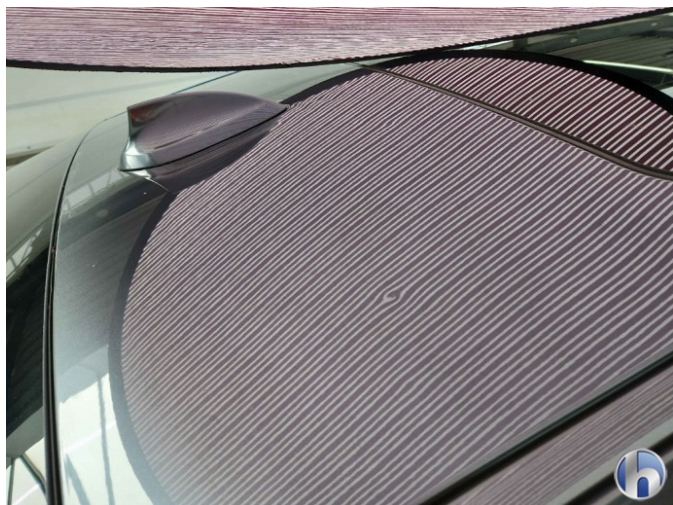
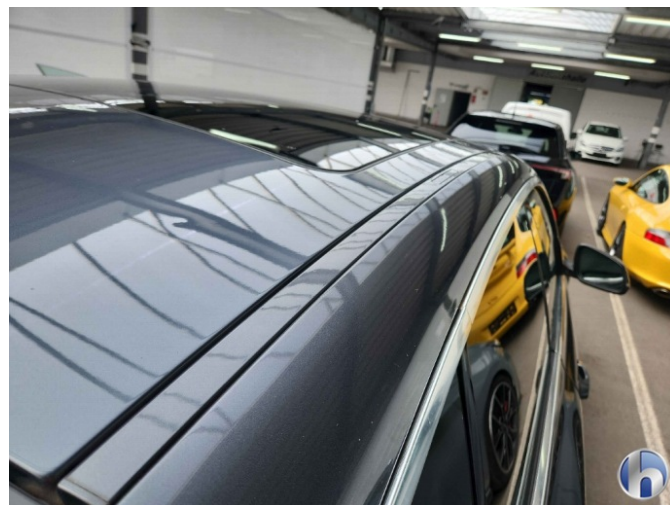
| | component | Damage | Rep kind |
|---|---|---|---|
| 11. | roof | Hail damage | Refurbish and paint |

11. roof

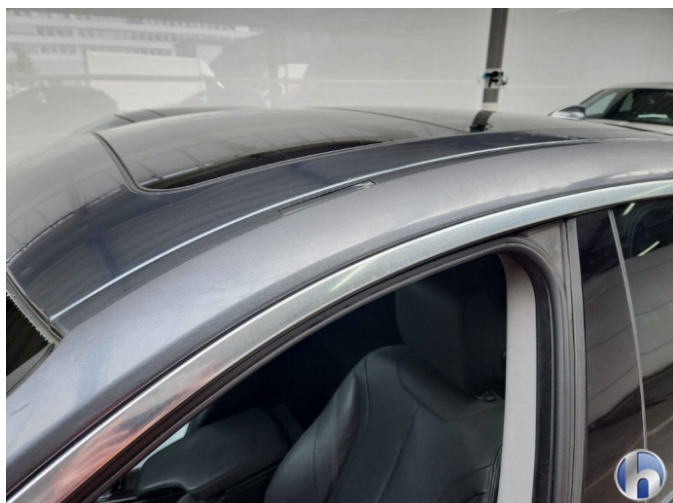
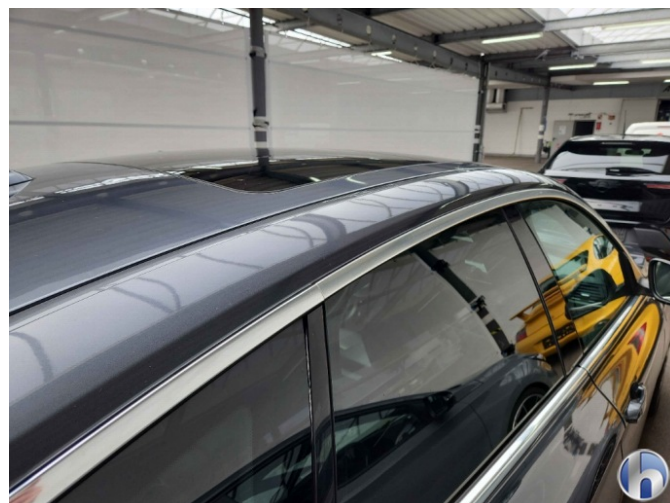
| | component | Damage | Rep kind |
|---|---|---|---|
| 14. | Roof frame - left | Execution defect | Refurbish and paint |

14. Roof frame - left

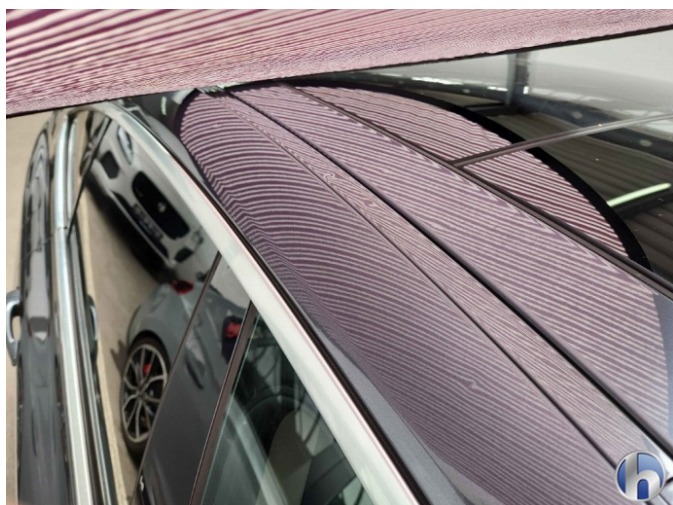
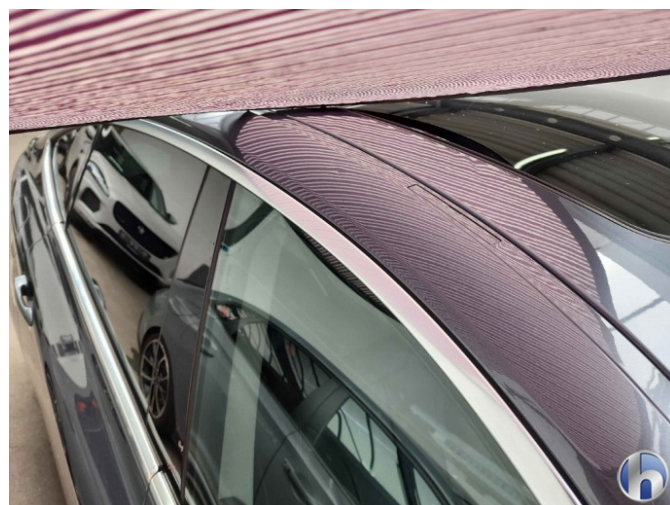
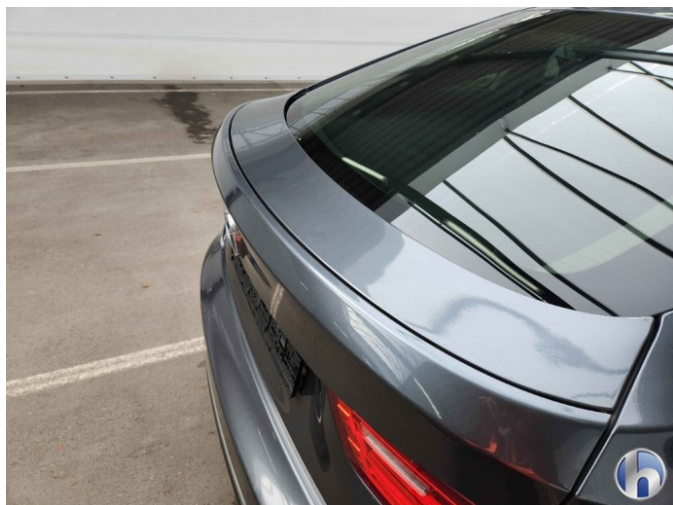
| | component | Damage | Rep kind |
|---|---|---|---|
| 15. | Roof frame - right | Hail damage | Refurbish and paint |

15. Roof frame - right

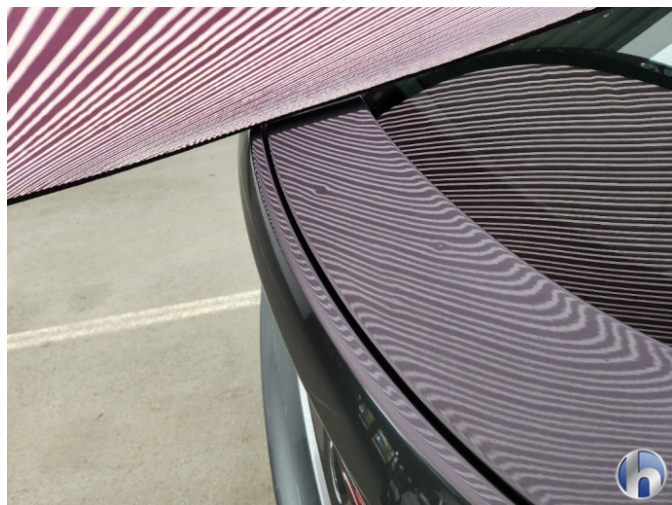
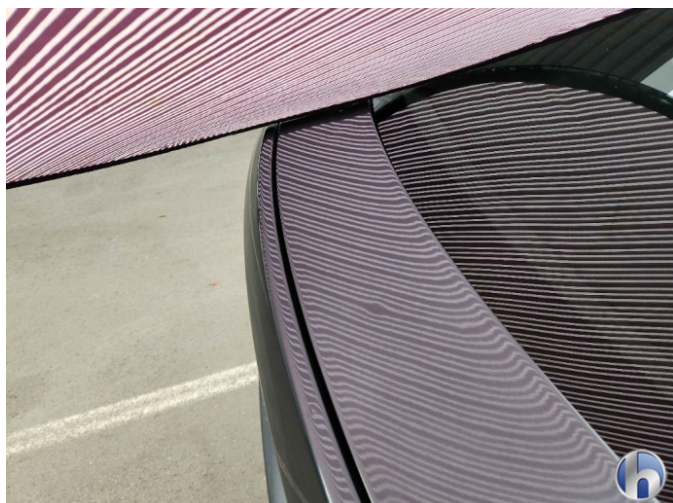
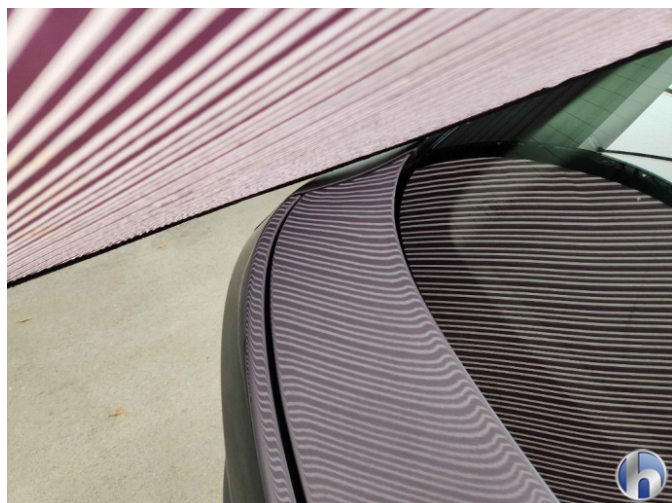
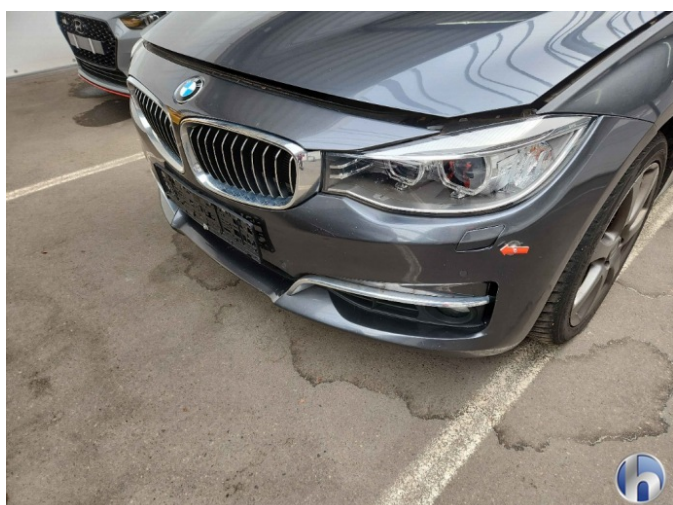
| | component | Damage | Rep kind |
|---|---|---|---|
| 16. | tailgate | Hail damage | Refurbish and paint |

16. tailgate

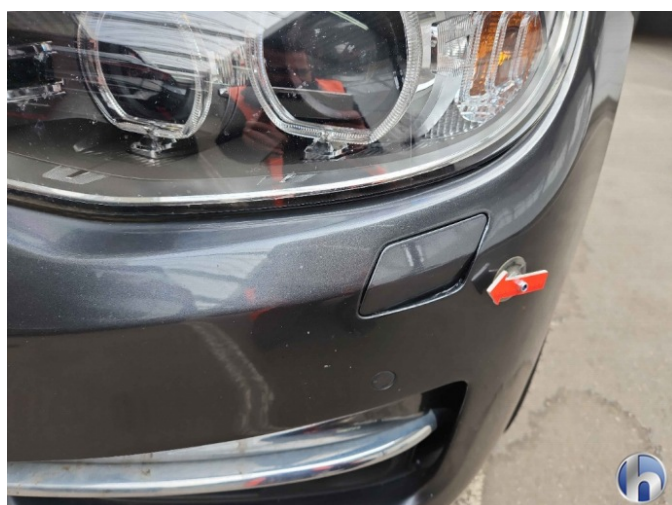
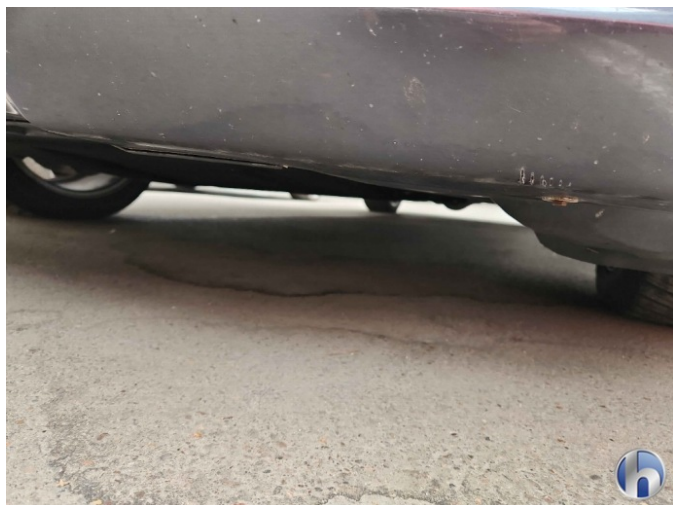
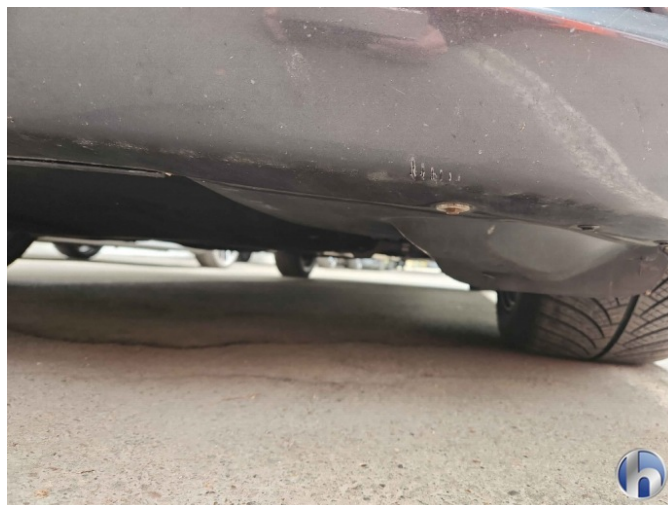
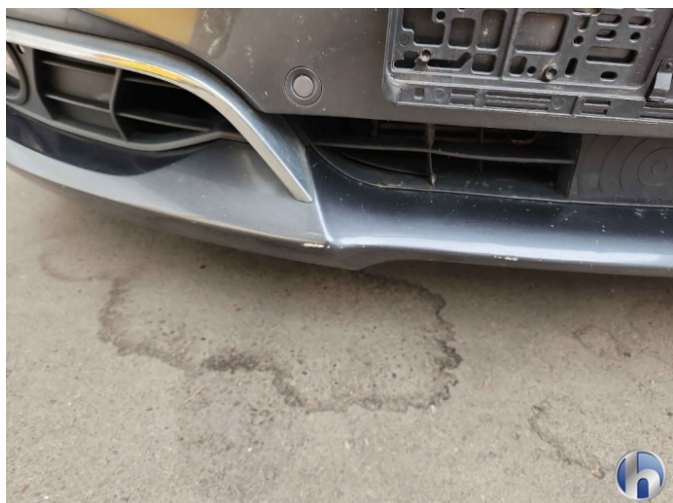
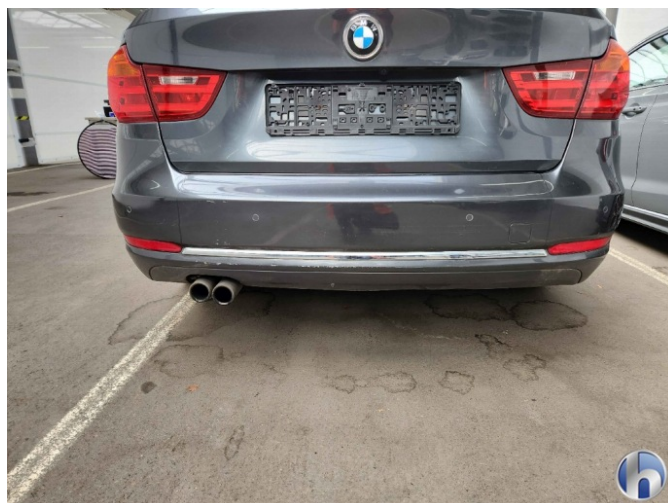
| | component | Damage | Rep kind |
|---|---|---|---|
| 17. | Front bumper | Damaged | Replace |

17. Front bumper

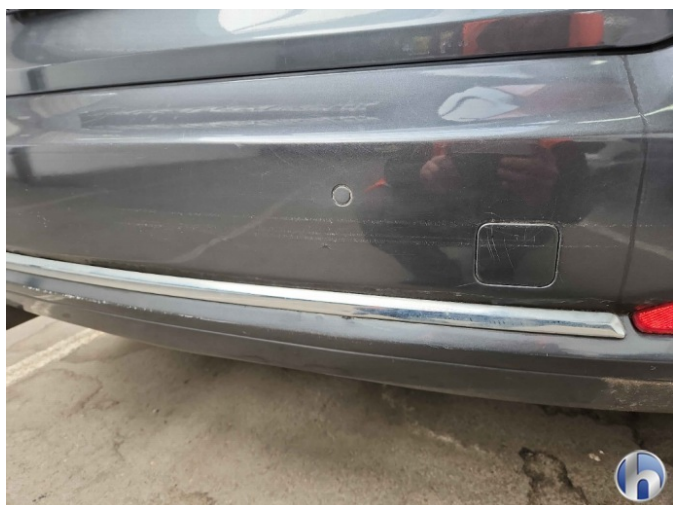
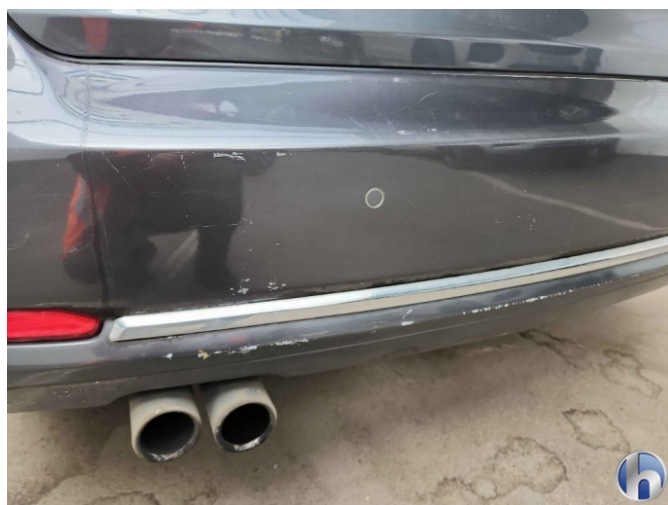
| | component | Damage | Rep kind |
|---|---|---|---|
| 18. | Rear bumper | Damaged | Replace |

18. Rear bumper

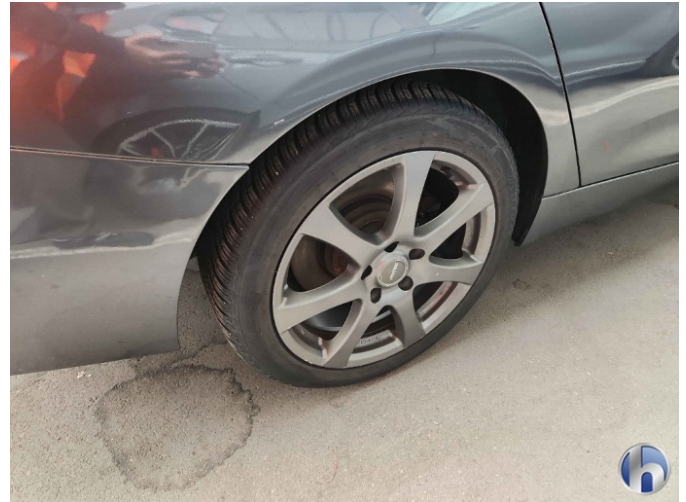
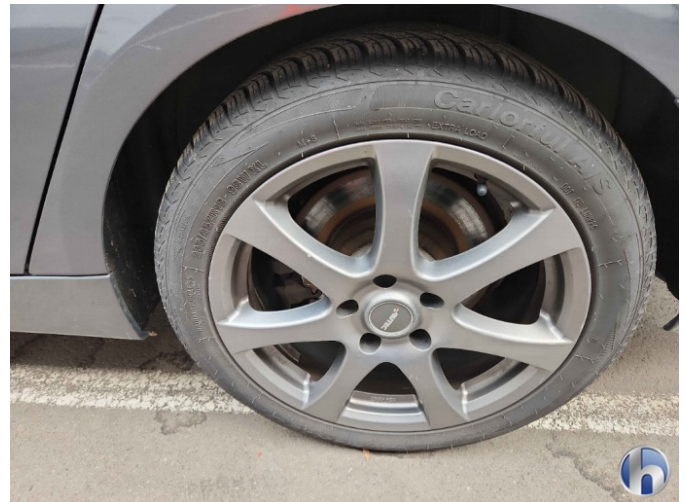
| | component | Damage | Rep kind |
|---|---|---|---|
| 19. | Rim rear - right | Scratch(es) | Paint |

19. Rim rear - right

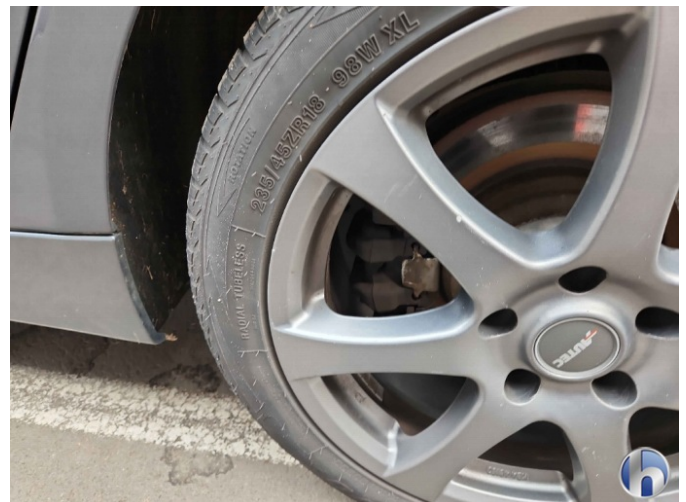
| | component | Damage | Rep kind |
|---|---|---|---|
| 20. | Rim rear - left | Scratch(es) | Paint |

20. Rim rear - left

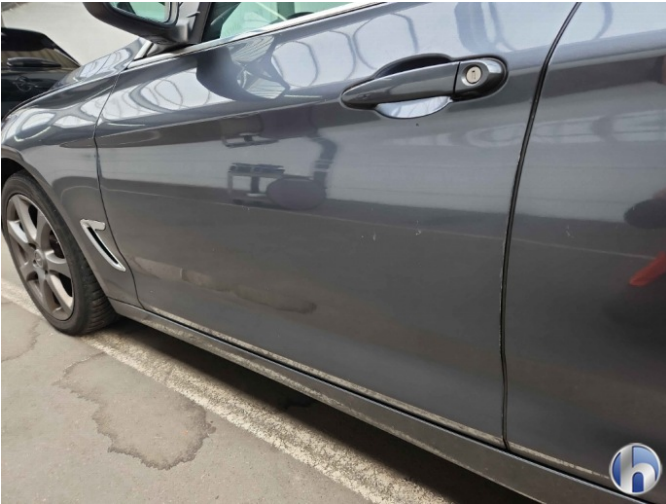
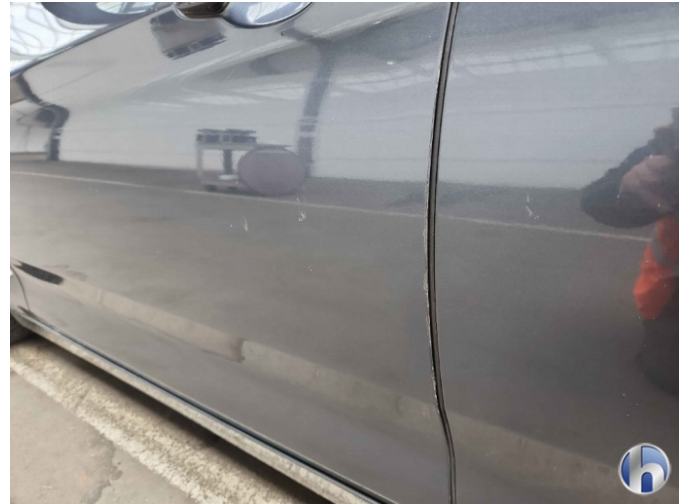
| | component | Damage | Rep kind |
|---|---|---|---|
| 21. | Front door - left | Sticker | Paint |

21. Front door - left

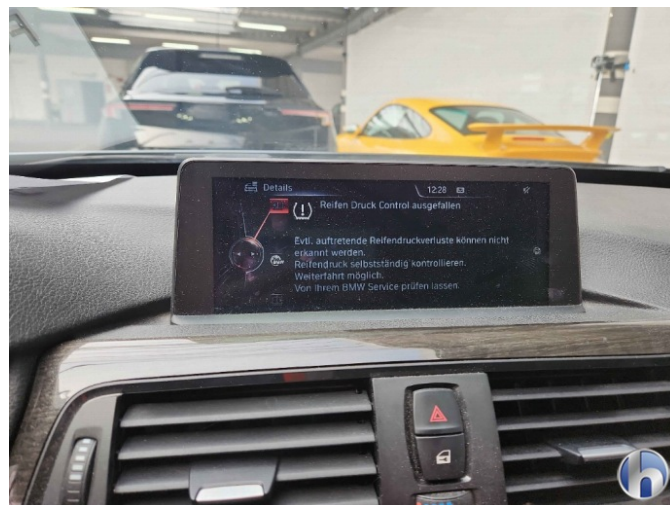
| | component | Damage | Rep kind |
|---|---|---|---|
| 24. | instrument cluster | Error message | Carry out a fault diagnosis |

24. instrument cluster
