## status report

#### BMW Baureihe 4 Gran Coupe 420 d xDrive Advantage

| Vehicle identification number | <b>WBA4K51010BP30329</b> | mileage read: | <b>183418 km</b> |

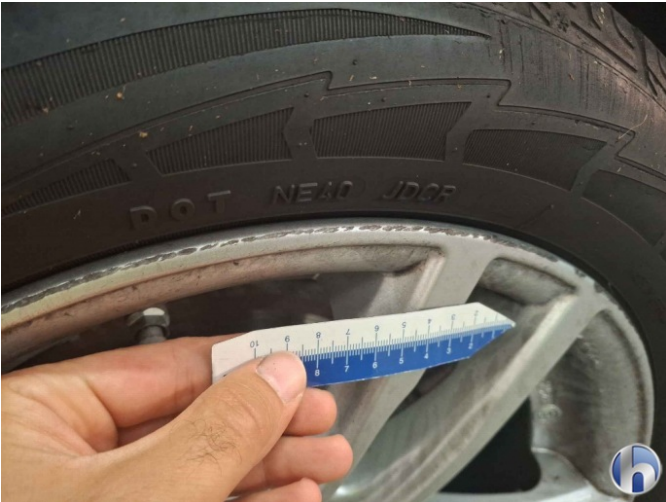
| component | Damage | Rep kind |
|---|---|---|
| 1. Rim front - left | Scratch(es) | Paint |

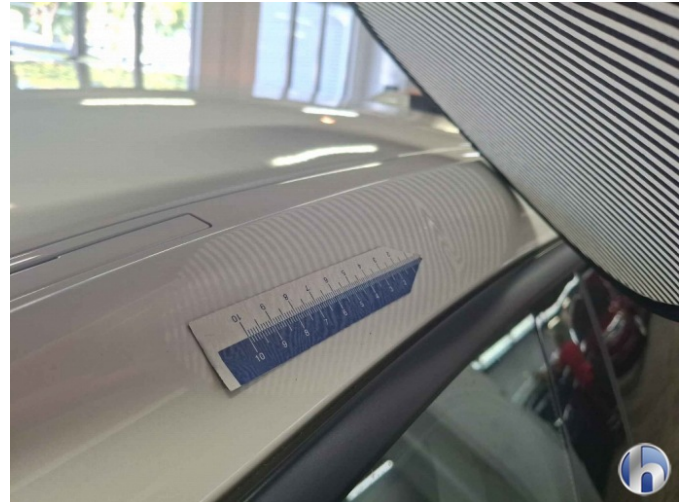
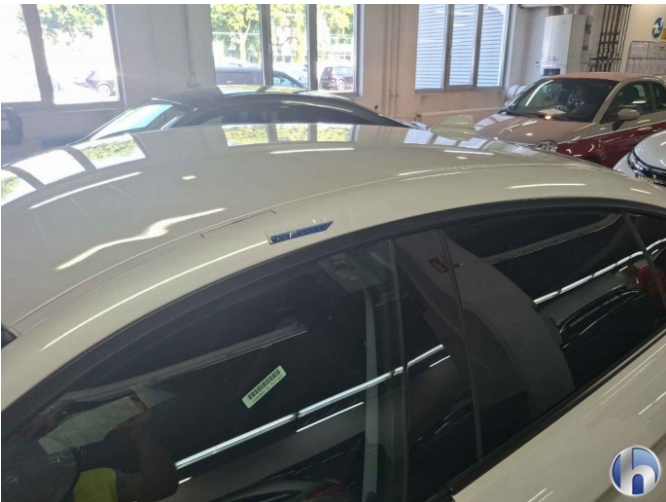
| component | Damage | Rep kind |
|---|---|---|
| 2. Roof frame - left | Deformed (slightly) | Refurbish and paint |

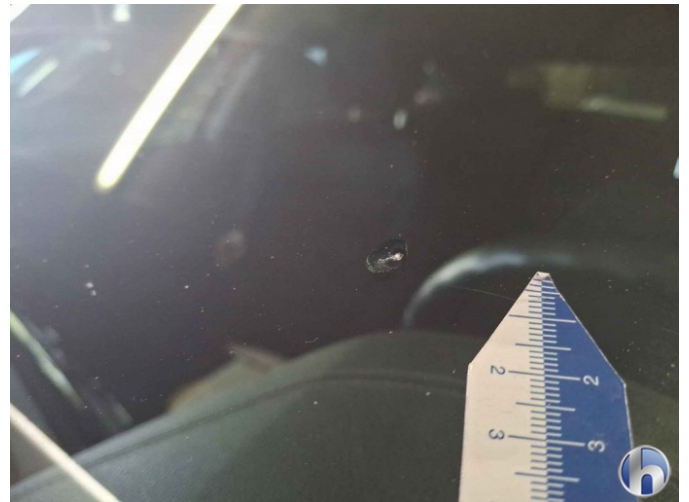
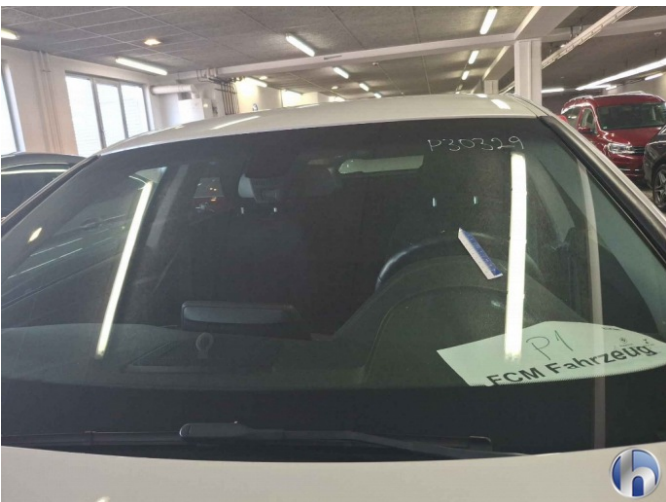
| component | Damage | Rep kind |
|---|---|---|
| 3. Windshield | Chipping from stones in field of view | Replace |

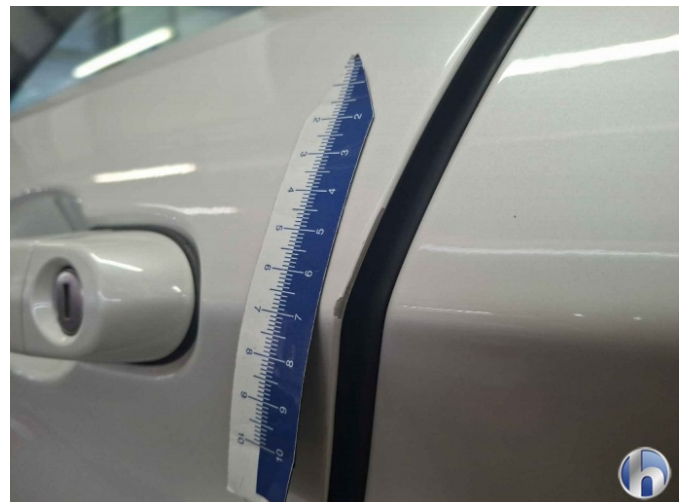
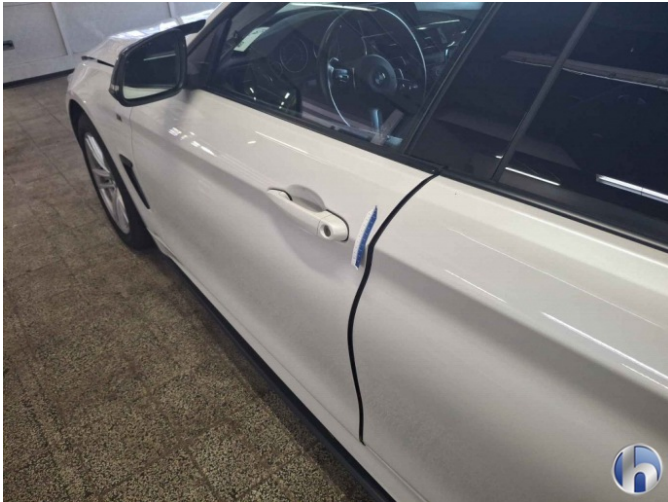
| component | Damage | Rep kind |
|---|---|---|
| 4. Front door - left | Scrape | Refurbish and paint |

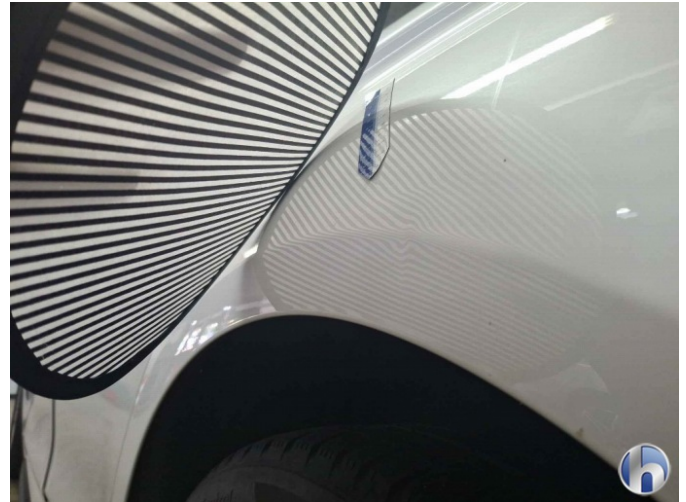
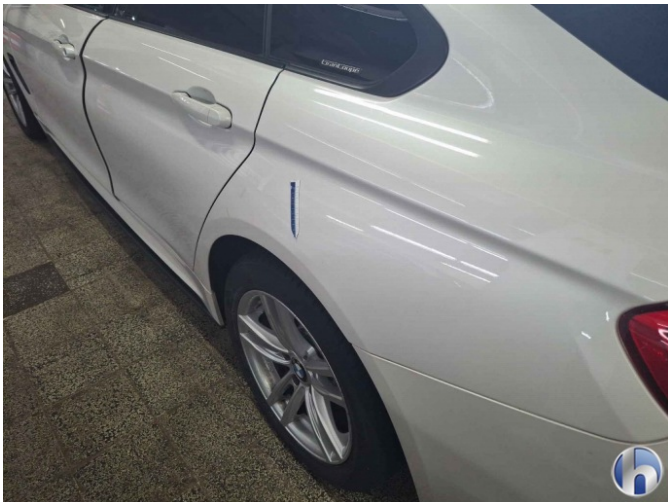
| component | Damage | Rep kind |
|---|---|---|
| 5. Sidewall - Rear - Left | Deformed (slightly) | Refurbish and paint |

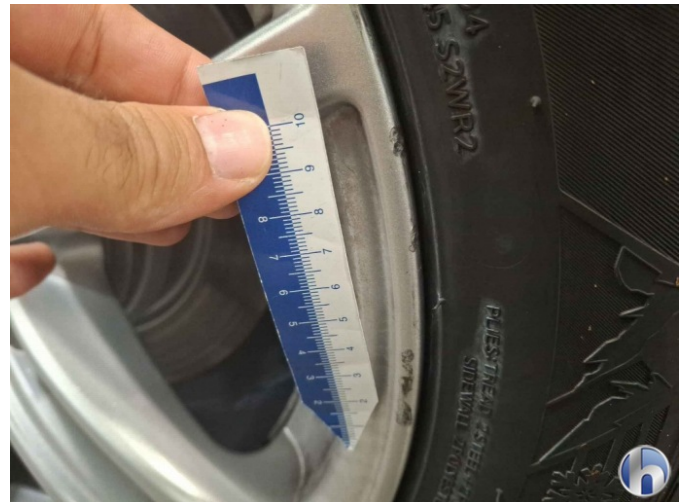
| component | Damage | Rep kind |
|---|---|---|
| 6. Rim rear - left | Scratch(es) | Paint |

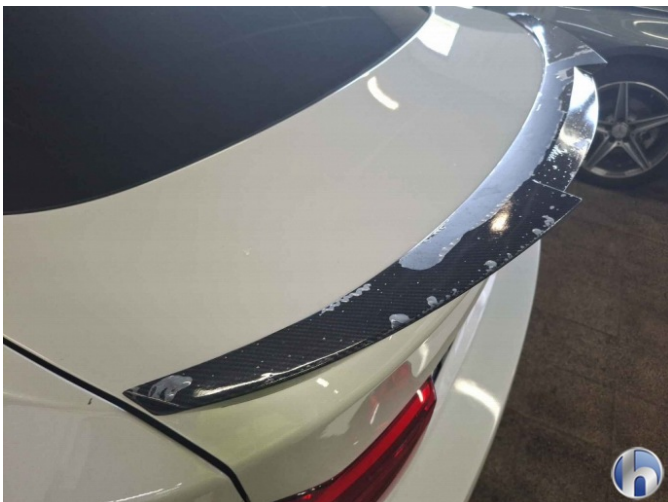
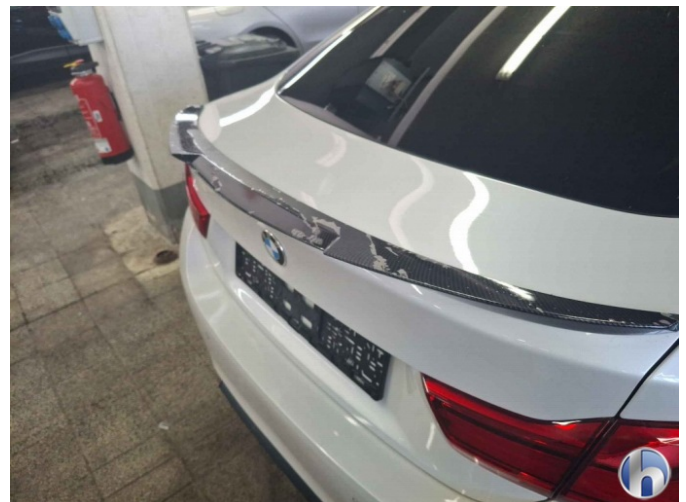
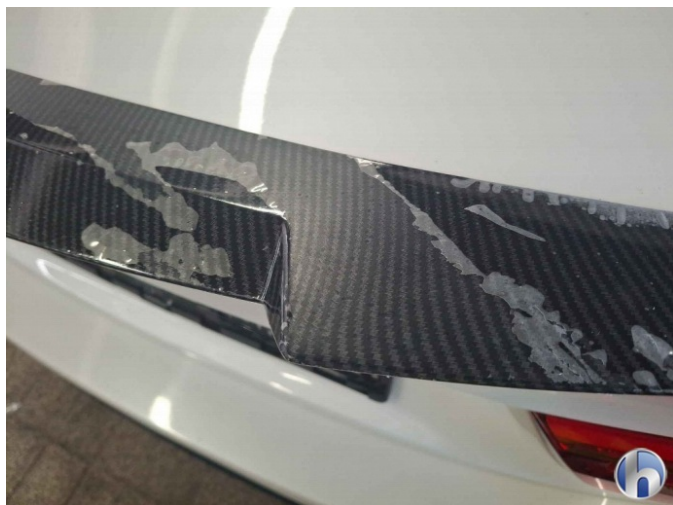
| component | Damage | Rep kind |
|---|---|---|
| 7. Rear spoiler | Clear lacquer chipping off | Replace |

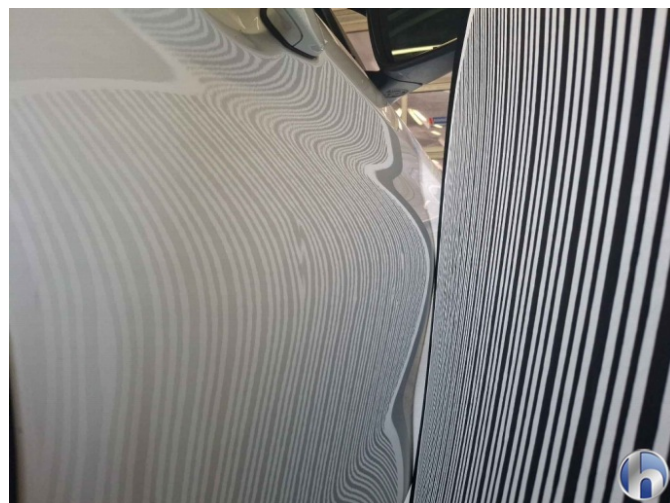
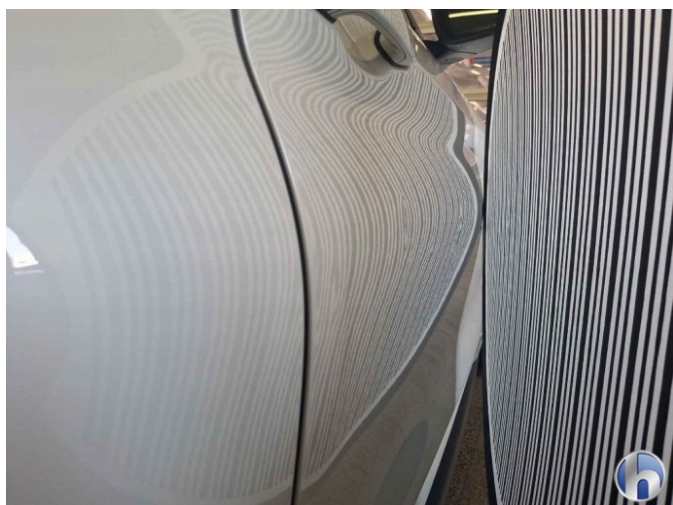
| component | Damage | Rep kind |
|---|---|---|
| 9. Front door - right | | Smart repair |

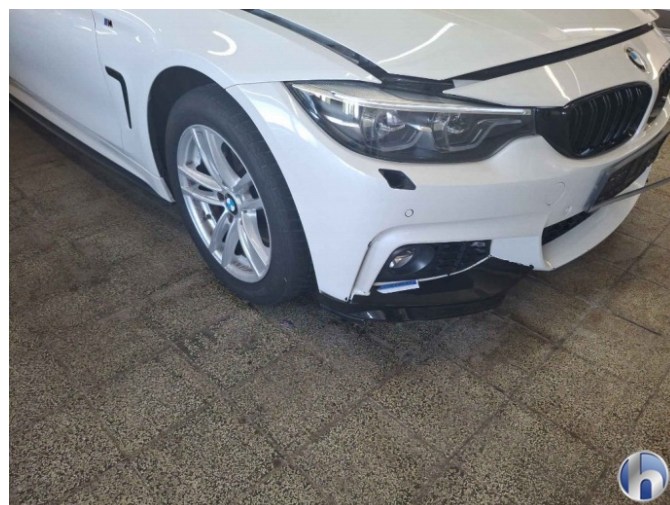
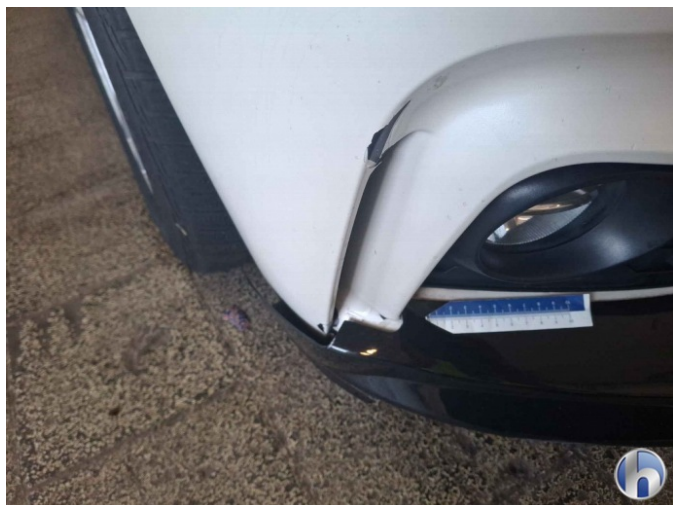
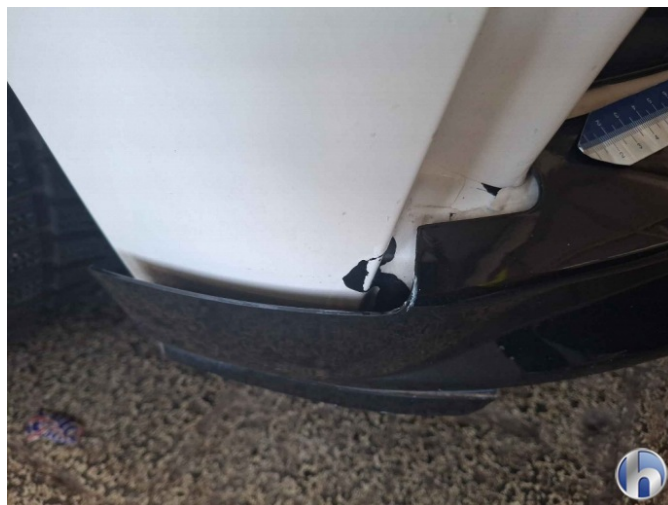
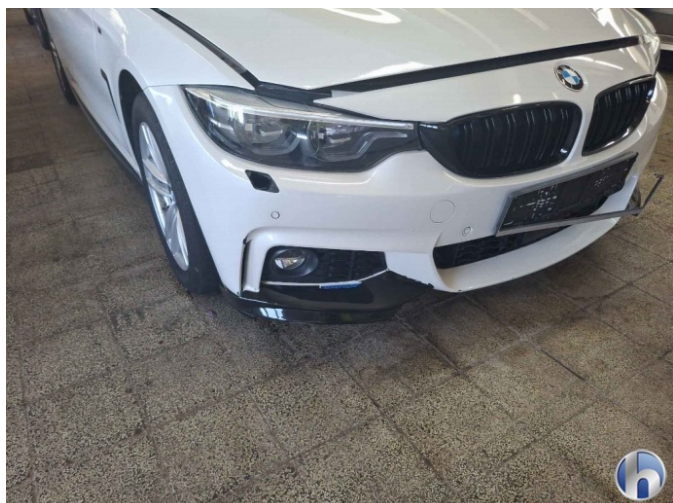
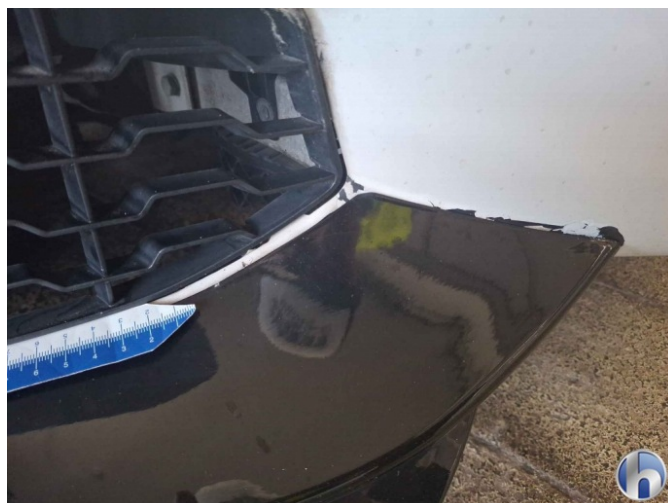
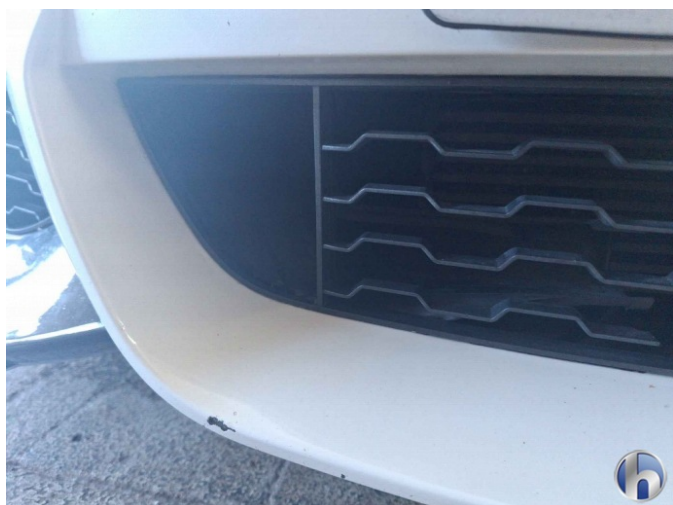
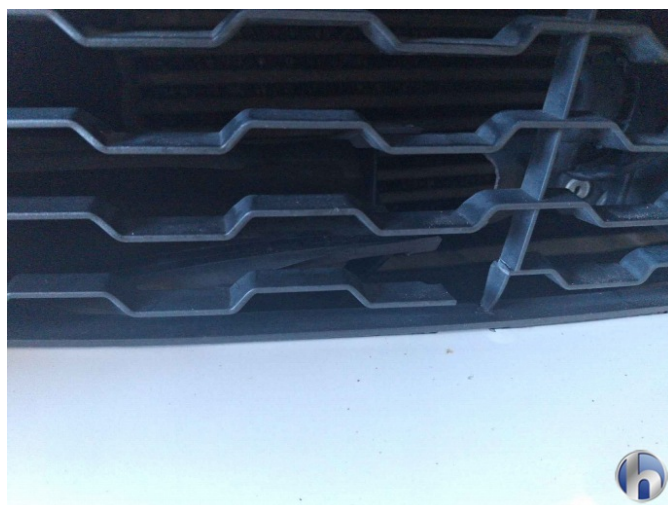
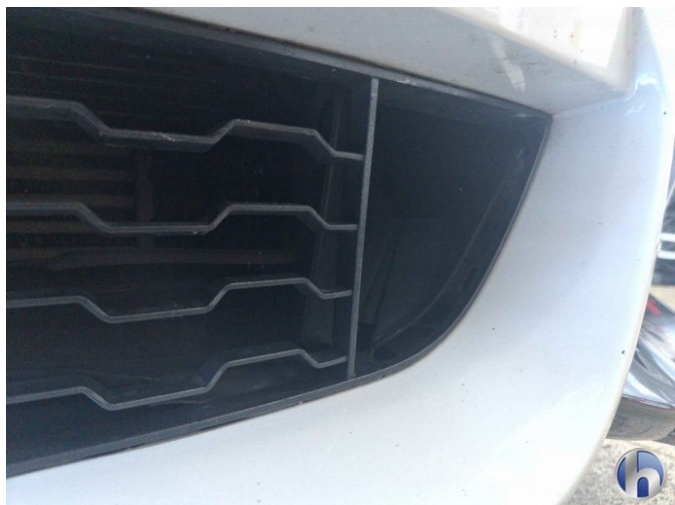
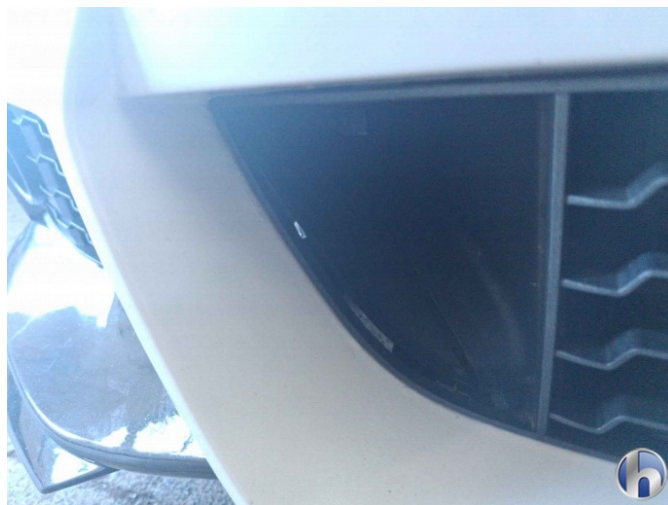
At the unrepared vehicle accident damage were observed on visual examination on the body skin .

Fahrzeug mit bestehenden Unfallschaden, zur Schadensermittlung wurden keine Demontearbeiten durchgeführt, verborgen gebliebene Schäden können nicht ausgeschlossen werden. Unfallschaden Kosten wurden überschlägig Kalkuliert, Kostenerweiterung möglich.

| component | Damage | Rep kind |
|---|---|---|
| 10. Front bumper | Accident damage | Replace |

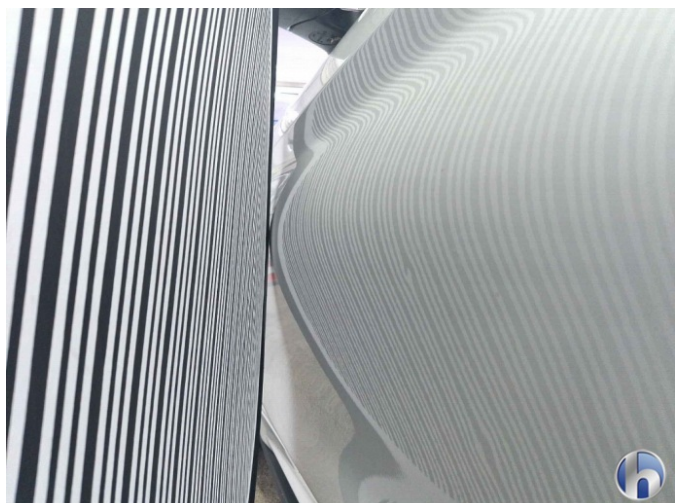
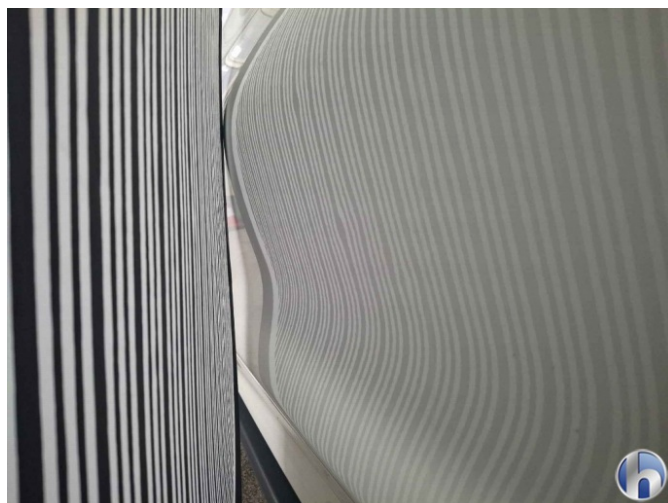
| component | Damage | Rep kind |
|---|---|---|
| 11. Front door - left | | Smart repair |
