## status report

**customer:** Bank 11, Neuss  
**contract number:** 944693130  
**reference:**

#### BMW 330i

| Vehicle identification number | <b>WBA5R11080FH35290</b> | mileage read: | <b>96834 km</b> |

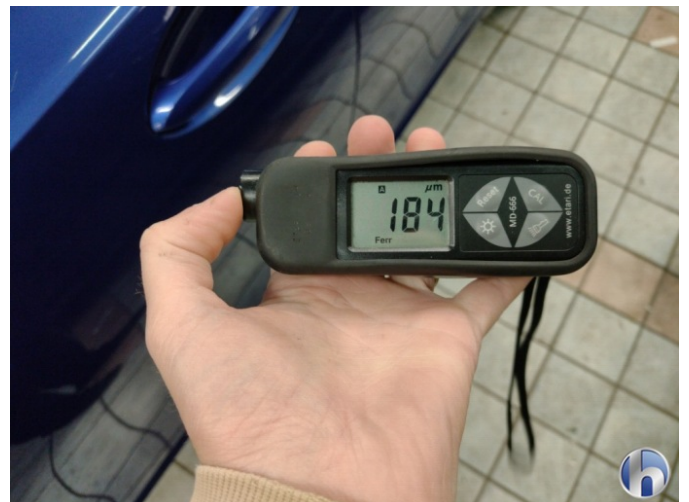
1. Front door - left

| | component | Damage | Rep kind |
|---|---|---|---|
| 1. | Front door - left | Subsequently painted | acceptable |

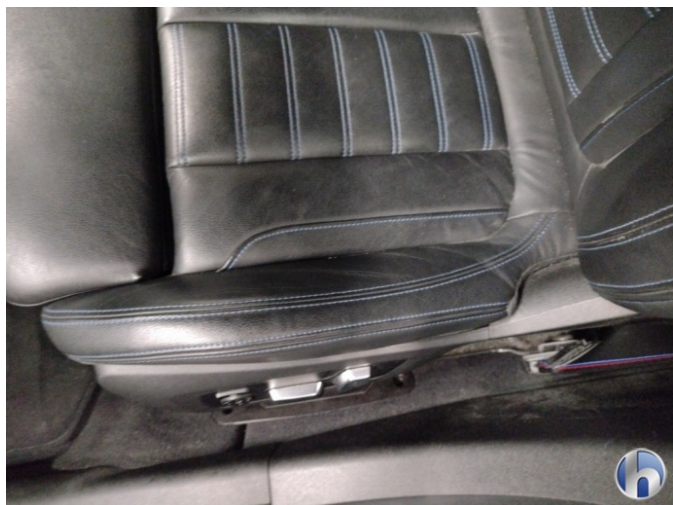
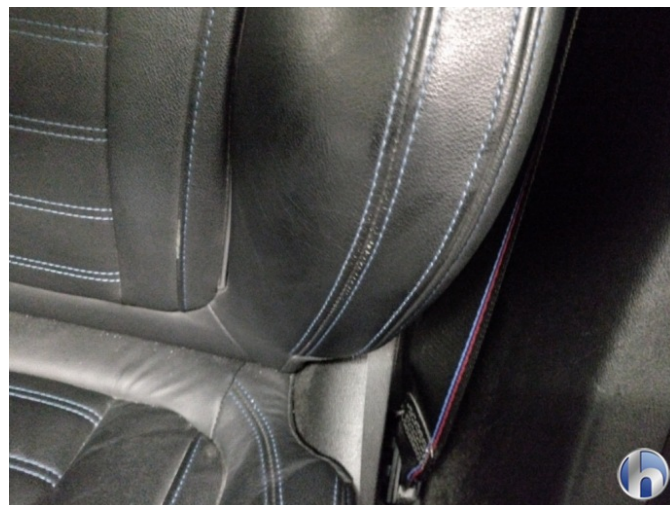
2. Sitz Vorne Links

| | component | Damage | Rep kind |
|---|---|---|---|
| 2. | Sitz Vorne Links | Wear and tear | acceptable |

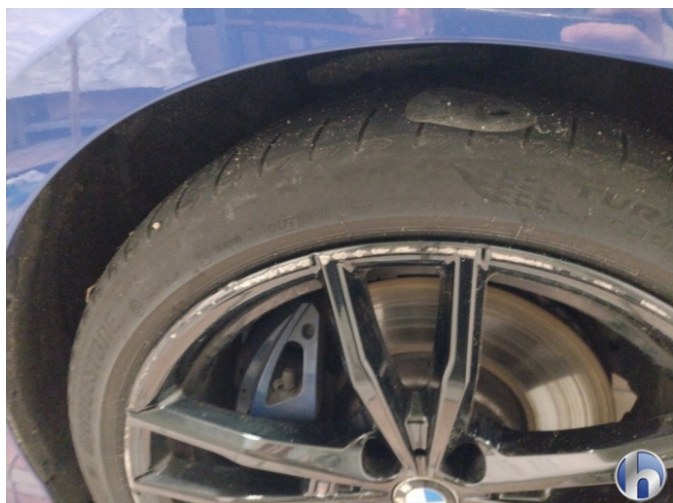
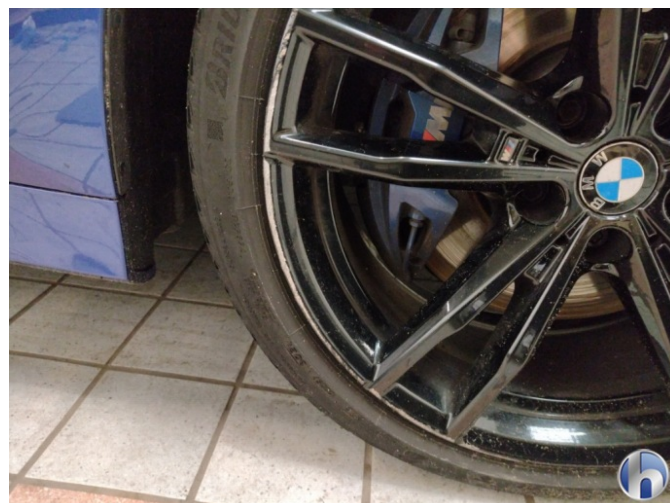
3. Rim front - right

| | component | Damage | Rep kind |
|---|---|---|---|
| 3. | Rim front - right | Scratch(es) | Paint |

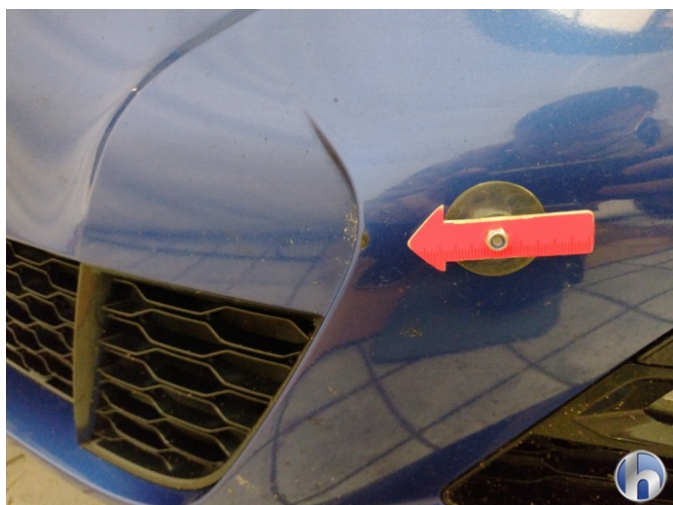
4. Front bumper

| | component | Damage | Rep kind |
|---|---|---|---|
| 4. | Front bumper | Wear and tear | acceptable |

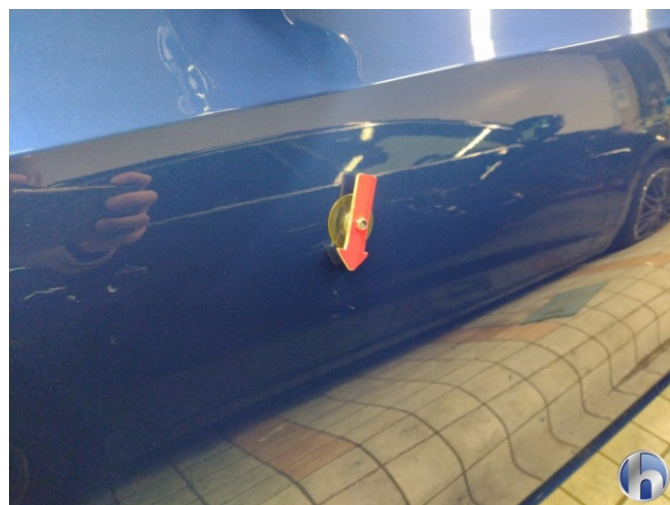
5. Front door - left

| | component | Damage | Rep kind |
|---|---|---|---|
| 5. | Front door - left | Scratch(es) | |

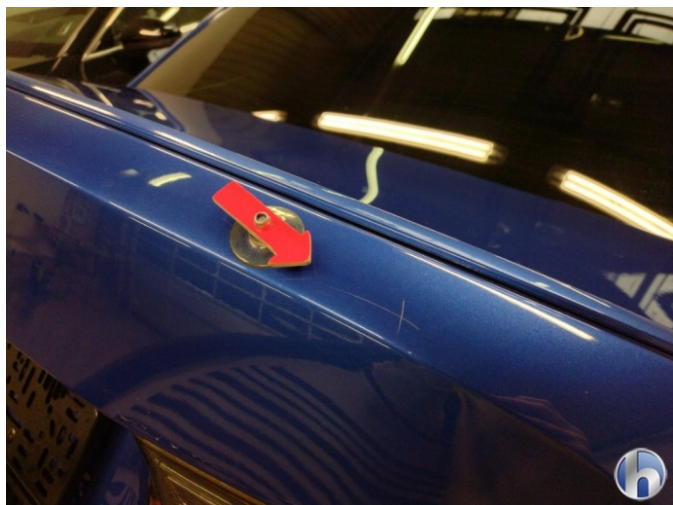
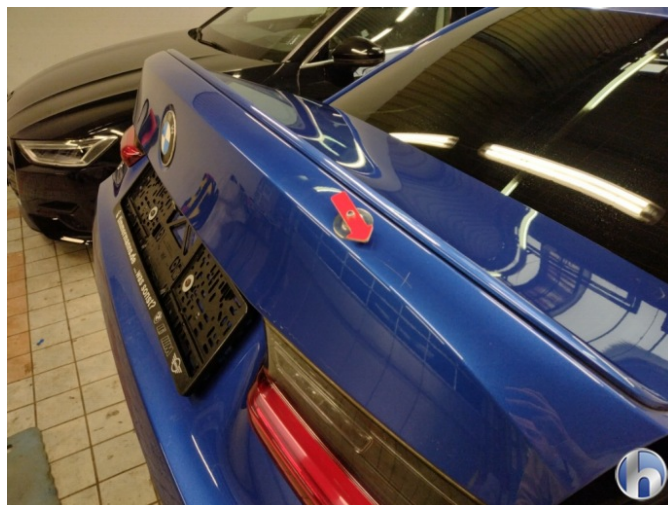
6. tailgate

| | component | Damage | Rep kind |
|---|---|---|---|
| 6. | tailgate | Scratch(es) | Paint |

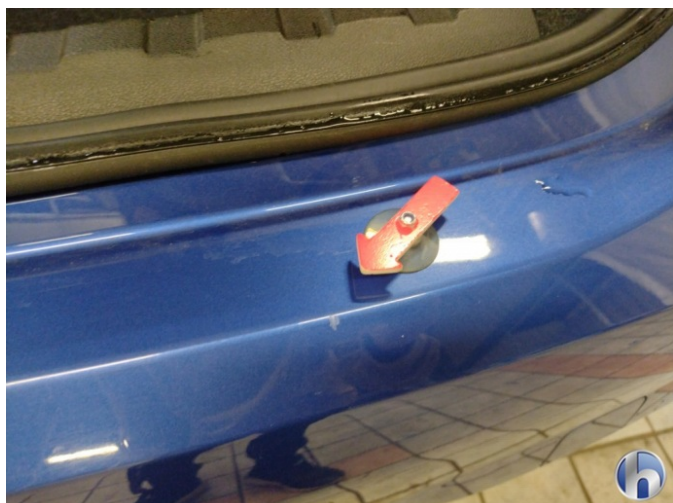
7. Rear bumper

| | component | Damage | Rep kind |
|---|---|---|---|
| 7. | Rear bumper | Wear and tear | acceptable |

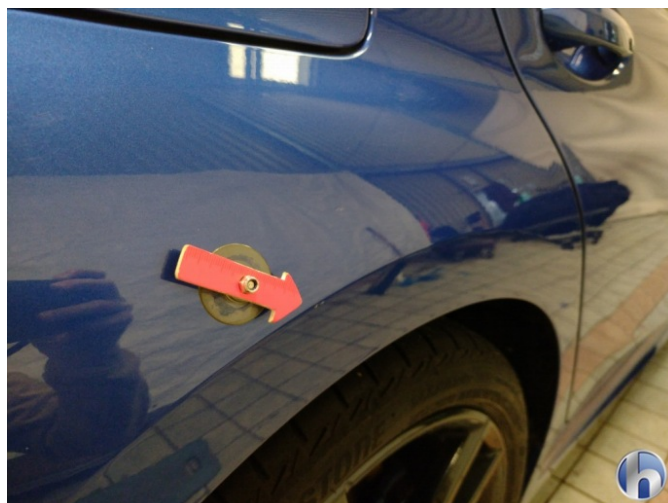
8. Sidewall - Rear - right

| | component | Damage | Rep kind |
|---|---|---|---|
| 8. | Sidewall - Rear - right | Wear and tear | acceptable |

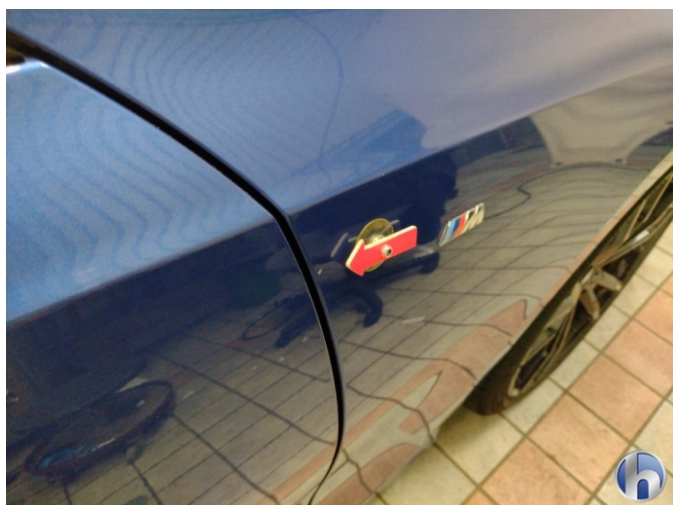
9. Front fender - right

| | component | Damage | Rep kind |
|---|---|---|---|
| 9. | Front fender - right | Wear and tear | acceptable |

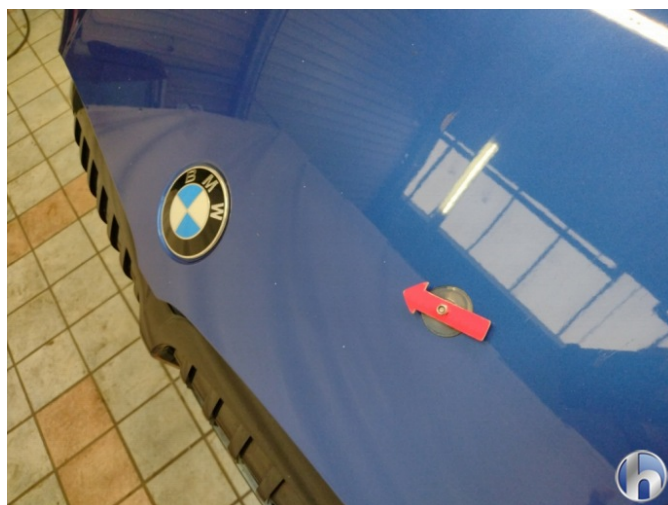
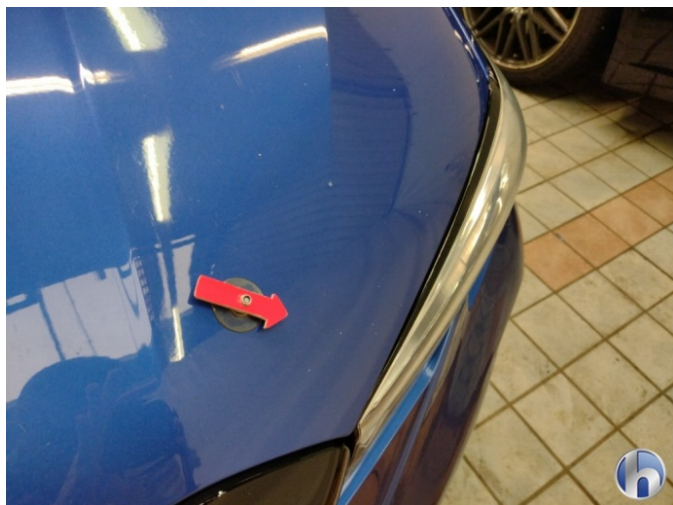
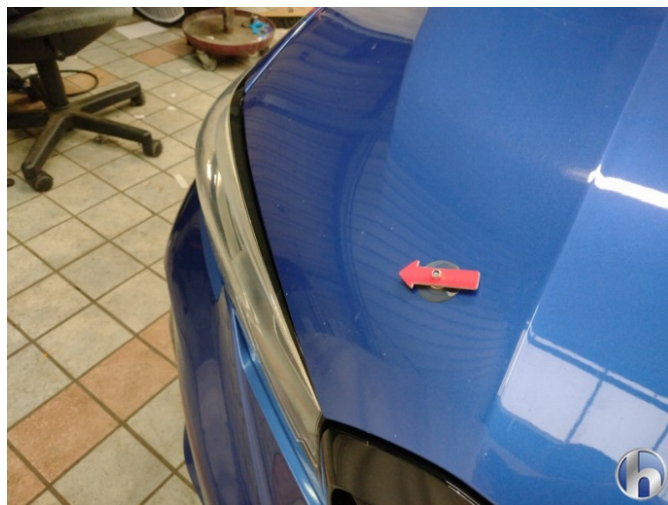
10. hood

| | component | Damage | Rep kind |
|---|---|---|---|
| 10. | hood | Wear and tear | acceptable |

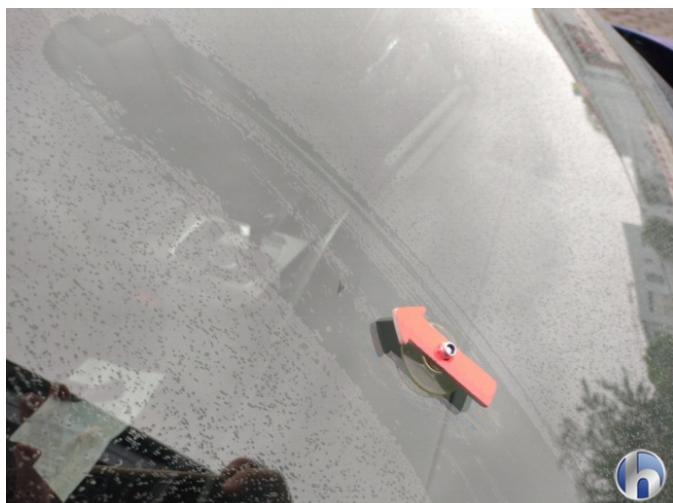
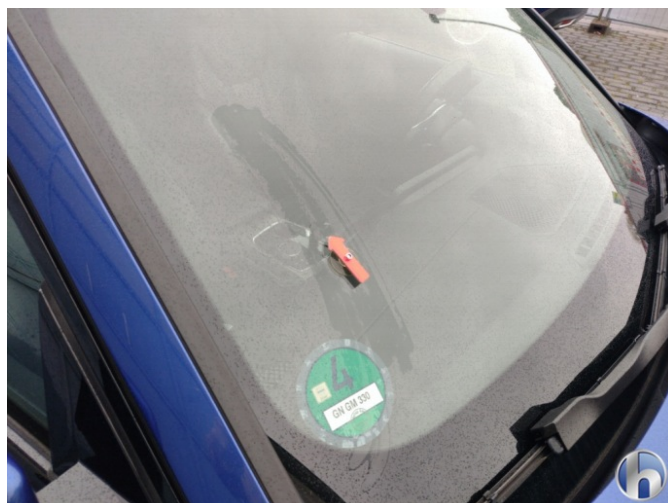
11. Windshield

| | component | Damage | Rep kind |
|---|---|---|---|
| 11. | Windshield | Chipping from stones | Smart repair |
