# BMW 3er 320d Touring Aut.

VIN NO WBA6L51000FJ23353  
Registration Number 000FJ23353

## Inspection Report Summary

| Customer | BCA Online | Report Number | P20250721143151 |

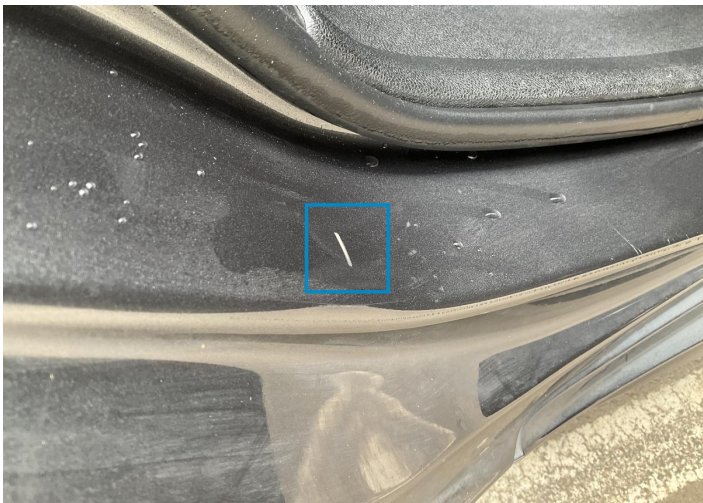
| Component | | Damage | Comments |
|---|---|---|---|
| 1 | Pillar / Back Right | Paint / Scratch / Scuff | |

1. Pillar / Back Right  
Paint / Scratch / Scuff -

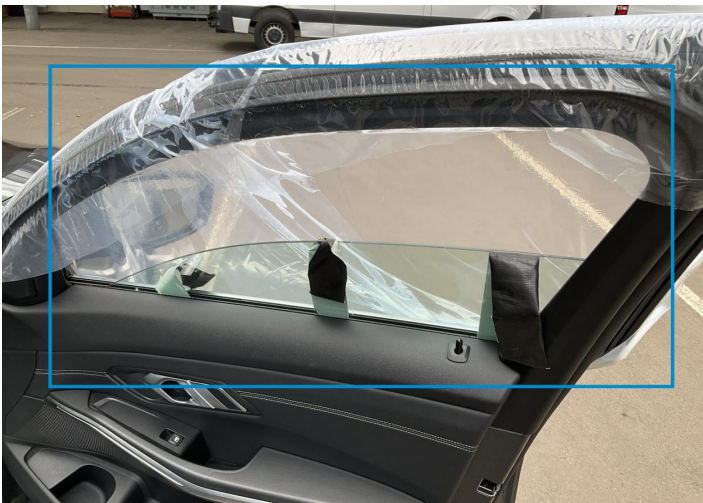
| Component | | Damage | Comments |
|---|---|---|---|
| 2 | Side Window / Front Right | Bodywork / Assembly | |

2. Side Window / Front Right  
Bodywork / Assembly -

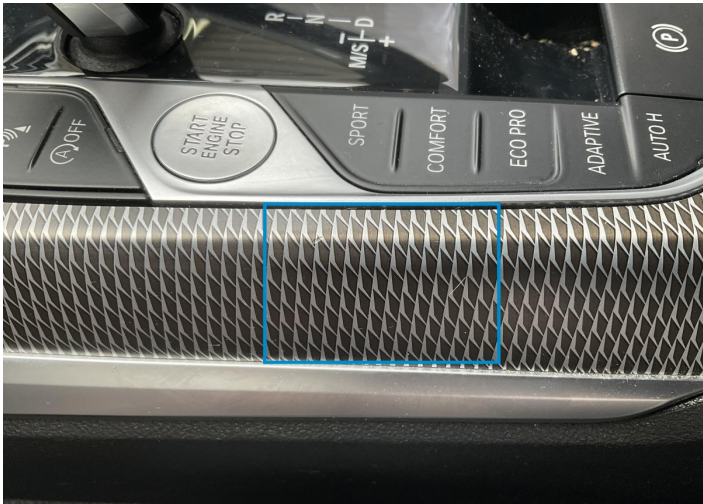
| Component | | Damage | Comments |
|---|---|---|---|
| 3 | Center Console | Interior / Scraped | |

3. Center Console  
Interior / Scraped -

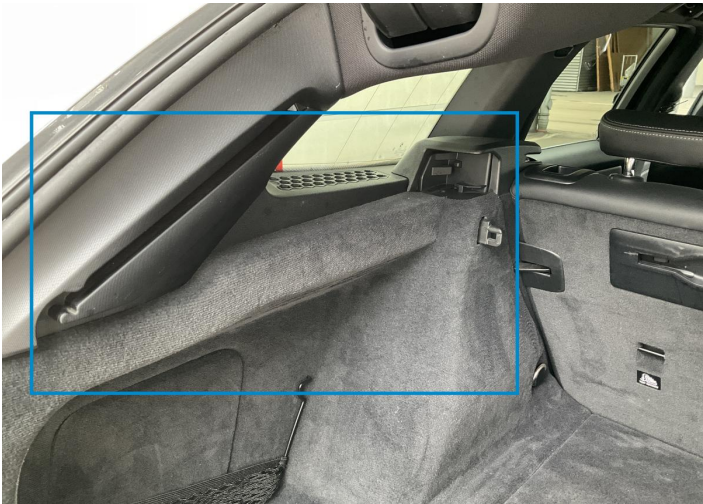
| Component | | Damage | Comments |
|---|---|---|---|
| 4 | Luggage Space Cover / Back | Interior / Missing | |

4. Luggage Space Cover / Back  
Interior / Missing -

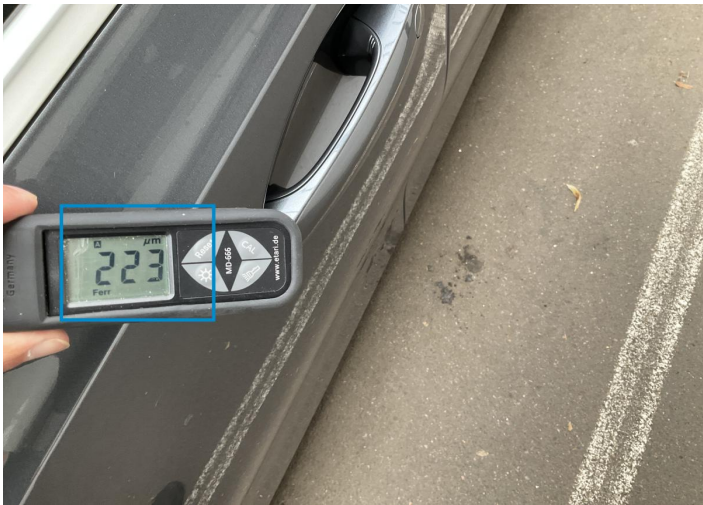
| Component | | Damage | Comments |
|---|---|---|---|
| 5 | Door / Front Left | Paint / Poor Previous Repair | |

5. Door / Front Left  
Paint / Poor Previous Repair -

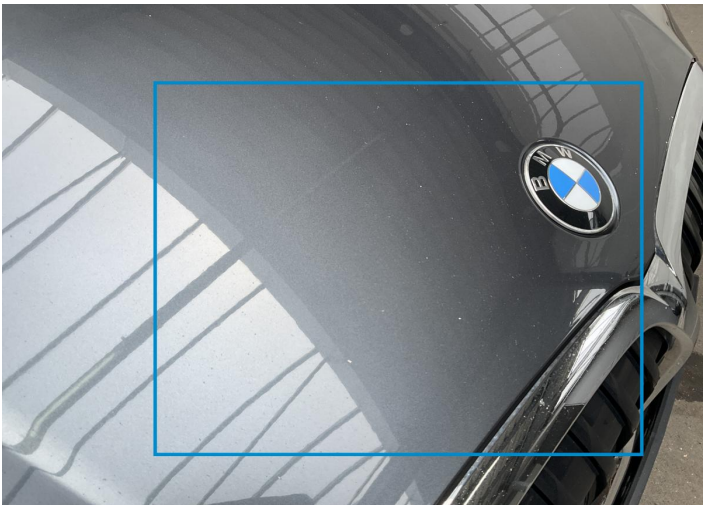
| Component | | Damage | Comments |
|---|---|---|---|
| 6 | Hood | Paint / Stone Chip | |

6. Hood  
Paint / Stone Chip -

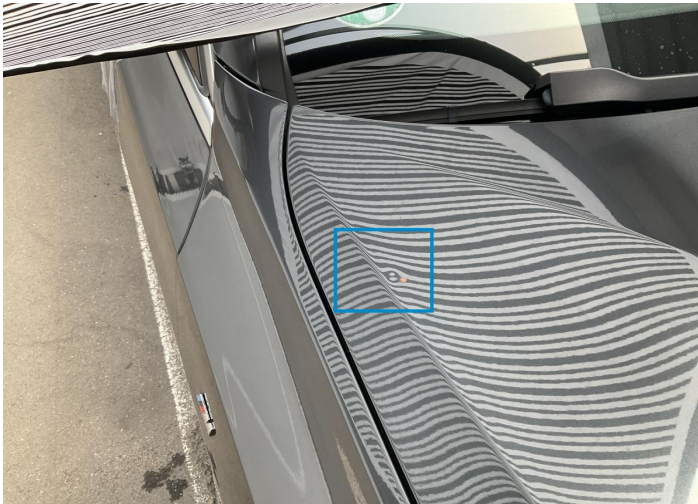
| Component | | Damage | Comments |
|---|---|---|---|
| 7 | Hood | Bodywork / Dent / Dent | |

7. Hood  
Bodywork / Dent / Dent -

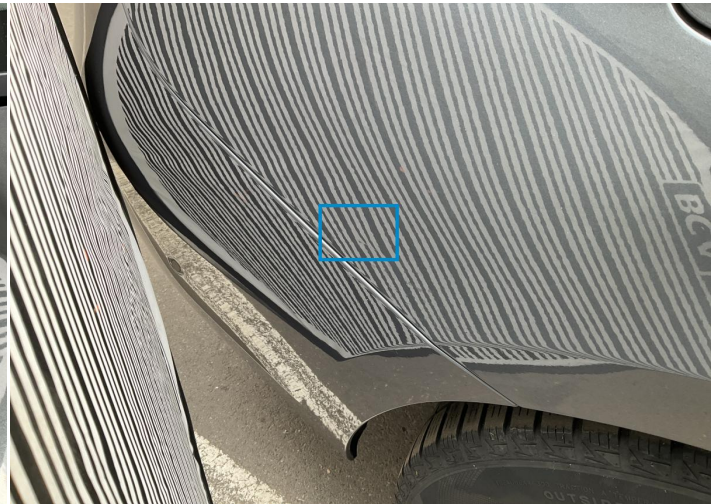
| Component | | Damage | Comments |
|---|---|---|---|
| 8 | Side Panel / Back Right | Bodywork / Dent / Dent | |

8. Side Panel / Back Right  
Bodywork / Dent / Dent -
