BMW 3er 320d Touring Aut.

VIN NO WBA6L51000FJ23353
Registration Number 000FJ23353

Inspection Report Summary

Customer	BCA Online	Report Number	P20250721143151
Inspection Date / Place	2025-07-21 / BCA Heidenheim	Cosmetic Grade	3

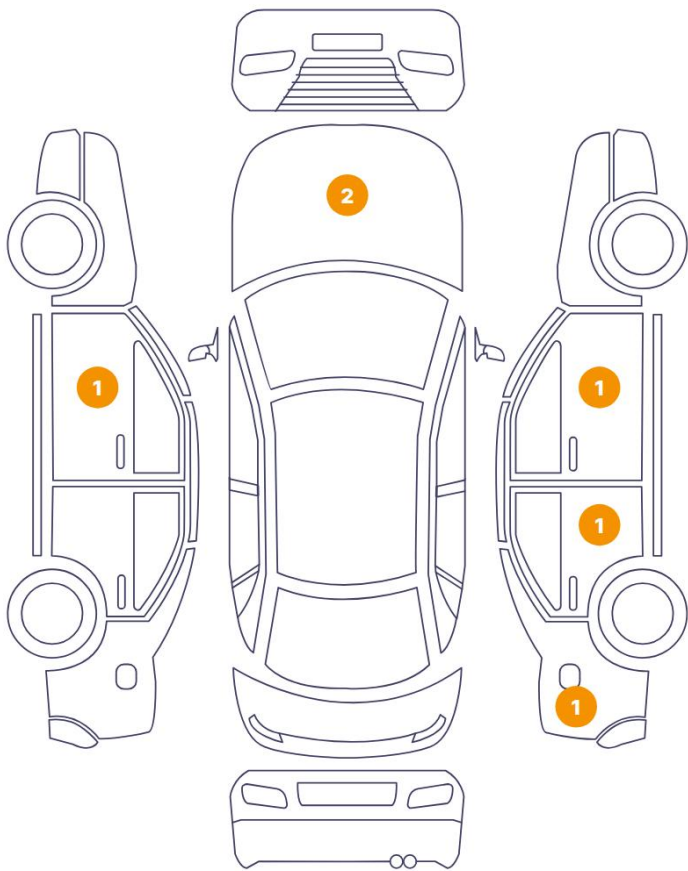
6 Schäden

Component		Damage	Comments
1	Pillar / Back Right	Paint / Scratch / Scuff	
2	Side Window / Front Right	Bodywork / Assembly	
3	Center Console	Interior / Scraped	
4	Luggage Space Cover / Back	Interior / Missing	
5	Door / Front Left	Paint / Poor Previous Repair	
6	Hood	Paint / Stone Chip	
7	Hood	Bodywork / Dent / Dent	
8	Side Panel / Back Right	Bodywork / Dent / Dent
