BMW 2er Active Tourer 218i Active Tourer Aut.

VIN NO WBA6S11050VF80549
Registration Number 050VF80549

Inspection Report Summary

Customer	BCA Online	Report Number	P20250930125120
Inspection Date / Place	2025-09-30 / SULOJA Mönchengladbach	Cosmetic Grade	2

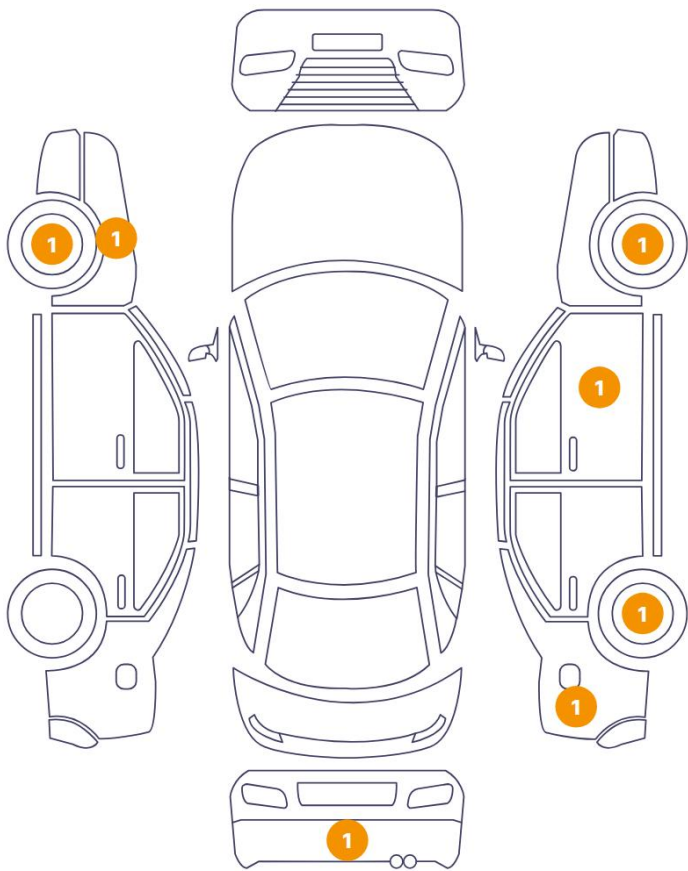
7 Schäden

Component	Damage	Comments
1 Fender / Front Left	Bodywork / Dent / Dent	
2 Rim / Front Left	Out of Bodywork / Scratch	
3 Bumper / Back	Paint / Scratch / Scuff	
4 Rim / Front Right	Out of Bodywork / Scratch	
5 Door / Front Right	Bodywork / Dent / Dent	
6 Side Panel / Back Right	Bodywork / Dent / Dent	
7 Rim / Back Right	Out of Bodywork / Scratch

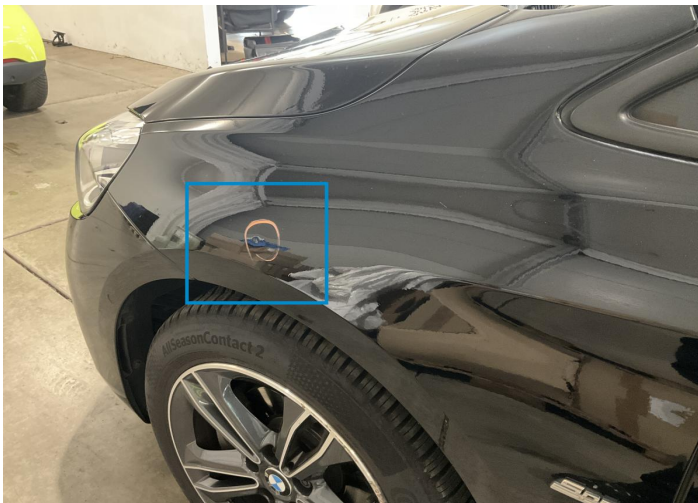
1. Fender / Front Left
Bodywork / Dent / Dent -

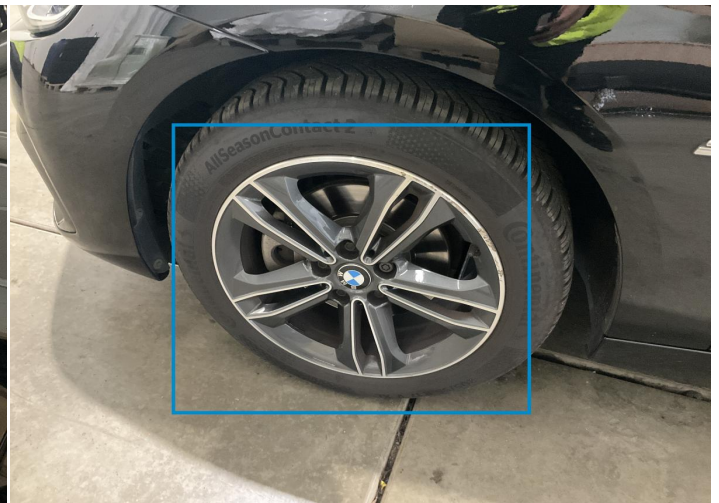
2. Rim / Front Left
Out of Bodywork / Scratch -

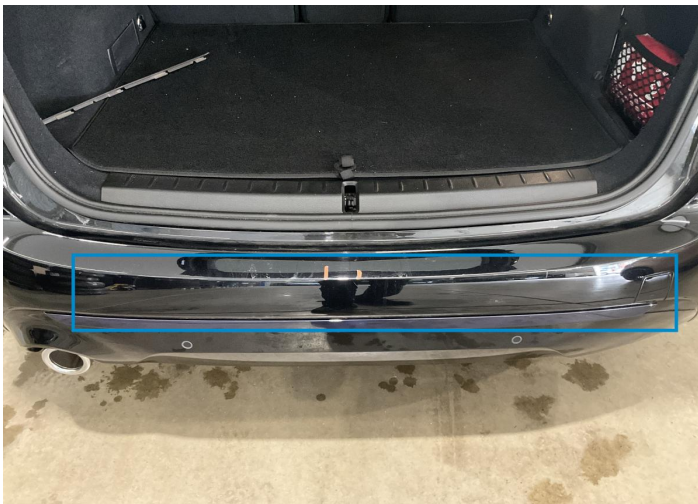
3. Bumper / Back
Paint / Scratch / Scuff -

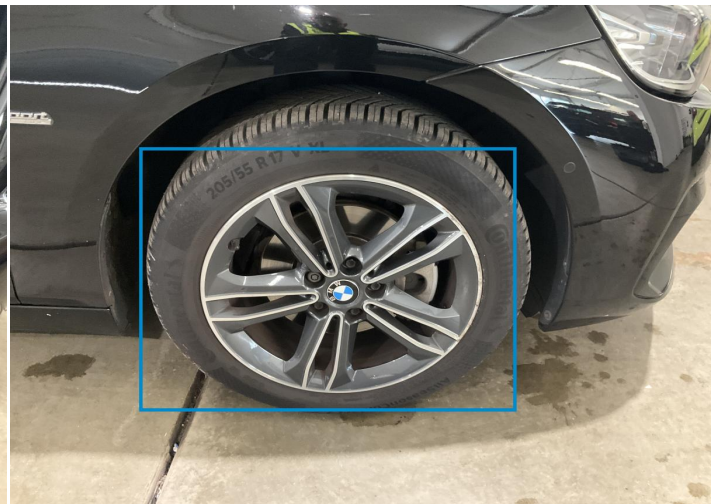
4. Rim / Front Right
Out of Bodywork / Scratch -

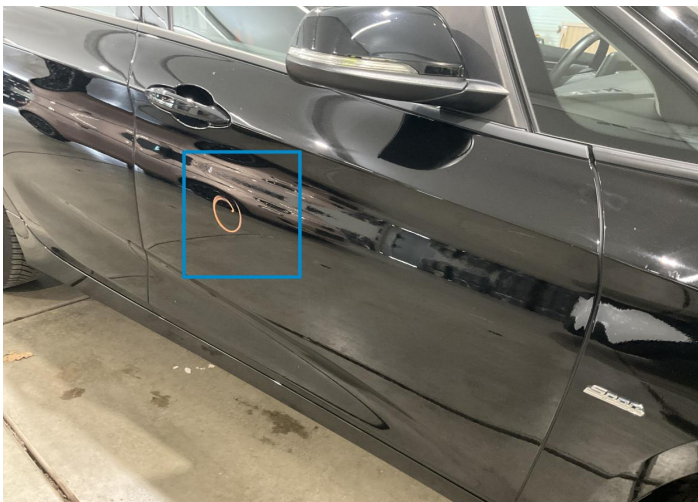
5. Door / Front Right
Bodywork / Dent / Dent -

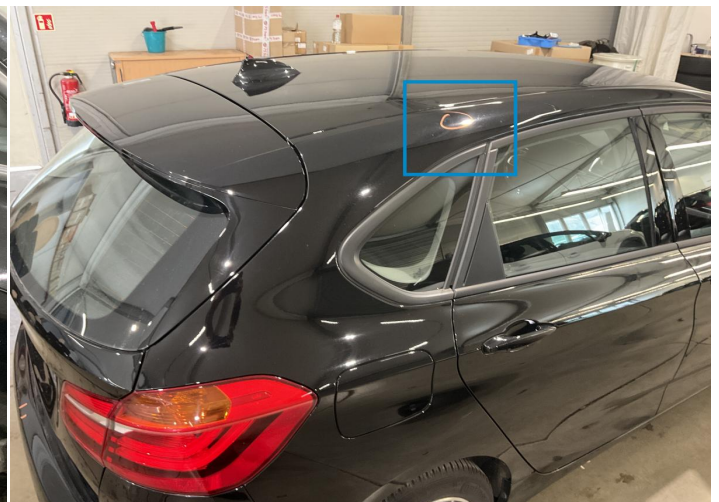
6. Side Panel / Back Right
Bodywork / Dent / Dent -

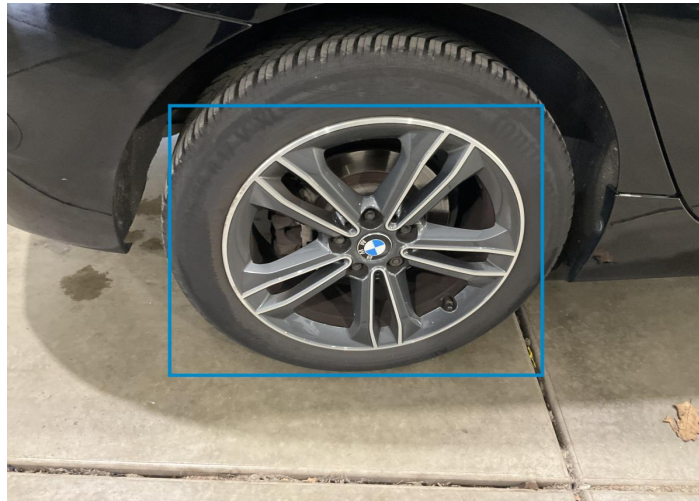
7. Rim / Back Right
Out of Bodywork / Scratch -
