## BMW 2-Reeks Active Tourer (UKL): 2ABS693

| Vinnnummer: | <b>WBA6T510807H91138</b> | Versionname: | <b>216d Active Tourer (F45) 1.5d 116pk/cv 5p</b> |

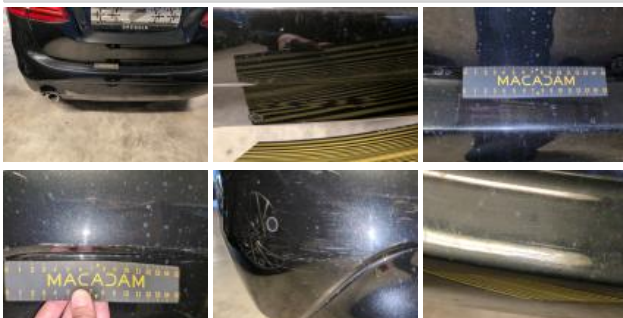
Bumper R, Dent(s) and scratch(es), Repair and paint (complete)

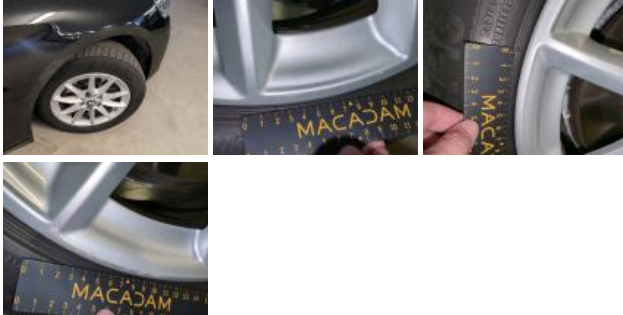
Alloy rim FR, Scratch(es), Repair and paint (complete)
