## status report

#### BMW Baureihe 7 Lim 740 d xDrive

| Vehicle identification number | <b>WBA7C61060G760249</b> | mileage read: | <b>163402 km</b> |

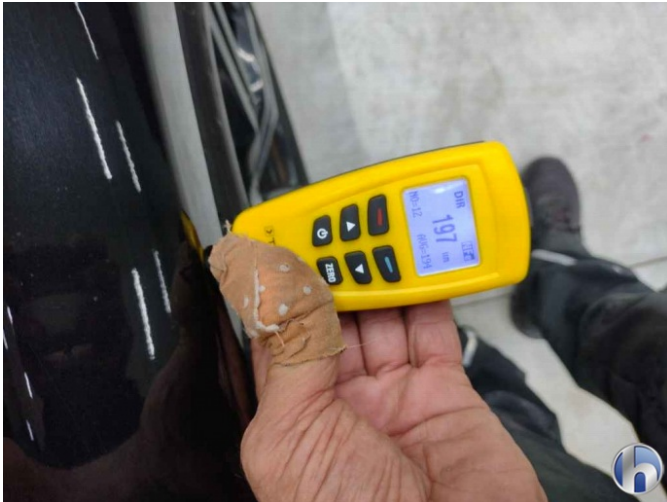
| component | Damage | Rep kind |
|---|---|---|
| 1. Front fender - left | Subsequently painted | acceptable |

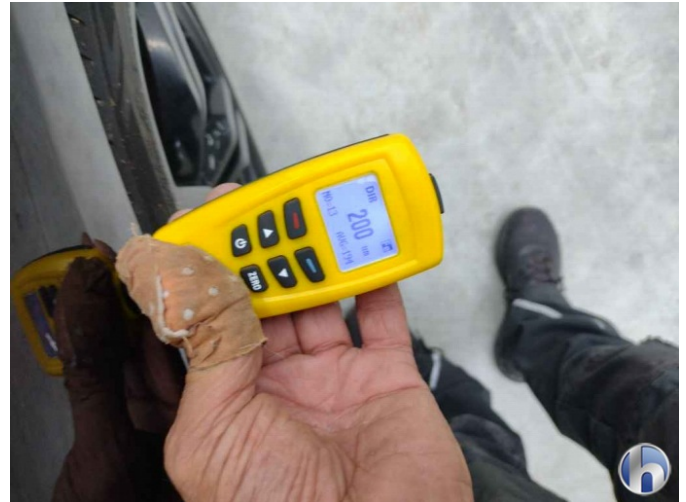
| component | Damage | Rep kind |
|---|---|---|
| 2. Sidewall - Rear - Left | Subsequently painted | acceptable |

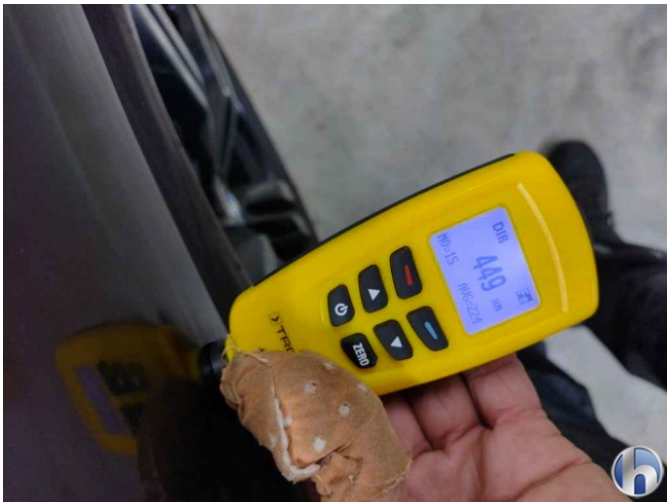
| component | Damage | Rep kind |
|---|---|---|
| 3. Sidewall - Rear - right | Subsequently painted | acceptable |

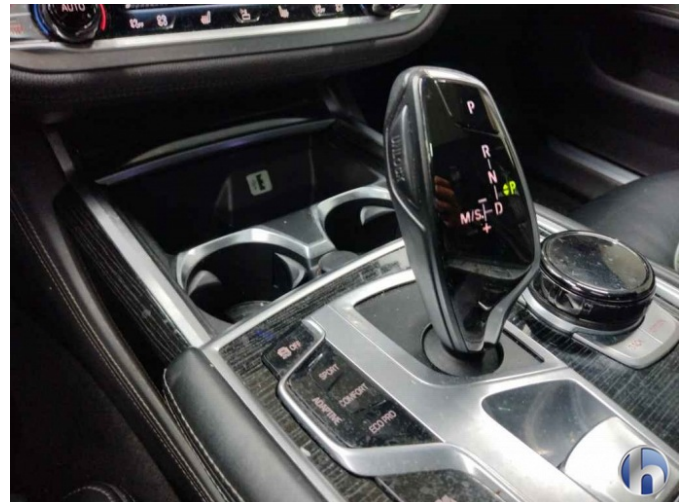
| <b>Note Road Safe:</b> | Getriebe schaltet nicht, beim Gang einlegen geht der Motor aus. |

| Performed testing technology | |
|---|---|
| <b>transmission:</b> | The transmission was wrong for visiting time .<br>*Schaltet keinen Gang.<br>**Transmission has problems switching on. |

| component | Damage | Rep kind |
|---|---|---|
| 4. Getriebe schaltet nicht | Not okay | Carry out a fault diagnosis |

4. Getriebe schaltet nicht

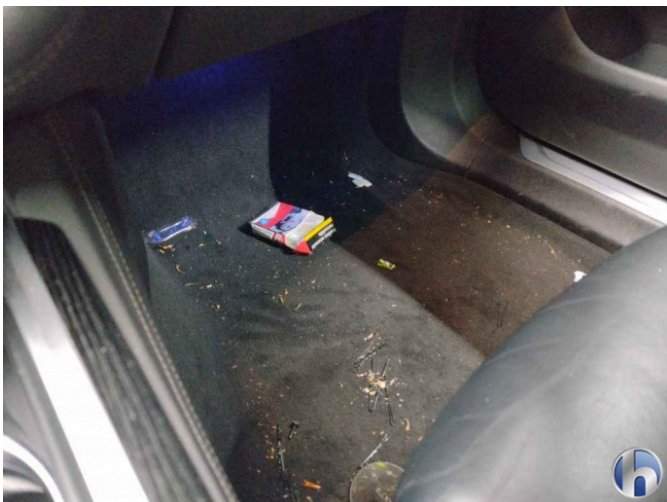
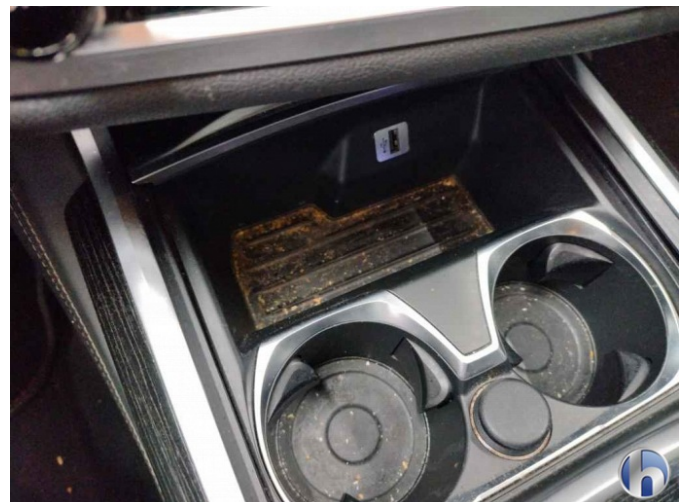
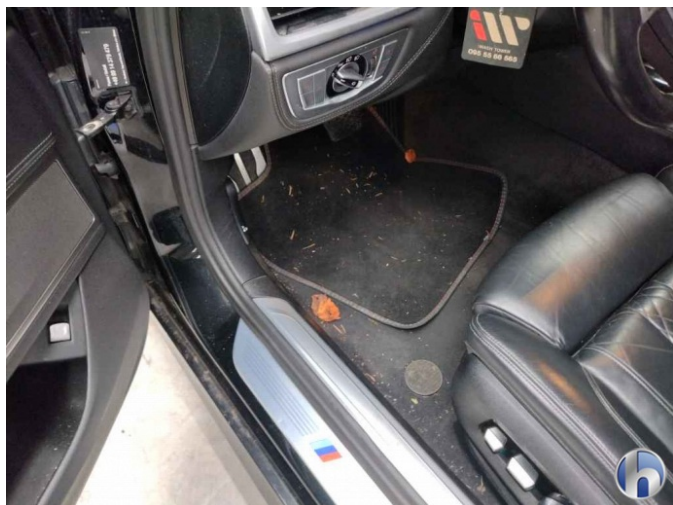
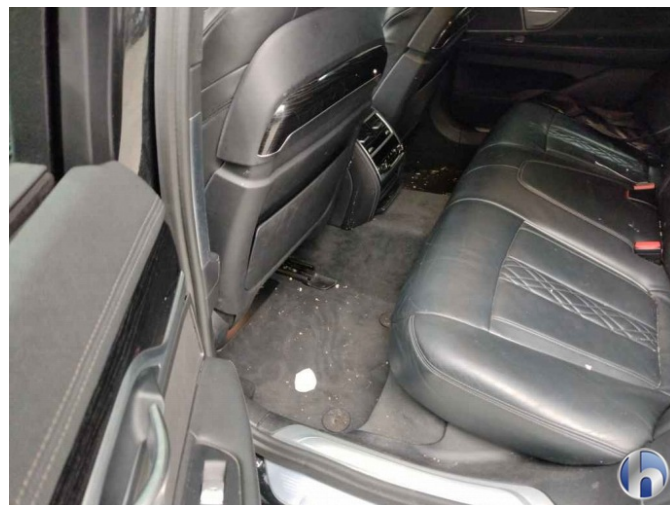
| component | Damage | Rep kind |
|---|---|---|
| 5. | Dirty (strong) | |

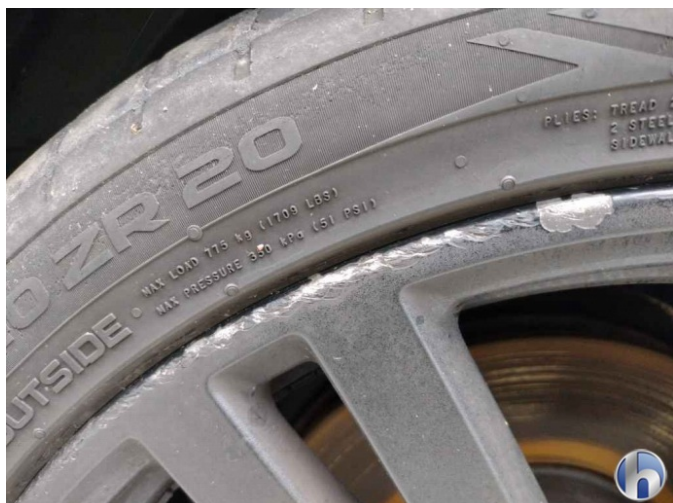
| component | Damage | Rep kind |
|---|---|---|
| 6. | Damaged | Replace |

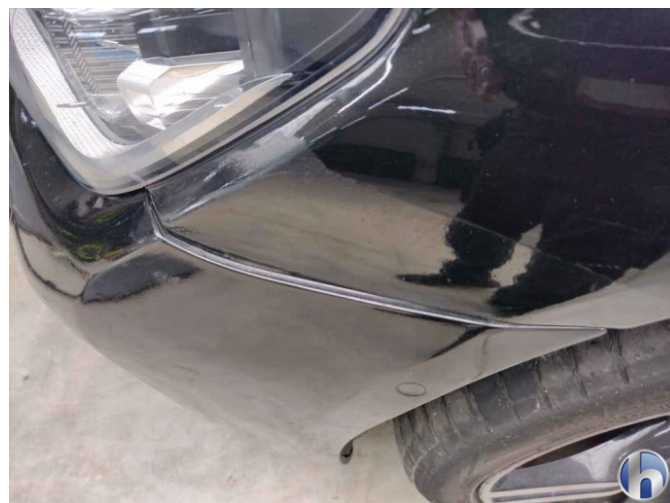
| component | Damage | Rep kind |
|---|---|---|
| 7. Front fender - left | Scratch(es) | Paint |

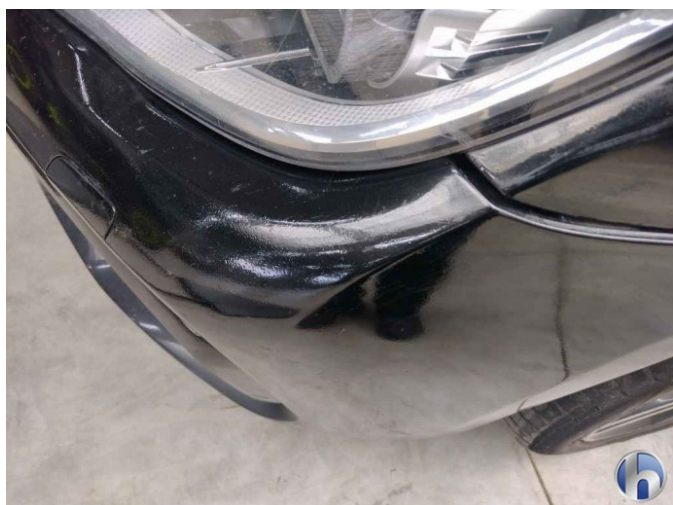
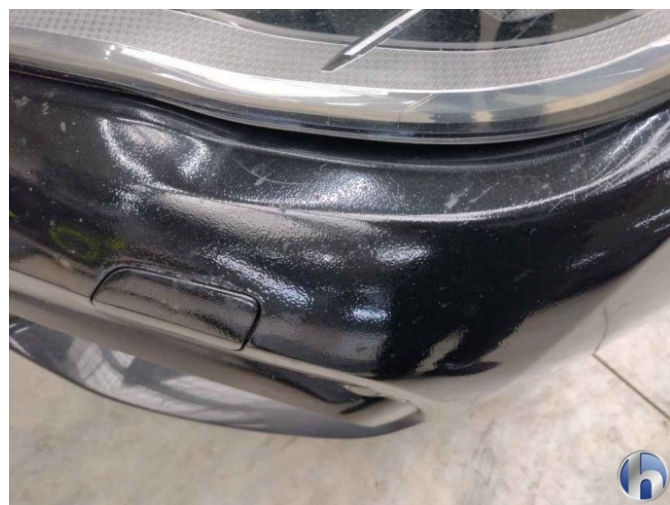
| component | Damage | Rep kind |
|---|---|---|
| 8. Front bumper | Execution defect | Replace |

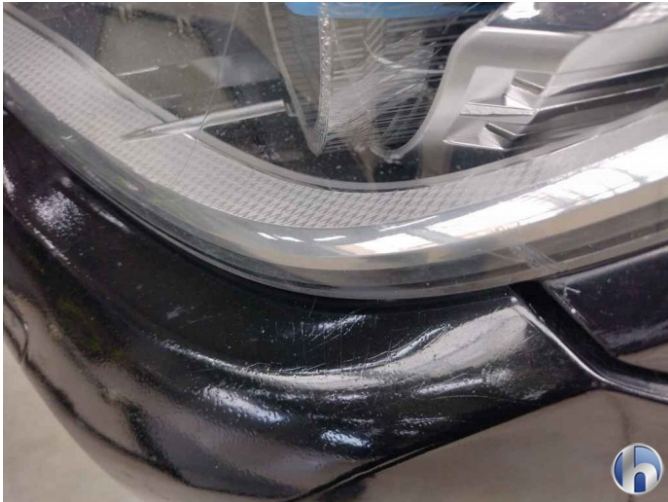
| component | Damage | Rep kind |
|---|---|---|
| 9. Halogen headlights - left | Damaged | Replace |

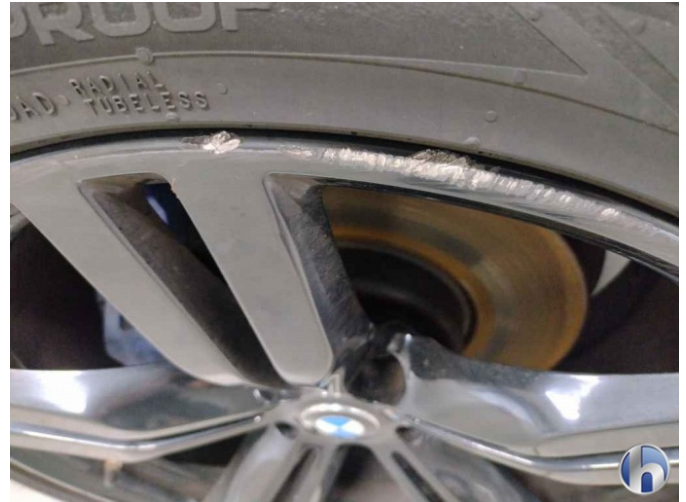
| component | Damage | Rep kind |
|---|---|---|
| 10. | Damaged | Replace |

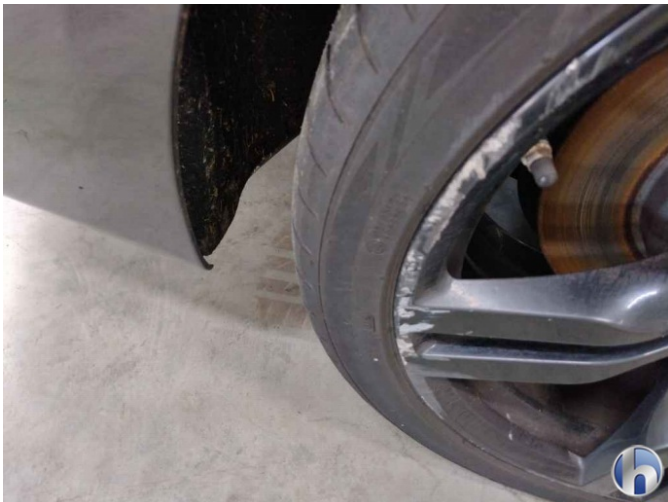
| component | Damage | Rep kind |
|---|---|---|
| 11. | Damaged | Replace |

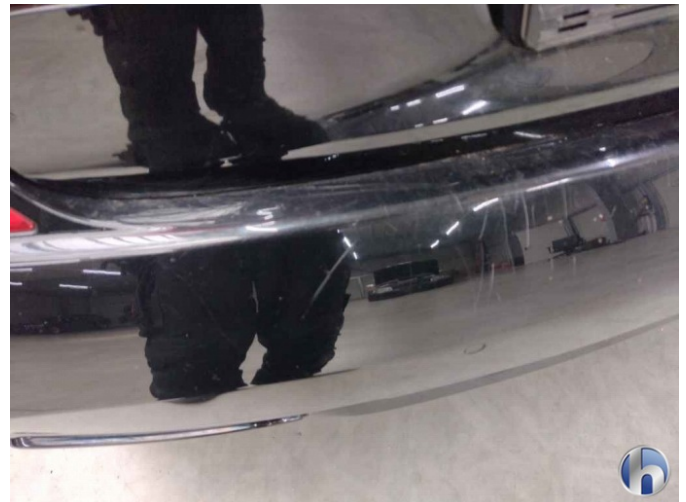
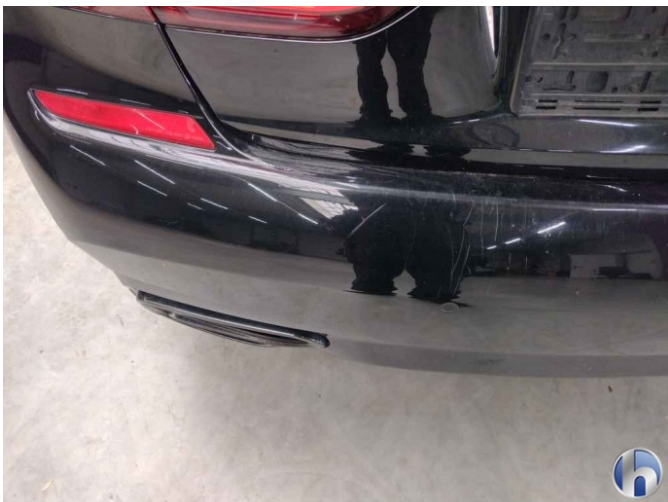
| component | Damage | Rep kind |
|---|---|---|
| 12. Rear bumper | Scratch(es) | Paint |

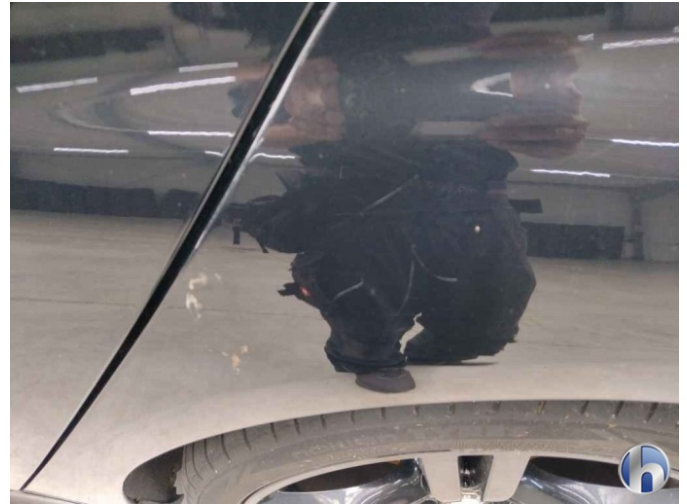
| component | Damage | Rep kind |
|---|---|---|
| 14. Sidewall - Rear - Left | Surface scratch(es) | |
