| BMW 1 HATCH: 1XRB667 | | | |

Limited Technical Inspection

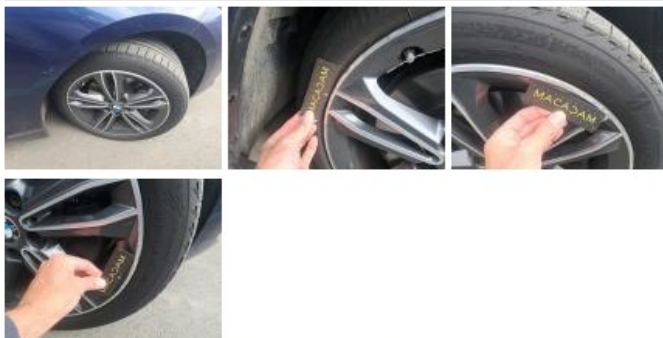
Alloy rim FR polished, Scratch(es), Repair and paint (complete)

199,04

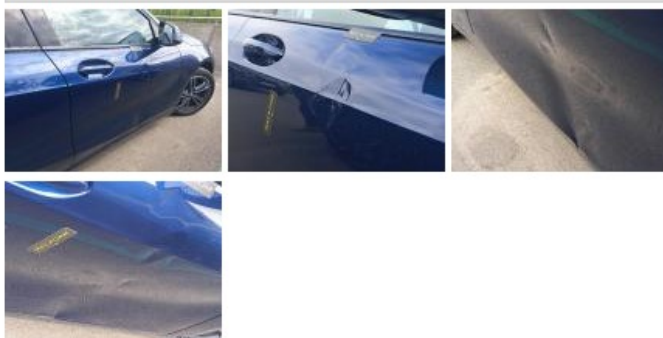
Door FR, Deformed / Strained, Replace and paint

0,00
