## status report

#### BMW Baureihe 3 Touring 320 d M Sport Shadow

| Vehicle identification number | <b>WBA8H91080A899860</b> | mileage read: | <b>175771 km</b> |

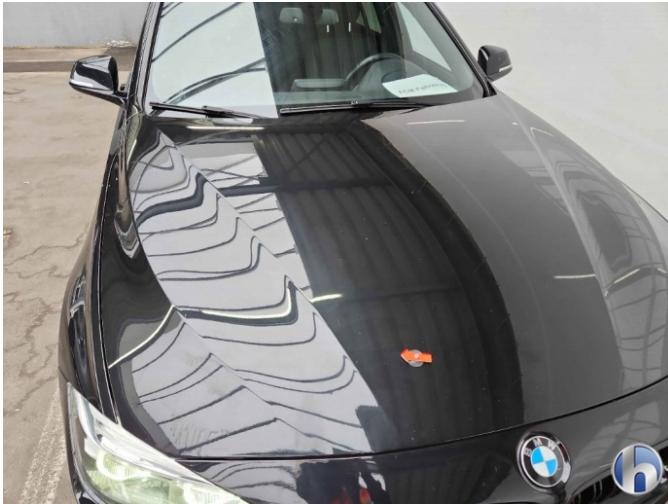
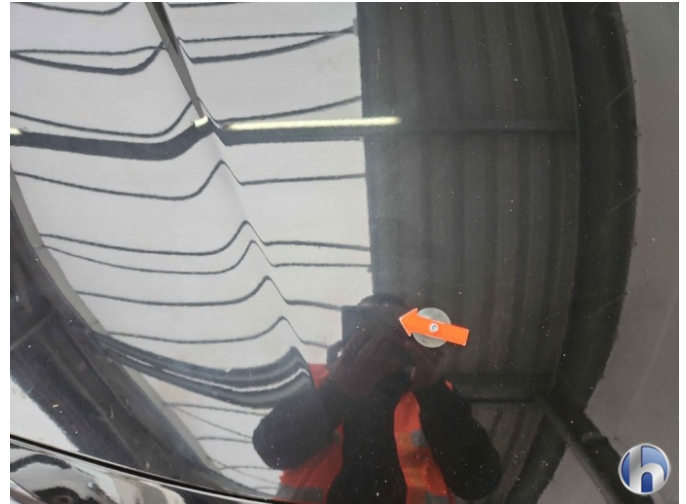
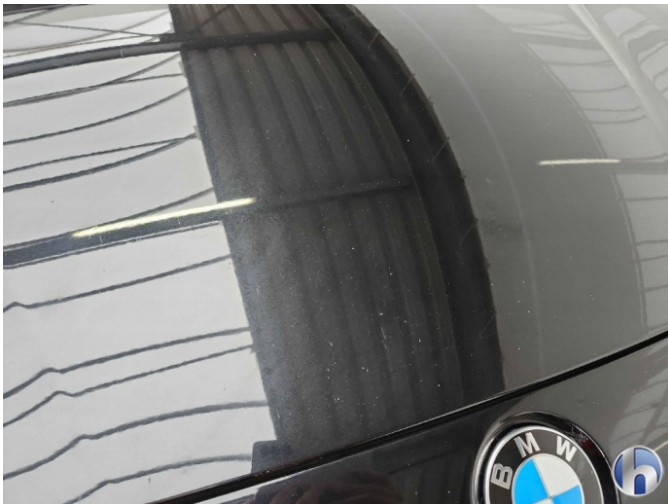
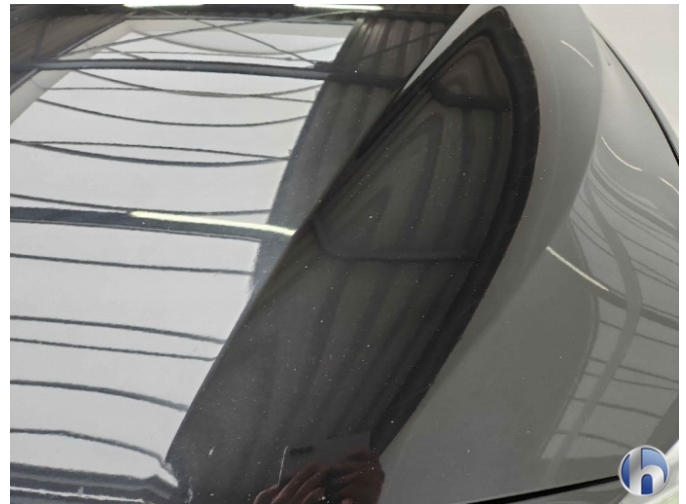
| component | Damage | Rep kind |
|---|---|---|
| 1. hood | Chipping from stones | Paint |

1. hood

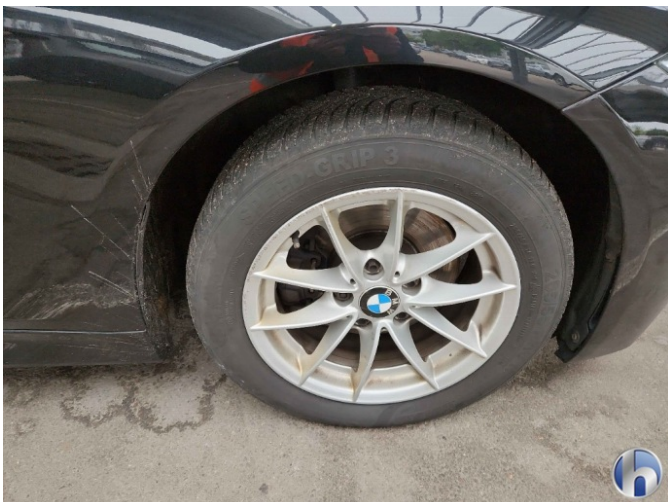
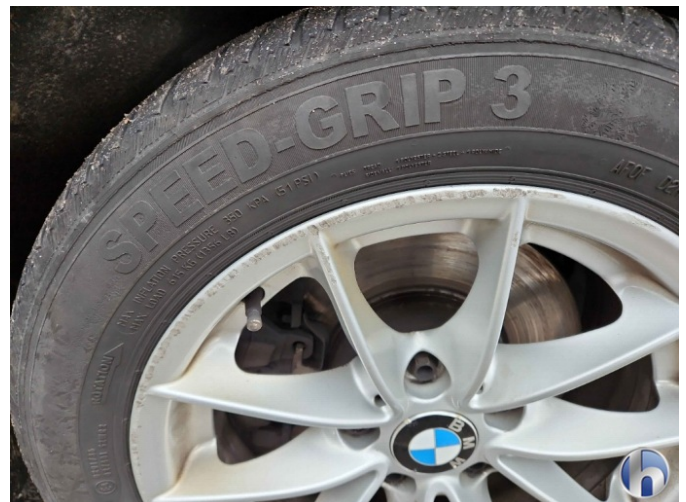
| component | Damage | Rep kind |
|---|---|---|
| 2. | Damaged | Replace |

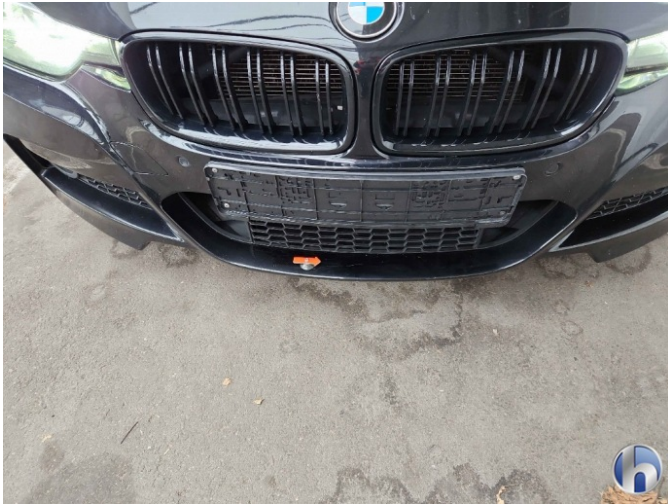
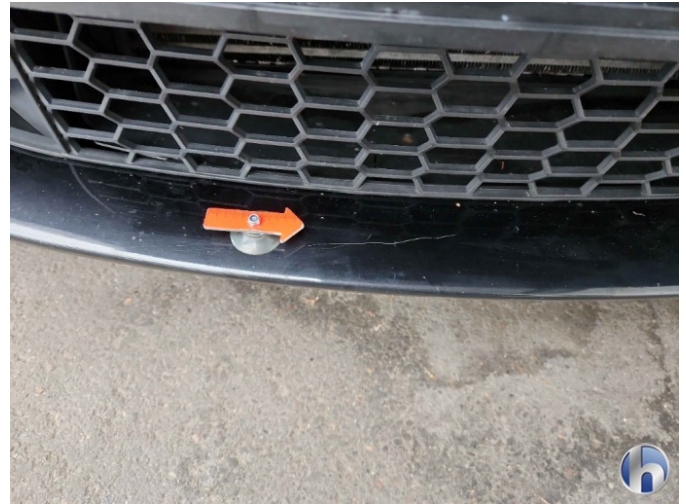
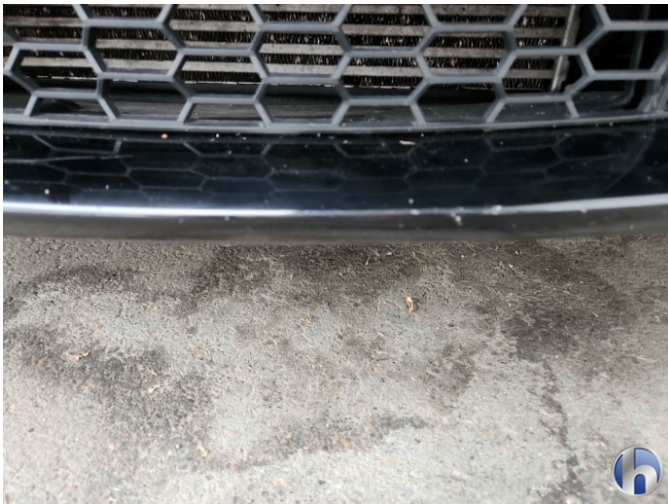
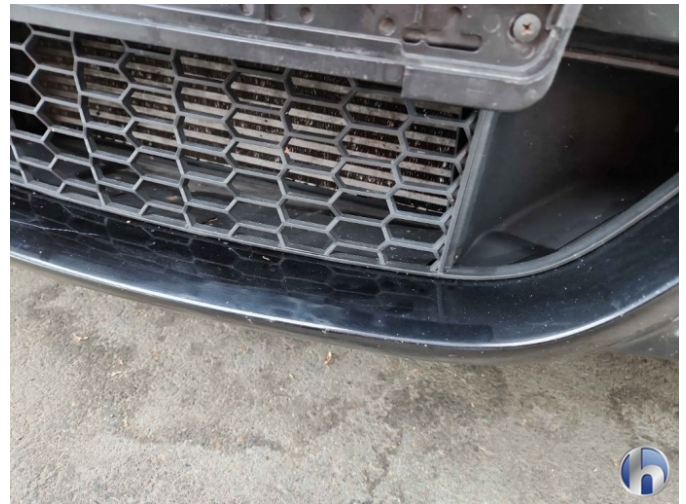
| component | Damage | Rep kind |
|---|---|---|
| 3. Front bumper | Damaged | Refurbish and paint |

3. Front bumper

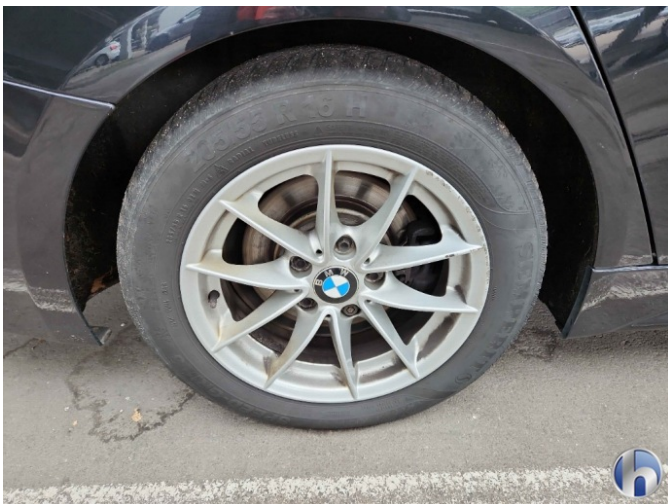
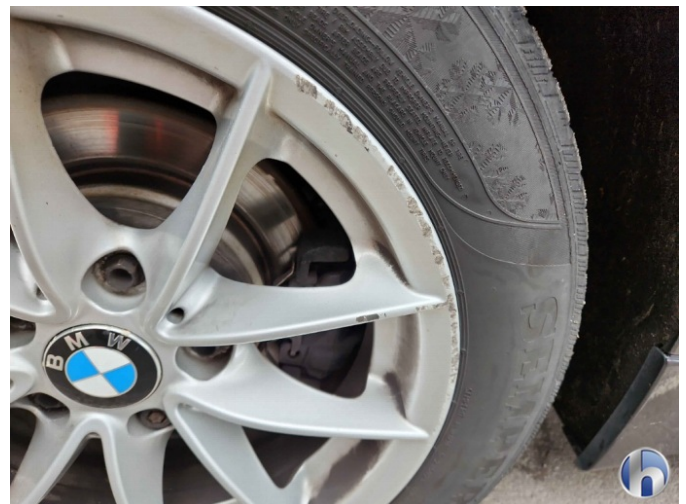
| component | Damage | Rep kind |
|---|---|---|
| 4. | Damaged | Replace |

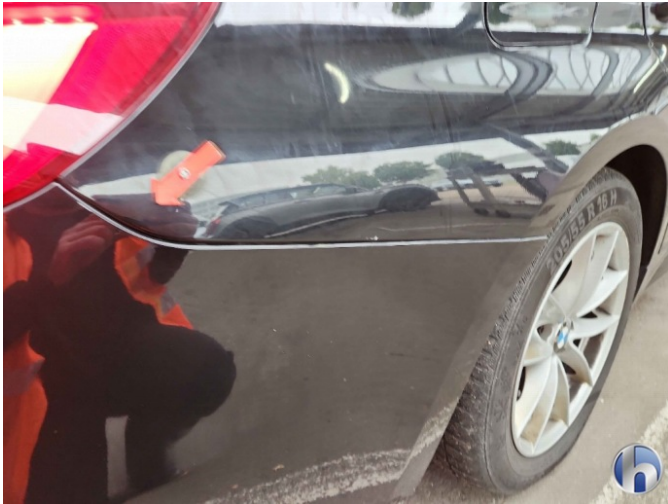
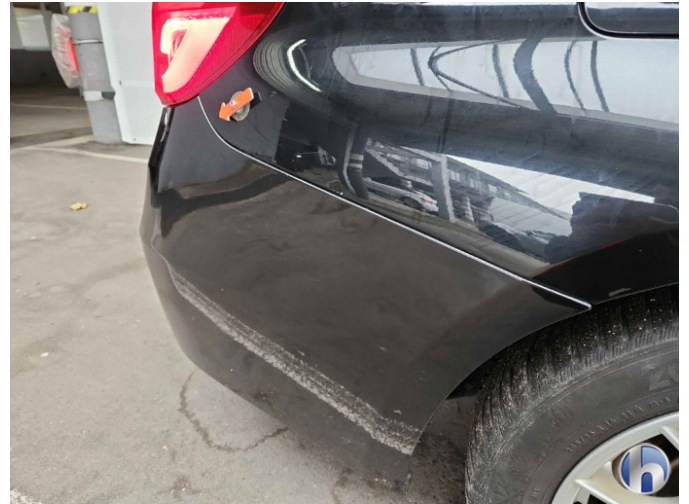
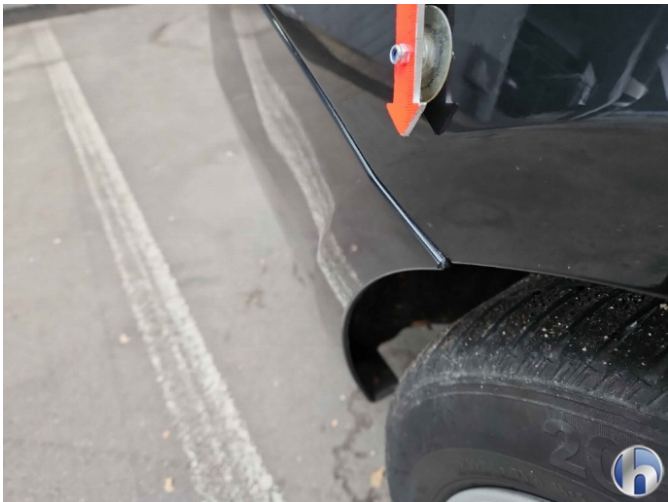
| component | Damage | Rep kind |
|---|---|---|
| 6. Rear bumper | Clearance not exact | Uninstall/install |

6. Rear bumper

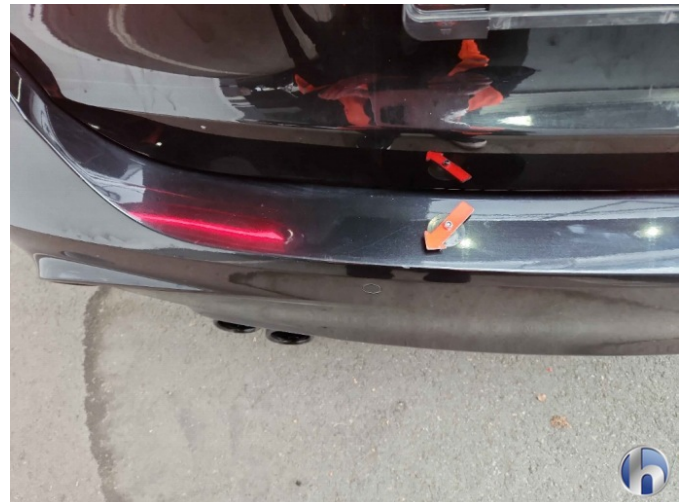
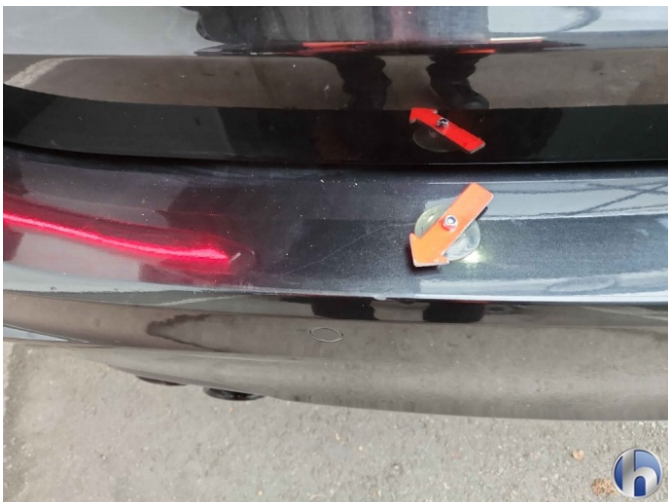
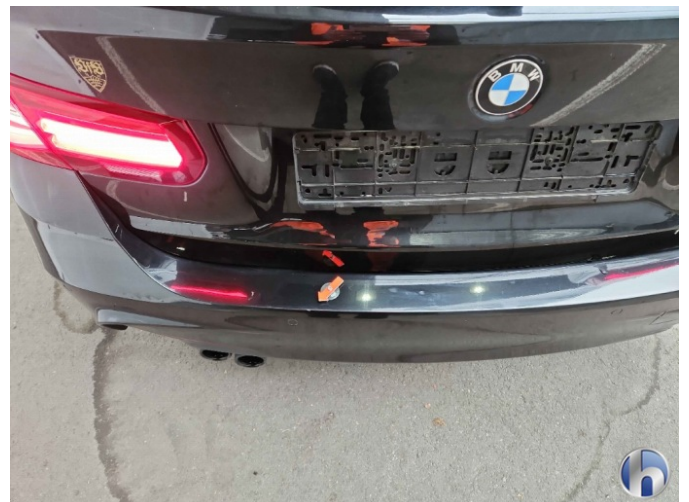
| component | Damage | Rep kind |
|---|---|---|
| 7. Rear bumper | Damaged | Refurbish and paint |

7. Rear bumper

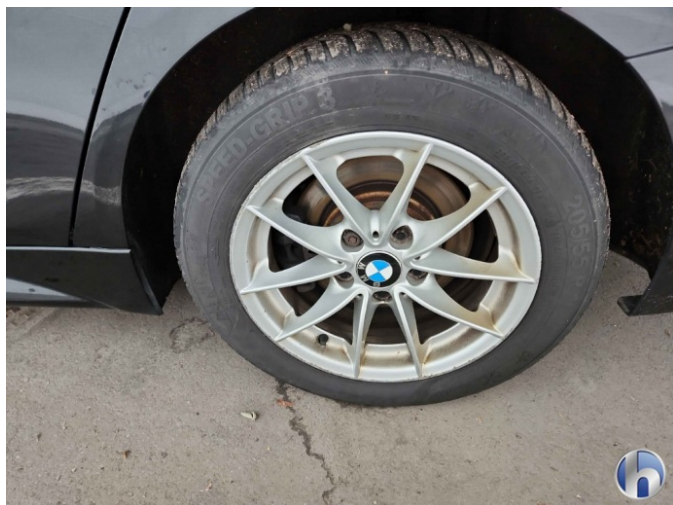
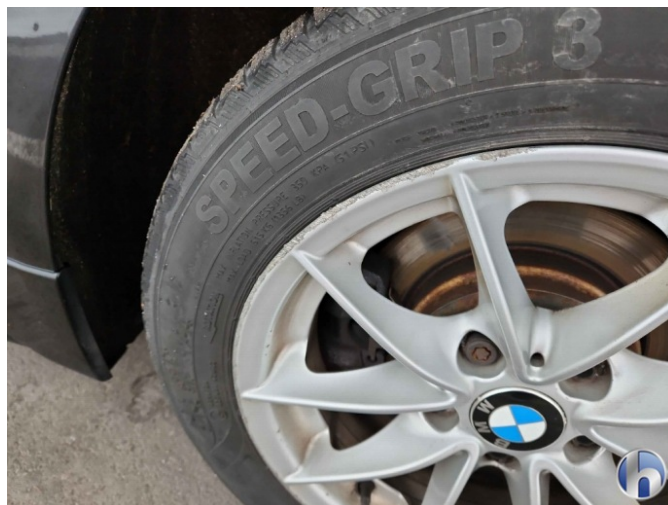
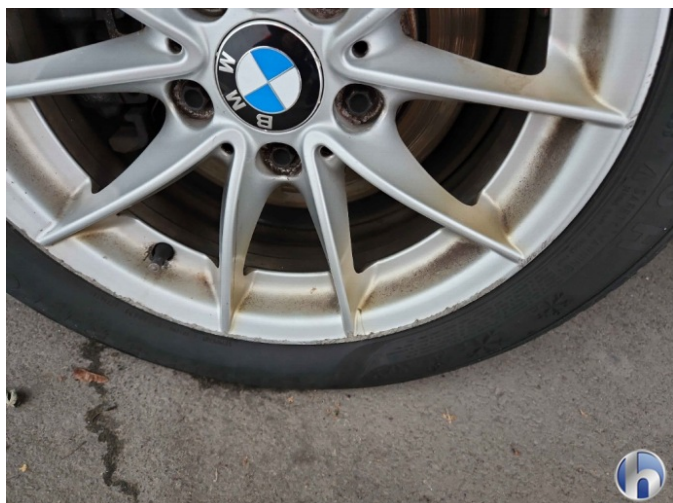
| component | Damage | Rep kind |
|---|---|---|
| 8. | Damaged | Replace |

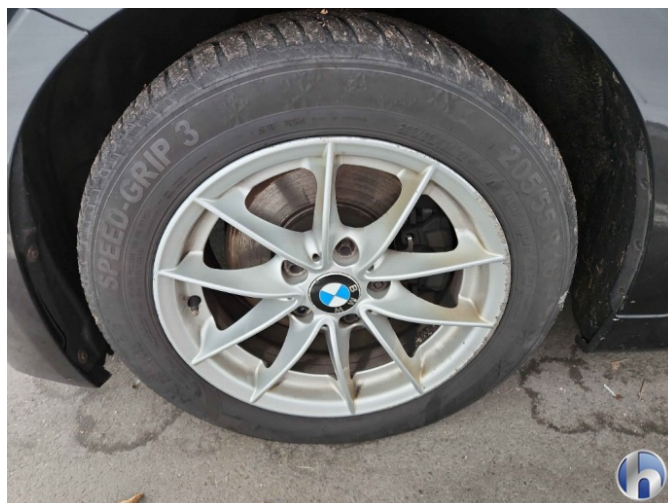
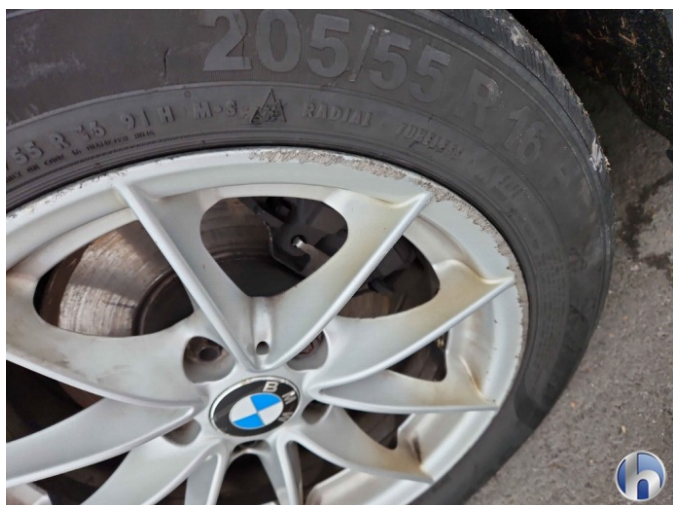
| component | Damage | Rep kind |
|---|---|---|
| 9. | Damaged | Replace |

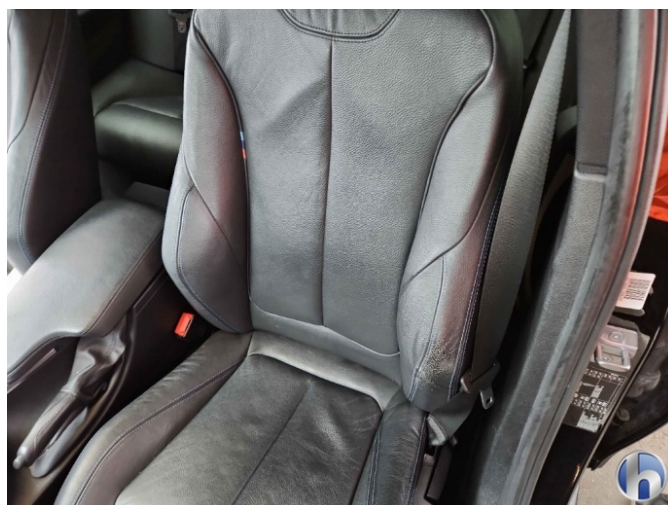
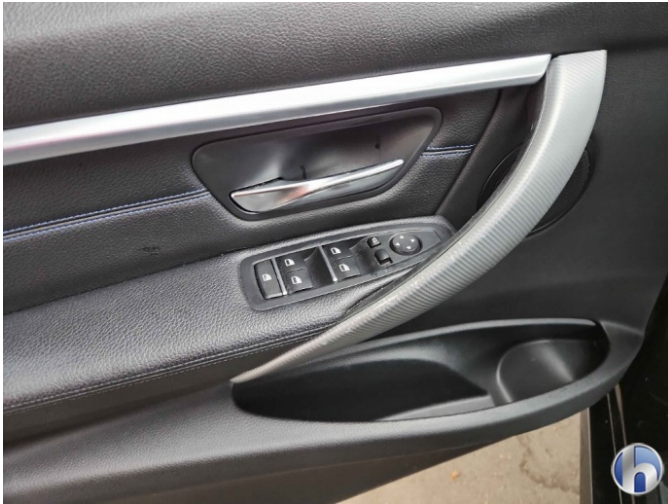
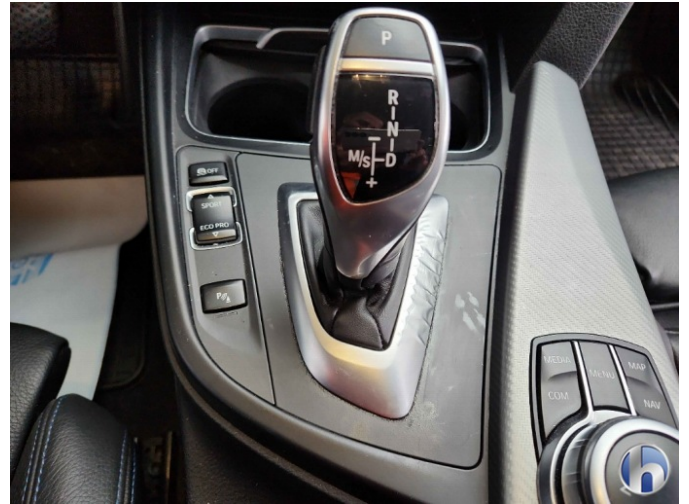
| component | Damage | Rep kind |
|---|---|---|
| 10. | Wear and tear | acceptable |
