## status report

#### BMW Baureihe 3 Cabrio 320d

| Vehicle identification number | <b>WBADY31010E828357</b> | mileage read: | <b>262248 km</b> |

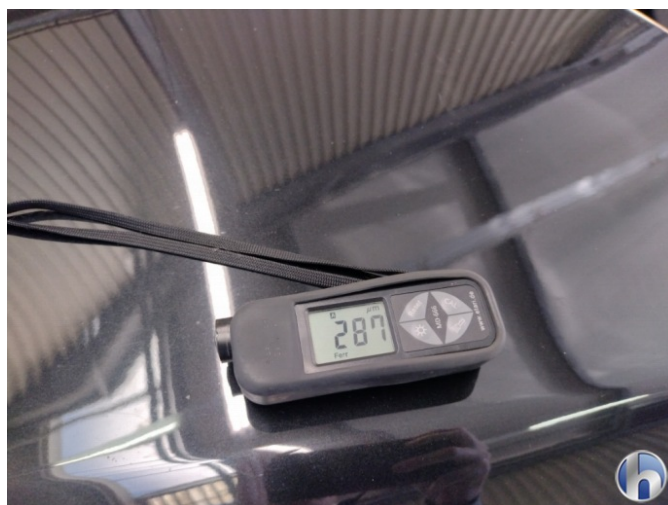
| component | Damage | Rep kind |
|---|---|---|
| 1. hood | Subsequently painted | acceptable |

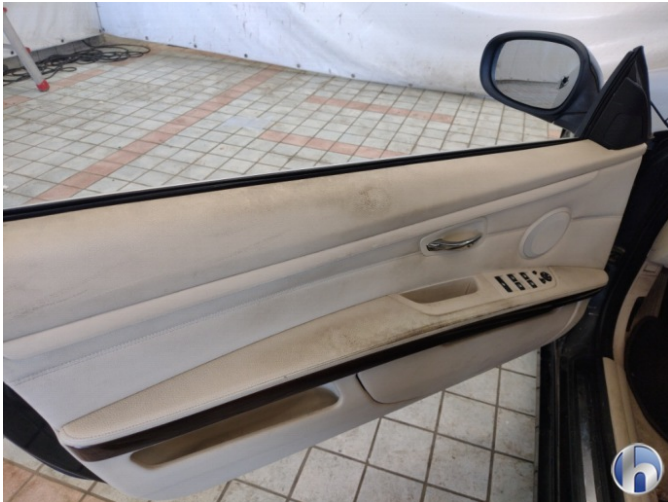
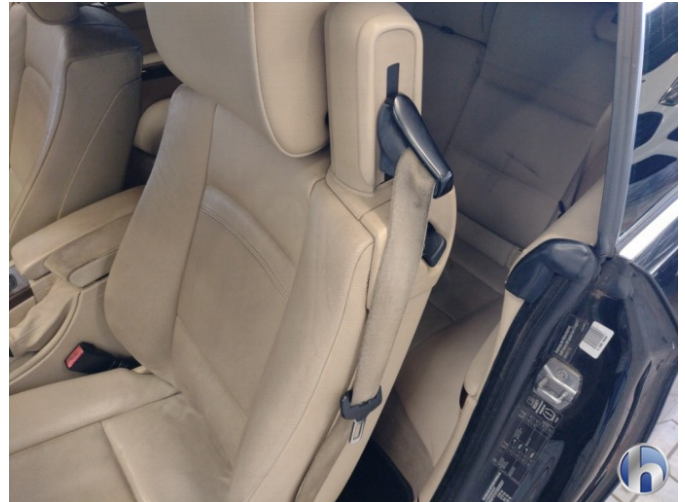
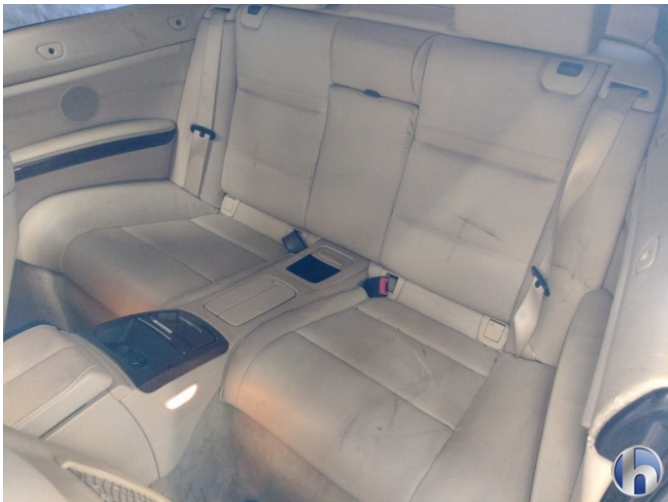
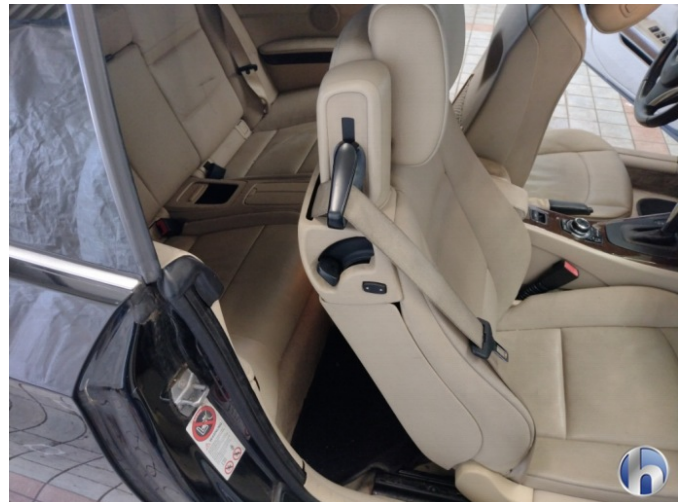
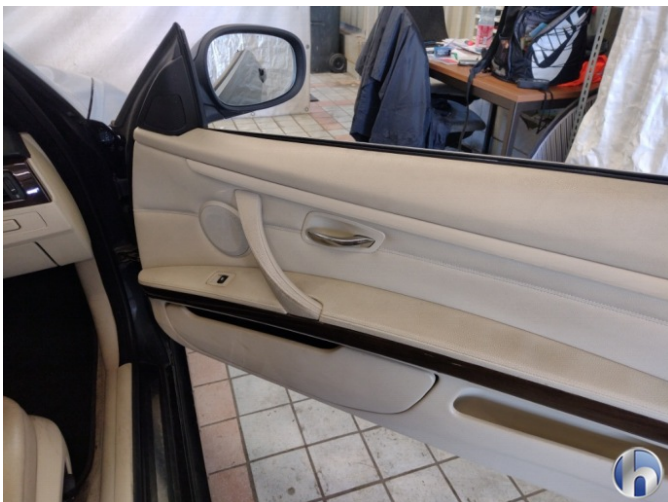
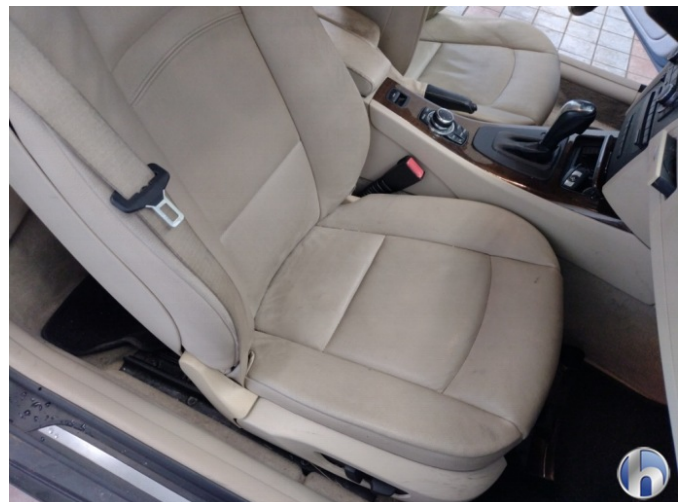
| component | Damage | Rep kind |
|---|---|---|
| 3. Innenraum, Sitze, Gurte, etc. | Dirty | |

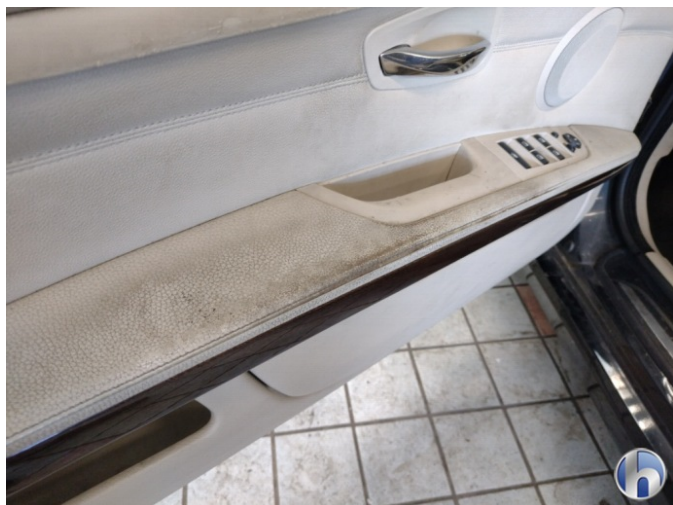
| component | Damage | Rep kind |
|---|---|---|
| 4. Front door trim - left | Damaged | Smart repair |

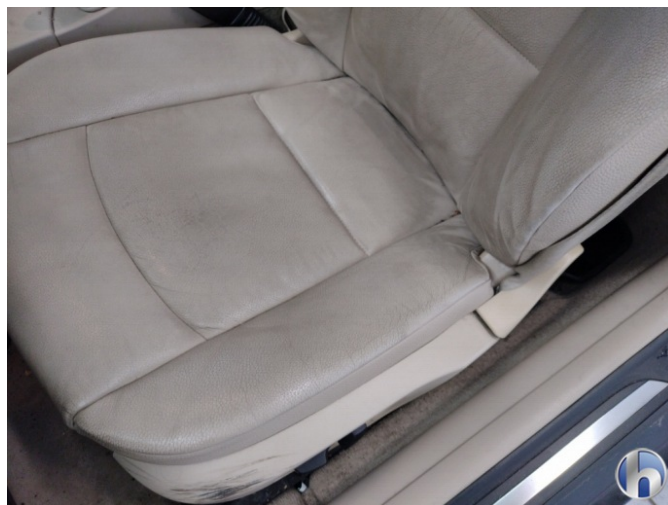
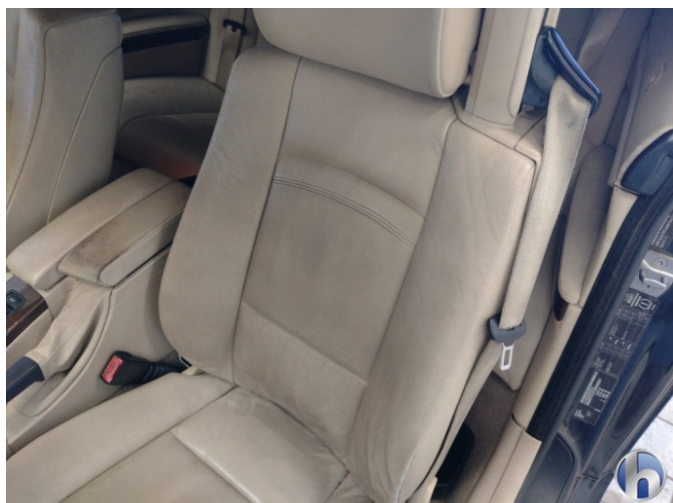
| component | Damage | Rep kind |
|---|---|---|
| 5. Sitz Vorne Links | Damaged | Smart repair |

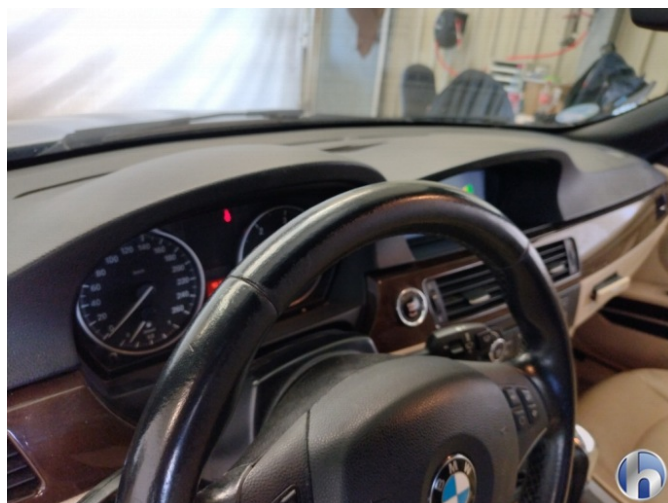
| component | Damage | Rep kind |
|---|---|---|
| 6. steering wheel | Damaged | Smart repair |

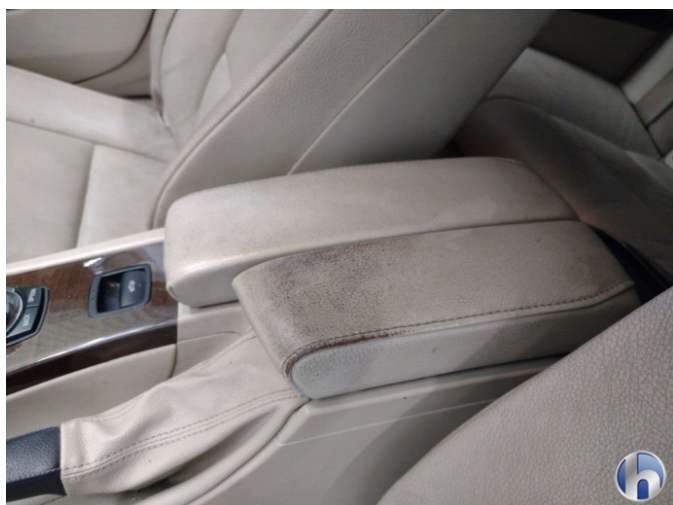
| component | Damage | Rep kind |
|---|---|---|
| 7. Mittelarmlehne | Damaged | Smart repair |

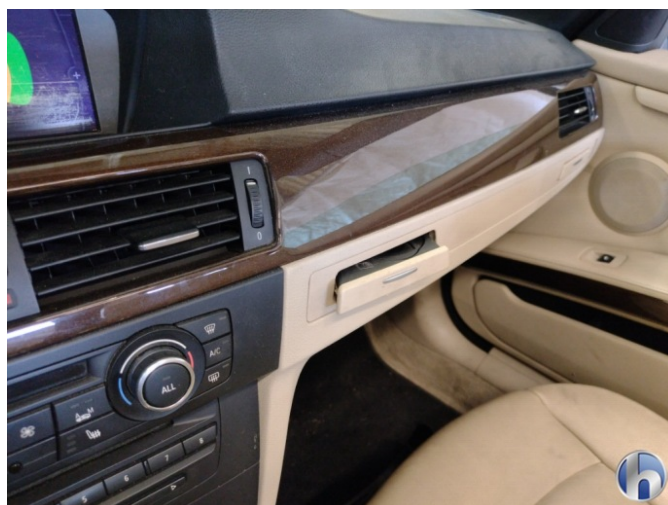
| component | Damage | Rep kind |
|---|---|---|
| 8. Getränkehalter Armaturenbrett | Damaged | Replace |

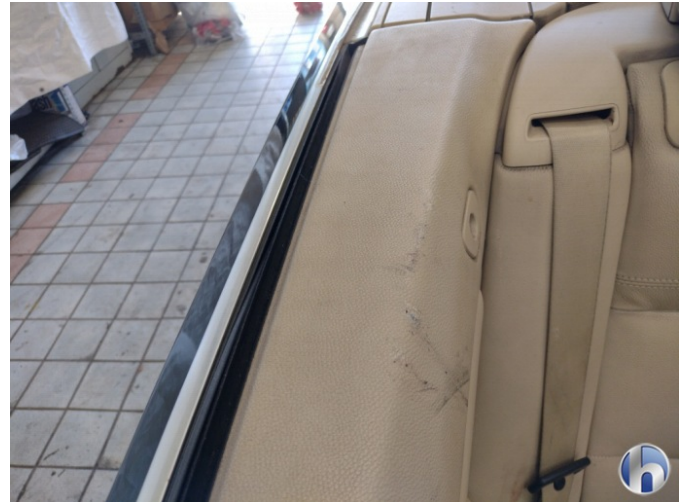
| component | Damage | Rep kind |
|---|---|---|
| 9. Innenverkleidung Hinten Links und Rechts | Damaged | Smart repair |

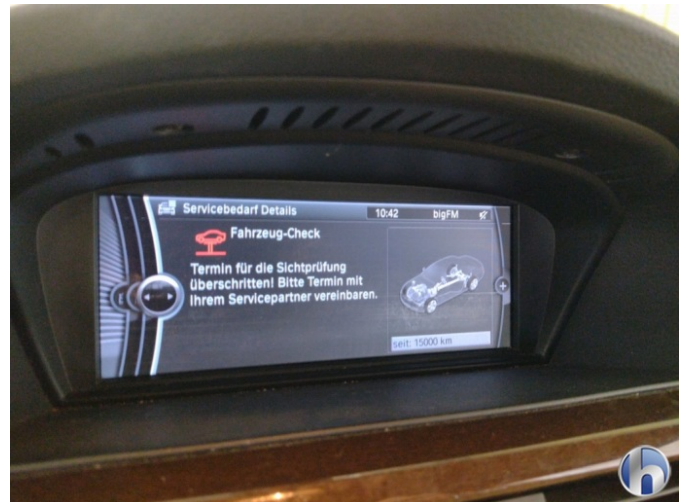
| component | Damage | Rep kind |
|---|---|---|
| 11. maintenance | Due | Replace |

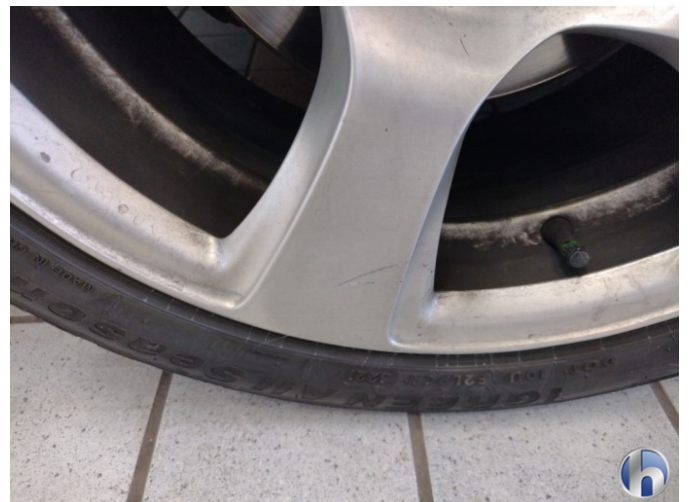
| component | Damage | Rep kind |
|---|---|---|
| 12. Rim front - left | Scratch(es) | Smart repair |

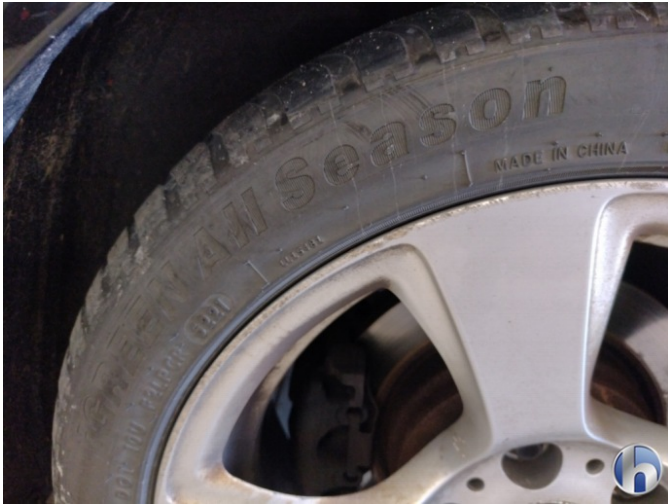
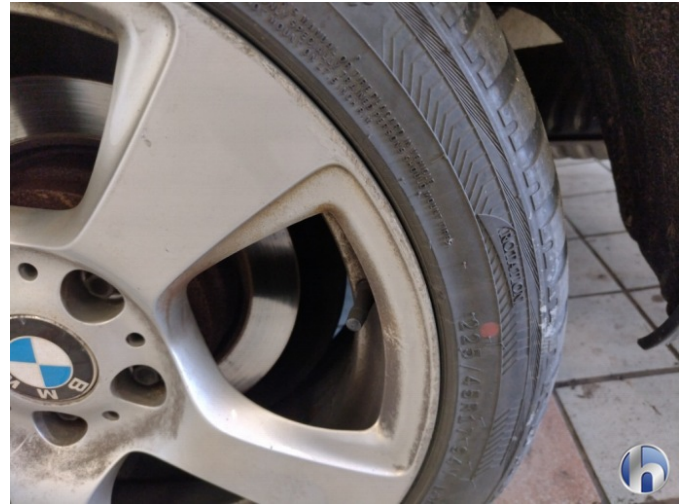
| component | Damage | Rep kind |
|---|---|---|
| 13. Rim rear - left | Scratch(es) | Smart repair |

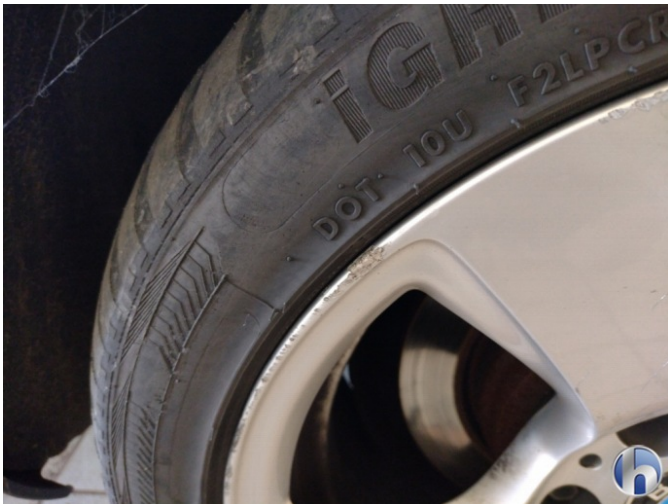
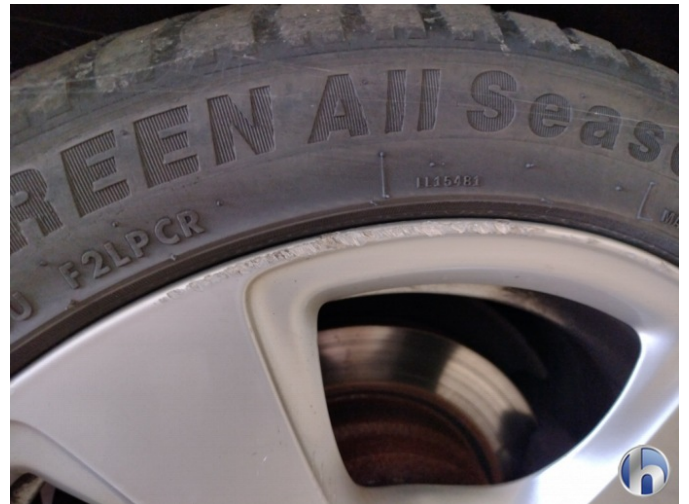
| component | Damage | Rep kind |
|---|---|---|
| 14. Rim rear - right | Scratch(es) | Smart repair |

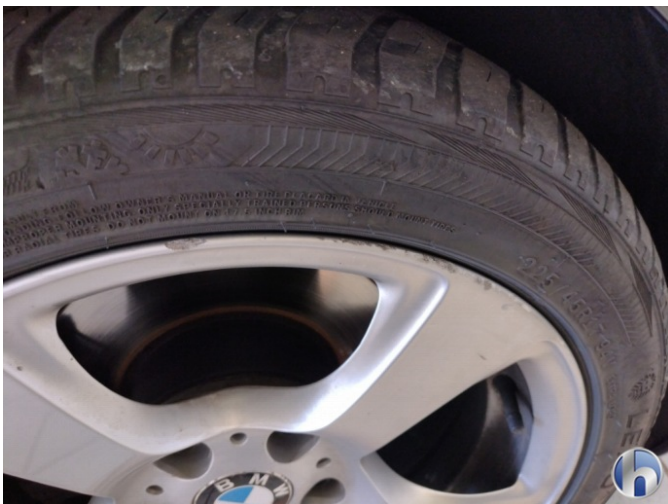
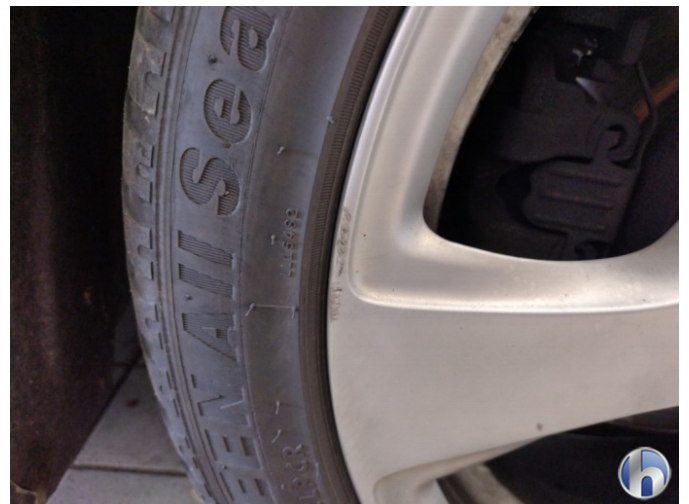
| component | Damage | Rep kind |
|---|---|---|
| 15. Rim front - right | Scratch(es) | Smart repair |

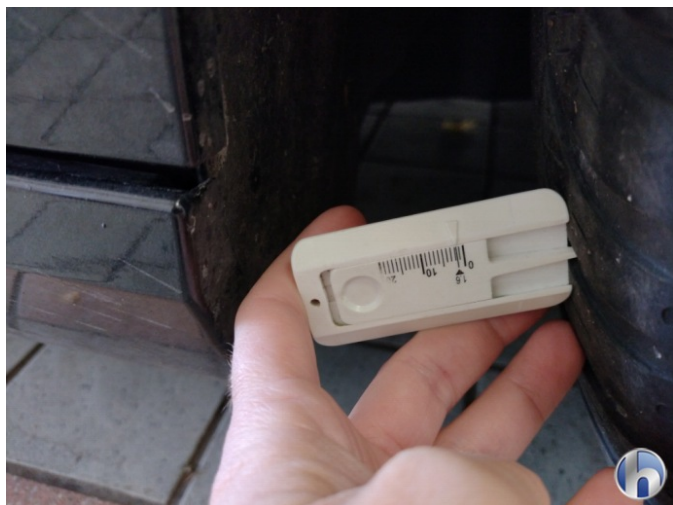
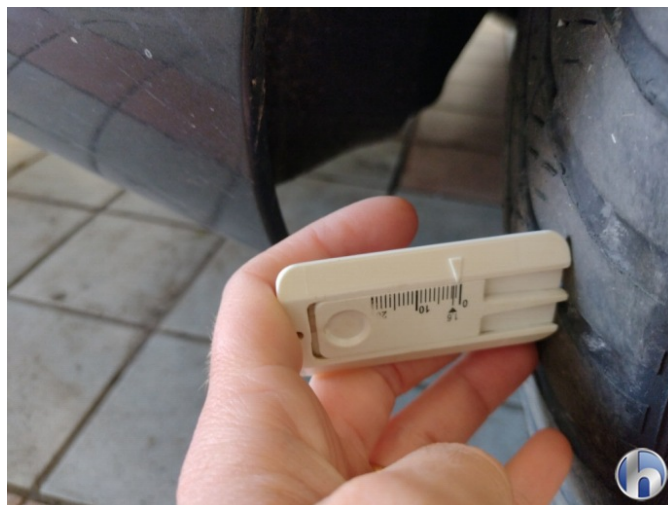
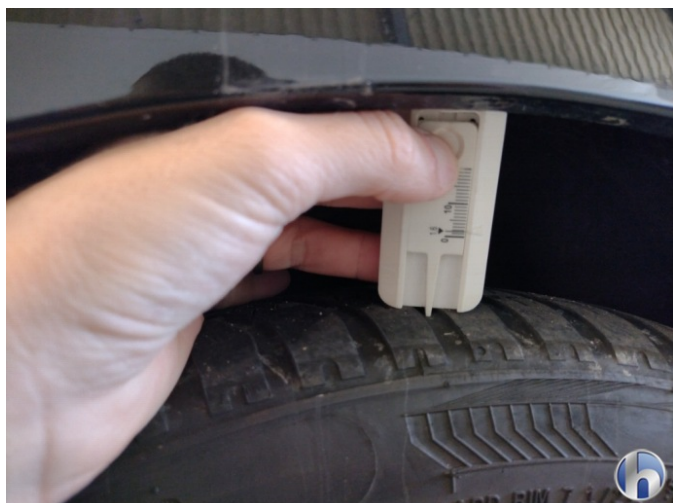
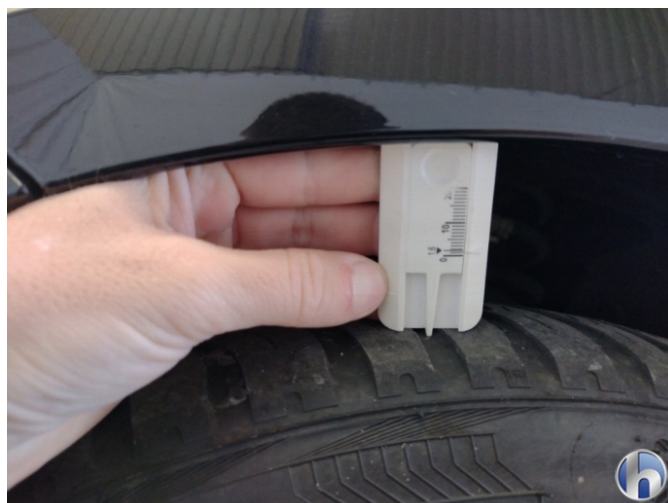
| mounted tires | | |
|---|---|---|
| 1st axis - Left / states . | <b>Anderer</b> | <b>225/45/R17/94V 1 mm</b> |
| 1st axis - right / states . | <b>Anderer</b> | <b>225/45/R17/94V 1 mm</b> |
| 2nd axis - Left / states . | <b>Anderer</b> | <b>225/45/R17/94V 2 mm</b> |
| 2nd axis - right / states . | <b>Anderer</b> | <b>225/45/R17/94V 0 mm</b> |
| traffic Safety: | <b>not roadworthy</b> | |

| component | Damage | Rep kind |
|---|---|---|
| 16. 4x Reifen | Worn | Replace |

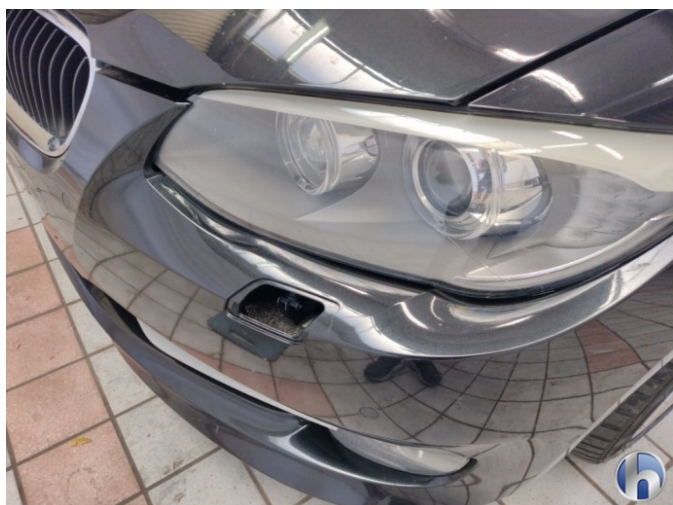
| component | Damage | Rep kind |
|---|---|---|
| 17. Scheinwerferreinigungsanlage Links | Damaged | Replace |

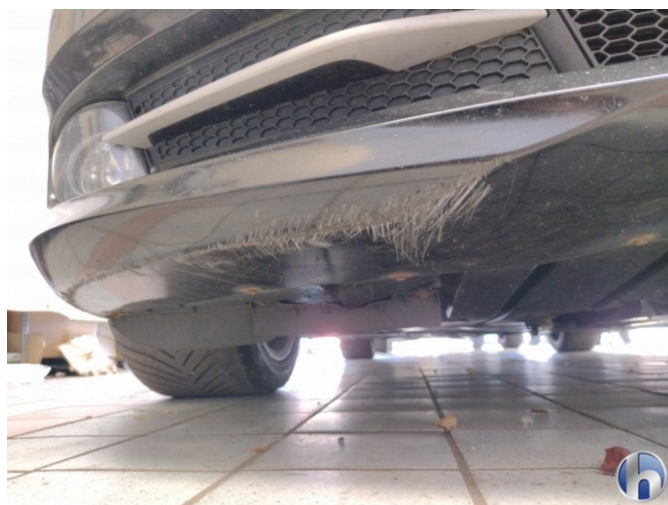
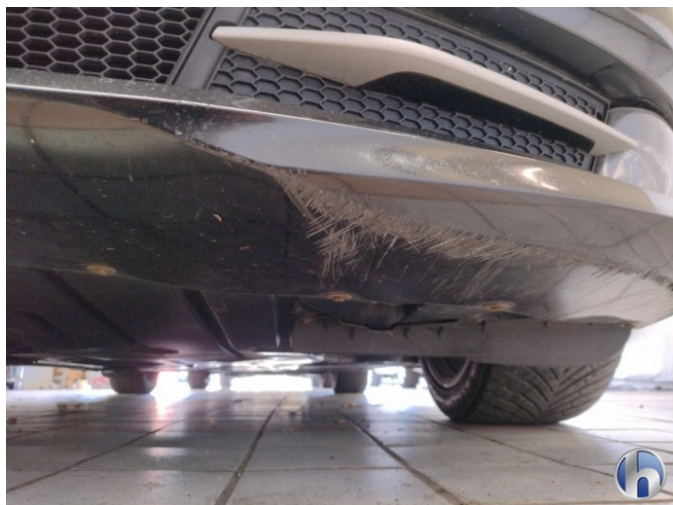
| component | Damage | Rep kind |
|---|---|---|
| 18. Front bumper | Scrape | Paint |

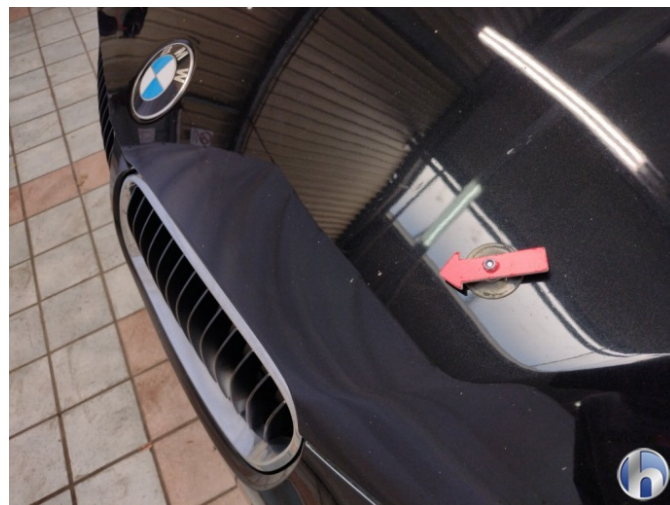
| component | Damage | Rep kind |
|---|---|---|
| 19. hood | Wear and tear | acceptable |

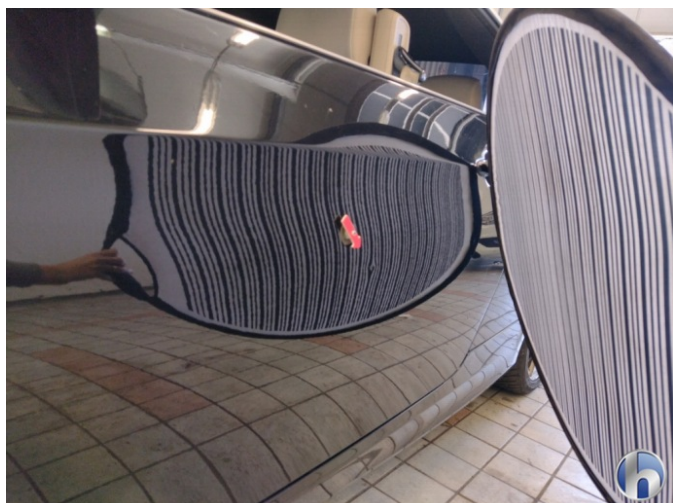
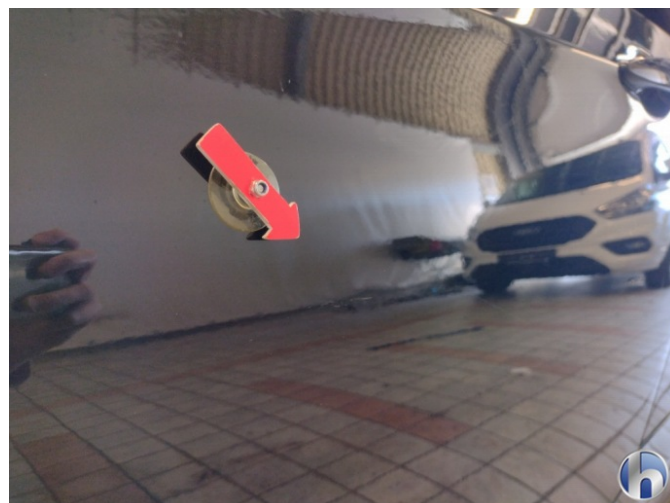
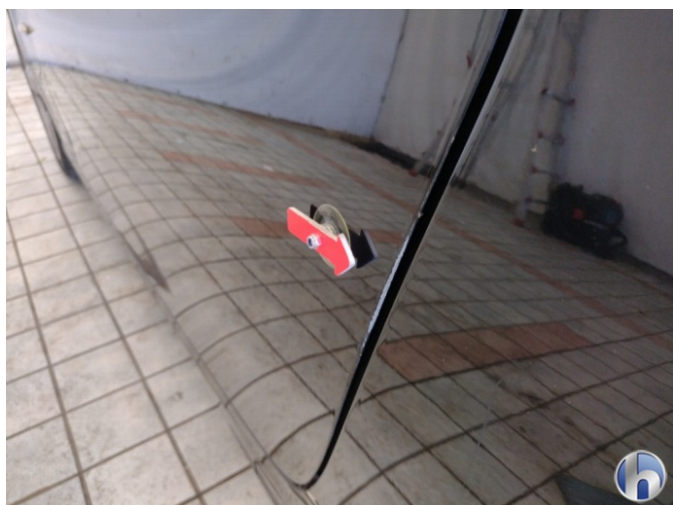
| component | Damage | Rep kind |
|---|---|---|
| 20. Front door - left | Damaged | Refurbish and paint |

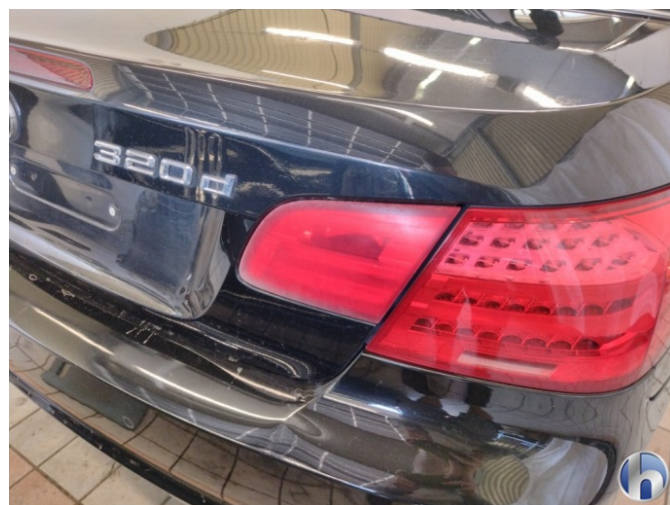
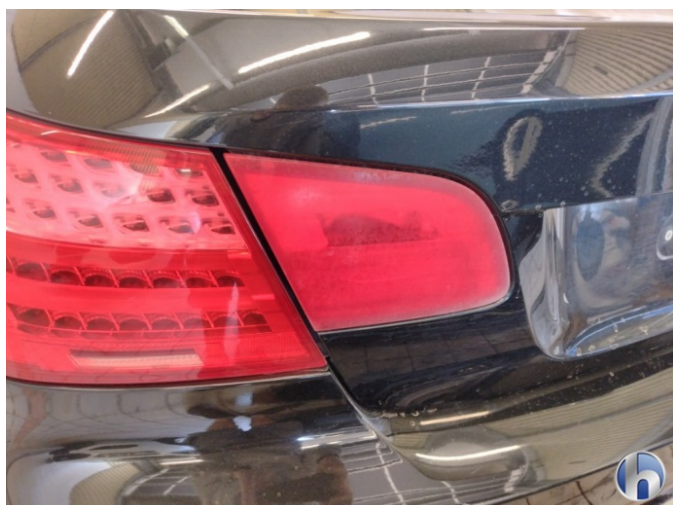
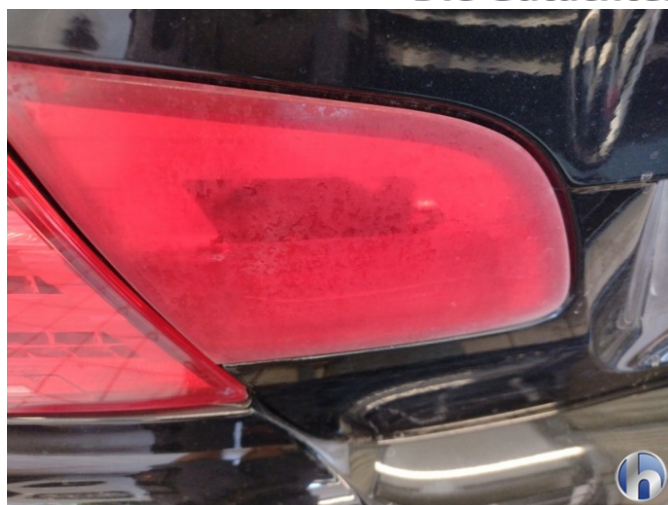
| component | Damage | Rep kind |
|---|---|---|
| 21. 2x Rückleuchte Heckklappe | Damaged | Replace |

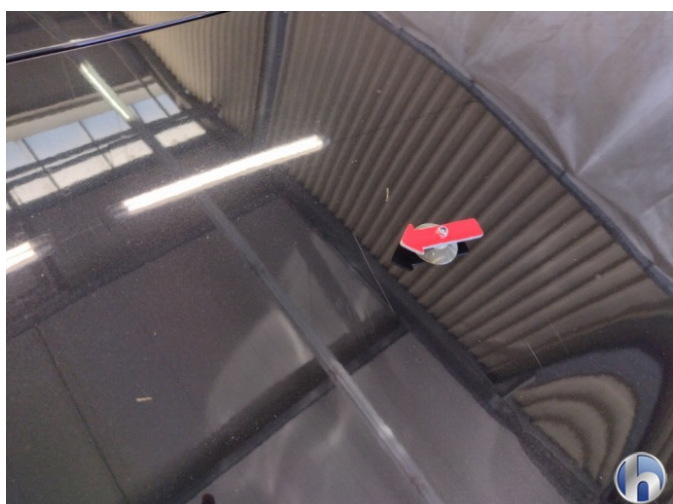
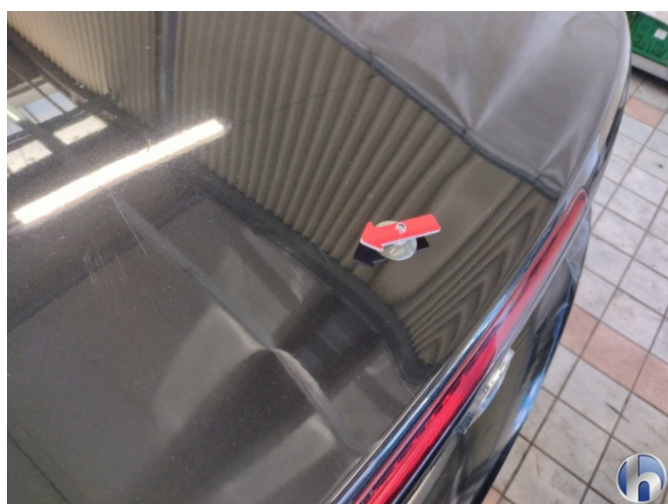
| component | Damage | Rep kind |
|---|---|---|
| 22. tailgate | Scratch(es) | Paint |

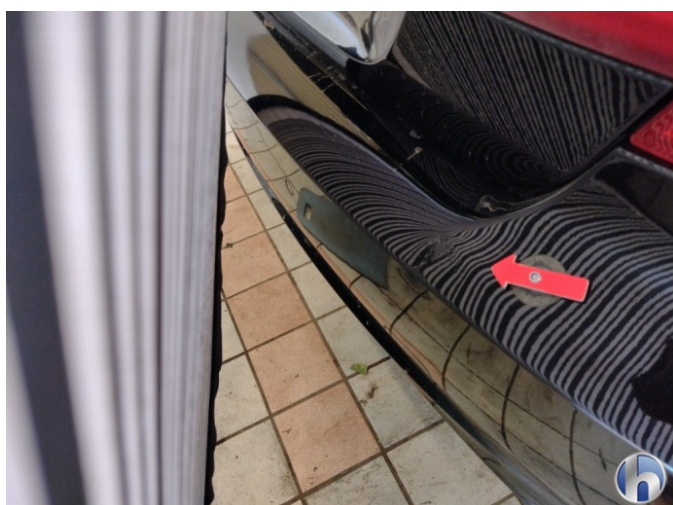
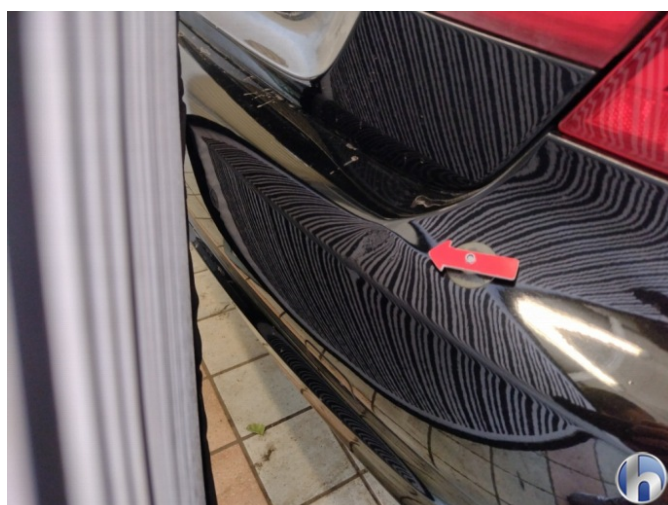
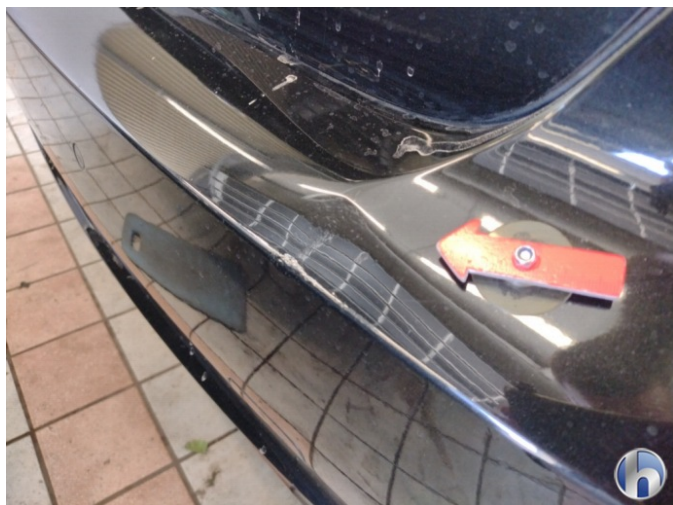
| component | Damage | Rep kind |
|---|---|---|
| 23. Rear bumper | Damaged | Refurbish and paint |

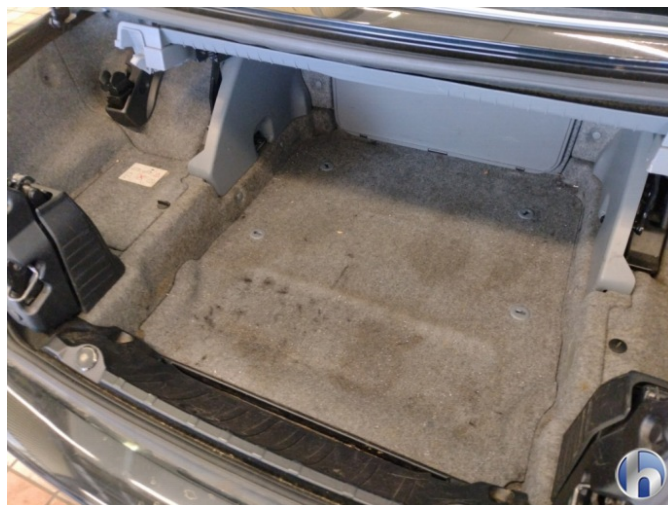
| component | Damage | Rep kind |
|---|---|---|
| 24. | Dirty | |

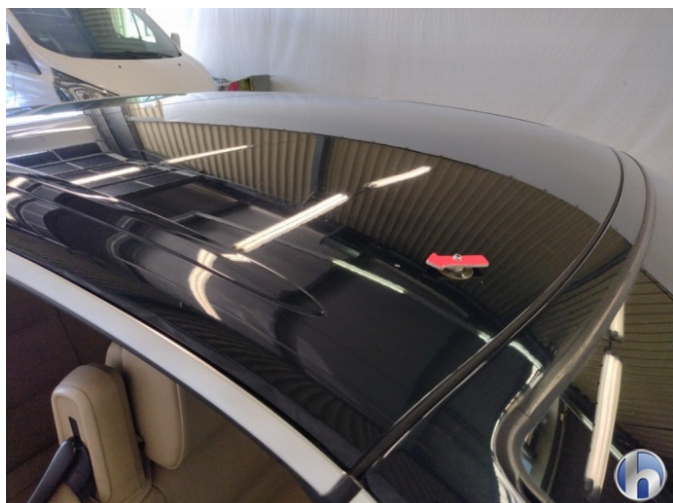
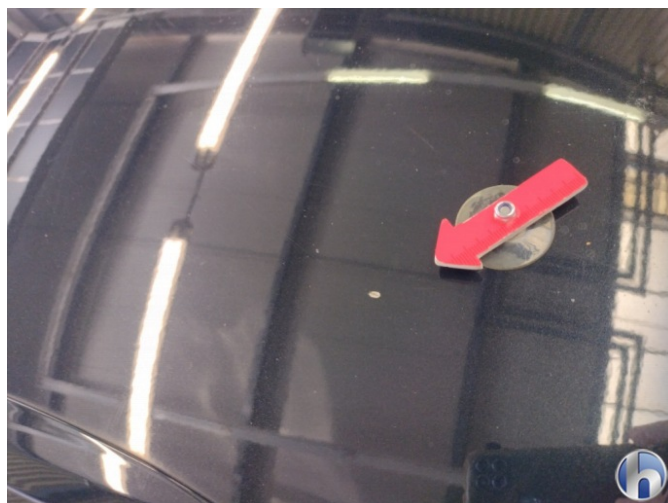
| component | Damage | Rep kind |
|---|---|---|
| 25. roof | Wear and tear | acceptable |

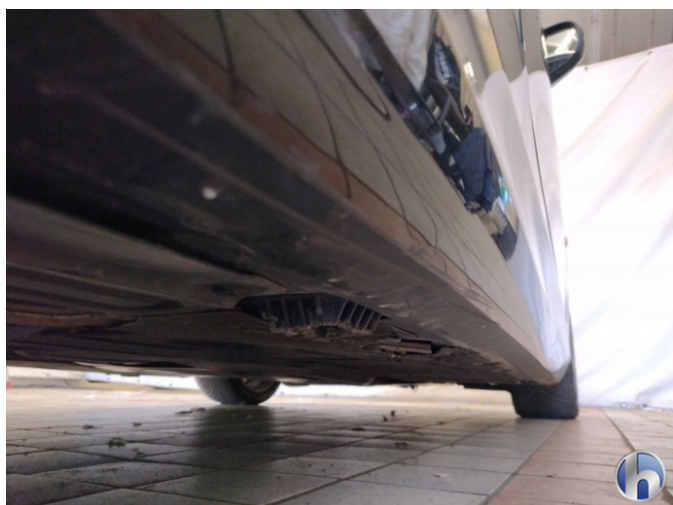
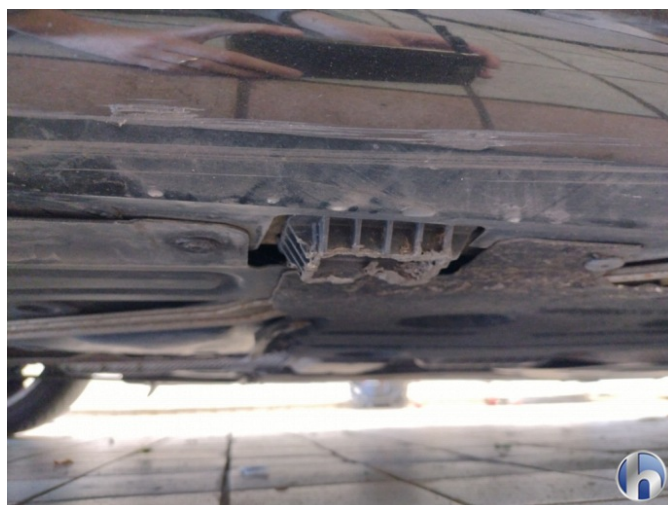
| component | Damage | Rep kind |
|---|---|---|
| 26. side skirt - right | Scrape | Paint |

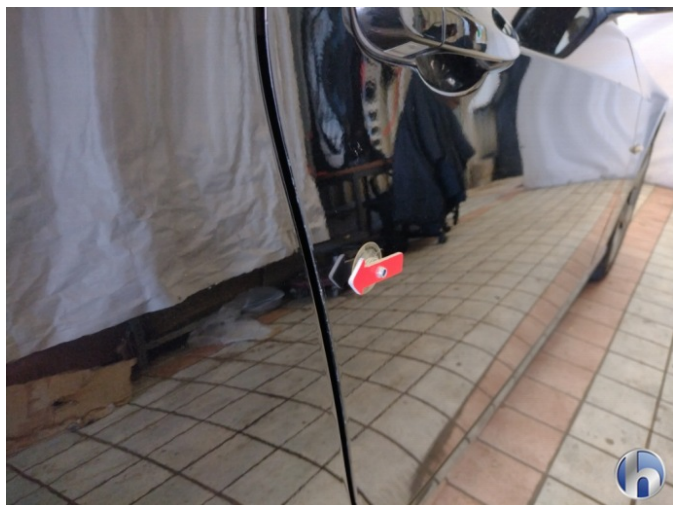
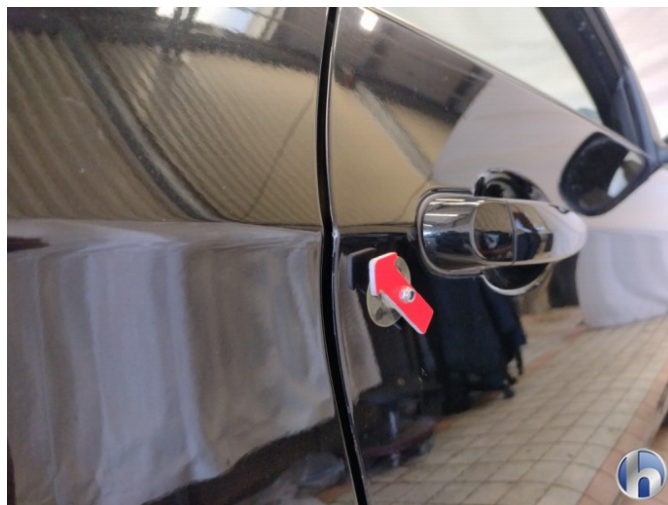
| component | Damage | Rep kind |
|---|---|---|
| 27. Front door - right | Scratch(es) | Paint |

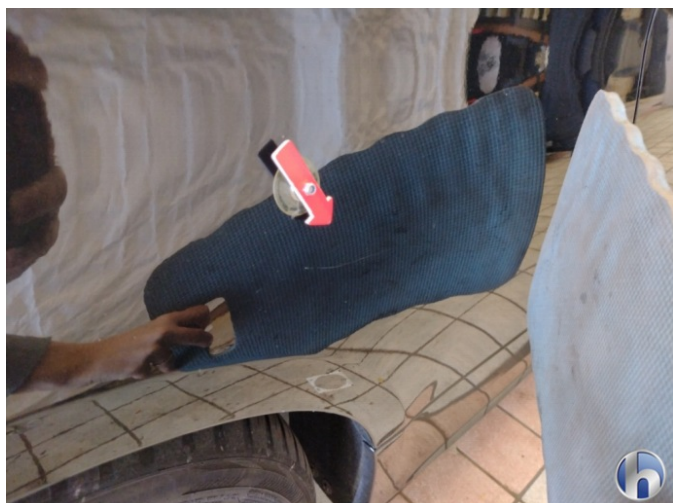
| component | Damage | Rep kind |
|---|---|---|
| 28. Sidewall - Rear - right | Scratch(es) | |

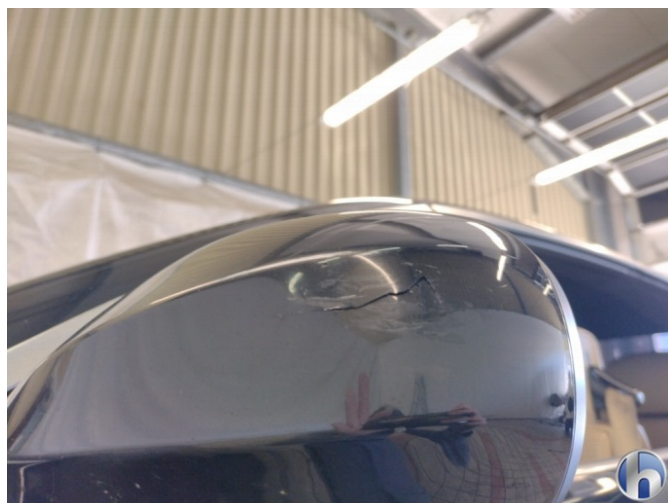
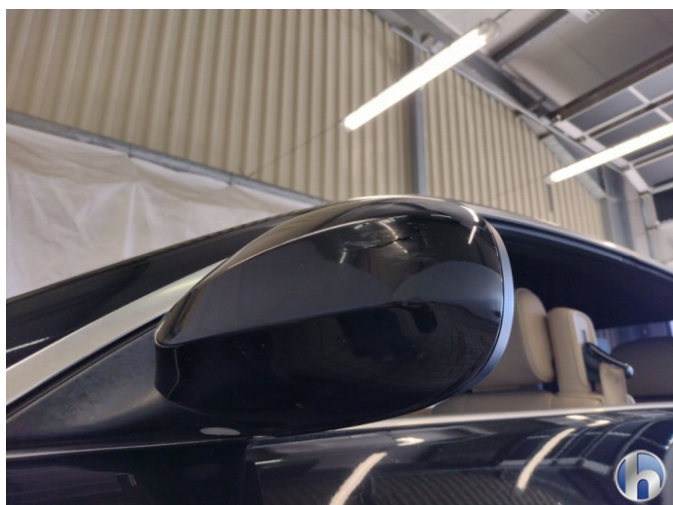
| component | Damage | Rep kind |
|---|---|---|
| 29. | Breakage | Replace |

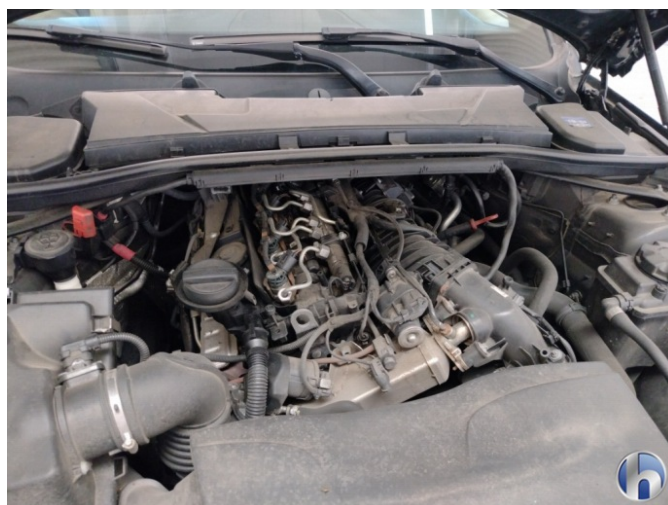
| component | Damage | Rep kind |
|---|---|---|
| 30. Motorabdeckung | Missing | Replace |

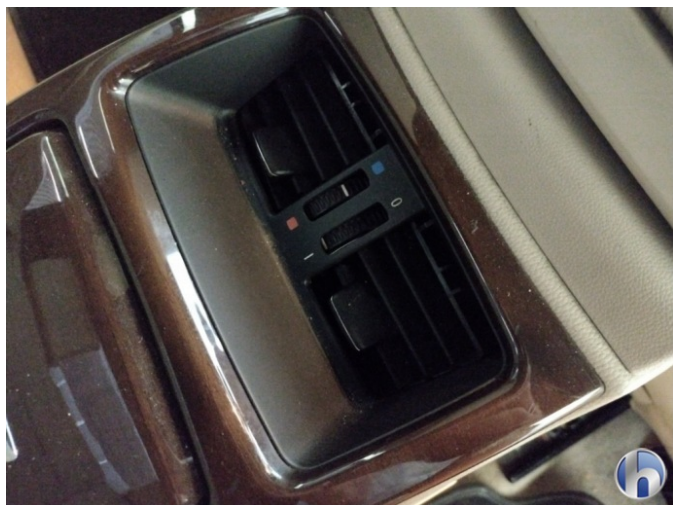
| component | Damage | Rep kind |
|---|---|---|
| 31. | Damaged | Replace |

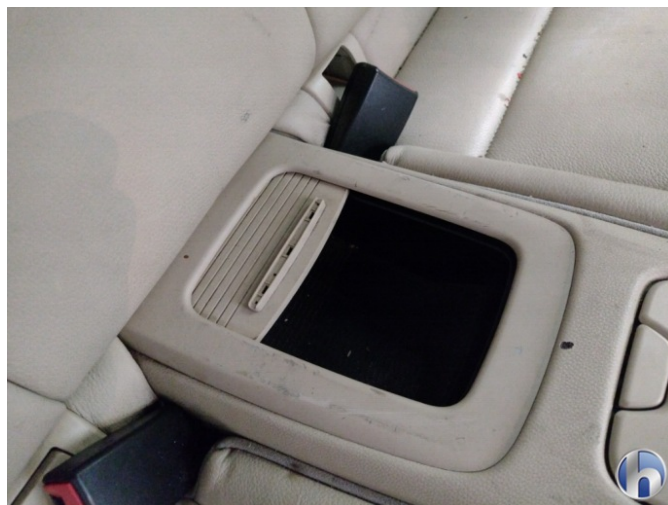
| component | Damage | Rep kind |
|---|---|---|
| 32. Sitzreihe Hinten Mitte Klappe | Damaged | Replace |
