BMW 3er 325d DPF Cabrio Aut.

Inspection Report Summary

Customer	BCA Online	Report Number	P20250905100838
Inspection Date / Place	2025-09-05 / BCA Oberndorf	Cosmetic Grade	2

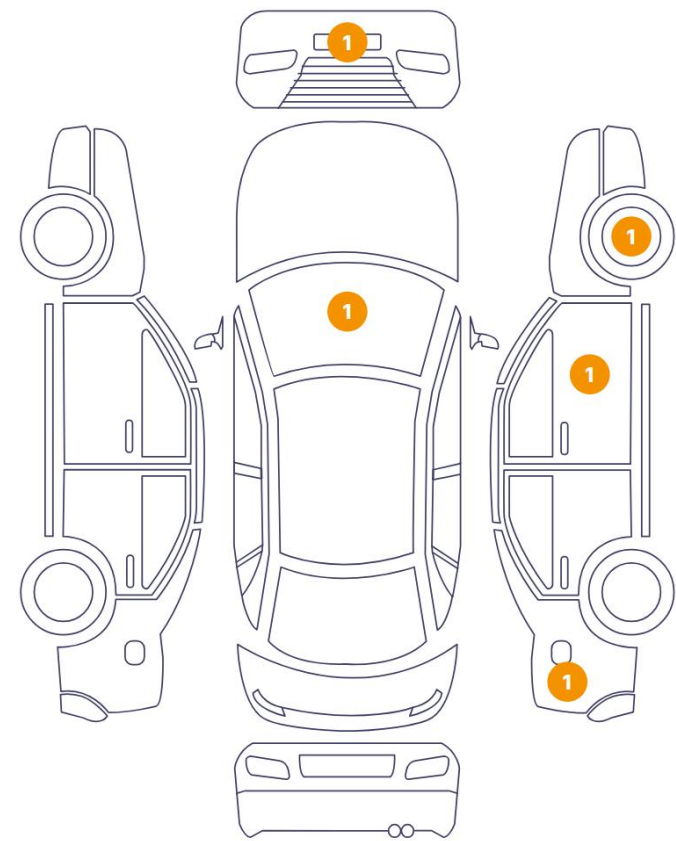
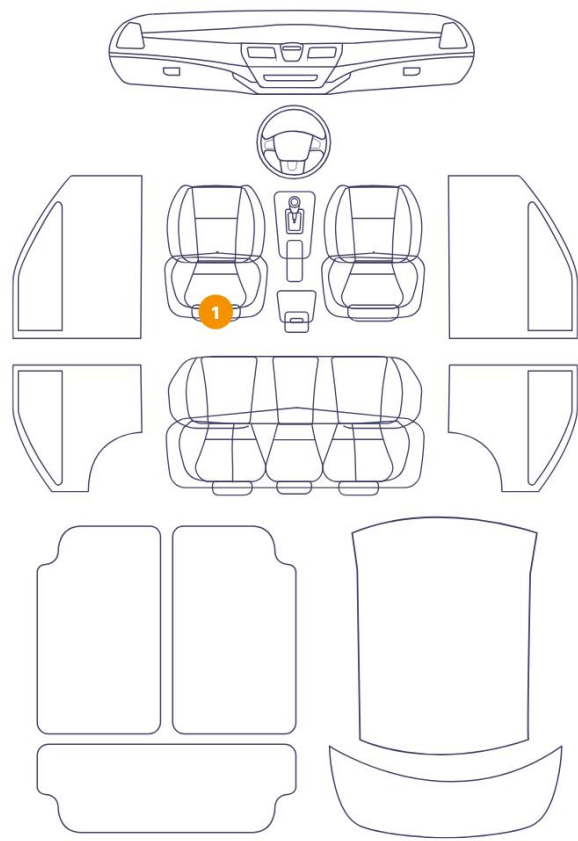
Component		Damage	Comments
1	Windshield / Front	Glass Break / Impact	
2	Bumper / Front	Paint / Stone Chip	
3	Seat / Front Left	Interior / Scratched	
4	Fender / Back Right	Paint / Scratch / Line	
5	Mirror / Front Right	Paint / Scratch / Scuff	
6	Rim / Front Right	Out of Bodywork / Scratch

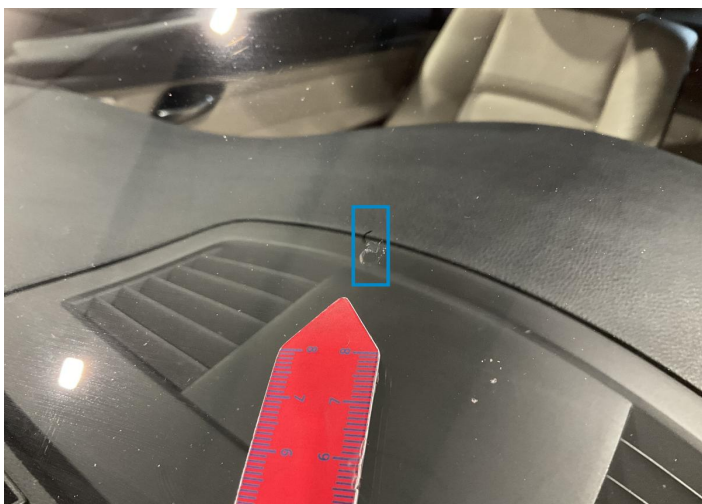
1. Windshield / Front
Glass Break / Impact -

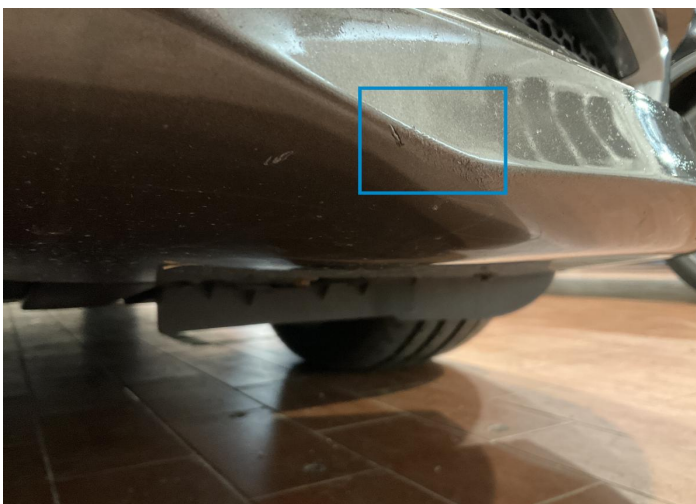
2. Bumper / Front
Paint / Stone Chip -

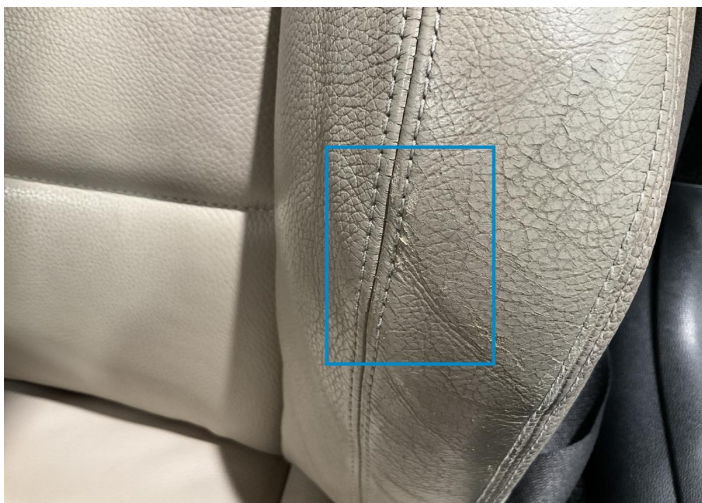
3. Seat / Front Left
Interior / Scratched -

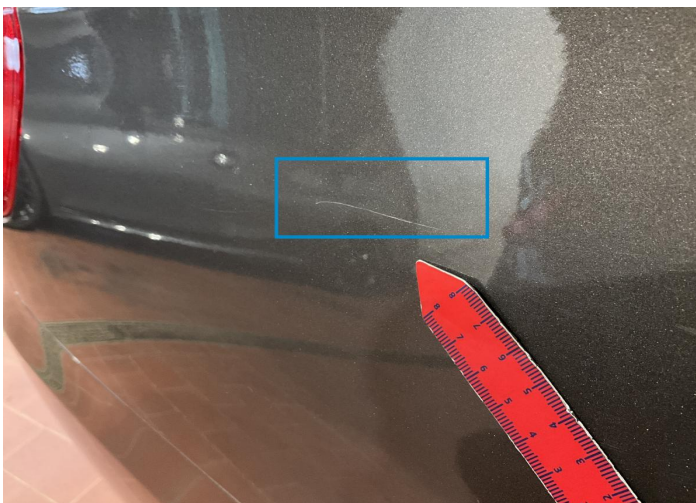
4. Fender / Back Right
Paint / Scratch / Line -

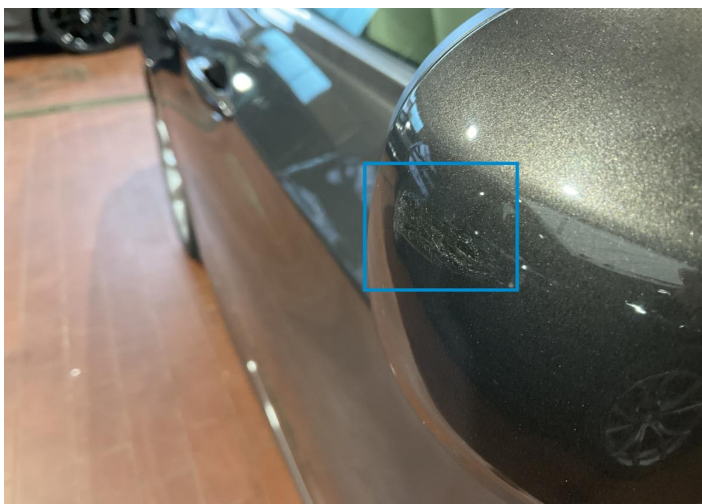
5. Mirror / Front Right
Paint / Scratch / Scuff -

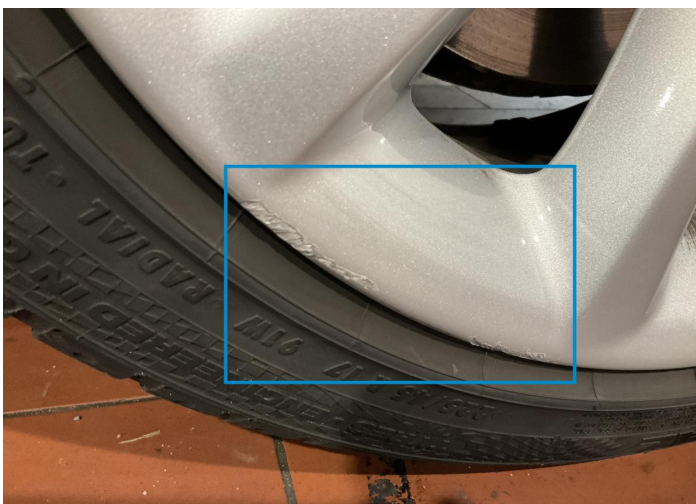
6. Rim / Front Right
Out of Bodywork / Scratch -
