## status report

#### BMW Baureihe 5 Lim. 520 i Sport Line

| Vehicle identification number | <b>WBAJK51020BX22422</b> | mileage read: | <b>111191 km</b> |

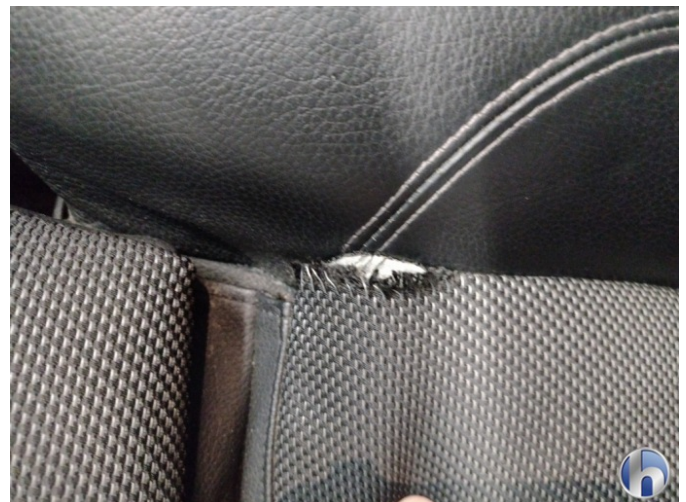
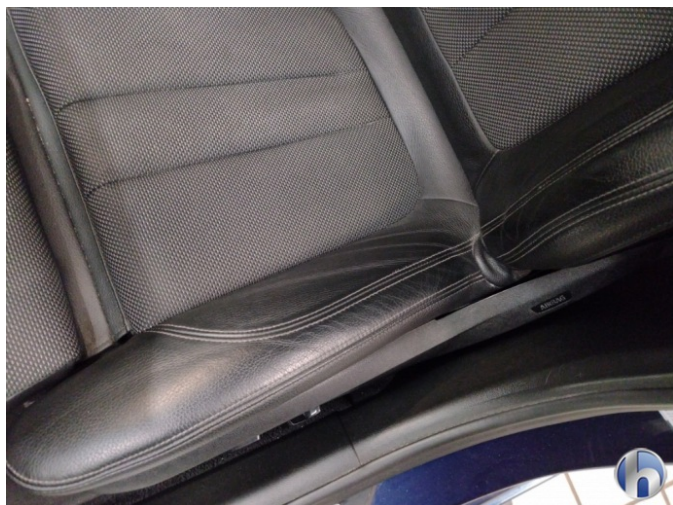
| component | Damage | Rep kind |
|---|---|---|
| 1. Sitz Vorne Links Kissen | Damaged | Replace |

1. Sitz Vorne Links Kissen

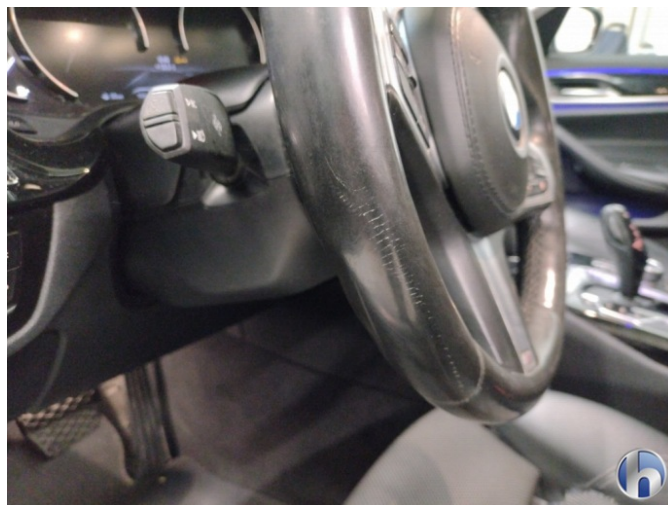
| component | Damage | Rep kind |
|---|---|---|
| 2. steering wheel | Damaged | Smart repair |

2. steering wheel

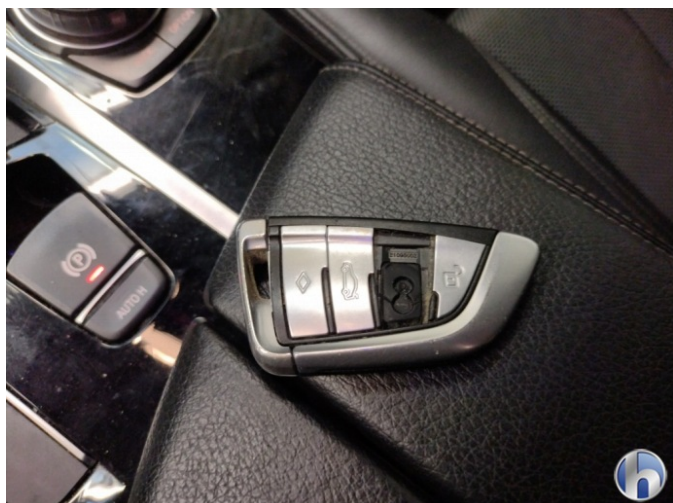
| component | Damage | Rep kind |
|---|---|---|
| 3. Key with remote control | Damaged | Replace |

3. Key with remote control

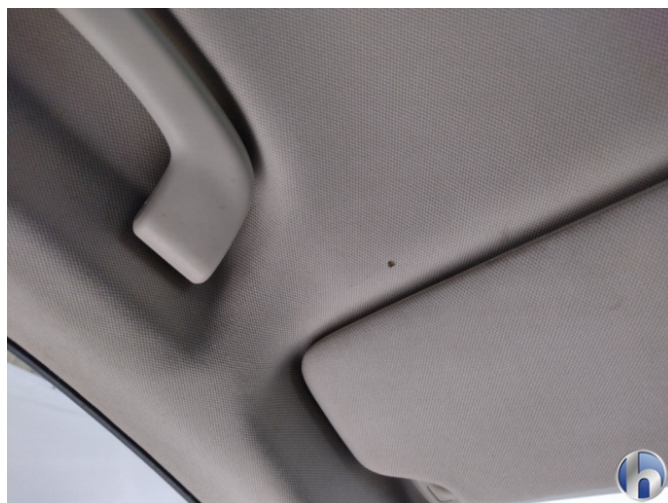
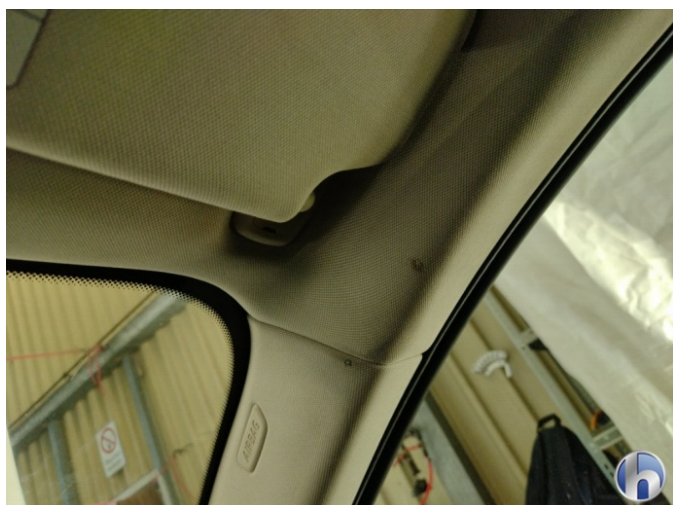
| component | Damage | Rep kind |
|---|---|---|
| 4. headlining | Damaged | Smart repair |

4. headlining

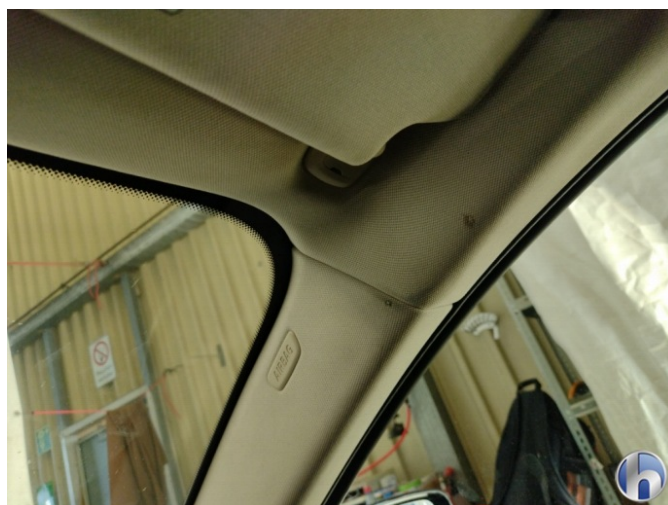
| component | Damage | Rep kind |
|---|---|---|
| 5. | Damaged | Smart repair |

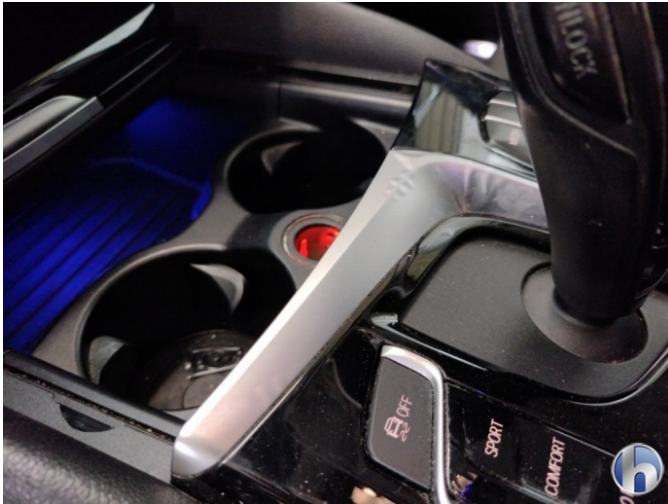
| component | Damage | Rep kind |
|---|---|---|
| 6. Mittelkonsole Zierleiste | Damaged | Replace |

6. Mittelkonsole Zierleiste

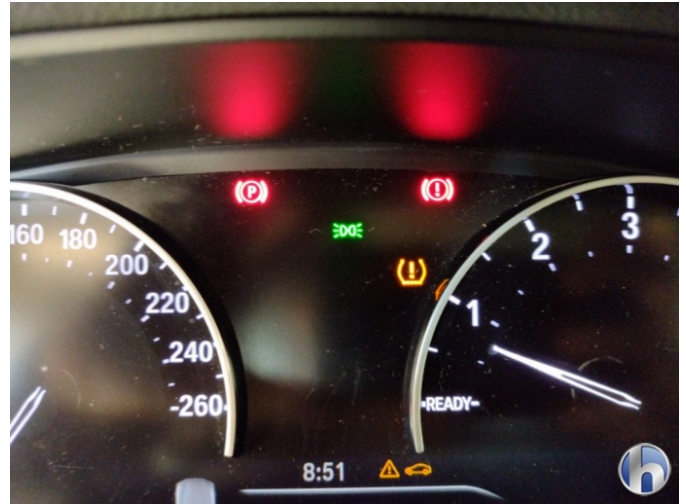
| component | Damage | Rep kind |
|---|---|---|
| 7. Reifendruckkontrollleuchte | Error message | Carry out a fault diagnosis |

7. Reifendruckkontrollleuchte

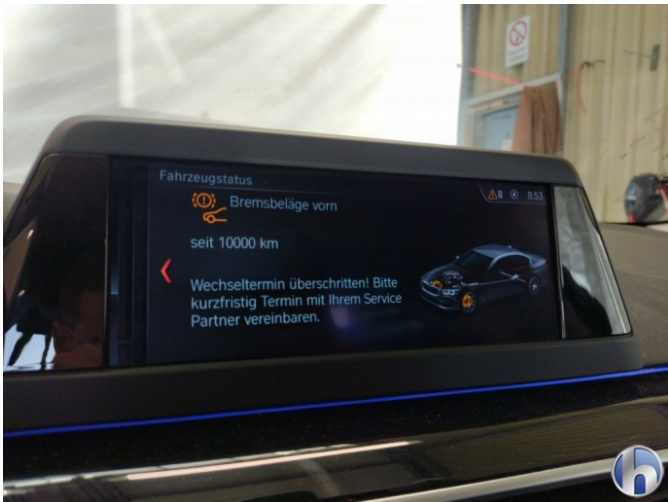
| General examination | |
|---|---|
| <b>Note Road Safe:</b> | Windschutzscheibe Bruch, Bremsen Verschlissen |

| component | Damage | Rep kind |
|---|---|---|
| 9. Bremsen Vorne | Worn | Replace |

9. Bremsen Vorne

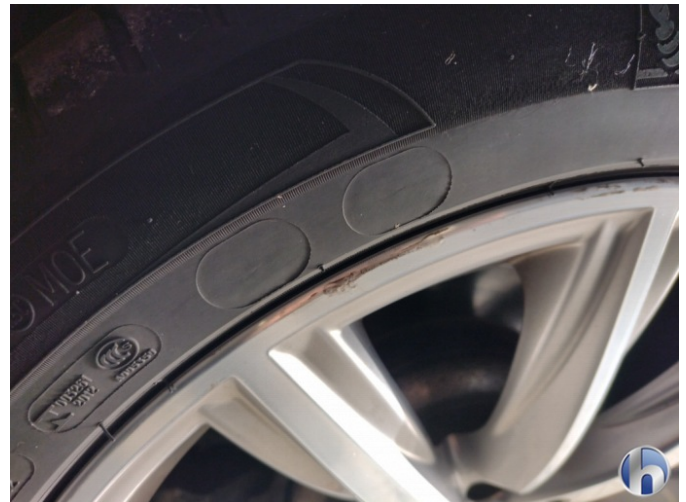
| component | Damage | Rep kind |
|---|---|---|
| 11. Rim rear - left | Damaged | Replace |

11. Rim rear - left

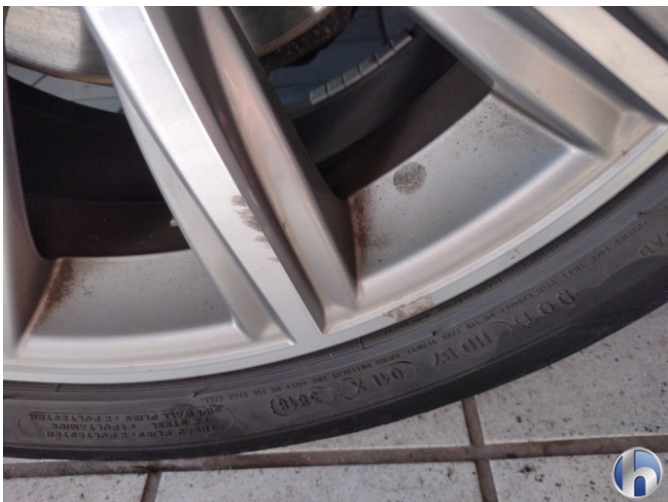
| component | Damage | Rep kind |
|---|---|---|
| 12. Rim rear - right | Damaged | Replace |

12. Rim rear - right

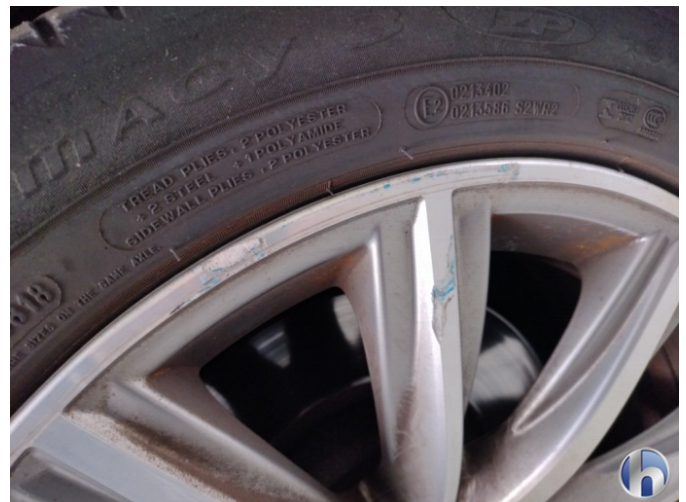
| component | Damage | Rep kind |
|---|---|---|
| 13. Rim front - right | Damaged | Replace |

13. Rim front - right

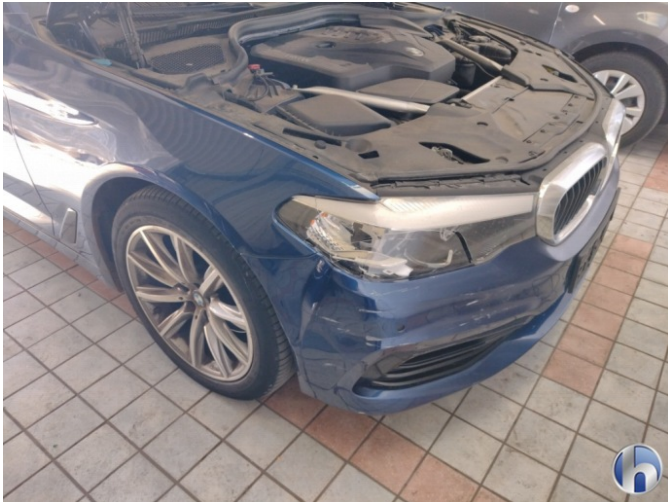
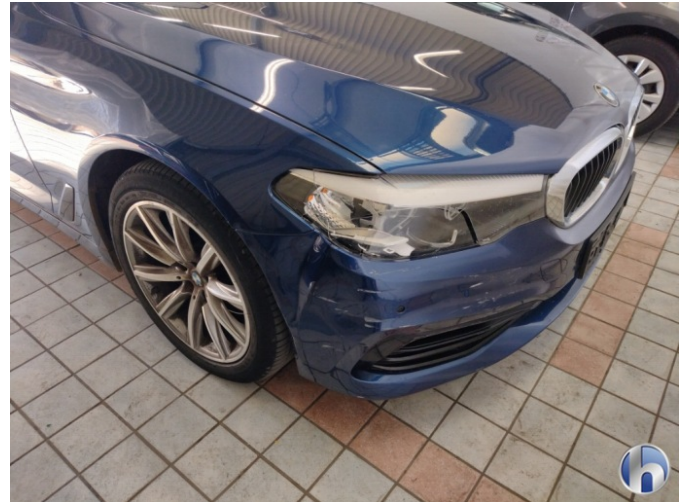
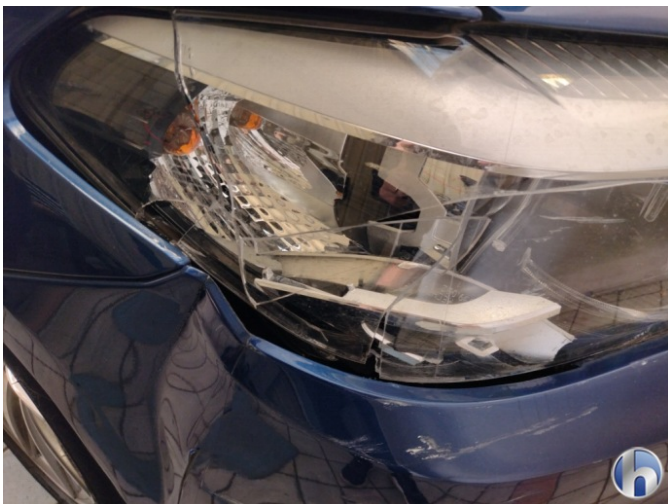
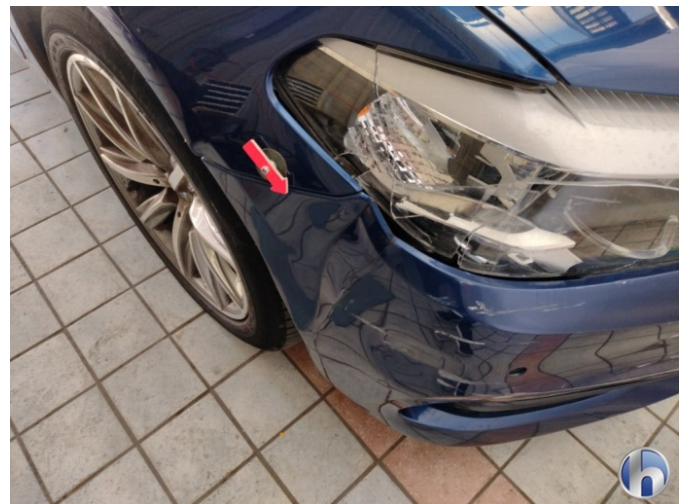
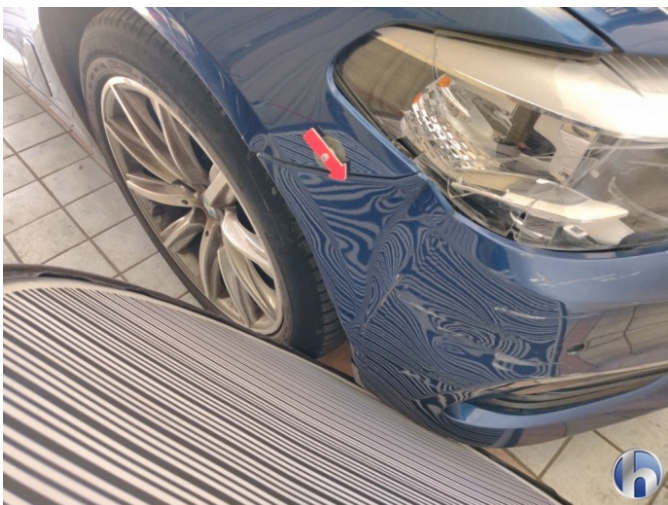
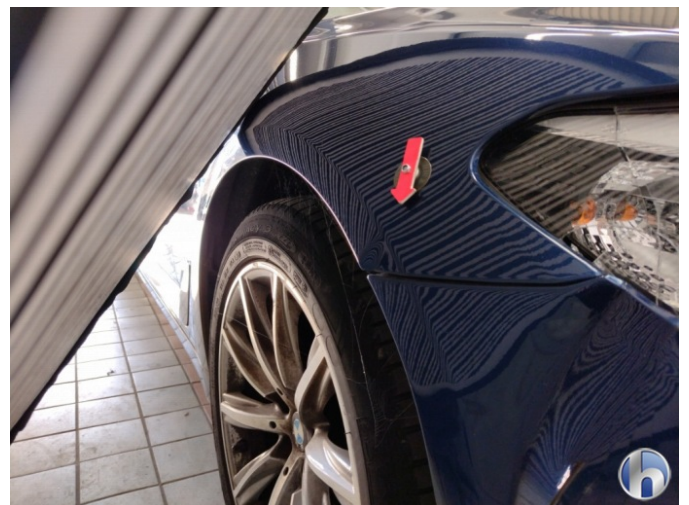
Fahrzeug mit bestehenden Unfallschaden, zur Schadensermittlung wurden keine Demontagearbeiten durchgeführt, verborgen gebliebene Schäden können nicht ausgeschlossen werden. Unfallschaden Kosten wurden überschlägig Kalkuliert, Kostenerweiterung möglich.

| Performed testing technology | |
|---|---|
| <b>lighting system:</b> | For sightseeing timing defects in the lighting system were noted .<br>*Unfallschaden Vorne Rechts Schadensenerweiterung möglich. |

| component | Damage | Rep kind |
|---|---|---|
| 14. Unfallschaden Vorne Rechts<br>Schadenserweiterung möglich | Accident damage | Replace |

14. Unfallschaden Vorne Rechts Schadenserweiterung möglich

14. Unfallschaden Vorne Rechts Schadenserweiterung

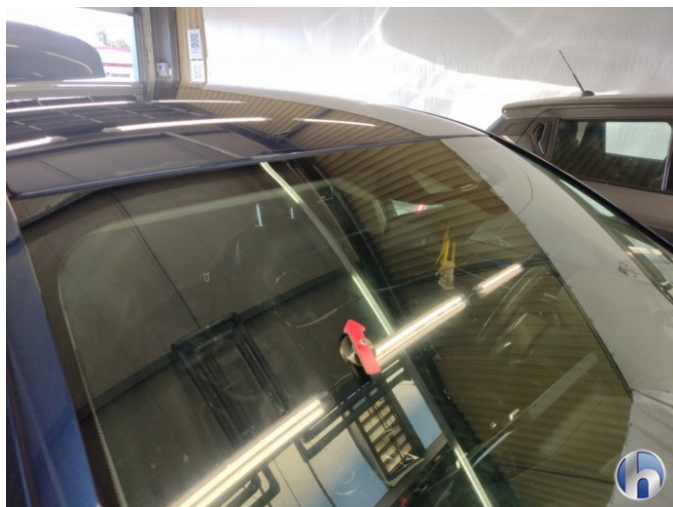
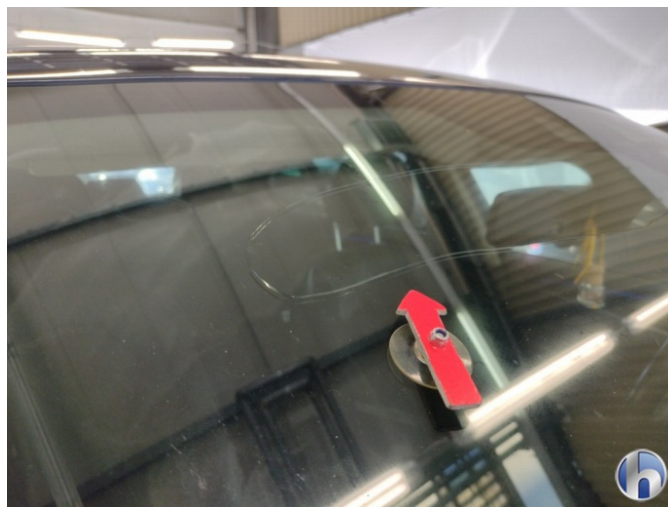
| component | Damage | Rep kind |
|---|---|---|
| 15. Windshield | Breakage | Replace |

15. Windshield

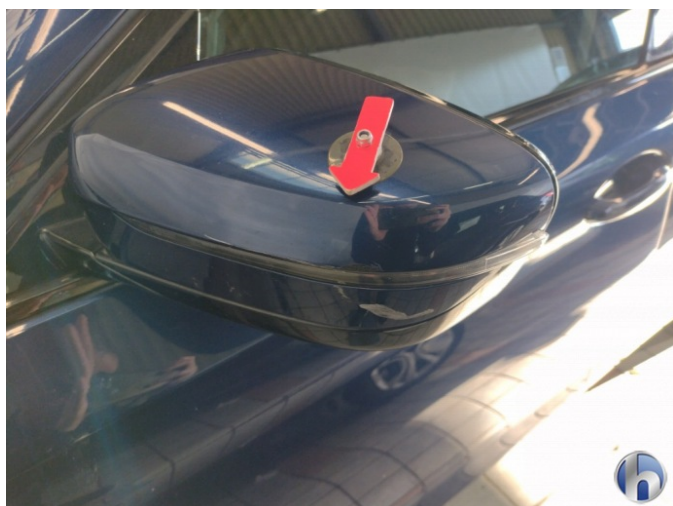
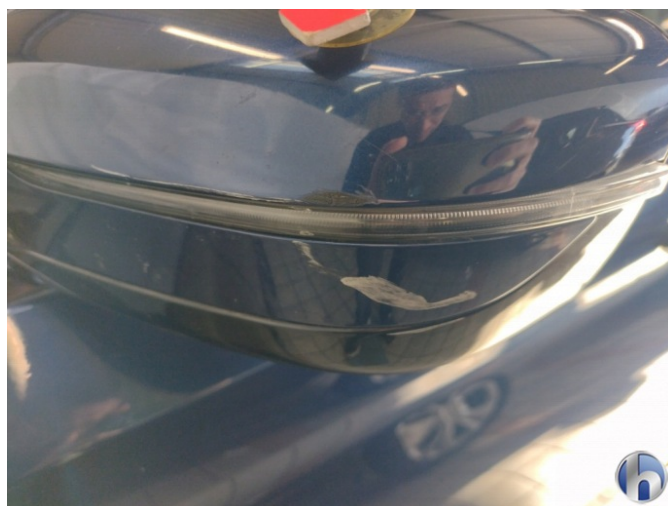
| component | Damage | Rep kind |
|---|---|---|
| 16. Außenspiegel - Links mit Blinker | Damaged | Replace |

16. Außenspiegel - Links mit Blinker

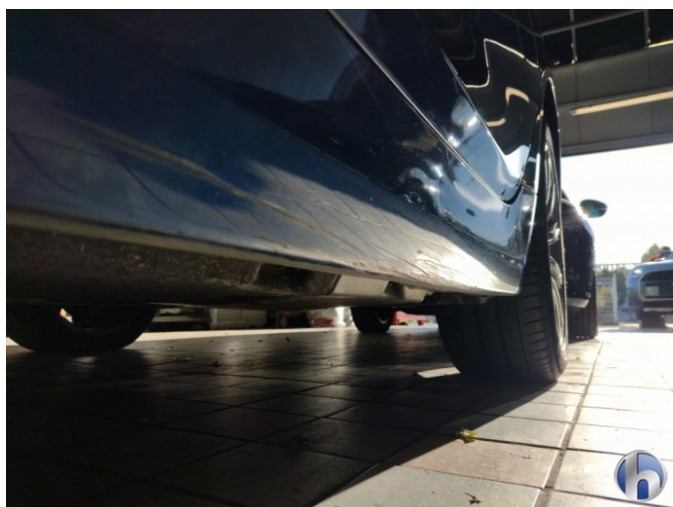
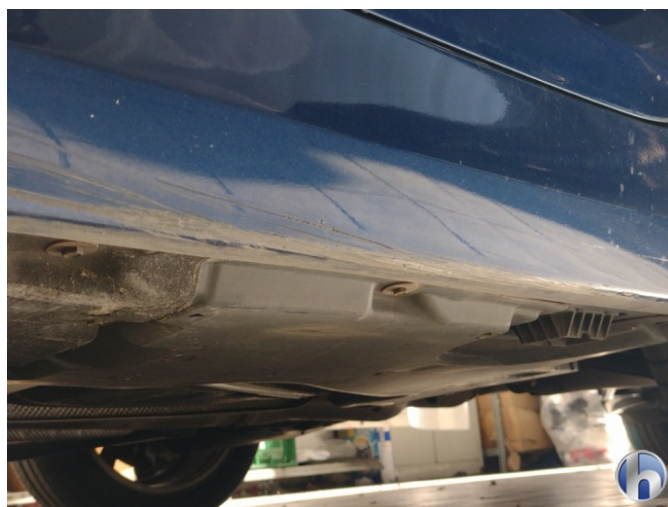
| component | Damage | Rep kind |
|---|---|---|
| 17. side skirt - left | Scrape | Paint |

17. side skirt - left

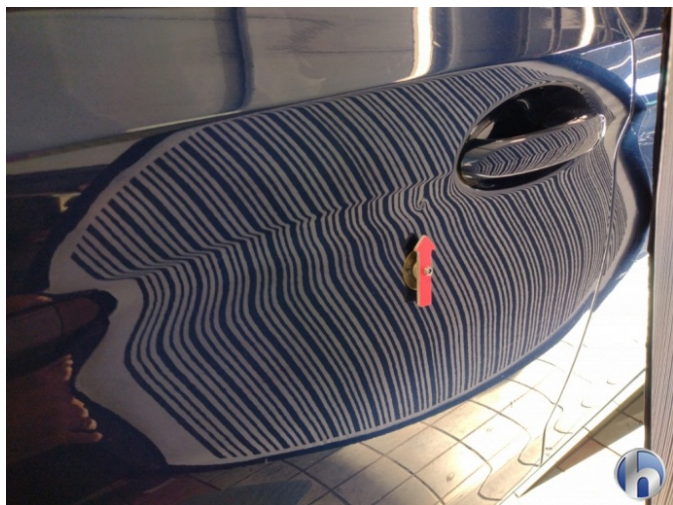
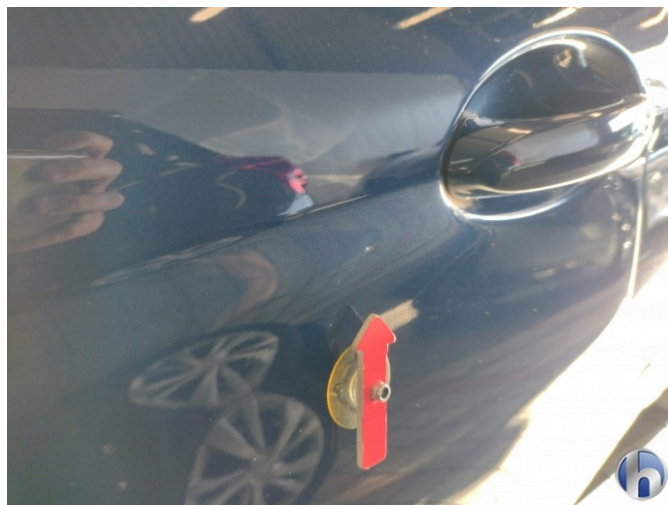
| component | Damage | Rep kind |
|---|---|---|
| 18. Front door - left | Delle | Refurbish and paint |

18. Front door - left

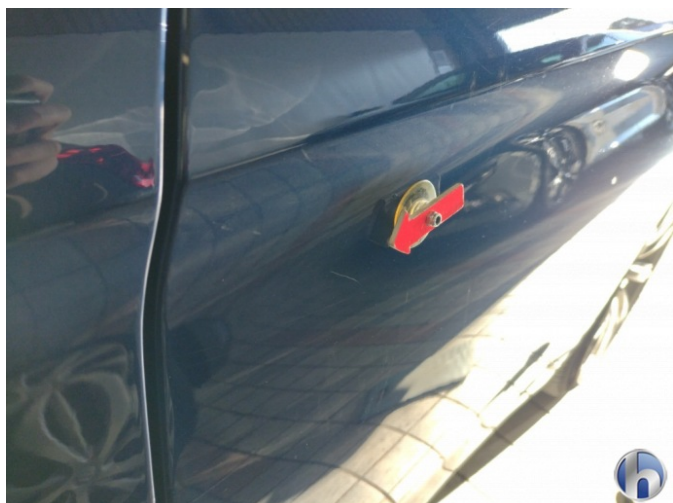
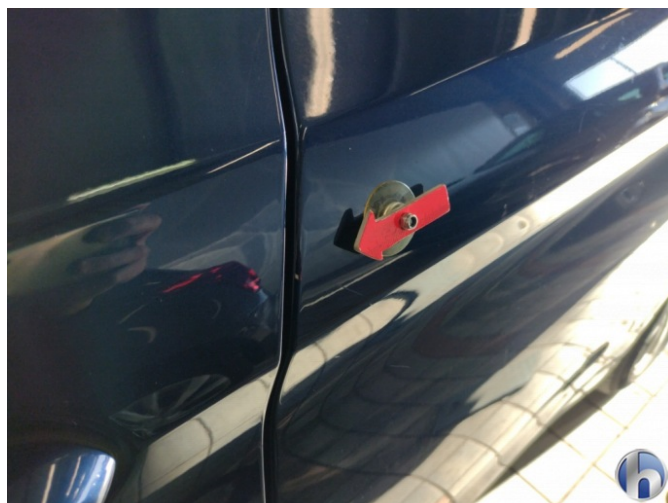
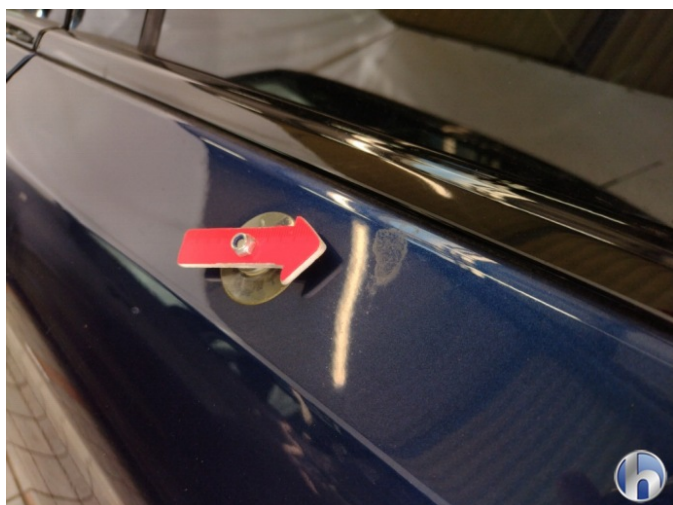
| component | Damage | Rep kind |
|---|---|---|
| 19. Rear door - left | Damaged | Paint |

19. Rear door - left

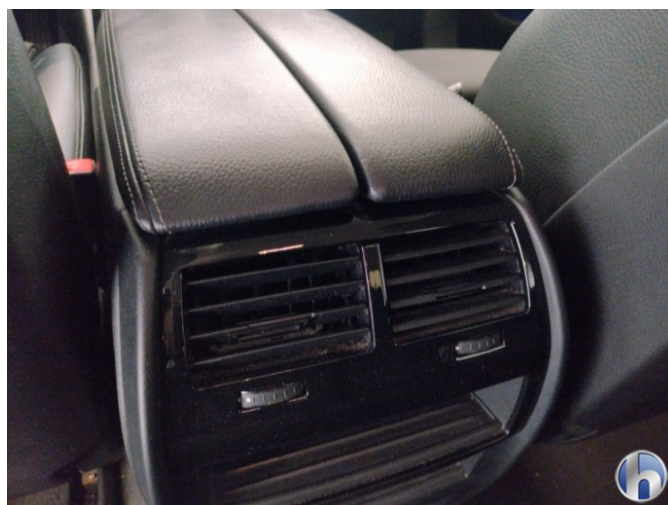
| component | Damage | Rep kind |
|---|---|---|
| 20. | Damaged | Replace |

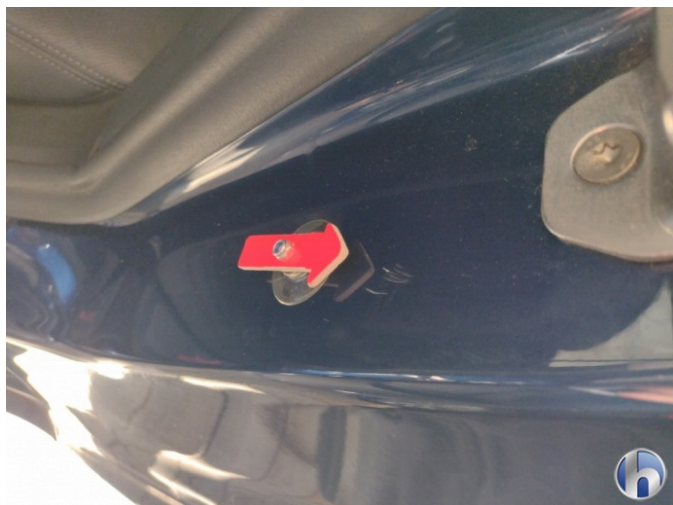
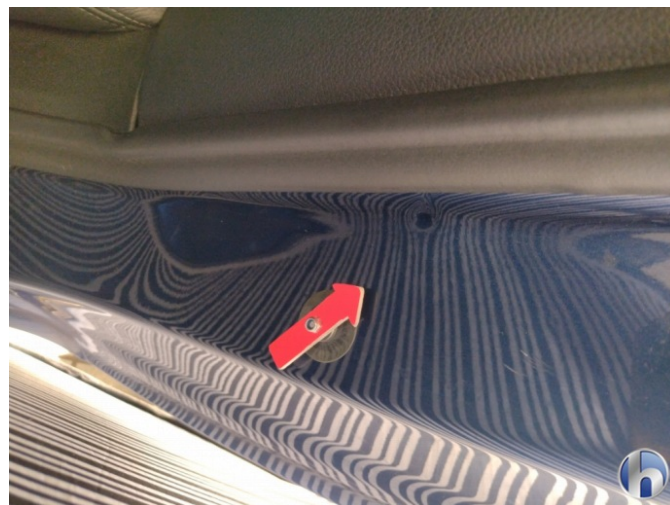
| component | Damage | Rep kind |
|---|---|---|
| 21. Türeinstieg Hinten - Links | Deformed | Refurbish and paint |

21. Türeinstieg Hinten - Links

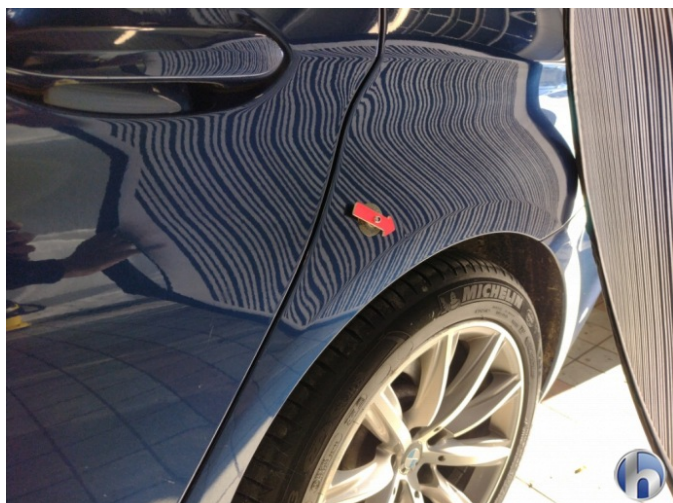
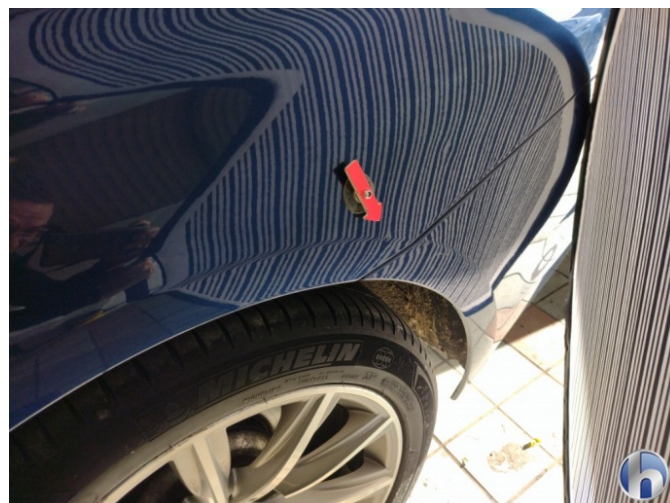
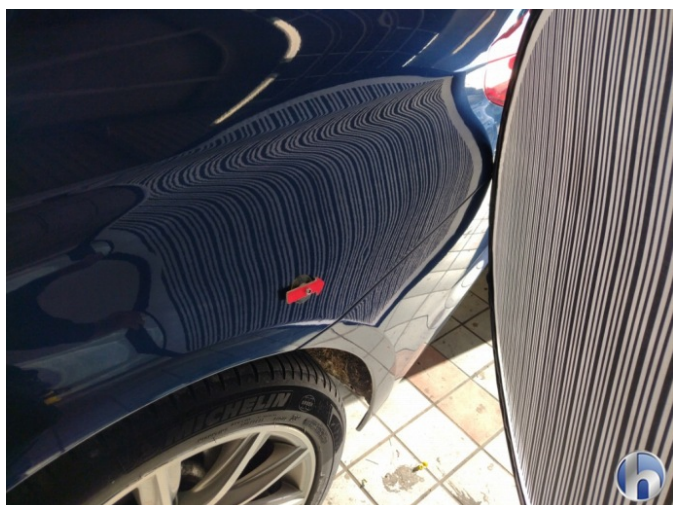
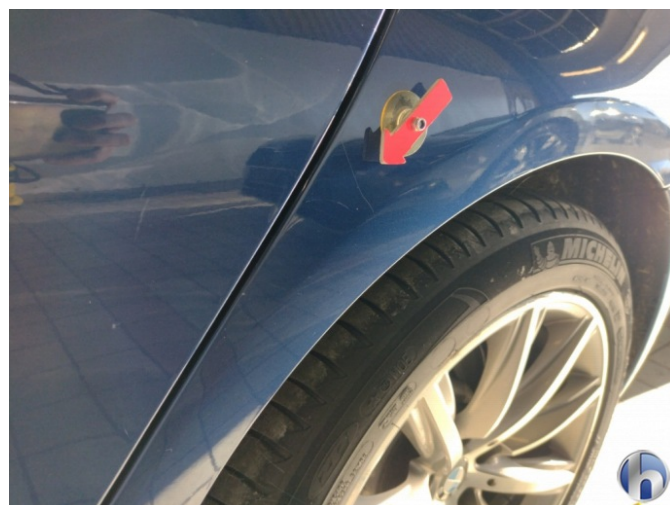
| component | Damage | Rep kind |
|---|---|---|
| 22. Sidewall - Rear - Left | Deformed | Refurbish and paint |

22. Sidewall - Rear - Left

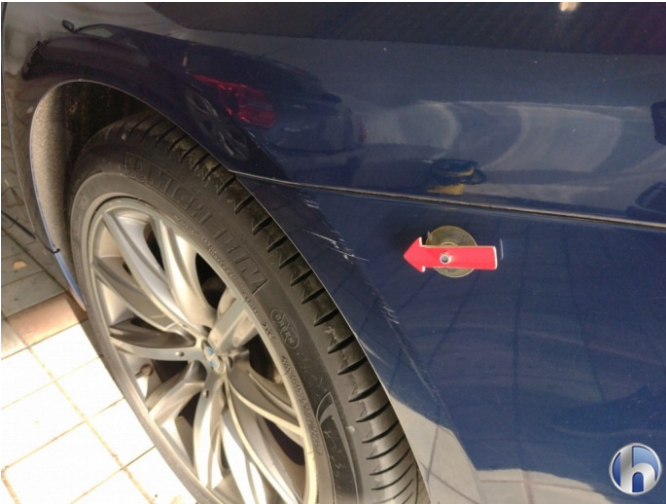
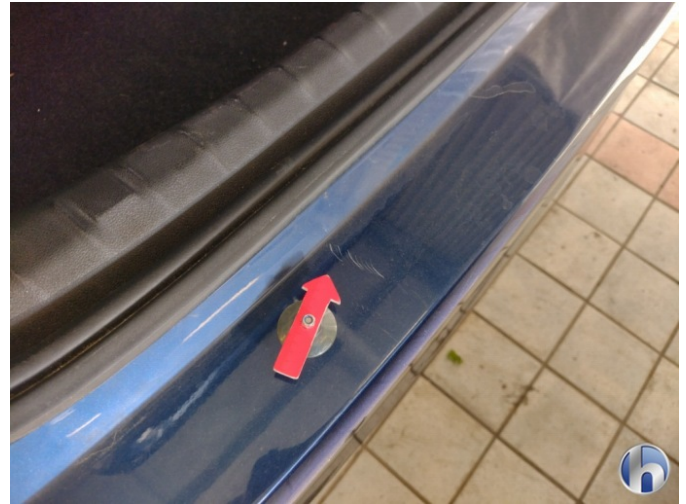
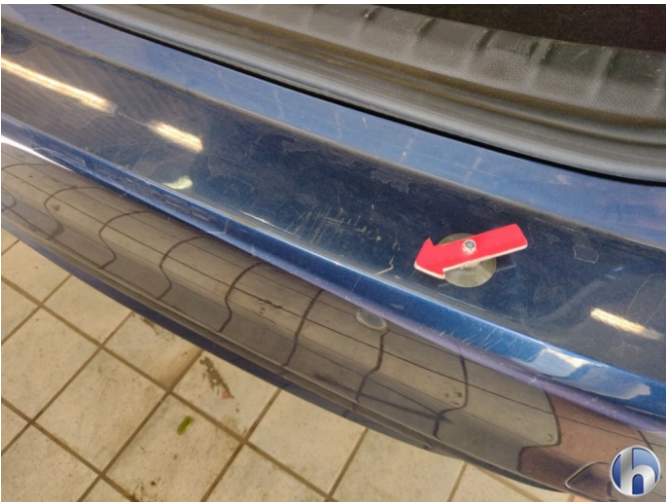
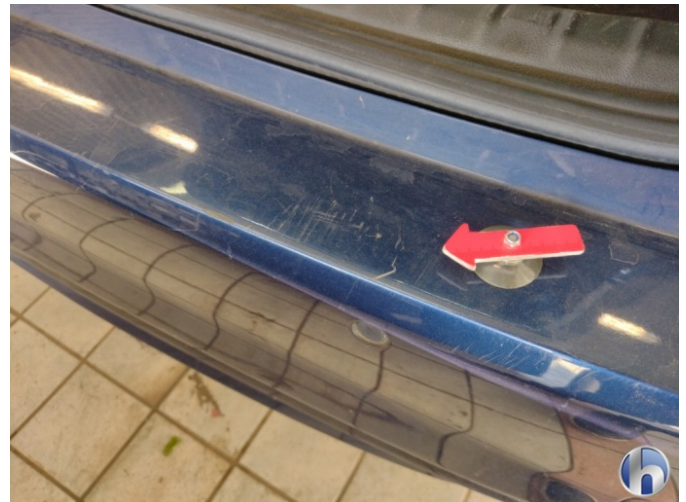
| component | Damage | Rep kind |
|---|---|---|
| 23. Rear bumper | Scratch(es) | Paint |

23. Rear bumper

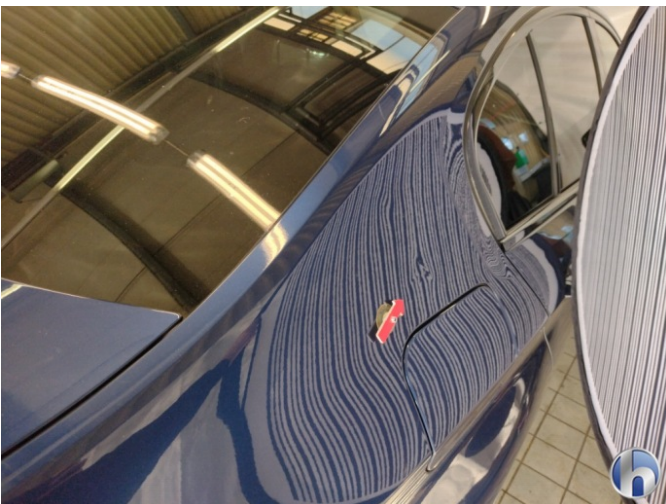
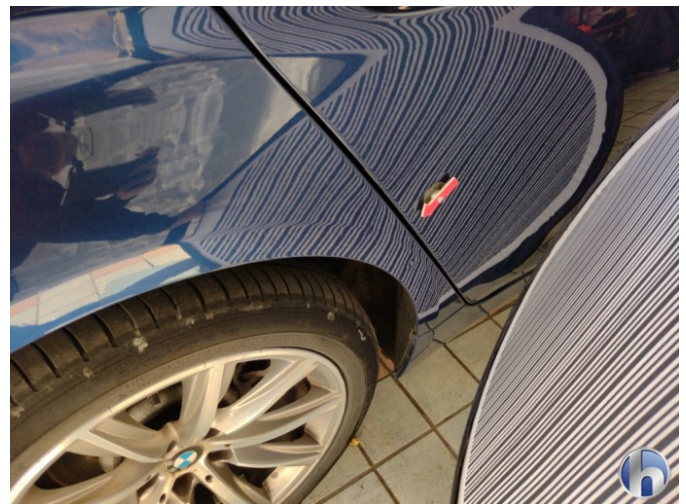
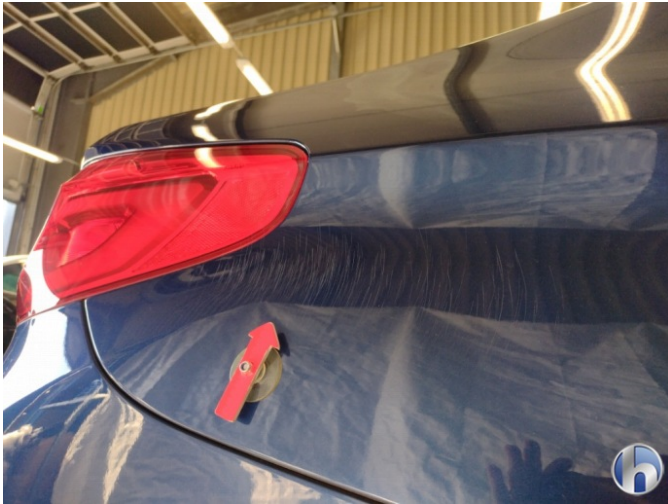
| component | Damage | Rep kind |
|---|---|---|
| 24. Sidewall - Rear - right | Deformed | Refurbish and paint |

24. Sidewall - Rear - right

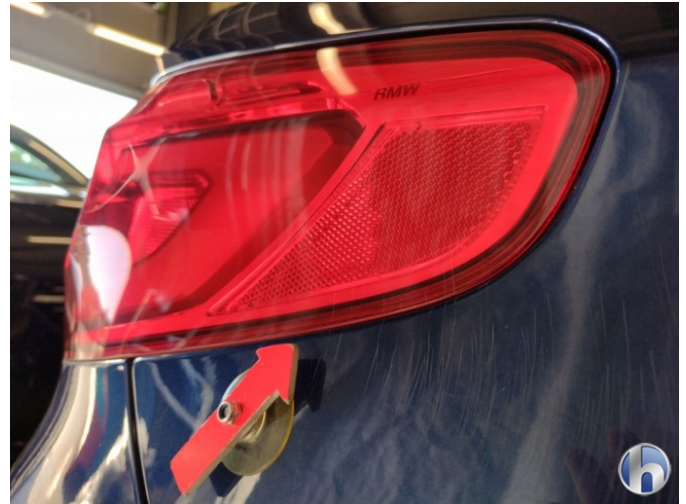
| component | Damage | Rep kind |
|---|---|---|
| 25. Taillight right | Wear and tear | acceptable |

25. Taillight right

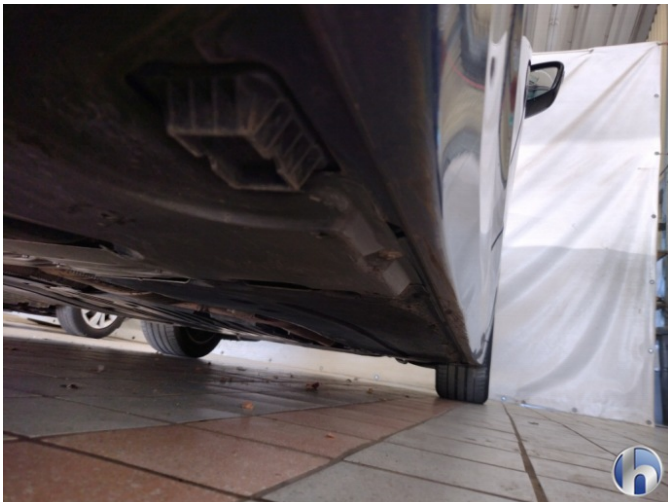
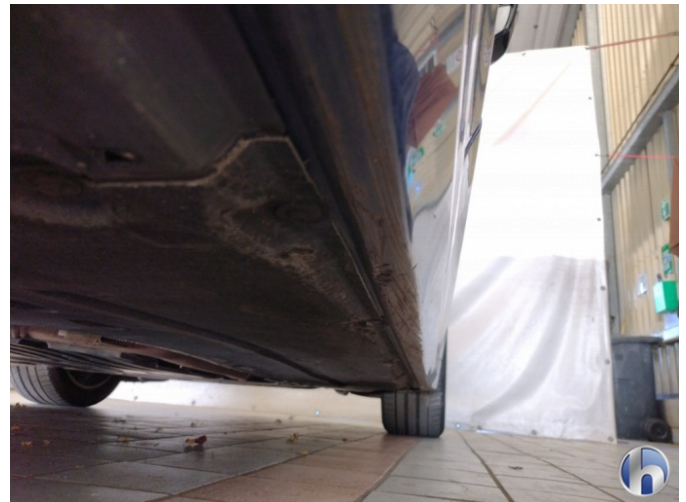
| component | Damage | Rep kind |
|---|---|---|
| 26. side skirt - right | Scrape | Paint |

26. side skirt - right

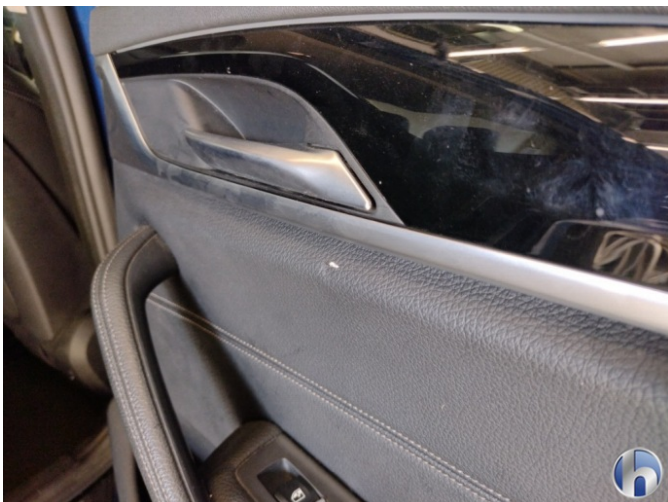
| component | Damage | Rep kind |
|---|---|---|
| 27. Door trim Rear - right | Damaged | Smart repair |

27. Door trim Rear - right

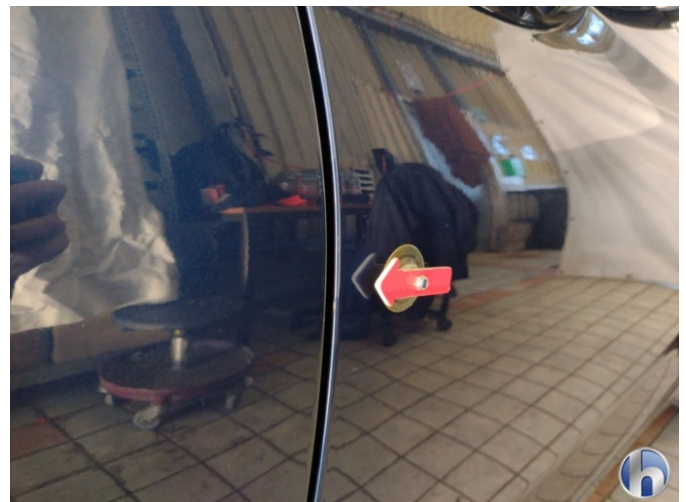
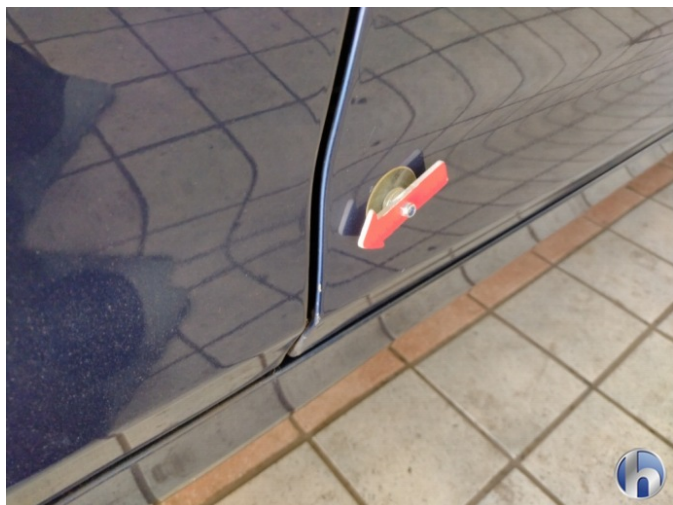
| component | Damage | Rep kind |
|---|---|---|
| 28. Front door - right | Scratch(es) | Smart repair |

28. Front door - right

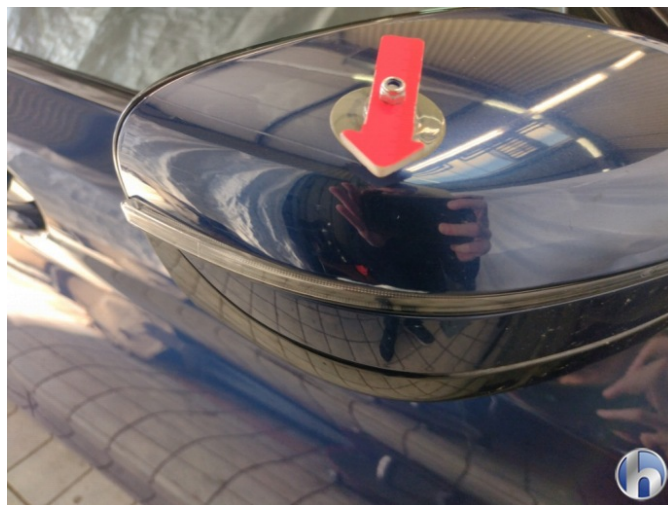
| component | Damage | Rep kind |
|---|---|---|
| 29. | Scratch(es) | Paint |

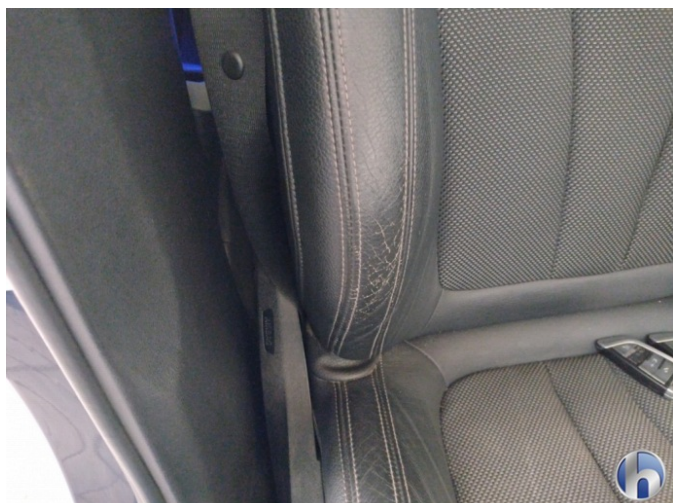
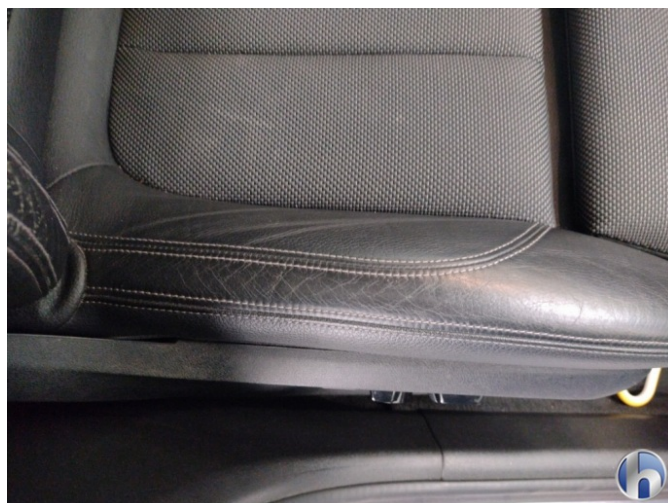
| component | Damage | Rep kind |
|---|---|---|
| 30. Sitz Vorne Rechts | Damaged | Smart repair |

30. Sitz Vorne Rechts
