## status report

#### BMW Baureihe 5 Touring 520 d M Sport

| Vehicle identification number | <b>WBAJM71020G961512</b> | mileage read: | <b>182599 km</b> |

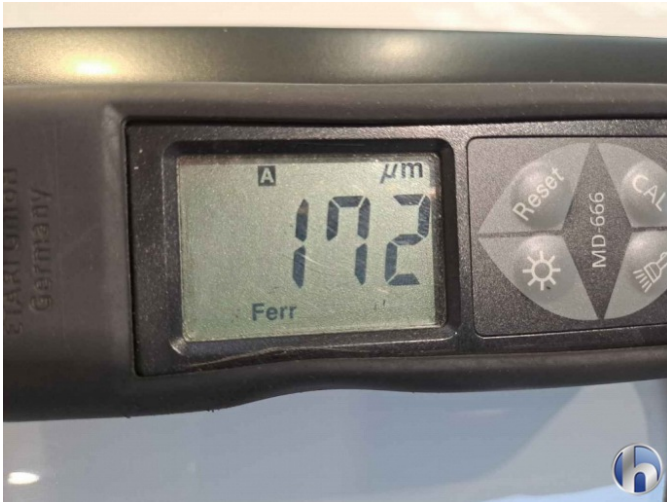
| Performed testing technology | |
|---|---|
| <b>reference:</b> | *Fahrzeug hat Alter und Laufleistungs bedingte Gebrauchsspuren innen und außen Dachrahmen links Nachlackiert |

| component | Damage | Rep kind |
|---|---|---|
| 1. Roof frame - left | Subsequently painted | acceptable |

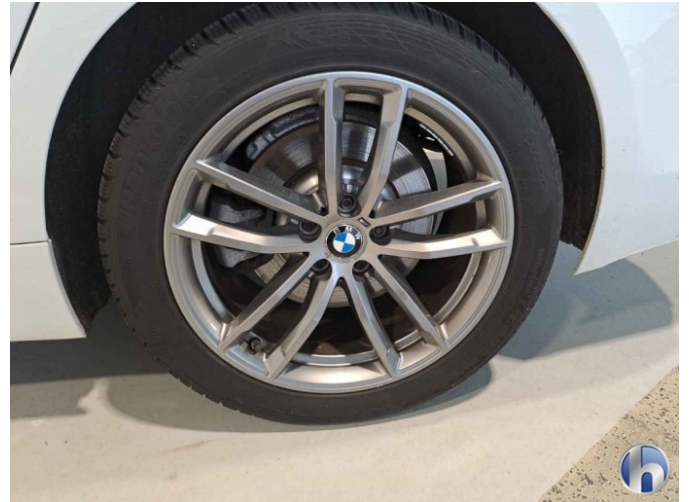
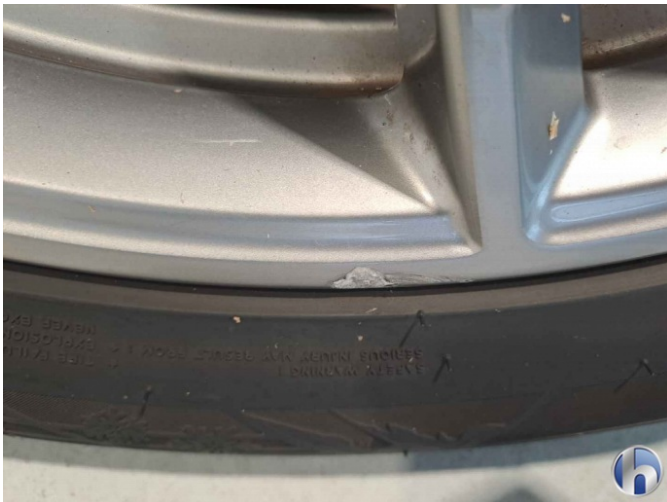
| component | Damage | Rep kind |
|---|---|---|
| 4. Felge (Aluminium) hinten links | Scratch(es) | Paint |

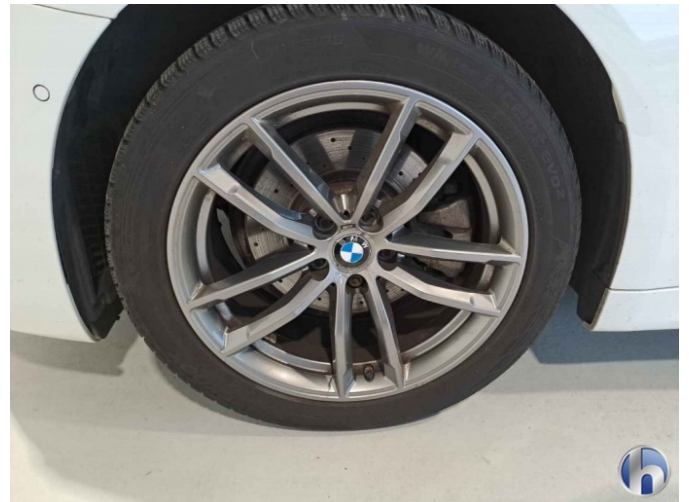
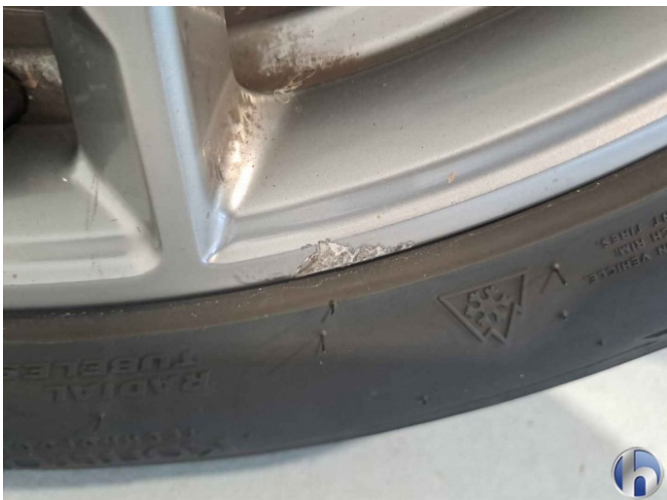
| component | Damage | Rep kind |
|---|---|---|
| 5. Felge (Aluminium) vorne links | Scratch(es) | Paint |

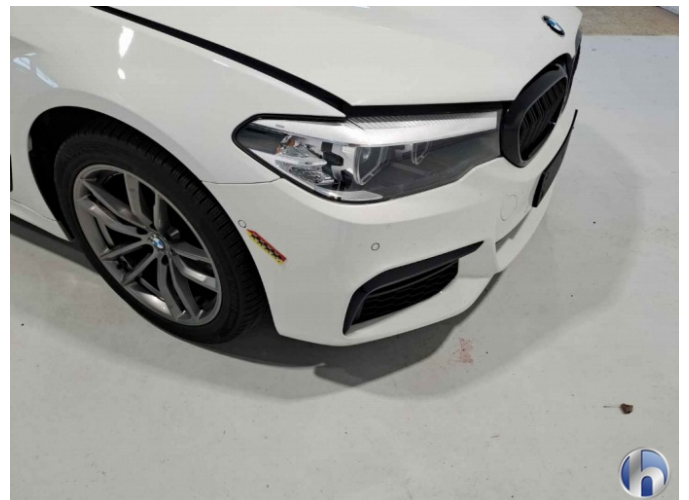
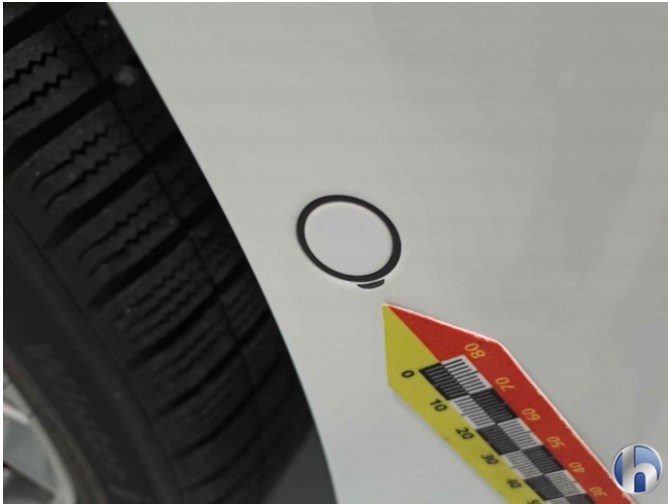
| component | Damage | Rep kind |
|---|---|---|
| 6. Front bumper | chipped paint | Smart repair |

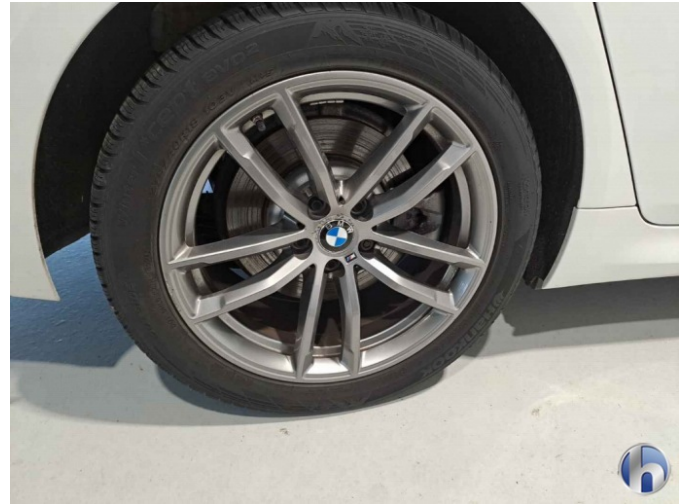
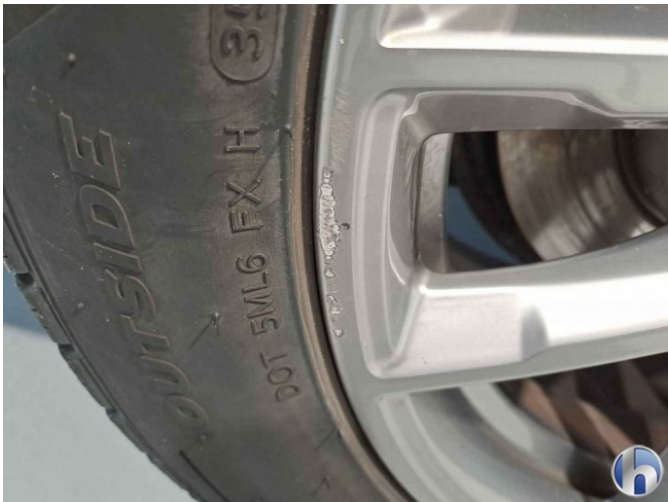
| component | Damage | Rep kind |
|---|---|---|
| 7. Felge (Aluminium) hinten rechts | Scratch(es) | Paint |

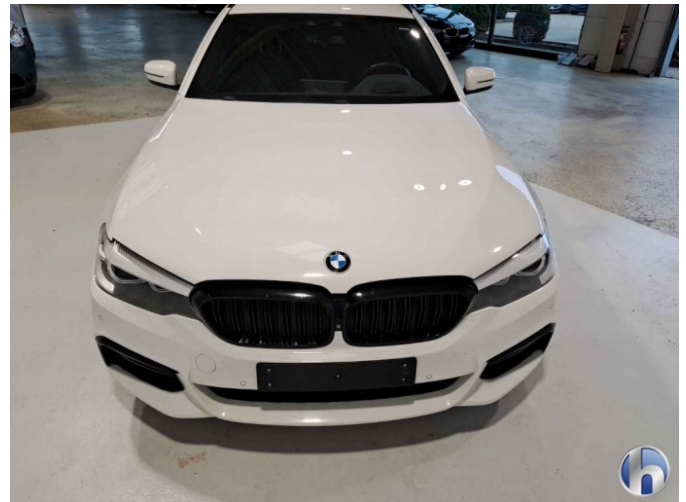
| component | Damage | Rep kind |
|---|---|---|
| 8. exterior body | Surface scratch(es) | |

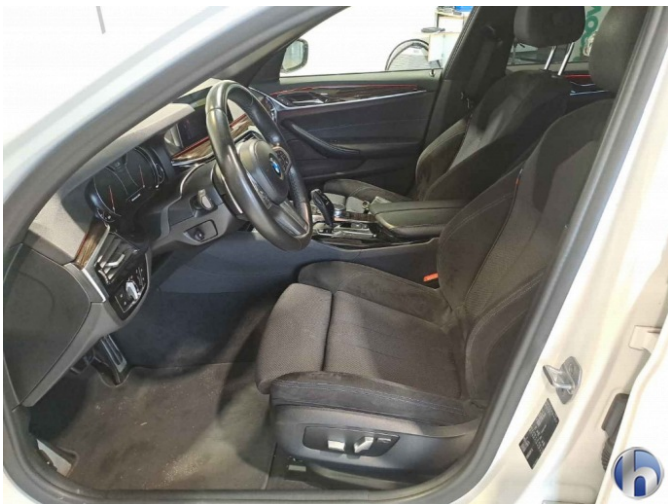
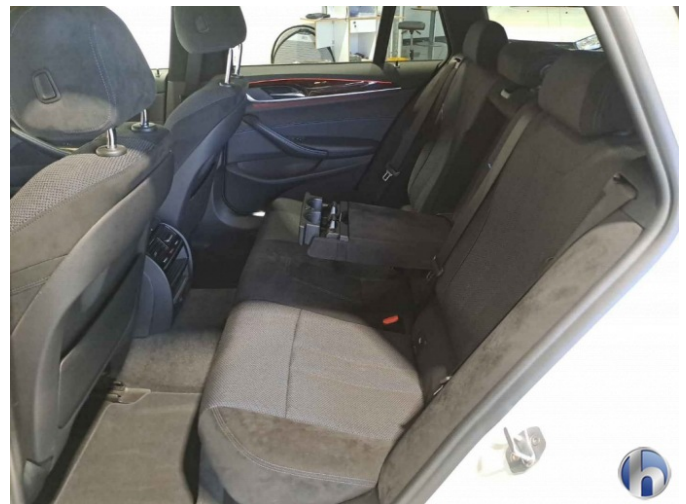
| component | Damage | Rep kind |
|---|---|---|
| 9. | Wear and tear | acceptable |

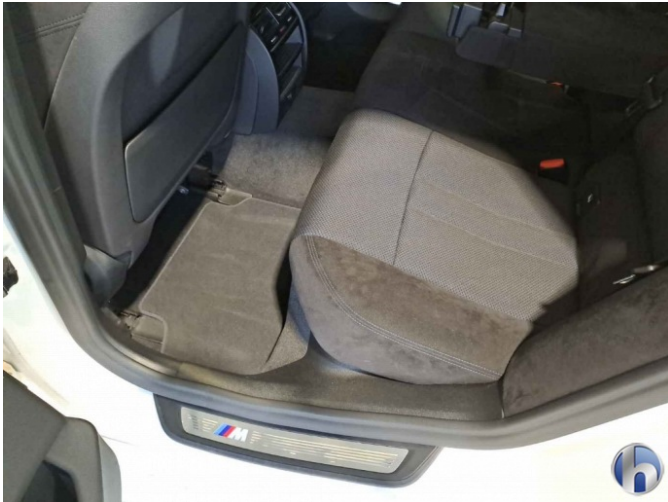
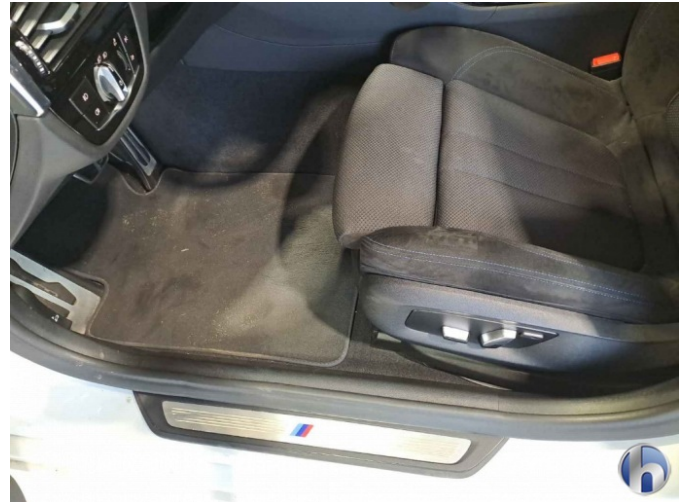
| component | Damage | Rep kind |
|---|---|---|
| 10. | Dirty | |

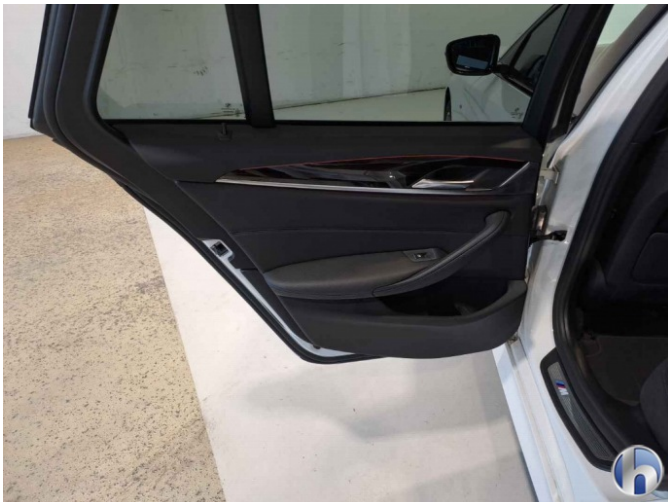
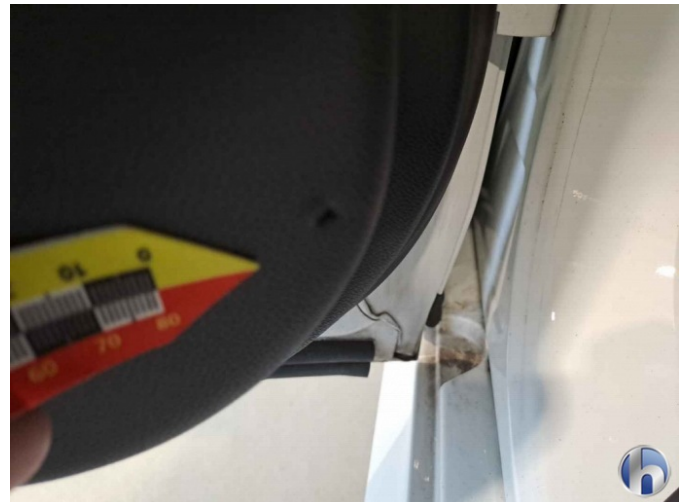
| component | Damage | Rep kind |
|---|---|---|
| 11. Rear door trim - left | Damaged | Replace |

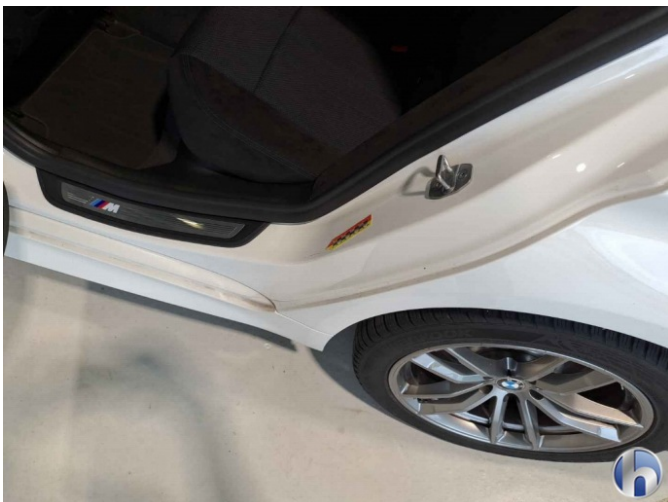
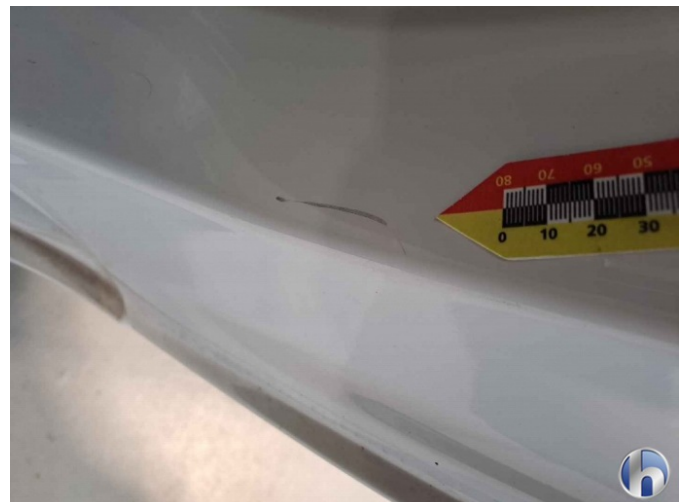
| component | Damage | Rep kind |
|---|---|---|
| 12. Türeinstieg Hinten - Links | Damaged | Smart repair |

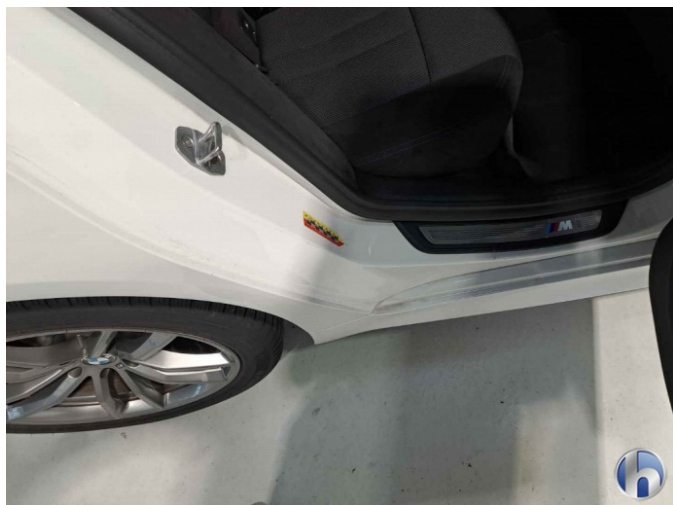
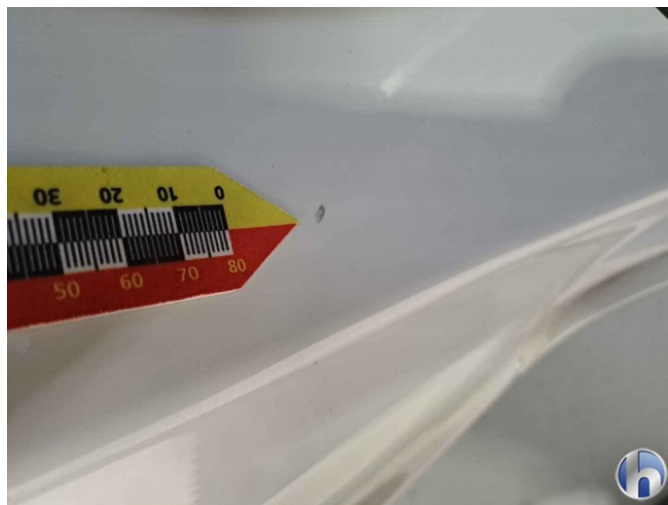
| component | Damage | Rep kind |
|---|---|---|
| 13. Türeinstieg Hinten - Rechts | Scrape | Smart repair |
