## status report

**customer:** BCA Autoauktionen GmbH

#### BMW Baureihe 7 740d xDrive

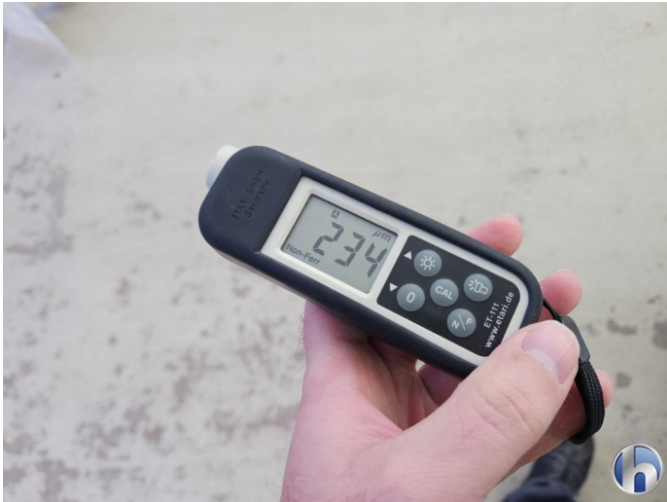
| component | Damage | Rep kind |
|---|---|---|
| 1. Front fender - left | Subsequently painted | acceptable |

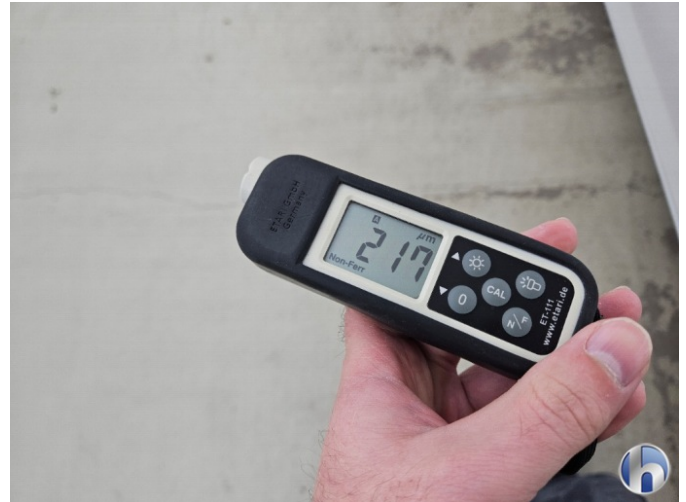
| component | Damage | Rep kind |
|---|---|---|
| 2. Front fender - right | Subsequently painted | acceptable |

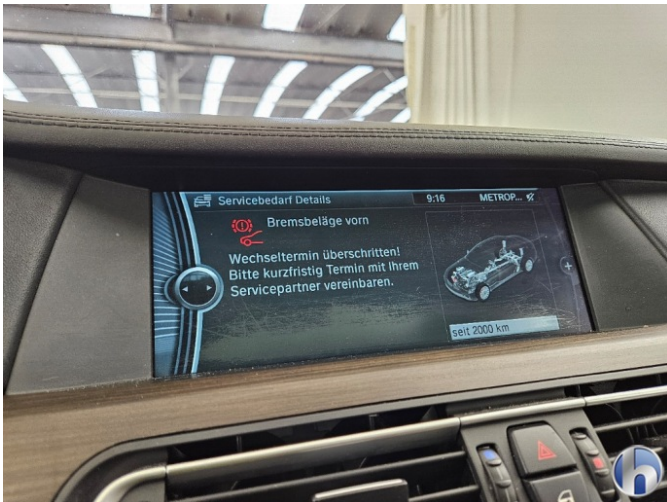
| General examination | |
|---|---|
| <b>Note Road Safe:</b> | Fehlermeldung Bremsanlage |

| component | Damage | Rep kind |
|---|---|---|
| 4. brake system | Error message | Carry out a fault diagnosis |

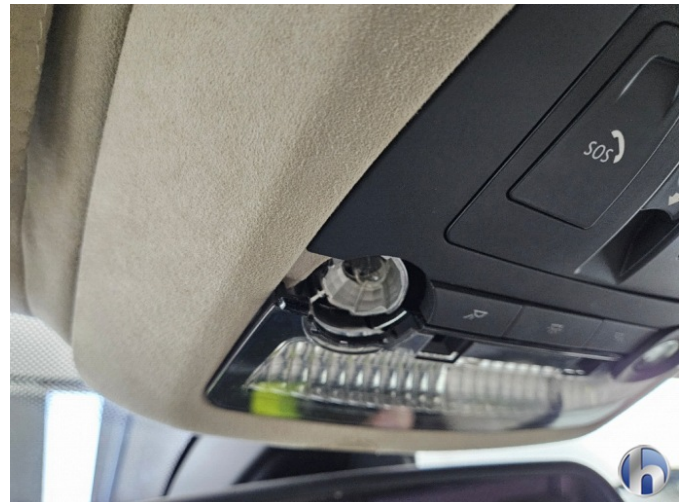
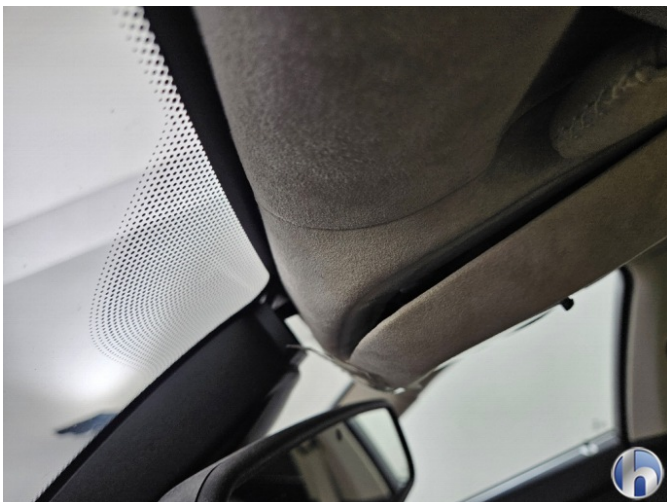
| component | Damage | Rep kind |
|---|---|---|
| 5. | Damaged | Replace |

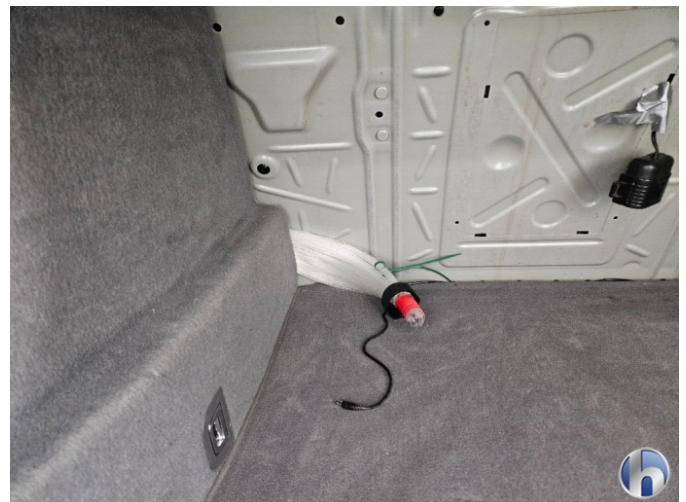
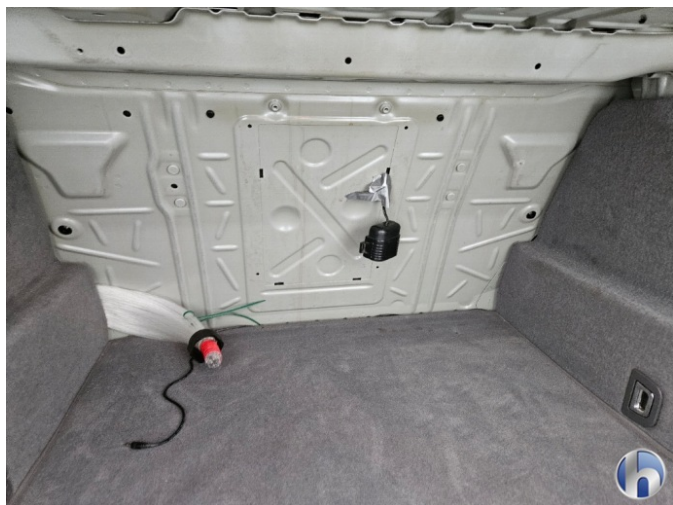
| component | Damage | Rep kind |
|---|---|---|
| 7. | Wear and tear | acceptable |

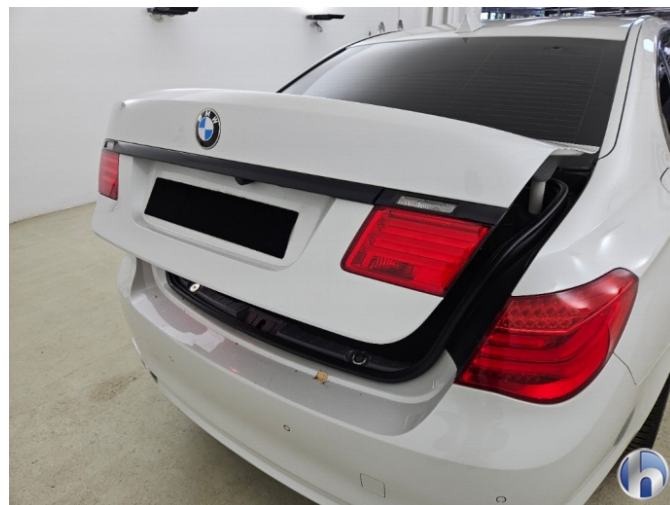
| component | Damage | Rep kind |
|---|---|---|
| 8. elektr. Heckklappe | Not open | Carry out a fault diagnosis |

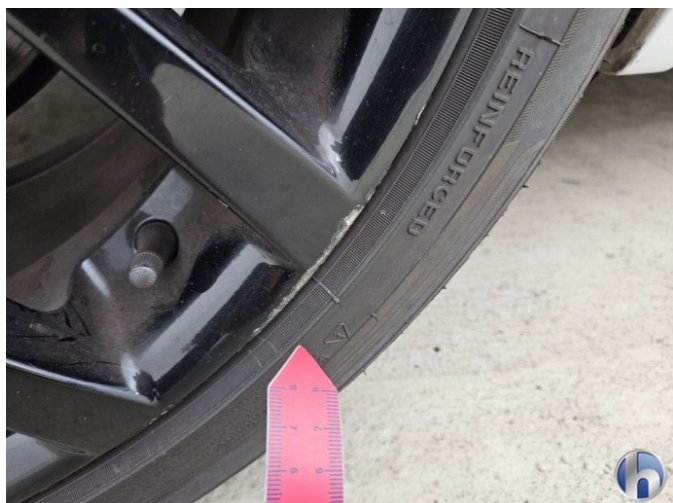
| component | Damage | Rep kind |
|---|---|---|
| 9. | Scratch(es) | Paint |

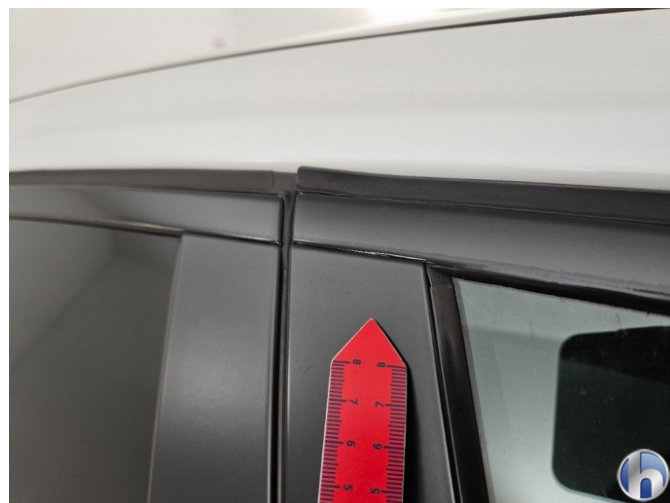
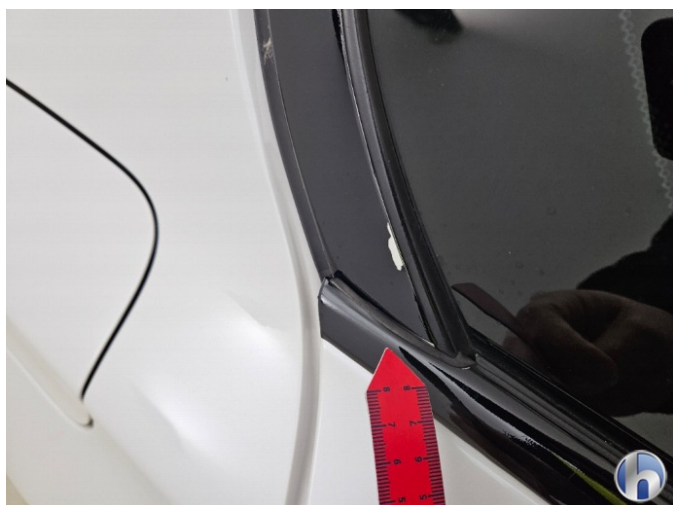
| component | Damage | Rep kind |
|---|---|---|
| 10. Zierleisten | Damaged | Replace |

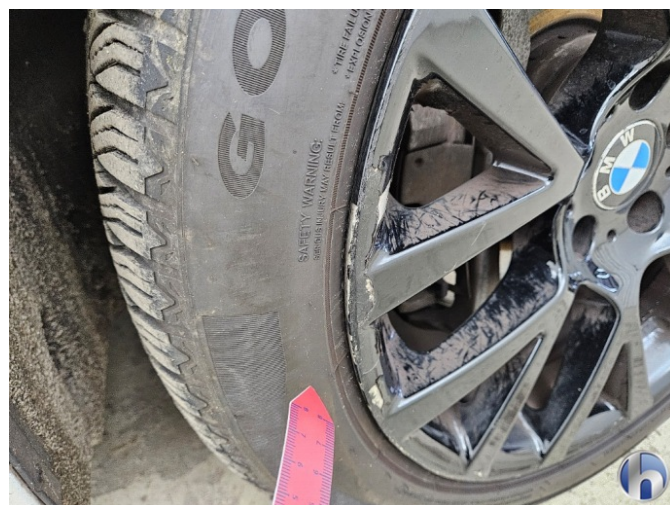
| component | Damage | Rep kind |
|---|---|---|
| 11. | Scratch(es) | Paint |

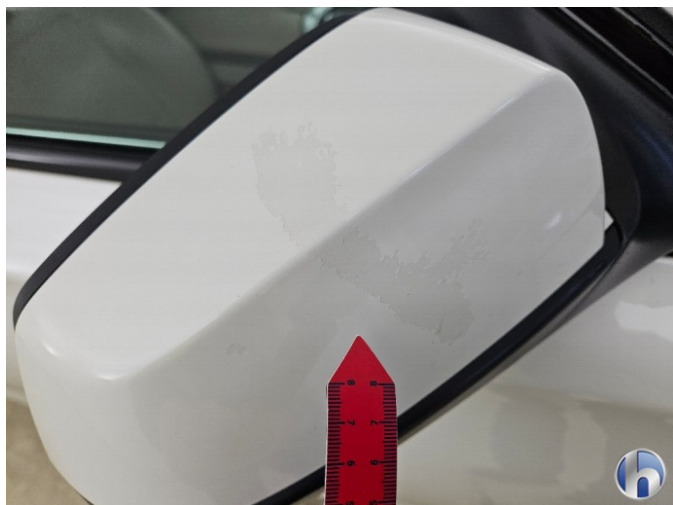
| component | Damage | Rep kind |
|---|---|---|
| 12. | Clear lacquer chipping off | Paint |

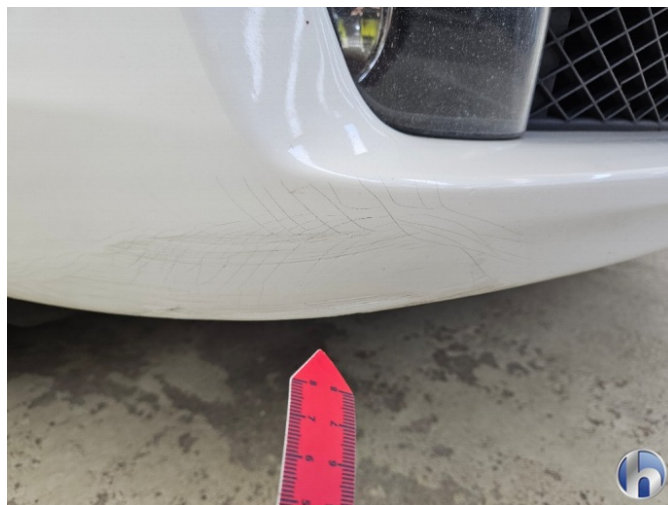
| component | Damage | Rep kind |
|---|---|---|
| 13. Front bumper | Damaged | Paint |

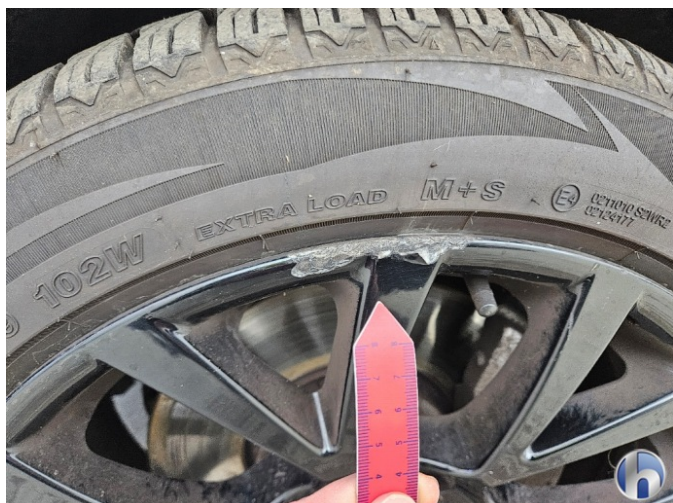
| component | Damage | Rep kind |
|---|---|---|
| 14. | Scratch(es) | Paint |

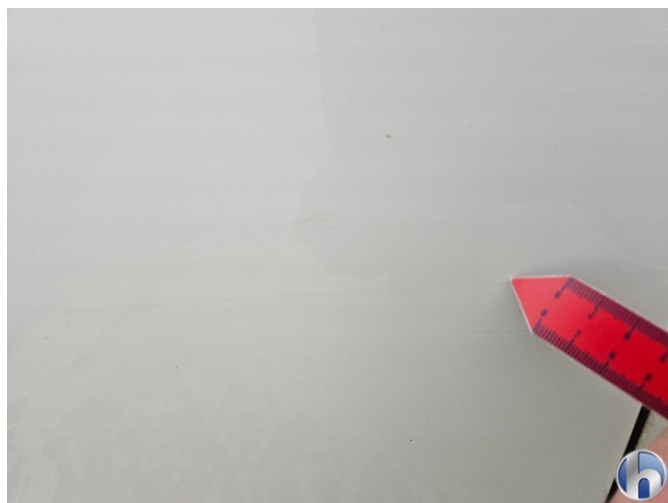
| component | Damage | Rep kind |
|---|---|---|
| 15. Front door - left | Wear and tear | acceptable |

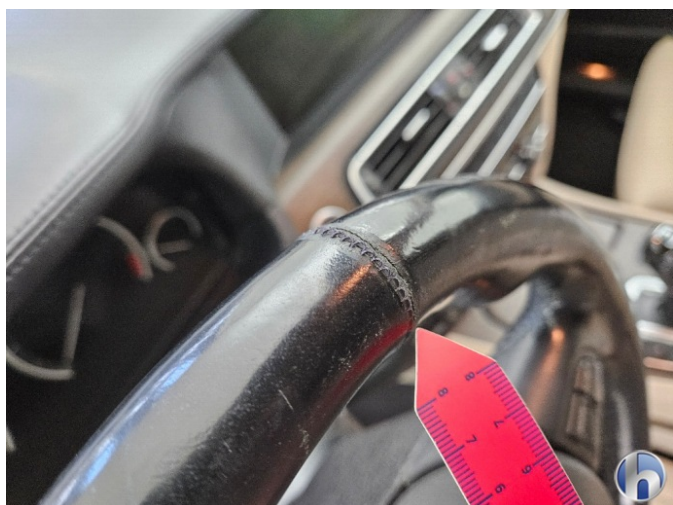
| component | Damage | Rep kind |
|---|---|---|
| 16. Steering wheel (leather) | Wear and tear | acceptable |

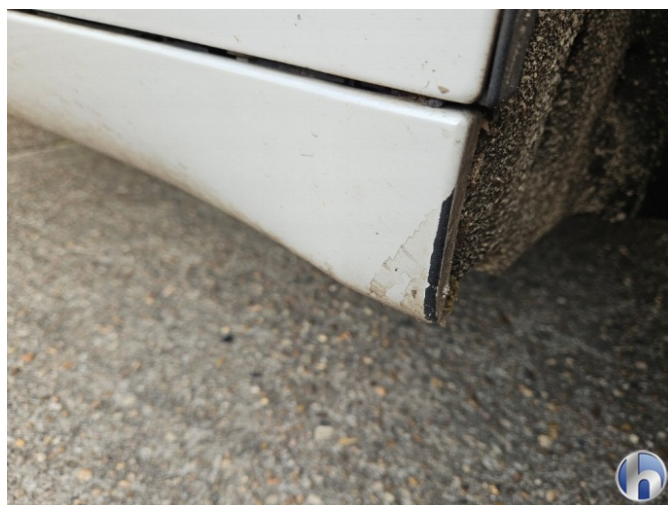
| component | Damage | Rep kind |
|---|---|---|
| 17. side skirt - right | Scratch(es) | Paint |
