## status report

#### BMW Baureihe X6 xDrive 40 d

| Vehicle identification number | <b>WBAKV410200P70830</b> | mileage read: | <b>182717 km</b> |

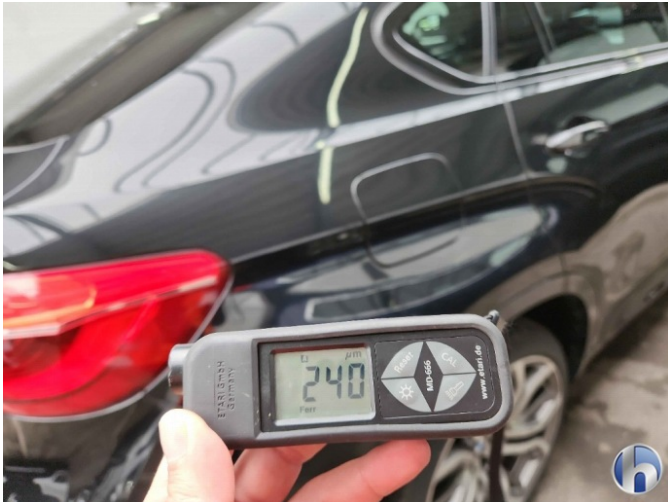
| component | Damage | Rep kind |
|---|---|---|
| 1. Sidewall - Rear - right | Subsequently painted | acceptable |

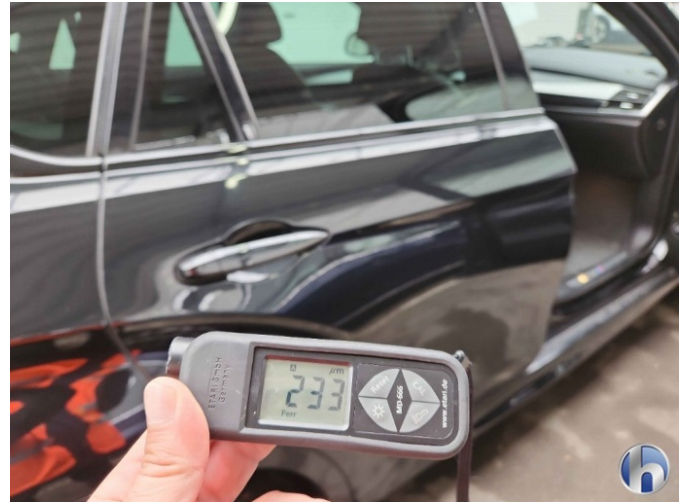
| component | Damage | Rep kind |
|---|---|---|
| 2. Door Rear - right | Subsequently painted | acceptable |

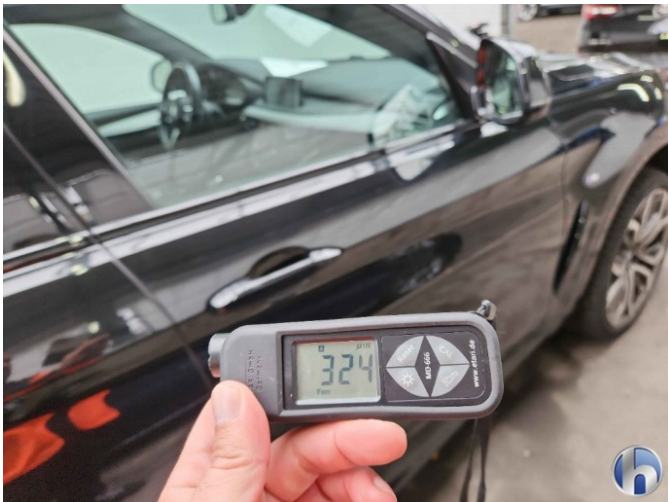
| component | Damage | Rep kind |
|---|---|---|
| 3. Front door - right | Subsequently painted | acceptable |

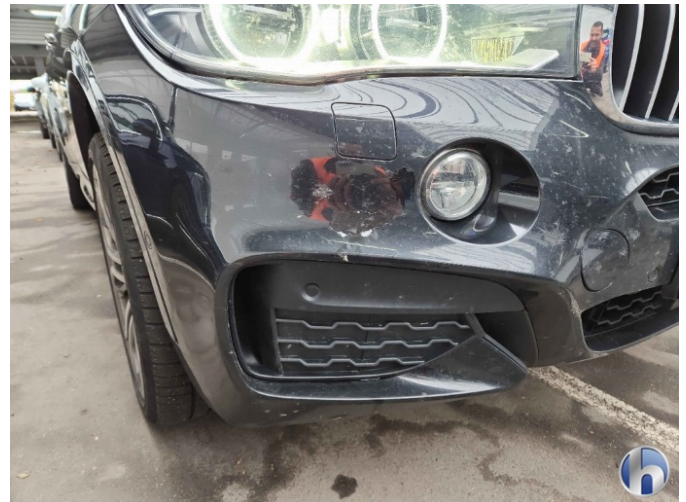
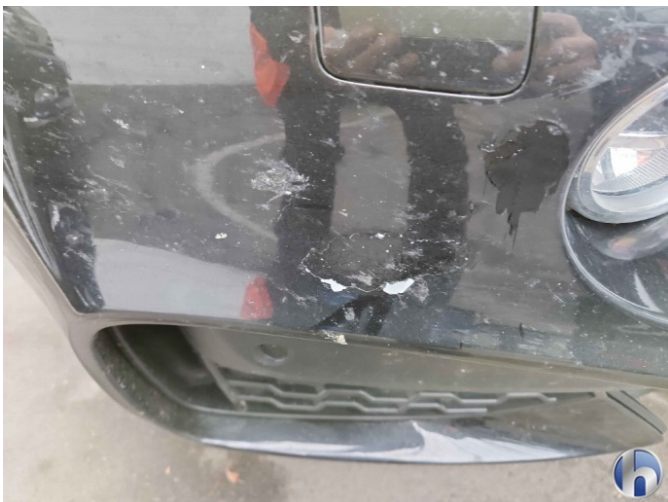
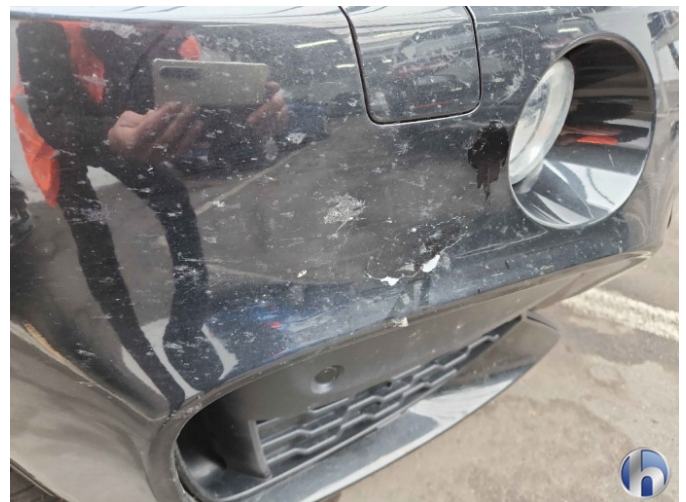
| component | Damage | Rep kind |
|---|---|---|
| 4. Front bumper | Damaged | Refurbish and paint |

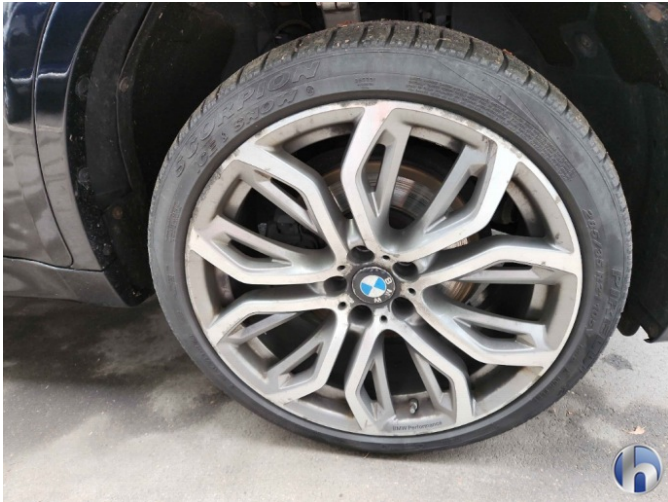
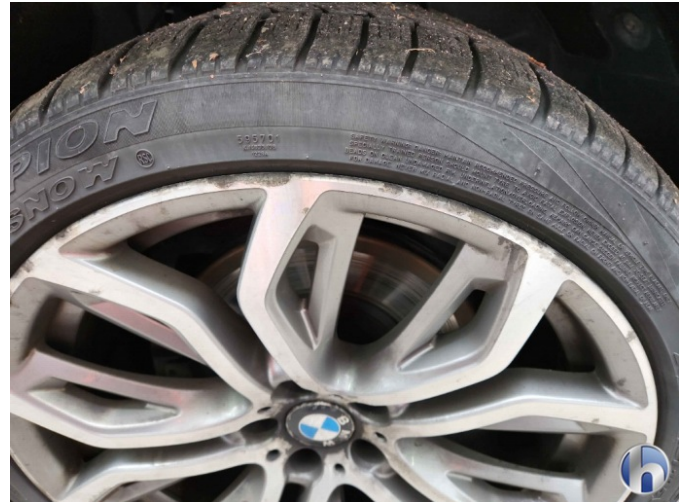
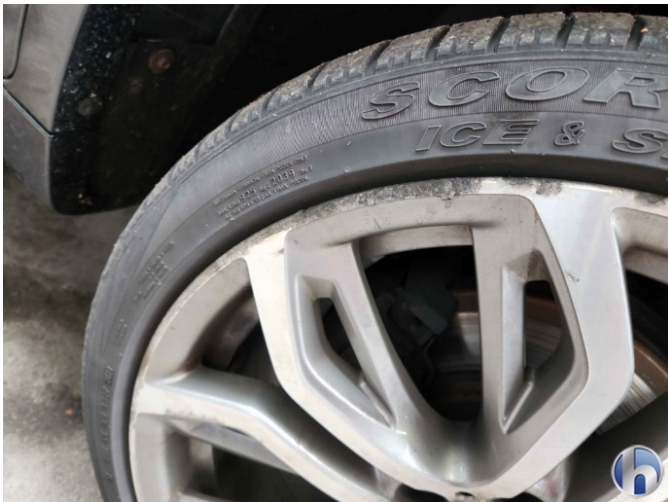
| component | Damage | Rep kind |
|---|---|---|
| 5. Rim rear - left | Damaged | Replace |

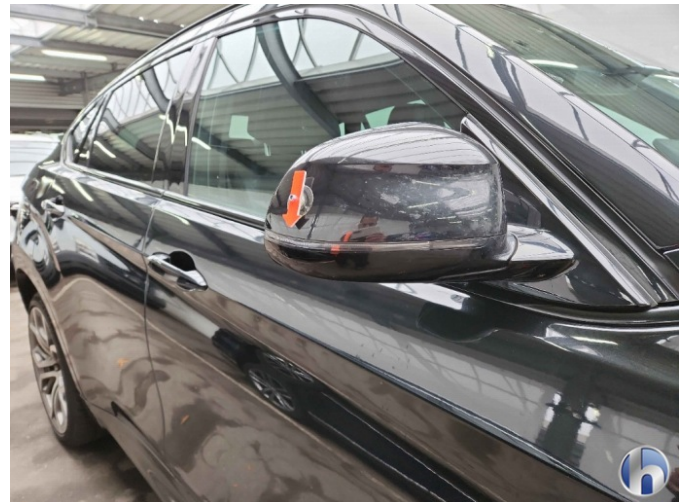
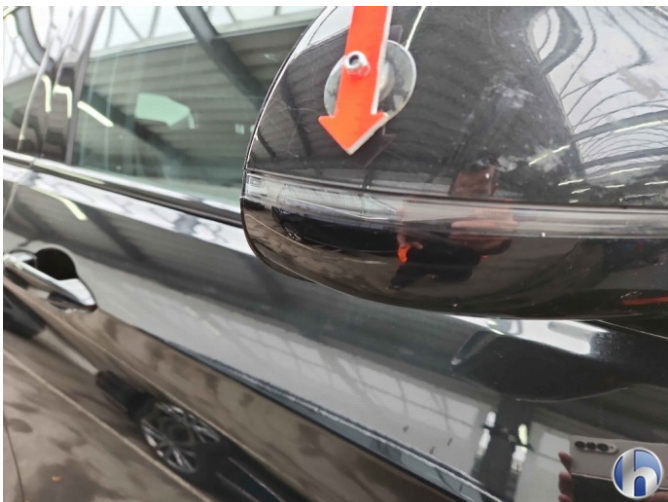
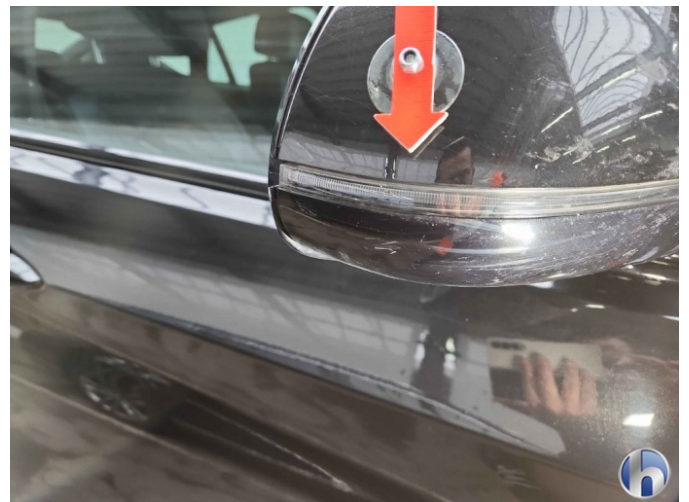
| component | Damage | Rep kind |
|---|---|---|
| 6. Outside mirror - right | Damaged | Replace |

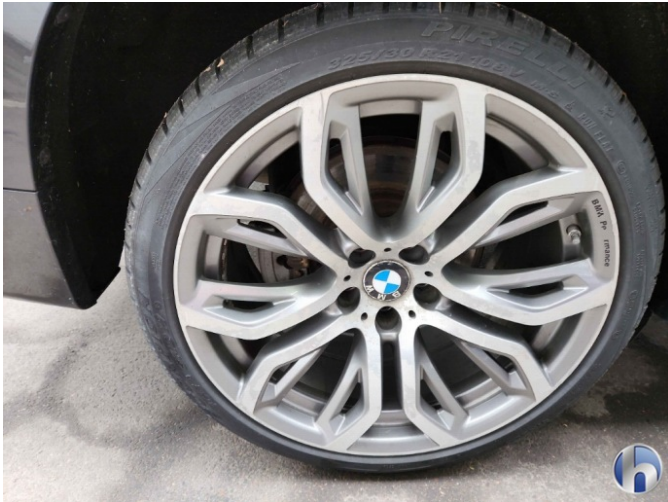
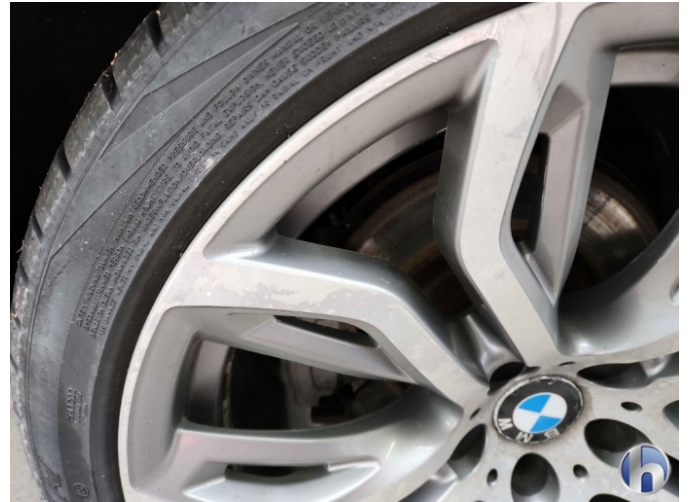
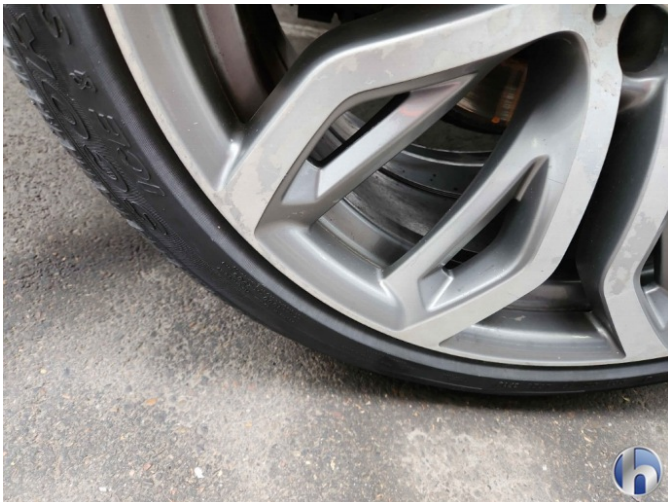
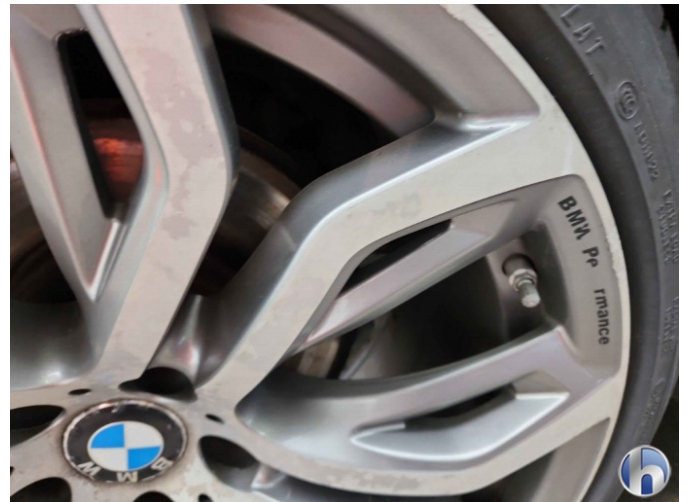
| component | Damage | Rep kind |
|---|---|---|
| 7. Rim rear - right | Damaged | Paint |

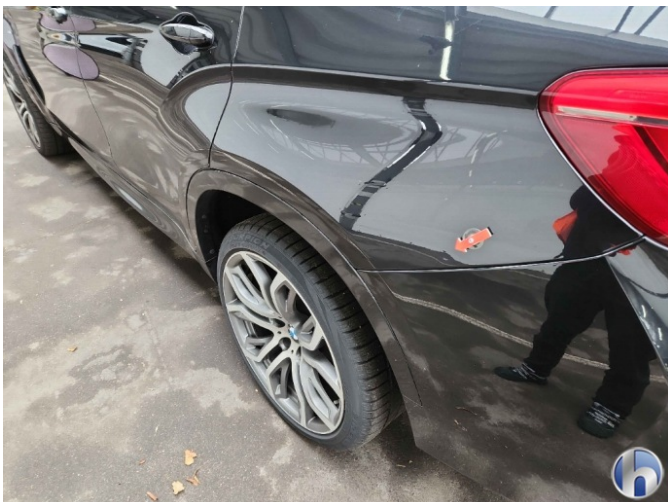
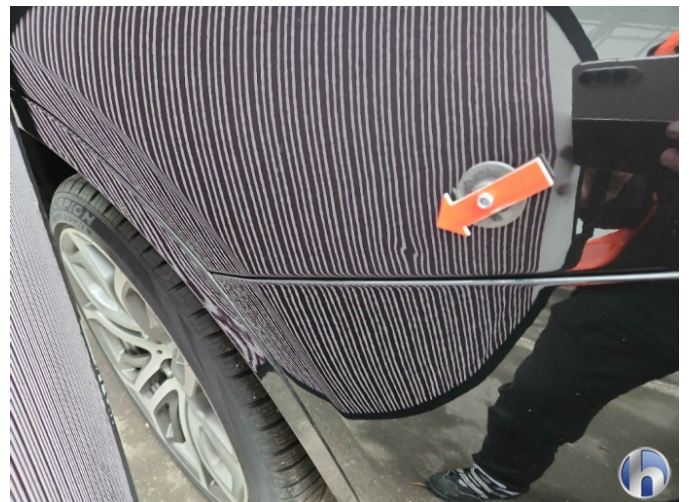
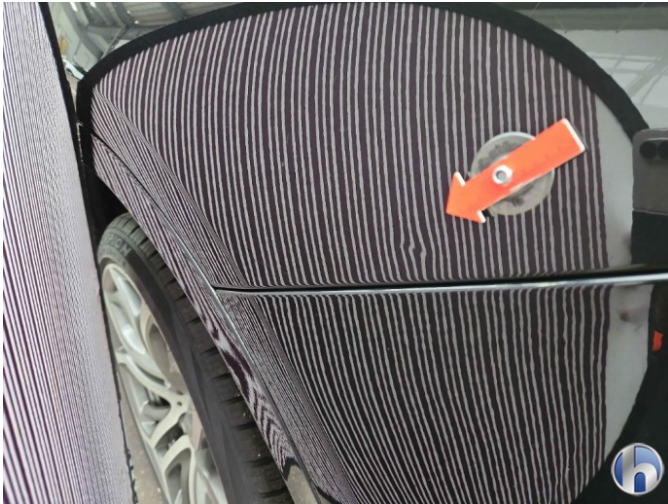
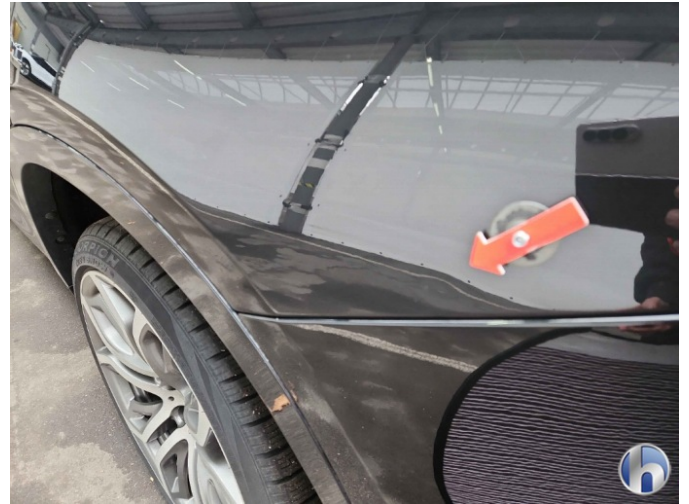
| component | Damage | Rep kind |
|---|---|---|
| 8. Sidewall - Rear - Left | Damaged | Refurbish and paint |

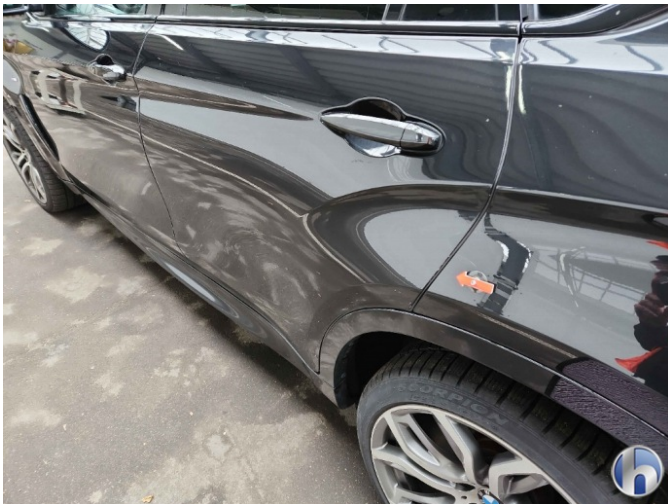
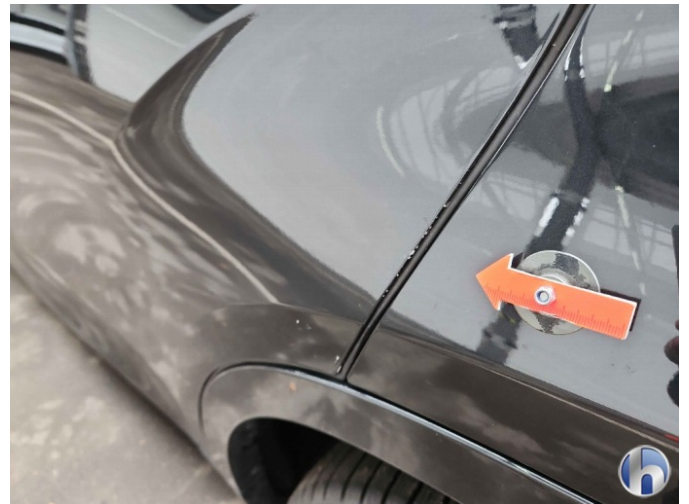
| component | Damage | Rep kind |
|---|---|---|
| 9. Rear door - left | Damaged | Paint |

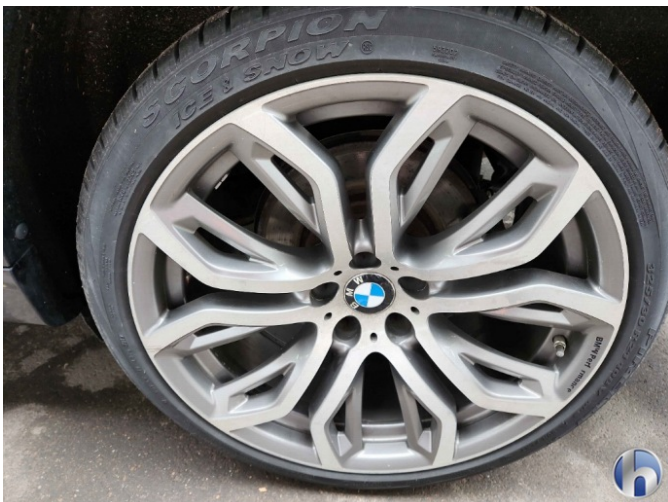
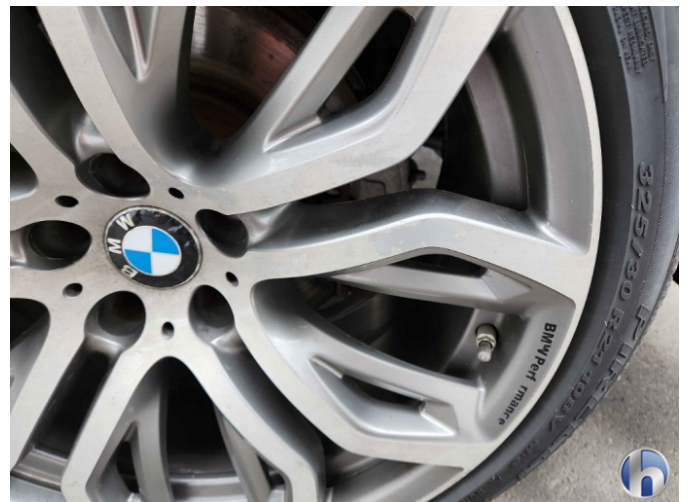
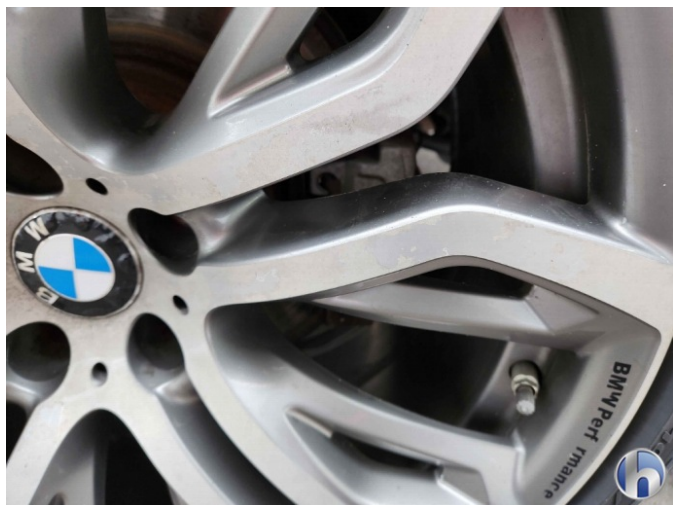
| component | Damage | Rep kind |
|---|---|---|
| 10. Rim rear - left | Damaged | Paint |

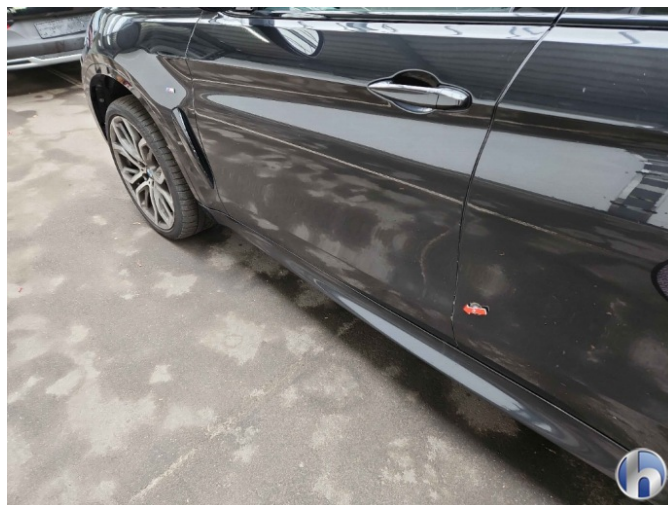
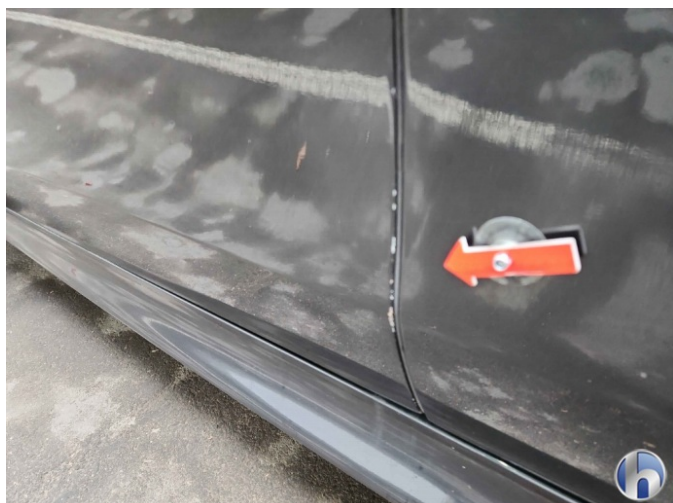
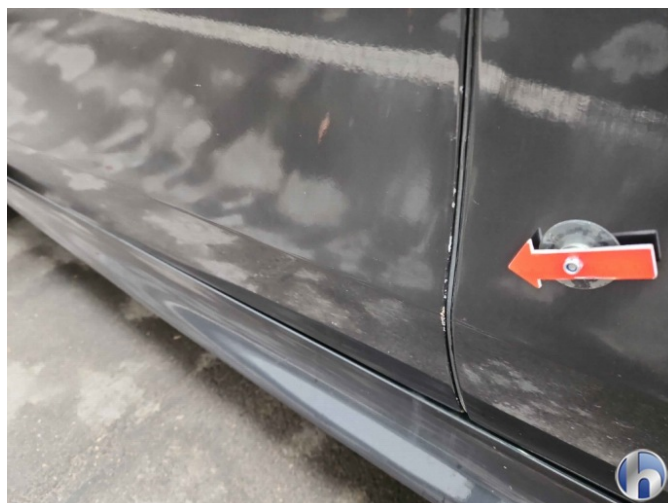
| component | Damage | Rep kind |
|---|---|---|
| 11. Front door - left | Damaged | Paint |

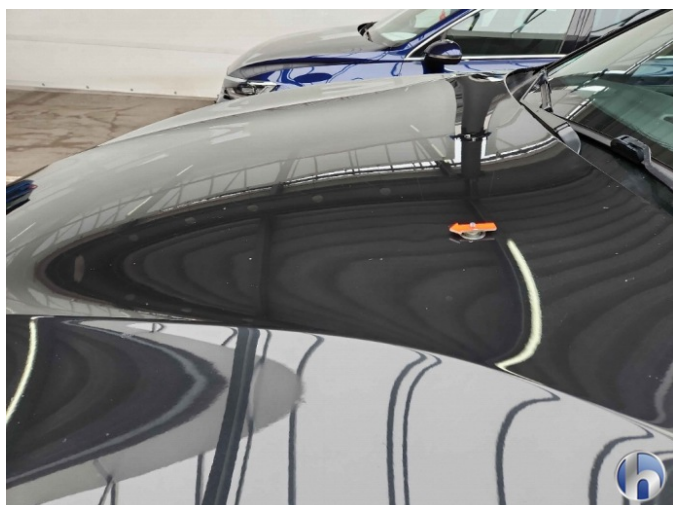
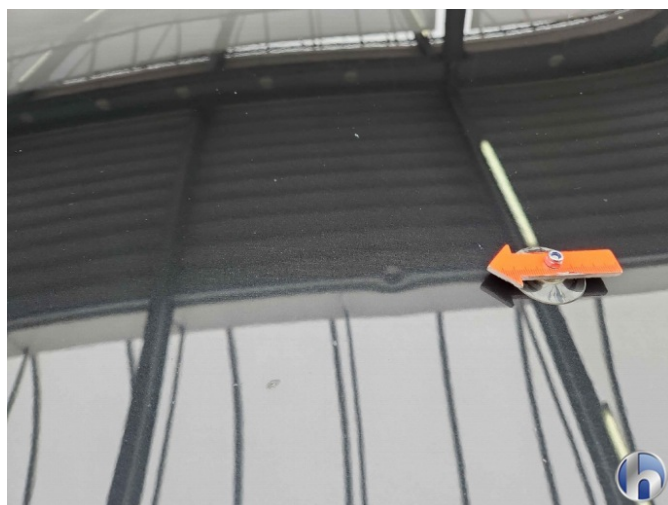
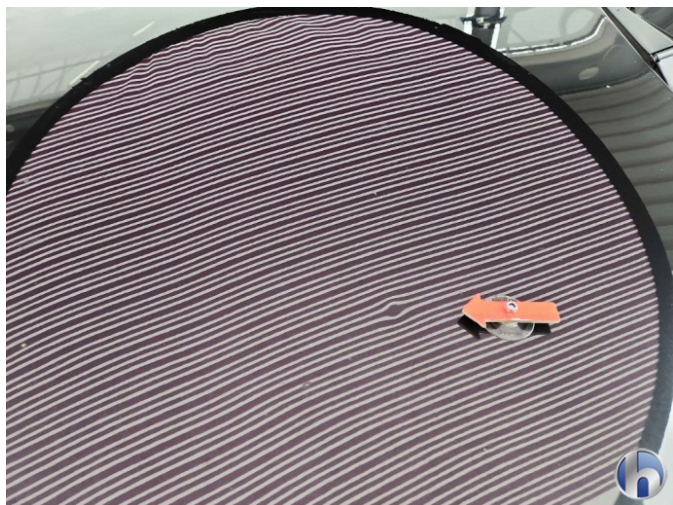
| component | Damage | Rep kind |
|---|---|---|
| 12. hood | Damaged | Smart repair |

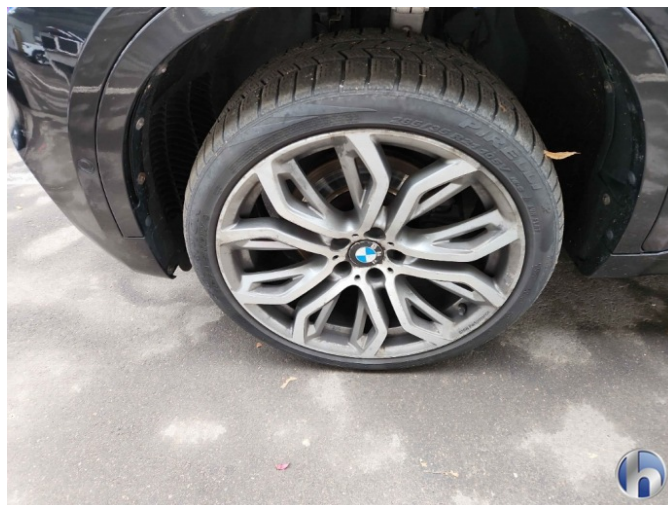
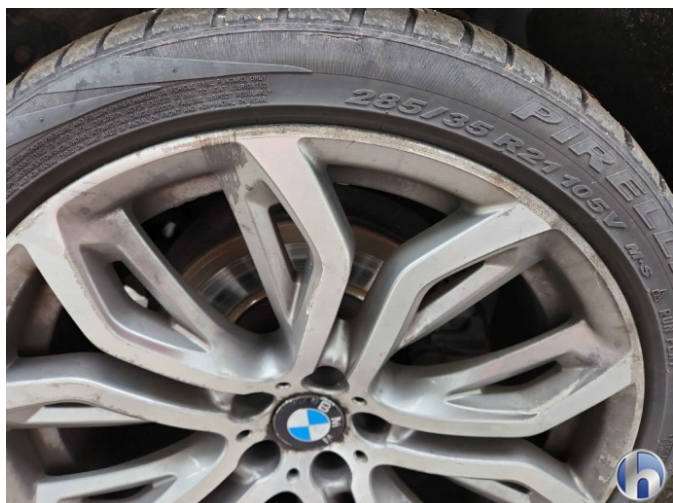
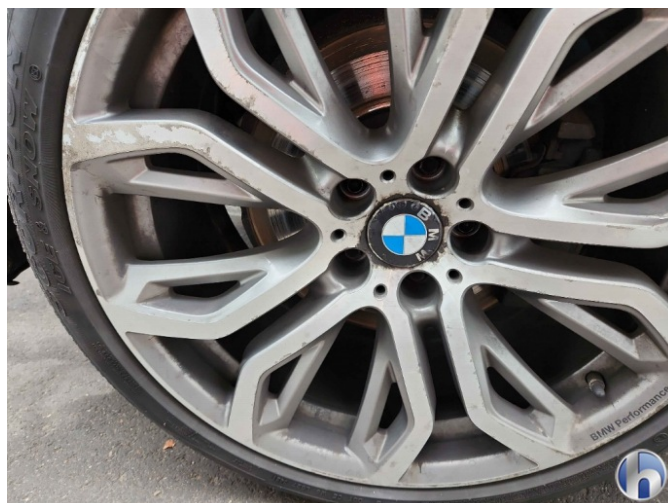
| component | Damage | Rep kind |
|---|---|---|
| 13. Rim front - left | Damaged | Paint |
