BMW 3er 325d DPF Touring Aut.

VIN NO WBAUX910X0F197320
Registration Number 0X0F197320

Inspection Report Summary

Customer	BCA Online	Report Number	P20250918110154
Inspection Date / Place	2025-09-18 / ARS Altmann AG Riedstadt	Cosmetic Grade	3

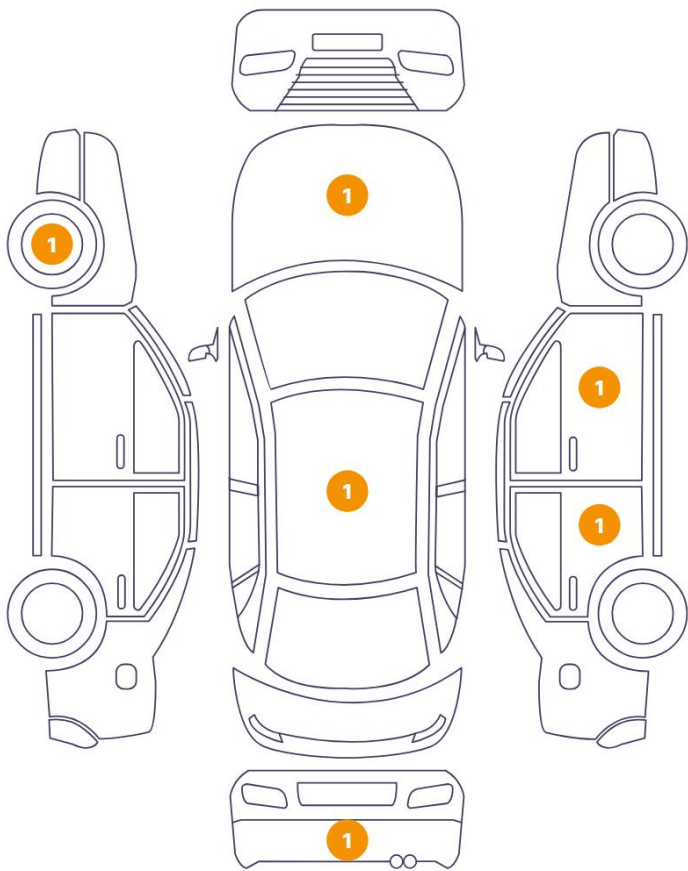
6 Schäden

Component	Damage	Comments
1 Hood	Bodywork / Dent / Dent	
2 Rim / Front Left	Out of Bodywork / Scratch	
3 Bumper / Back	Paint / Chemical Damage	
4 Door / Back Right	Bodywork / Dent / Dent	
5 Roof	Bodywork / Dent / Dent	
6 Mirror Shell / Front Right	Paint / Scratch / Scuff

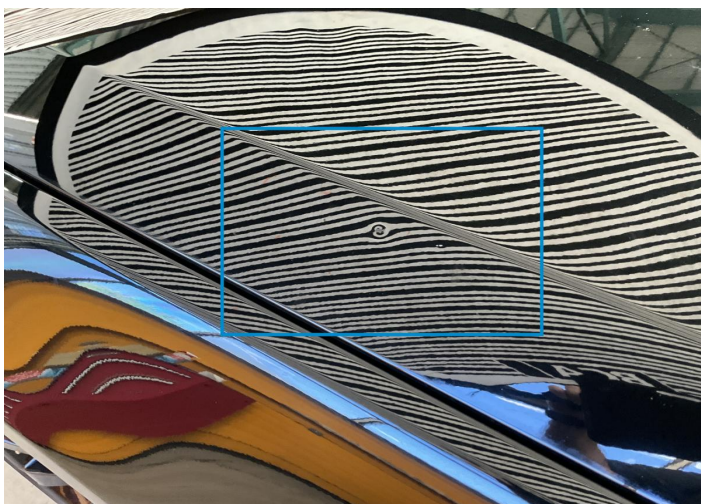
1. Hood
Bodywork / Dent / Dent -

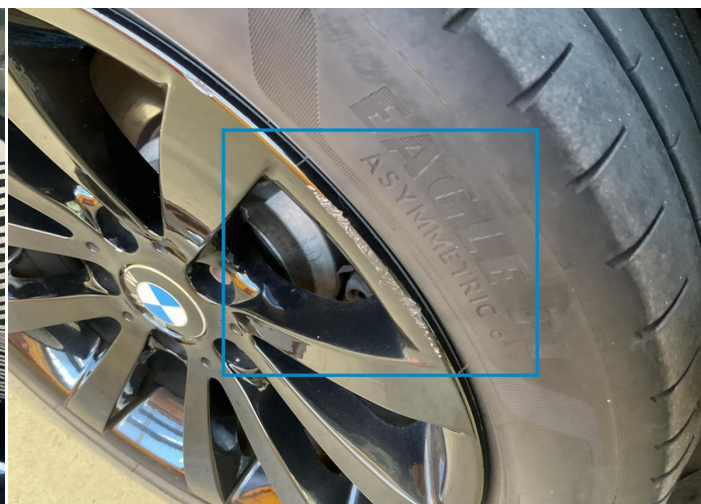
2. Rim / Front Left
Out of Bodywork / Scratch -

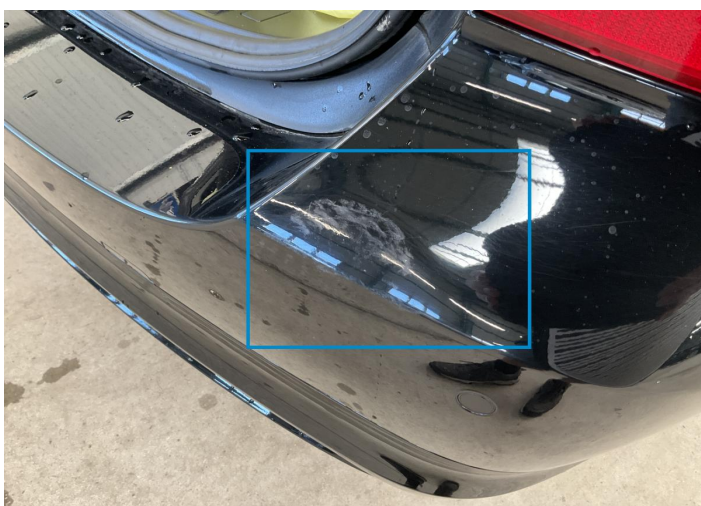
3. Bumper / Back
Paint / Chemical Damage -

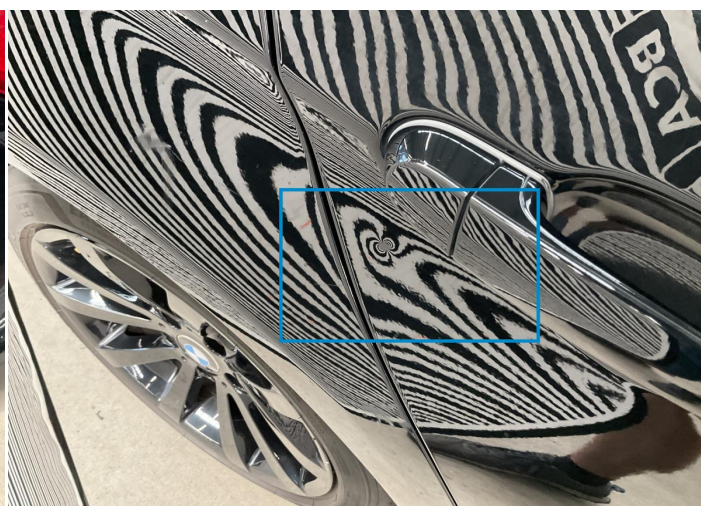
4. Door / Back Right
Bodywork / Dent / Dent -

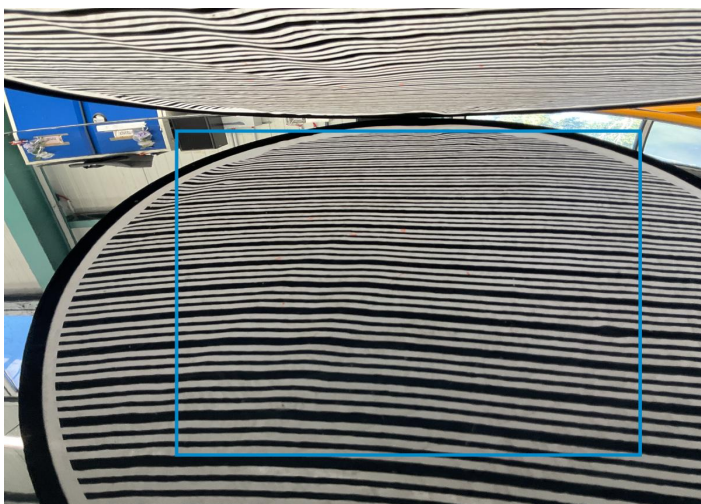
5. Roof
Bodywork / Dent / Dent -

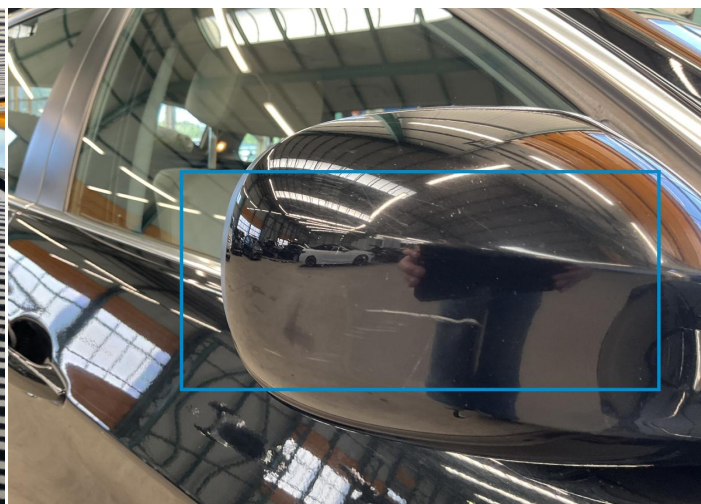
6. Mirror Shell / Front Right
Paint / Scratch / Scuff -
