BMW 3er 320d DPF Touring Aut.

VIN NO WBAVU51000A322098 Registration Number 000A322098

Inspection Report Summary

Customer	BCA Online	Report Number	P20250911104534
Inspection Date / Place	2025-09-11 / BCA Oberndorf	Cosmetic Grade	4

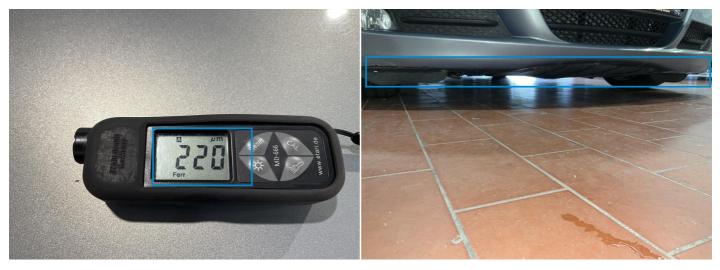
1. Anomalyon Element -

2. Bumper / Front Paint / Scratch / Scuff -

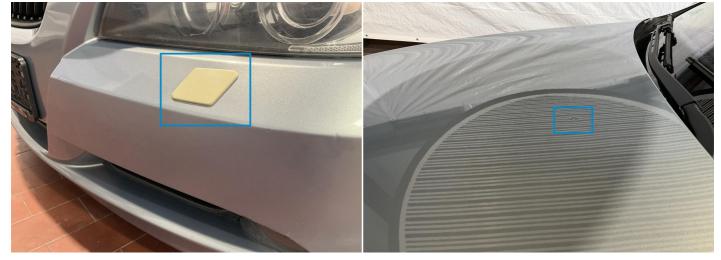
3. Headlight Nozzle / Front Left Paint / Poor Previous Repair -

4. Hood Bodywork / Dent / Dent -

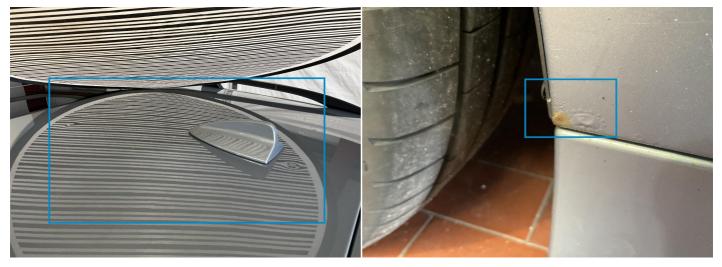
5. Roof Bodywork / Dent / Dent -

6. Fender / Front Left Paint / Scratch / Line -

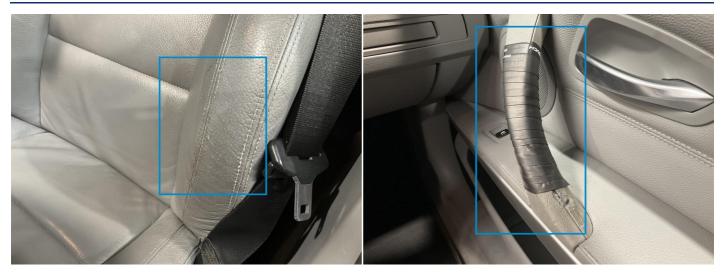
7. Seat / Front Left Interior / Scratched -

8. Panel Filling / Front Right Interior / Scratched -

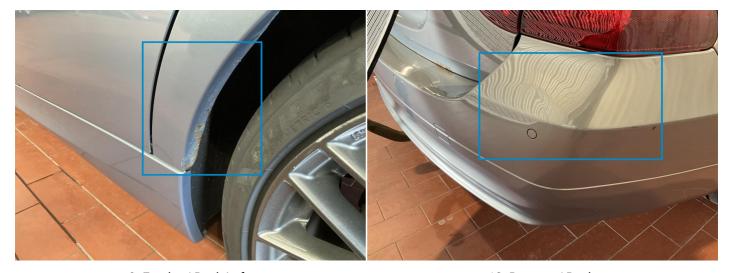
9. Fender / Back Left Paint / Scratch / Line -

10. Bumper / Back Bodywork / Dent / Dent -

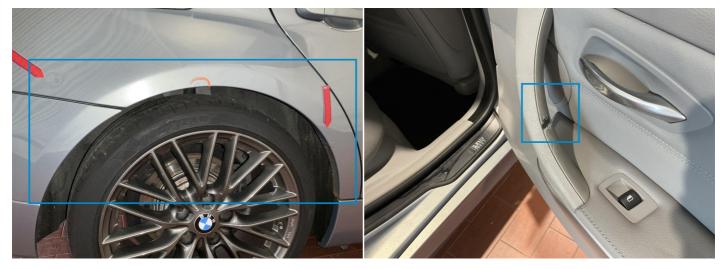
11. Fender / Back Right Paint / Scratch / Line -

12. Interior door handle Back right Interior / Scratched -

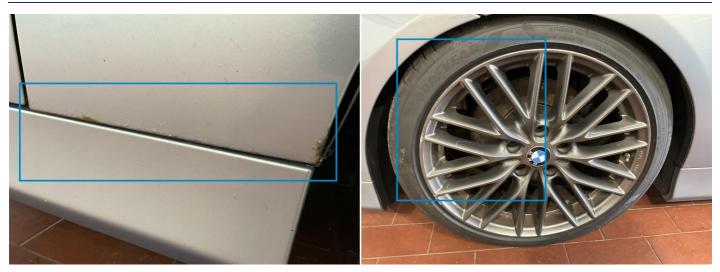
13. Fender / Front Right Paint / Scratch / Line -

14. Paint / Scratch / Scuff -

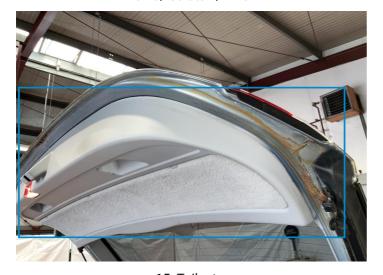
15. Tailgate Paint / Corrosion -
