BMW 3er 320d DPF Touring Aut.

VIN NO WBAVU51080A317991 Registration Number 080A317991

Inspection Report Summary

Customer	BCA Online	Report Number	P20250508132400
Inspection Date / Place	2025-05-08 / BCA Neuss	Cosmetic Grade	4

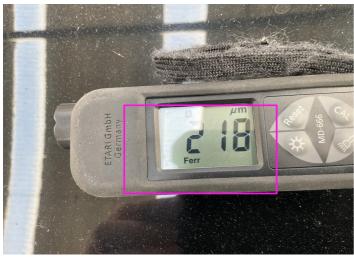
1. Hood Paint / Poor Previous Repair -

2. Pillar / Front Left Bodywork / Dent / Dent -

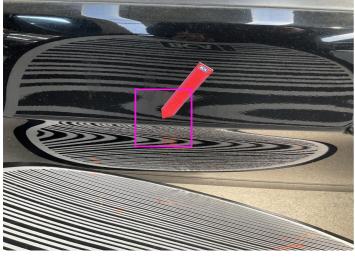
3. Door / Front Left Bodywork / Dent / Dent -

4. Door / Back Left Paint / Scratch / Scuff -

5. Door / Back Left Bodywork / Dent / Dent -

6. Panel Filling / Back Left Interior / Scraped -

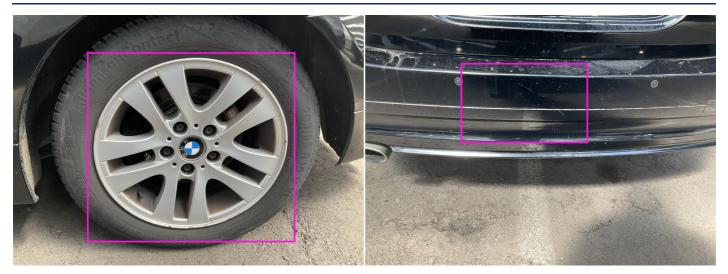
7. Rim / Back Left Out of Bodywork / Scratch -

8. Bumper / Back Paint / Scratch / Scuff -

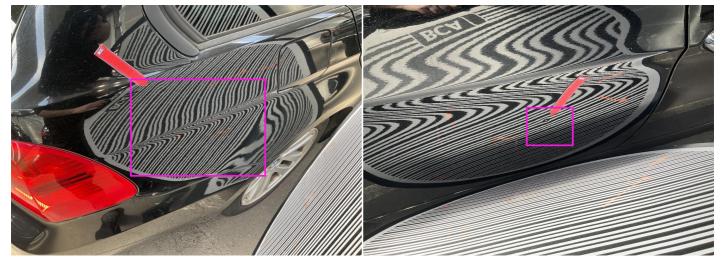
9. Side Panel / Back Right Bodywork / Dent / Dent -

10. Door / Back Right Bodywork / Dent / Dent -

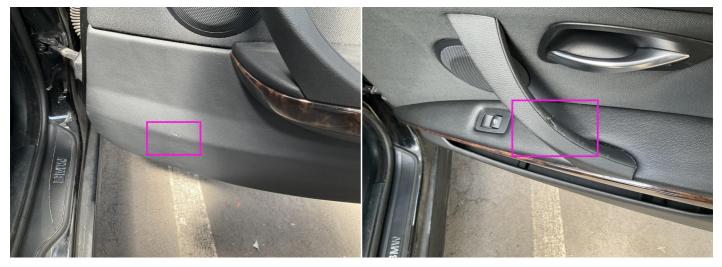
11. Panel Filling / Back Right Interior / Scraped -

12. Panel Filling / Front Right Interior / Distorted -

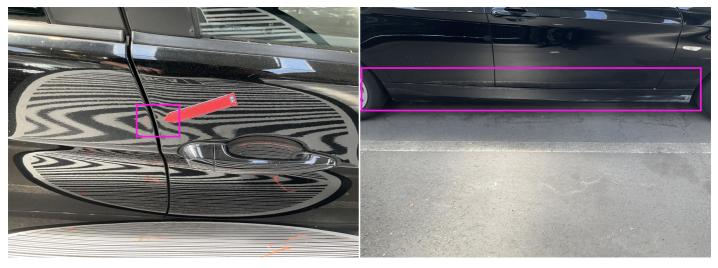
13. Door / Front Right Bodywork / Dent / Dent -

14. Rocker Panel / Center Right Paint / Scratch / Scuff -

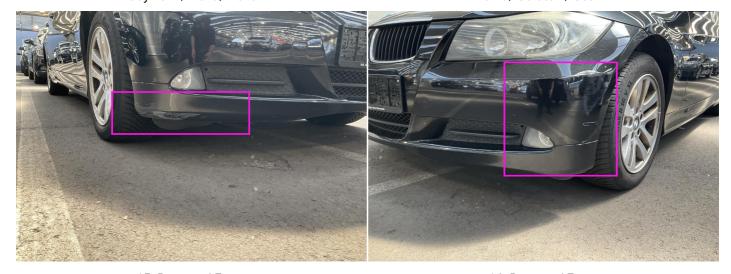
15. Bumper / Front Paint / Scratch / Scuff -

17. Rim / Front Left
Out of Bodywork / Scratch -

16. Bumper / Front Paint / Scratch / Scuff -
