## status report

#### BMW Baureihe X4 xDrive 30 d

| Vehicle identification number | <b>WBAXX310400K82344</b> | mileage read: | <b>215540 km</b> |

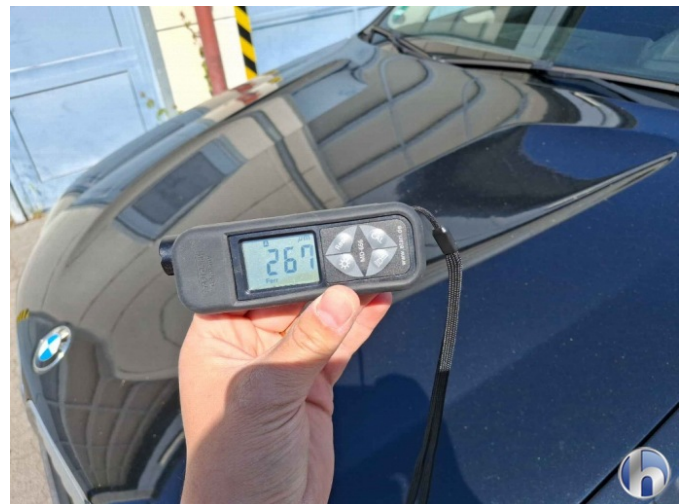
| component | Damage | Rep kind |
|---|---|---|
| 1. hood | Subsequently painted | acceptable |

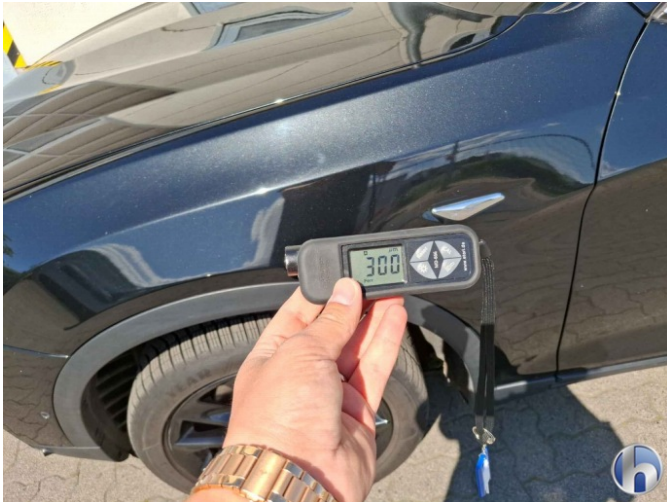
| component | Damage | Rep kind |
|---|---|---|
| 2. Front fender - left | Subsequently painted | acceptable |

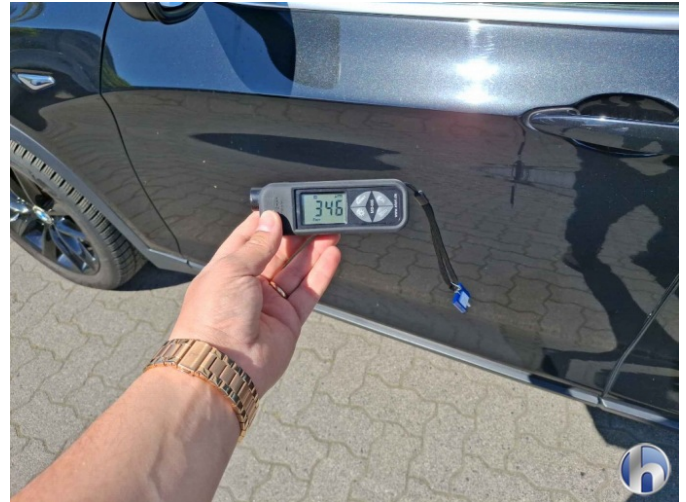
| component | Damage | Rep kind |
|---|---|---|
| 3. Front door - left | Subsequently painted | acceptable |

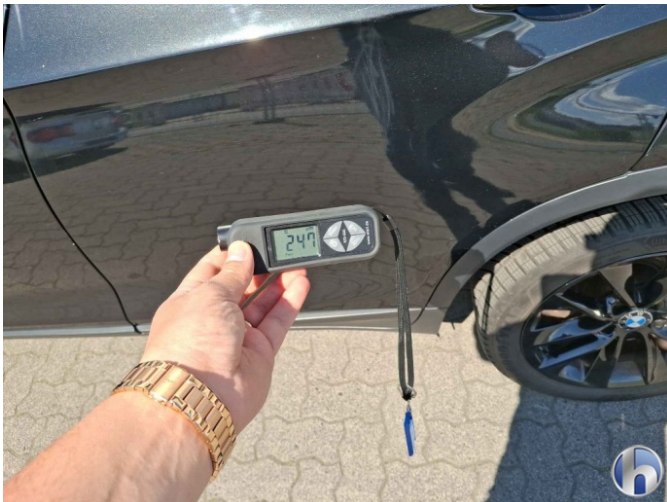
| component | Damage | Rep kind |
|---|---|---|
| 4. Rear door - left | Subsequently painted | acceptable |

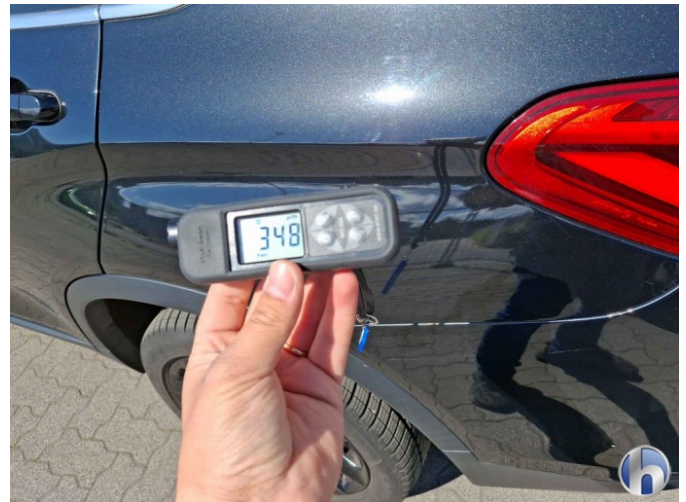
| component | Damage | Rep kind |
|---|---|---|
| 5. Sidewall - Rear - Left | Subsequently painted | acceptable |

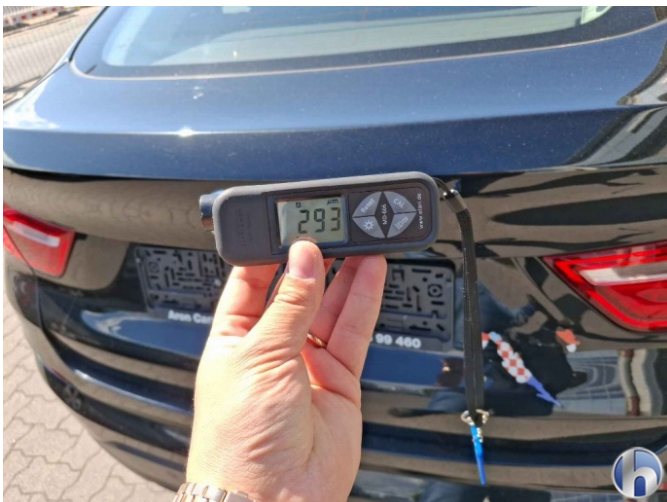
| component | Damage | Rep kind |
|---|---|---|
| 6. tailgate | Subsequently painted | acceptable |

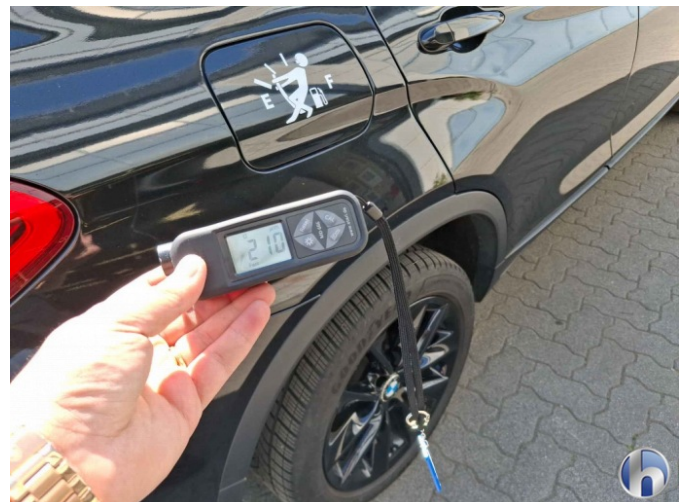
| component | Damage | Rep kind |
|---|---|---|
| 7. Sidewall - Rear - right | Subsequently painted | acceptable |

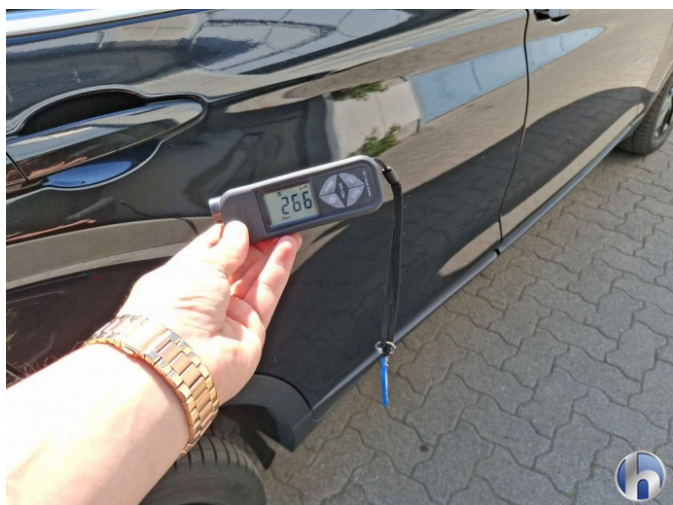
| component | Damage | Rep kind |
|---|---|---|
| 8. Door Rear - right | Subsequently painted | acceptable |

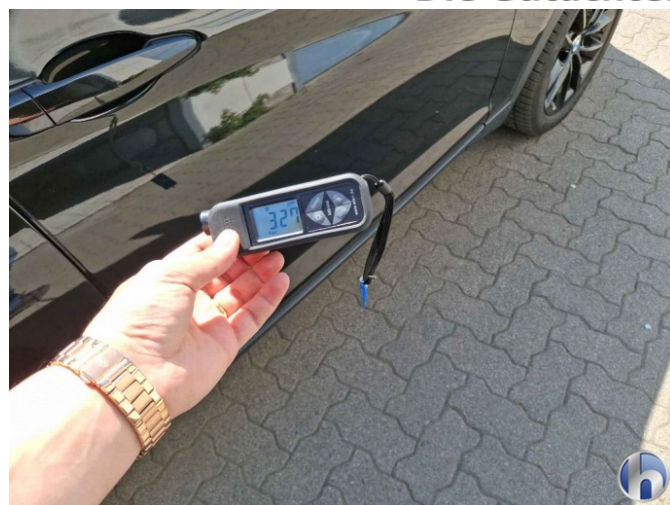
| component | Damage | Rep kind |
|---|---|---|
| 9. Front door - right | Subsequently painted | acceptable |

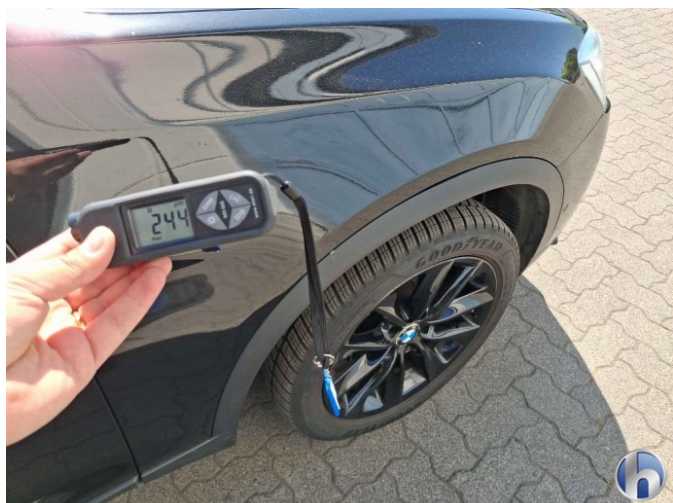
| component | Damage | Rep kind |
|---|---|---|
| 10. Front fender - right | Subsequently painted | acceptable |

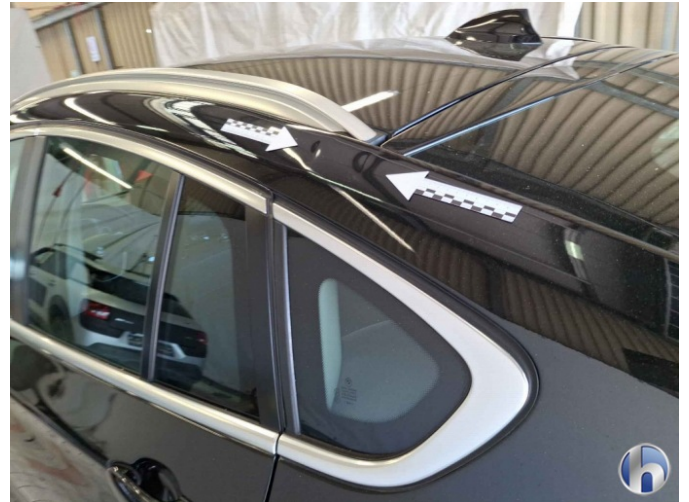
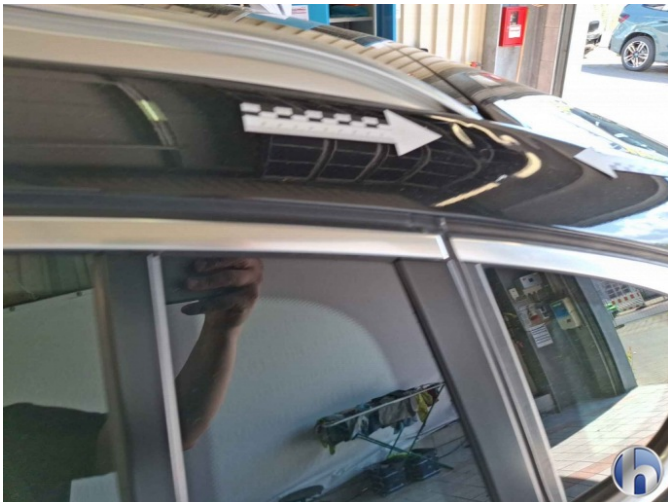
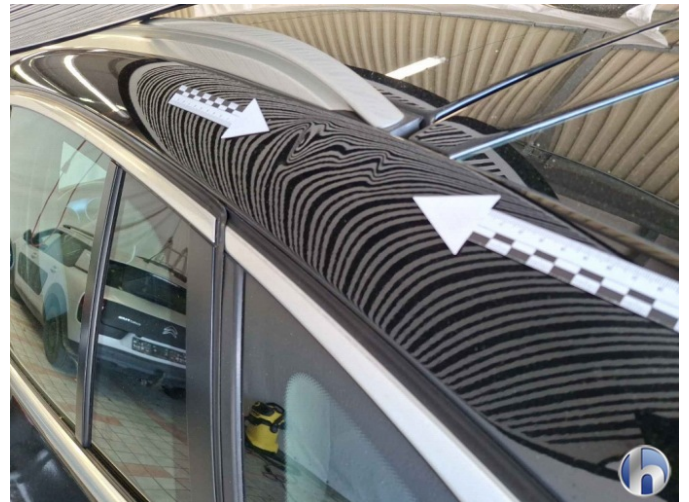
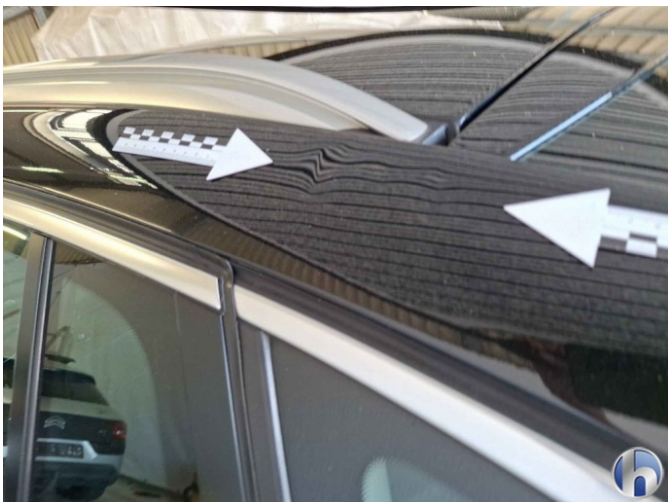
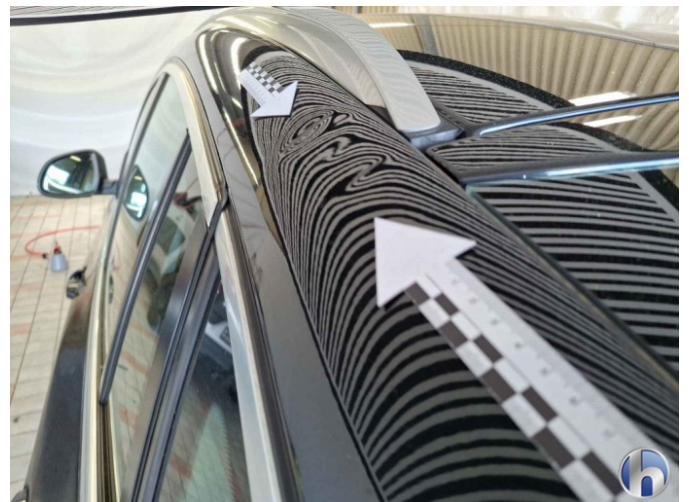
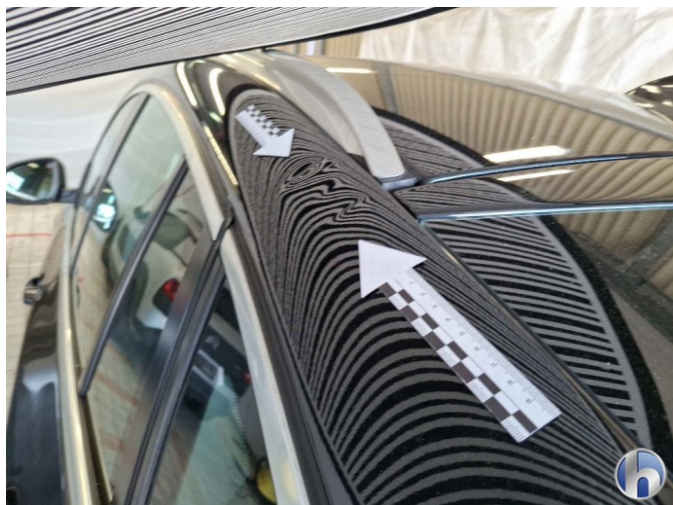
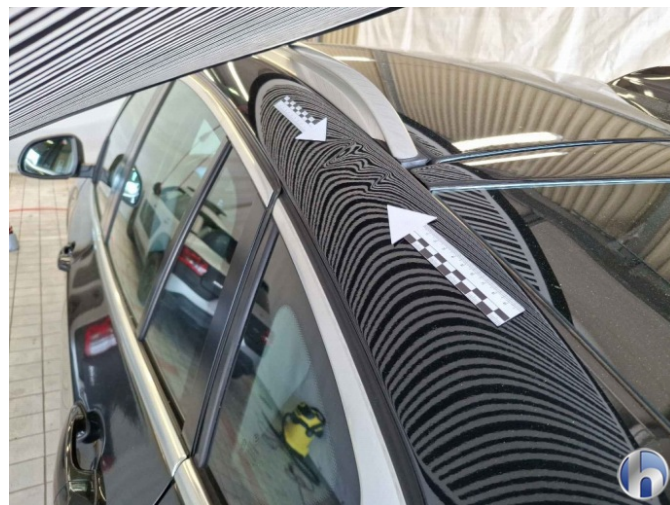
| component | Damage | Rep kind |
|---|---|---|
| 12. Roof frame - left | | Refurbish and paint |

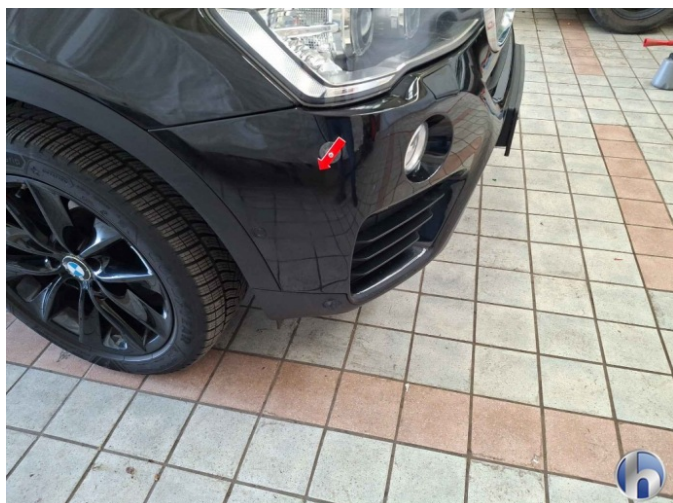
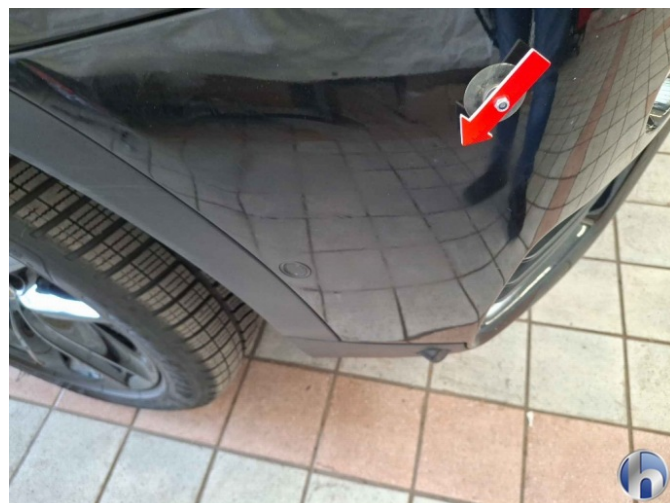
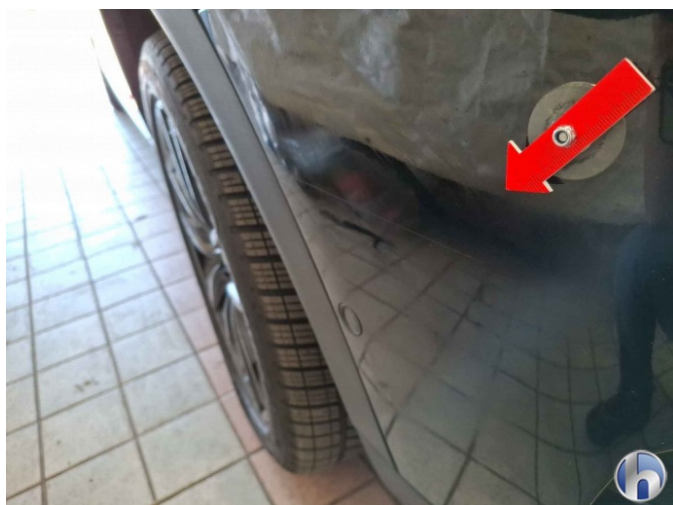
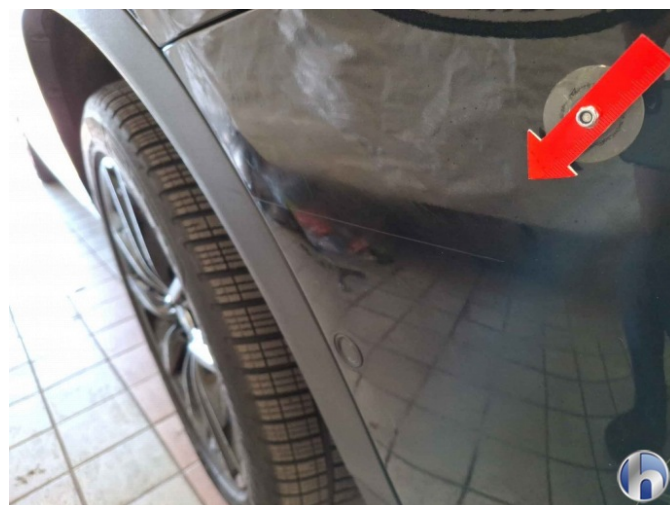
| component | Damage | Rep kind |
|---|---|---|
| 13. Front bumper | Scratch(es) | Paint |

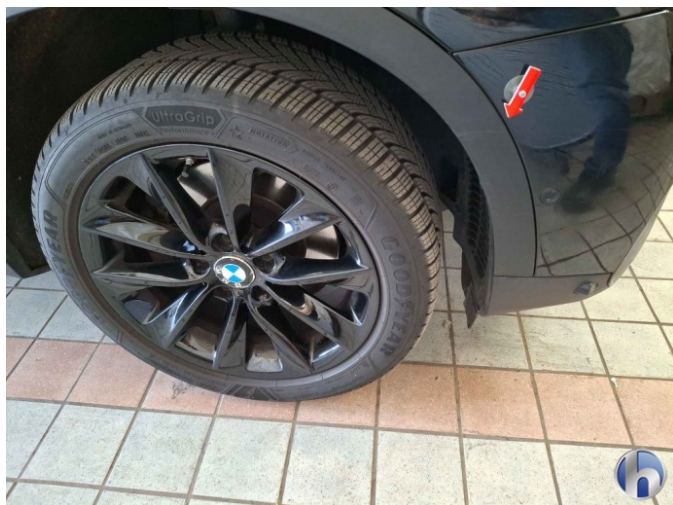
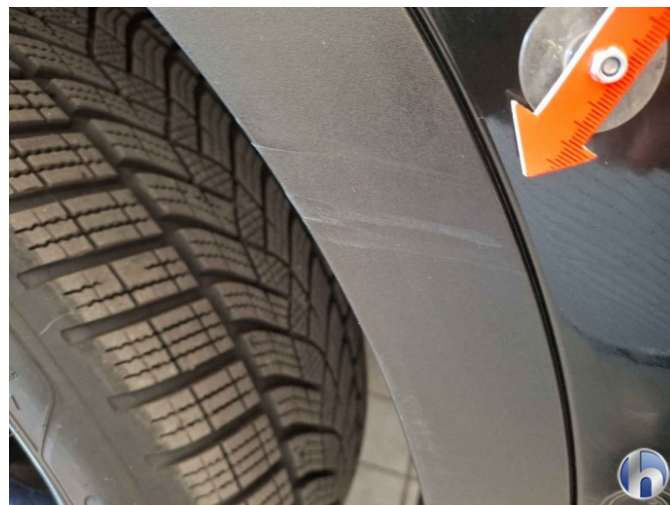
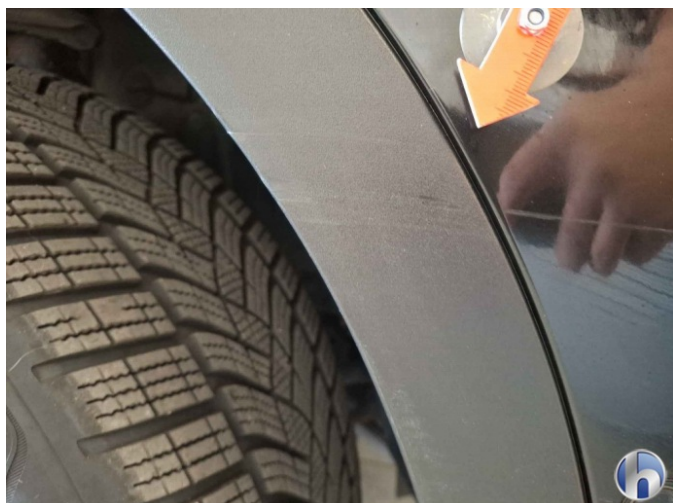
| component | Damage | Rep kind |
|---|---|---|
| 14. Radlaufleiste Rechts | Damaged | Replace |

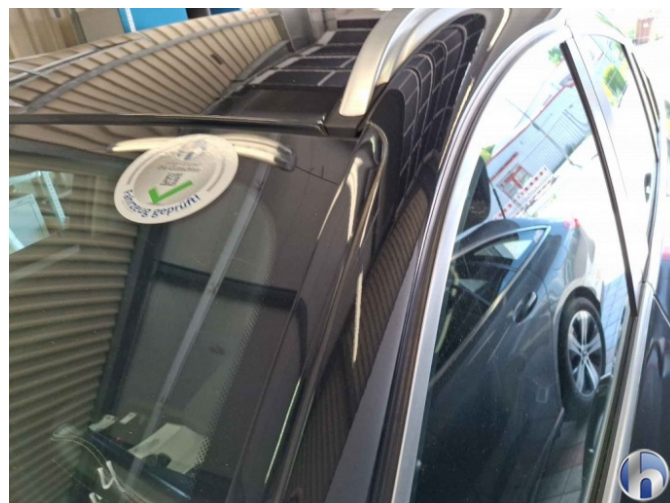
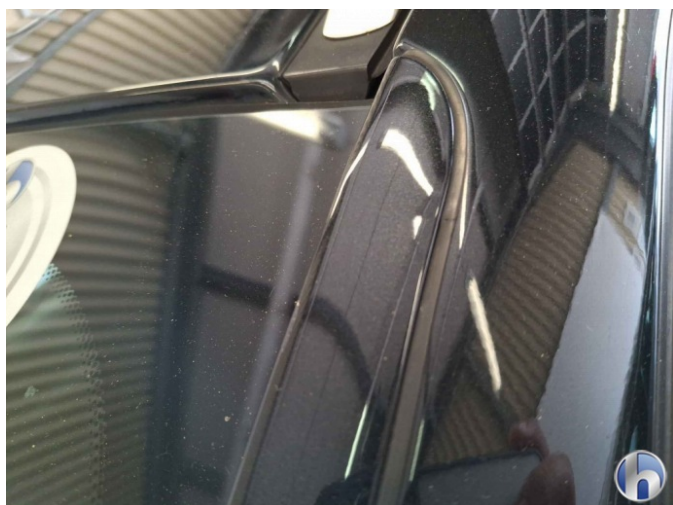
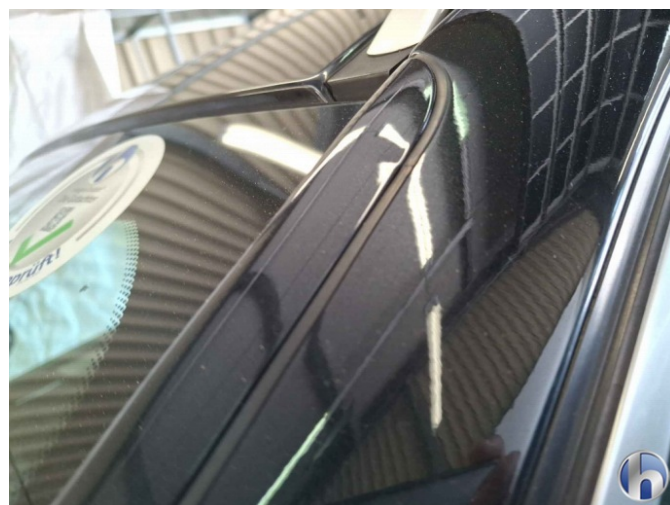
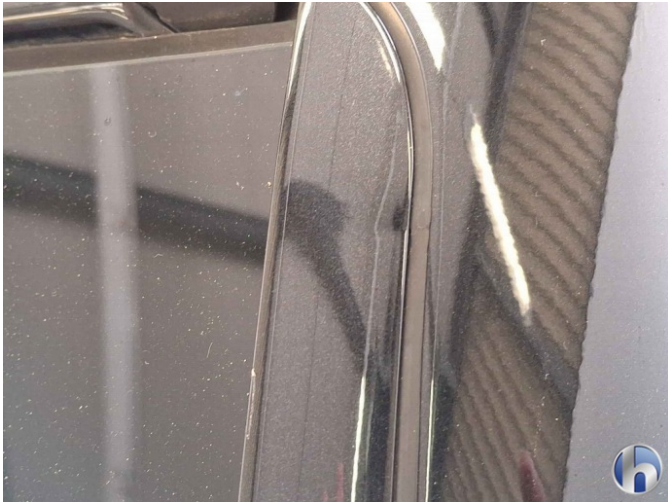
| component | Damage | Rep kind |
|---|---|---|
| 15. Windschutzscheibe Leiste Links | Damaged | Replace |

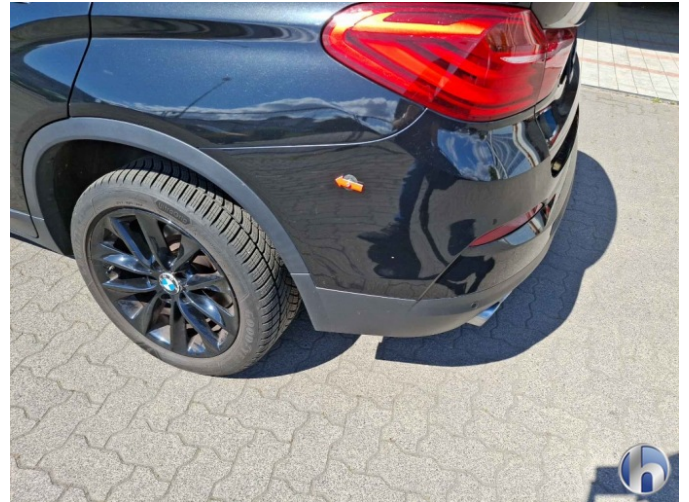
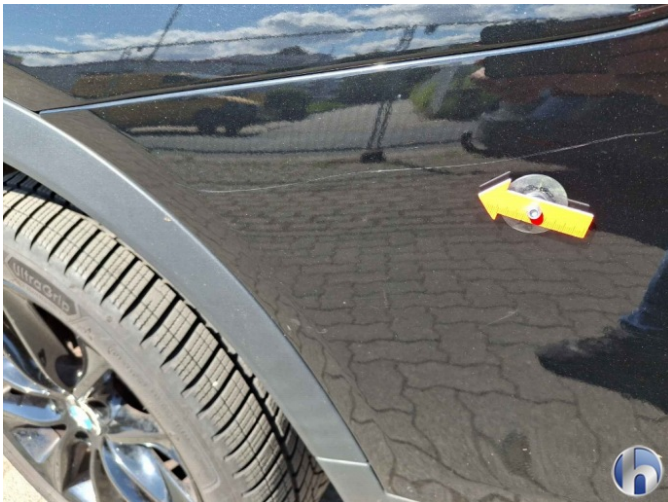
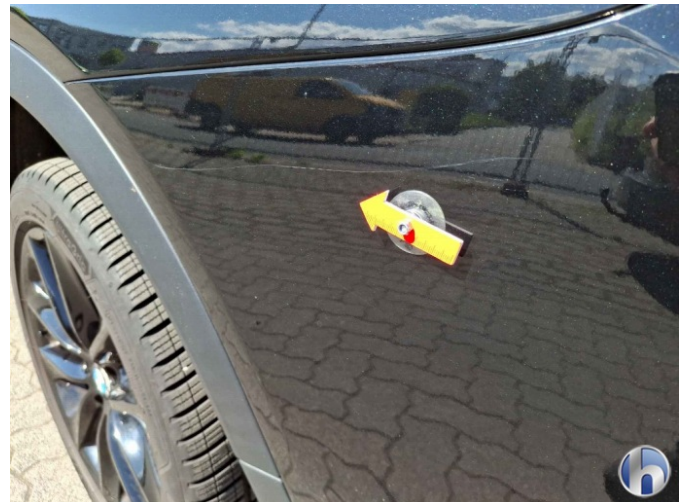
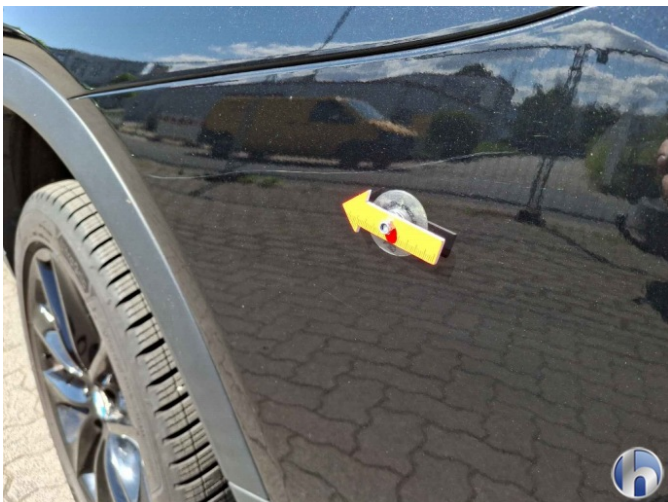
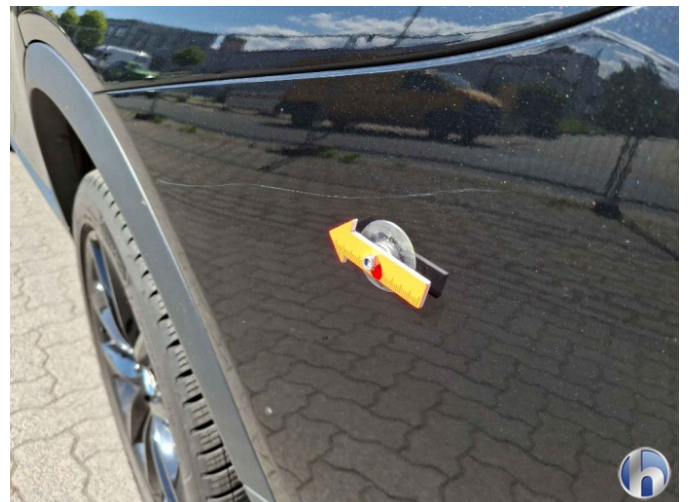
| component | Damage | Rep kind |
|---|---|---|
| 16. Rear bumper | Scratch(es) | Paint |

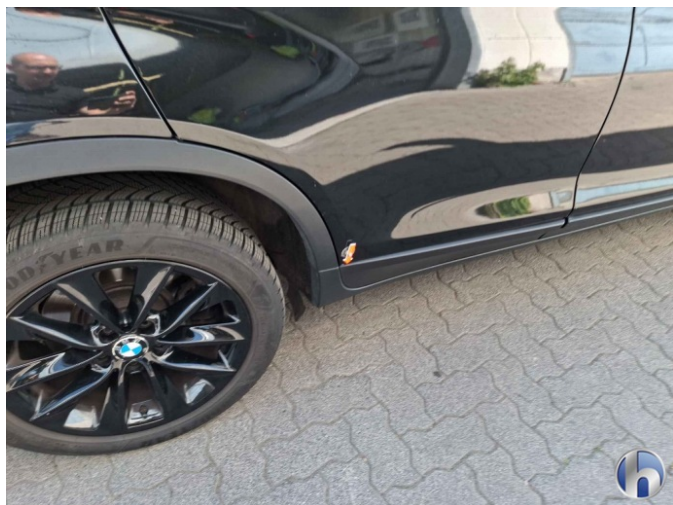
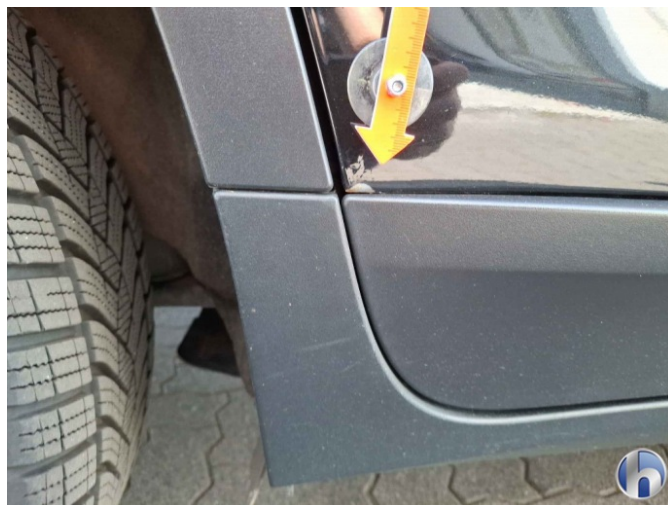
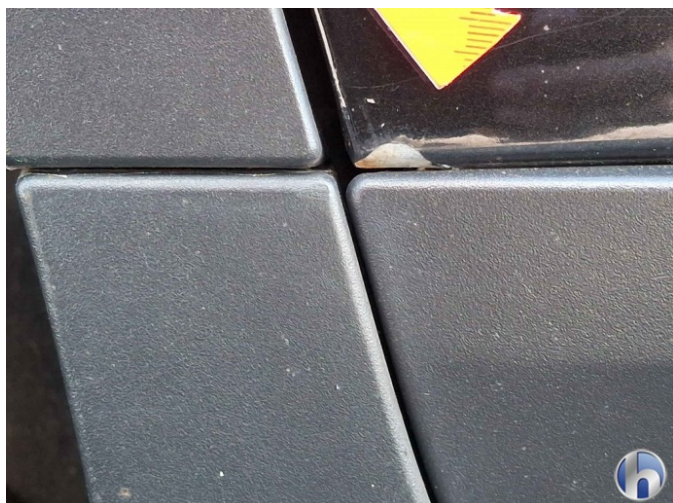
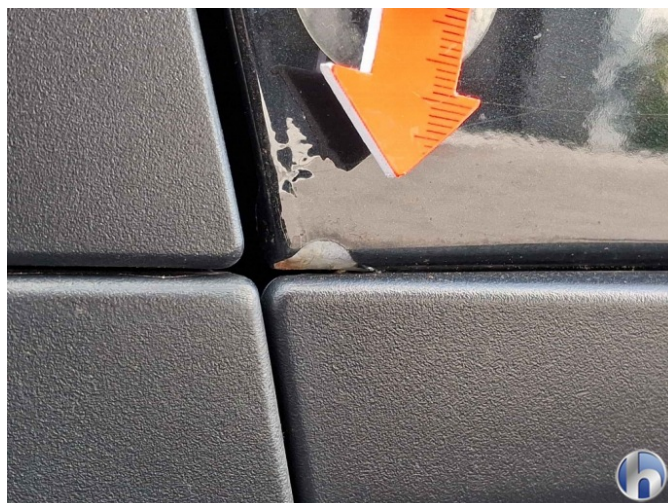
| component | Damage | Rep kind |
|---|---|---|
| 17. Door Rear - right | chipped paint | Paint |
