## status report

#### BMW Baureihe M4 Coupe Competition

| Vehicle identification number | <b>WBS31AZ070CF72163</b> | mileage read: | <b>29364 km</b> |

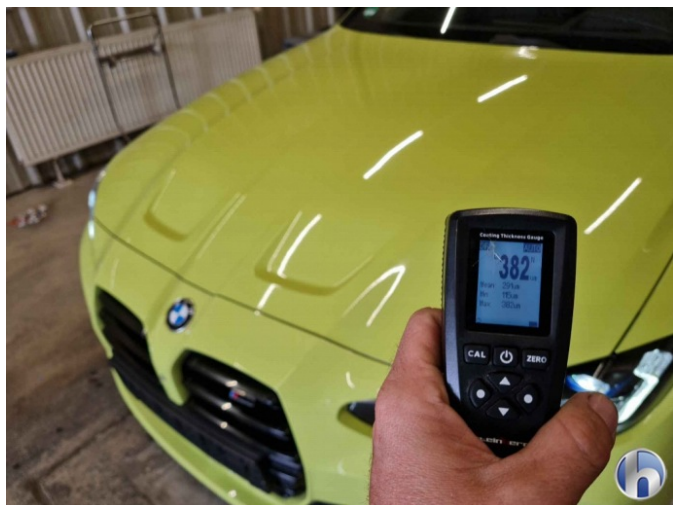
| component | Damage | Rep kind |
|---|---|---|
| 1. hood | Subsequently painted | acceptable |

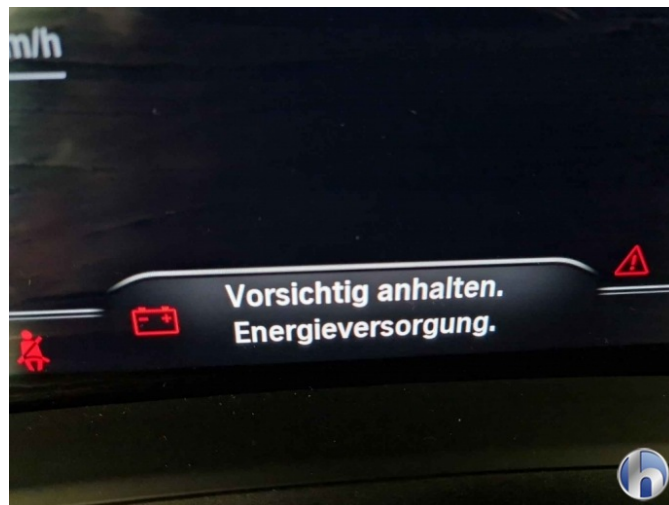
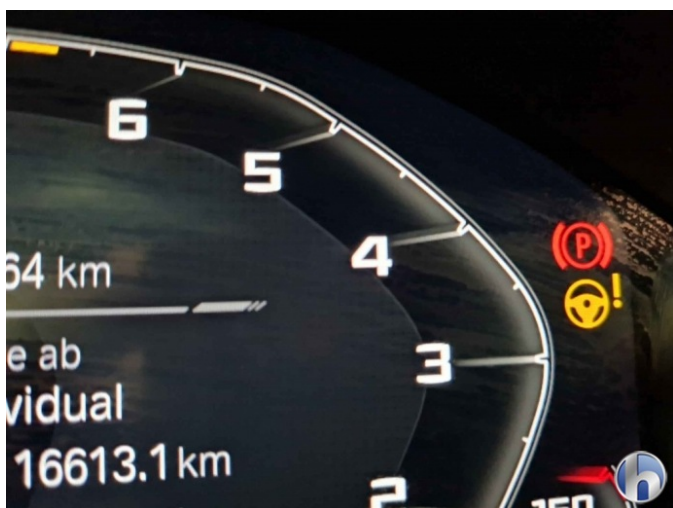
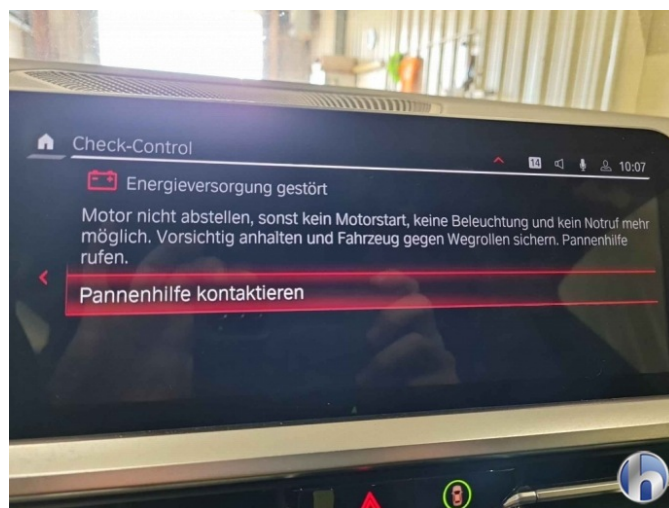
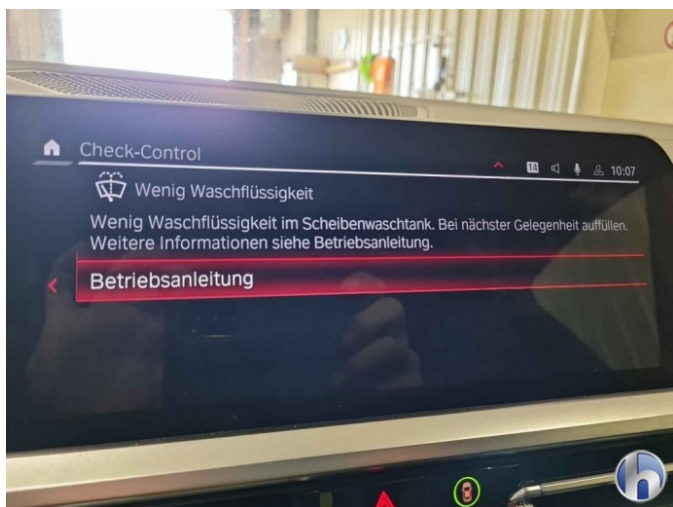
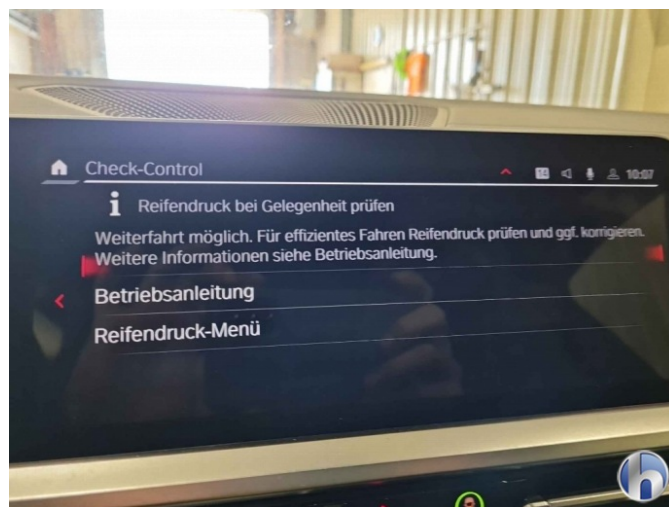
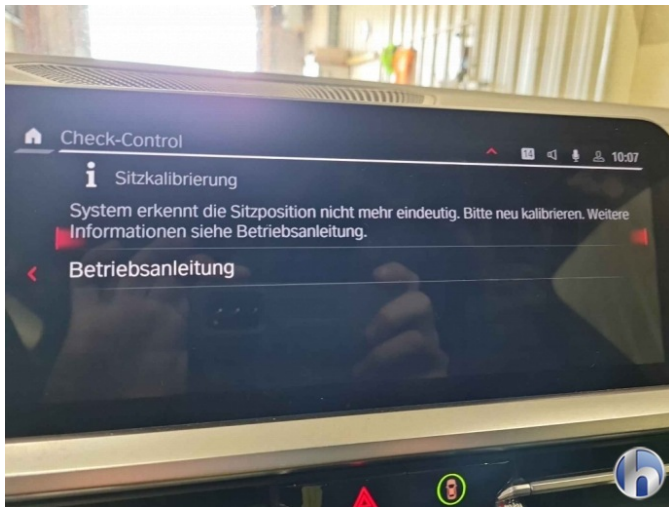
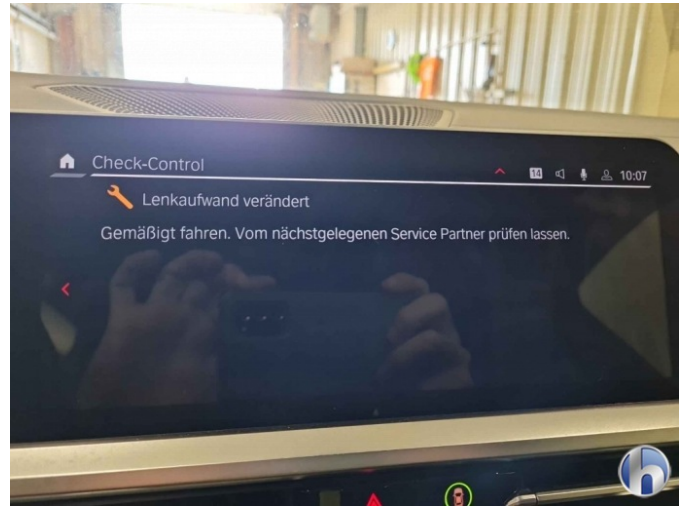
| General examination | |
|---|---|
| <b>Note Road Safe:</b> | Frontscheibe Steinschlag, diverse Fehlermeldungen |

| component | Damage | Rep kind |
|---|---|---|
| 3. diverse Fehlermeldungen (Lenkung, Energieversorgung, Sitz, Reifen, Wischwasser...) | Error message | Carry out a fault diagnosis |

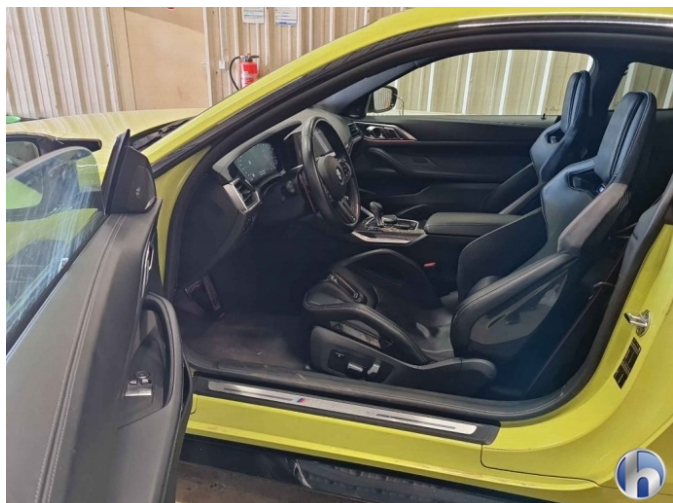
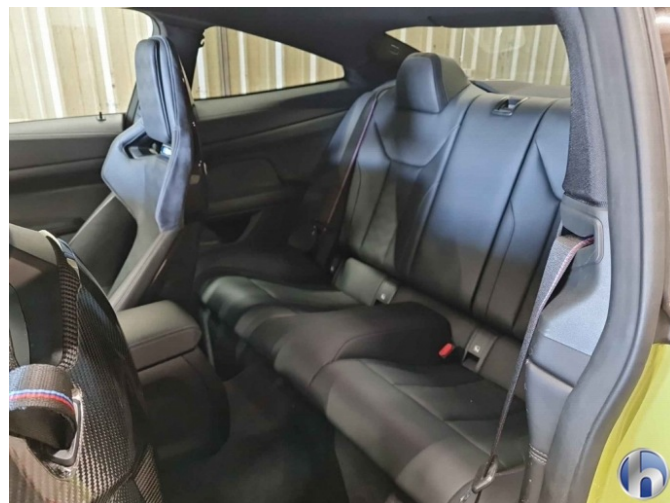
| Performed testing technology | |
|---|---|
| <b>reference:</b> | *Das Fahrzeug hat starke Alters- und Gebrauchsspuren |

| component | Damage | Rep kind |
|---|---|---|
| 5. Kofferraum und Innenraum | Wear and tear | acceptable |

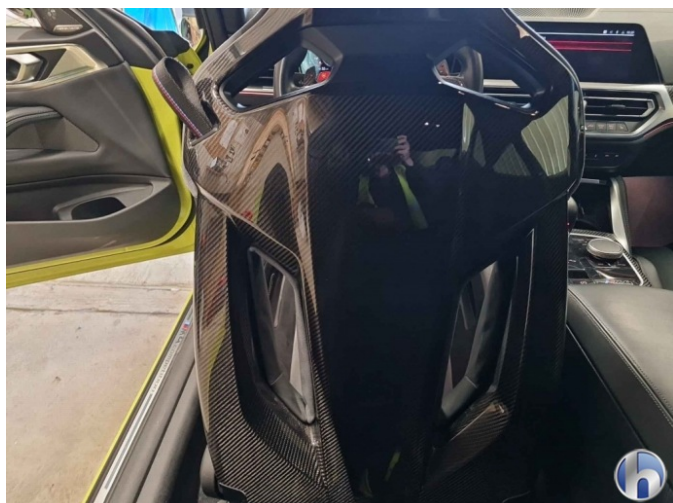
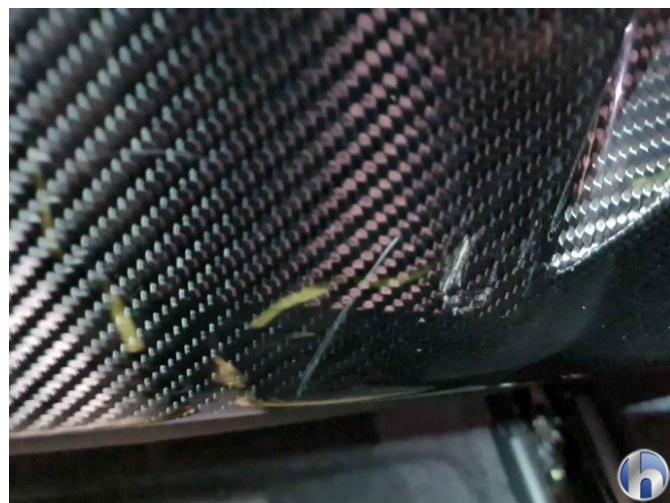
| component | Damage | Rep kind |
|---|---|---|
| 6. Sitz - Vorne - Links: Lehnverkleidung | Scrape | Replace |

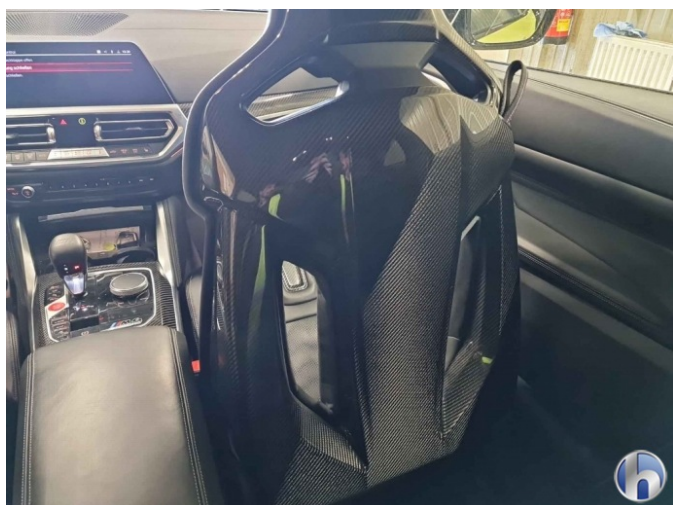
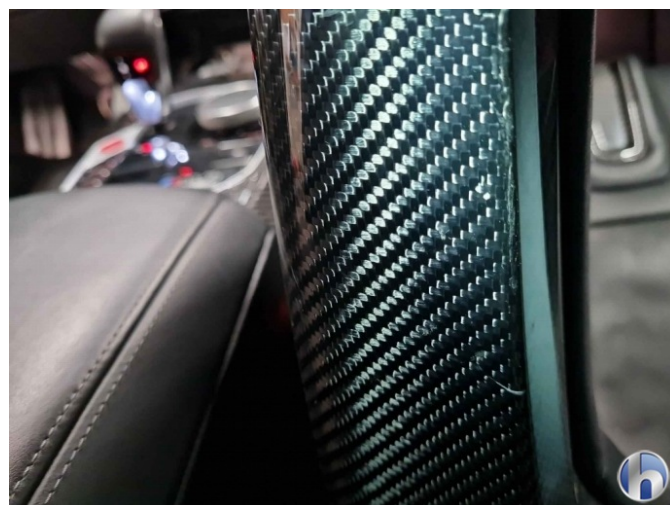
| component | Damage | Rep kind |
|---|---|---|
| 7. Sitz - Vorne - Rechts: Lehnverkleidung | Scrape | Replace |

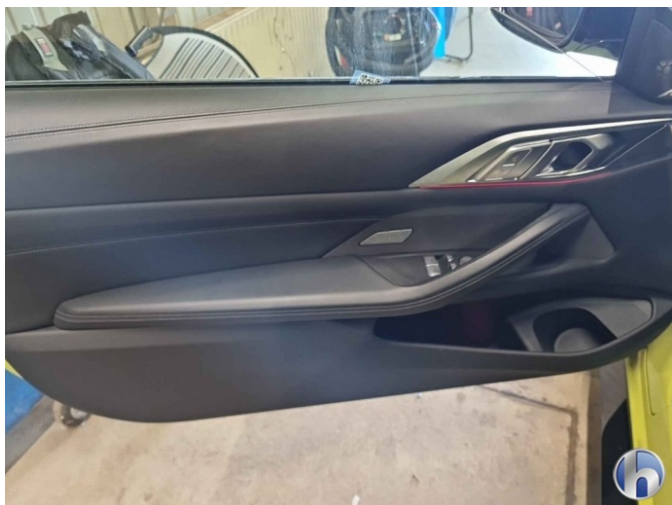
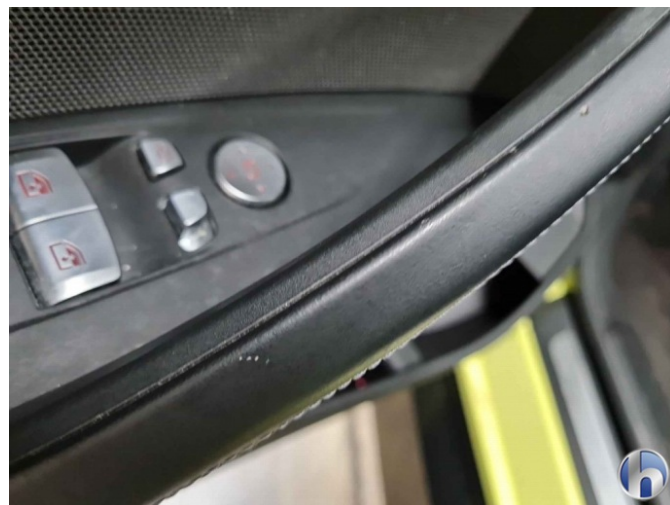
| component | Damage | Rep kind |
|---|---|---|
| 8. Türverkleidung Vorne - Links | Scrape | Smart repair |

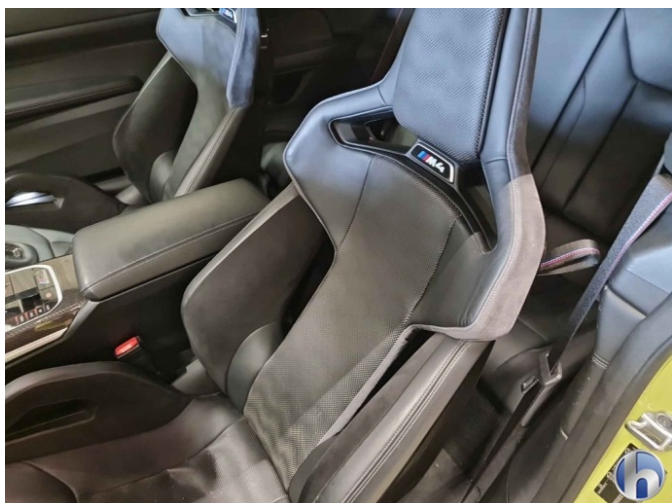
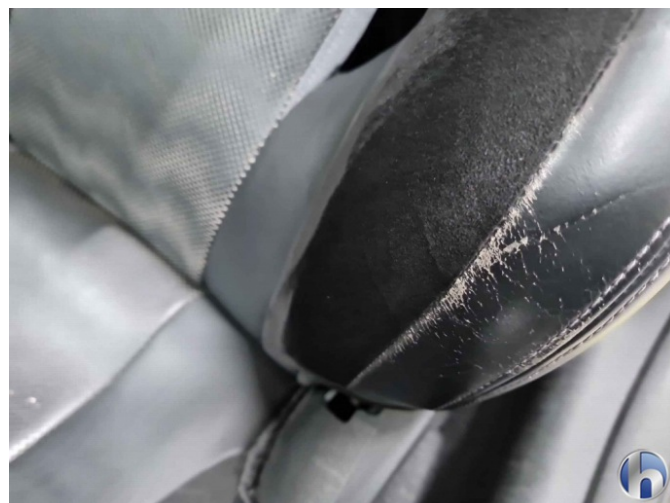
| component | Damage | Rep kind |
|---|---|---|
| 9. | Scrape | Smart repair |

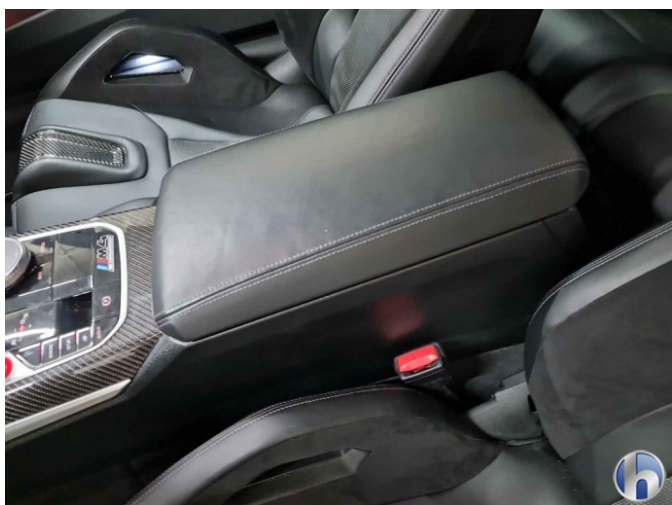
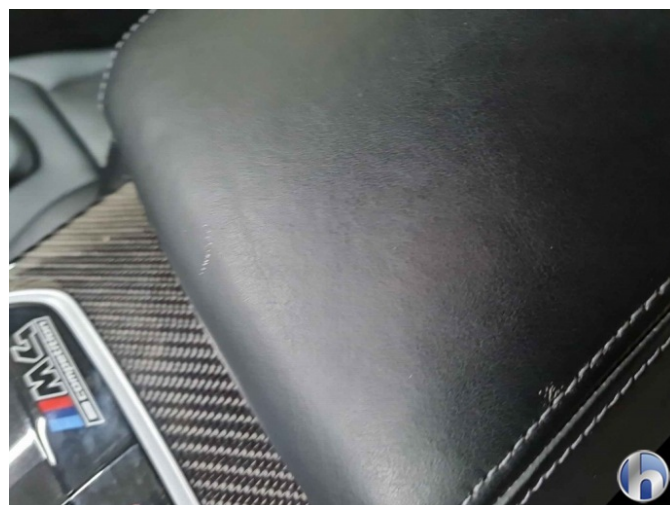
| component | Damage | Rep kind |
|---|---|---|
| 10. center console - flap | Scrape | Smart repair |

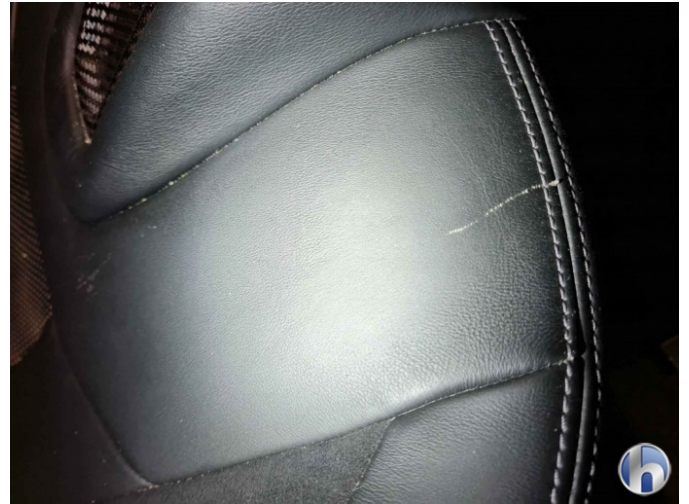
| component | Damage | Rep kind |
|---|---|---|
| 11. | Scrape | Smart repair |

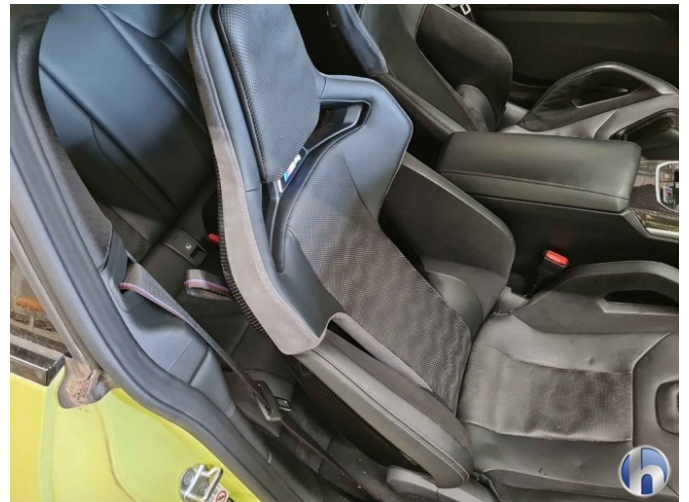
| component | Damage | Rep kind |
|---|---|---|
| 12. | Scrape | Smart repair |

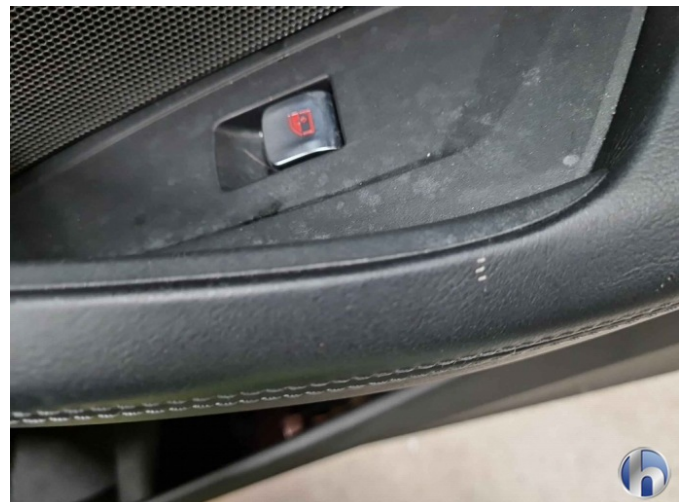
| component | Damage | Rep kind |
|---|---|---|
| 13. Door trim Front - right | Scrape | Smart repair |

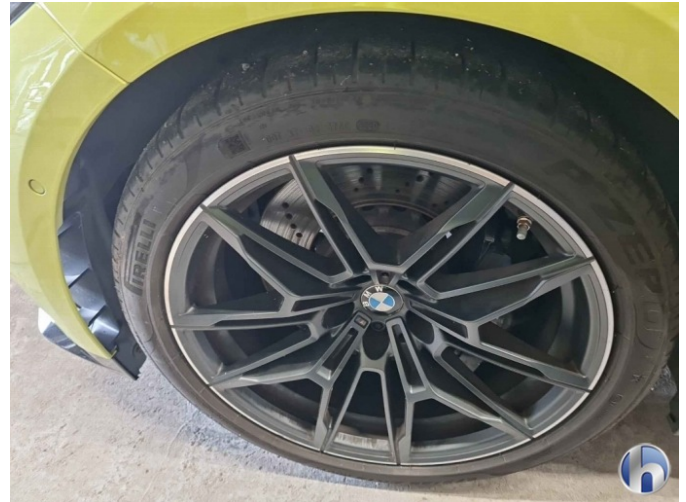
| component | Damage | Rep kind |
|---|---|---|
| 14. | Damaged | Replace |

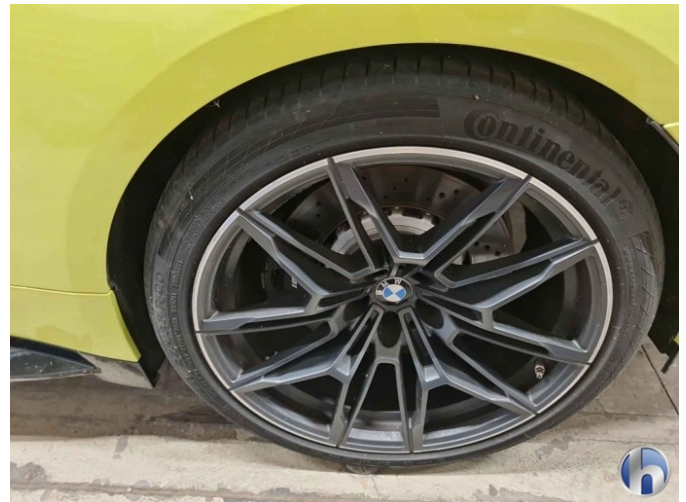
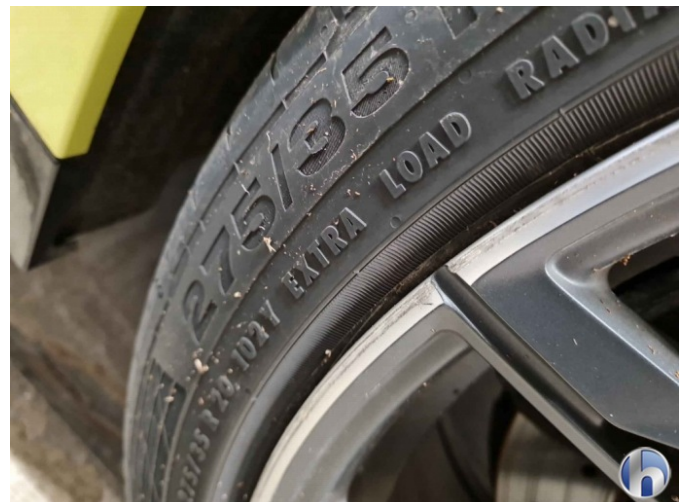
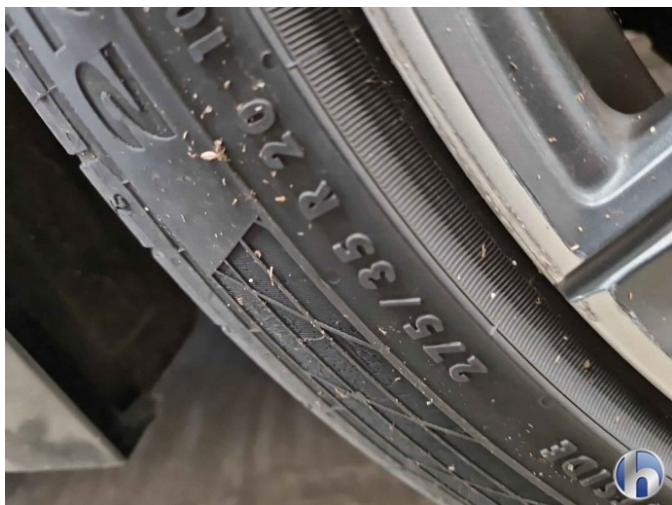
| component | Damage | Rep kind |
|---|---|---|
| 15. | Damaged | Replace |

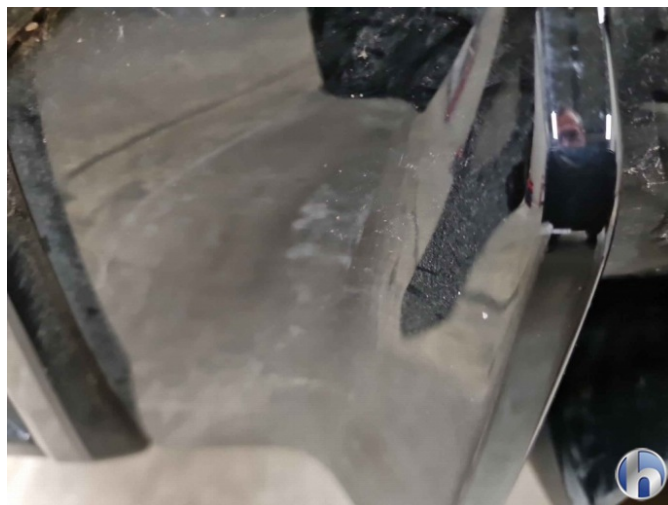
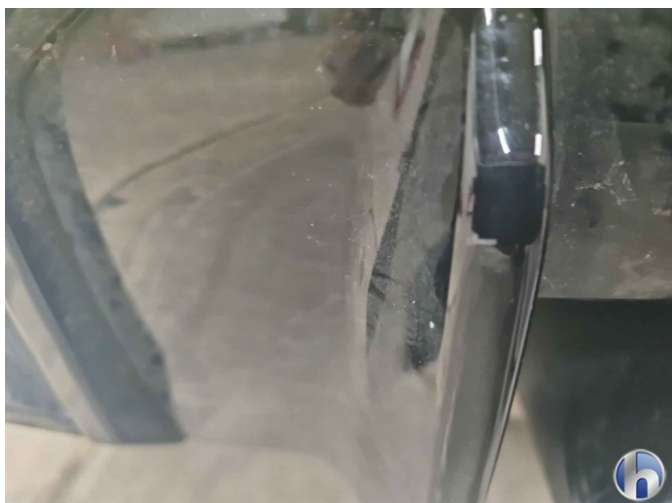
| component | Damage | Rep kind |
|---|---|---|
| 16. | Scrape | Smart repair |

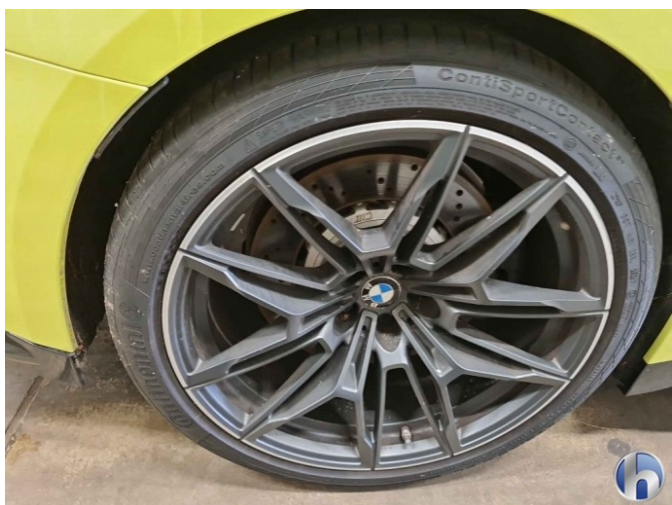
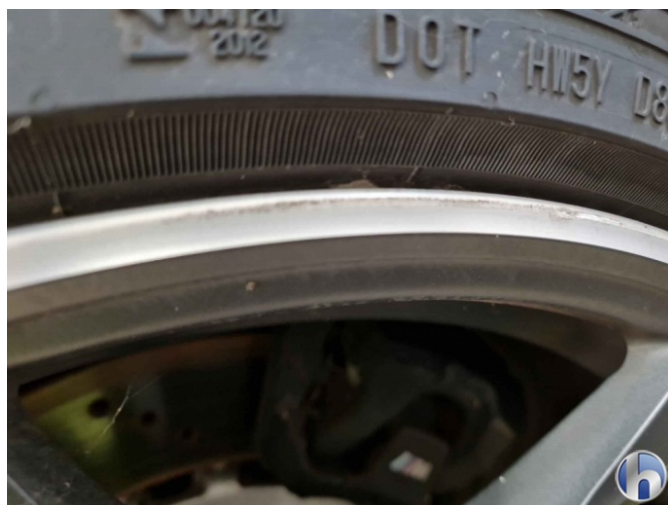
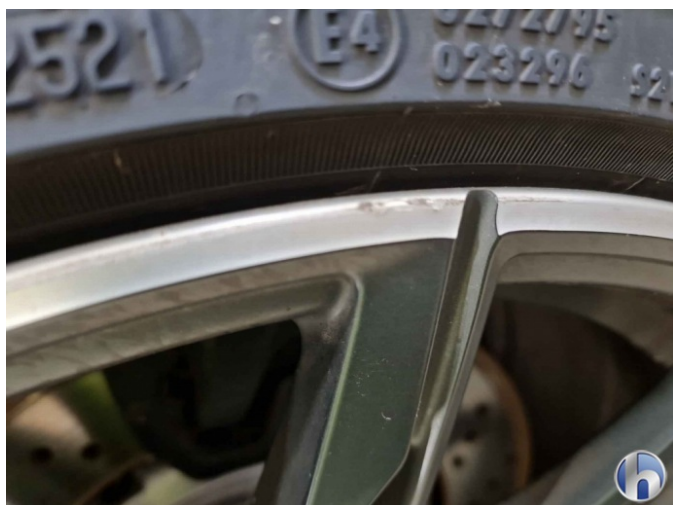
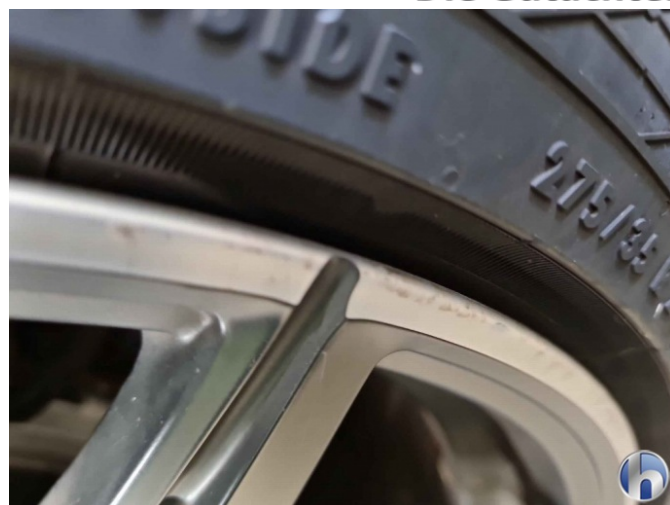
| component | Damage | Rep kind |
|---|---|---|
| 17. | Damaged | Replace |

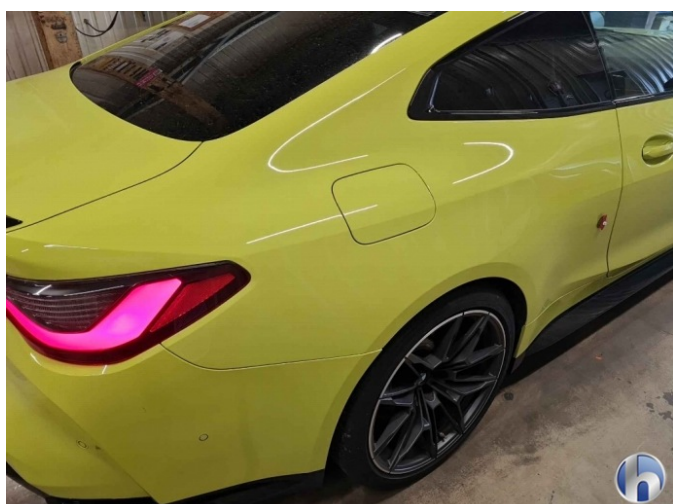
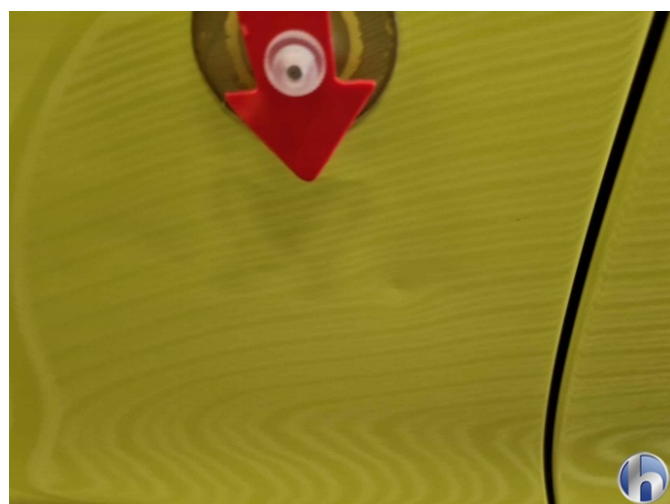
| component | Damage | Rep kind |
|---|---|---|
| 18. Sidewall - Rear - right | | Smart repair |

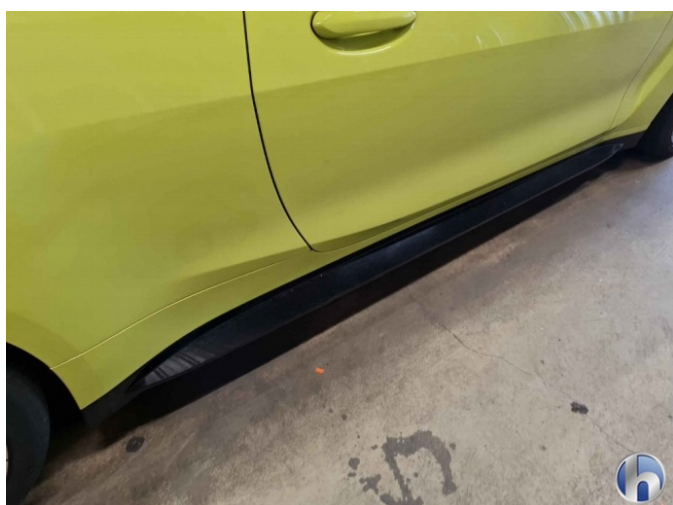
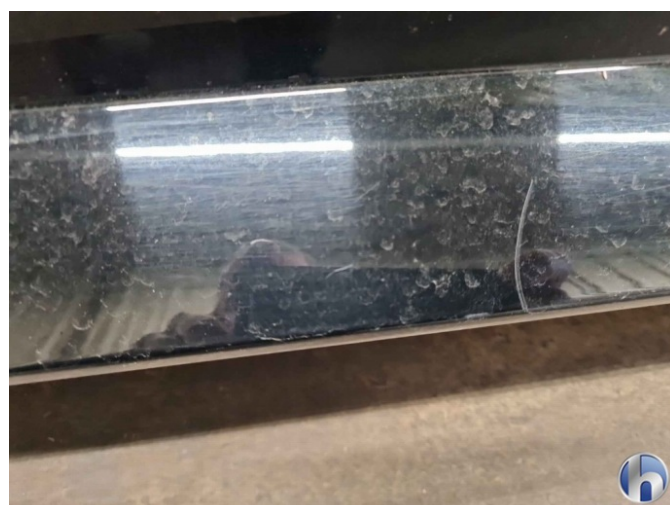
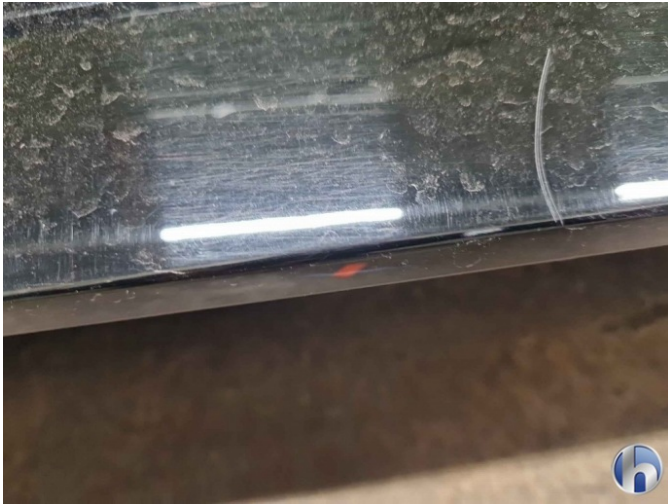
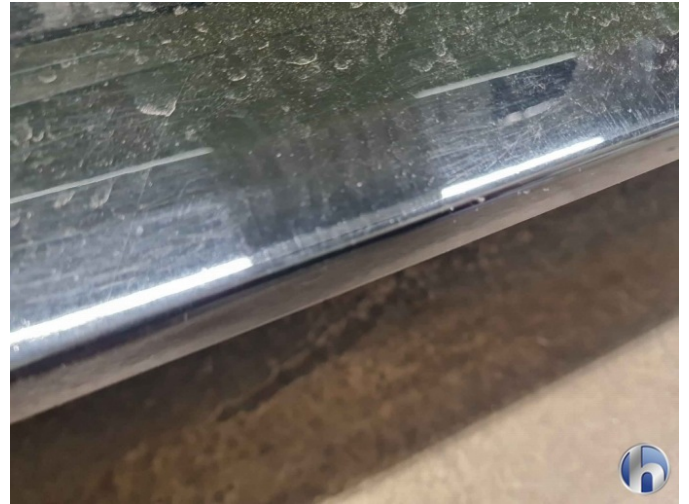
| component | Damage | Rep kind |
|---|---|---|
| 19. | Scratch(es) | Paint |

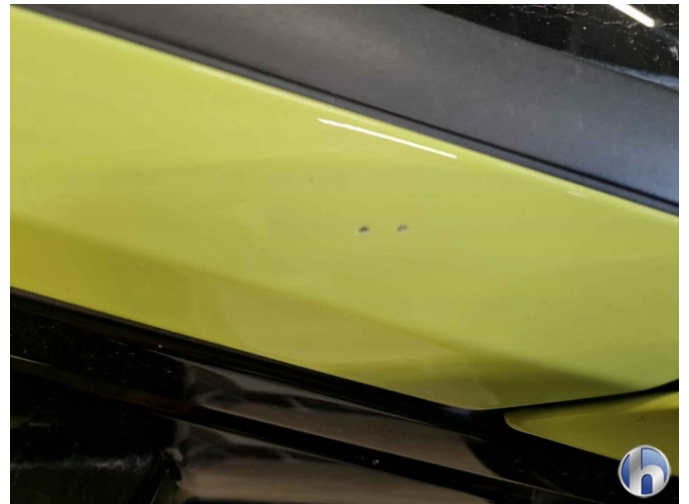
| component | Damage | Rep kind |
|---|---|---|
| 20. A-pillar Front - right | Chipping from stones | Smart repair |

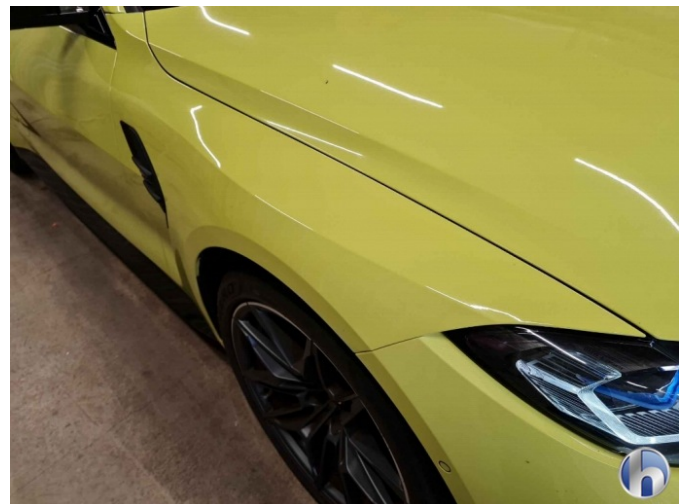
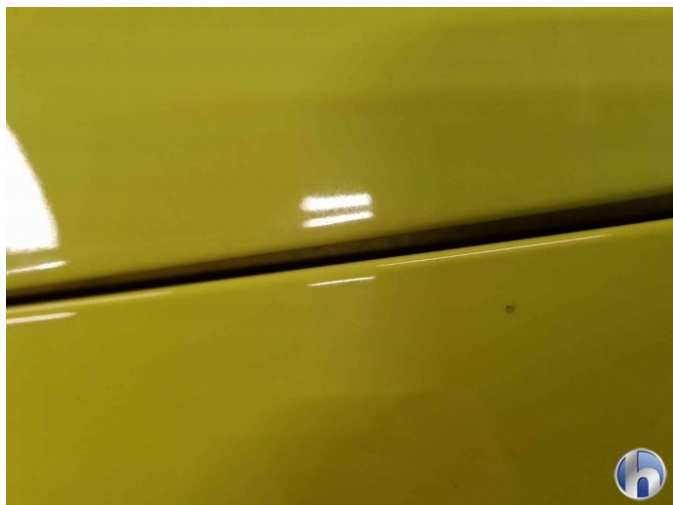
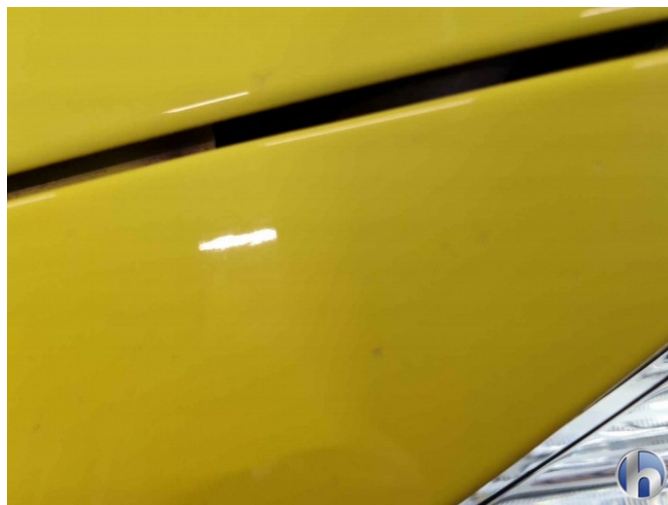
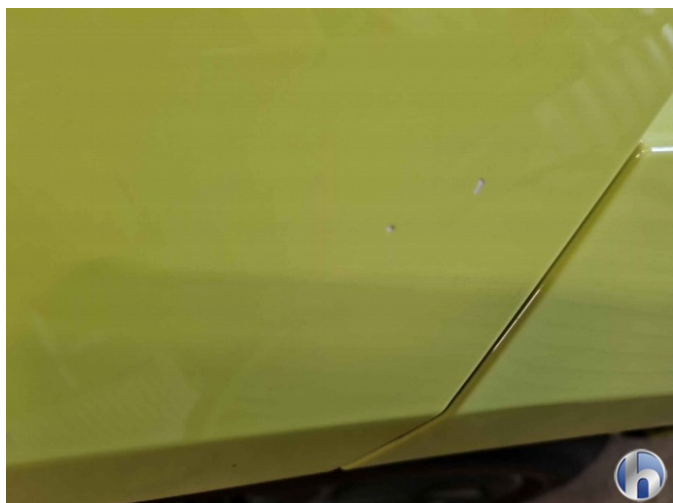
| component | Damage | Rep kind |
|---|---|---|
| 21. Front fender - right | Chipping from stones | Smart repair |

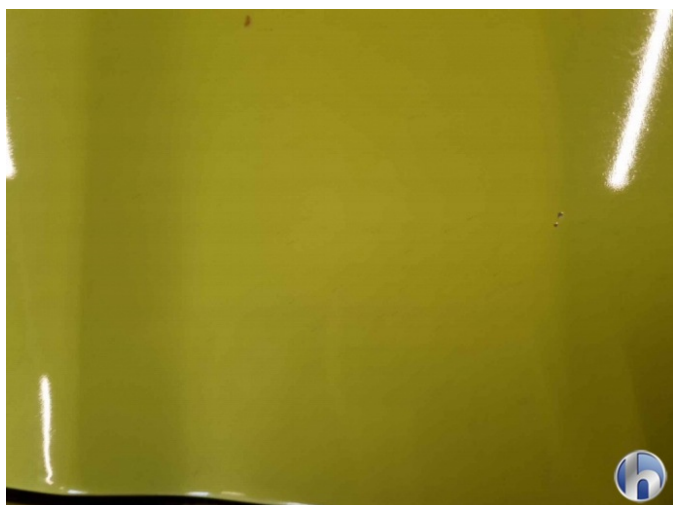
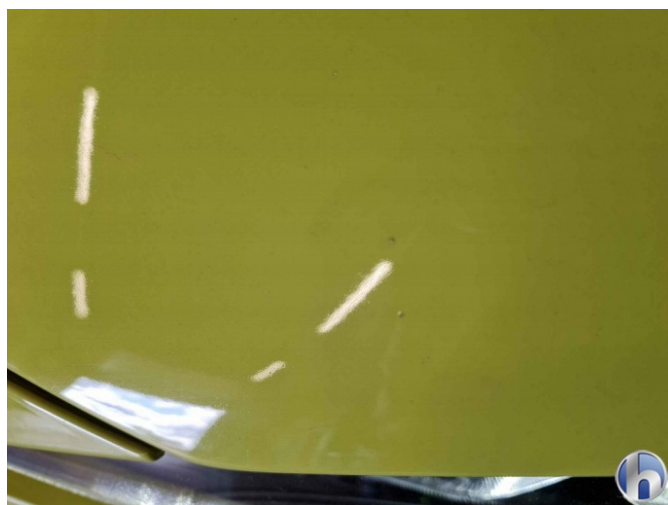
| component | Damage | Rep kind |
|---|---|---|
| 22. hood | Chipping from stones | Smart repair |

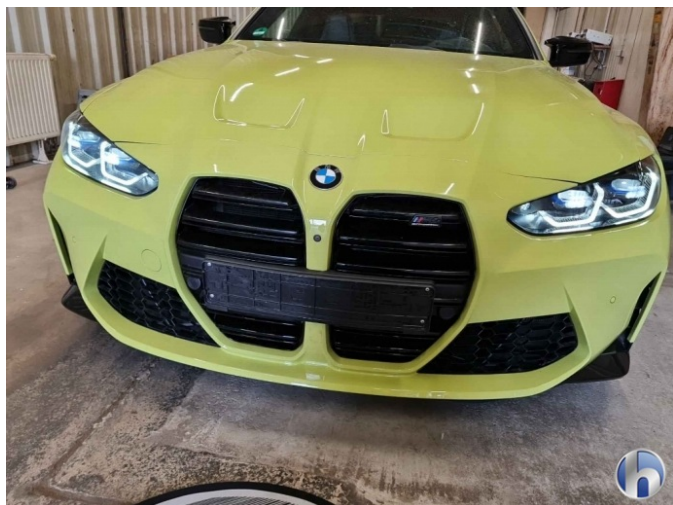
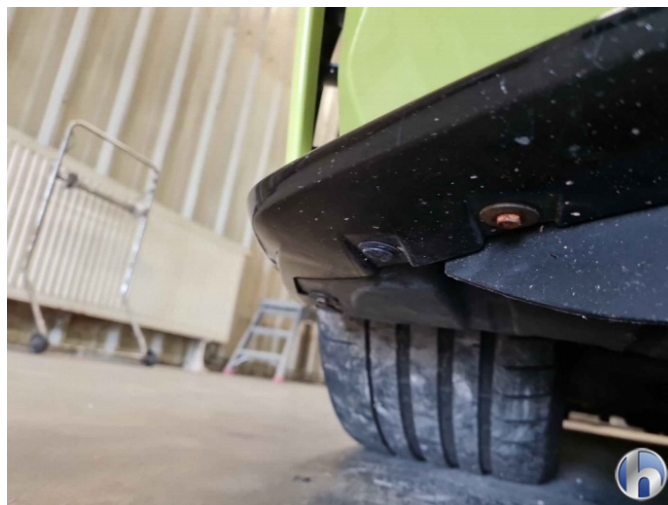
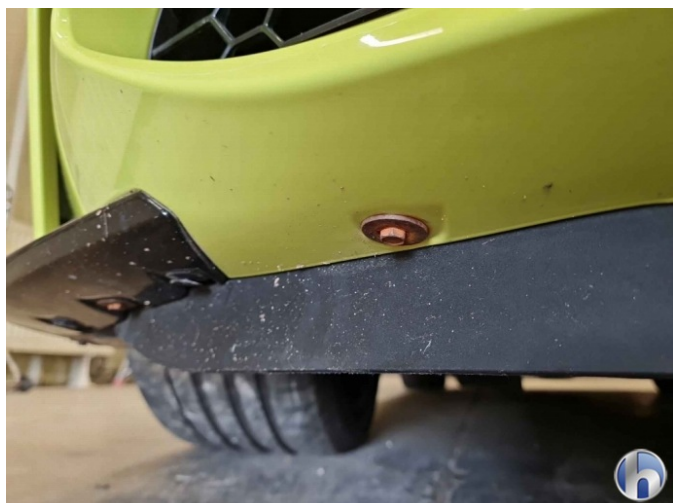
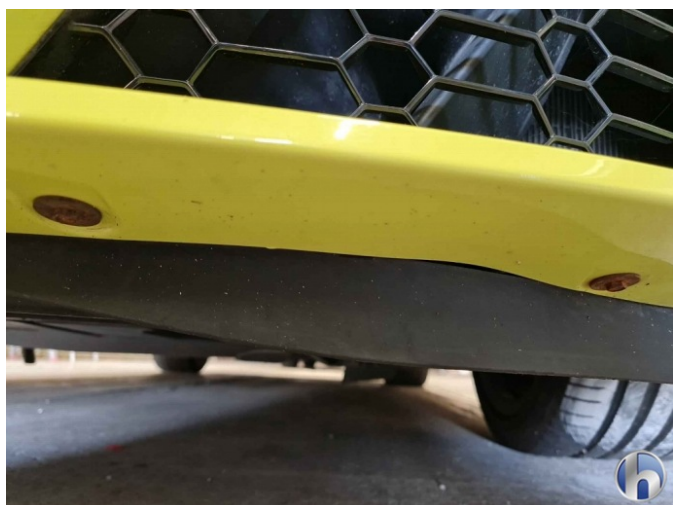
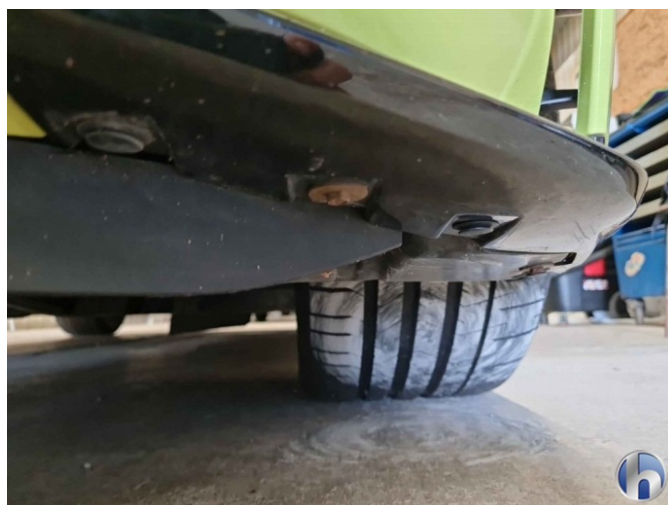
| component | Damage | Rep kind |
|---|---|---|
| 23. Stoßfänger Vorne: Schrauben | Rust | Replace |

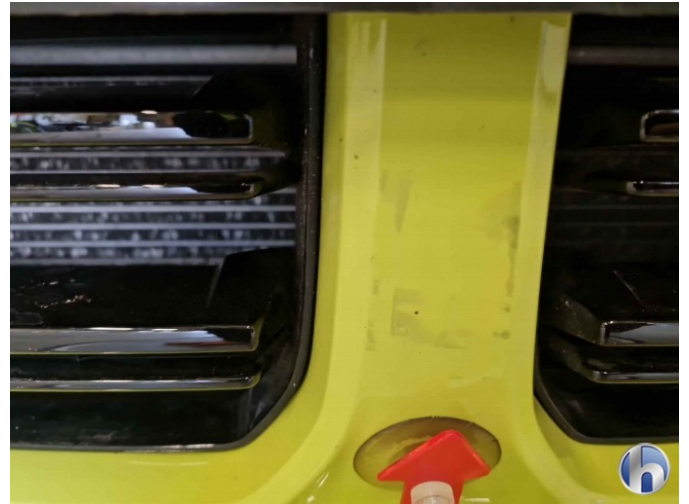
| component | Damage | Rep kind |
|---|---|---|
| 24. Front bumper | Scrape | Smart repair |

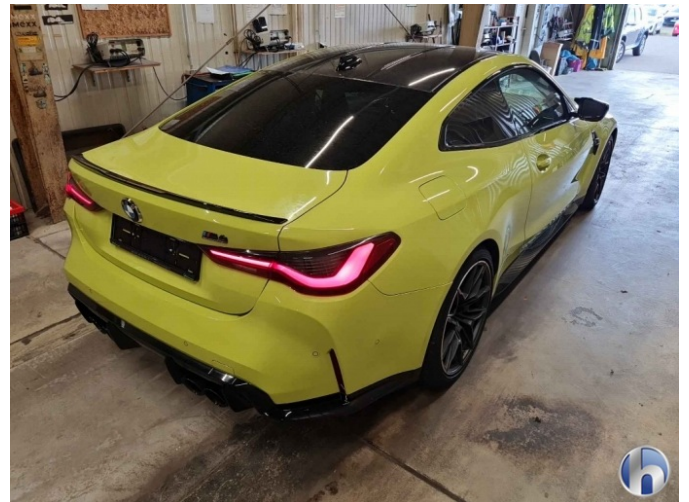
| component | Damage | Rep kind |
|---|---|---|
| 25. Fahrzeug (Kratzer, Harz-/Säureeinwirkung, Verschmutzungen) | Not okay | |

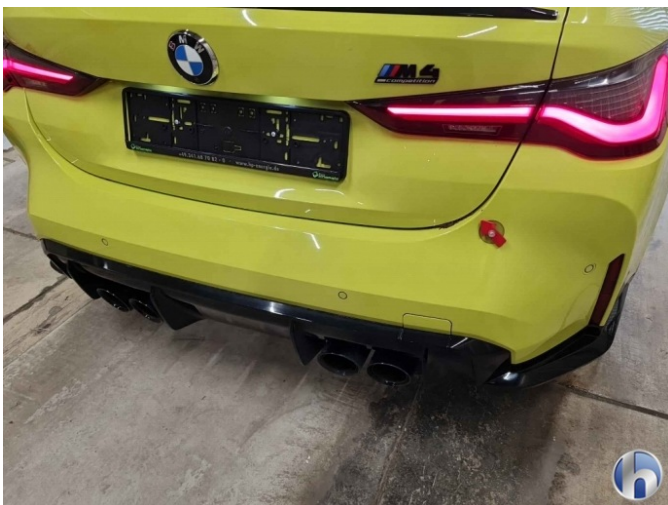
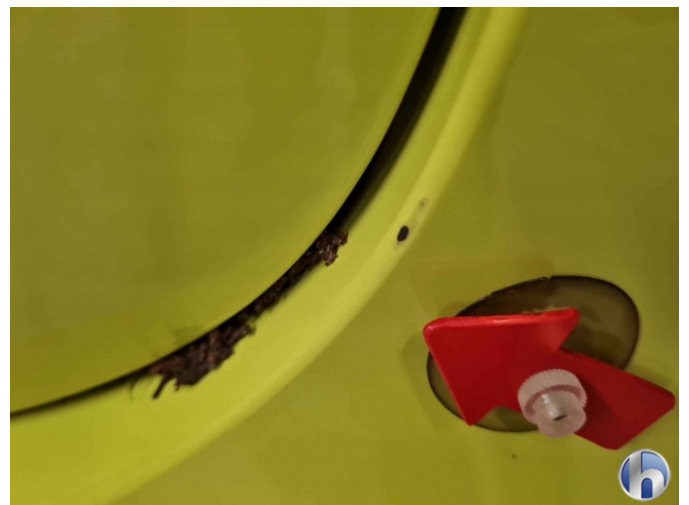
| component | Damage | Rep kind |
|---|---|---|
| 26. Rear bumper | Scrape | Smart repair |

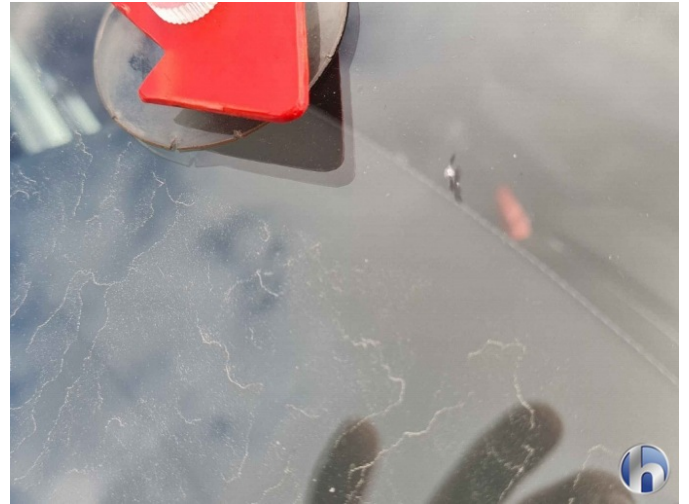
| component | Damage | Rep kind |
|---|---|---|
| 27. Windshield | Chipping from stones in field of view | Replace |
