## status report

#### Mercedes-Benz C -Klasse Lim. C 220 CDI

| Vehicle identification number | <b>WDB2030081A861170</b> | mileage read: | <b>161428 km</b> |

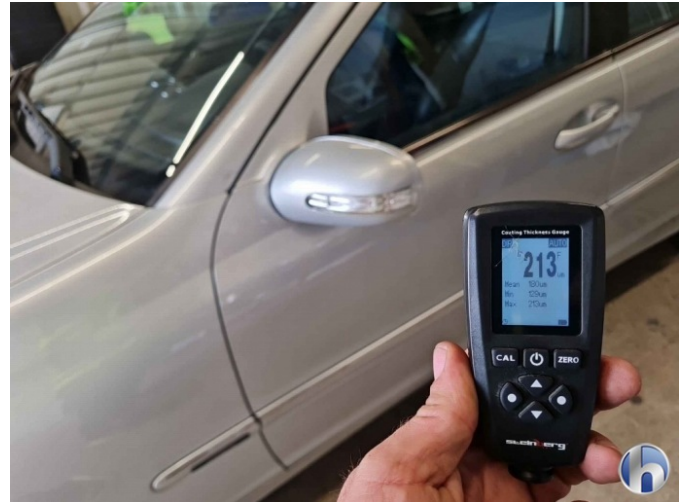
| component | Damage | Rep kind |
|---|---|---|
| 2. Front door - left | Subsequently painted | acceptable |

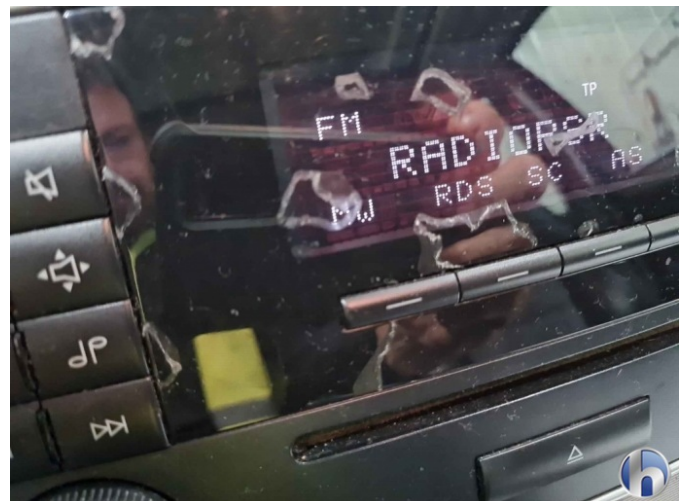
| component | Damage | Rep kind |
|---|---|---|
| 3. Radio: Display | Not okay | Replace |

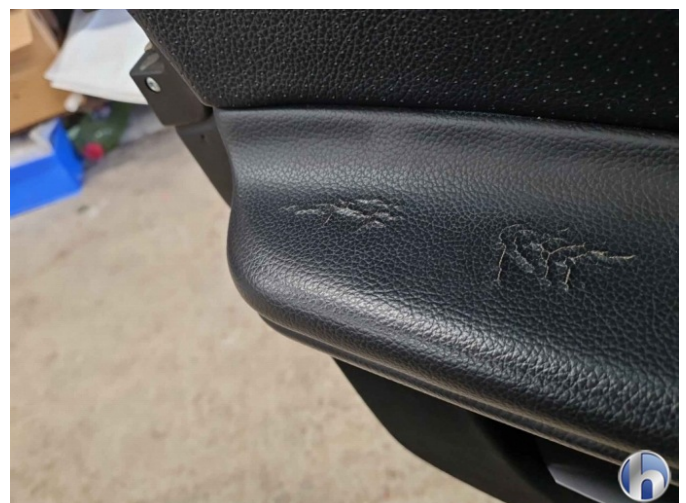
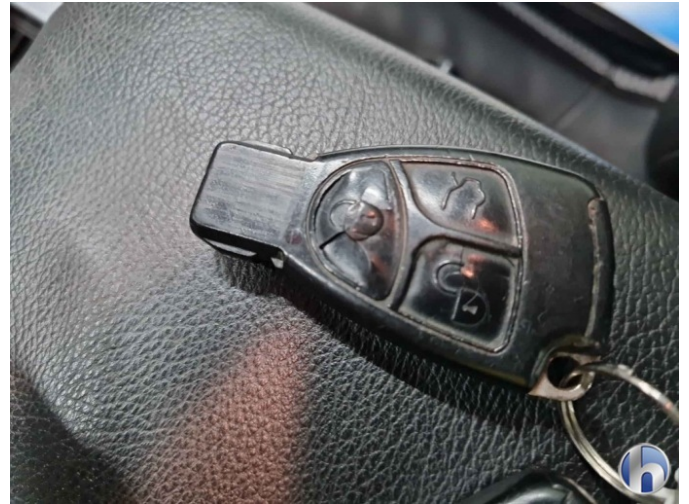
| component | Damage | Rep kind |
|---|---|---|
| 4. Front door trim - left | Damaged | Replace |

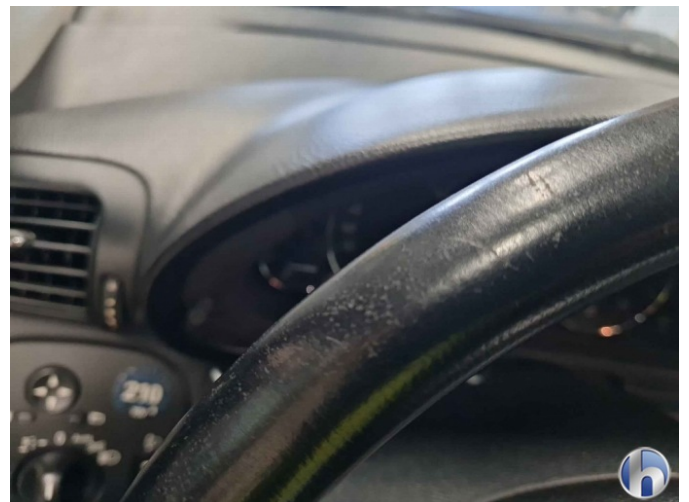
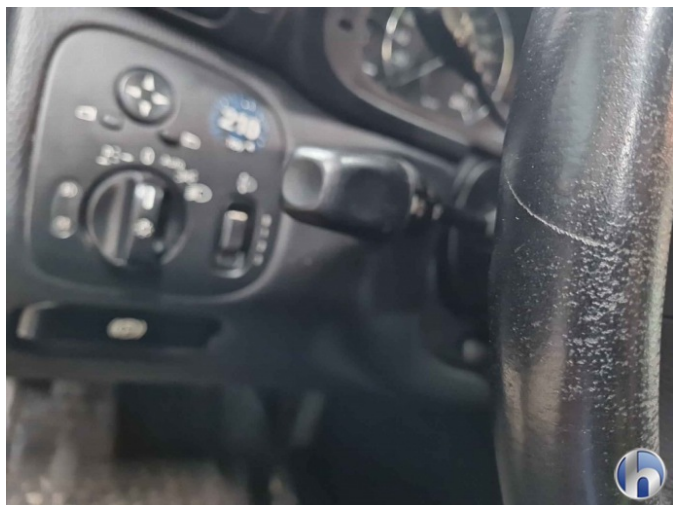
| component | Damage | Rep kind |
|---|---|---|
| 6. steering wheel | Material wear | Replace |

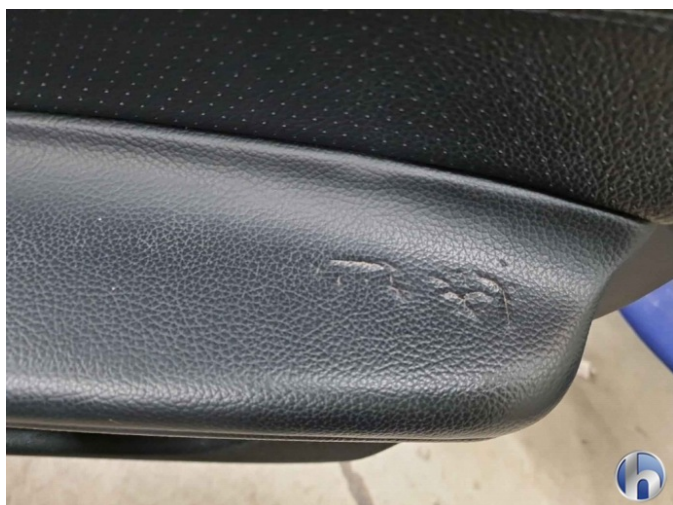
| component | Damage | Rep kind |
|---|---|---|
| 7. Door trim Front - right | Damaged | Replace |

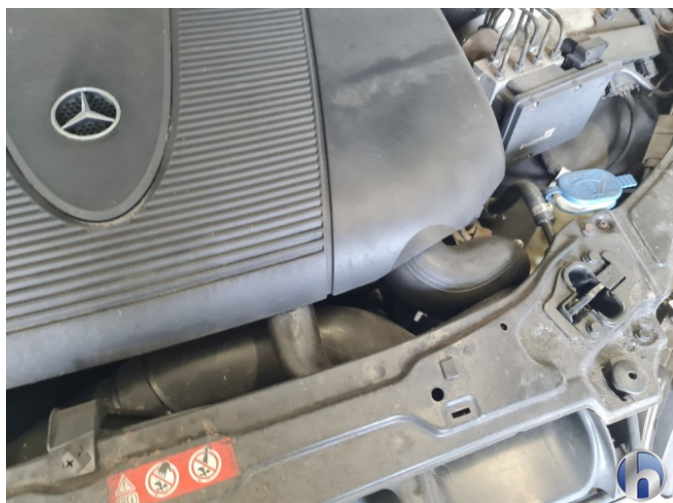
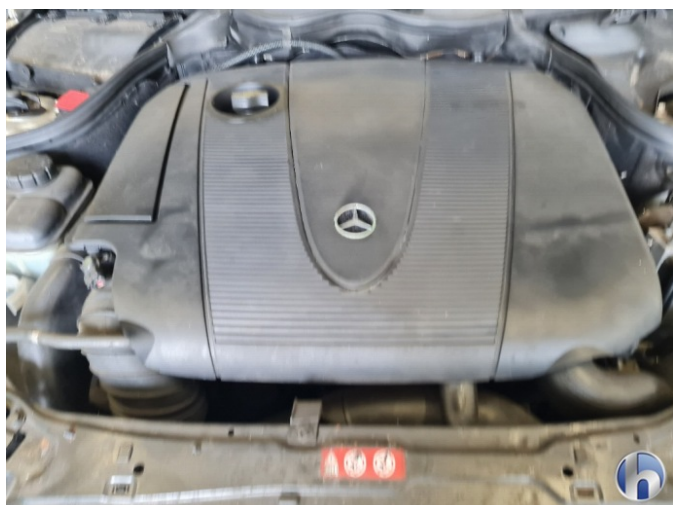
| component | Damage | Rep kind |
|---|---|---|
| 10. Schlauch | Damaged | Replace |

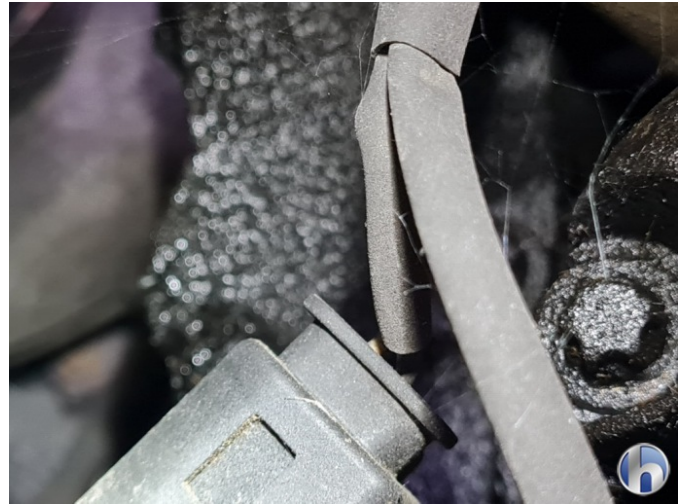
| Performed testing technology | |
|---|---|
| <b>oil loss:</b> | The vehicle was inspected during the visit to an oil leak .<br>**motor. |

| component | Damage | Rep kind |
|---|---|---|
| 11. Motor | oil loss | Carry out a fault diagnosis |

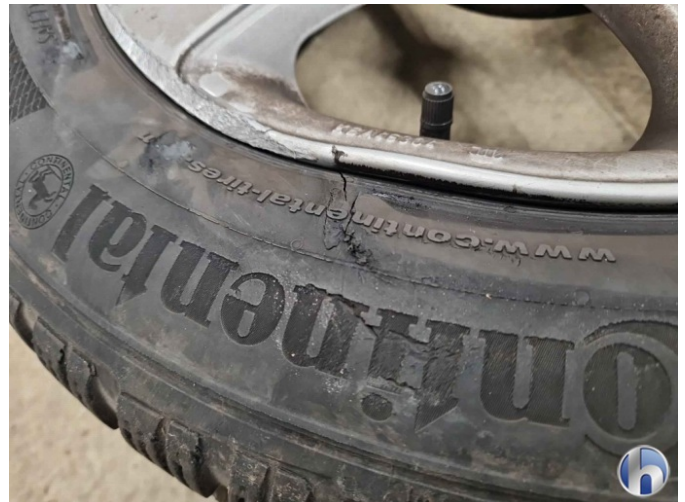
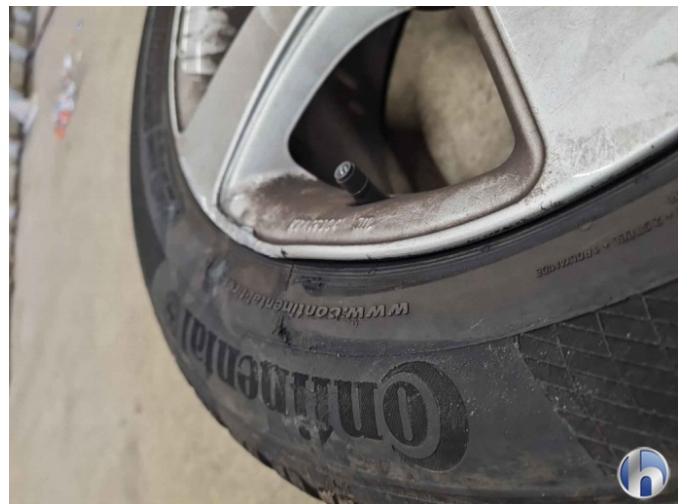
| component | Damage | Rep kind |
|---|---|---|
| 12. Winterrad (Aluminium - nicht montiert) | Damaged | Replace |

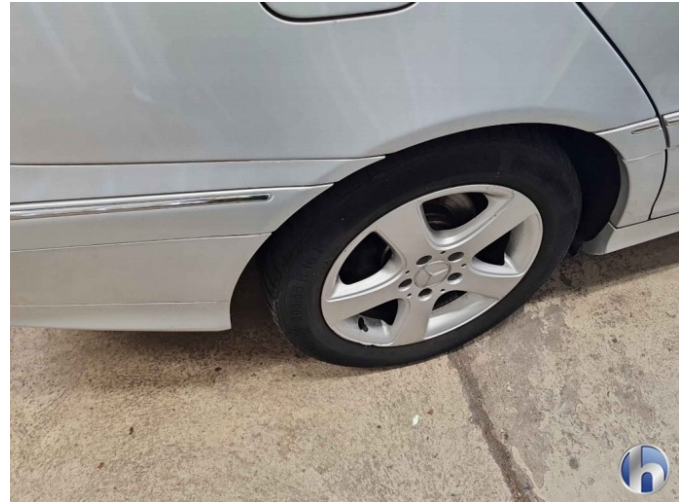
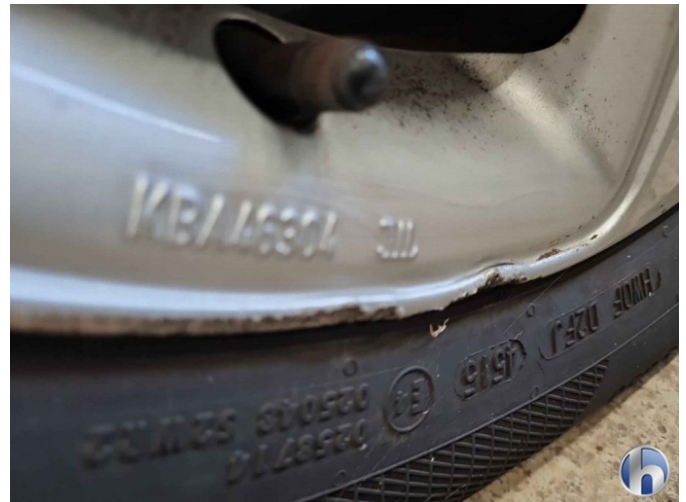
| component | Damage | Rep kind |
|---|---|---|
| 13. Komplettrad (Aluminium) hinten rechts | Damaged | Replace |

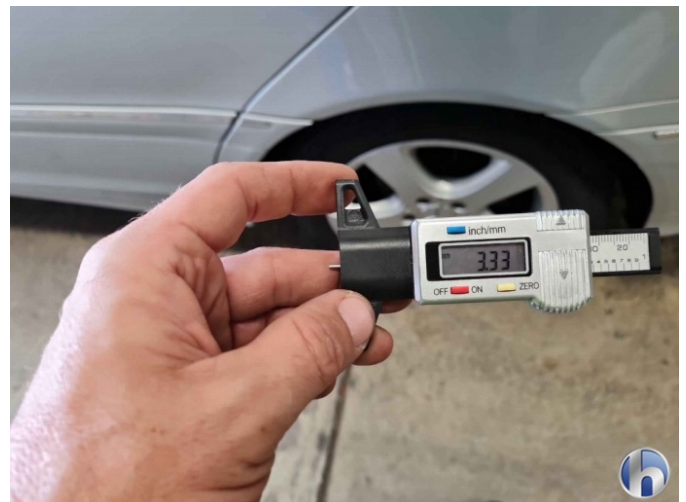
| component | Damage | Rep kind |
|---|---|---|
| 14. tire rear - left | Worn | Replace |

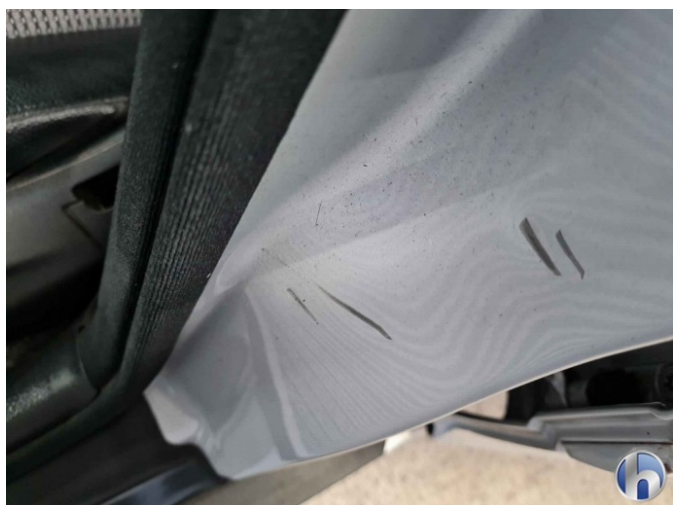
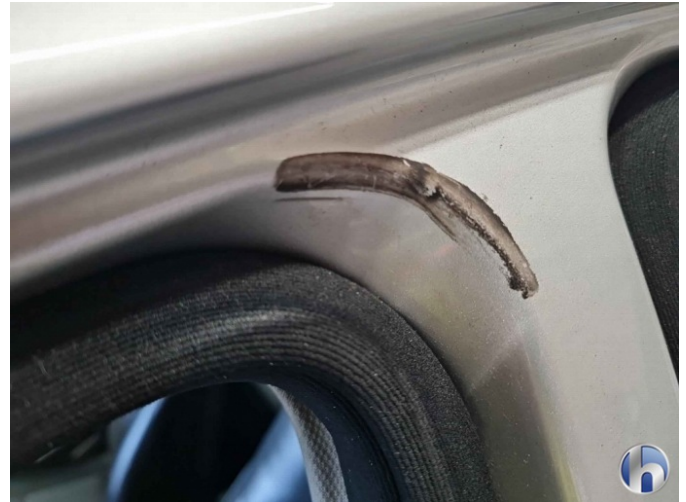
| component | Damage | Rep kind |
|---|---|---|
| 17. Türeinstieg Vorne - Links | Damaged | Refurbish and paint |

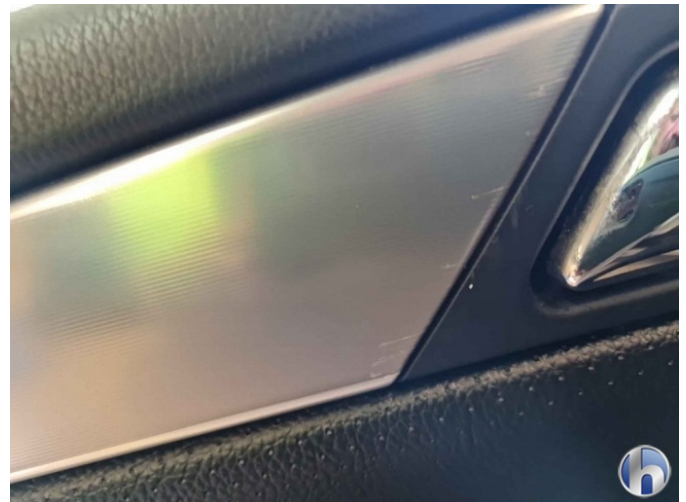
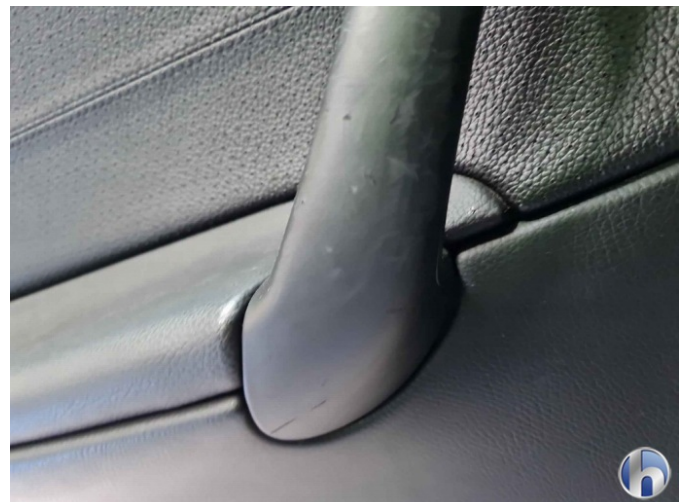
| component | Damage | Rep kind |
|---|---|---|
| 18. Rear door trim - left | Damaged | Replace |

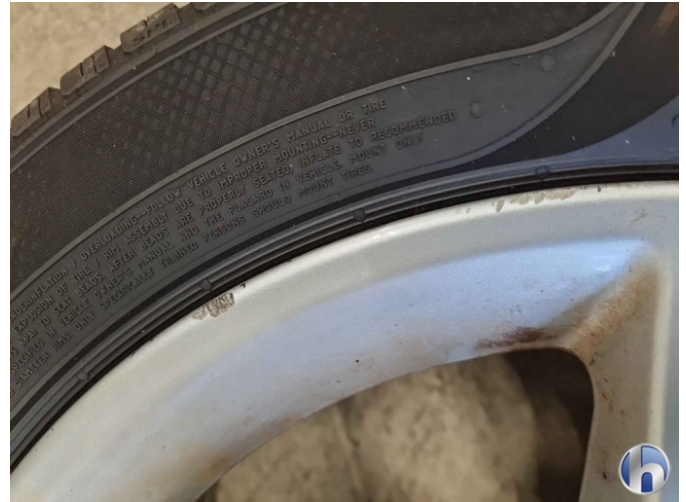
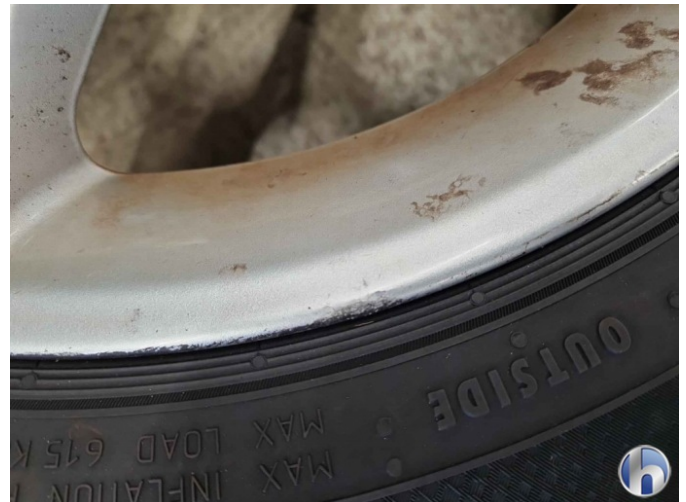
| component | Damage | Rep kind |
|---|---|---|
| 21. Felge (Aluminium) nicht montiert | Scrape | Paint |

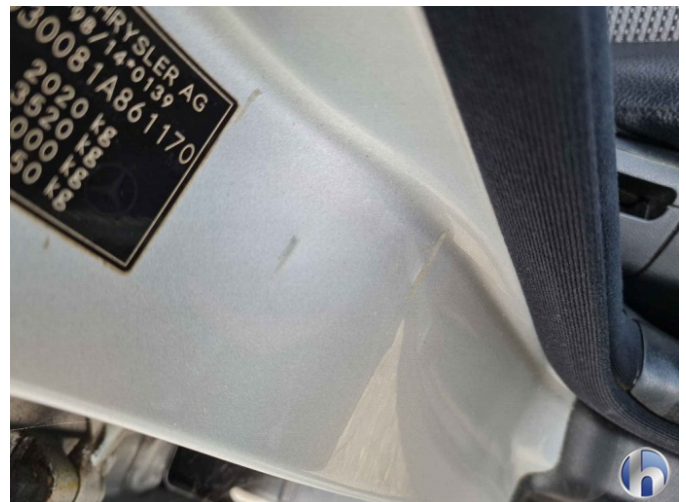
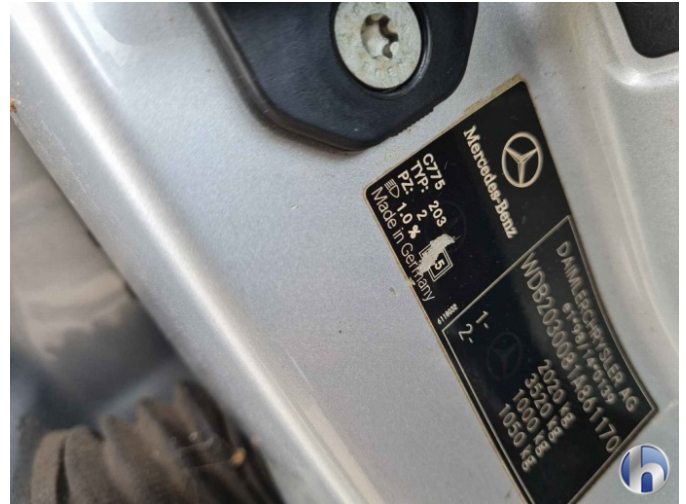
| component | Damage | Rep kind |
|---|---|---|
| 23. Türeinstieg Vorne - Rechts | Damaged | Refurbish and paint |

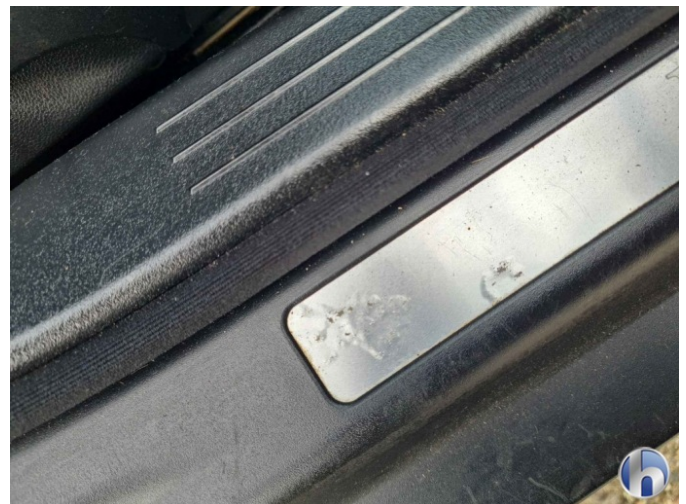
| component | Damage | Rep kind |
|---|---|---|
| 25. front door sill panel - right | Damaged | Replace |

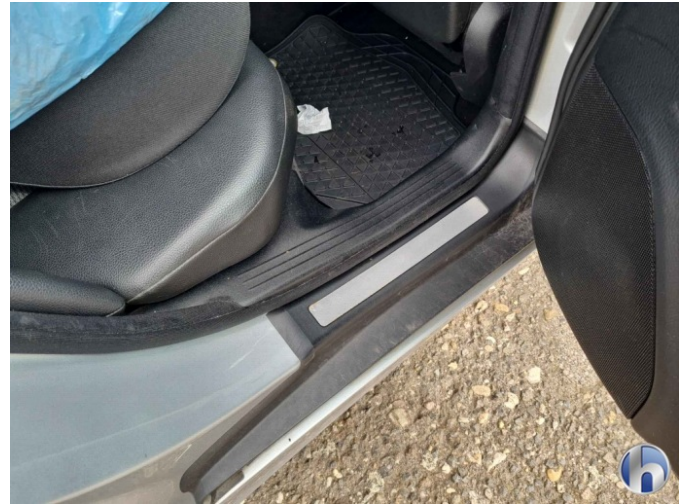
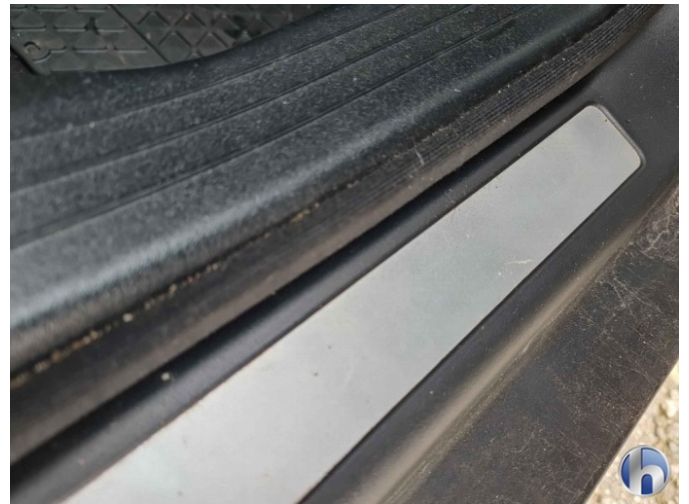
| component | Damage | Rep kind |
|---|---|---|
| 26. rear door sill panel - right | Damaged | Replace |

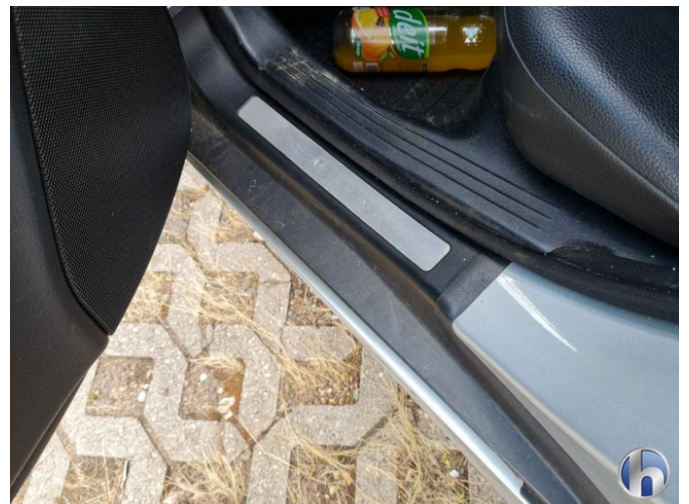
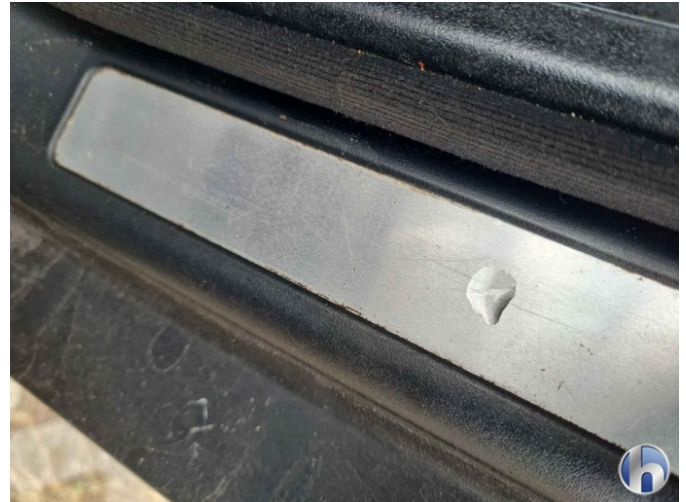
| component | Damage | Rep kind |
|---|---|---|
| 27. rear door sill panel - Left | Damaged | Replace |

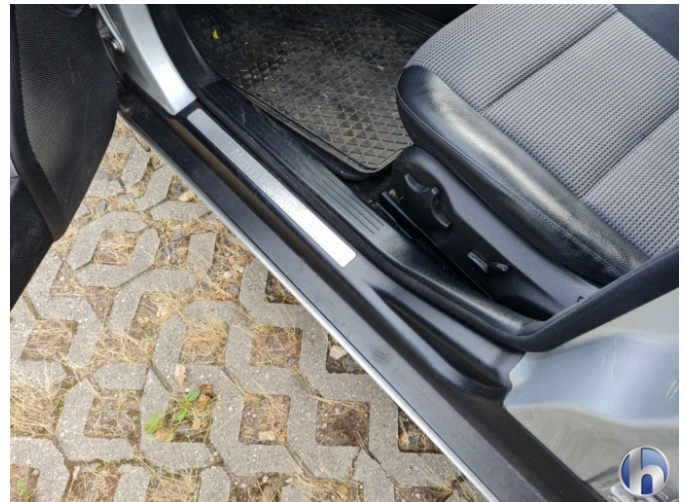
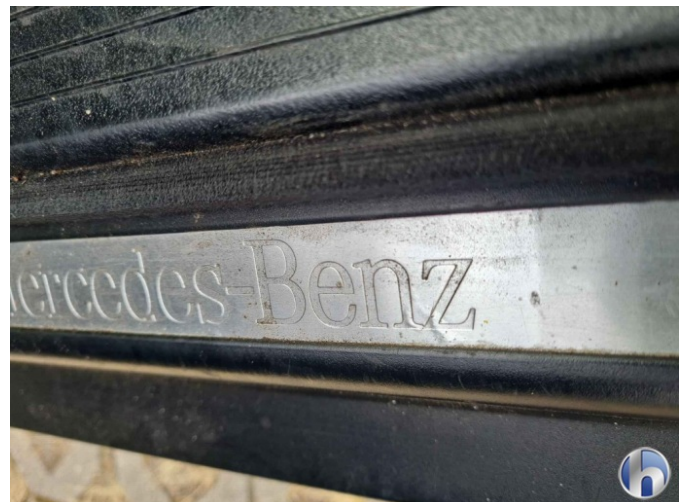
| component | Damage | Rep kind |
|---|---|---|
| 28. front door sill panel - Left | Damaged | Replace |

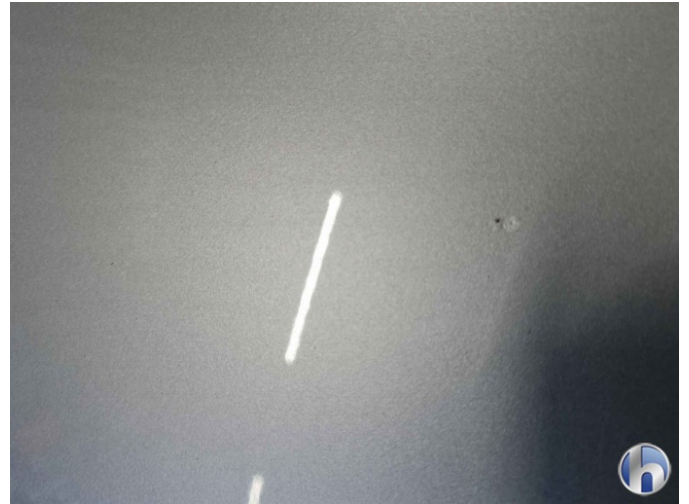
| component | Damage | Rep kind |
|---|---|---|
| 31. hood | Damaged | Refurbish and paint |

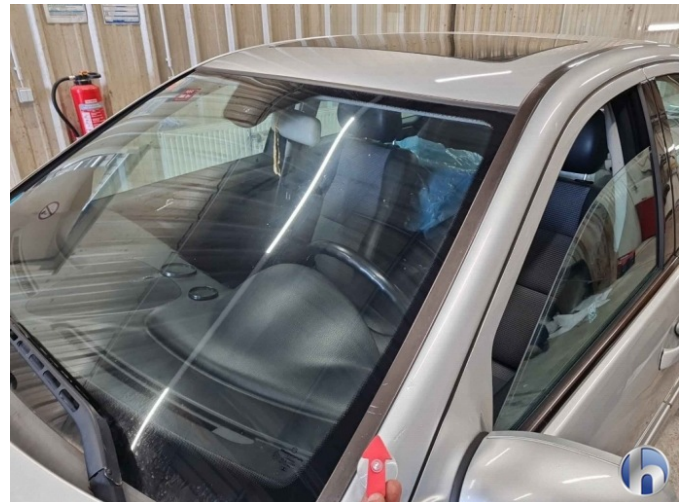
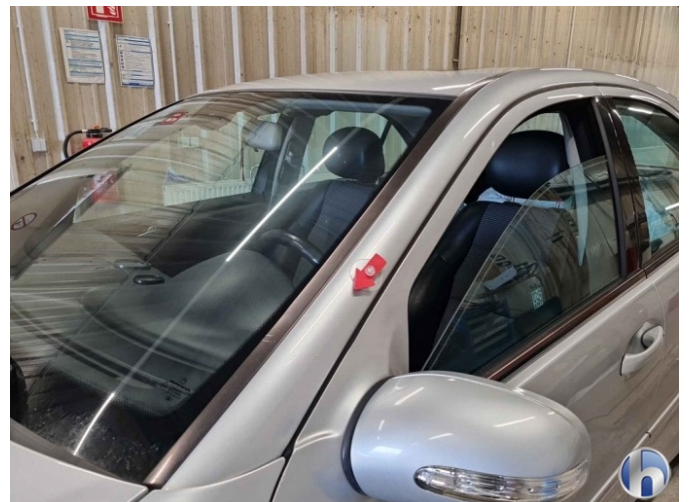
| component | Damage | Rep kind |
|---|---|---|
| 32. Frontscheibenleiste/Dachleiste links | Scrape | Replace |

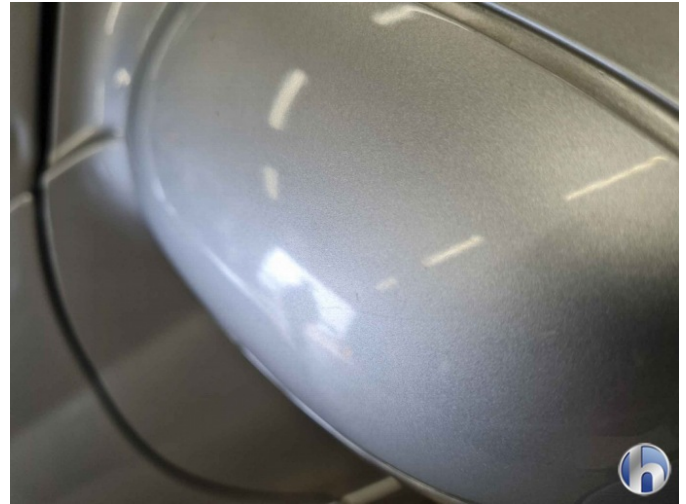
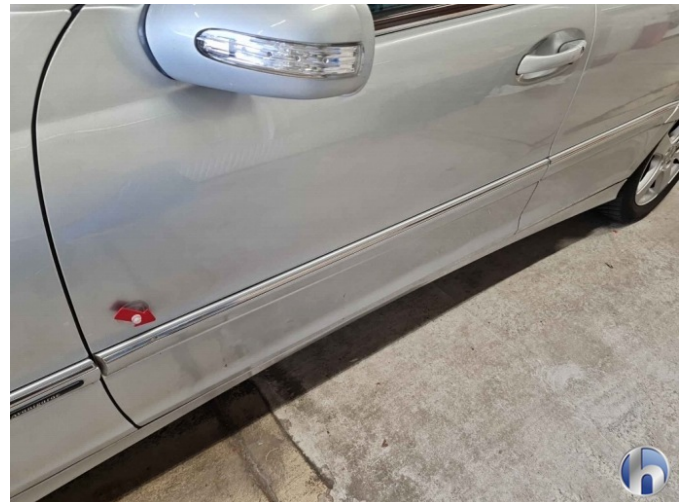
| component | Damage | Rep kind |
|---|---|---|
| 36. Outside mirror - left | Scratch(es) | Paint |

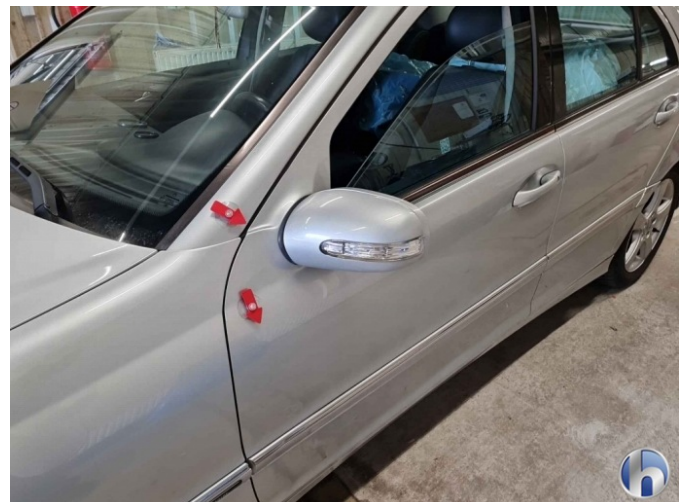
| component | Damage | Rep kind |
|---|---|---|
| 37. Tür Vorne - Links: Zierleiste | Damaged | Replace |

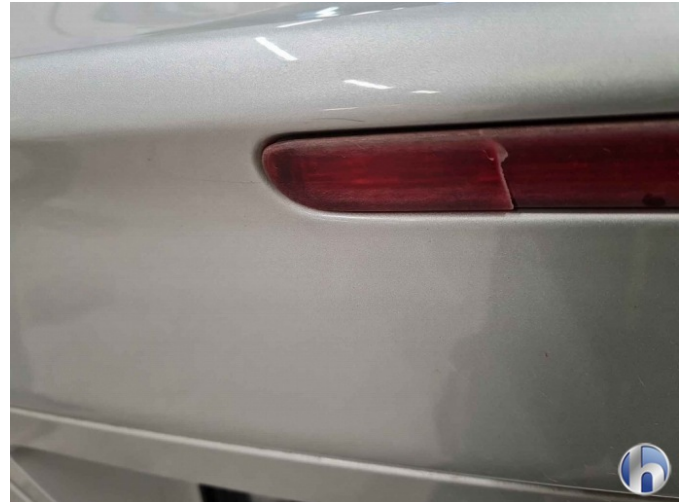
41. Zusatzbremsleuchte

| 41. | Zusatzbremsleuchte | Damaged | Replace |

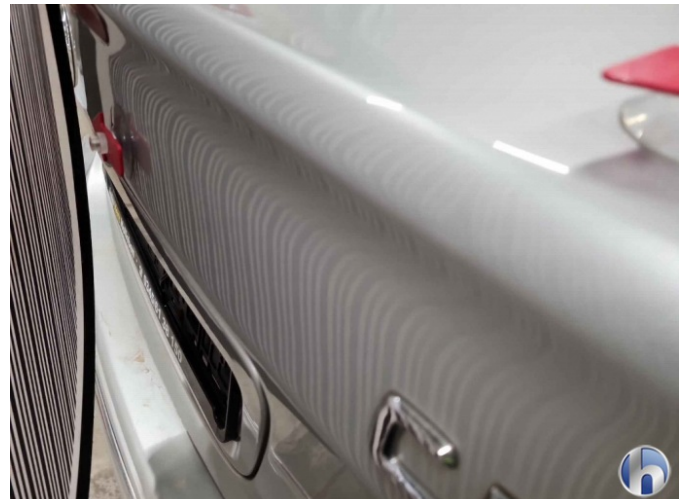
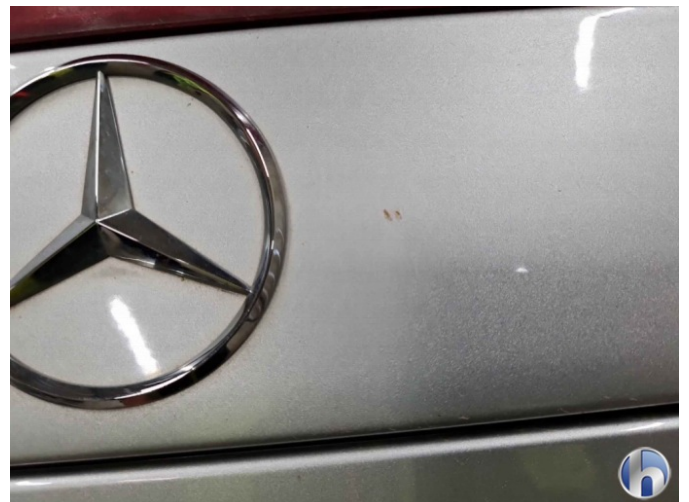
42. tailgate

| 42. | tailgate | Damaged | Refurbish and paint |

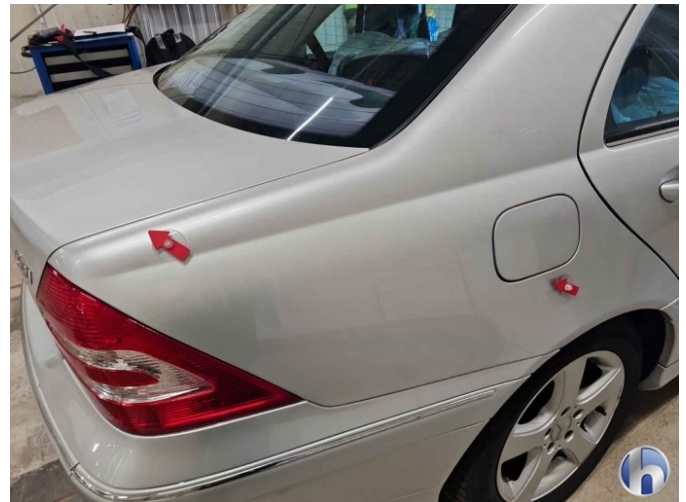
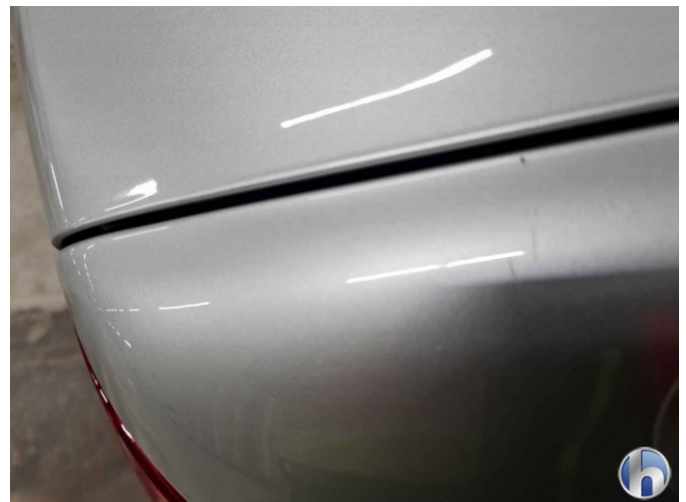
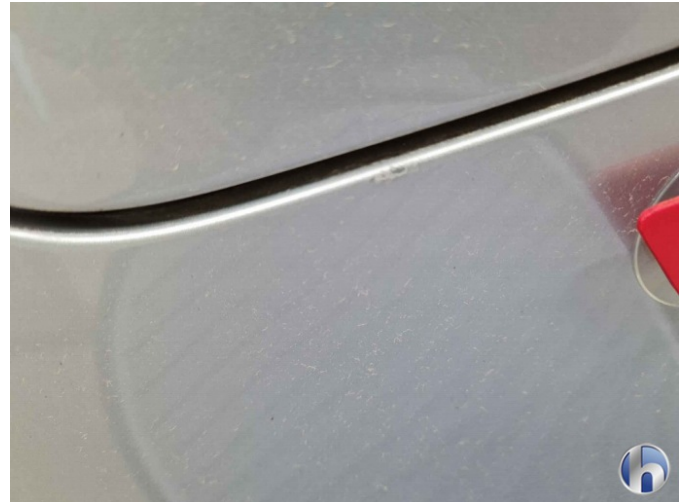
45. Sidewall - Rear - right

| 45. | Sidewall - Rear - right | Scratch(es) | Paint |

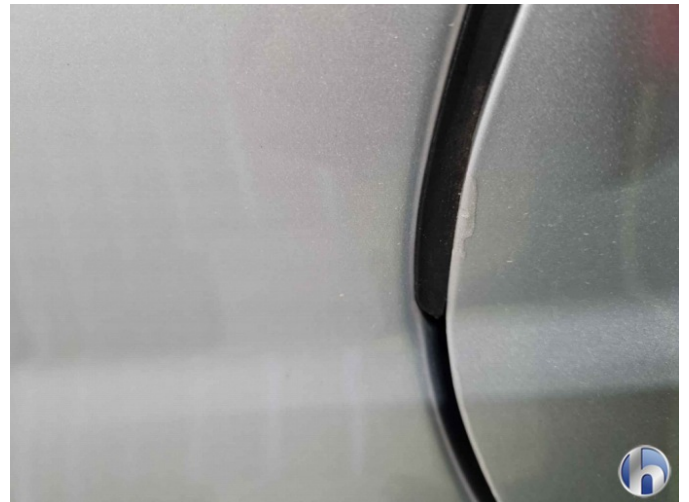
46. Door Rear - right

| 46. | Door Rear - right | chipped paint | Smart repair |

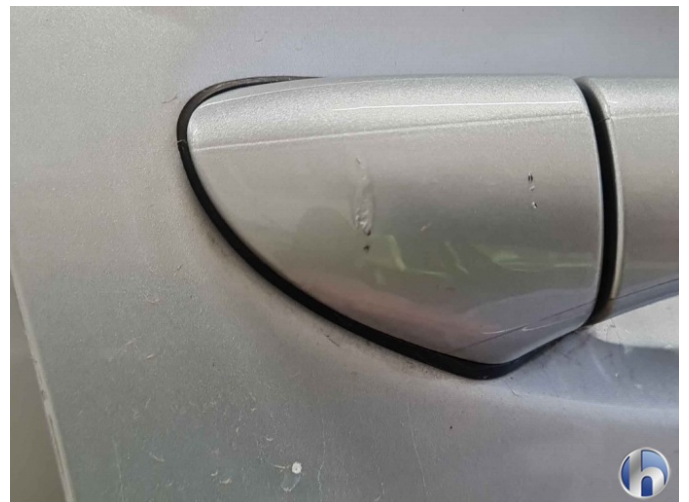
47. Front door - right

| 47. | Front door - right | Rust | Paint |

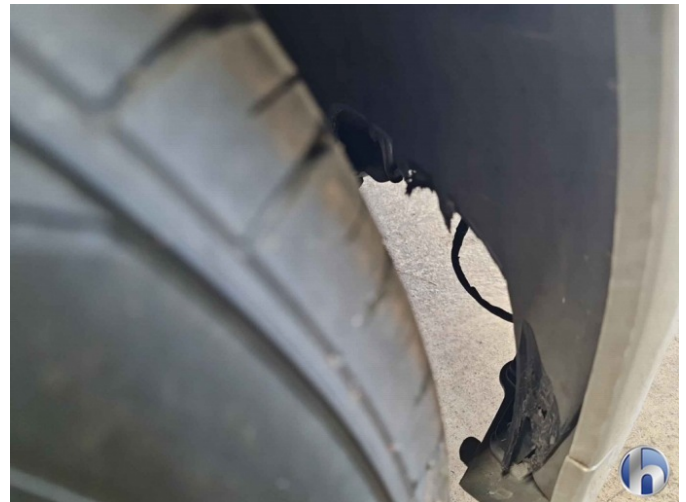
51. Front right wheel housing liner

| 51. | Front right wheel housing liner | Damaged | Replace |

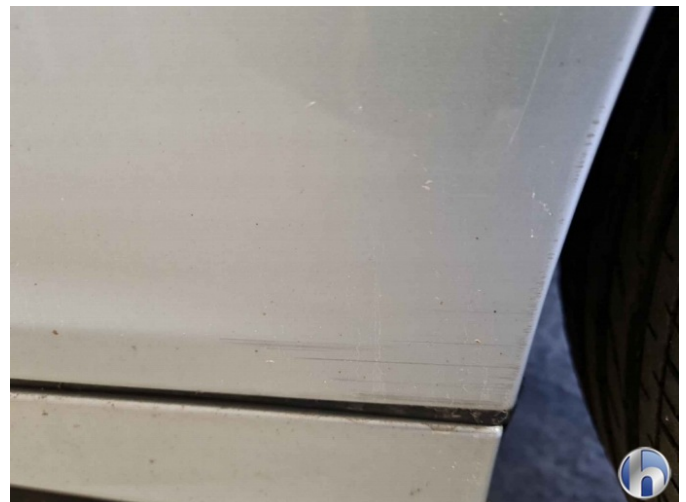
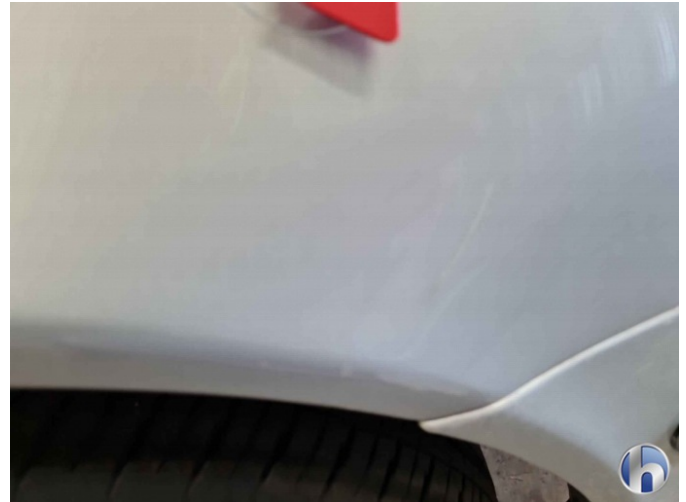
52. Front fender - right

| 52. | Front fender - right | Scrape | Paint |

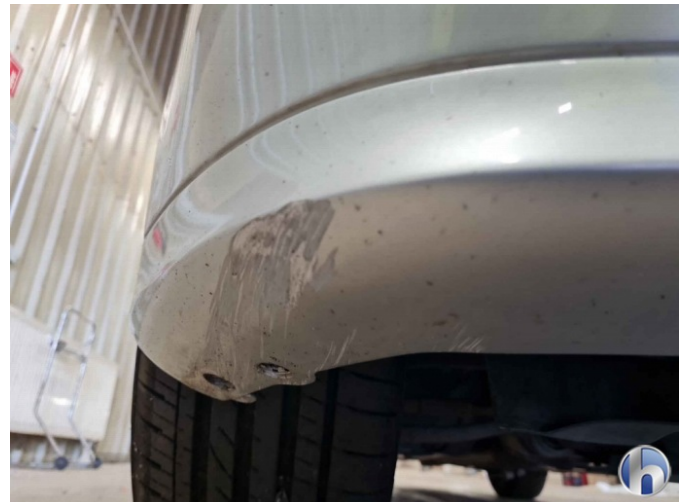
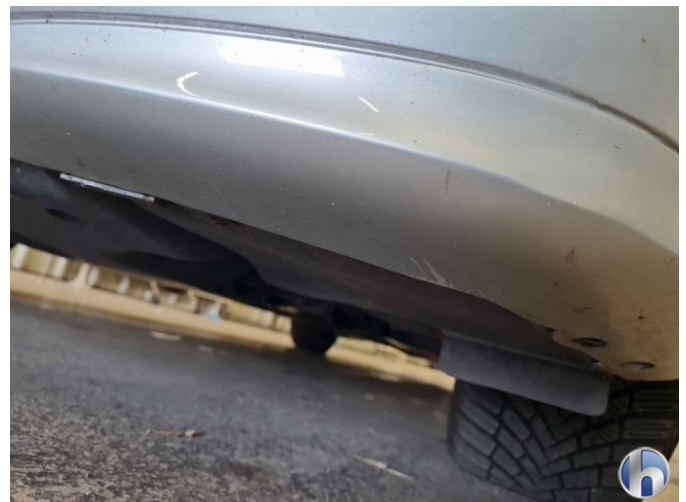
53. Front bumper

| 53. | Front bumper | Scrape | Paint |
