## status report

**customer:** BCA Autoauktionen GmbH

#### Mercedes-Benz Sprinter II Kasten 310/311/313/314/316 CDI

| Vehicle identification number | <b>WDB9066331P334142</b> | mileage read: | <b>246686 km</b> |

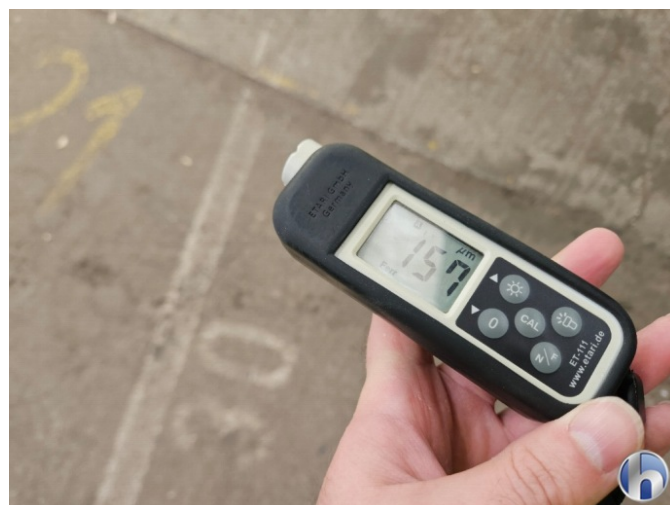
| component | Damage | Rep kind |
|---|---|---|
| 1. tailgate | Subsequently painted | acceptable |

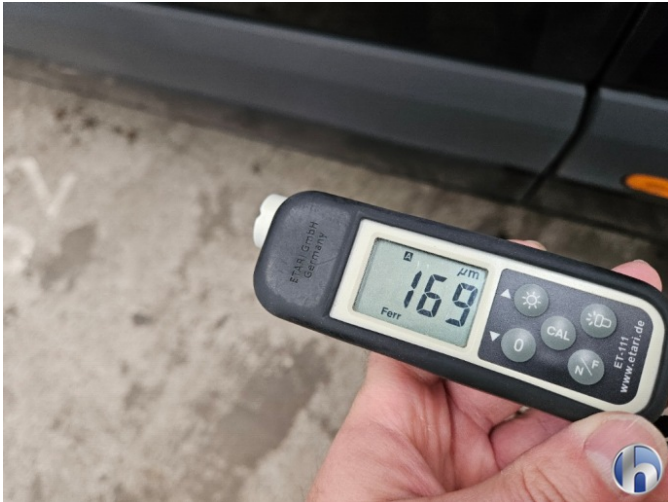
| component | Damage | Rep kind |
|---|---|---|
| 2. Sidewall - Rear - Left | Subsequently painted | acceptable |

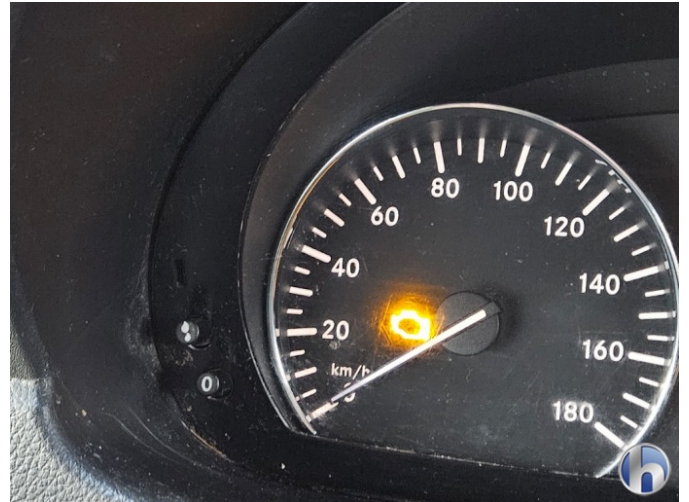
| Performed testing technology | |
|---|---|
| <b>engine running:</b> | A field test of the engine had to acoustic or visual defects for visiting time .<br>**Engine warning light. |

| component | Damage | Rep kind |
|---|---|---|
| 3. motor | Error message | Carry out a fault diagnosis |

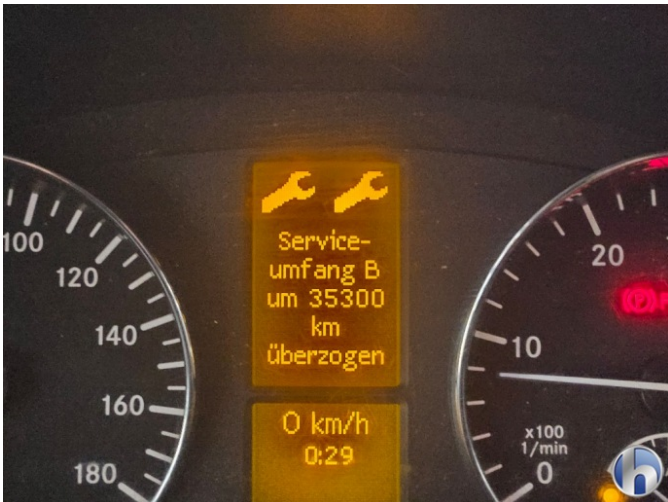
| component | Damage | Rep kind |
|---|---|---|
| 6. maintenance | Due | Replace |

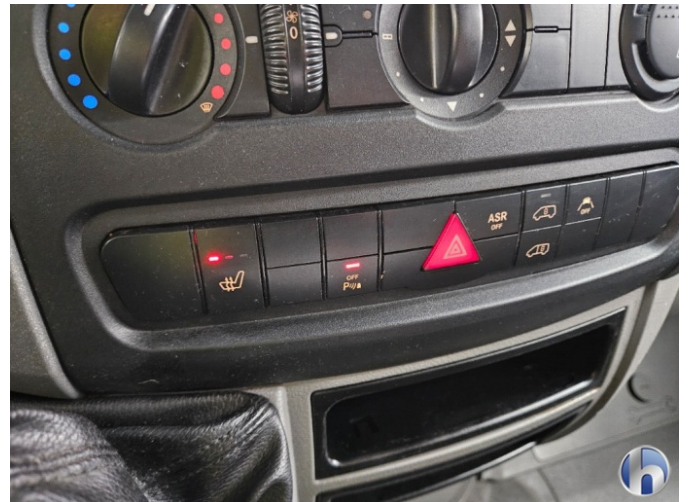
| component | Damage | Rep kind |
|---|---|---|
| 8. PDC | Error message | Carry out a fault diagnosis |

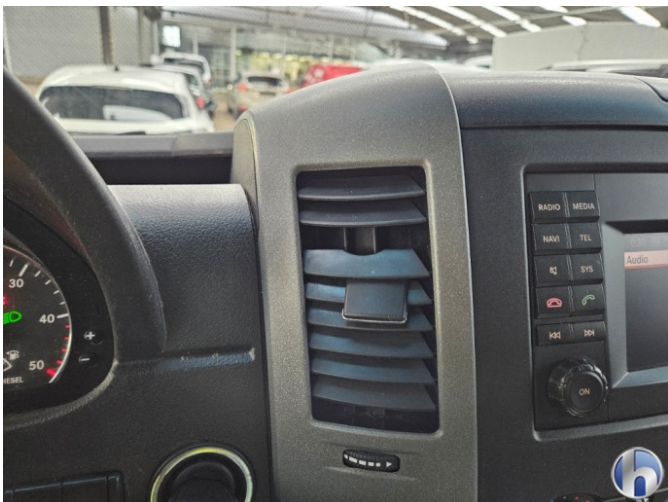
| component | Damage | Rep kind |
|---|---|---|
| 9. Luftausströmer | Damaged | Replace |

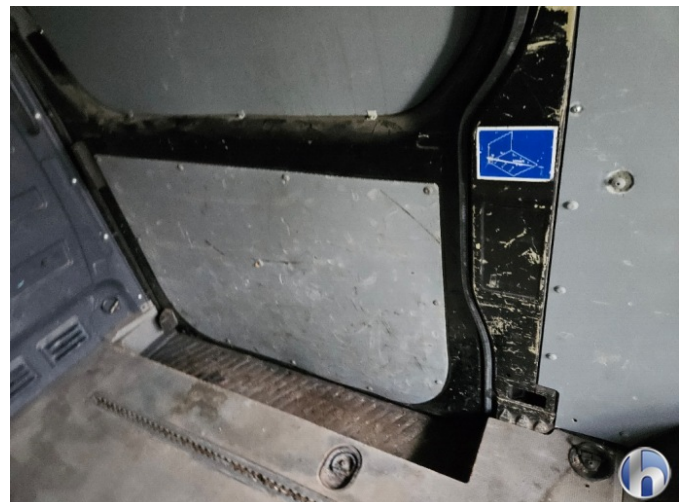
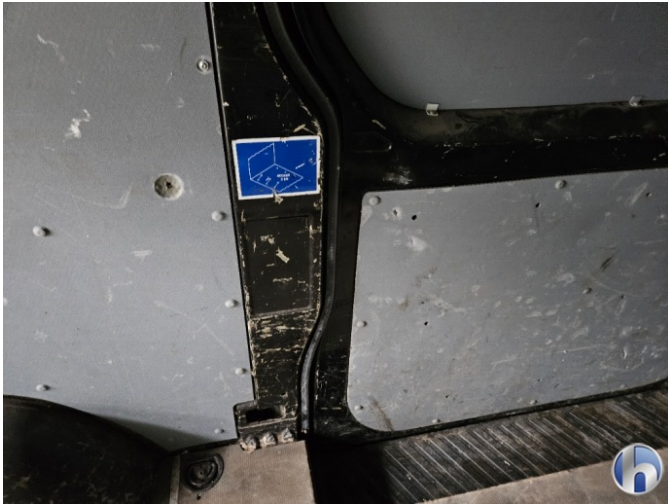
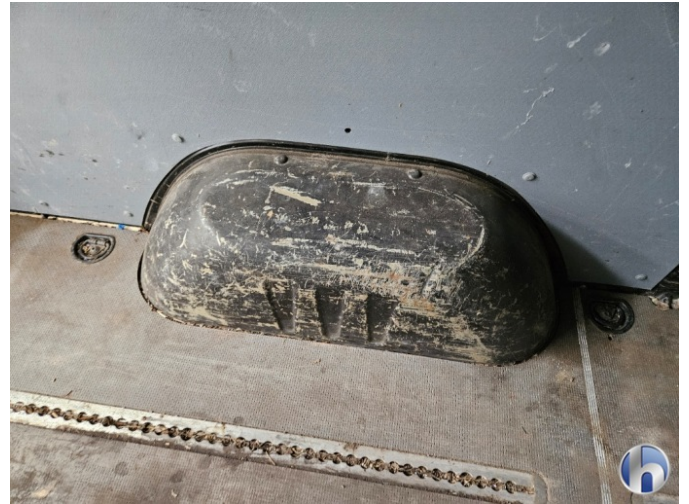
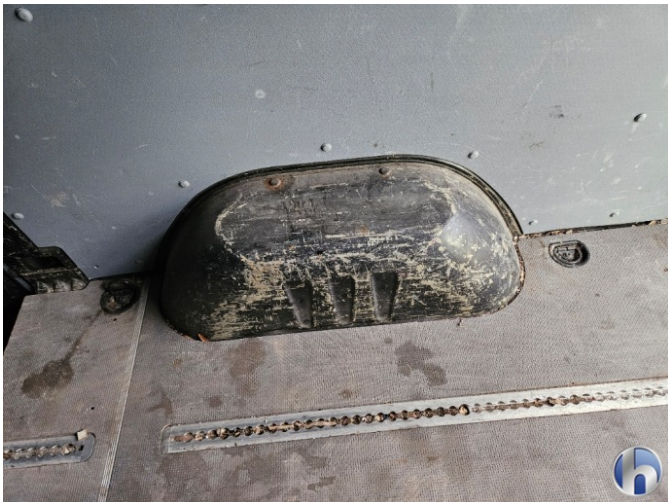
| component | Damage | Rep kind |
|---|---|---|
| 12. | Wear and tear | acceptable |

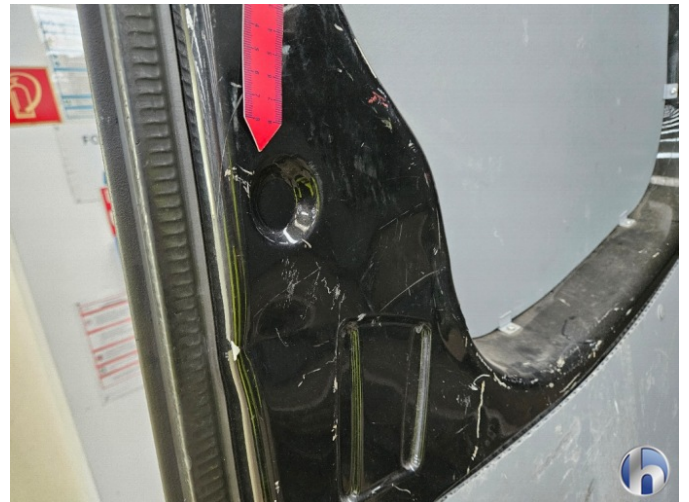
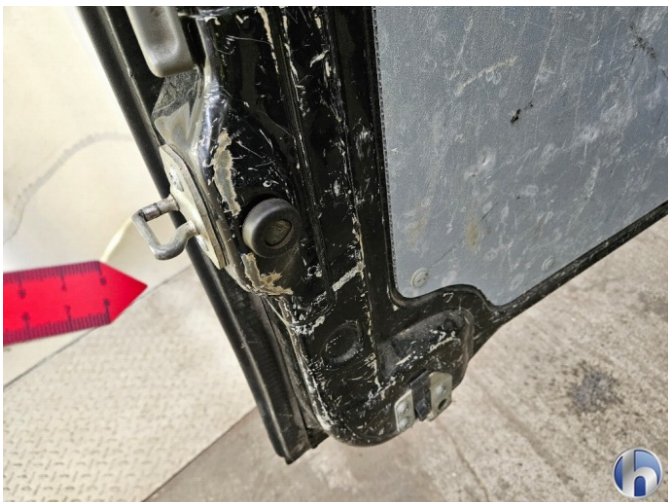
| component | Damage | Rep kind |
|---|---|---|
| 13. Tailgate left | Damaged | Refurbish and paint |

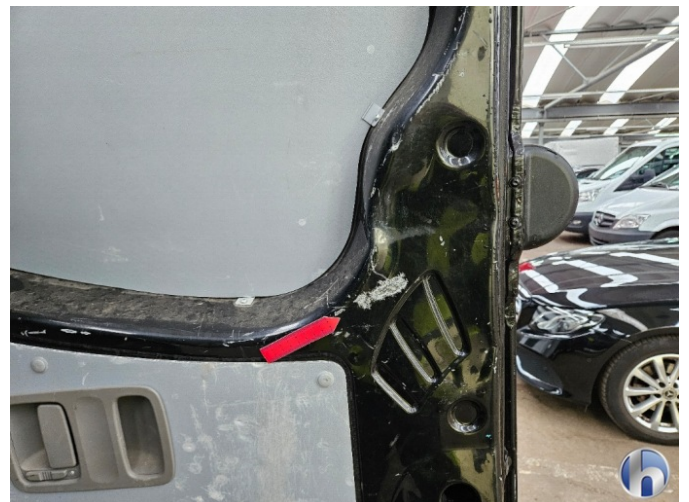
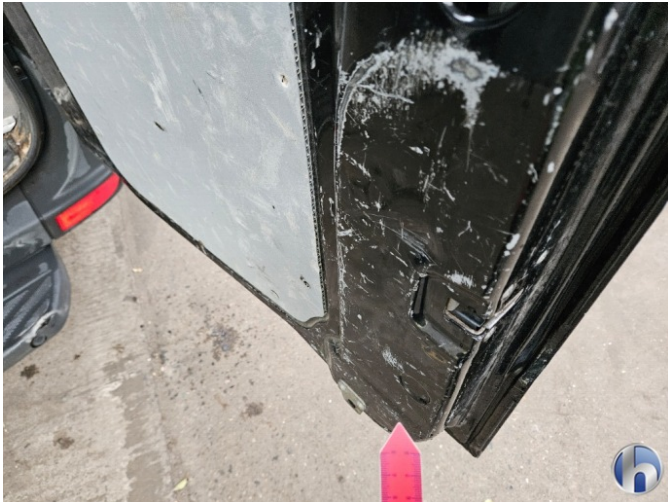
| component | Damage | Rep kind |
|---|---|---|
| 14. Tailgate right | Damaged | Refurbish and paint |

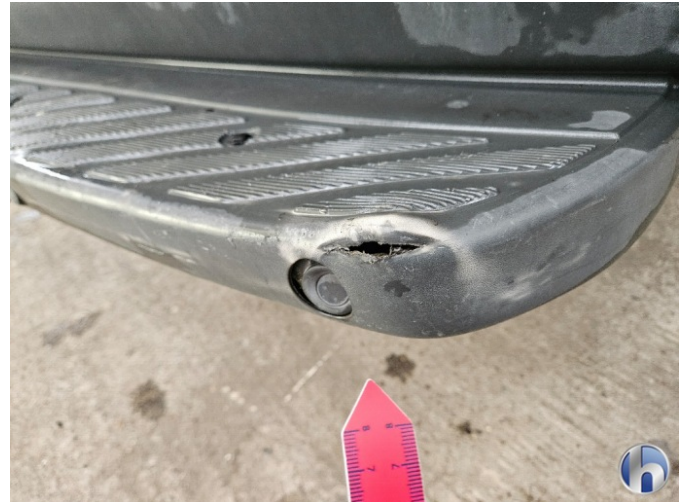
| component | Damage | Rep kind |
|---|---|---|
| 15. Rear bumper | Damaged | Replace |

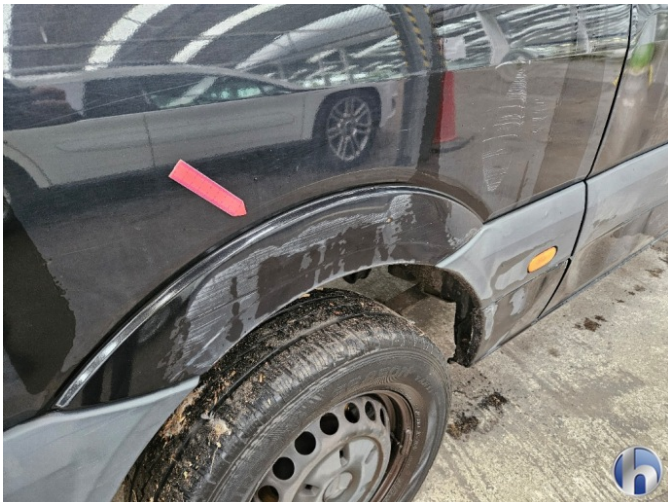
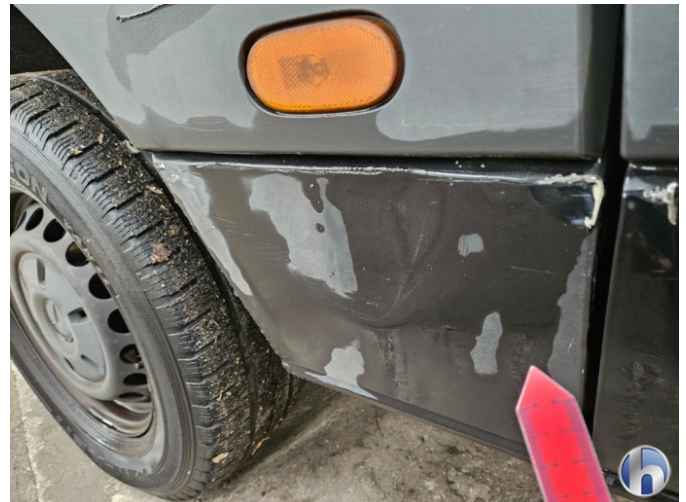
| component | Damage | Rep kind |
|---|---|---|
| 16. Sidewall - Rear - right | Damaged | Refurbish and paint |

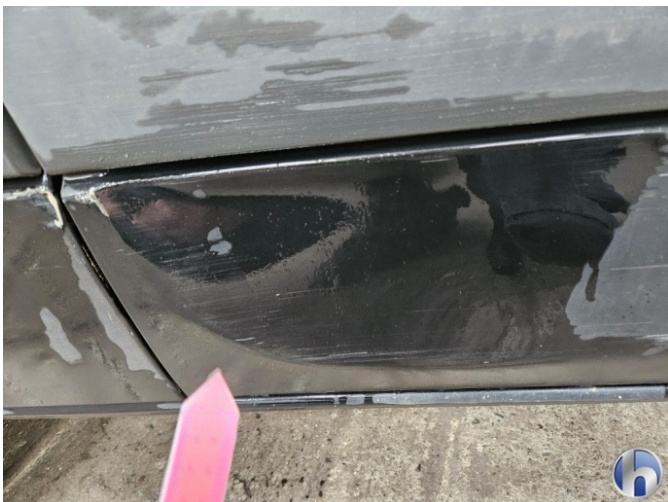
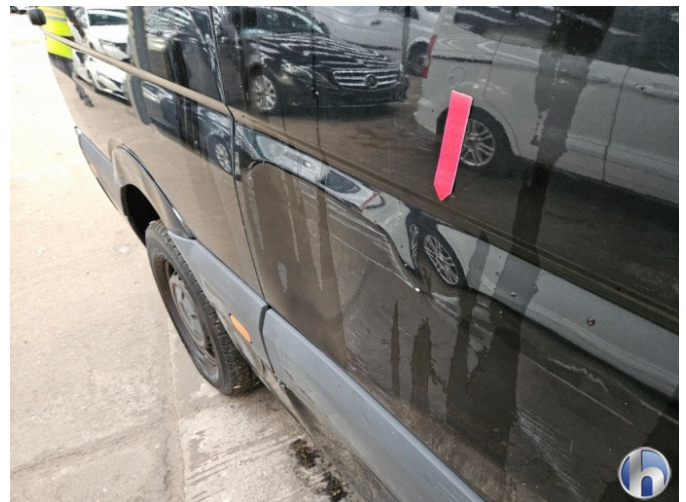
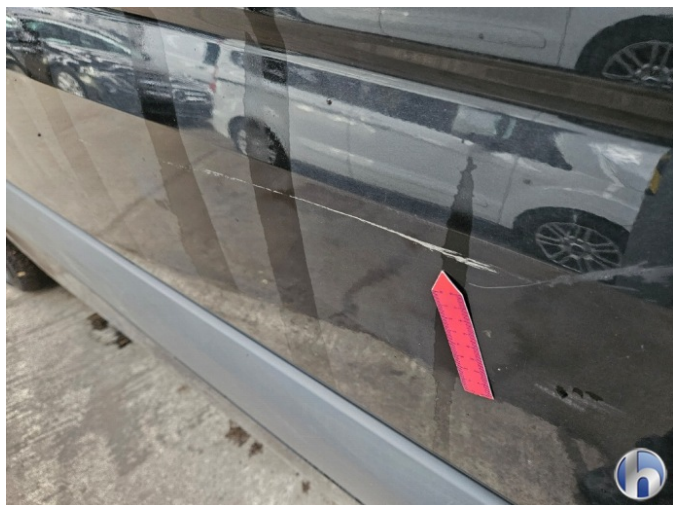
| component | Damage | Rep kind |
|---|---|---|
| 17. Door Rear - right | Deformed | Refurbish and paint |

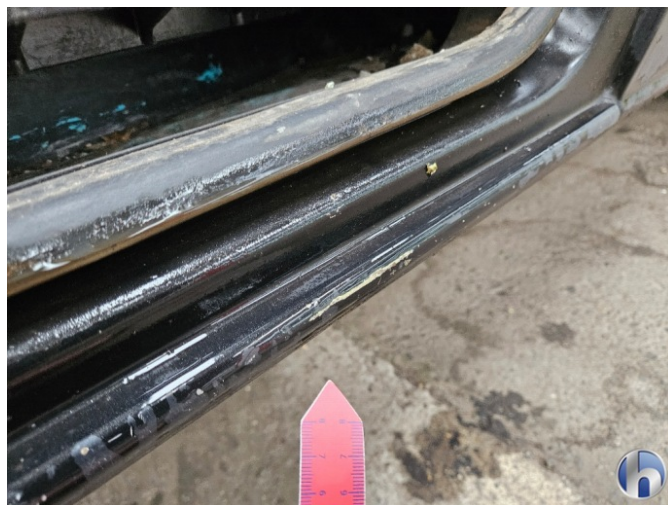
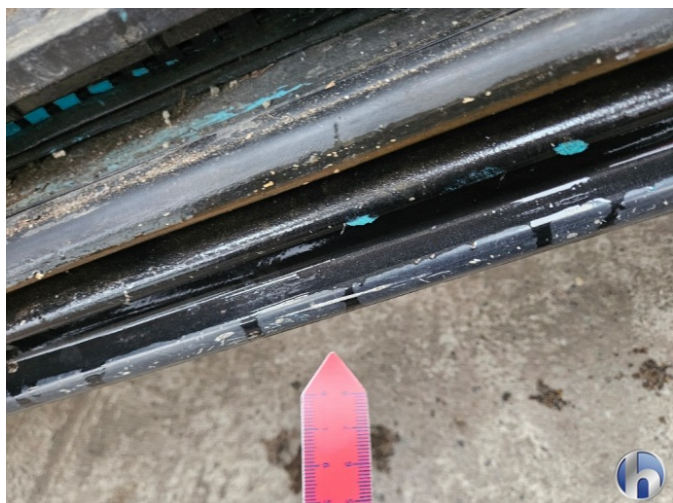
| component | Damage | Rep kind |
|---|---|---|
| 18. side skirt - right | Scratch(es) | Paint |

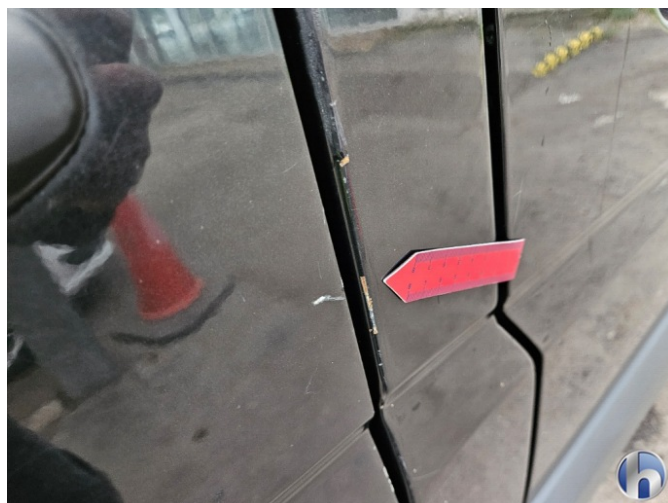
| component | Damage | Rep kind |
|---|---|---|
| 19. B-pillar center - right | Corroded | Paint |

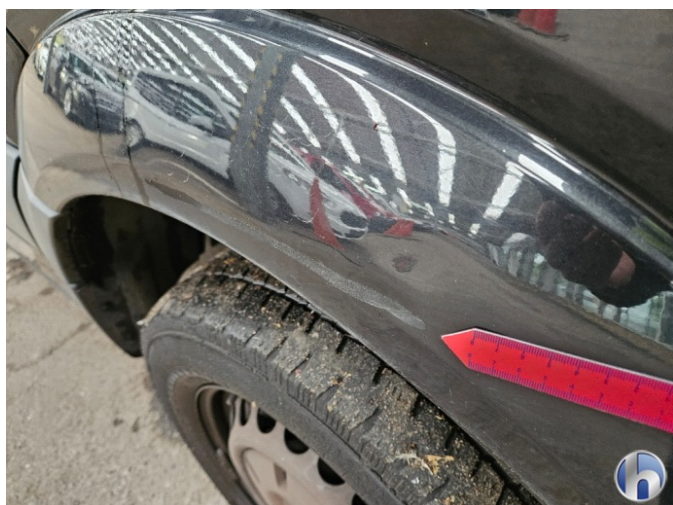
| component | Damage | Rep kind |
|---|---|---|
| 20. Front fender - right | Deformed (slightly) | Refurbish and paint |

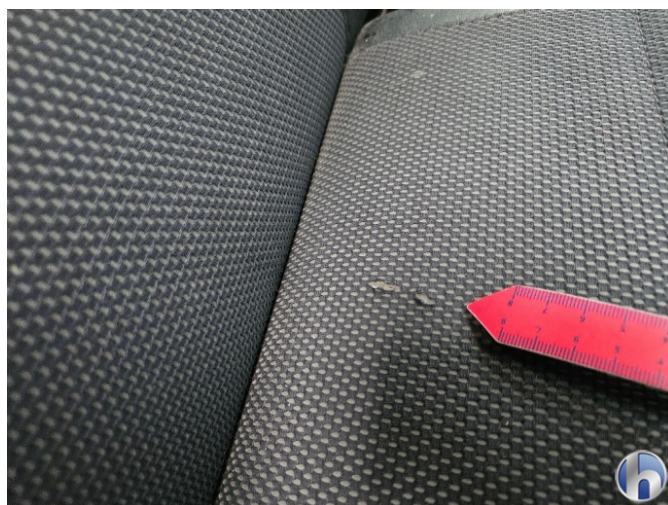
| component | Damage | Rep kind |
|---|---|---|
| 21. | Wear and tear | acceptable |

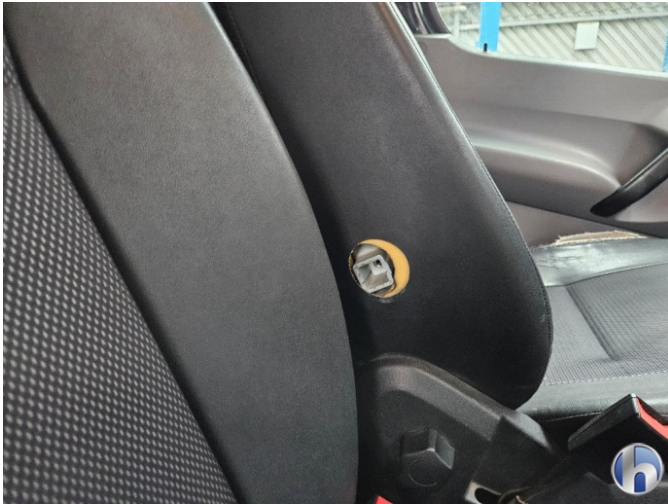
| component | Damage | Rep kind |
|---|---|---|
| 22. | Missing | Replace |

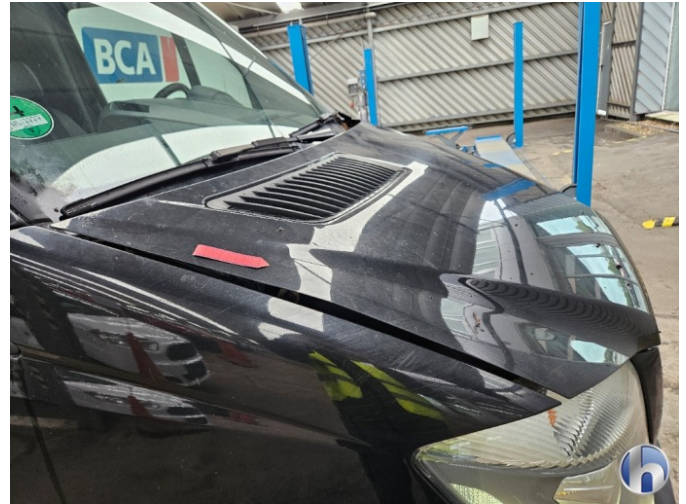
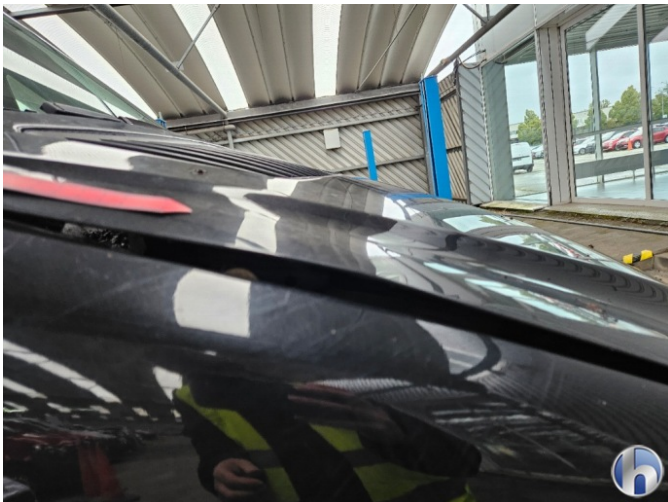
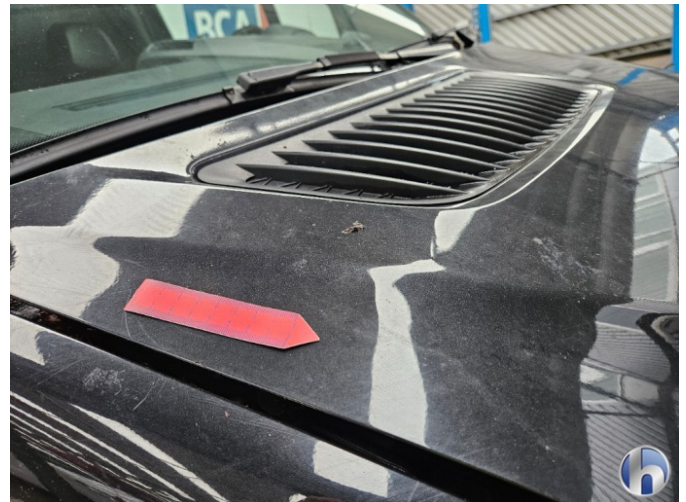
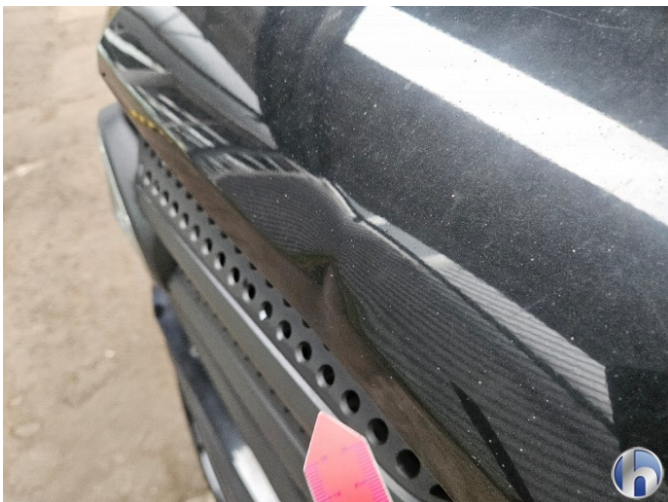
| component | Damage | Rep kind |
|---|---|---|
| 23. hood | Deformed | Replace |

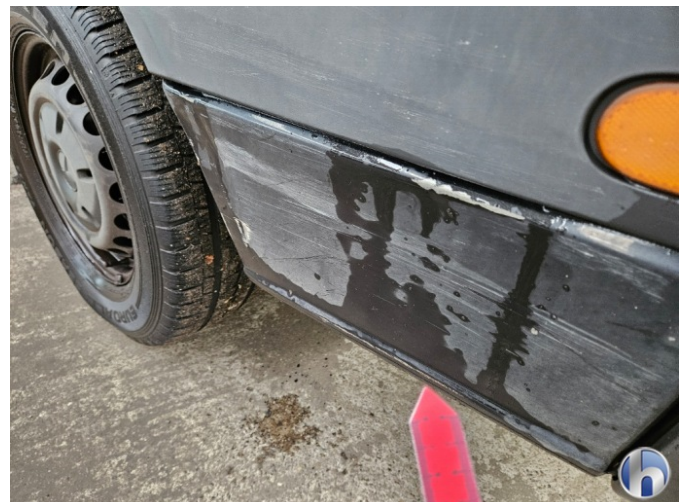
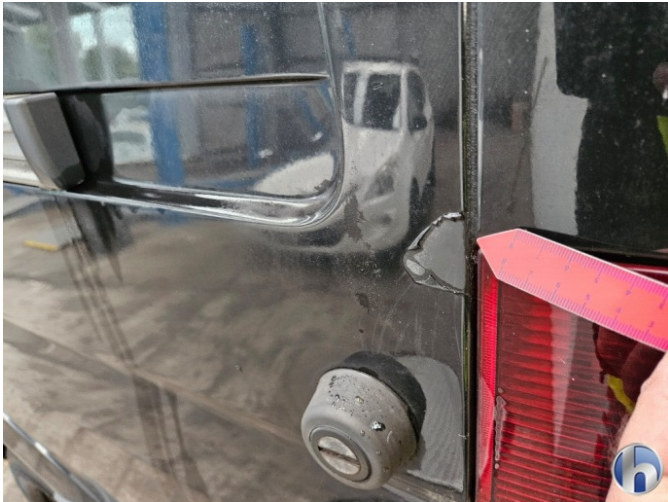
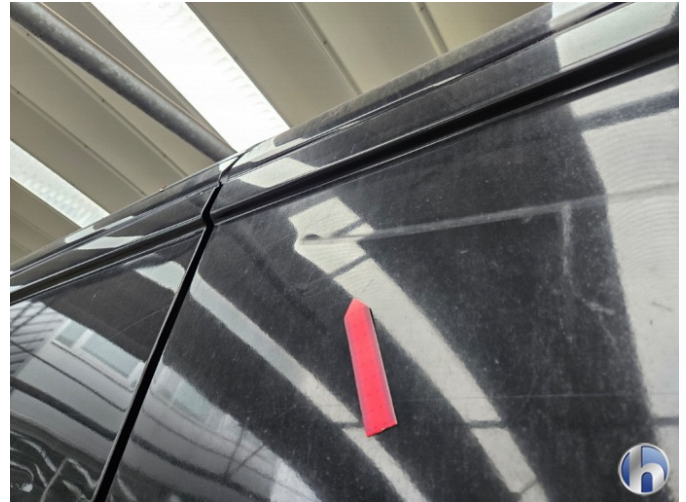
| component | Damage | Rep kind |
|---|---|---|
| 24. Sidewall - Rear - Left | Damaged | Refurbish and paint |

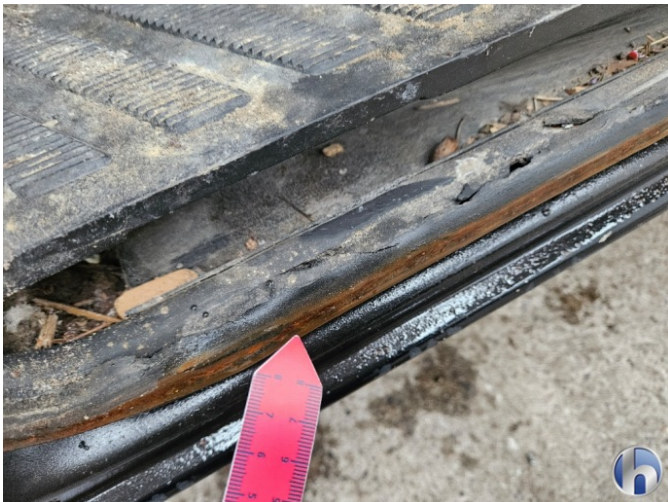
| component | Damage | Rep kind |
|---|---|---|
| 25. Rear door seal - left | Damaged | Replace |

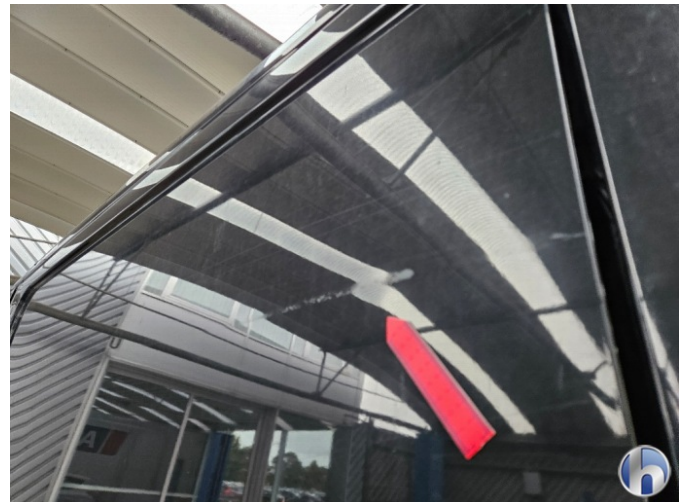
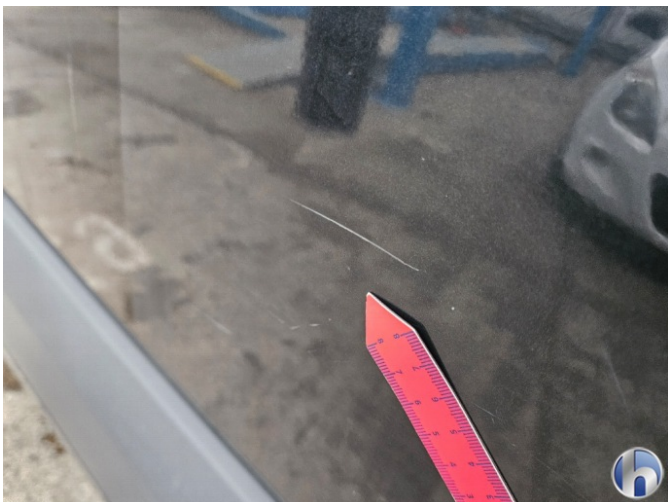
| component | Damage | Rep kind |
|---|---|---|
| 26. Rear door - left | Wear and tear | acceptable |

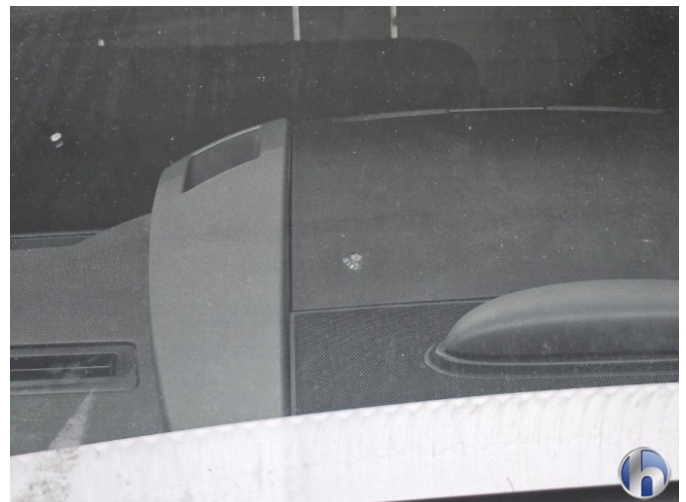
| component | Damage | Rep kind |
|---|---|---|
| 27. Windshield | Chipping from stones | Smart repair |

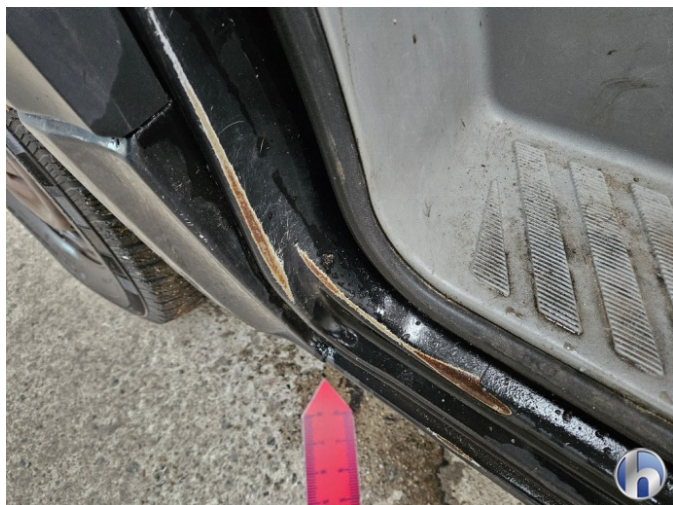
| component | Damage | Rep kind |
|---|---|---|
| 28. Türeinstieg Vorne - Links | Scrape | Paint |

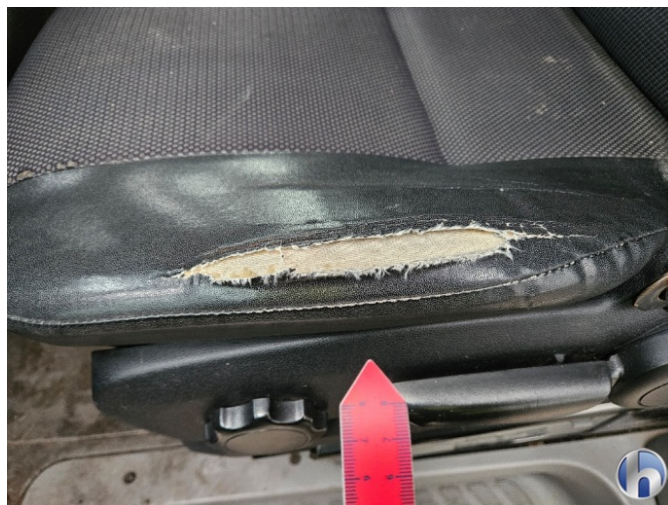
| component | Damage | Rep kind |
|---|---|---|
| 29. | Damaged | Replace |

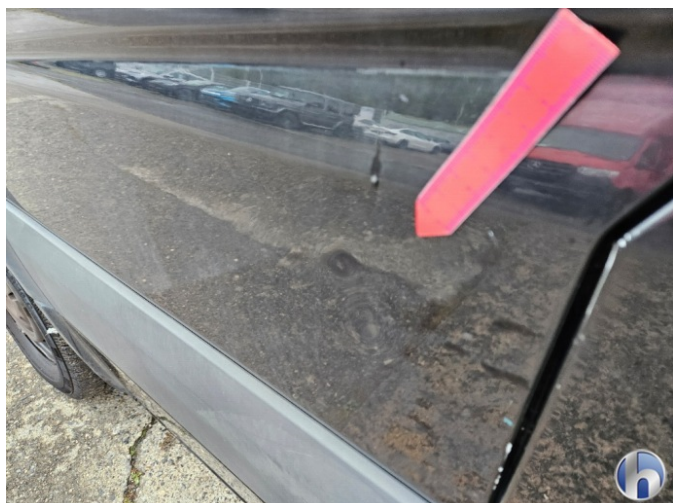
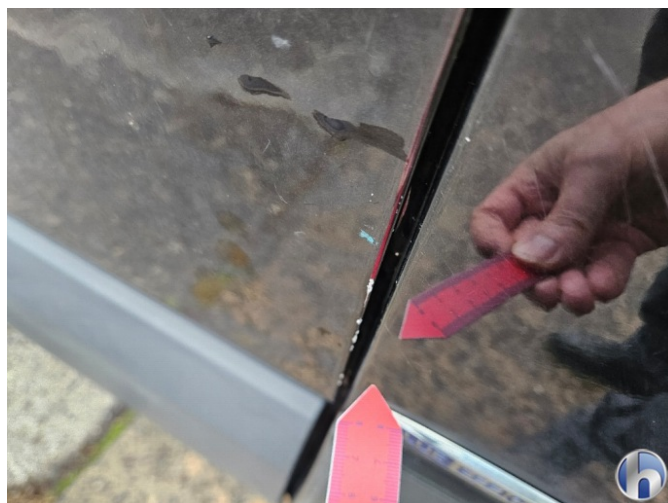
| component | Damage | Rep kind |
|---|---|---|
| 30. Front door - left | Wear and tear | acceptable |
