Expertise

Protocol number: 41703864
Order No. / Reference: 24977852
Inspection date: 26 Sept 2025

Manufacturer: Mercedes-Benz
VIN: WDB9076331P185704

Model: 316 CDI Sprinter 4x4 Standard

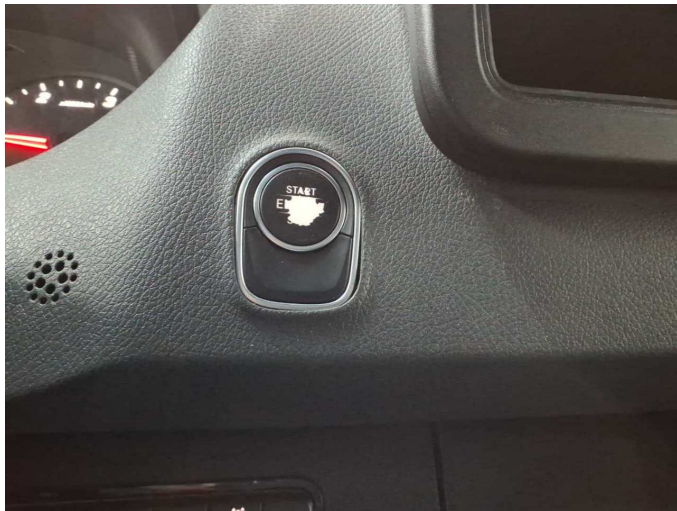
Damage 1: Interior: Interior (Startknopf) - Worn - Loss in value

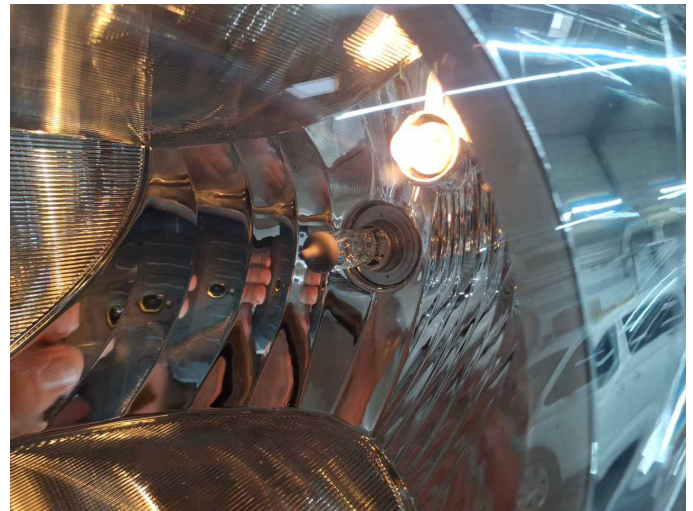
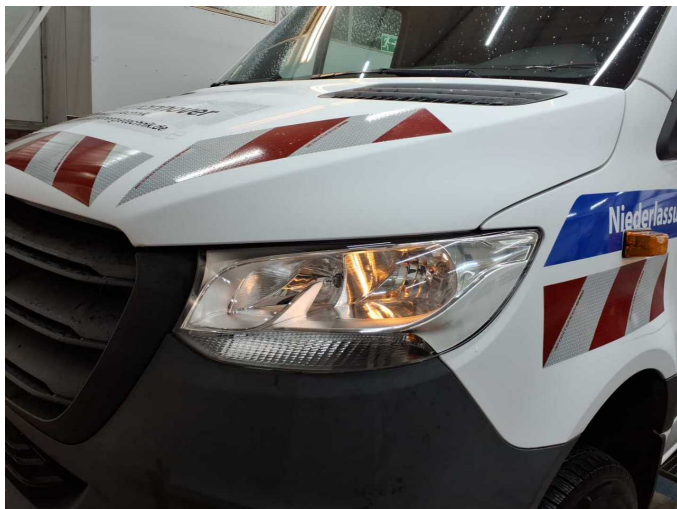
Damage 2: Headlight: Headlight - left side (Abblendlicht) - Defective - Replace

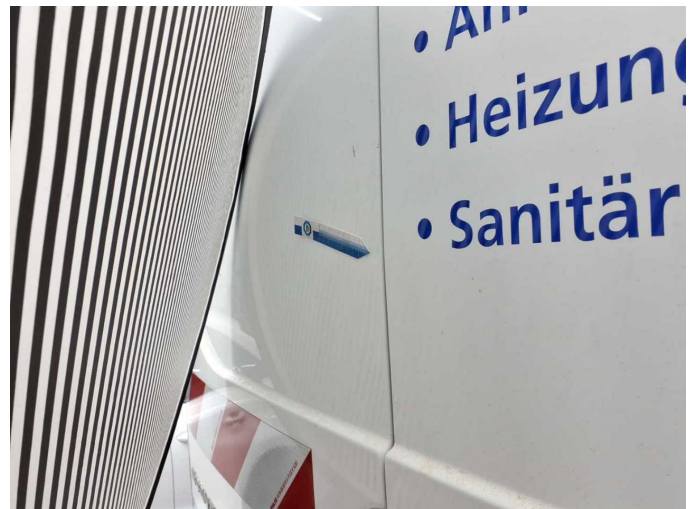
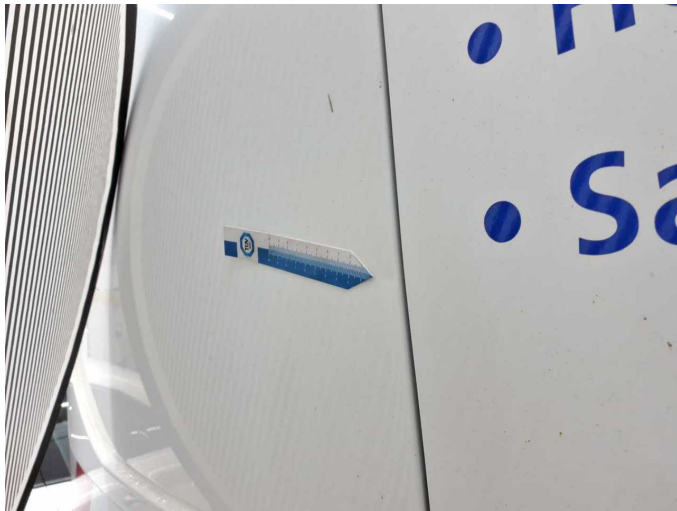
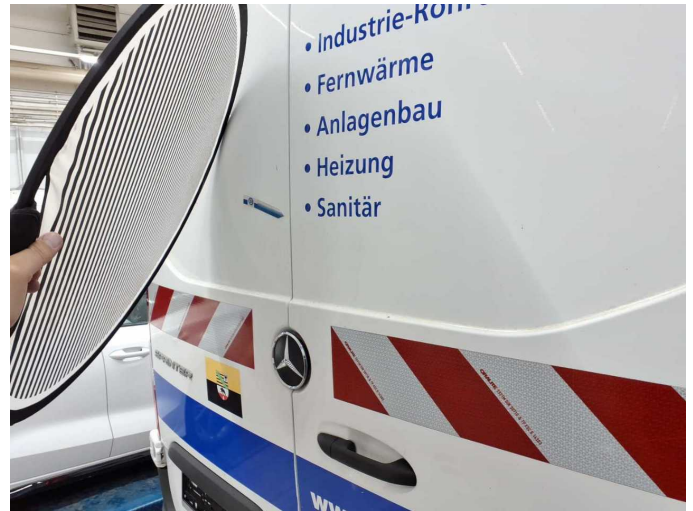
Damage 3: Boot lid / rear door: Rear door - left side - dent(s) - Smart repair

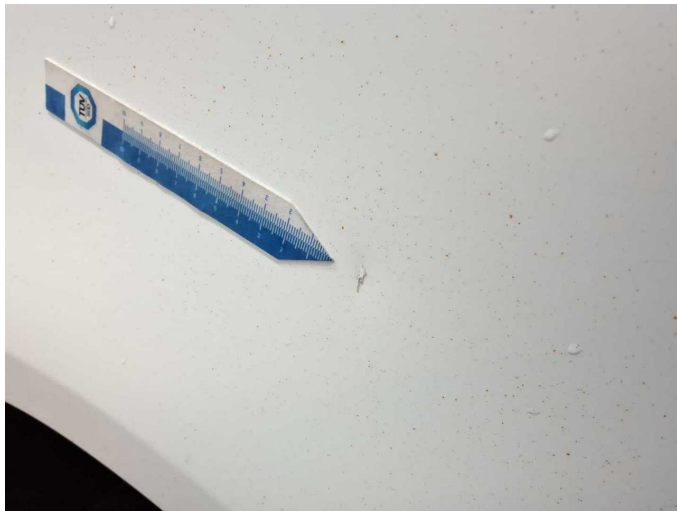
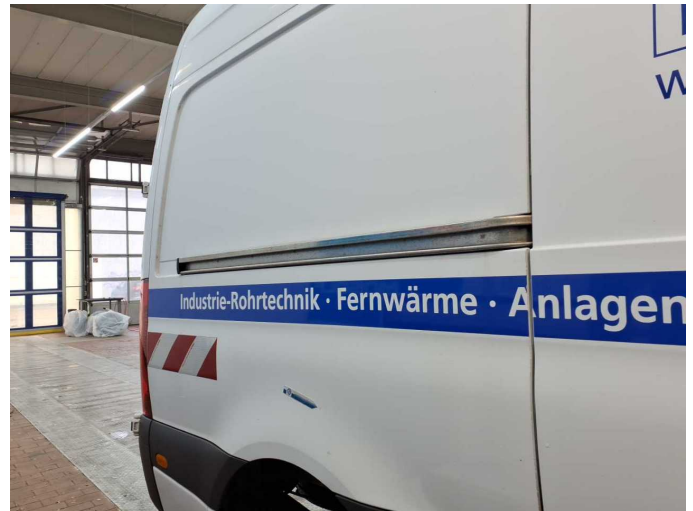
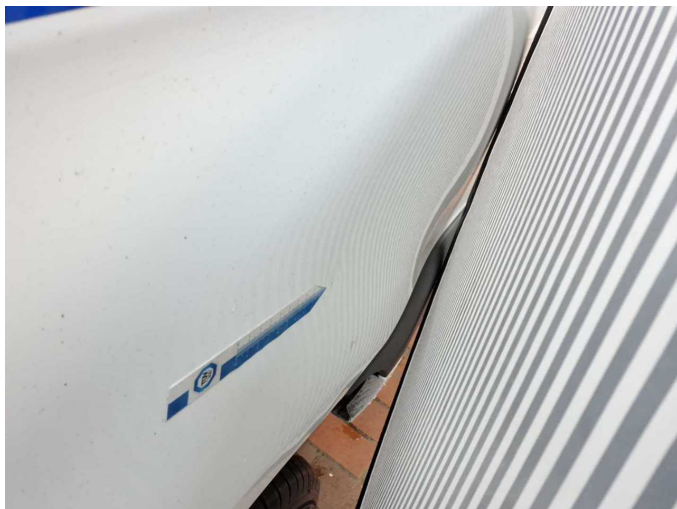
Damage 4: Side panel - rear right side: Side panel - Dent / paintcoat damage - Smart repair

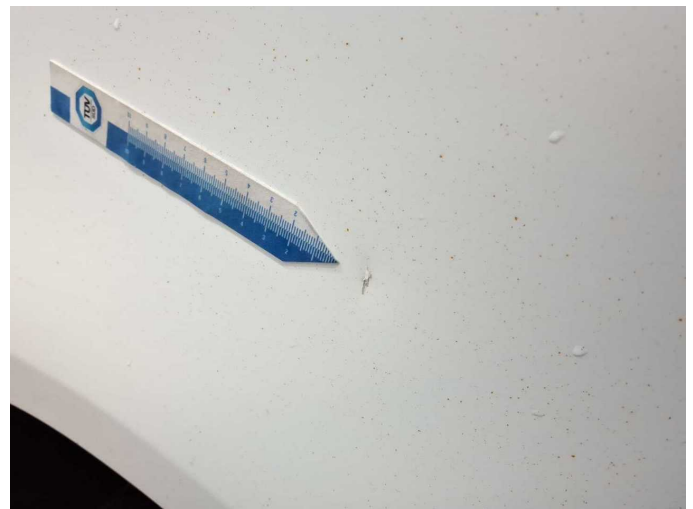
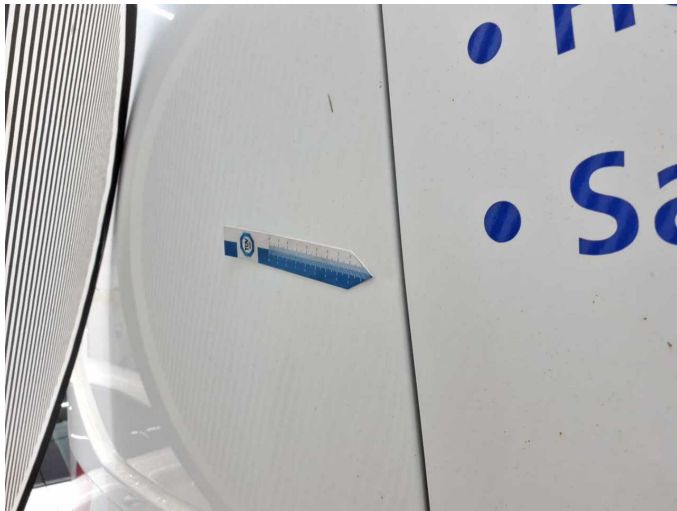
Damage 5: Body: Body (Flugrost) - Paint defect - Conditioning

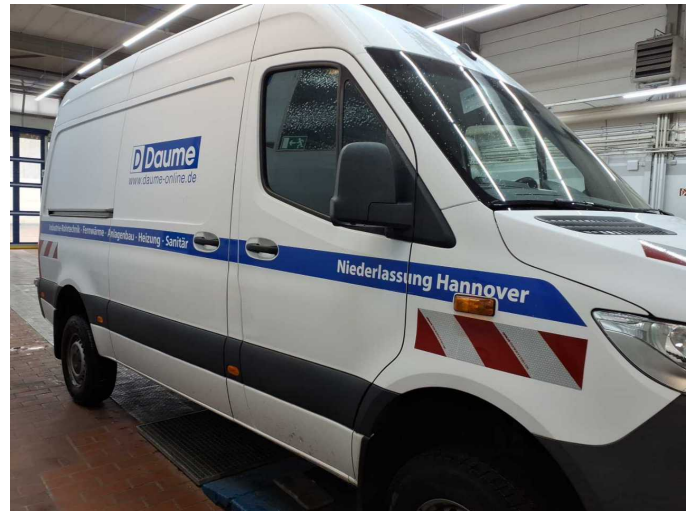
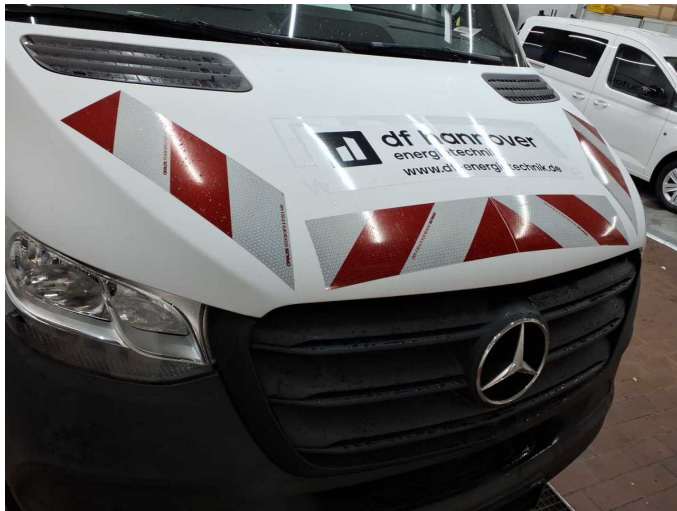
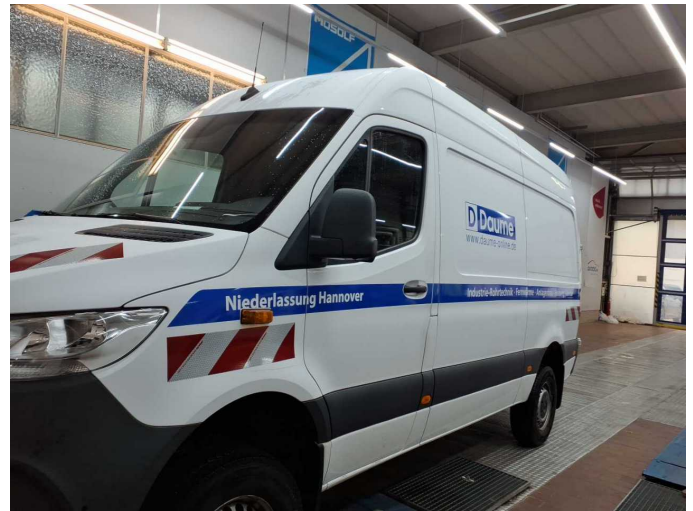
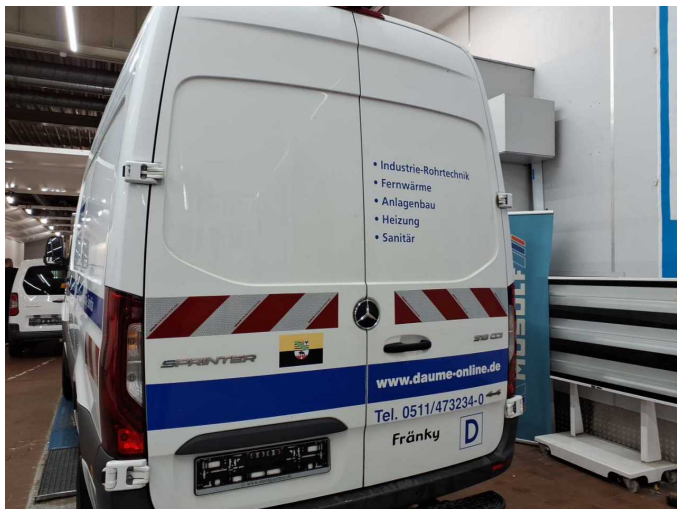
Damage 6: Body: Body - Glued / labelled - De-glue / neutralise

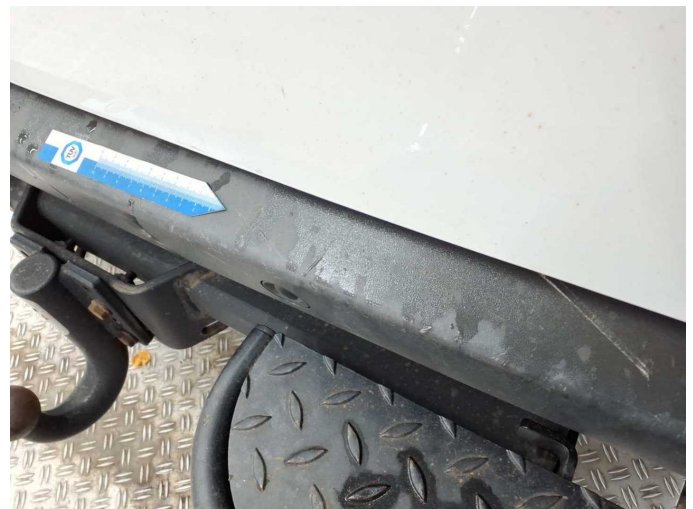
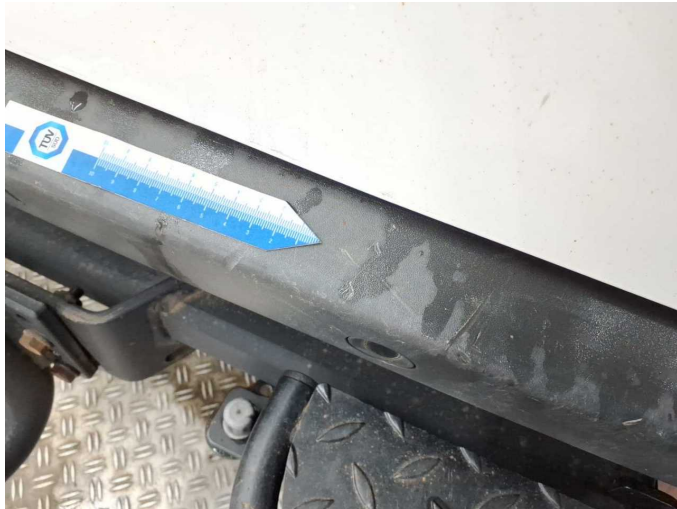
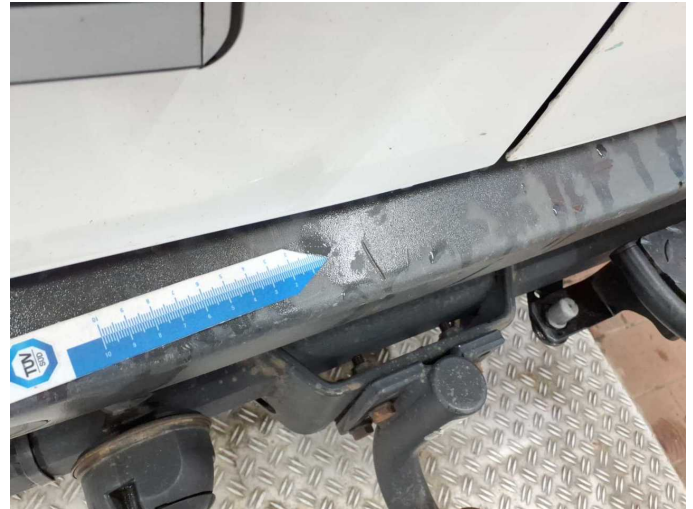
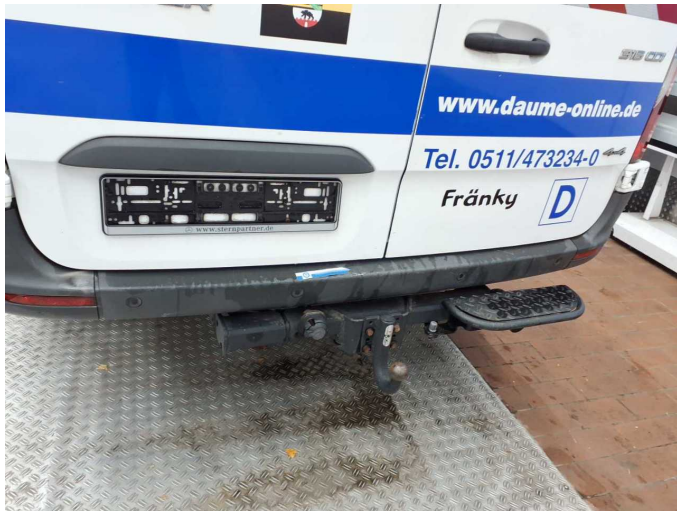
Wear and tear 4: Rear bumper: Rear bumper (unpainted)
(Verladebereich / Einstieg) - Scratch(es) - No deduction

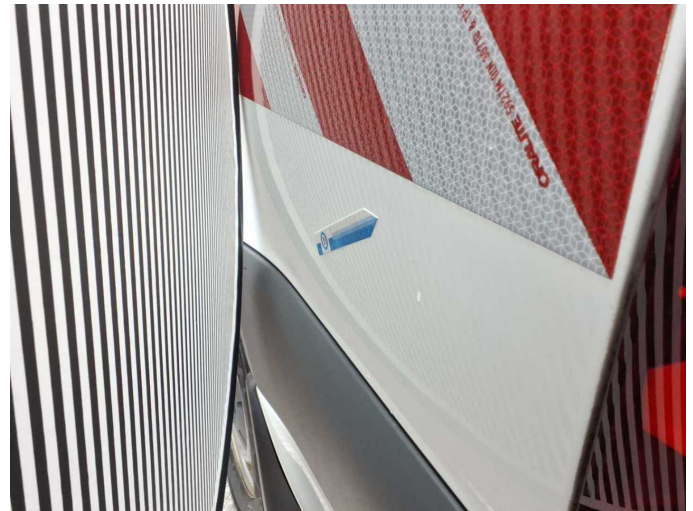
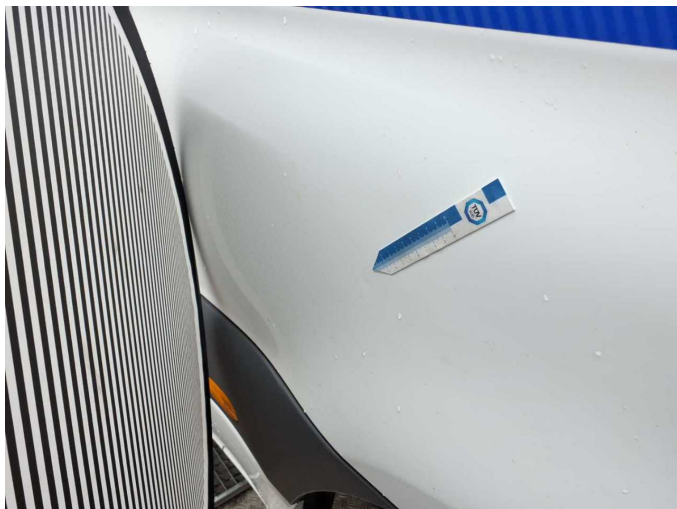
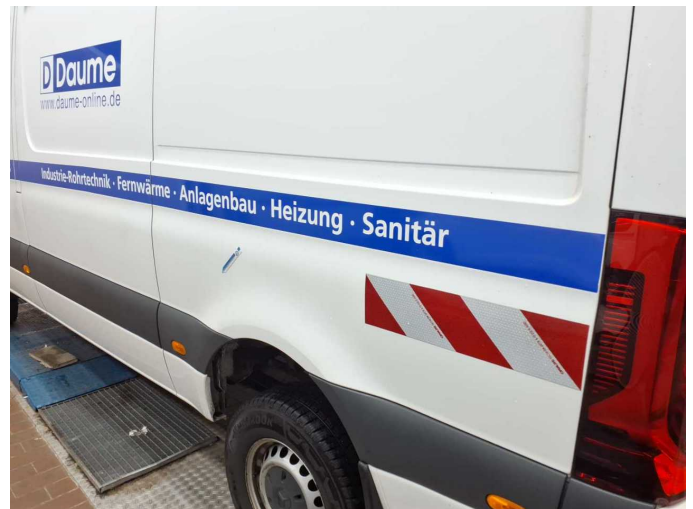
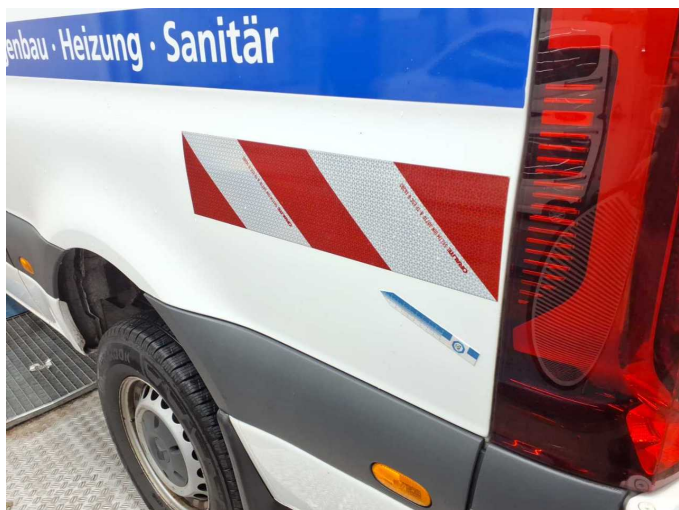
Wear and tear 5: Side panel - rear left side: Side panel - dent(s) - No deduction
