## MERCEDES-BENZ M-Klasse ML 350 4MATIC (BlueEFFICIENCY) 7G-**TRONIC**

VIN NO WDC1660571A007638 Registration Number 571A007638

### **Inspection Report Summary**

| Customer | BCA Online | Report Number | P20250725094810 |

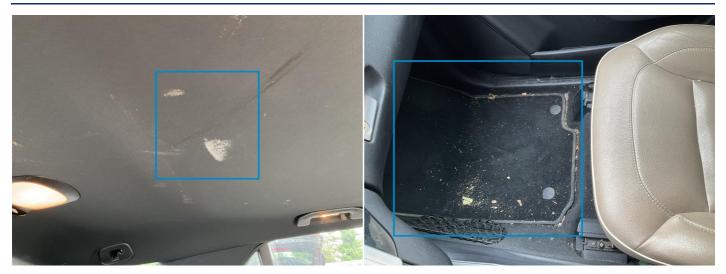
1. Roof Upholstery Interior / Dirty -

2. Floor Carpet Interior / Dirty -

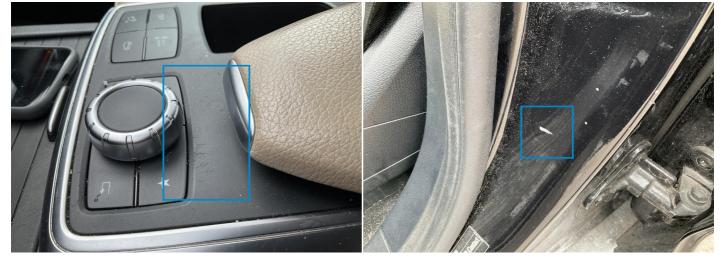
3. Center Console Interior / Scraped -

4. B Pillar / Center Left Paint / Scratch / Scuff -

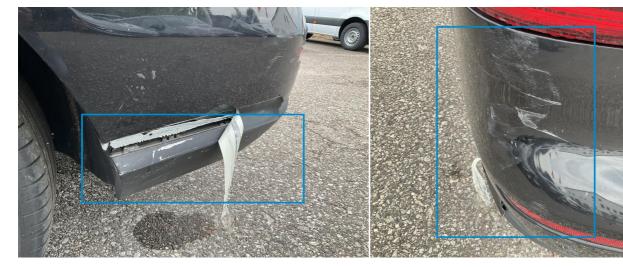
5. Bumper / Back Bodywork / Breakage / Crack -

6. Bumper / Back Paint / Scratch / Scuff -

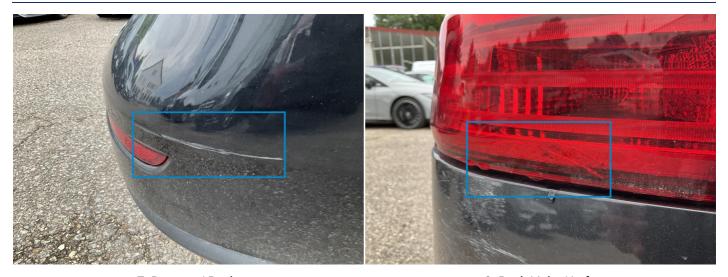
7. Bumper / Back Paint / Scratch / Scuff -

8. Back Light / Left Bodywork / Breakage -

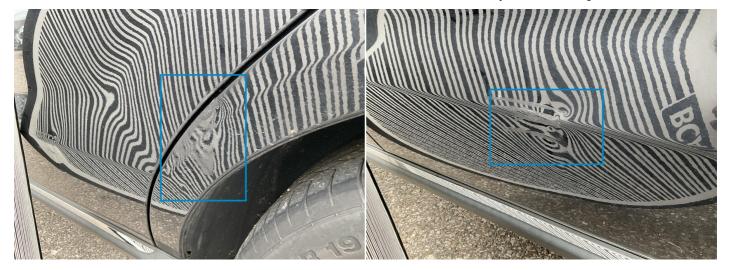
9. Side Panel / Back Left Bodywork / Dent / Dent -

10. Door / Back Left Bodywork / Dent / Dent -

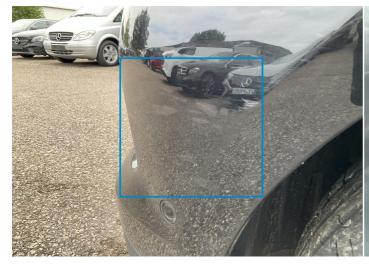
11. Bumper / Front Paint / Scratch / Scuff -

12. Windshield / Front Glass Break / Impact -

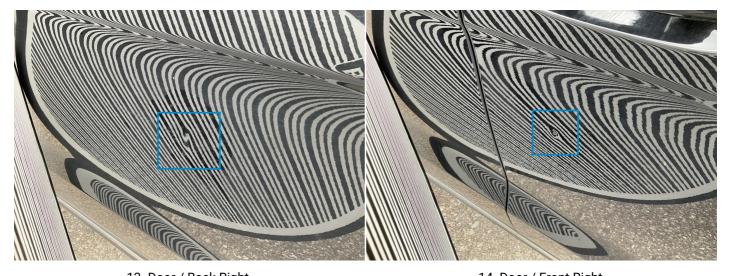
13. Door / Back Right Bodywork / Dent / Dent -

14. Door / Front Right Bodywork / Dent / Dent -

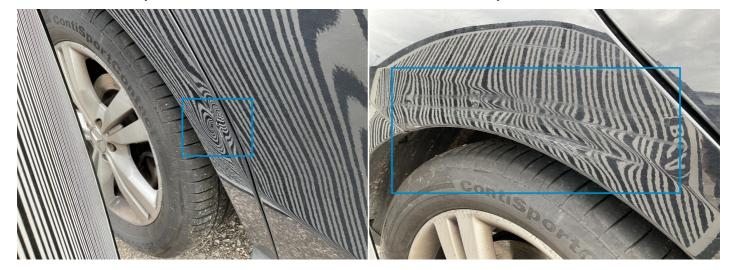
15. Side Panel / Back Right Bodywork / Dent / Dent -

16. Side Panel / Back Right Bodywork / Dent / Dent -

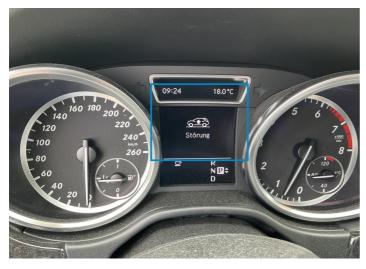
17. Anomalyon Element -
