## status report

| vehicle data | | | |
|---|---|---|---|
| <b>Mercedes-Benz CLA -Klasse CLA 250 4Matic Sport (117.351)</b> | | | |
| Vehicle identification number | <b>WDD1173511N516572</b> | mileage read: | <b>109787 km</b> |

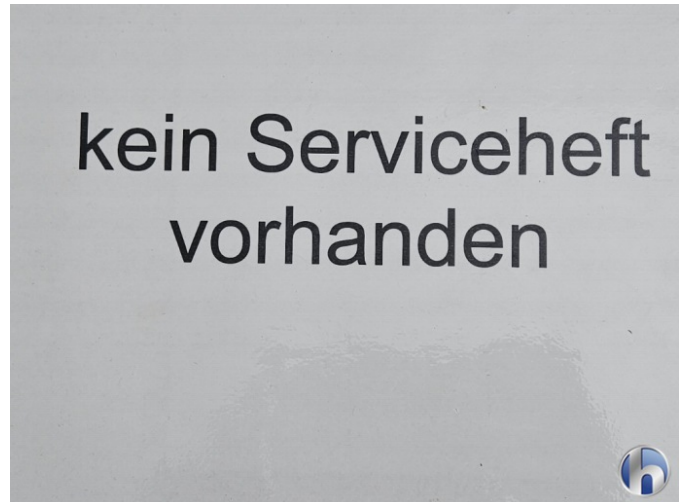
service book

| component | Damage | Rep kind |
|---|---|---|
| 1. proof of maintenance | Missing | Replace |

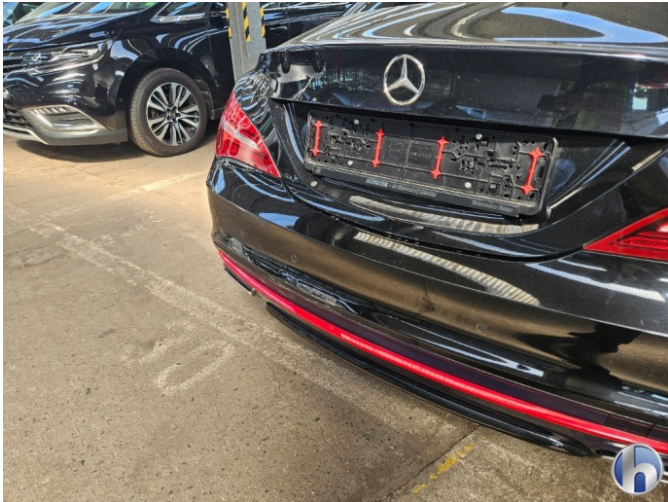
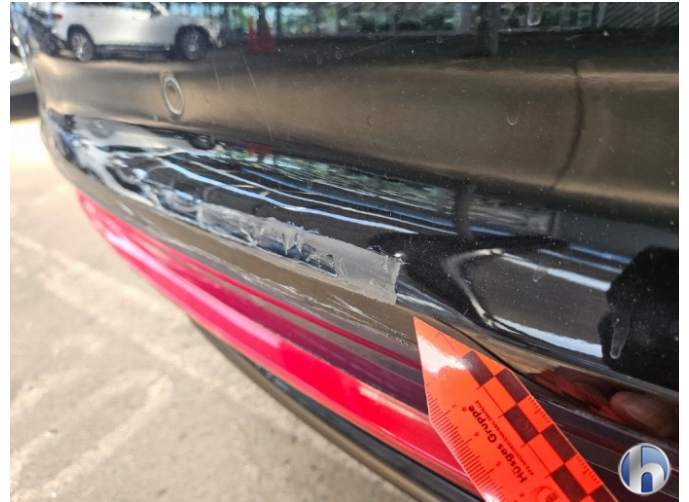
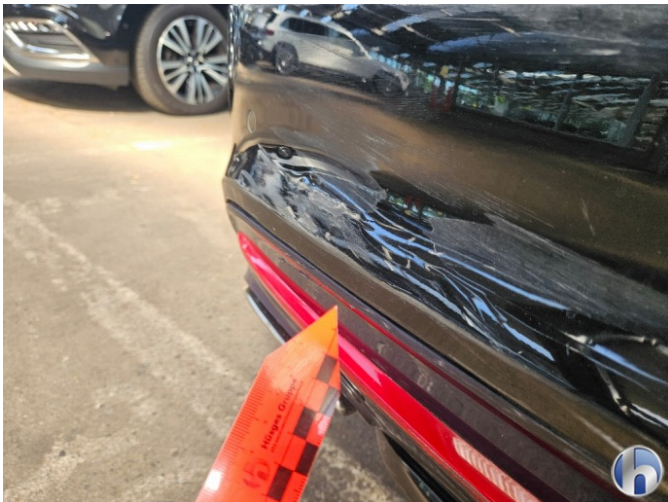
| component | Damage | Rep kind |
|---|---|---|
| 3. Rear bumper | Damaged | Replace |

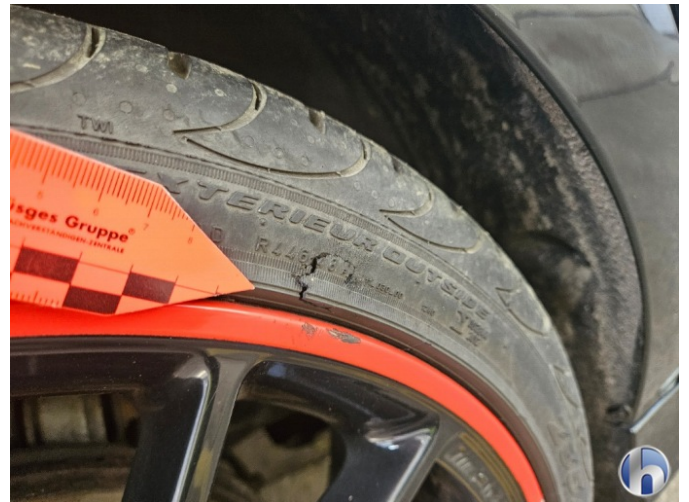
| component | Damage | Rep kind |
|---|---|---|
| 4. tire rear - right | Wear and tear | acceptable |

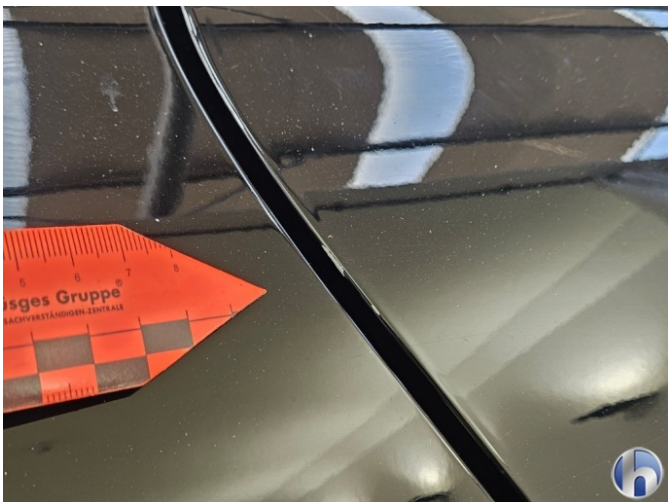
| component | Damage | Rep kind |
|---|---|---|
| 5. Door Rear - right | Wear and tear | acceptable |

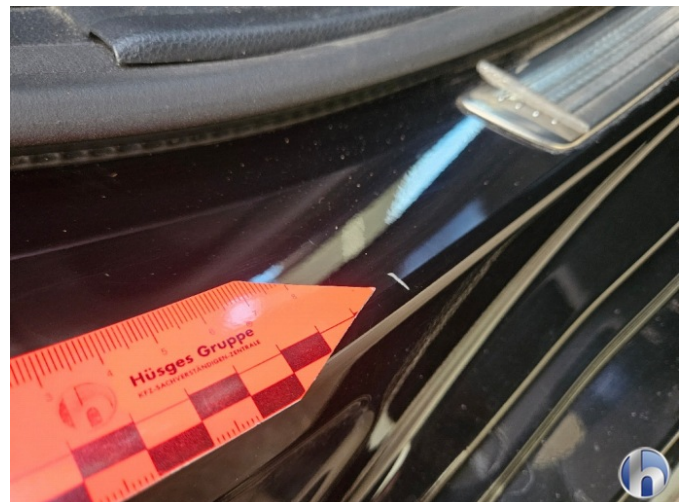
| component | Damage | Rep kind |
|---|---|---|
| 6. Türeinstieg Hinten - Rechts | Wear and tear | acceptable |

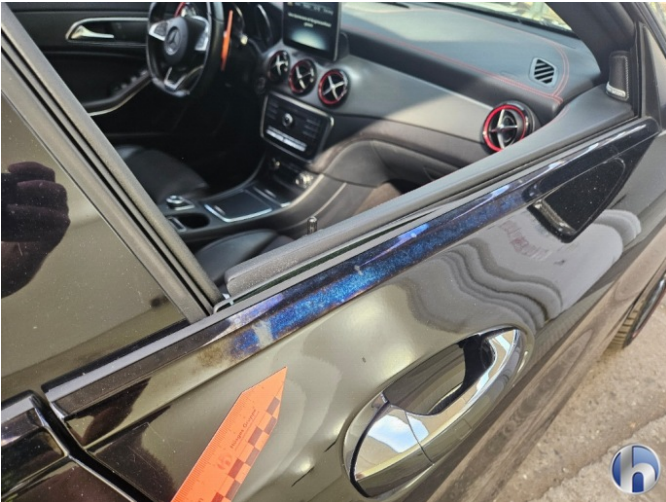
| component | Damage | Rep kind |
|---|---|---|
| 7. Zierleisten | Wear and tear | acceptable |

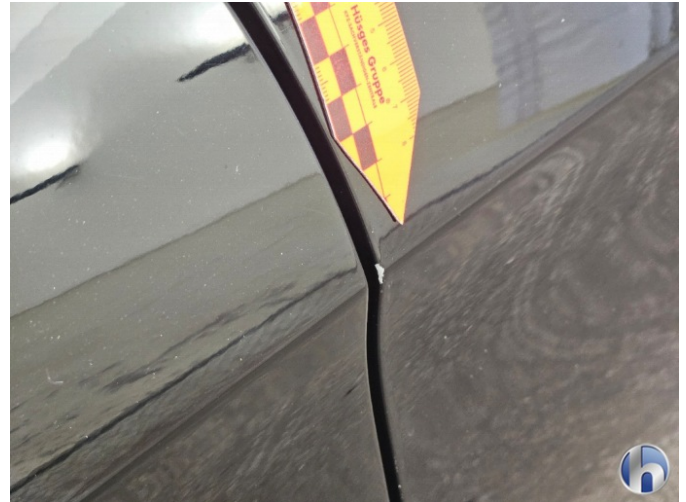
| component | Damage | Rep kind |
|---|---|---|
| 8. Front door - right | Wear and tear | acceptable |

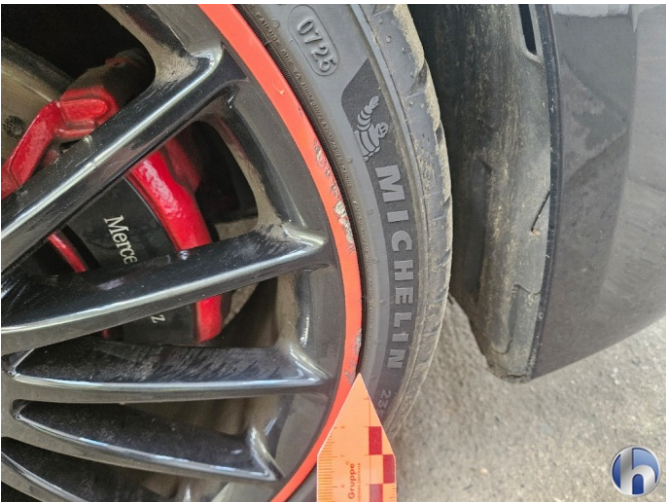
| component | Damage | Rep kind |
|---|---|---|
| 9. | Scratch(es) | Paint |

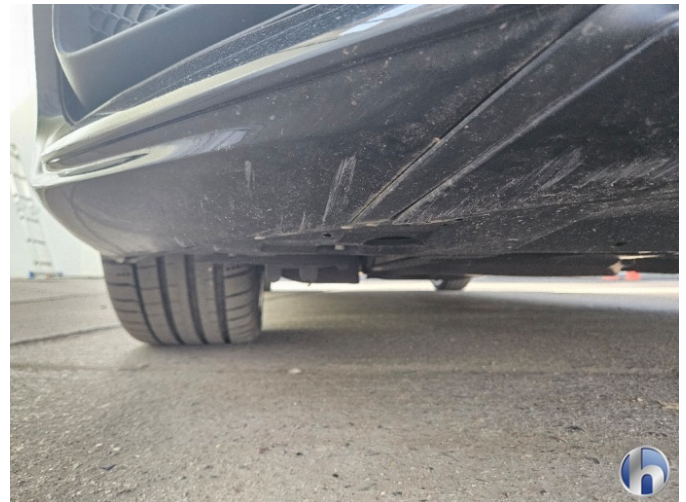
| component | Damage | Rep kind |
|---|---|---|
| 10. Front bumper | Wear and tear | acceptable |

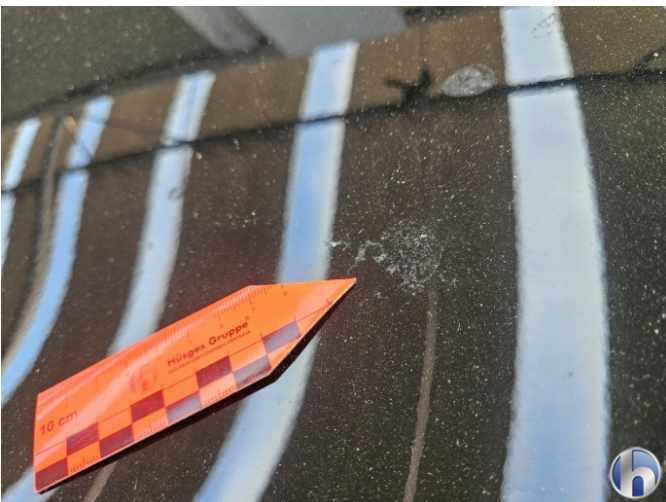
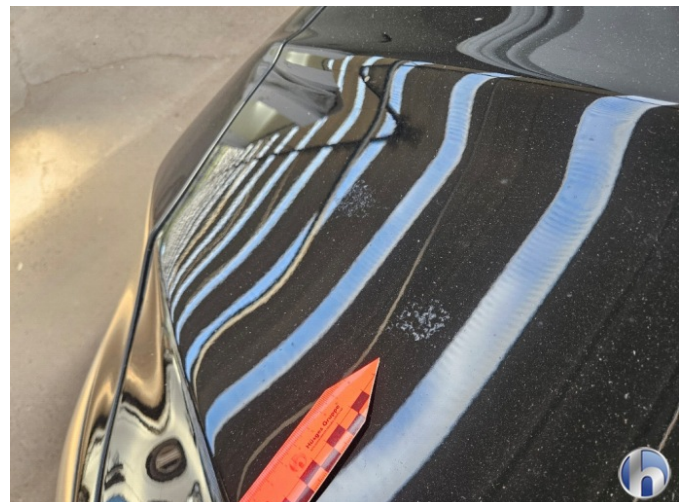
| component | Damage | Rep kind |
|---|---|---|
| 11. hood | | Paint |

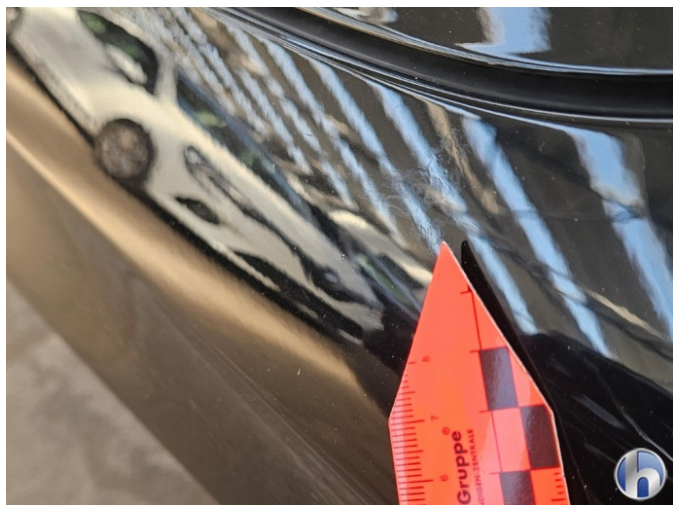
| component | Damage | Rep kind |
|---|---|---|
| 12. Front fender - left | | Paint |

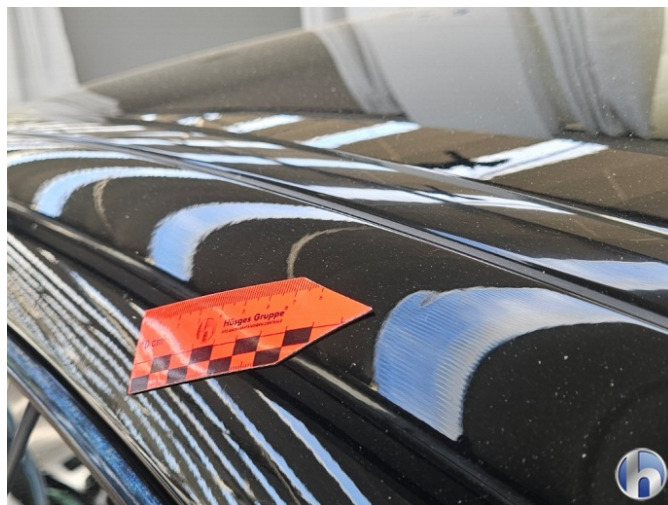
| component | Damage | Rep kind |
|---|---|---|
| 13. Roof frame - left | Wear and tear | acceptable |

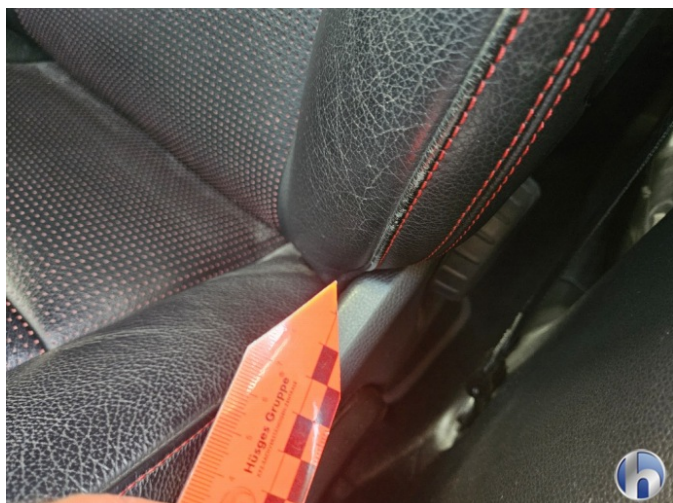
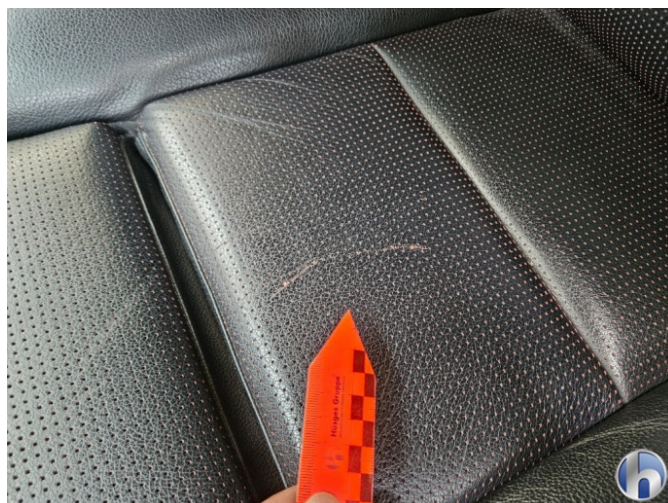
14. Fahrsitz

| component | Damage | Rep kind |
|---|---|---|
| 14. Fahrersitz | Wear and tear | acceptable |
