## status report

#### Mercedes-Benz A -Klasse A 220 CDI / d BlueEfficiency

| Vehicle identification number | <b>WDD1760031J461457</b> | mileage read: | <b>101062 km</b> |

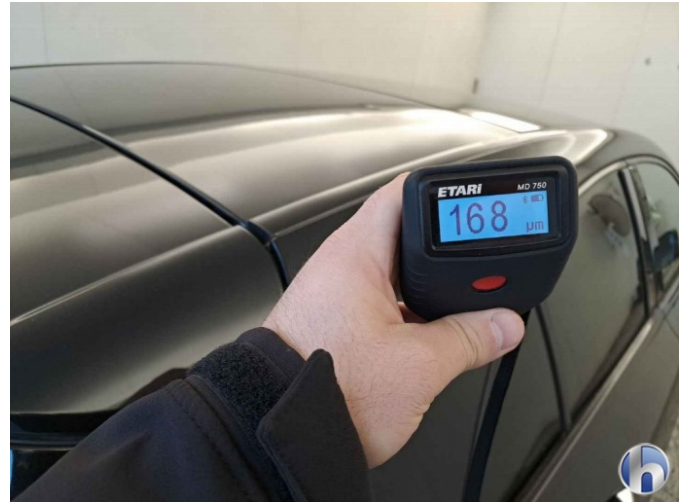
| component | Damage | Rep kind |
|---|---|---|
| 2. Roof frame - right | Subsequently painted | acceptable |

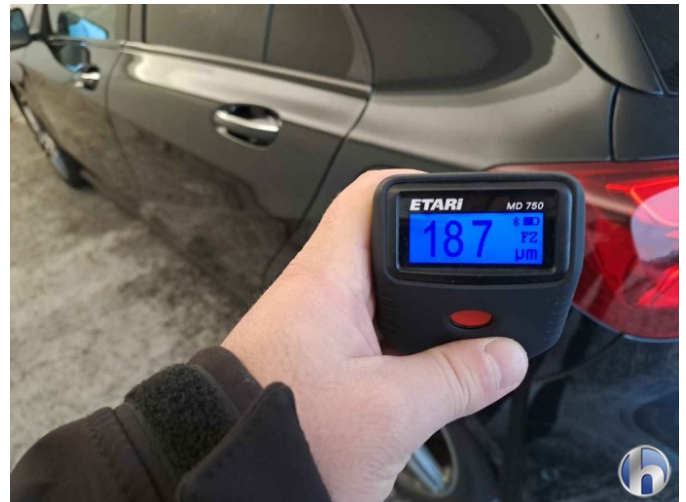
| component | Damage | Rep kind |
|---|---|---|
| 4. Sidewall - Rear - Left | Subsequently painted | acceptable |

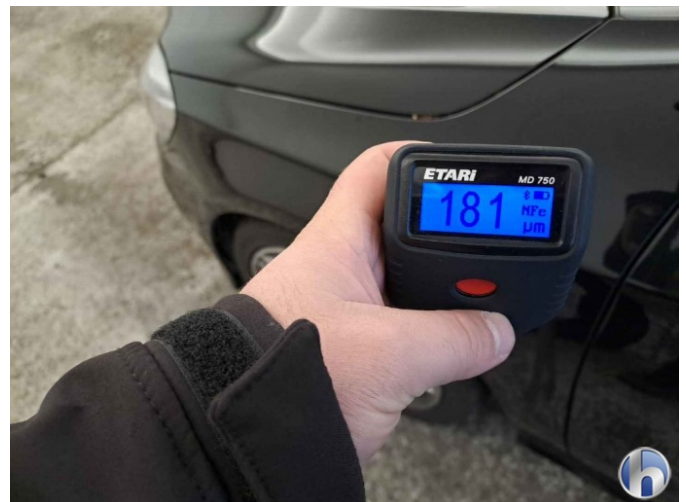
| component | Damage | Rep kind |
|---|---|---|
| 6. Front fender - left | Subsequently painted | acceptable |

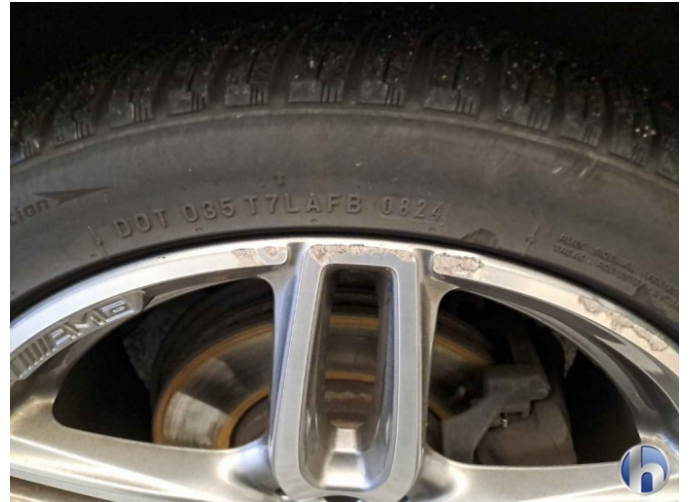
**Note Road Safe:** Reifen beschädigt.

| component | Damage | Rep kind |
|---|---|---|
| 11. tire front - right | Damaged | Replace |

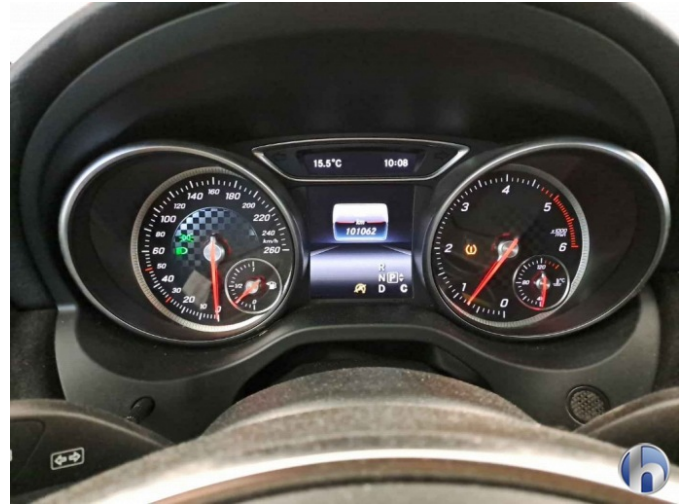
| component | Damage | Rep kind |
|---|---|---|
| 15. warning light | Error message | Carry out a fault diagnosis |

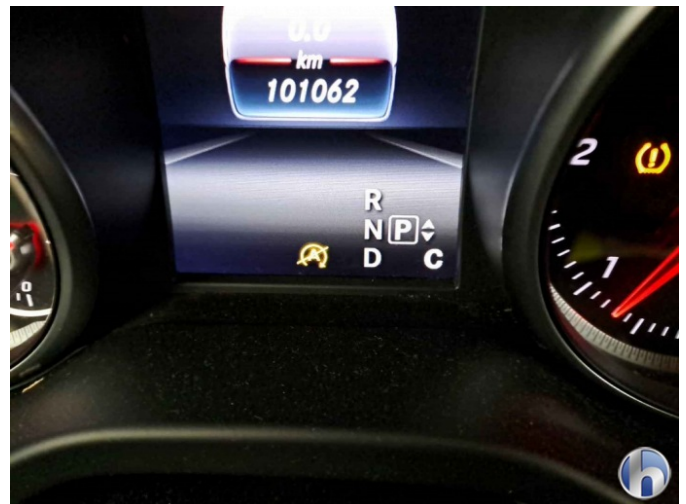
| component | Damage | Rep kind |
|---|---|---|
| 16. warning light | Error message | Carry out a fault diagnosis |

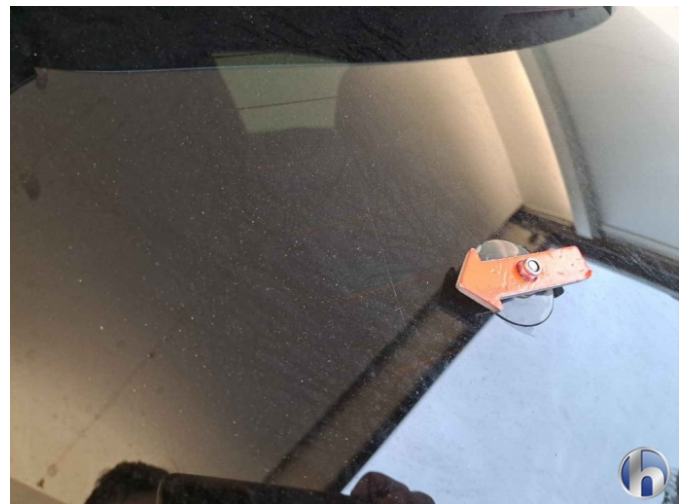
| component | Damage | Rep kind |
|---|---|---|
| 17. rear window | Scratch(es) | Replace |

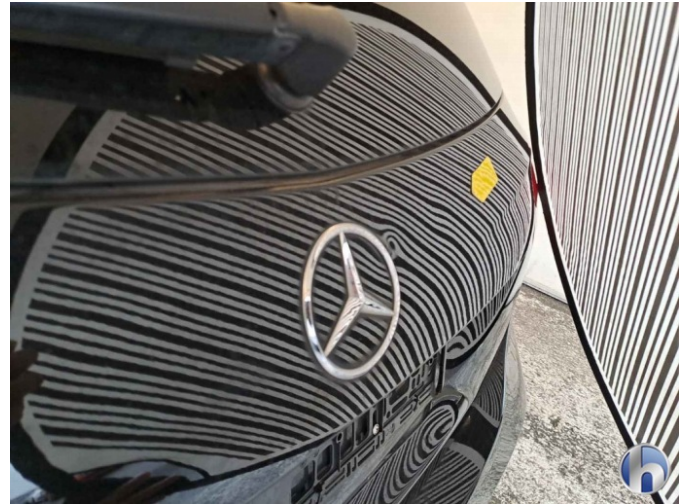
| component | Damage | Rep kind |
|---|---|---|
| 18. tailgate | Damaged | Refurbish and paint |

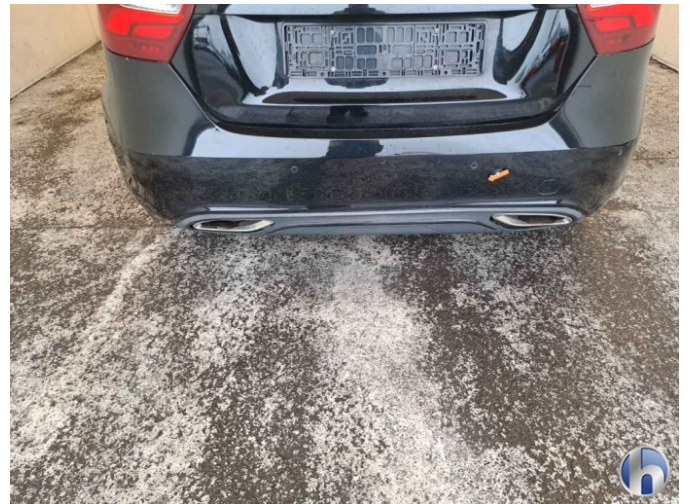
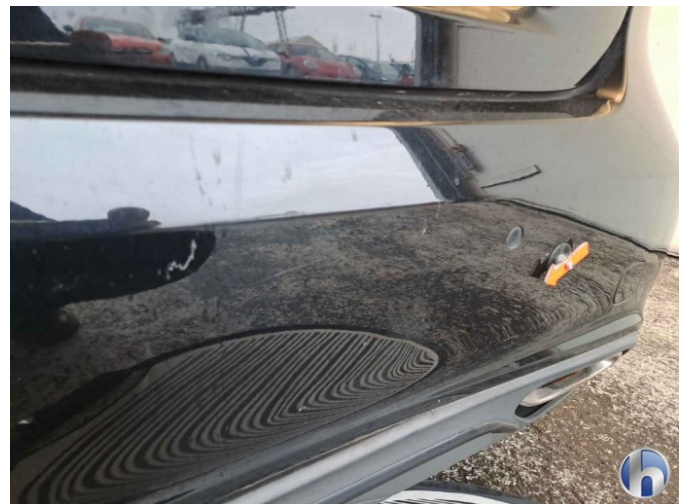
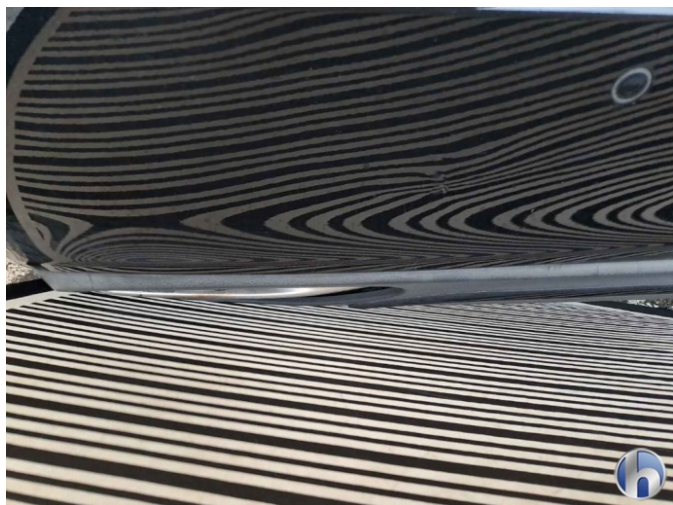
| component | Damage | Rep kind |
|---|---|---|
| 19. Rear bumper | Damaged | Replace |

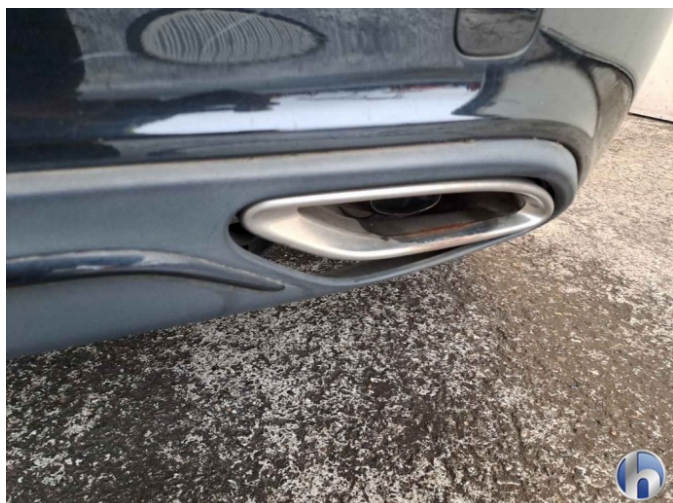
| component | Damage | Rep kind |
|---|---|---|
| 20. Auspuffblende | Damaged | Replace |

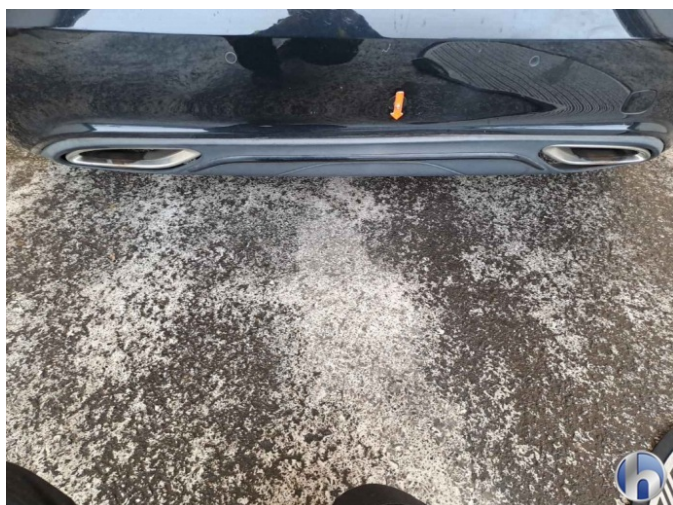
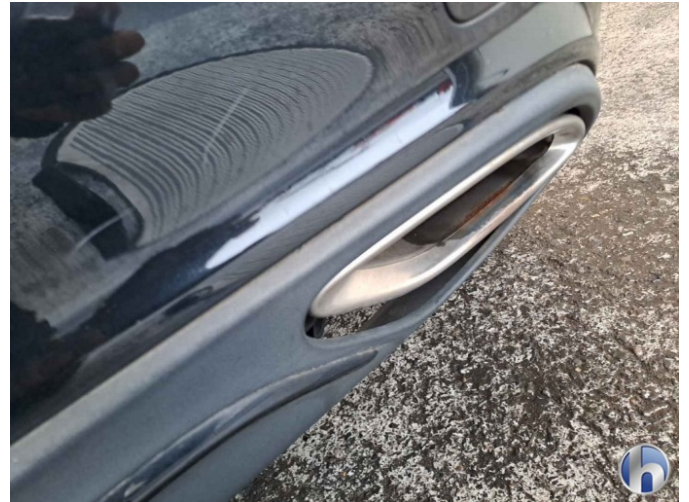
| component | Damage | Rep kind |
|---|---|---|
| 21. Diffusor | Damaged | Replace |

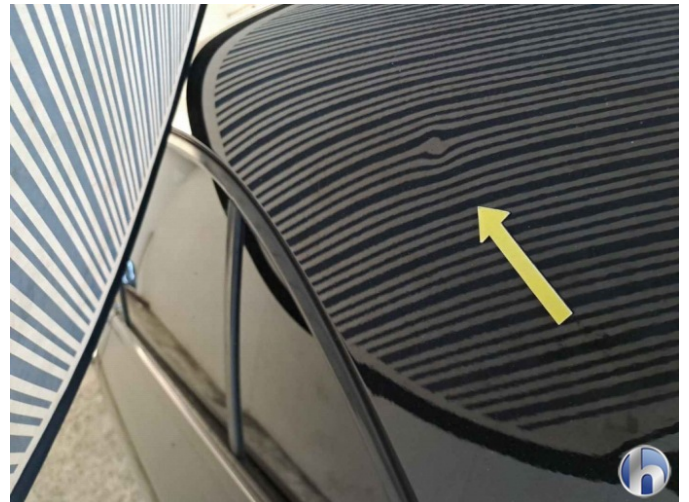
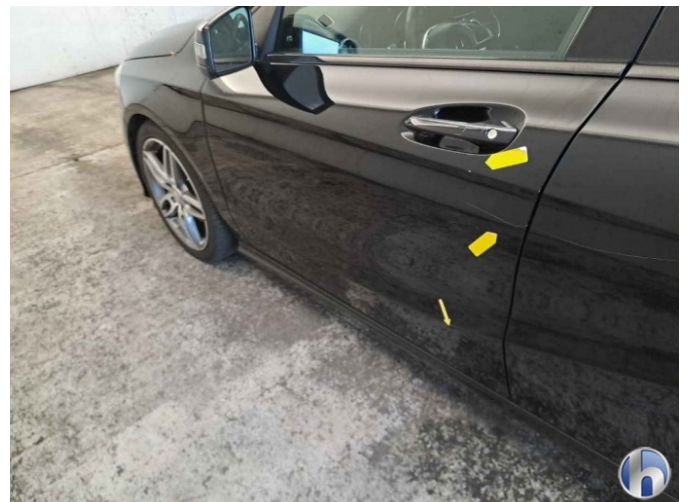
| component | Damage | Rep kind |
|---|---|---|
| 22. Roof frame - left | Damaged | Refurbish and paint |

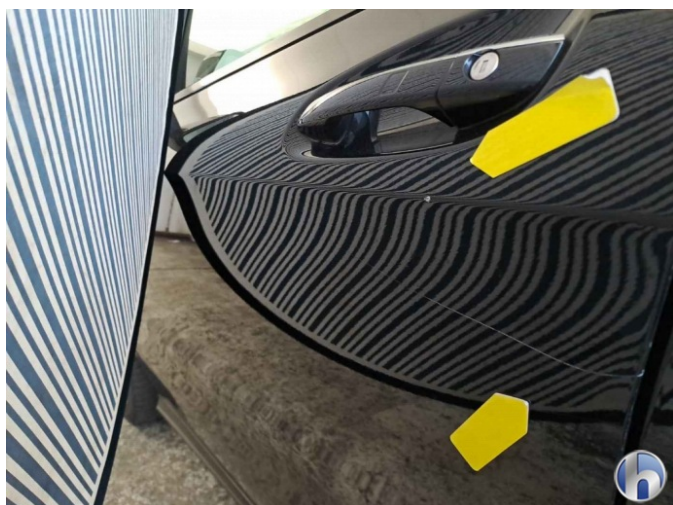
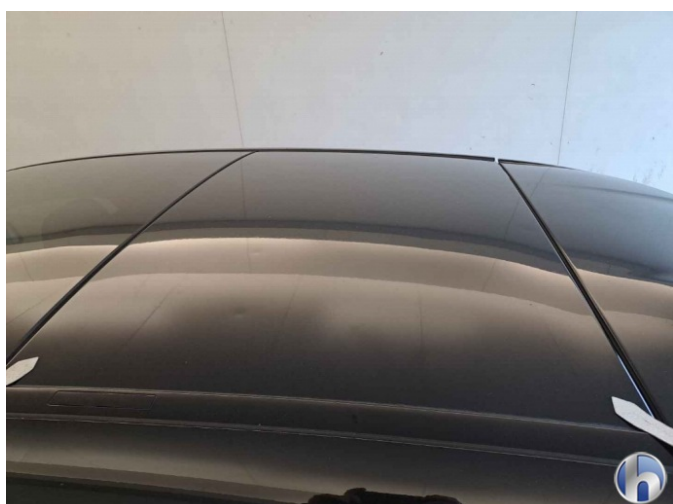
| component | Damage | Rep kind |
|---|---|---|
| 23. Front door - left | Damaged | Refurbish and paint |

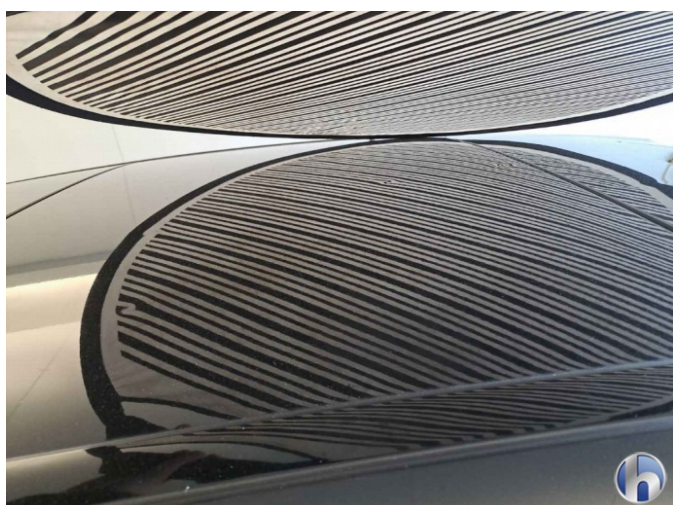
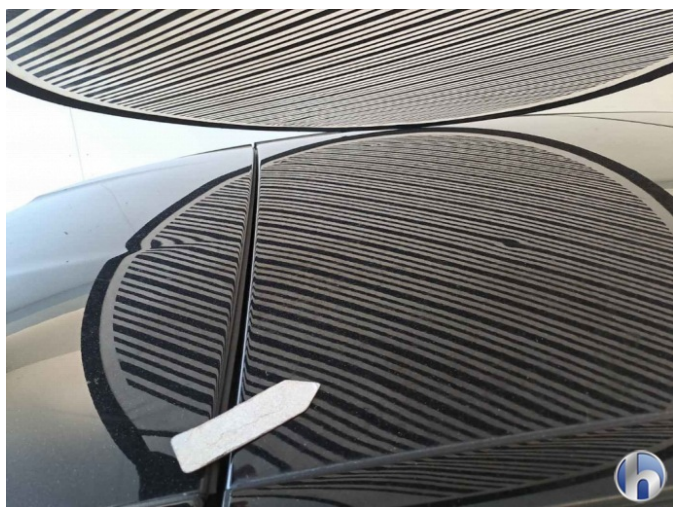
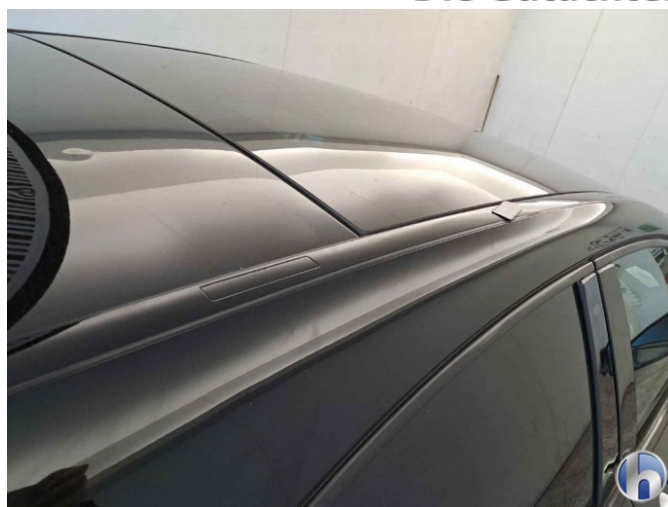
| component | Damage | Rep kind |
|---|---|---|
| 24. Dach mit 15 Dellen à 20mm-30mm | Hail damage | Refurbish and paint |

24. Dach mit 15 Dellen à 20mm-30mm

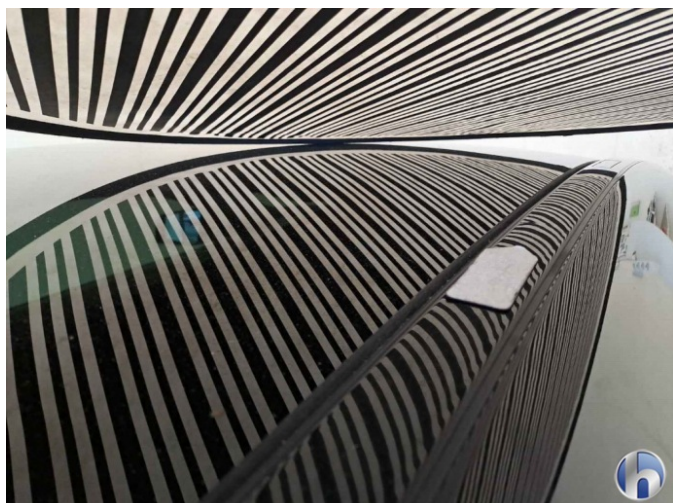
| component | Damage | Rep kind |
|---|---|---|
| 25. Dachleiste Rechts | Deformed | Replace |

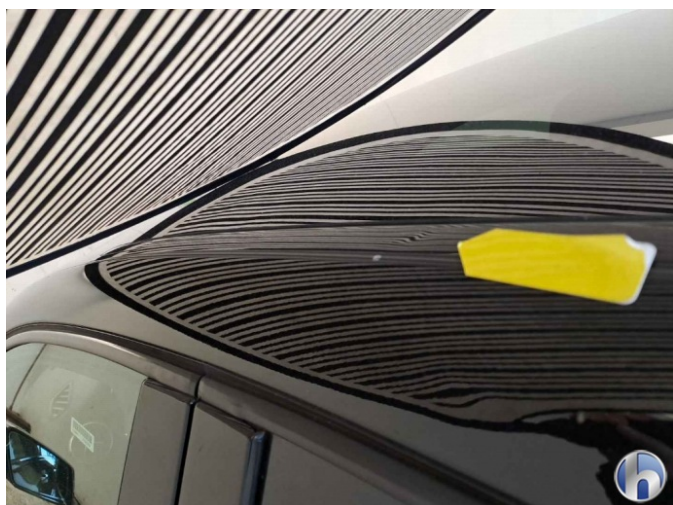
| component | Damage | Rep kind |
|---|---|---|
| 26. Dachleiste Links | Deformed | Replace |

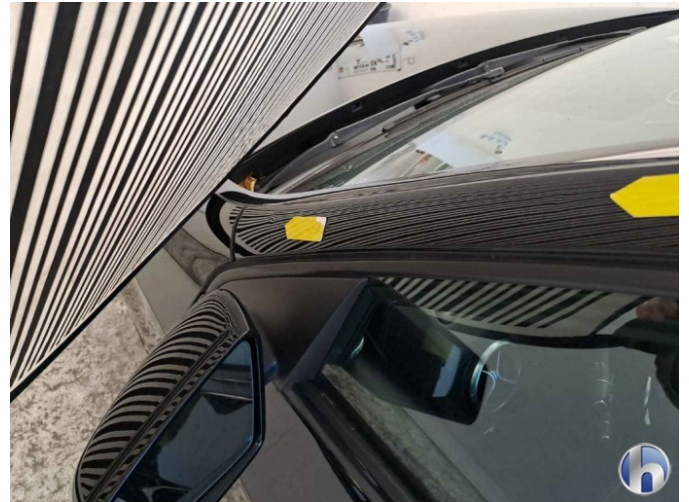
| component | Damage | Rep kind |
|---|---|---|
| 27. A-pillar Front - Left | Deformed | Refurbish and paint |

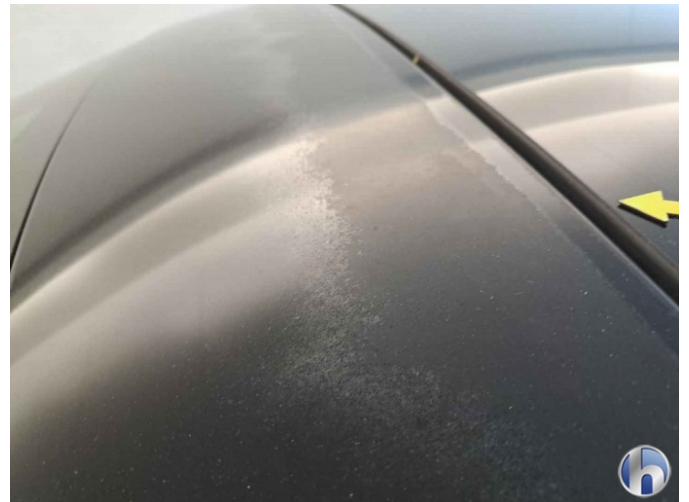
| component | Damage | Rep kind |
|---|---|---|
| 28. Dach Vorne | Damaged | Replace |

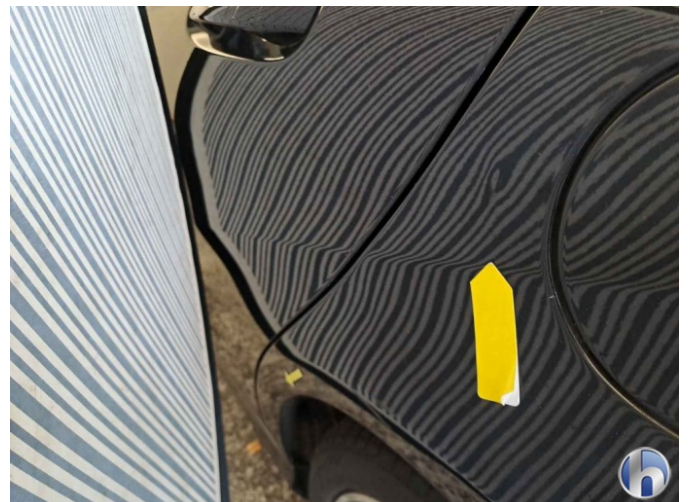
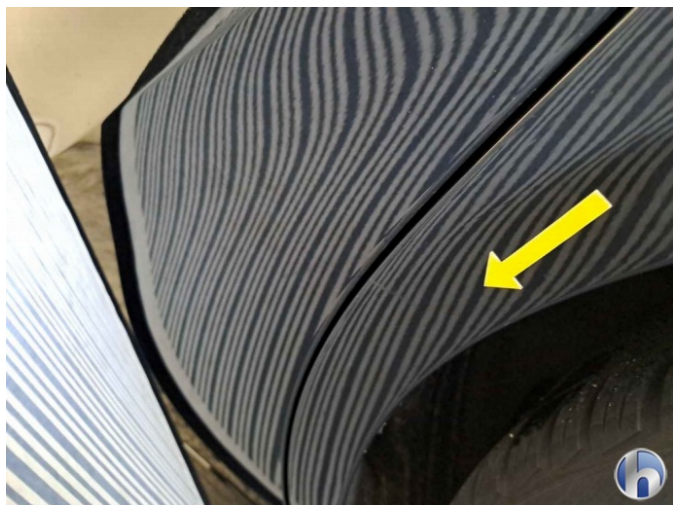
| component | Damage | Rep kind |
|---|---|---|
| 29. Sidewall - Rear - Left | Damaged | Refurbish and paint |

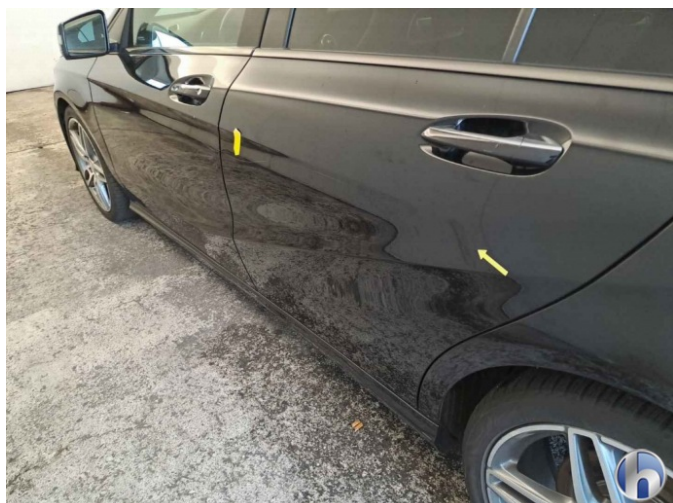
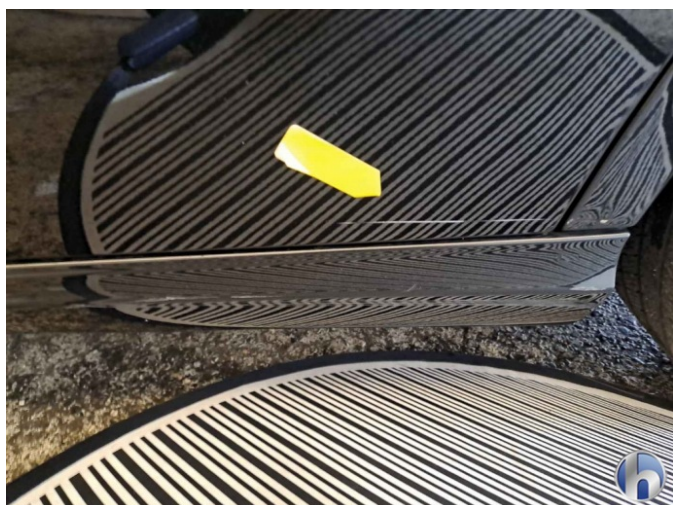
| component | Damage | Rep kind |
|---|---|---|
| 30. Rear door - left | Scratch(es) | Paint |

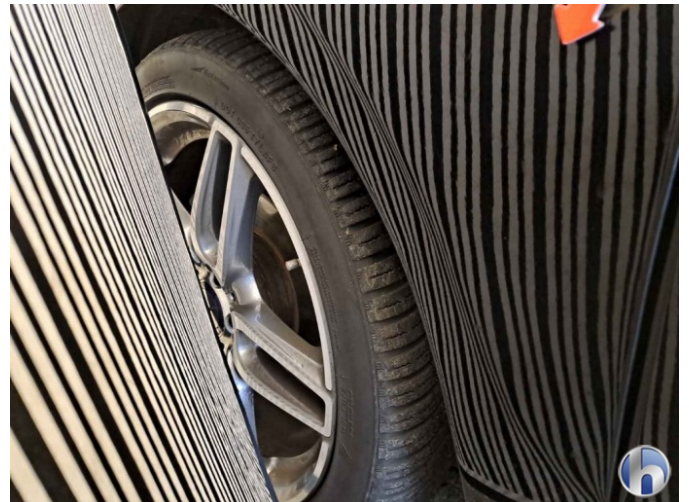
| component | Damage | Rep kind |
|---|---|---|
| 32. Front fender - left | Execution defect | Refurbish and paint |

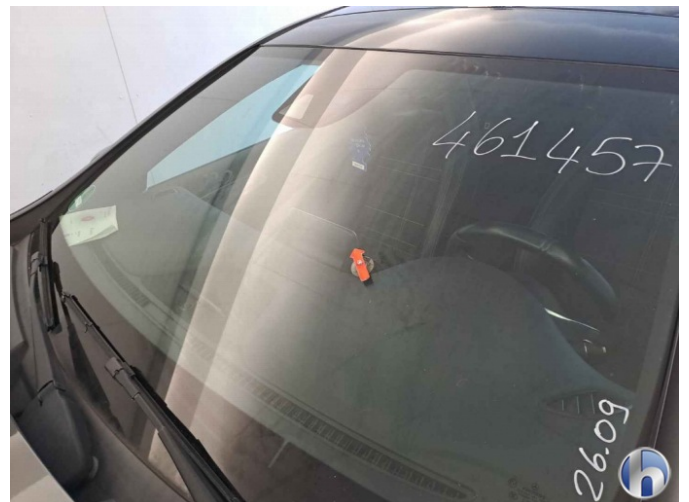
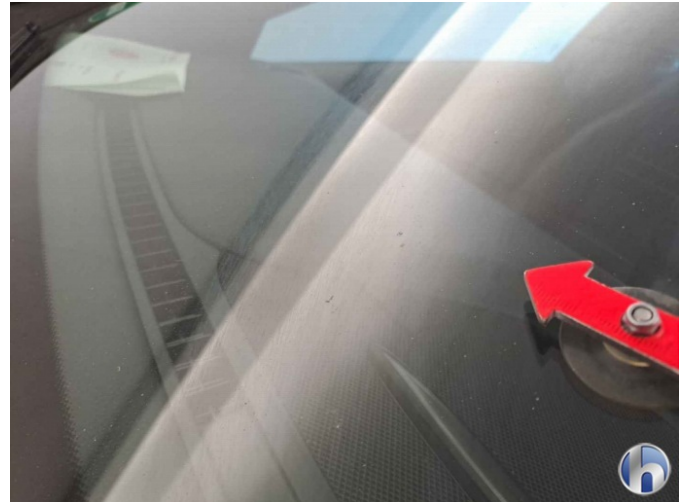
| component | Damage | Rep kind |
|---|---|---|
| 33. Windshield | Chipping from stones in field of view | Replace |

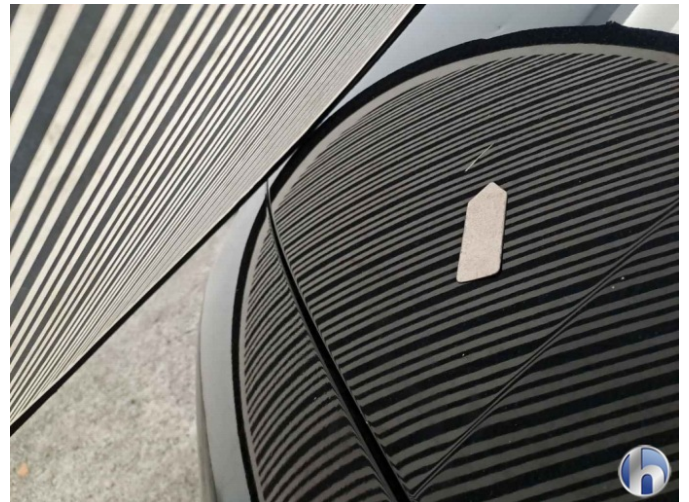
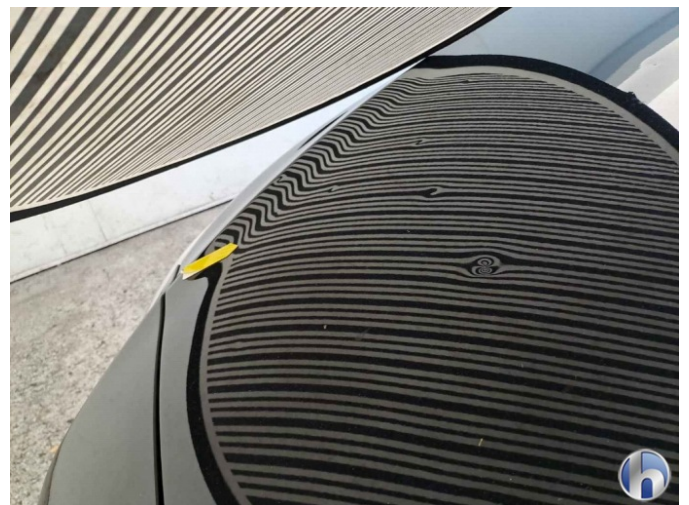
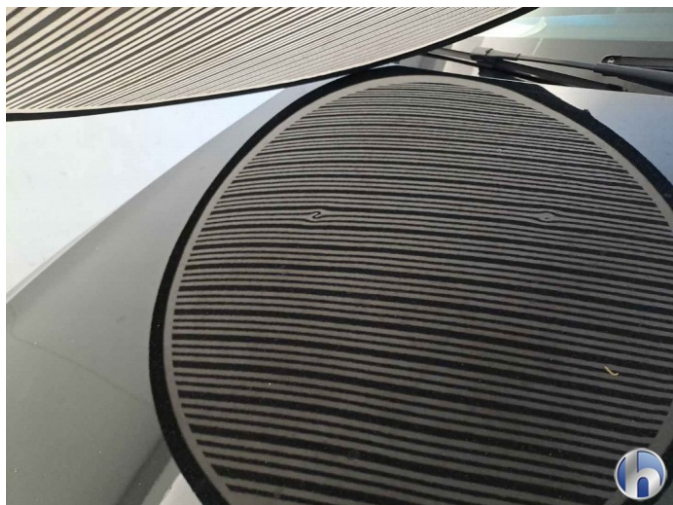
| component | Damage | Rep kind |
|---|---|---|
| 34. Motorhaube mit 30 Dellen à 20mm-30mm und einer Verformung mit Kratzer | Damaged | Refurbish and paint |

34. Motorhaube mit 30 Dellen à 20mm-30mm und einer Verformung mit Kratzer

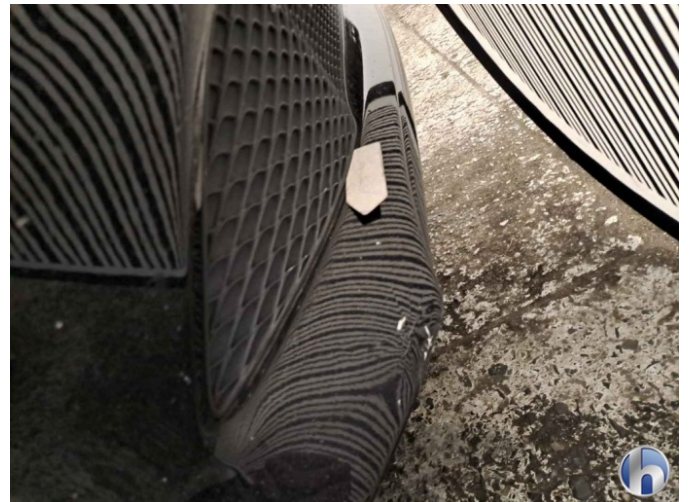
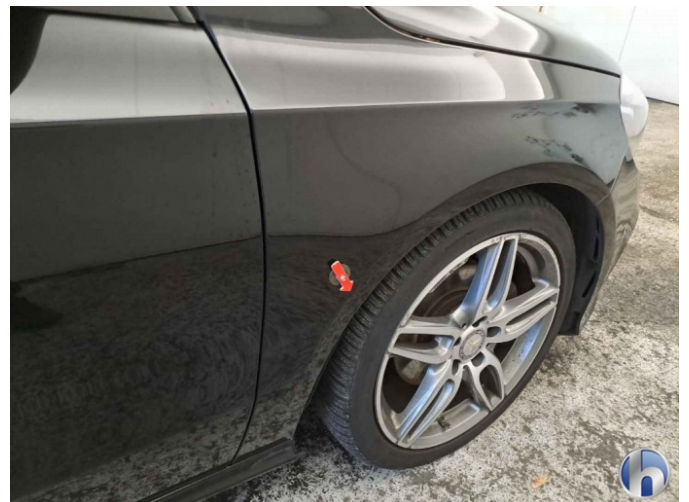
| component | Damage | Rep kind |
|---|---|---|
| 37. Front bumper | Execution defect | Replace |

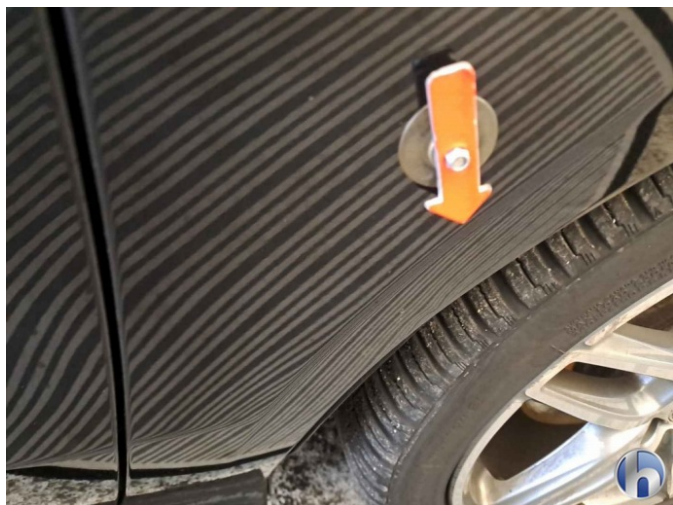
38. Front fender - right

| 38. | Front fender - right | Deformed | Refurbish and paint |

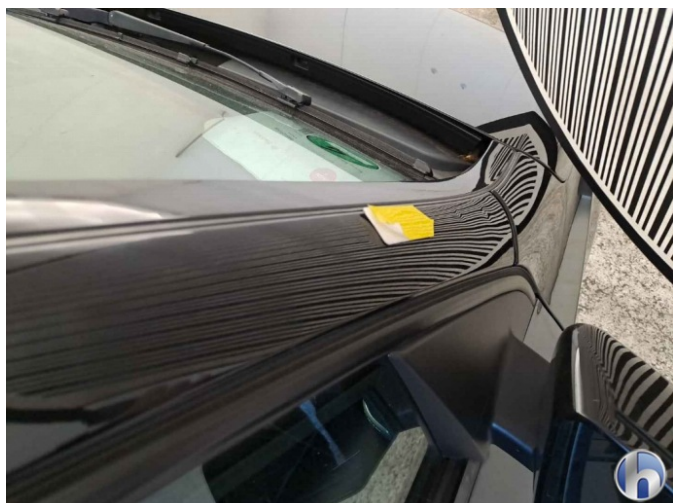
39. A-pillar Front - right

| 39. | A-pillar Front - right | Deformed | Refurbish and paint |

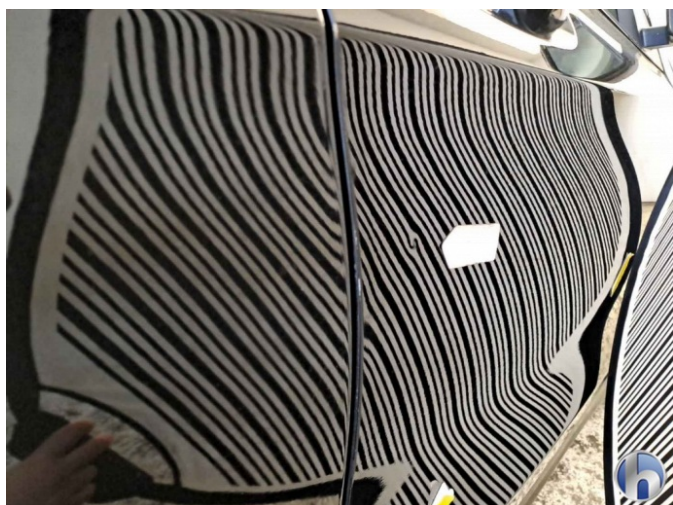
40. Front door - right

| 40. | Front door - right | Damaged | Refurbish and paint |

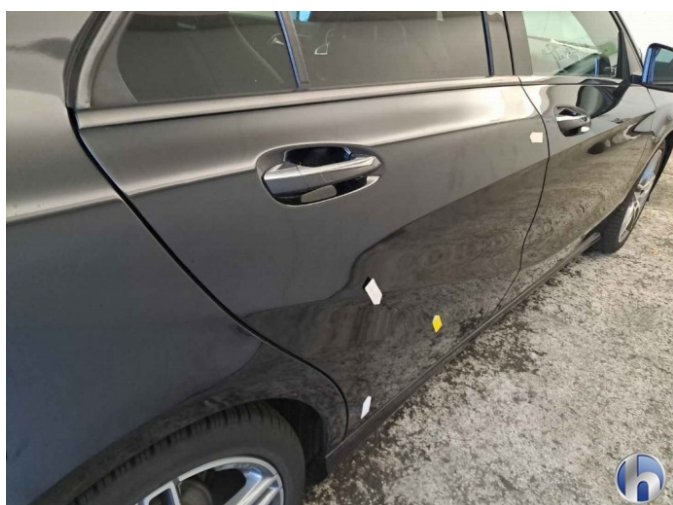
43. Door Rear - right

| 43. | Door Rear - right | Execution defect | Refurbish and paint |

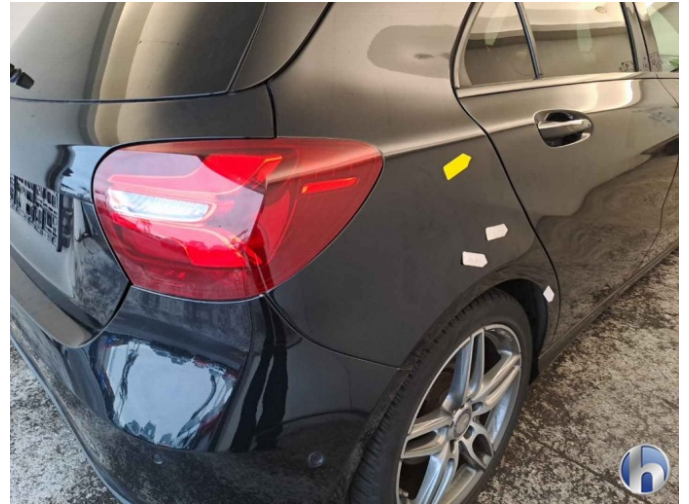
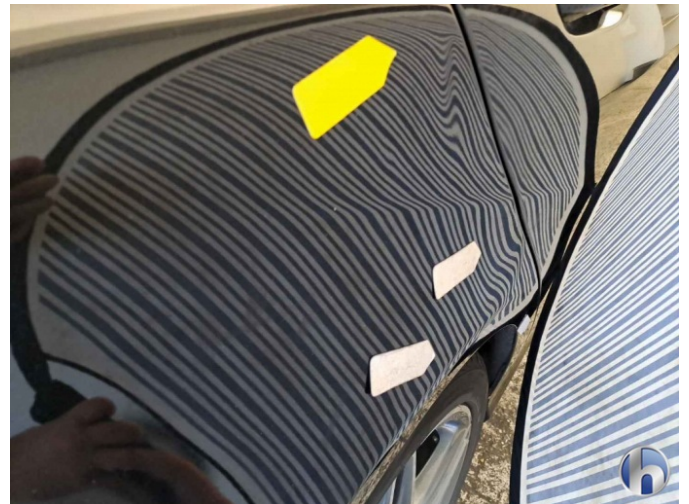
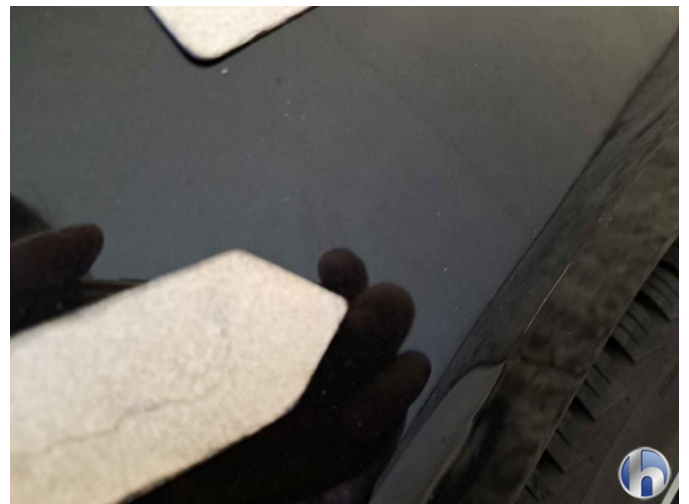
44. Sidewall - Rear - right

| 44. | Sidewall - Rear - right | Damaged | Refurbish and paint |

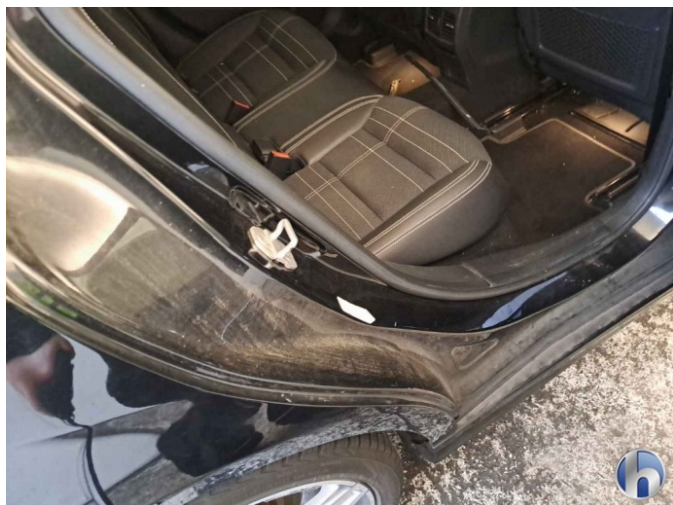
45. Türeinstieg Hinten - Rechts

| 45. | Türeinstieg Hinten - Rechts | Scratch(es) | Paint |

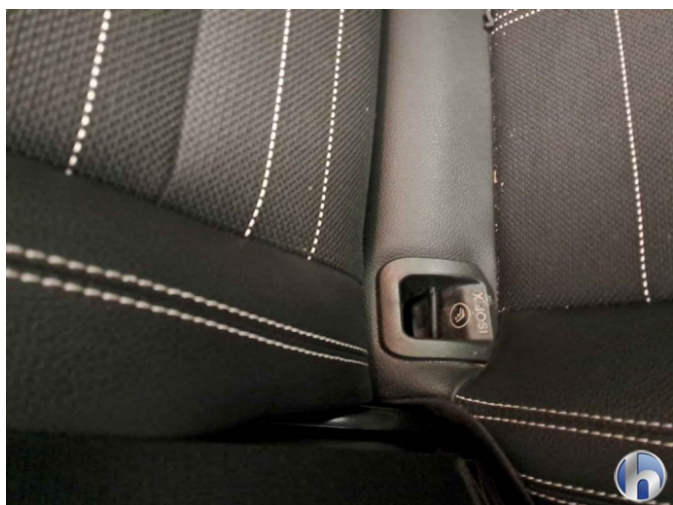
46. Sitzbank - Hinten: Kissen

| 46. | Sitzbank - Hinten: Kissen | Damaged | Replace |

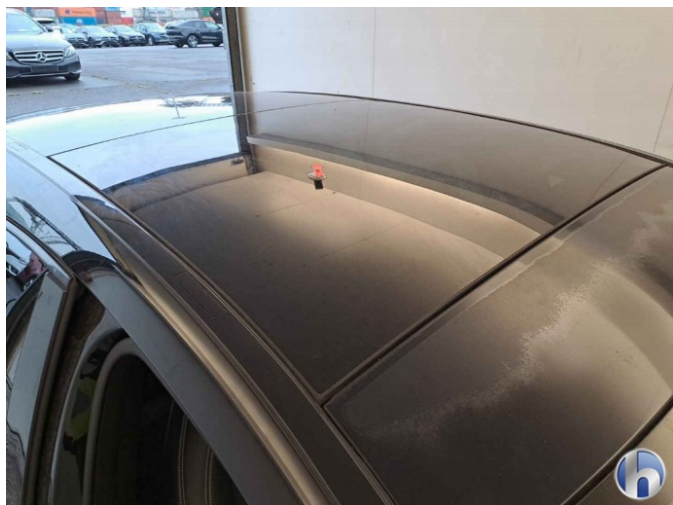
47. Sunroof

| 47. | Sunroof | Scratch(es) | Replace |

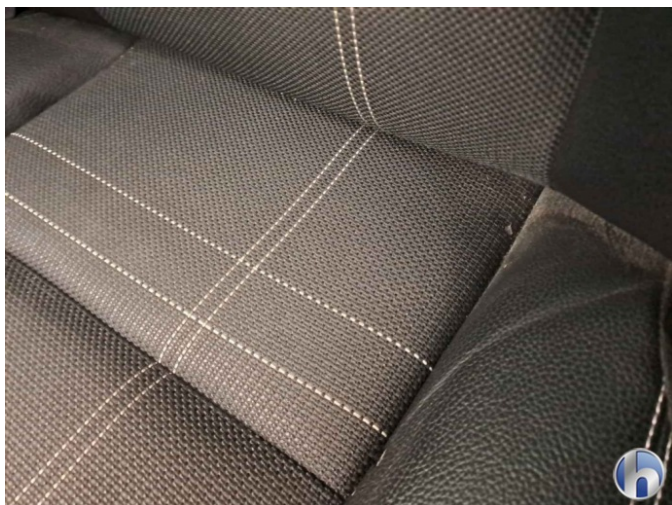
49. Sitz - Vorne - Links: Kissen

| 49. | Sitz - Vorne - Links: Kissen | Burn hole | Smart repair |
