## status report

| <b>customer:</b> | <b>Bank 11, Neuss</b> |

| vehicle data | | | |
|---|---|---|---|
| <b>Mercedes-Benz C -Klasse Lim. C 220 CDI BlueEfficiency</b> | | | |
| Vehicle identification number | <b>WDD2040021A861718</b> | mileage read: | <b>215306 km</b> |

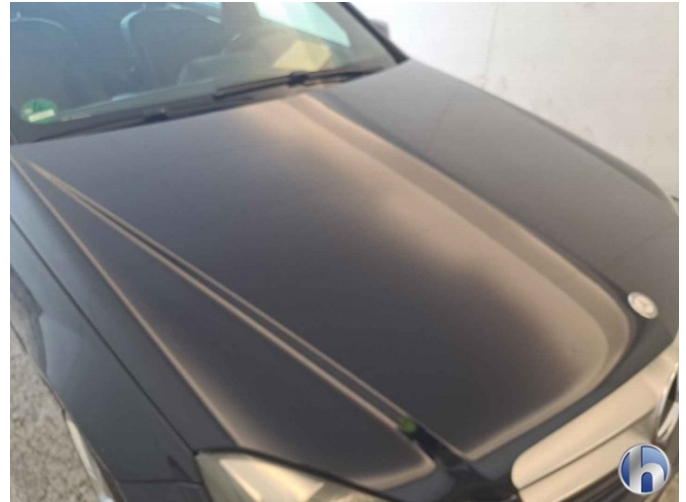
| component | Damage | Rep kind |
|---|---|---|
| 1. hood | Subsequently painted | acceptable |
| 23. hood | Damaged | Refurbish and paint |

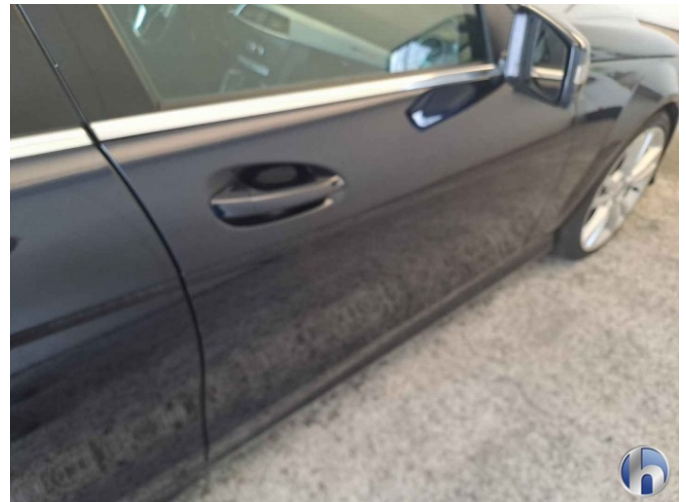
| component | Damage | Rep kind |
|---|---|---|
| 2. Front door - right | Subsequently painted | acceptable |

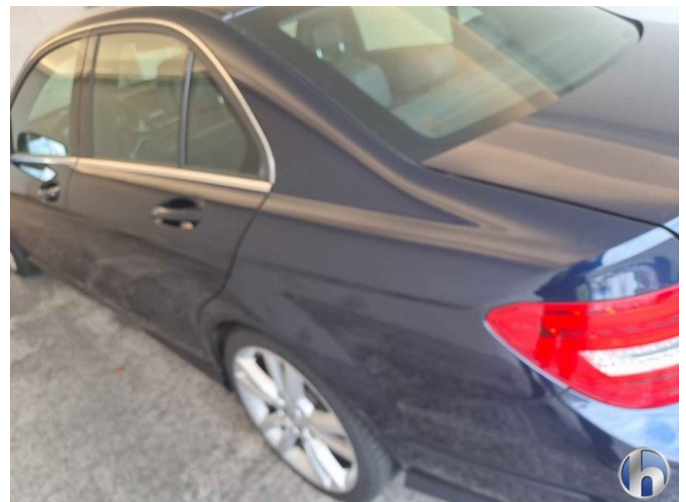
| component | Damage | Rep kind |
|---|---|---|
| 3. Sidewall - Rear - Left | Subsequently painted | acceptable |

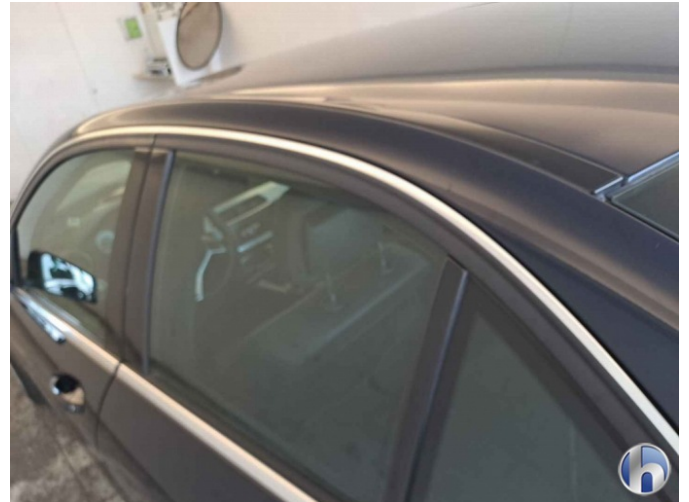
| component | Damage | Rep kind |
|---|---|---|
| 4. Roof frame - left | Subsequently painted | acceptable |

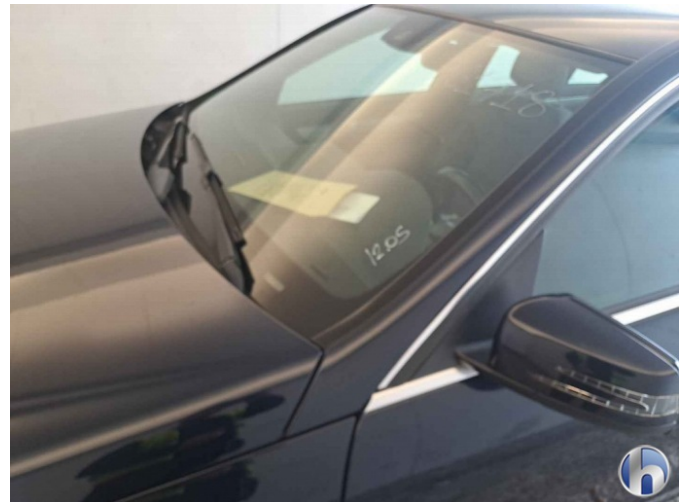
| component | Damage | Rep kind |
|---|---|---|
| 5. A-pillar Front - Left | Subsequently painted | acceptable |

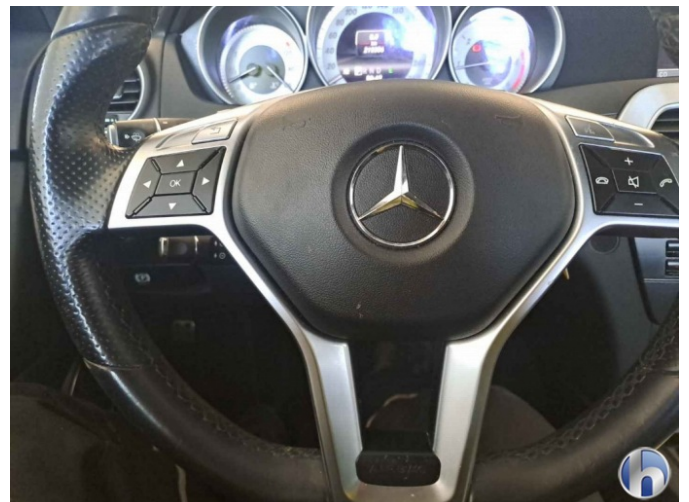
| component | Damage | Rep kind |
|---|---|---|
| 8. Lenkrad Spange | Damaged | Replace |

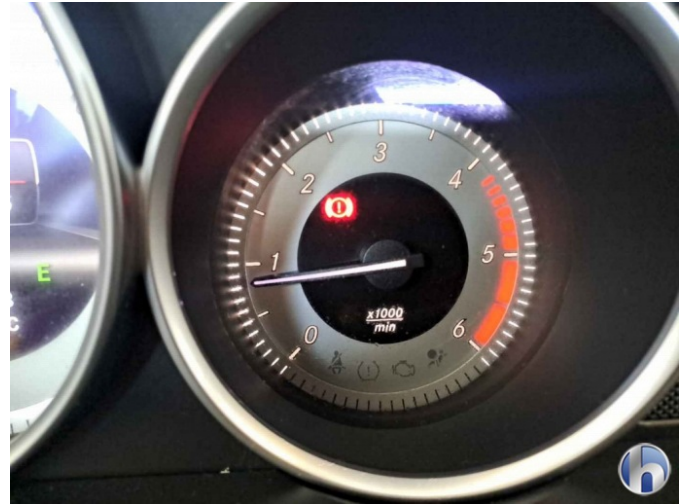
| component | Damage | Rep kind |
|---|---|---|
| 9. warning light | Error message | Carry out a fault diagnosis |

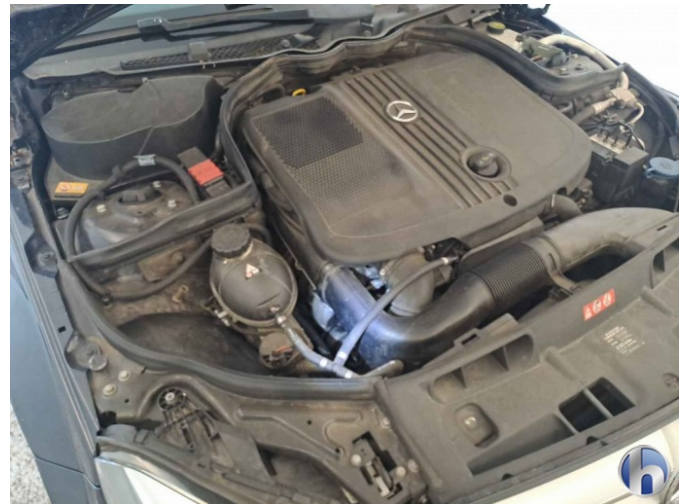
| component | Damage | Rep kind |
|---|---|---|
| 10. motor | oil loss | Carry out a fault diagnosis |

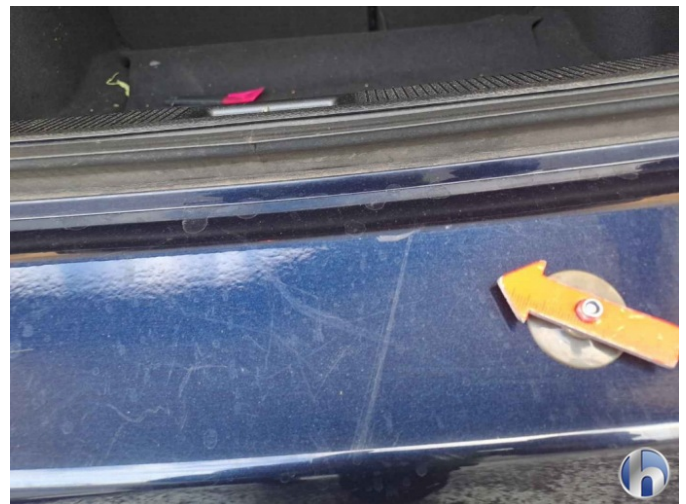
| component | Damage | Rep kind |
|---|---|---|
| 11. Rear bumper | Scratch(es) | Paint |

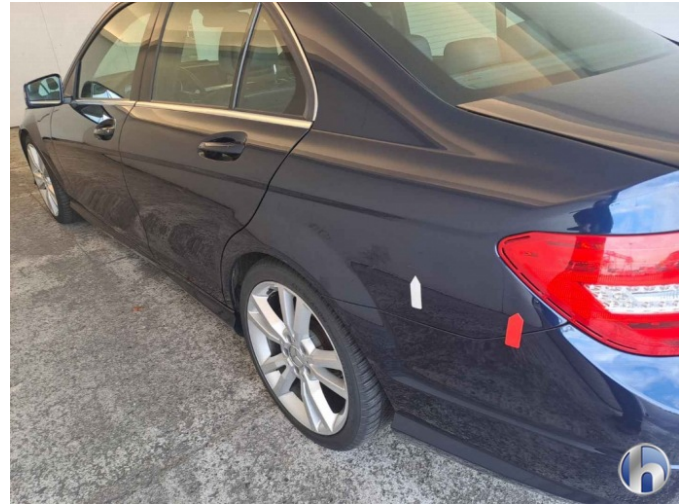
| component | Damage | Rep kind |
|---|---|---|
| 12. exterior body | Surface scratch(es) | |

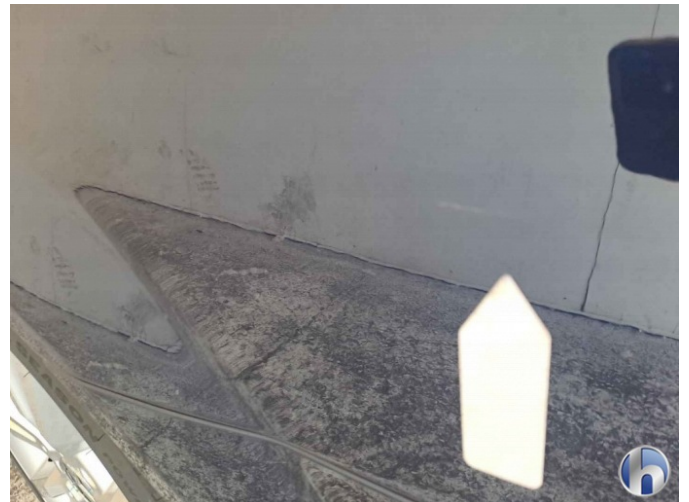
| component | Damage | Rep kind |
|---|---|---|
| 13. Sidewall - Rear - Left | Scratch(es) | Paint |

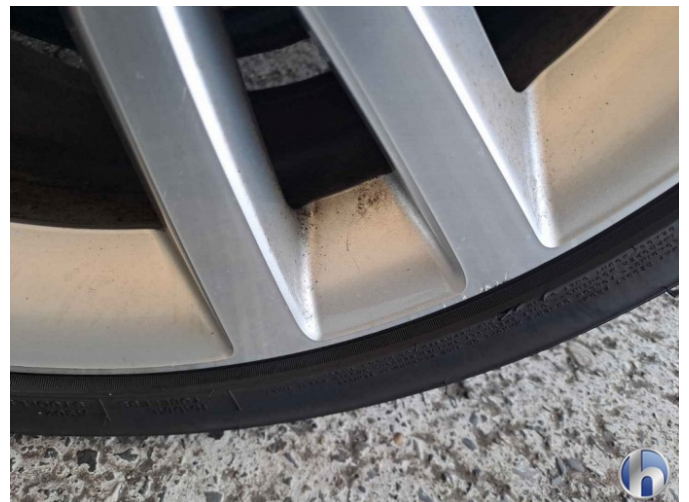
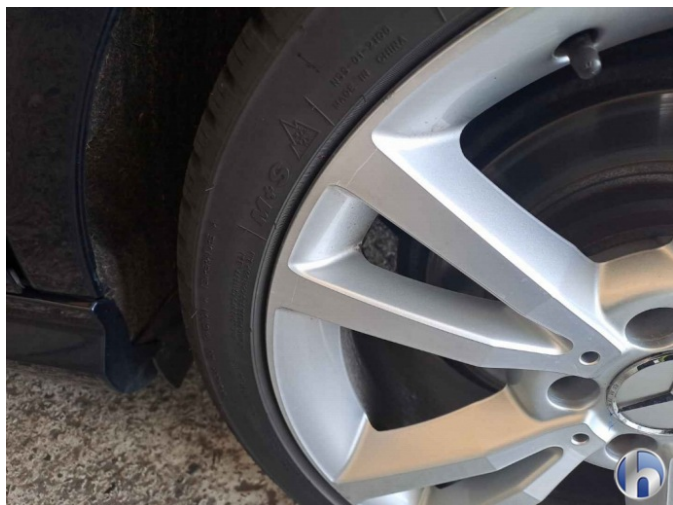
| component | Damage | Rep kind |
|---|---|---|
| 14. | Scratch(es) | Replace |

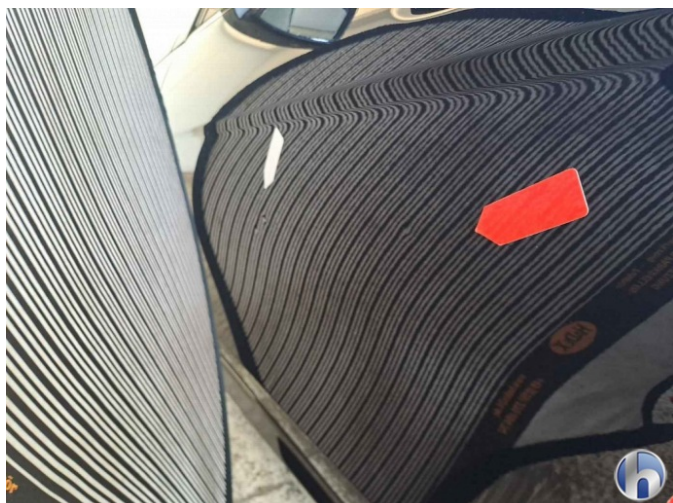
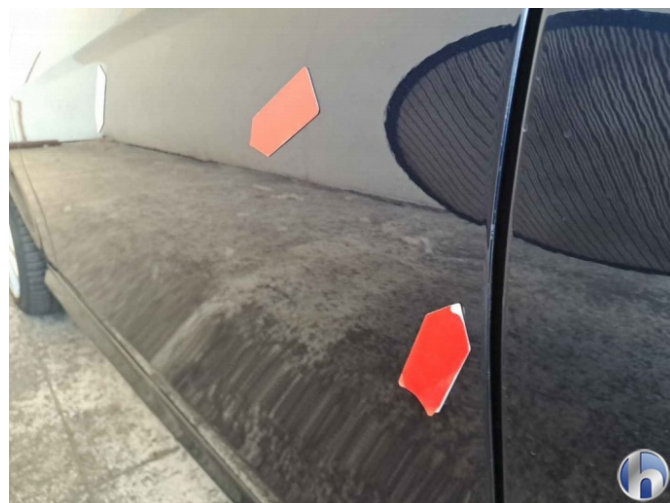
| component | Damage | Rep kind |
|---|---|---|
| 15. Front door - left | Damaged | Refurbish and paint |

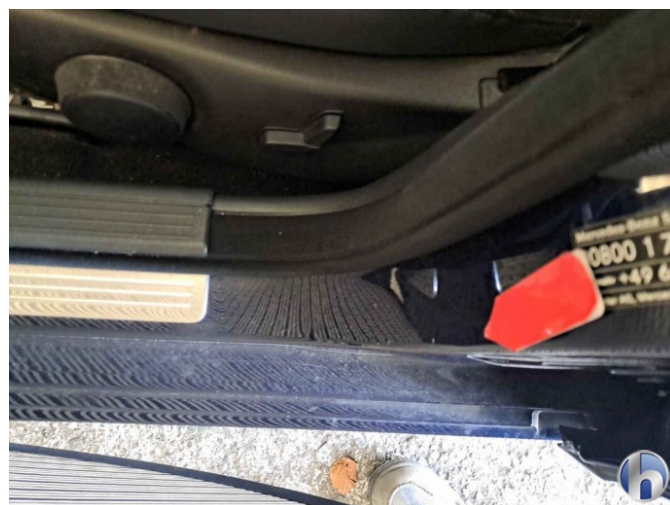
| component | Damage | Rep kind |
|---|---|---|
| 16. Türeinstieg Vorne - Links | Damaged | Refurbish and paint |

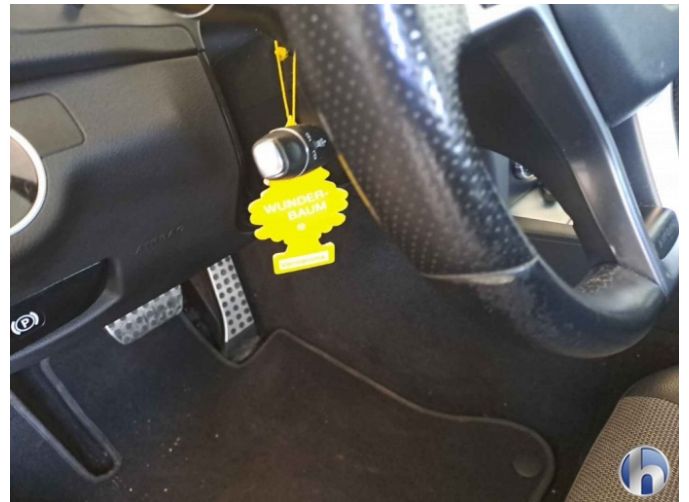
| component | Damage | Rep kind |
|---|---|---|
| 18. Steering wheel (leather) | Scrape | Replace |

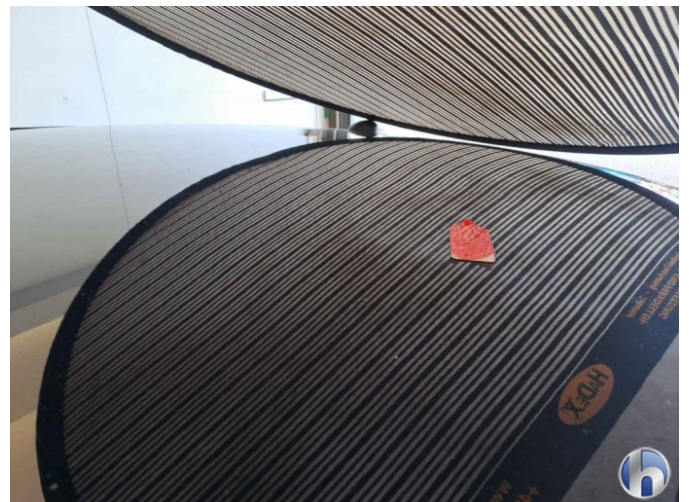
| component | Damage | Rep kind |
|---|---|---|
| 19. roof | Deformed | Refurbish and paint |

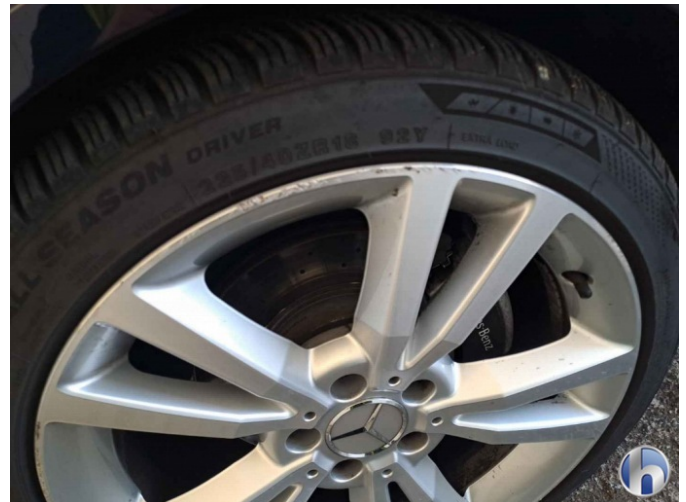
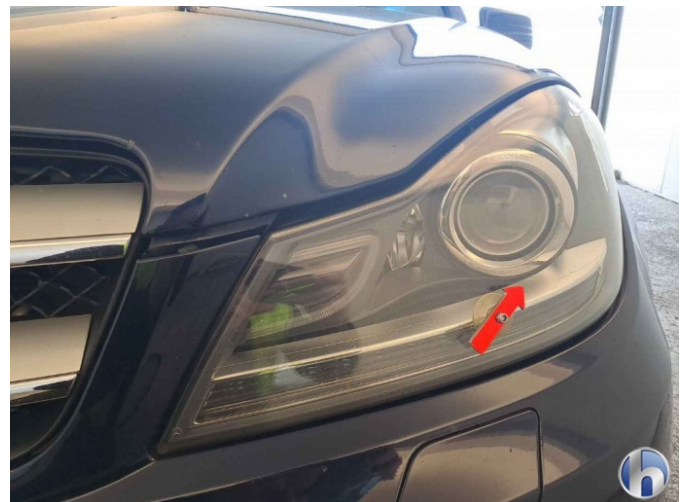
| component | Damage | Rep kind |
|---|---|---|
| 24. | Scratch(es) | Replace |

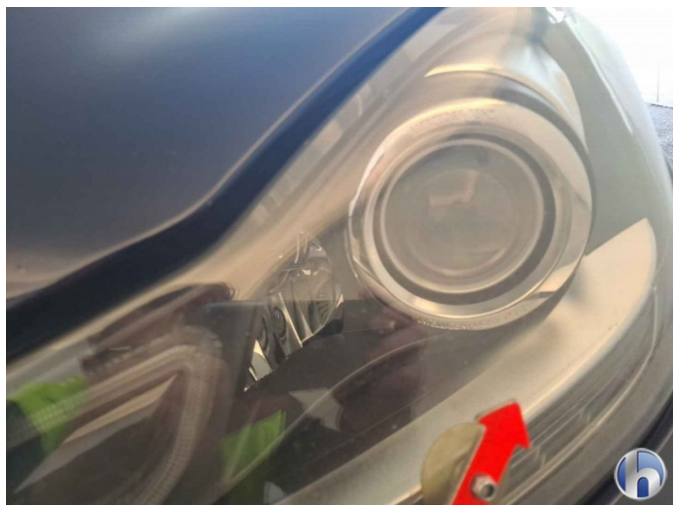
| component | Damage | Rep kind |
|---|---|---|
| 25. Scheinwerfer - Links | Scratch(es) | Replace |

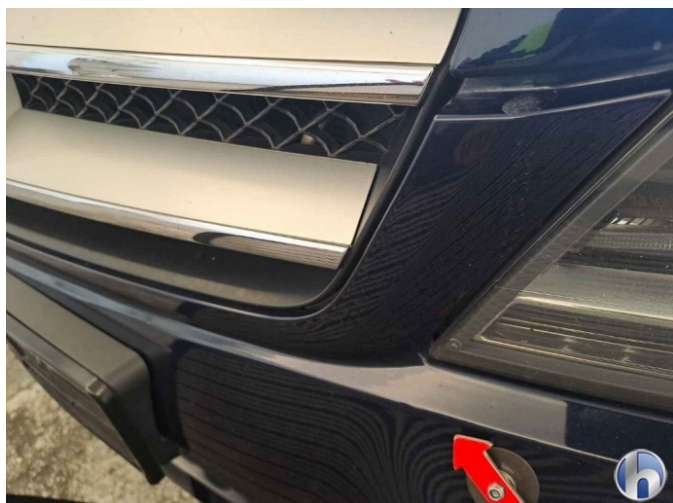
| component | Damage | Rep kind |
|---|---|---|
| 26. Front bumper | Execution defect | Paint |

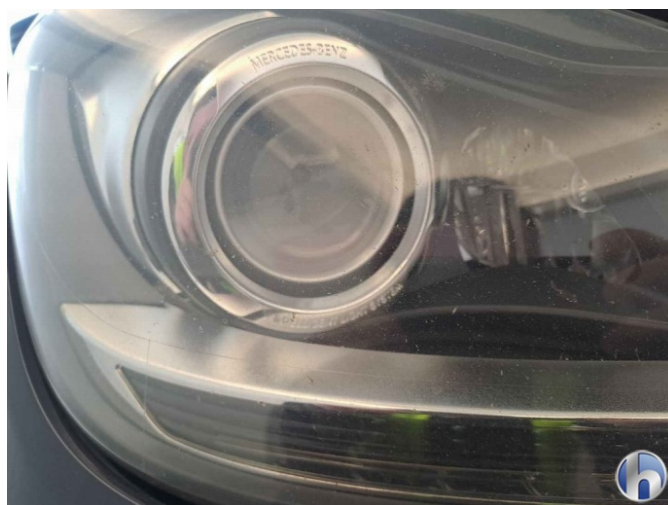
| component | Damage | Rep kind |
|---|---|---|
| 27. Scheinwerfer - Rechts | Scratch(es) | Replace |

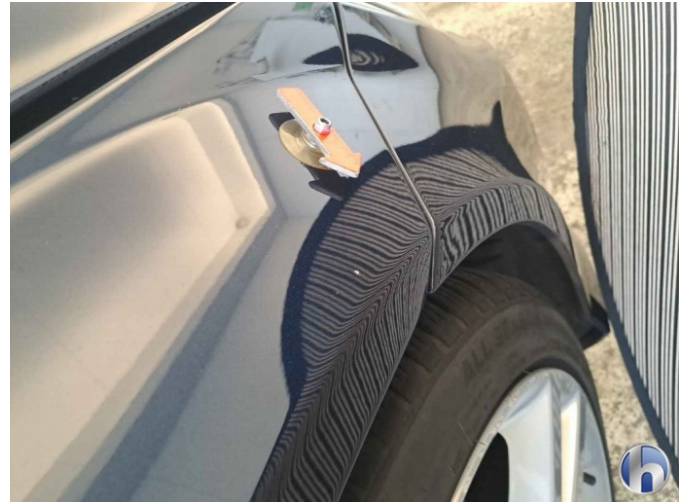
| component | Damage | Rep kind |
|---|---|---|
| 28. Front fender - right | Damaged | Refurbish and paint |

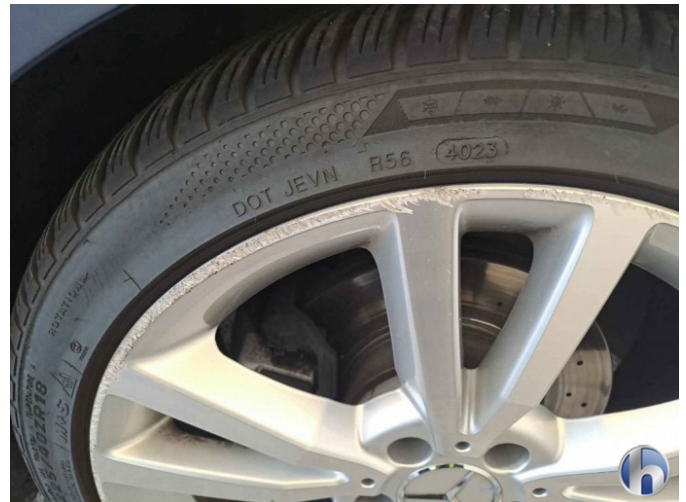
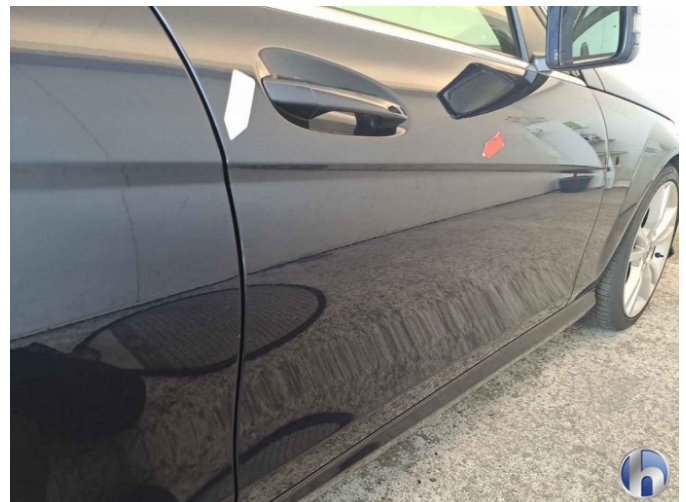
| component | Damage | Rep kind |
|---|---|---|
| 29. | Scratch(es) | Replace |

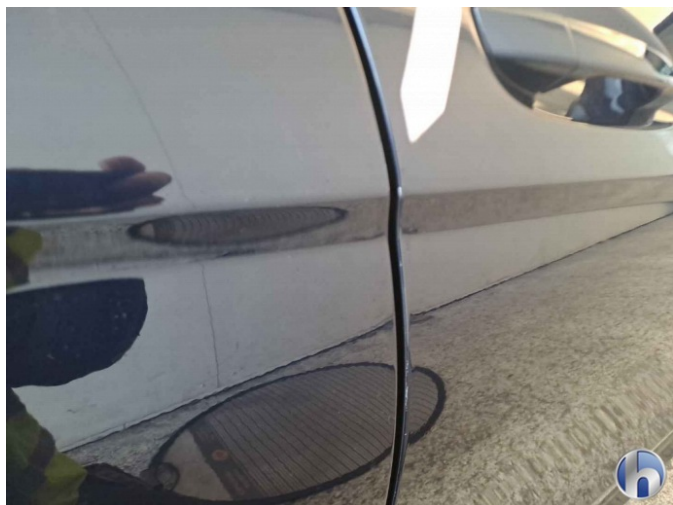
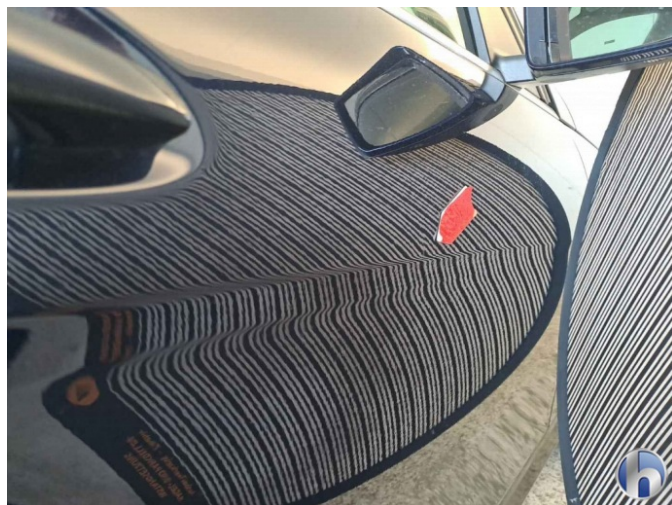
| component | Damage | Rep kind |
|---|---|---|
| 30. Front door - right | Damaged | Refurbish and paint |

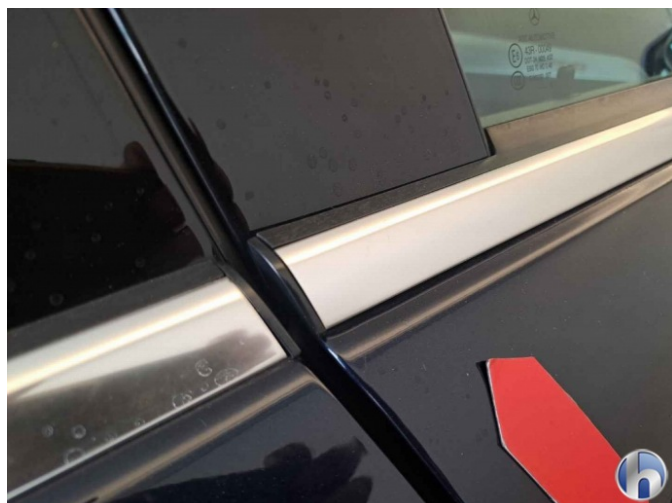
| component | Damage | Rep kind |
|---|---|---|
| 31. | Damaged | Replace |

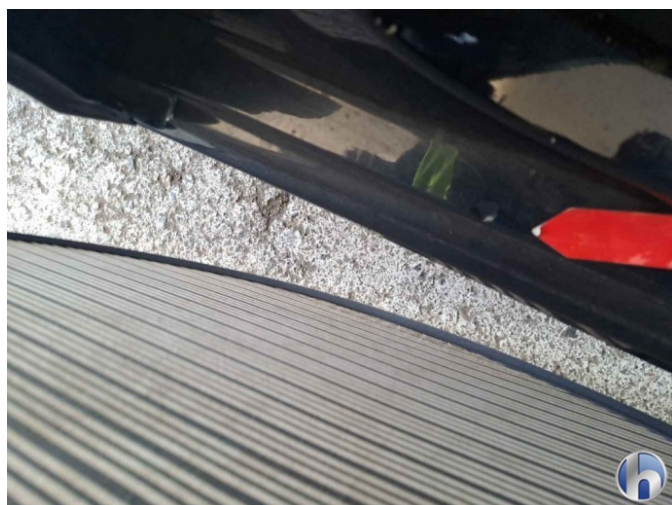
| component | Damage | Rep kind |
|---|---|---|
| 32. Türeinstieg Vorne - Rechts | Damaged | Refurbish and paint |

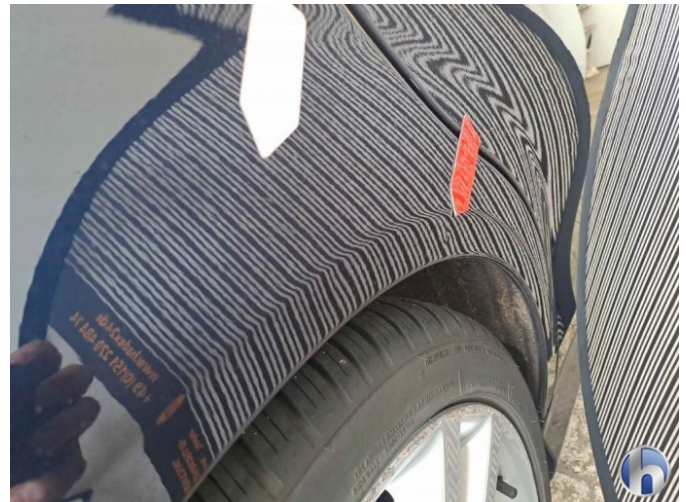
| component | Damage | Rep kind |
|---|---|---|
| 34. Sidewall - Rear - right | Damaged | Refurbish and paint |

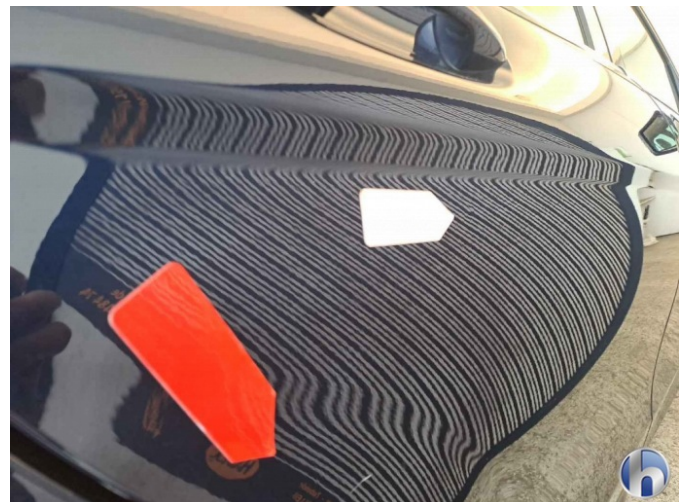
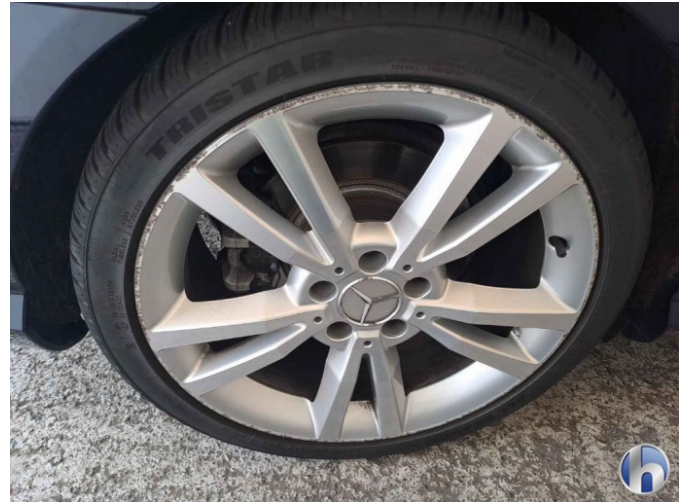
| component | Damage | Rep kind |
|---|---|---|
| 35. Door Rear - right | Damaged | Refurbish and paint |

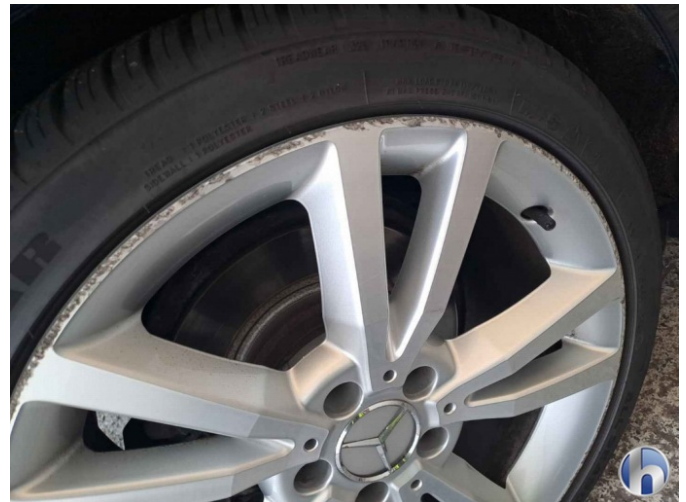
| component | Damage | Rep kind |
|---|---|---|
| 36. | Scratch(es) | Replace |

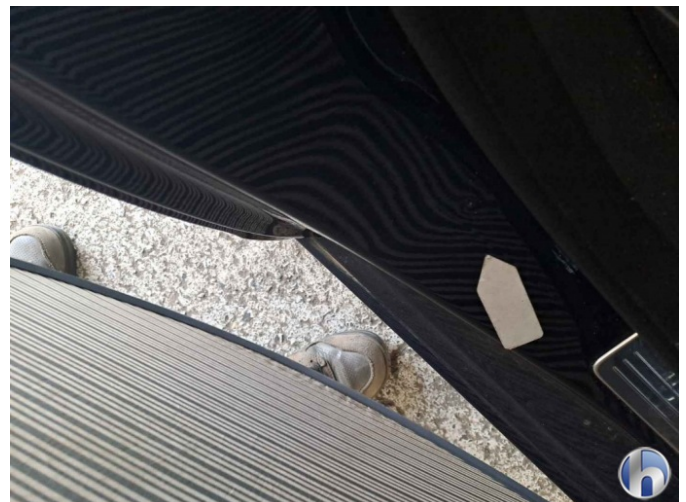
| component | Damage | Rep kind |
|---|---|---|
| 37. Türeinstieg Hinten - Rechts | | Refurbish and paint |

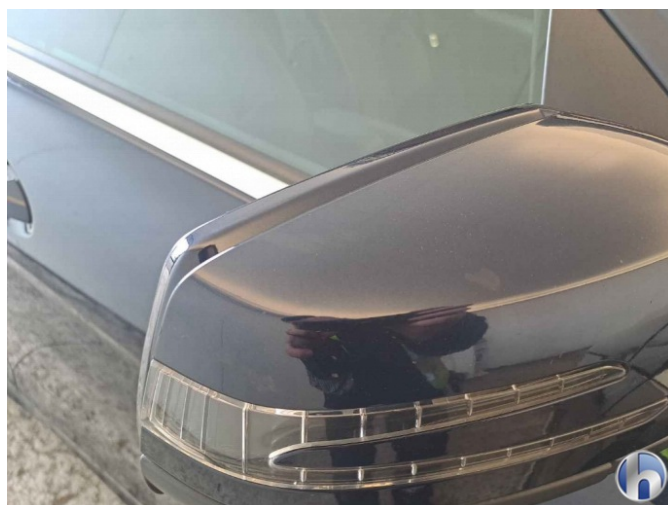
39. exterior body

| 39. | exterior body | Wear and tear | acceptable |
