## status report

**customer:** BCA Autoauktionen GmbH

#### Mercedes-Benz C -Klasse Lim. C 180 CGI BlueEfficiency (204.031)

| Vehicle identification number | <b>WDD2040311A751394</b> | mileage read: | <b>302429 km</b> |

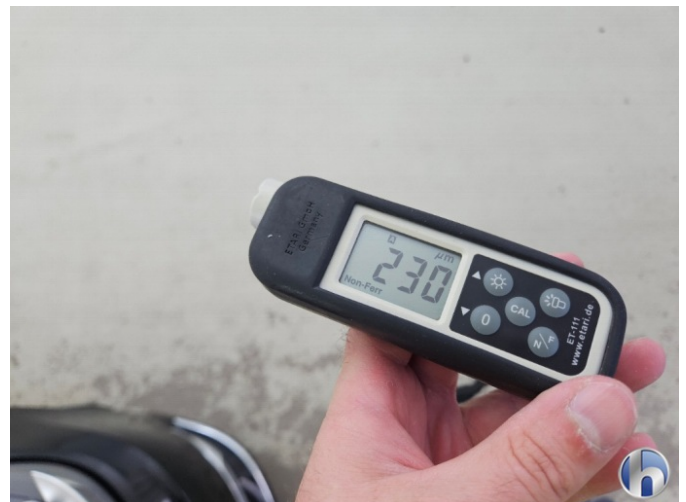
| component | Damage | Rep kind |
|---|---|---|
| 1. hood | Subsequently painted | acceptable |

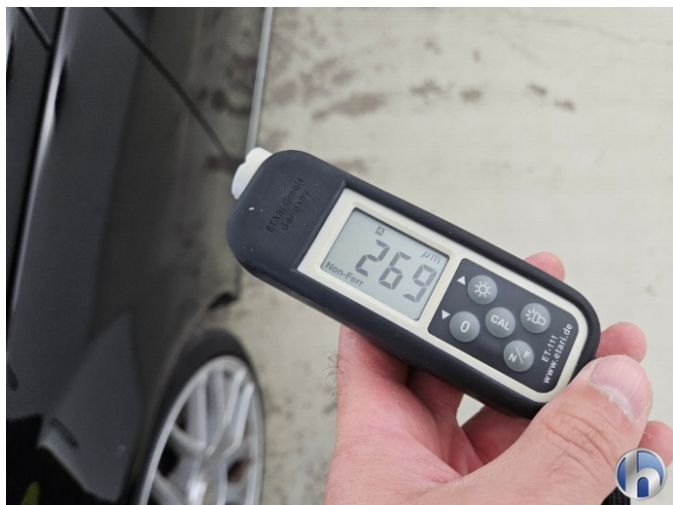
| component | Damage | Rep kind |
|---|---|---|
| 2. Front fender - right | Subsequently painted | acceptable |

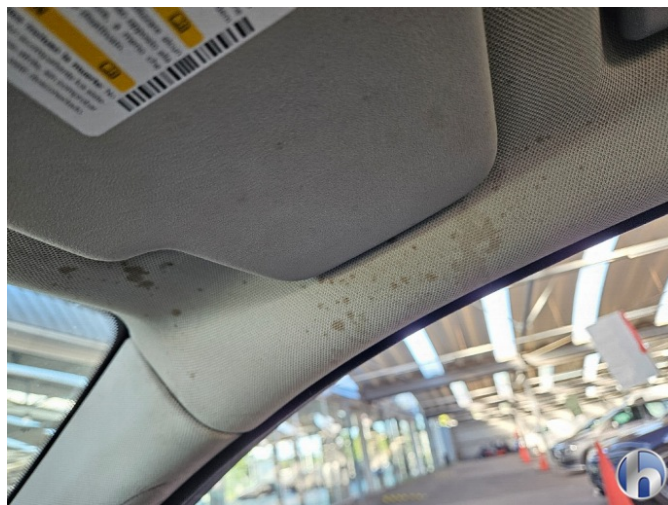
| component | Damage | Rep kind |
|---|---|---|
| 6. headlining | Dirty | |

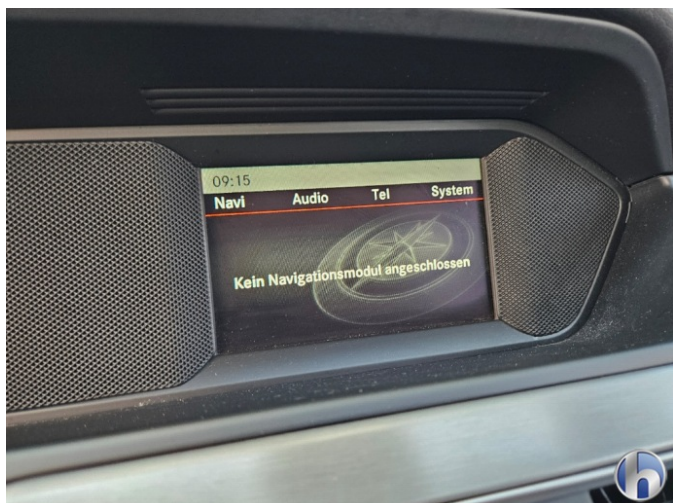
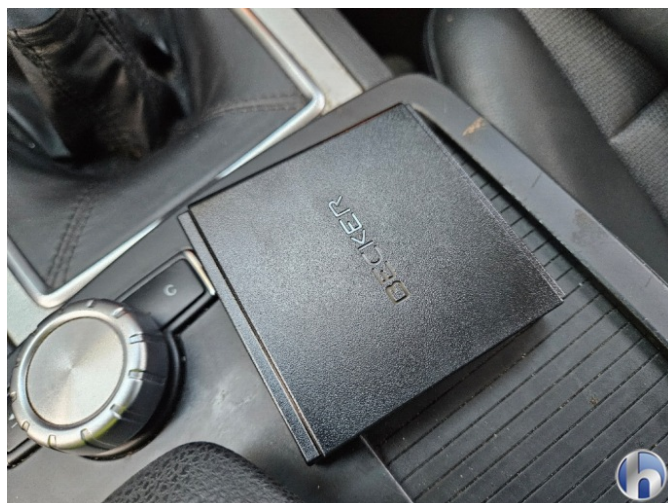
| component | Damage | Rep kind |
|---|---|---|
| 7. Navigations-Modul | No functionality | Carry out a fault diagnosis |

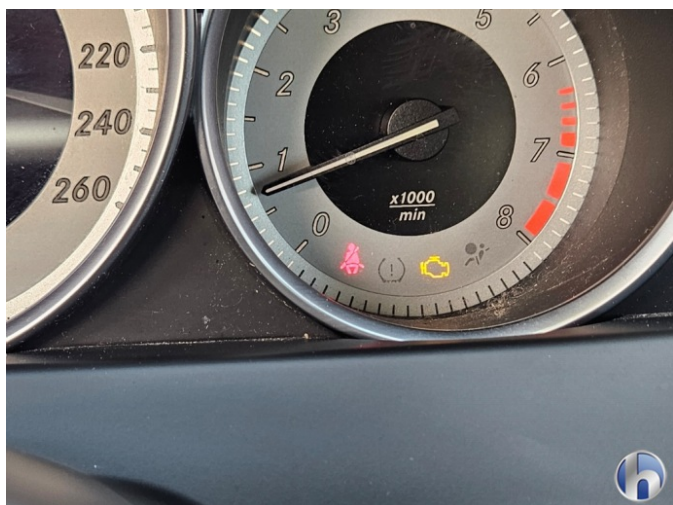
| Performed testing technology | |
|---|---|
| <b>engine running:</b> | A field test of the engine had to acoustic or visual defects for visiting time .<br>**Engine warning light. |

| component | Damage | Rep kind |
|---|---|---|
| 8. motor | Error message | Carry out a fault diagnosis |

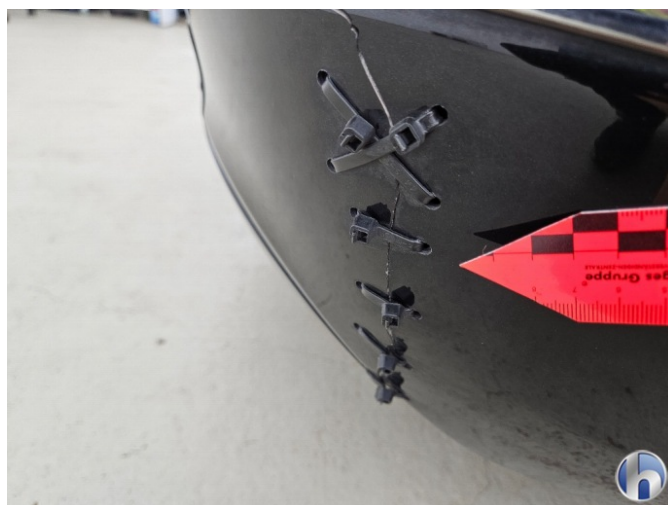
| component | Damage | Rep kind |
|---|---|---|
| 9. Rear bumper | Breakage | Replace |

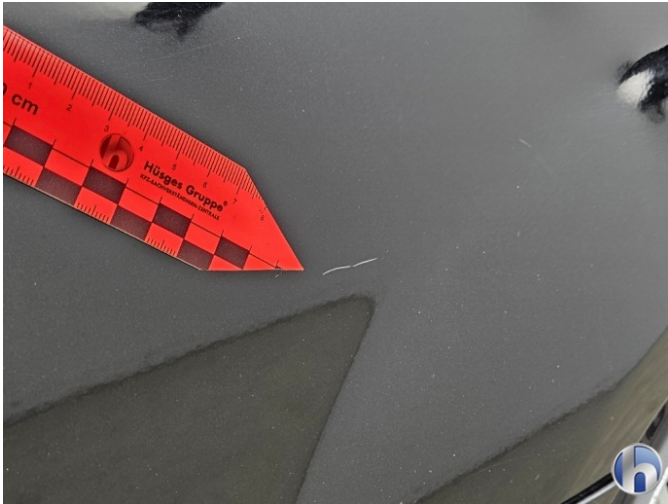
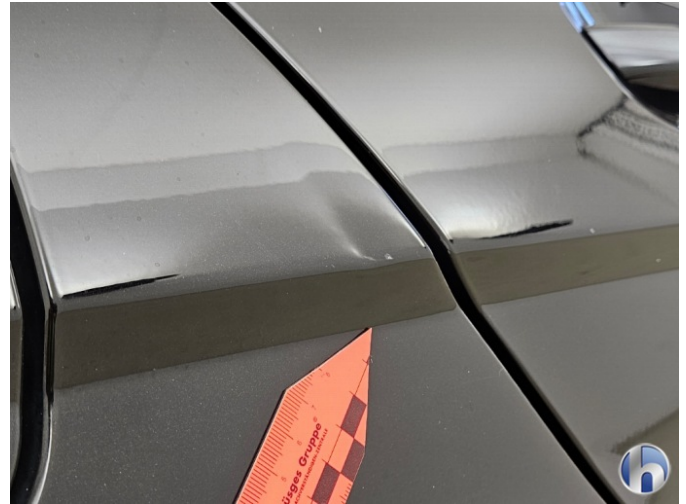
| component | Damage | Rep kind |
|---|---|---|
| 10. Sidewall - Rear - right | Wear and tear | acceptable |

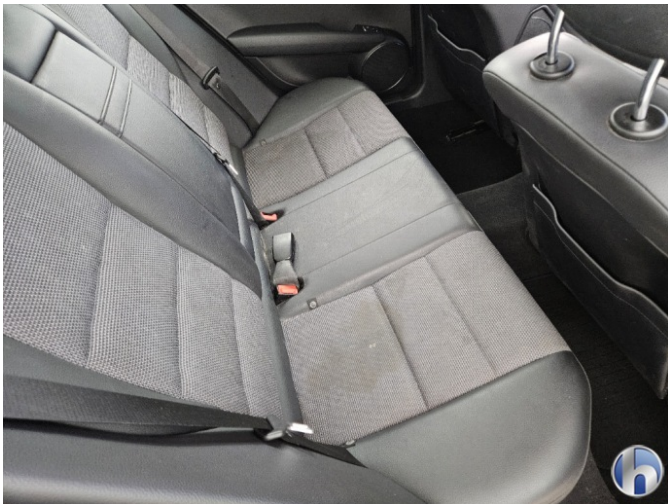
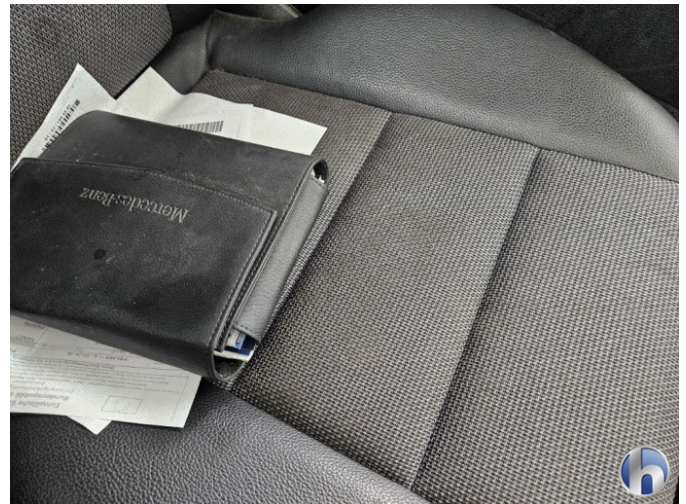
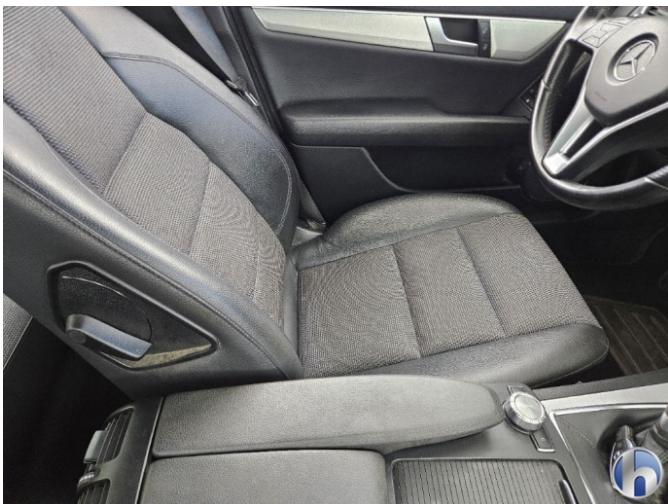
| component | Damage | Rep kind |
|---|---|---|
| 11. | Dirty | |

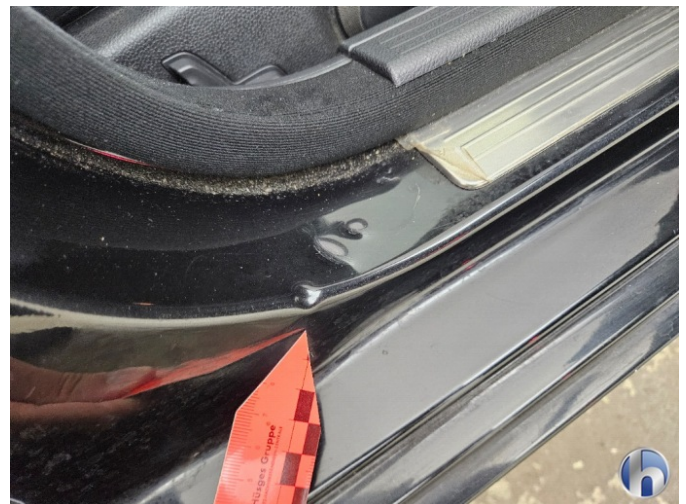
| component | Damage | Rep kind |
|---|---|---|
| 12. Türeinstieg Hinten - Rechts | Wear and tear | acceptable |

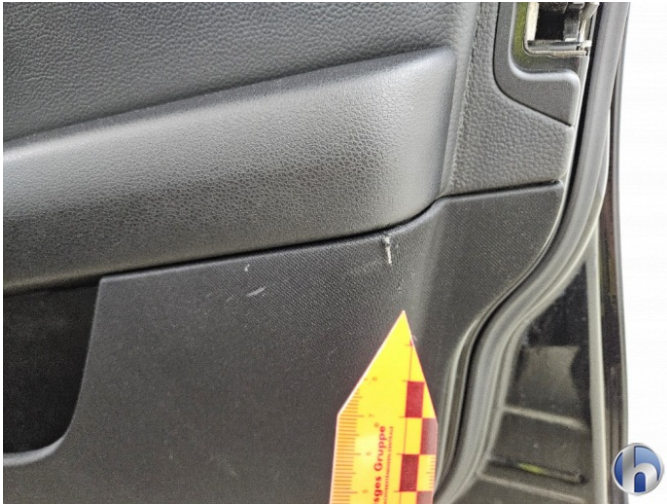
| component | Damage | Rep kind |
|---|---|---|
| 13. Door trim Front - right | Wear and tear | acceptable |

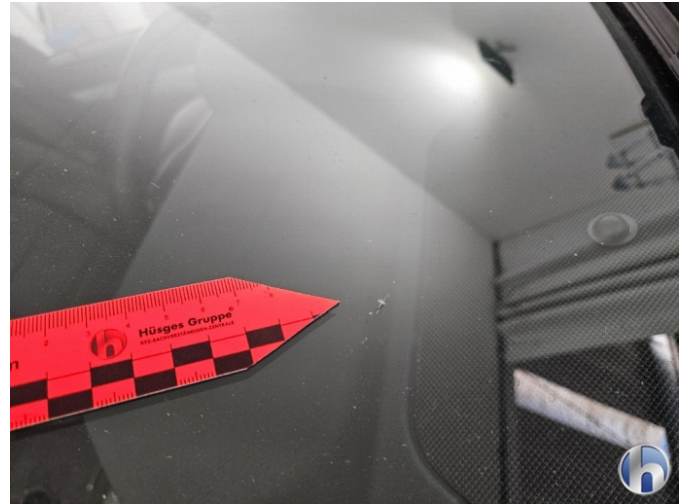
| component | Damage | Rep kind |
|---|---|---|
| 14. Windshield | Chipping from stones | Smart repair |

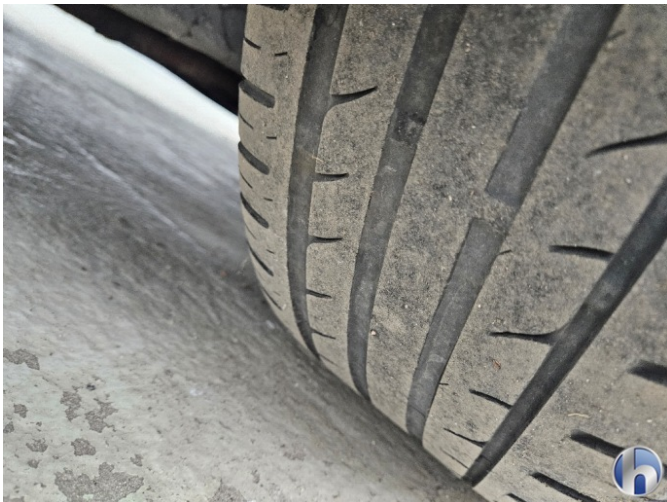
| component | Damage | Rep kind |
|---|---|---|
| 15. Reifen 2x | Not safe for road traffic | Replace |

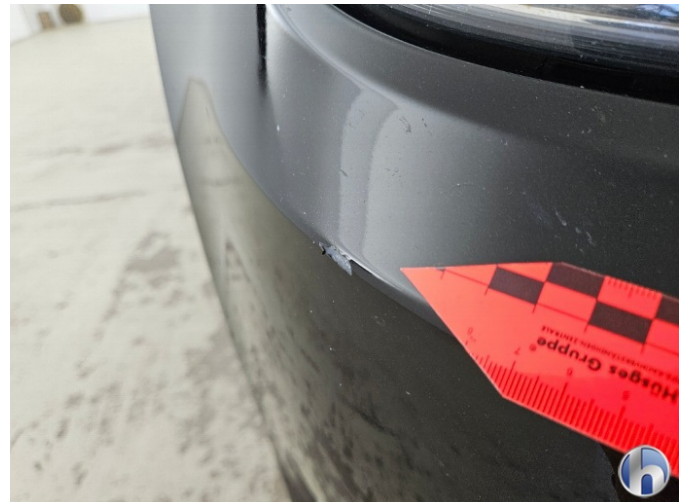
| component | Damage | Rep kind |
|---|---|---|
| 16. Front bumper | Wear and tear | acceptable |

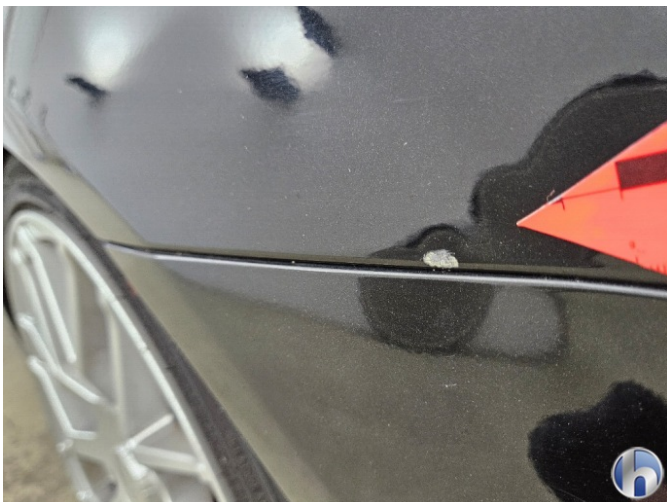
| component | Damage | Rep kind |
|---|---|---|
| 17. Sidewall - Rear - Left | Wear and tear | acceptable |

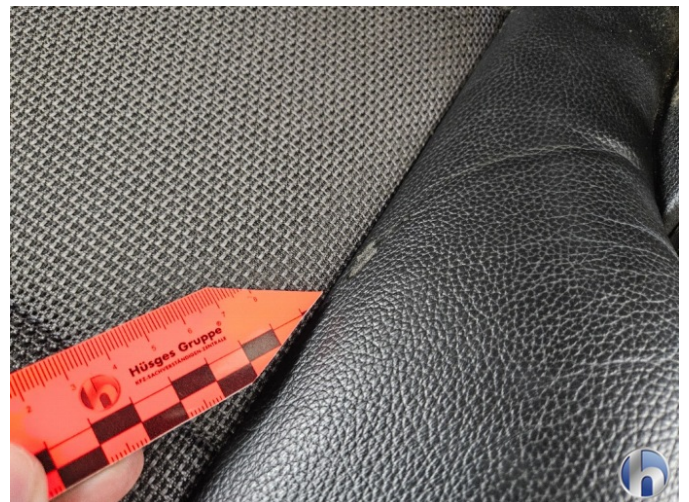
| component | Damage | Rep kind |
|---|---|---|
| 18. Fahrersitz | Wear and tear | acceptable |
