MERCEDES-BENZ C-Klasse C 200 T CDI DPF Automatik

Inspection Report Summary

Customer	BCA Online	Report Number	P20250520112152
Inspection Date / Place	2025-05-20 / BCA Heidenheim	Cosmetic Grade	4

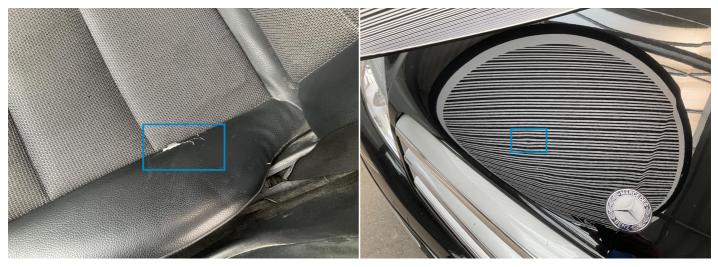
1. Seat / Front Left Interior / Holed -

2. Hood Bodywork / Dent / Dent -

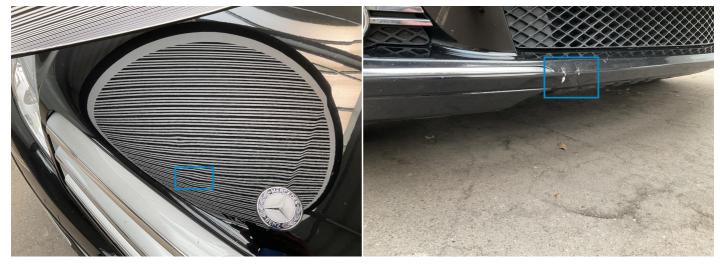
3. Hood Bodywork / Dent / Dent -

4. Corner Bumper / Front Right Bodywork / Dent / Dent -

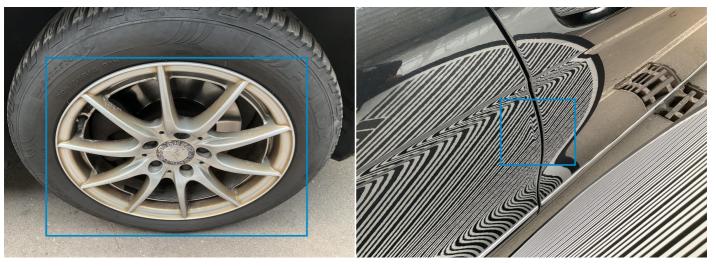
5. Rim / Front Right Paint / Corrosion -

6. Door / Back Right Bodywork / Dent / Dent -

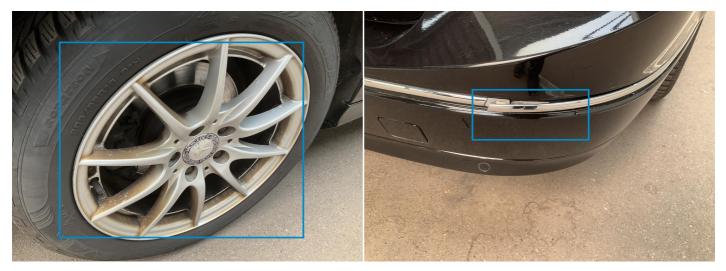
7. Rim / Back Right Paint / Corrosion -

8. Corner Bumper / Back Right Bodywork / Breakage / Hole -

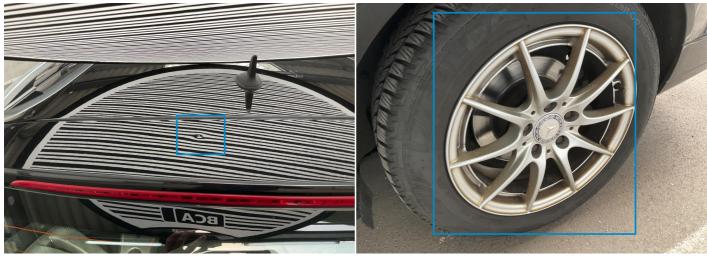
9. Tailgate Bodywork / Dent / Dent -

10. Rim / Back Left Paint / Corrosion -

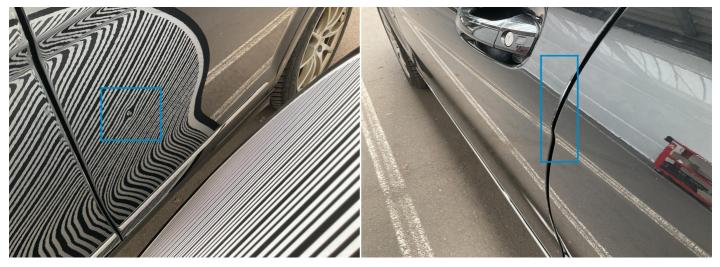
11. Door / Back Left Bodywork / Dent / Dent -

12. Door / Front Left Paint / Scratch / Scuff -

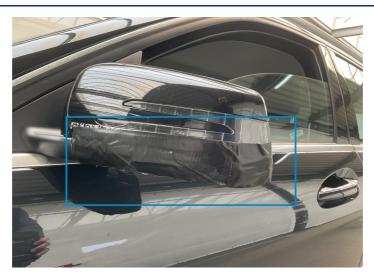
13. Mirror Shell / Front Left Bodywork / Breakage / Crack -
