## status report

**customer:** Bank 11, Neuss  
**contract number:** 369723170  
**reference:**

#### Mercedes-Benz E -Klasse Lim. E 350 CDI 4Matic

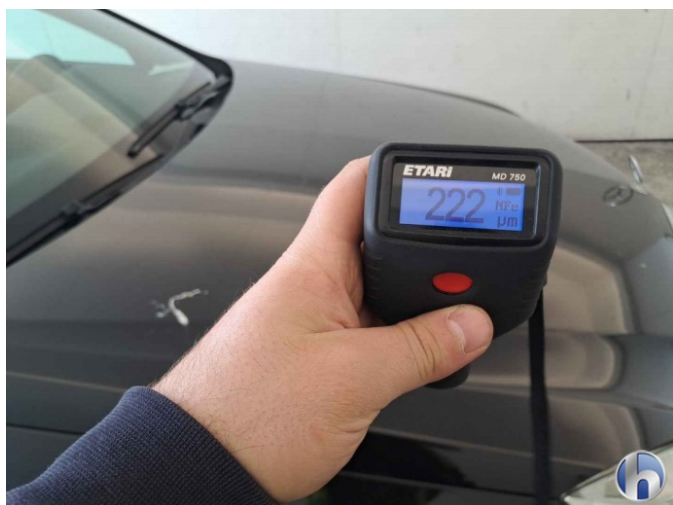
| component | Damage | Rep kind |
|---|---|---|
| 1. hood | Subsequently painted | acceptable |

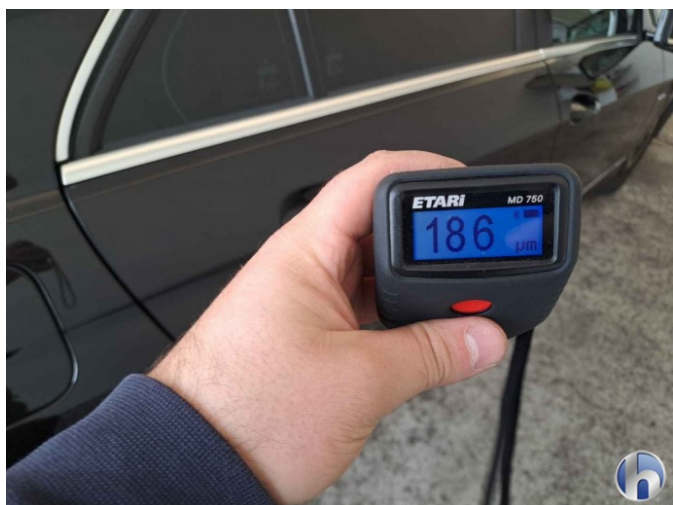
| component | Damage | Rep kind |
|---|---|---|
| 4. Front door - right | Subsequently painted | acceptable |

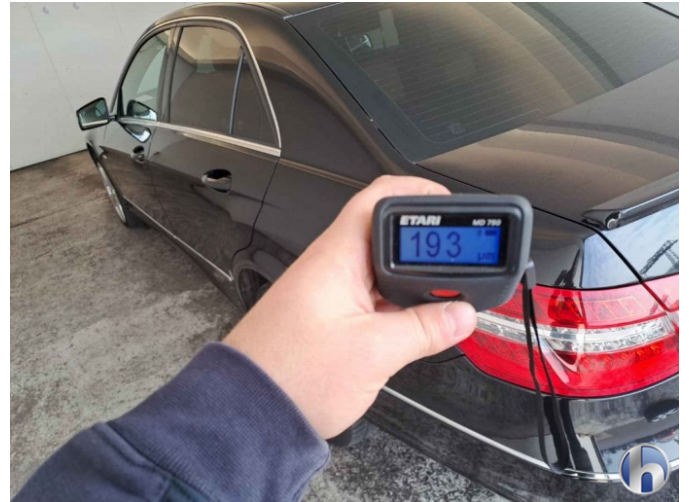
| component | Damage | Rep kind |
|---|---|---|
| 8. Sidewall - Rear - Left | Subsequently painted | acceptable |

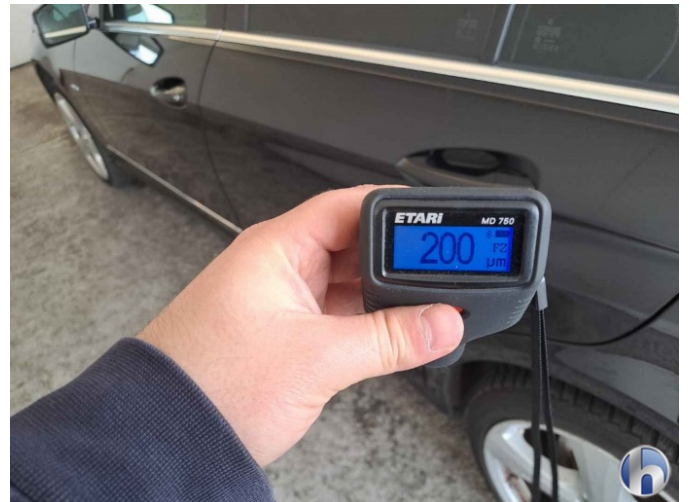
| component | Damage | Rep kind |
|---|---|---|
| 10. Rear door - left | Subsequently painted | acceptable |

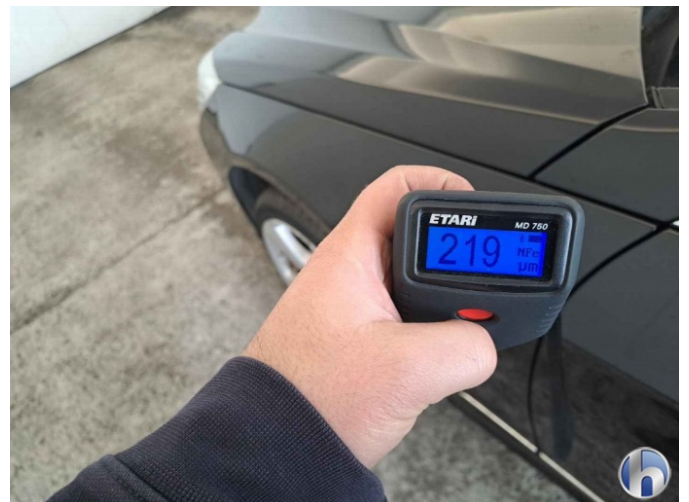
| component | Damage | Rep kind |
|---|---|---|
| 12. Front fender - left | Subsequently painted | acceptable |

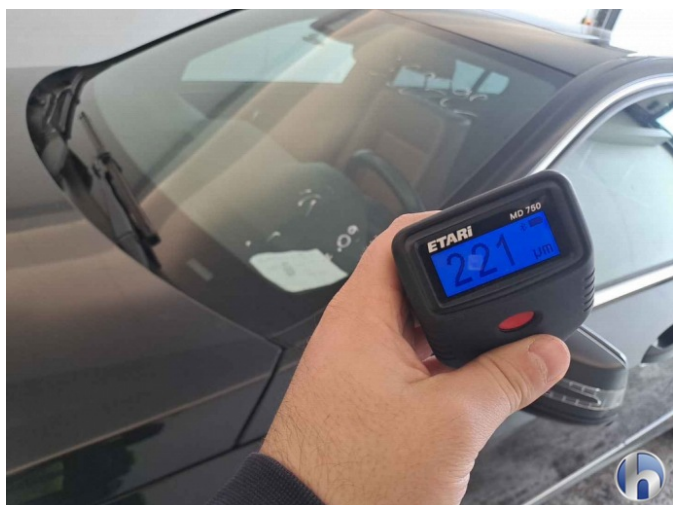
| component | Damage | Rep kind |
|---|---|---|
| 13. A-pillar Front - Left | Subsequently painted | acceptable |

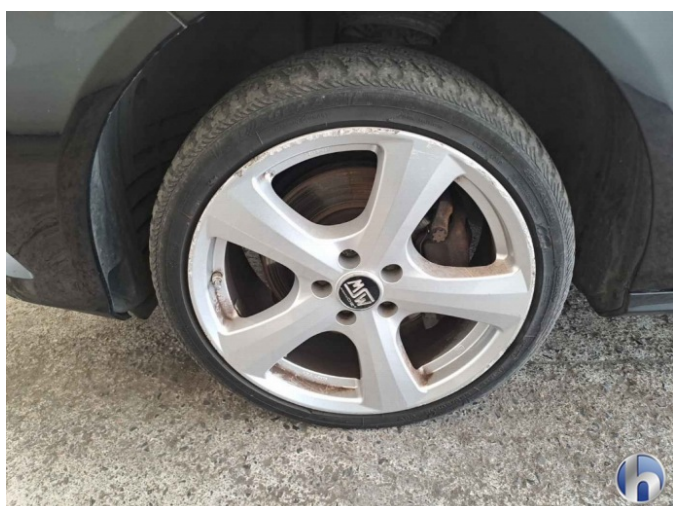
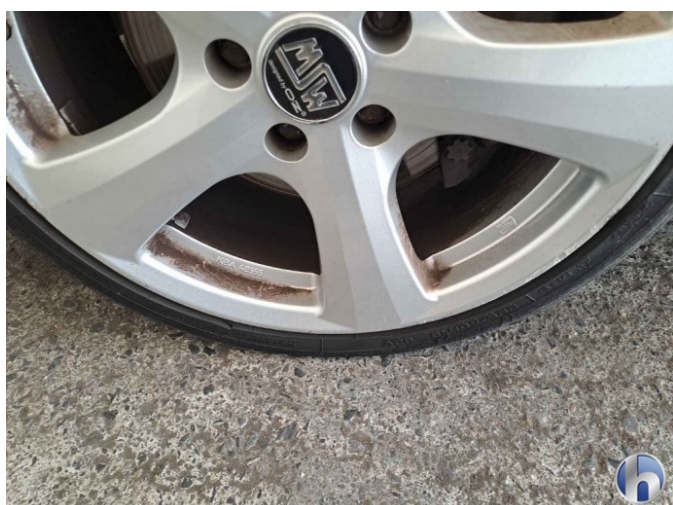
| component | Damage | Rep kind |
|---|---|---|
| 19. Rim front - left | Damaged | Replace |

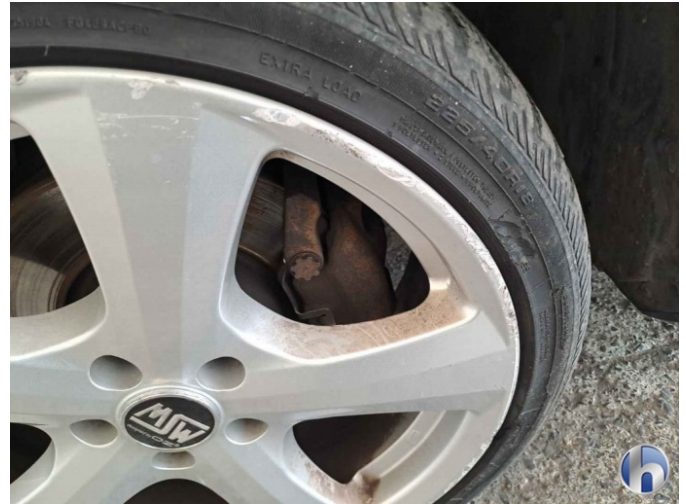
| component | Damage | Rep kind |
|---|---|---|
| 20. tire front - left | Damaged | Replace |

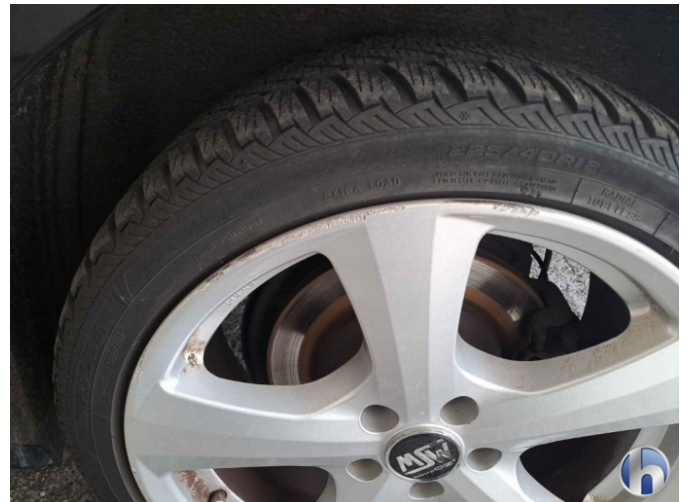
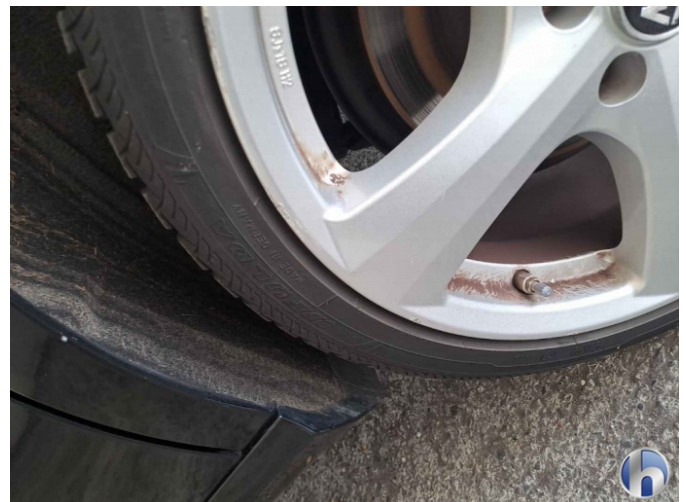
| component | Damage | Rep kind |
|---|---|---|
| 21. Rim rear - left | Scratch(es) | Smart repair |

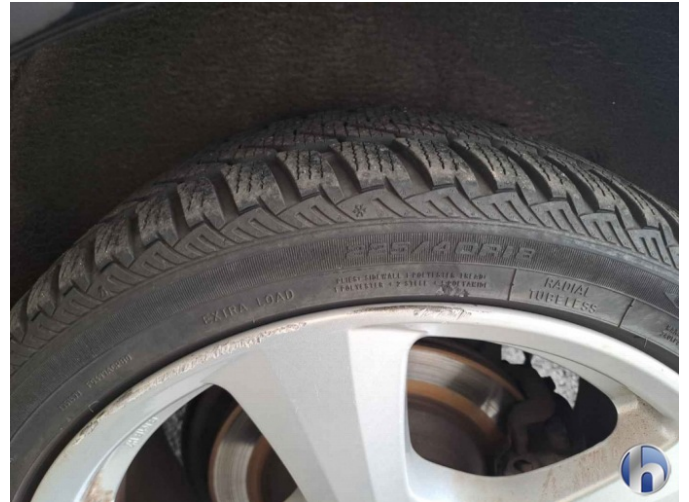
| component | Damage | Rep kind |
|---|---|---|
| 22. tire rear - left | Damaged | Replace |

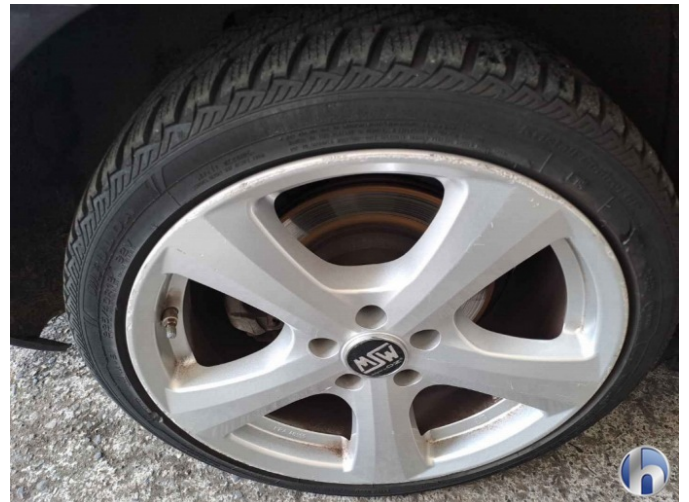
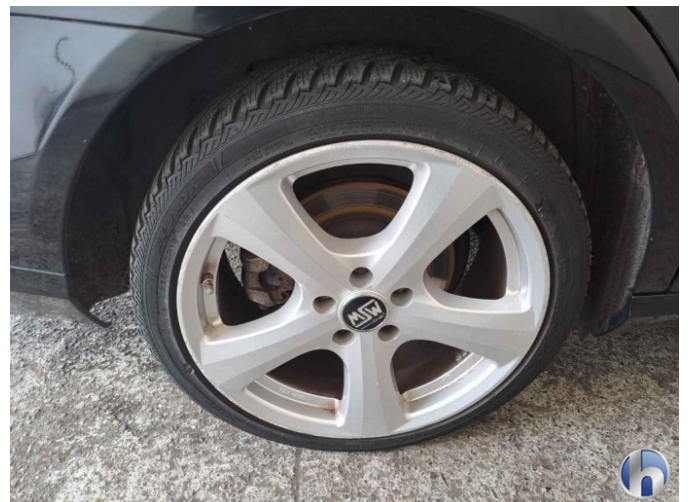
| component | Damage | Rep kind |
|---|---|---|
| 23. Rim rear - right | Damaged | Replace |

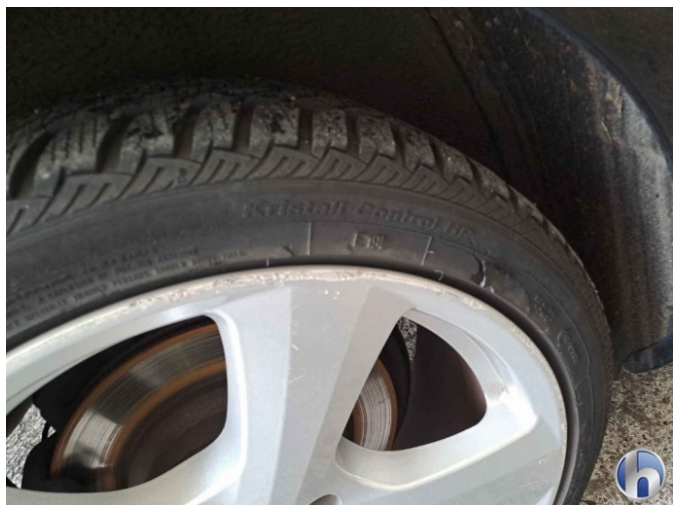
| component | Damage | Rep kind |
|---|---|---|
| 24. tire rear - right | Damaged | Replace |

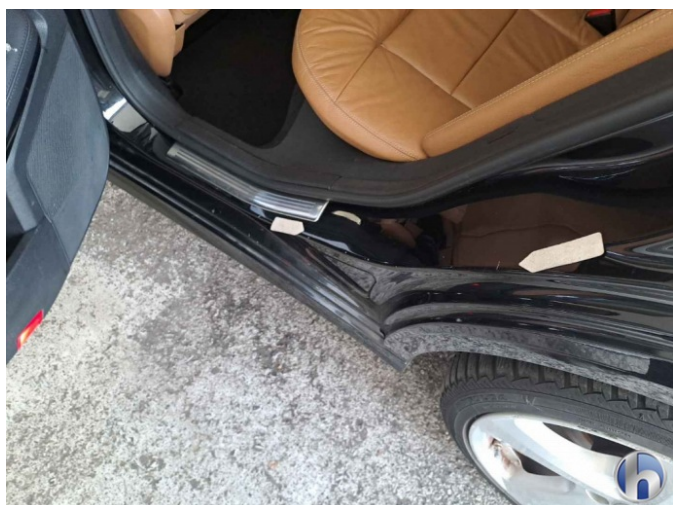
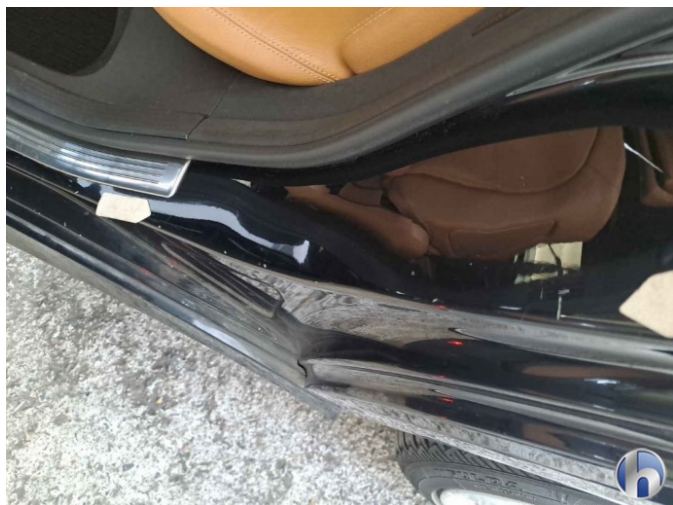
| component | Damage | Rep kind |
|---|---|---|
| 30. Türeinstieg Hinten - Links | Damaged | Refurbish and paint |

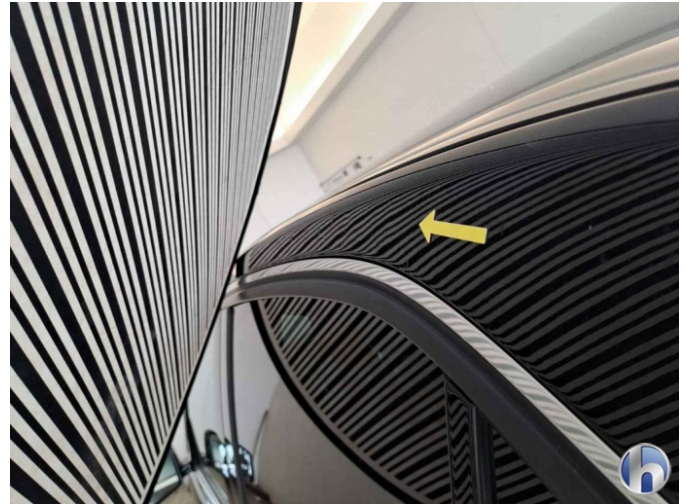
| component | Damage | Rep kind |
|---|---|---|
| 34. Roof frame - left | Execution defect | Refurbish and paint |

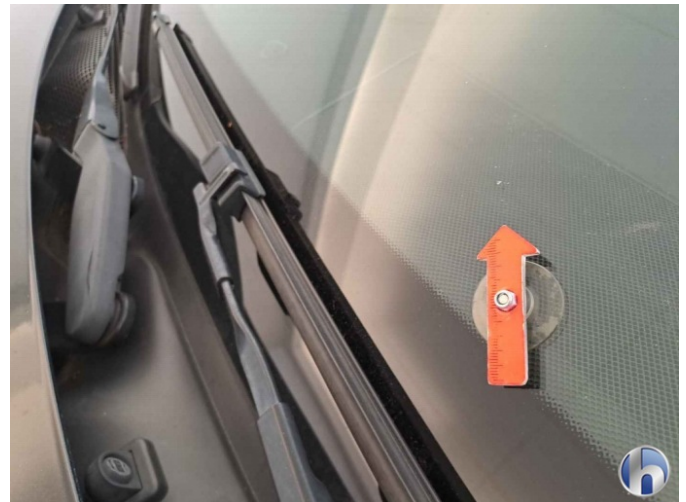
| component | Damage | Rep kind |
|---|---|---|
| 35. Windshield | Chipping from stones in field of view | Replace |

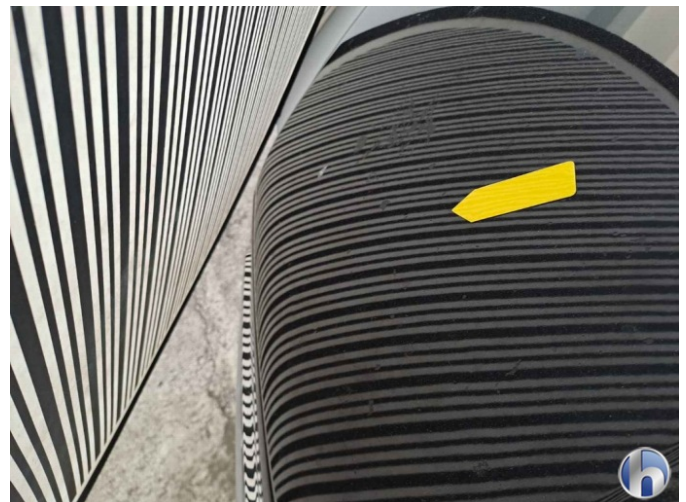
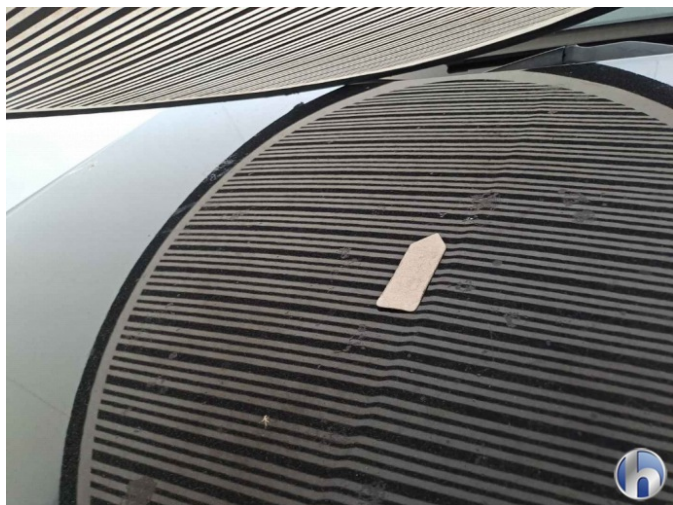
| component | Damage | Rep kind |
|---|---|---|
| 36. hood | Execution defect | Refurbish and paint |

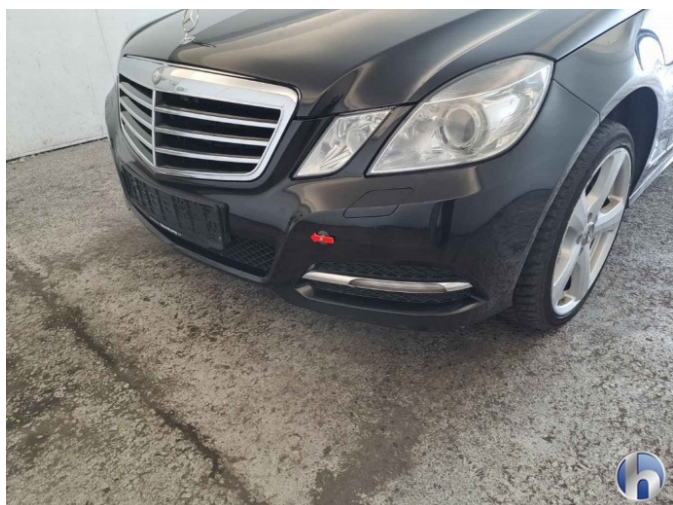
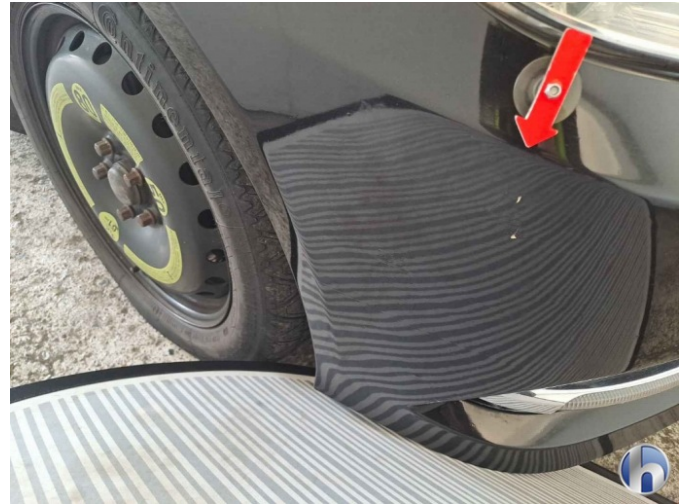
| component | Damage | Rep kind |
|---|---|---|
| 38. Front bumper | Execution defect | Replace |

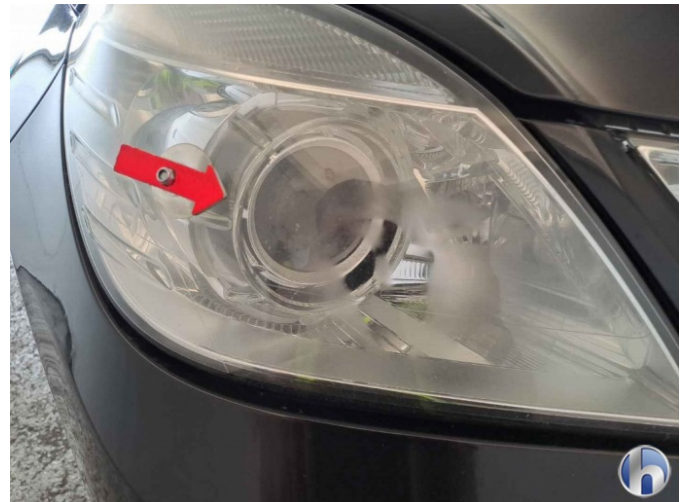
39. Scheinwerfer - Rechts

| 39. | Scheinwerfer - Rechts | Damaged | Replace |

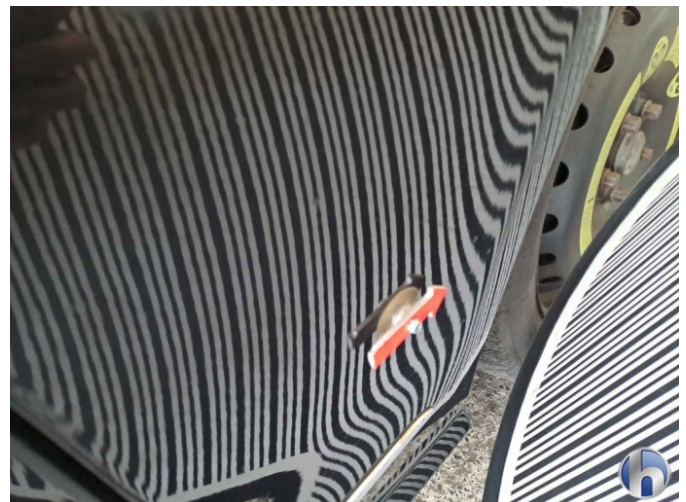
40. Front fender - right

| 40. | Front fender - right | Execution defect | Paint |

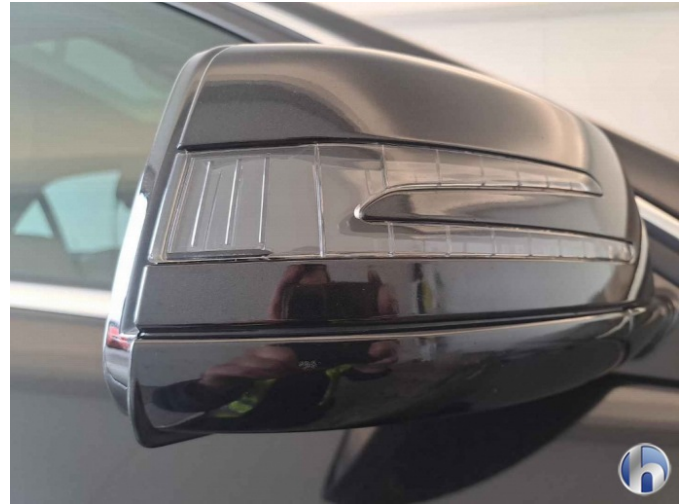
41. Outside mirror - right

| 41. | Outside mirror - right | Scratch(es) | Paint |

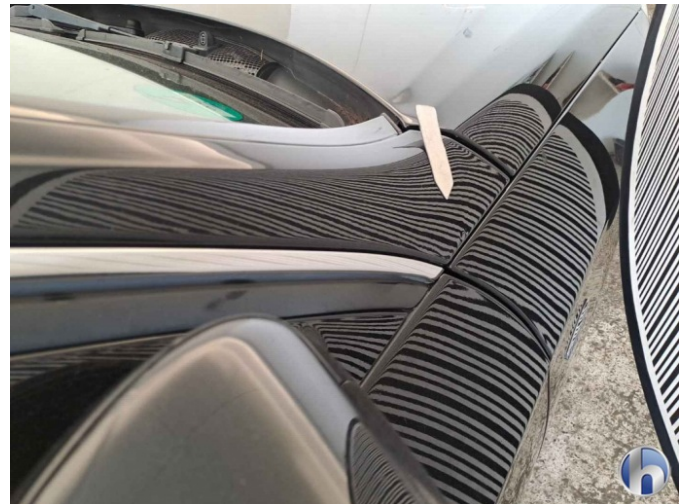
42. A-pillar Front - right

| 42. | A-pillar Front - right | Execution defect | Refurbish and paint |

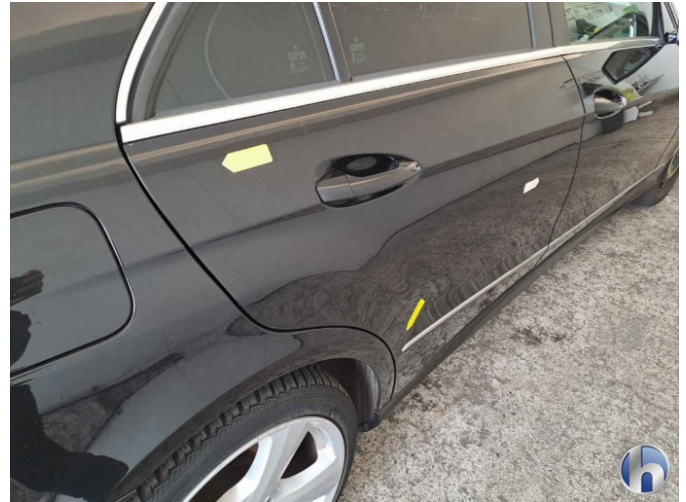
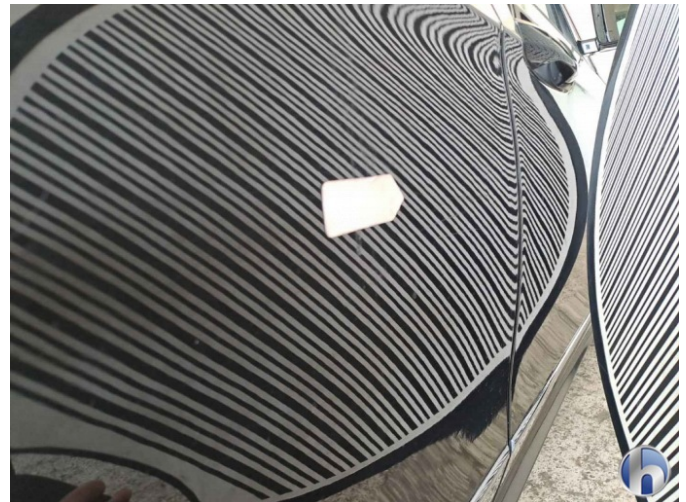
45. Door Rear - right

| 45. | Door Rear - right | Execution defect | Refurbish and paint |

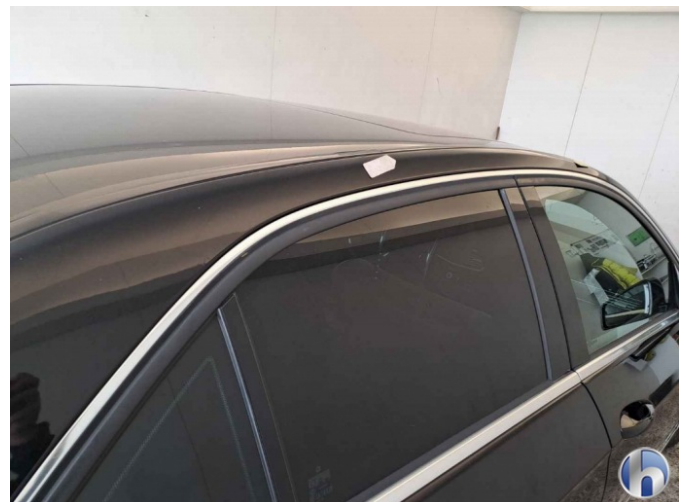
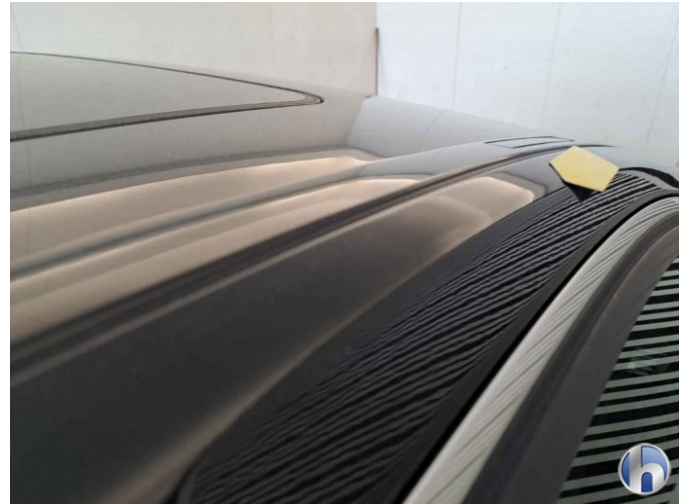
46. Roof frame - right

| 46. | Roof frame - right | Execution defect | Refurbish and paint |

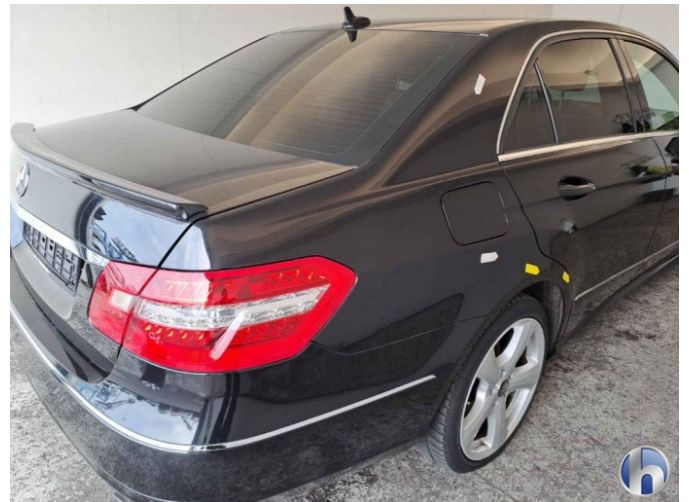
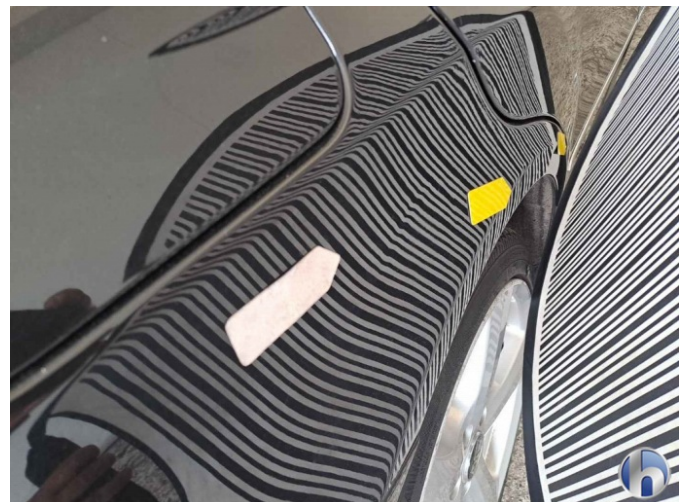
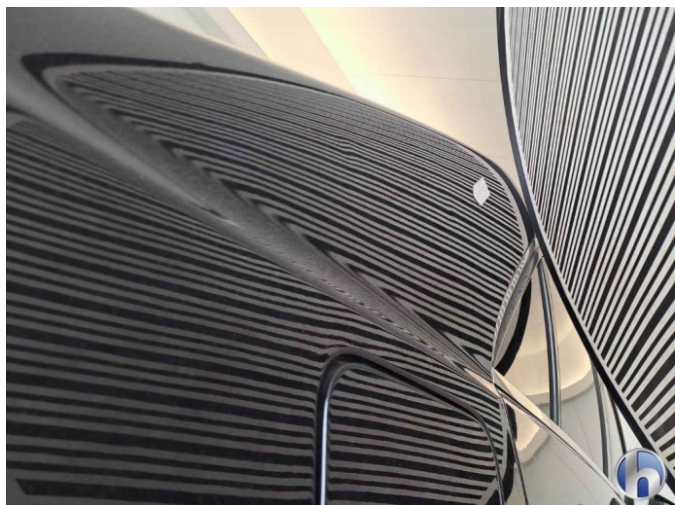
47. Sidewall - Rear - right

| 47. | Sidewall - Rear - right | Execution defect | Refurbish and paint |

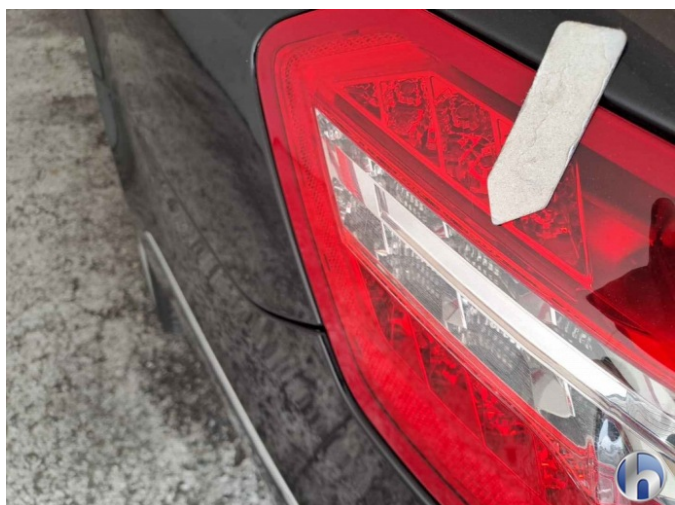
49. Taillight left

| 49. | Taillight left | Crack | Replace |

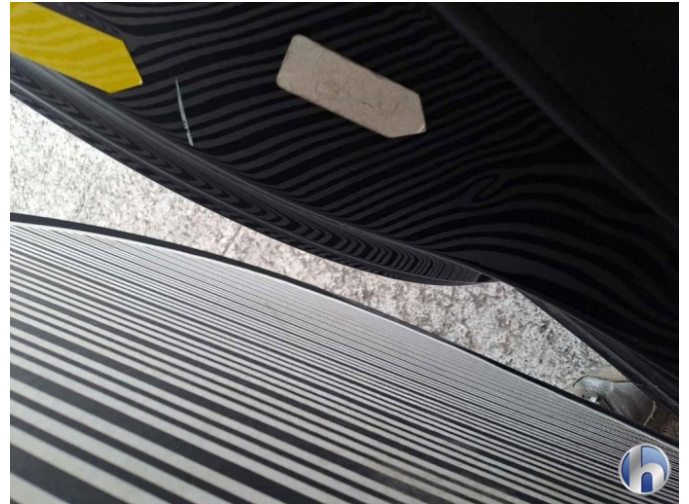
51. Türeinstieg Hinten - Rechts

| 51. | Türeinstieg Hinten - Rechts | Damaged | Refurbish and paint |

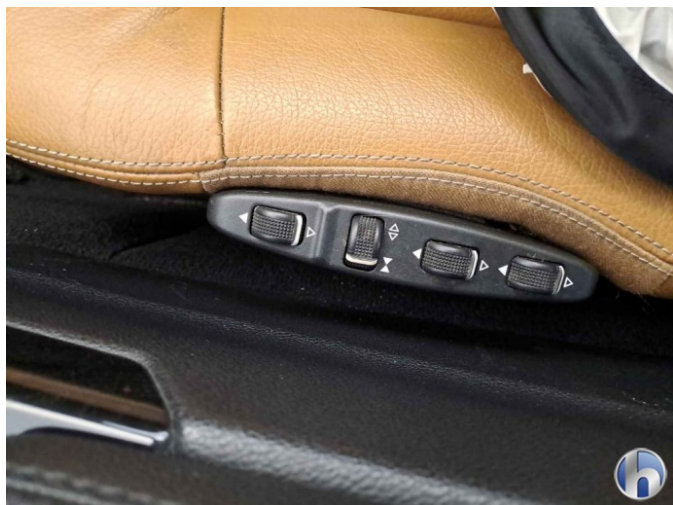
53. Sitz Bedienung

| 53. | Sitz Bedienung | Defective | Carry out a fault diagnosis |

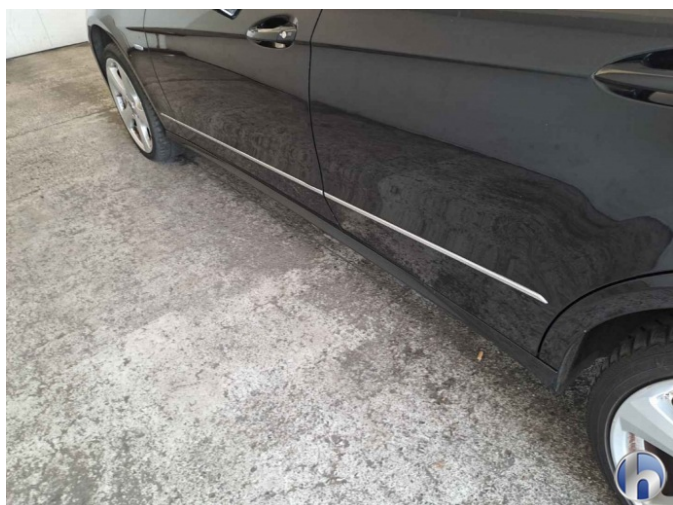
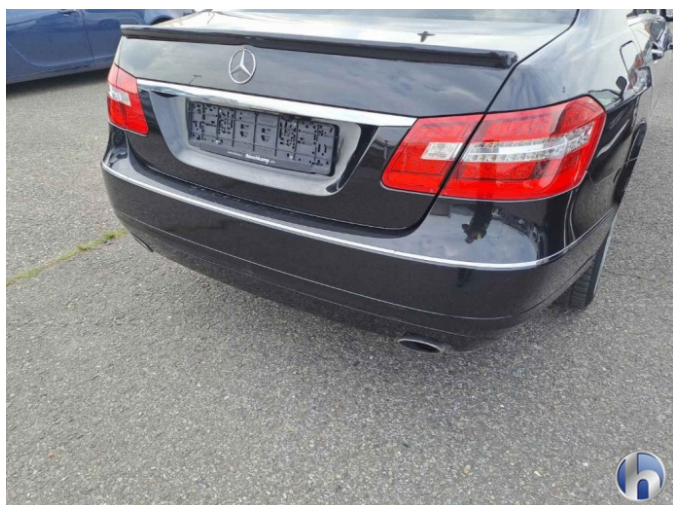
55. Karosserie Außen Zierleisten

| 55. | Karosserie Außen Zierleisten | Damaged | Replace |

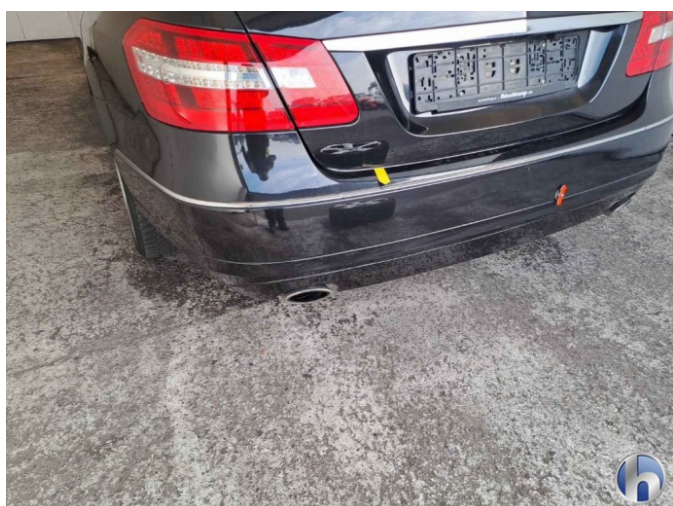
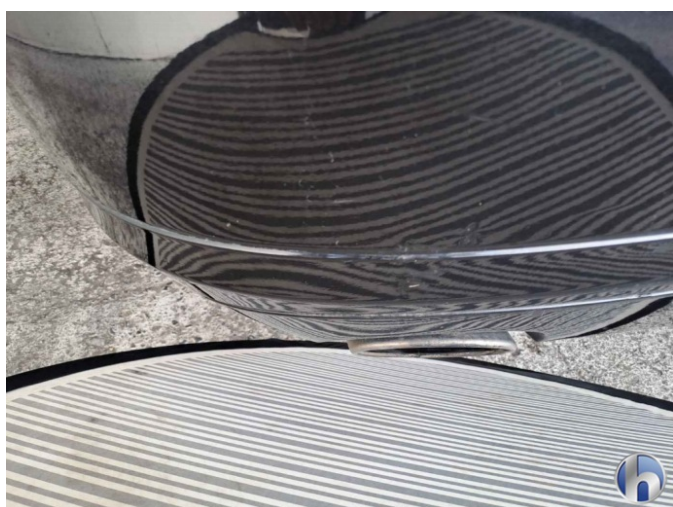
58. Rear bumper

| 58. | Rear bumper | Damaged | Replace |

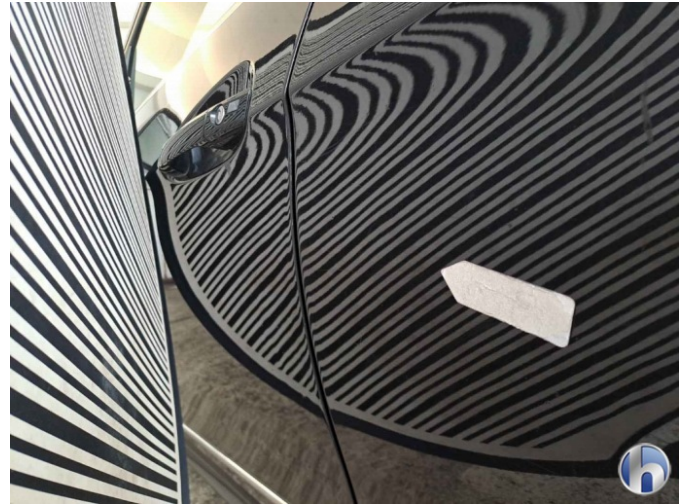
59. Rear door - left

| 59. | Rear door - left | Execution defect | Refurbish and paint |

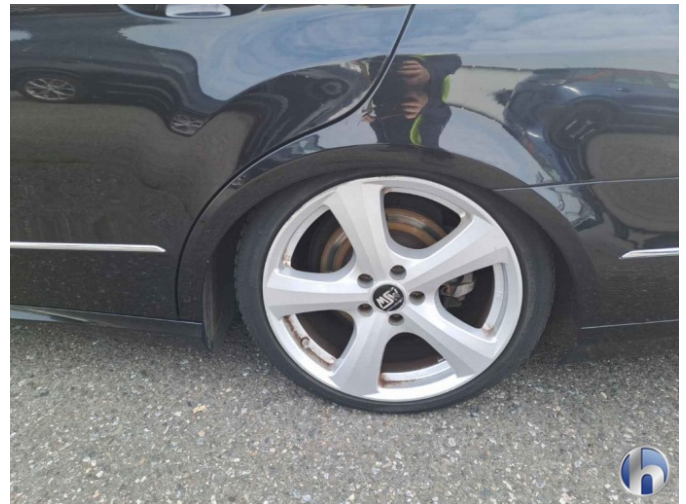
60. Fahrwerk

| 60. | Fahrwerk | Defective | Carry out a fault diagnosis |

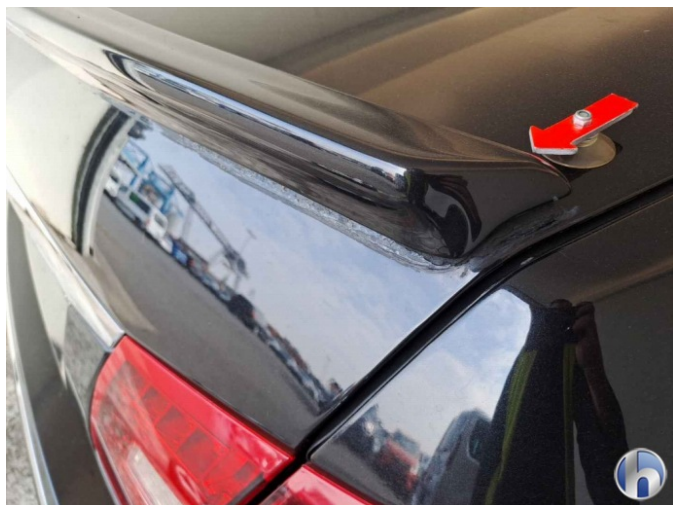
66. tailgate

| 66. | tailgate | Damaged | Refurbish and paint |

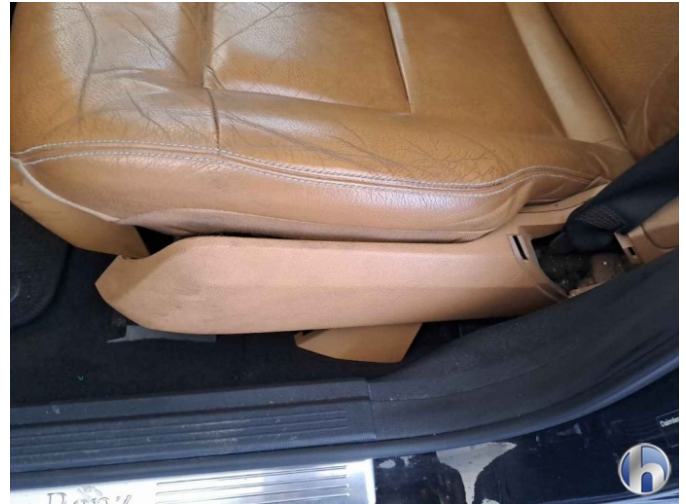
71. Sitz - Vorne - Links: Kissen (Verkleidung)

| 71. | Sitz - Vorne - Links: Kissen (Verkleidung) | Damaged | Replace |

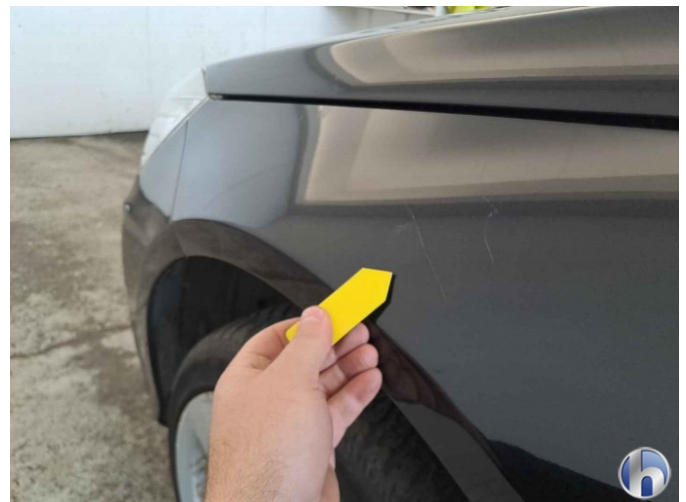
73. Front fender - left

| 73. | Front fender - left | Execution defect | Paint |

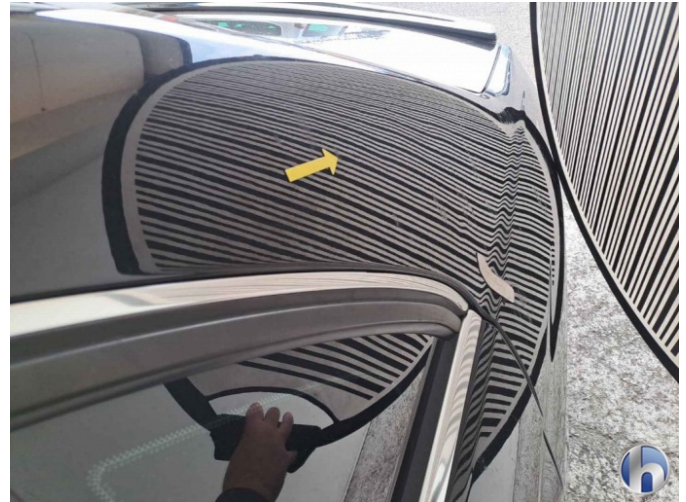
76. Sidewall - Rear - Left

| 76. | Sidewall - Rear - Left | Execution defect | Refurbish and paint |

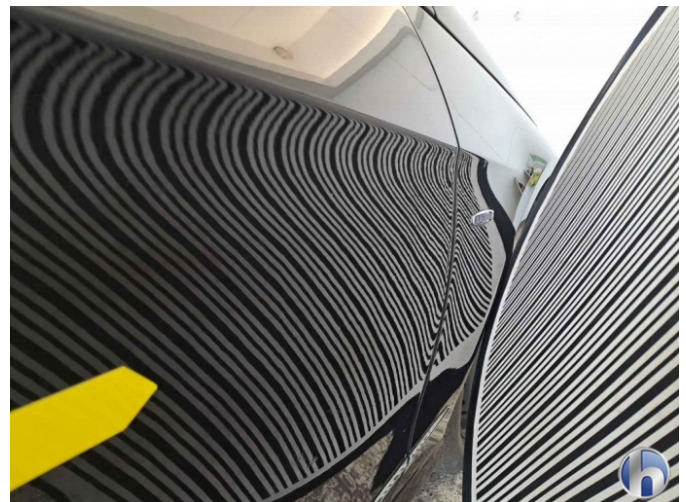
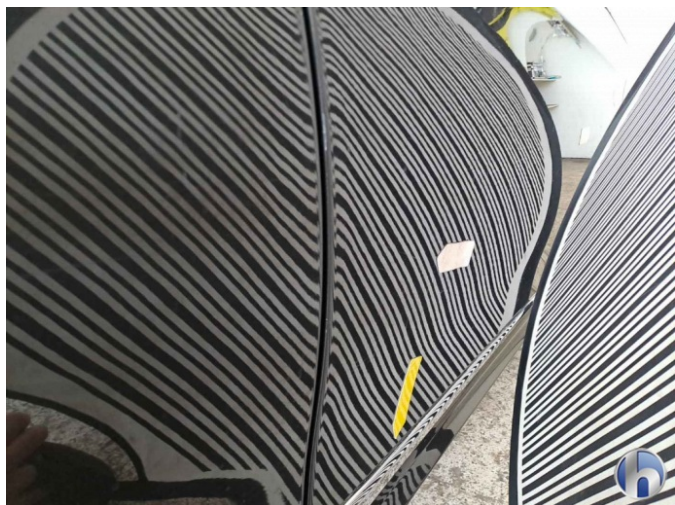
78. Front door - right

| 78. | Front door - right | Execution defect | Refurbish and paint |
