## status report

| vehicle data | | | |
|---|---|---|---|
| <b>Mercedes-Benz E -Klasse Lim. E 220 d (213.004)</b> | | | |
| Vehicle identification number | <b>WDD2130041A345610</b> | mileage read: | <b>73185 km</b> |

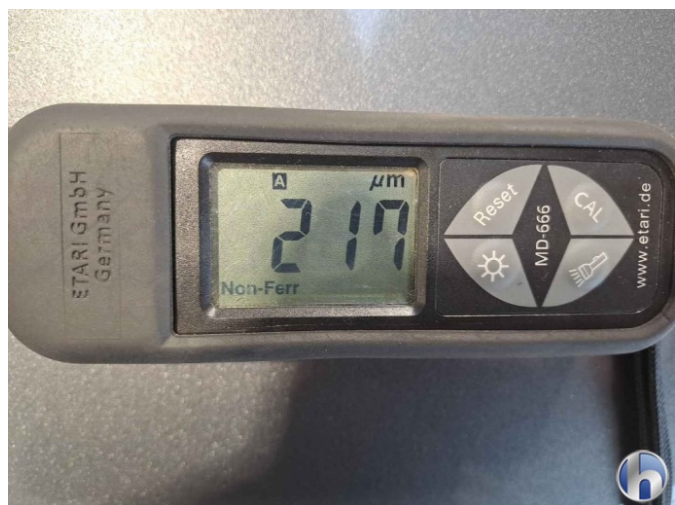
| Performed testing technology | |
|---|---|
| <b>reference:</b> | *Fahrzeug hat Alter und Laufleistungs bedingte Gebrauchsspuren innen und außen Kotflügel VL Nachlackiert |

| component | Damage | Rep kind |
|---|---|---|
| 1. Front fender - left | Subsequently painted | acceptable |

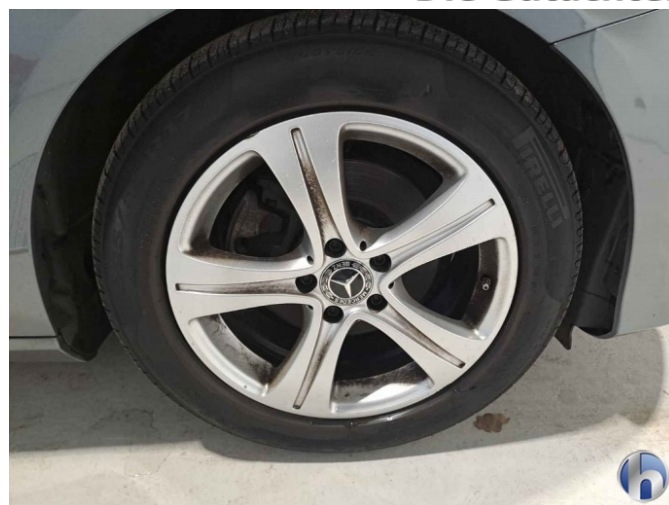
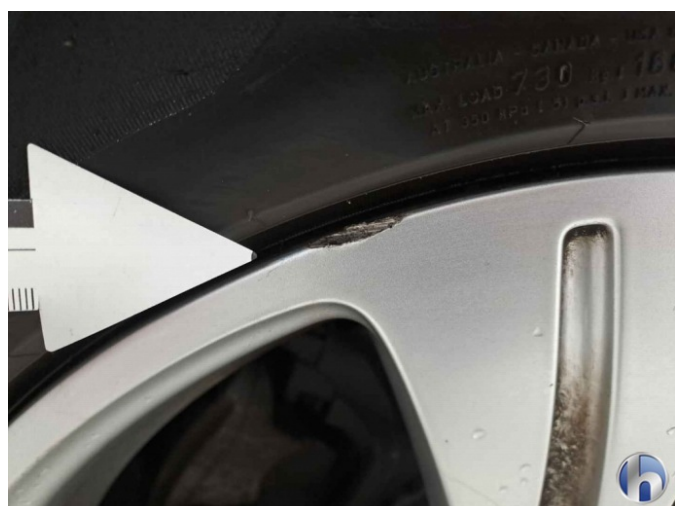
| component | Damage | Rep kind |
|---|---|---|
| 6. Felge (Aluminium) vorne rechts | Scratch(es) | Paint |

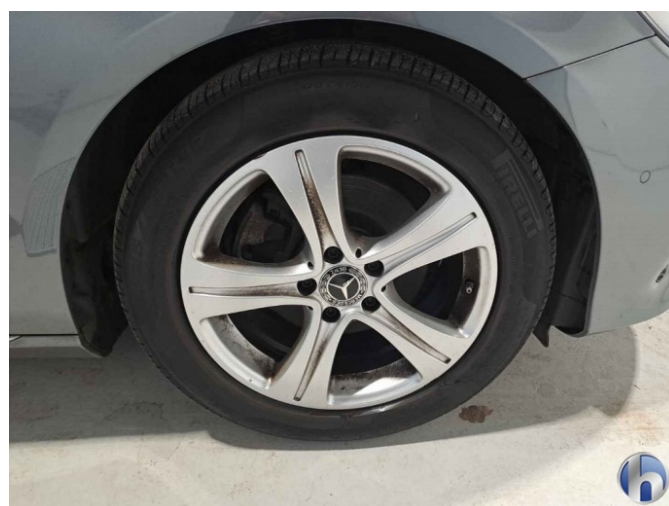
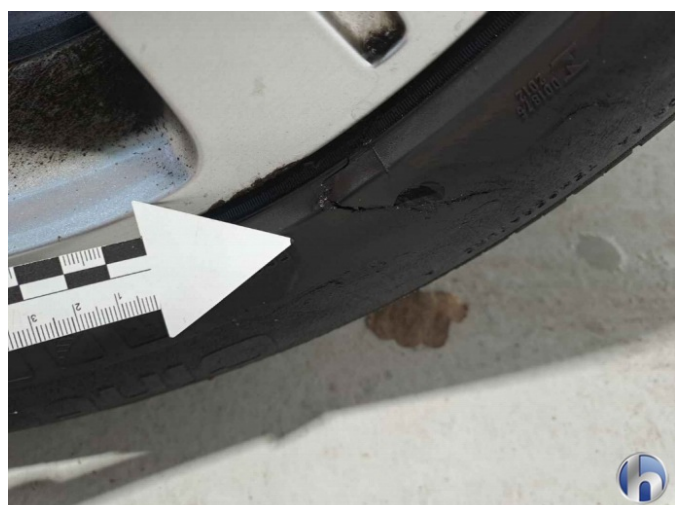
| General examination | |
|---|---|
| <b>Note Road Safe:</b> | Reifen VR beschädigt |

| component | Damage | Rep kind |
|---|---|---|
| 7. | Damaged | Replace |

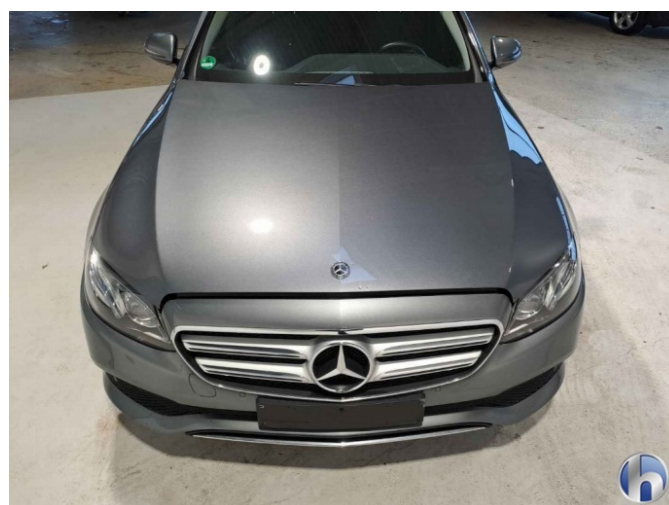
| component | Damage | Rep kind |
|---|---|---|
| 8. exterior body | Surface scratch(es) | |

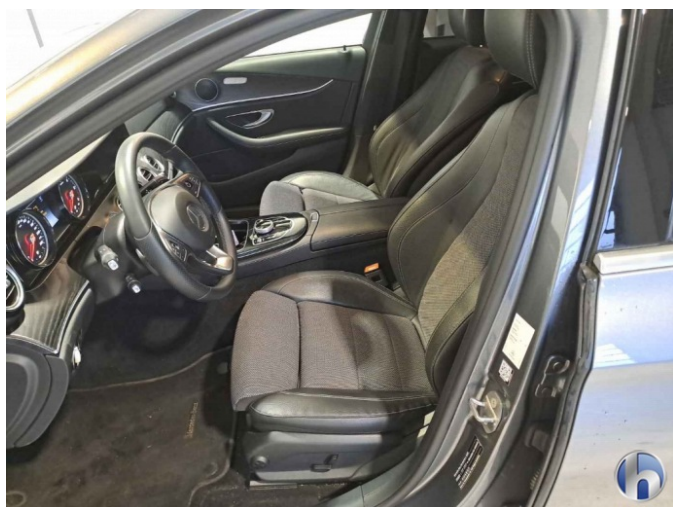
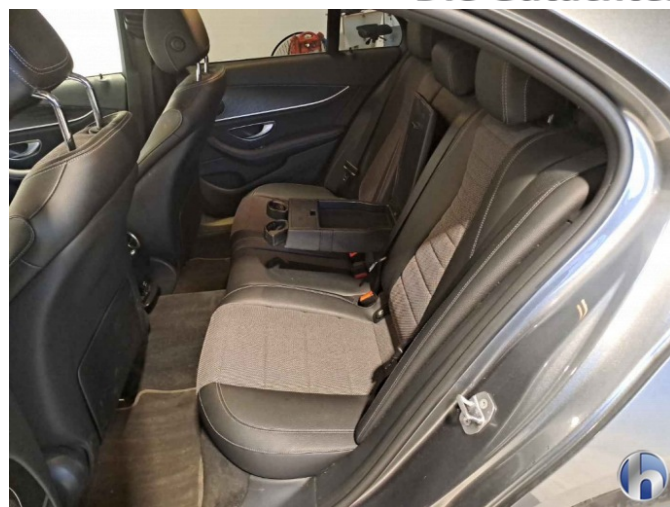
| component | Damage | Rep kind |
|---|---|---|
| 9. | Wear and tear | acceptable |

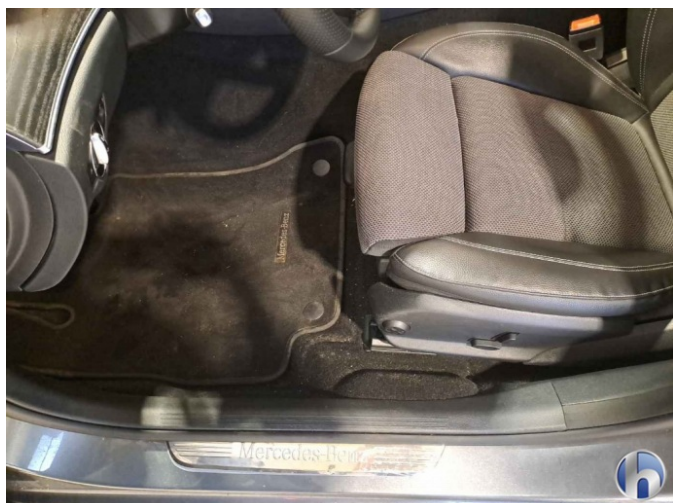
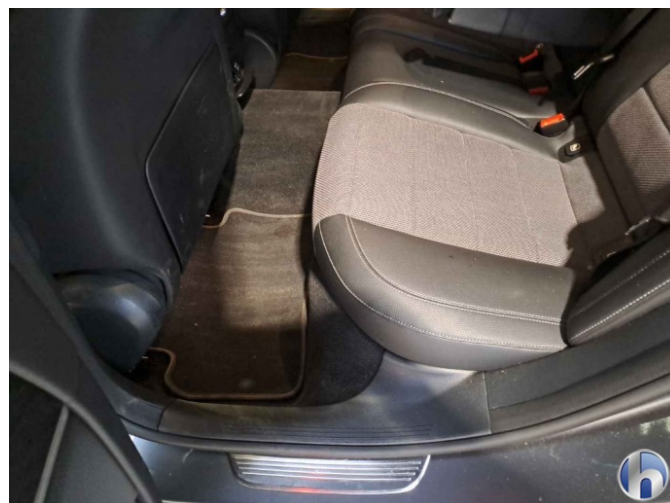
| component | Damage | Rep kind |
|---|---|---|
| 10. | Dirty | |

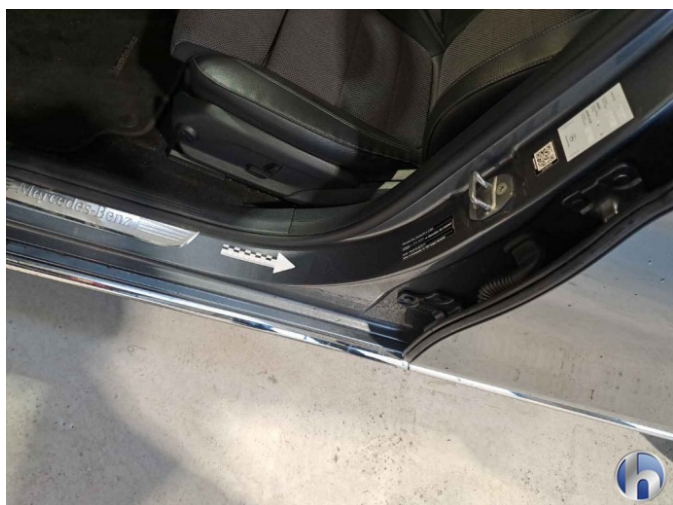
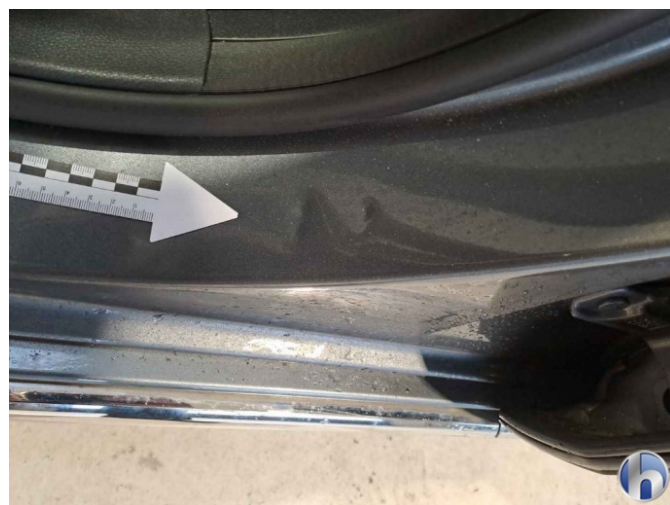
| component | Damage | Rep kind |
|---|---|---|
| 11. Türeinstieg Vorne - Links | Dented | Smart repair |

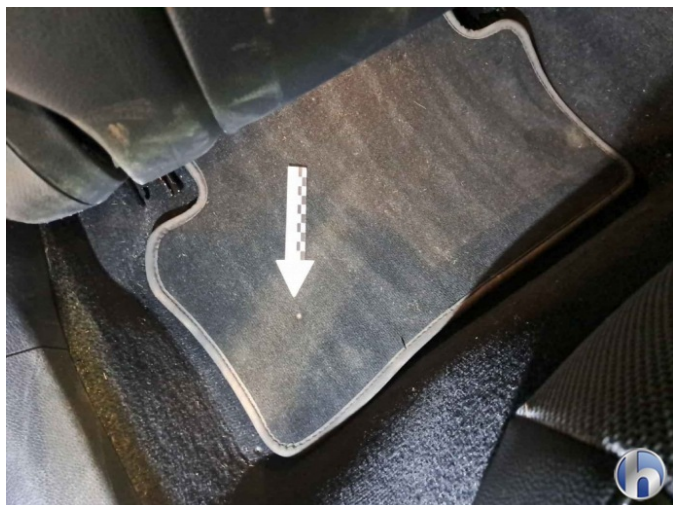
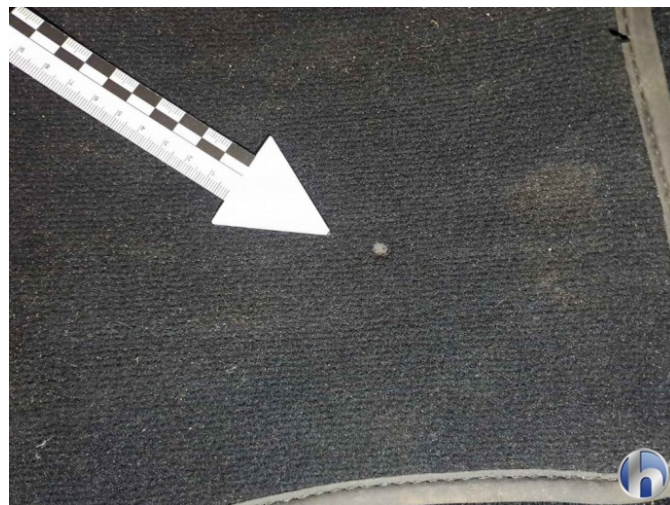
| component | Damage | Rep kind |
|---|---|---|
| 13. | Burn hole | Replace |

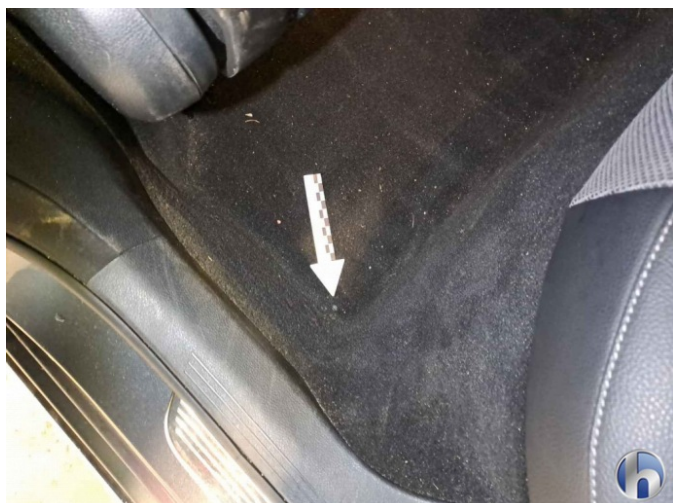
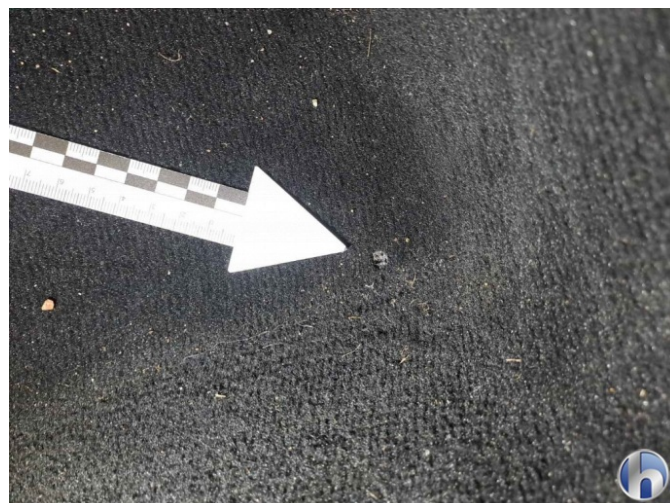
| component | Damage | Rep kind |
|---|---|---|
| 14. flooring | Burn hole | Replace |
