MERCEDES Classe E - S213 SW Diesel
E SW 200 d Sport auto

VIN NO WDD2132131A455312
Registration Number GP415EK

Inspection Report Summary

Customer	BCA Lodi	Report Number	P20251009091403
Inspection Date / Place	2025-10-09 / BCA Lodi	Cosmetic Grade	3

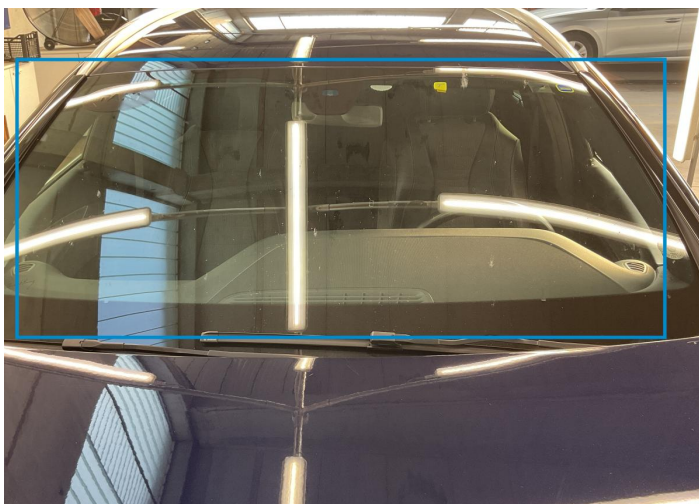
1. Windshield / Front
Glass Break / Impact -

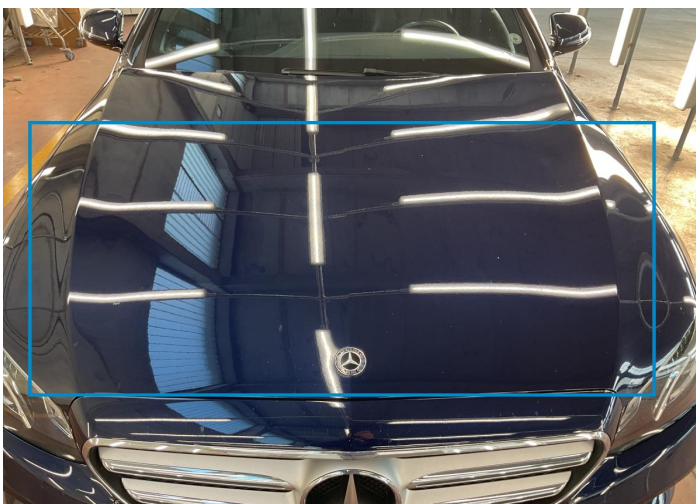
2. Hood
Paint / Chipping -

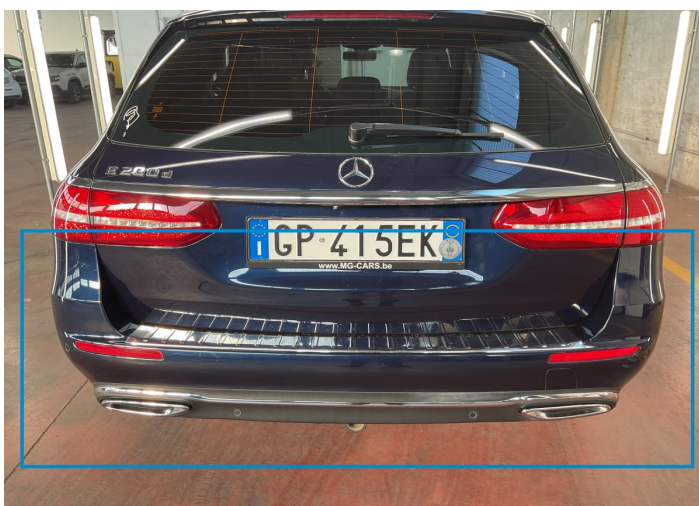
3. Bumper / Back
Paint / Scratch / Line -

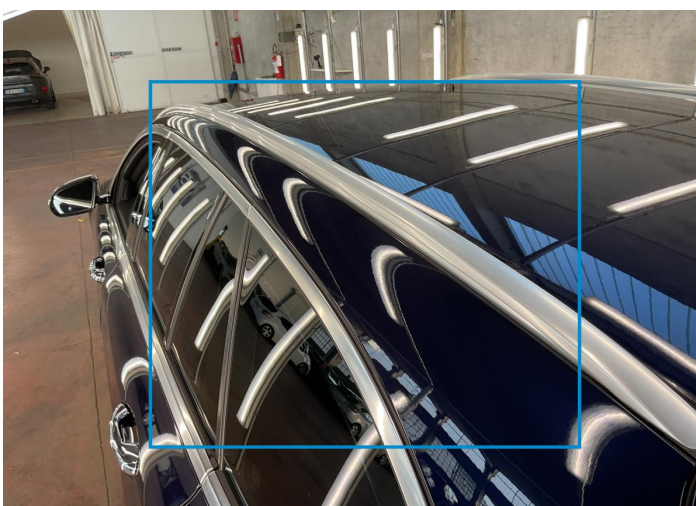
4. Pillar / Front Left
Bodywork / Poor Previous Repair -

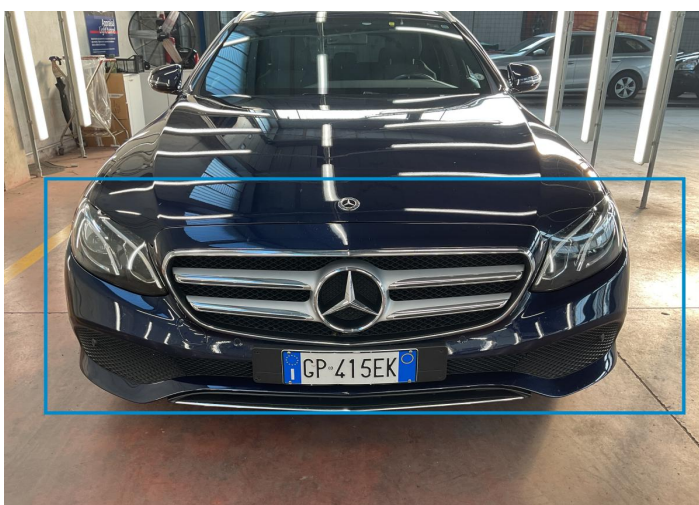
5. Bumper / Front
Paint / Chipping -

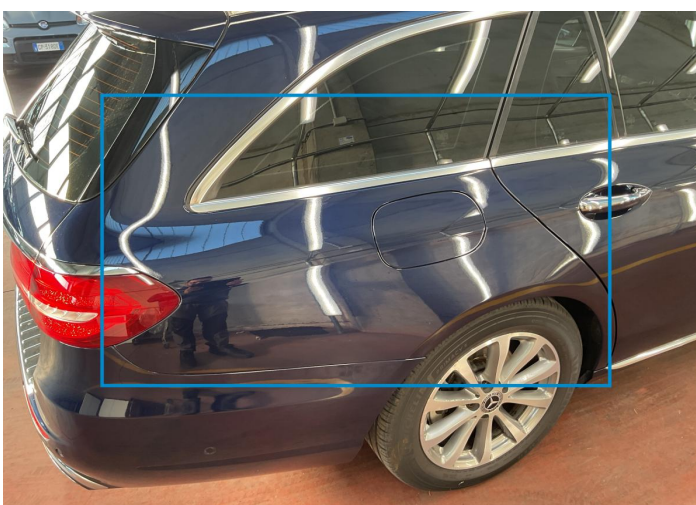
6. Fender / Back Right
Bodywork / Poor Previous Repair -

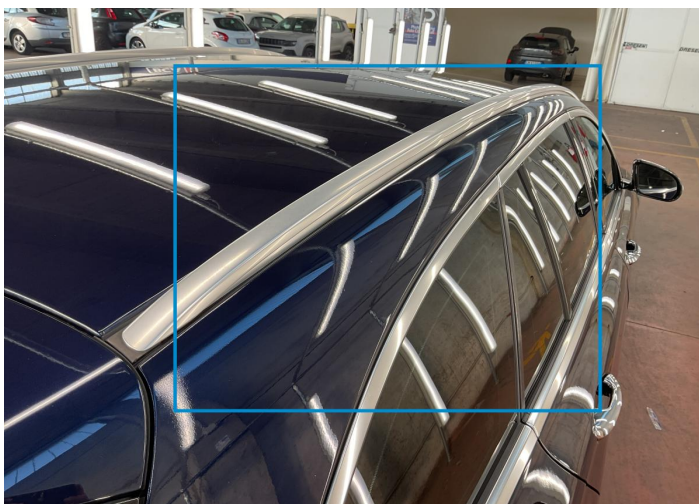
7. Pillar / Front Right
Bodywork / Poor Previous Repair -

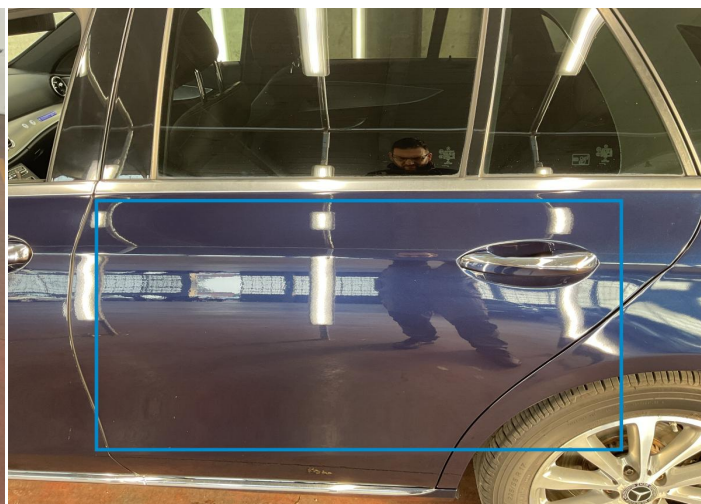
8. Door / Back Left
Bodywork / Dent -

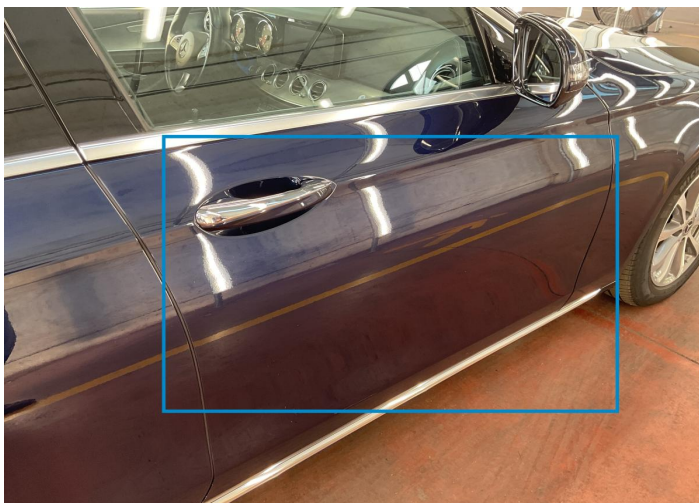
9. Door / Front Right
Bodywork / Poor Previous Repair -

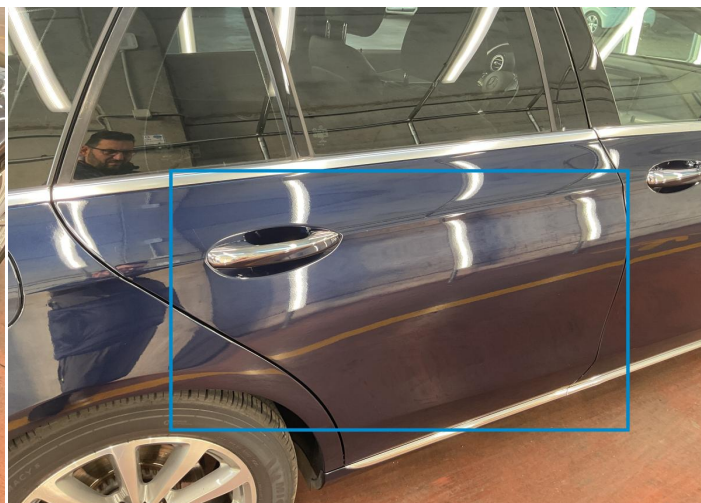
10. Door / Back Right
Bodywork / Poor Previous Repair -

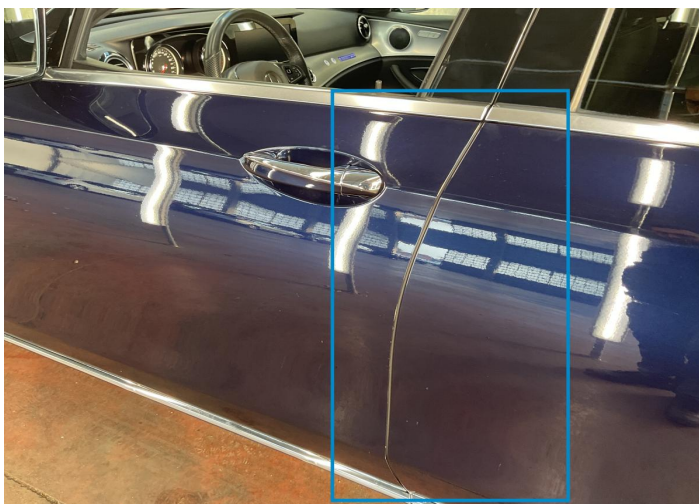
11. Door / Front Left
Paint / Scratch / Line -

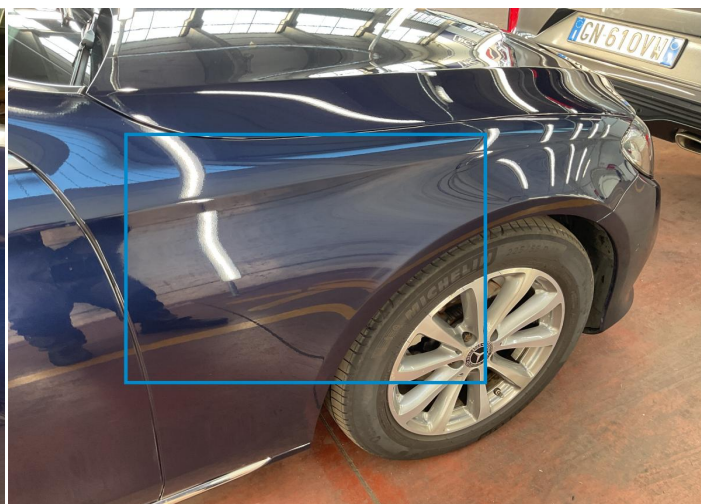
12. Fender / Front Right
Bodywork / Poor Previous Repair -

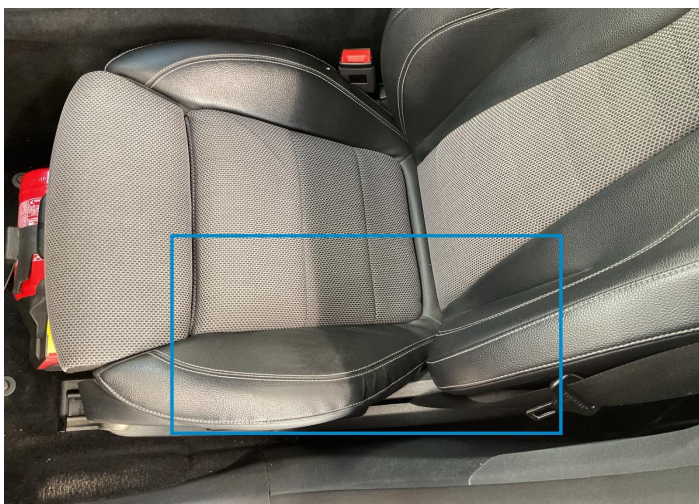
13. Seat / Front Left
Interior / Worn - out -

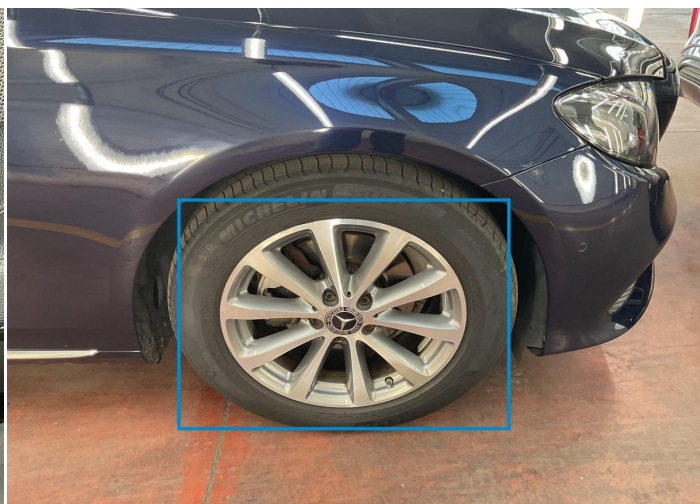
14. Rim / Front Right
Out of Bodywork / Scratch -

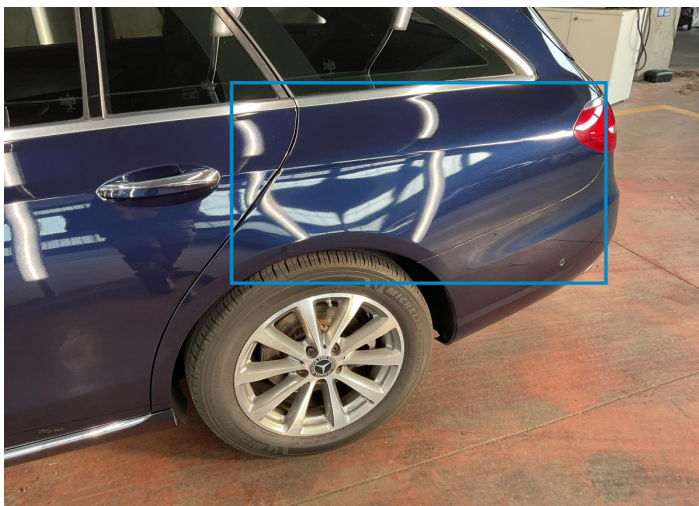
15. Fender / Back Left
Bodywork / Poor Previous Repair -

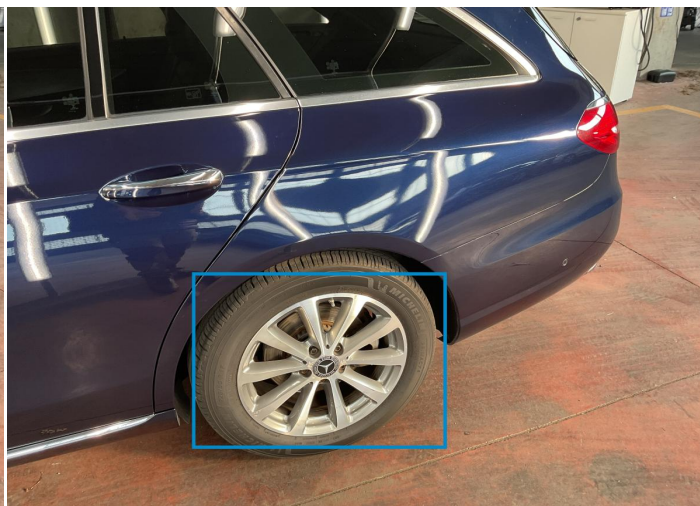
16. Rim / Back Left
Out of Bodywork / Scratch -

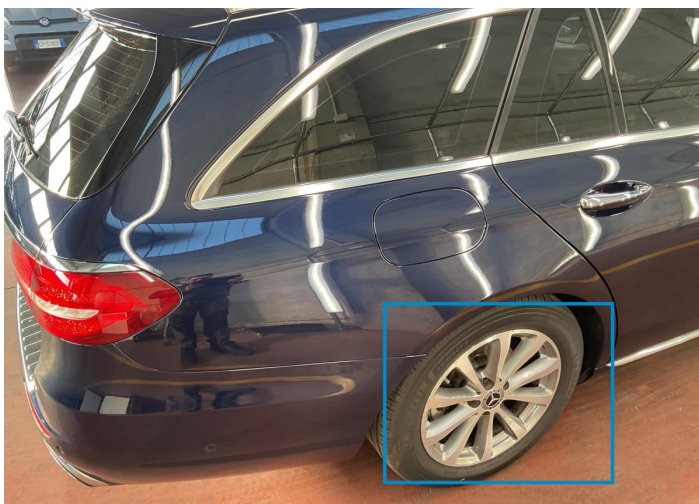
17. Rim / Back Right
Out of Bodywork / Scratch -

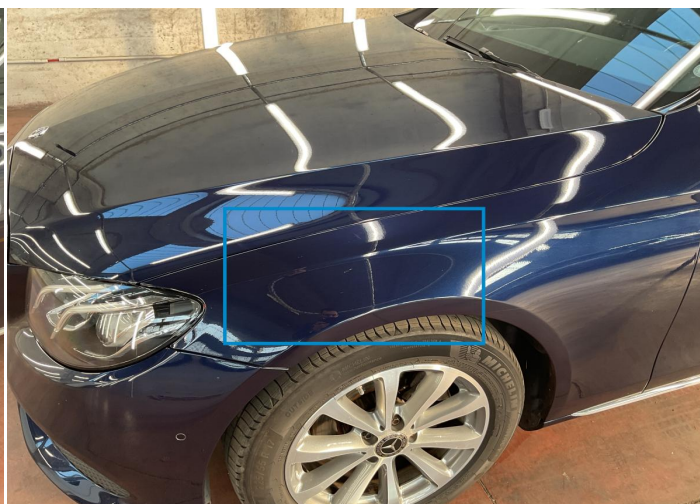
18. Fender / Front Left
Paint / Scratch / Line -
