# MERCEDES CLASSE CLS Classe CLS Shooting Brake 350 d Executive A

VIN NO WDD2189261A195824 Registration Number ER602KQ

### **Inspection Report Summary**

Customer	BCAuto Encheres	Report Number	P20250922090110
Inspection Date / Place	2025-09-22 / BCA MITRY	Cosmetic Grade	3

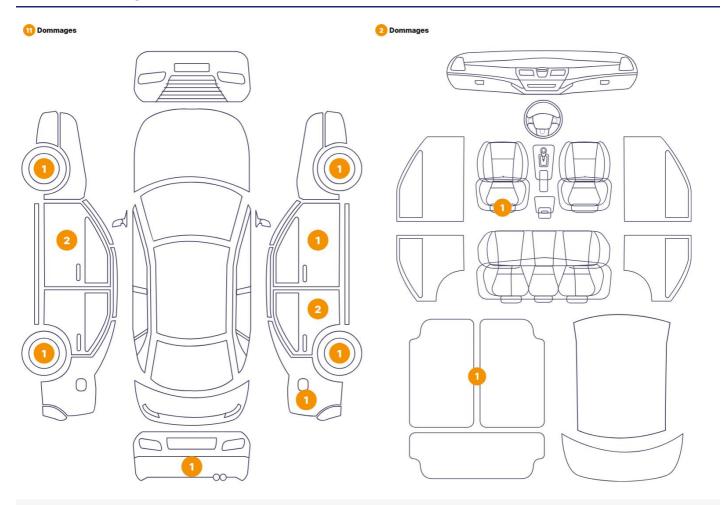
Component	Damage	Comments
1	Bumper / Back	Paint / Scratch / Line	
2	Rim	Out of Bodywork / Scratch	
3	Door / Front Left	Paint / Scratch / Line	
4	Door / Front Left	Paint / Scratch / Line	
5	Rim / Front Left	Out of Bodywork / Scratch	
6	Rim	Out of Bodywork / Scratch	
7	Mirror / Front Right	Paint / Scratch / Line	
8	Door / Back Right	Bodywork / Dent / Deformation	
9	Door / Back Right	Paint / Scratch / Line	
10	Side Panel / Back Right	Bodywork / Dent / Deformation	
11	Rim Brake pads	Out of Bodywork / Scratch	
12	Seat / Front Left	Interior / Scraped

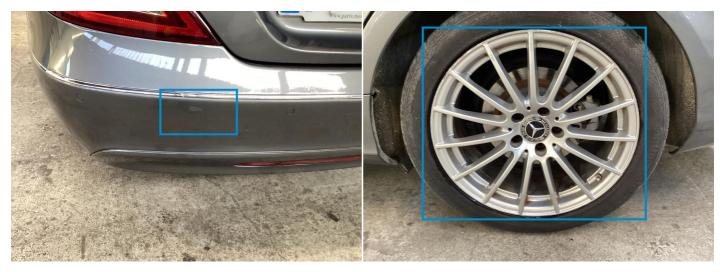
1. Bumper / Back Paint / Scratch / Line -

2. Rim Out of Bodywork / Scratch -

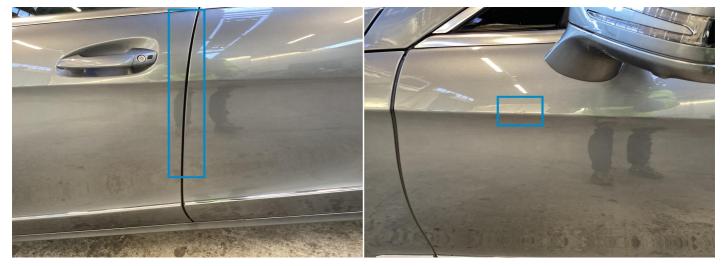
3. Door / Front Left Paint / Scratch / Line -

4. Door / Front Left Paint / Scratch / Line -

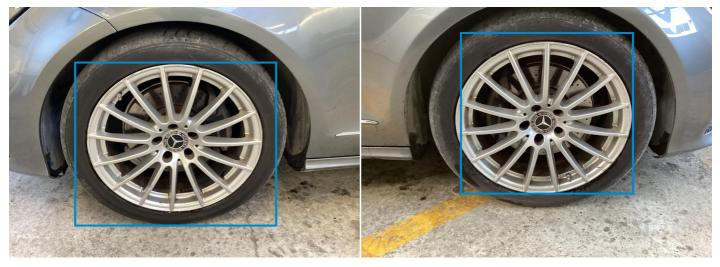
5. Rim / Front Left Out of Bodywork / Scratch -

6. Rim Out of Bodywork / Scratch -

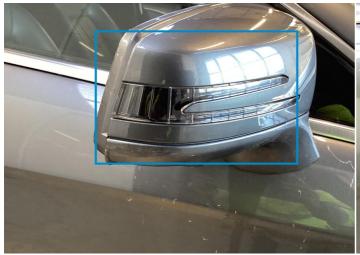
7. Mirror / Front Right Paint / Scratch / Line -

8. Door / Back Right Bodywork / Dent / Deformation -

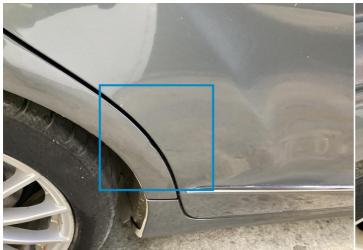
9. Door / Back Right Paint / Scratch / Line -

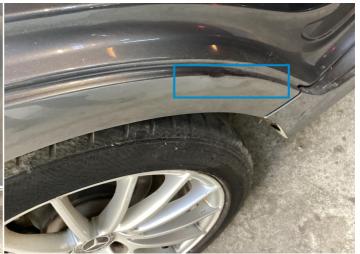
10. Side Panel / Back Right Bodywork / Dent / Deformation -

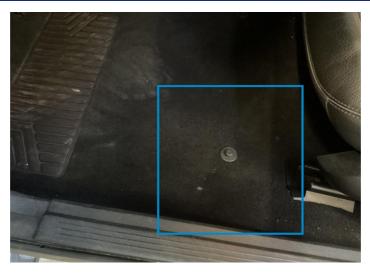
13. Floor Carpet Interior / Burn -
