MERCEDES Classe S W/V 222 Benzina S 500 V8 Maximum 4matic auto

VIN NO WDD2220851A151149 Registration Number EY714VK

Inspection Report Summary

Customer	BCA Lodi	Report Number	P20250926091310
Inspection Date / Place	2025-09-26 / BCA Lodi	Cosmetic Grade	4

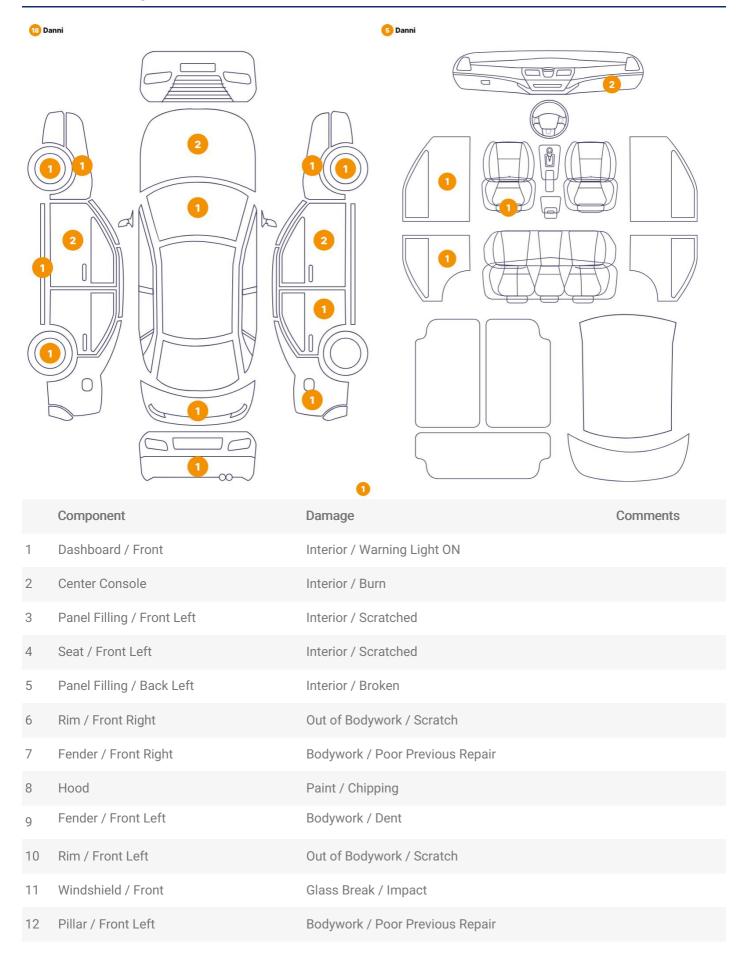
13	Door / Front Left	Paint / Scratch / Line
14	Rim / Back Left	Out of Bodywork / Scratch
15	Rocker Panel / Center Left	Paint / Scratch / Line
16	Bumper / Back	Paint / Scratch / Line
17	Fender / Back Right	Bodywork / Poor Previous Repair
18	Door / Back Right	Bodywork / Dent
19	Door / Front Right	Bodywork / Poor Previous Repair
20	Pillar / Front Right	Bodywork / Poor Previous Repair
21	Hood	Bodywork / Dent
22	Tailgate	Bodywork / Poor Previous Repair
23	Other	Bodywork / Poor Previous Repair

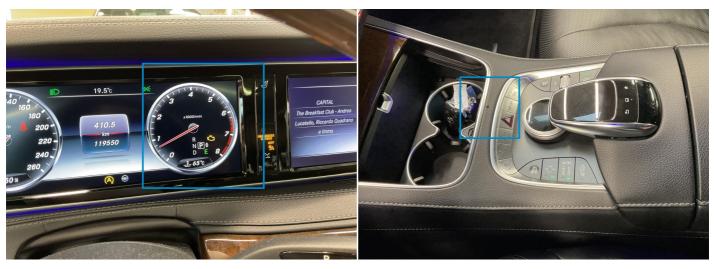
1. Dashboard / Front Interior / Warning Light ON -

2. Center Console Interior / Burn -

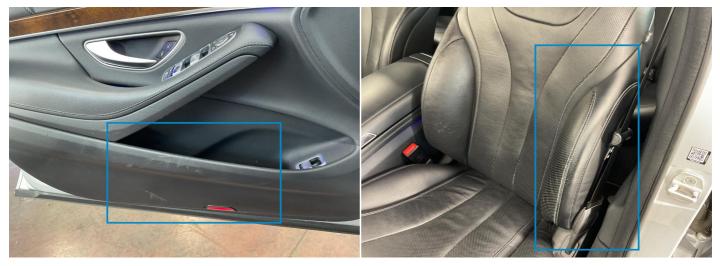
3. Panel Filling / Front Left Interior / Scratched -

4. Seat / Front Left Interior / Scratched -

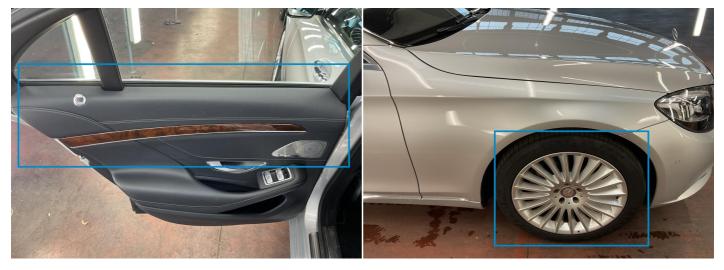
5. Panel Filling / Back Left Interior / Broken -

6. Rim / Front Right
Out of Bodywork / Scratch -

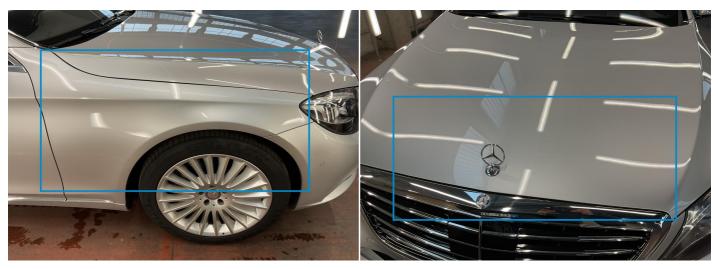
7. Fender / Front Right Bodywork / Poor Previous Repair -

8. Hood Paint / Chipping -

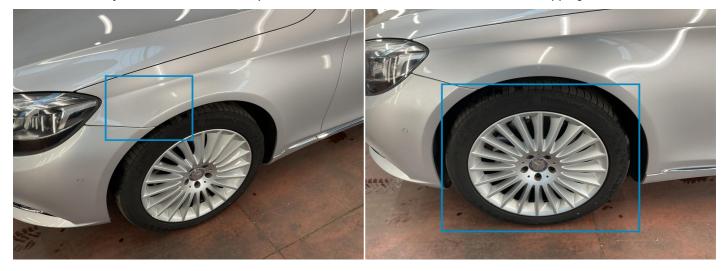
9. Fender / Front Left Bodywork / Dent -

10. Rim / Front Left Out of Bodywork / Scratch -

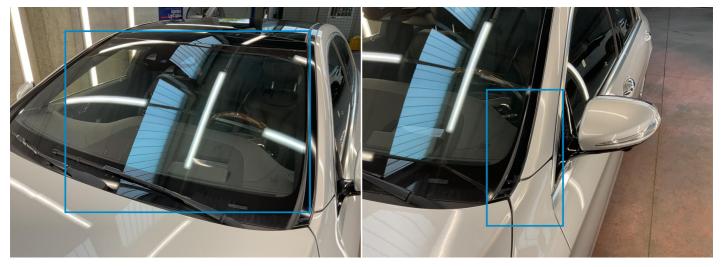
11. Windshield / Front Glass Break / Impact -

12. Pillar / Front Left Bodywork / Poor Previous Repair -

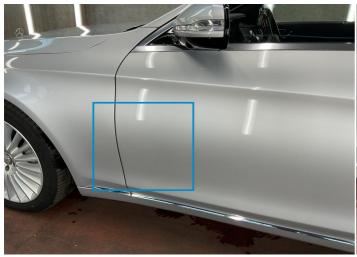
13. Door / Front Left Paint / Scratch / Line -

14. Rim / Back Left Out of Bodywork / Scratch -

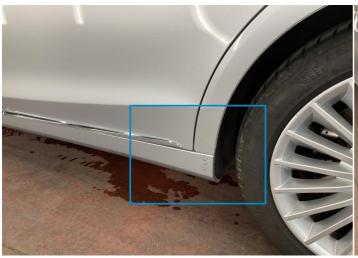
15. Rocker Panel / Center Left Paint / Scratch / Line -

16. Bumper / Back Paint / Scratch / Line -

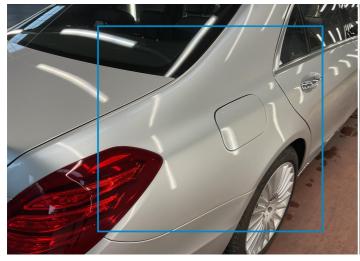
17. Fender / Back Right Bodywork / Poor Previous Repair -

18. Door / Back Right Bodywork / Dent -

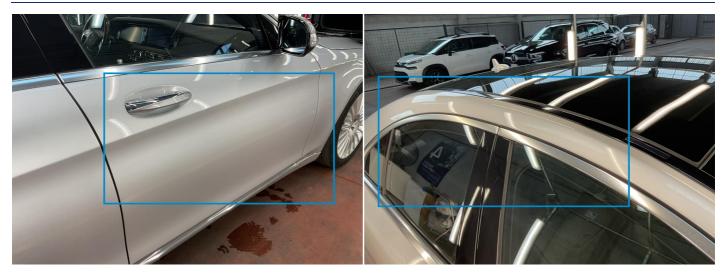
19. Door / Front Right Bodywork / Poor Previous Repair -

20. Pillar / Front Right Bodywork / Poor Previous Repair -

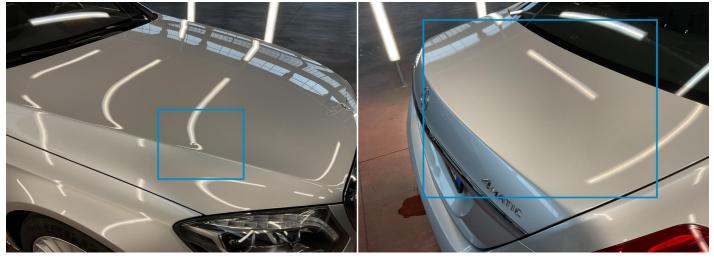
21. Hood Bodywork / Dent -

22. Tailgate Bodywork / Poor Previous Repair -

23. Bodywork / Poor Previous Repair -
