## status report

#### Mercedes-Benz B -Klasse B 220 CDI / d

| Vehicle identification number | <b>WDD2462031J303444</b> | mileage read: | <b>232925 km</b> |

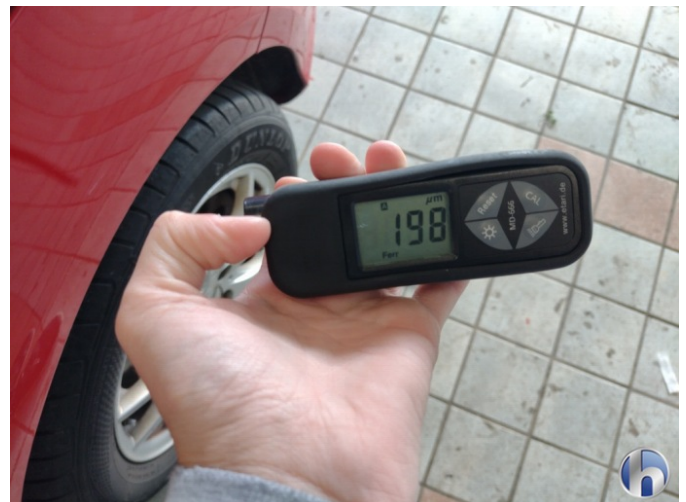
| component | Damage | Rep kind |
|---|---|---|
| 1. Sidewall - Rear - Left | Subsequently painted | acceptable |

1. Sidewall - Rear - Left

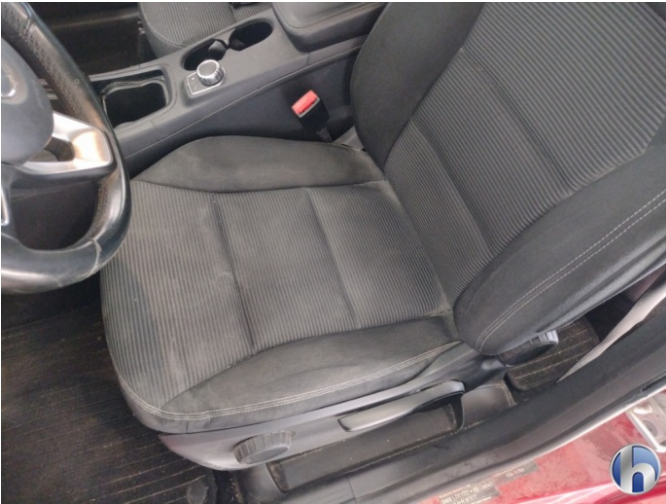
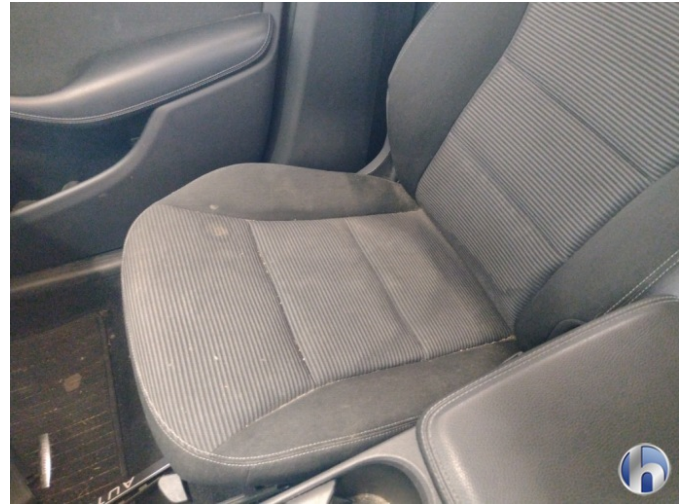
| component | Damage | Rep kind |
|---|---|---|
| 2. Beide Vorderen Sitze | Dirty | |

2. Beide Vorderen Sitze

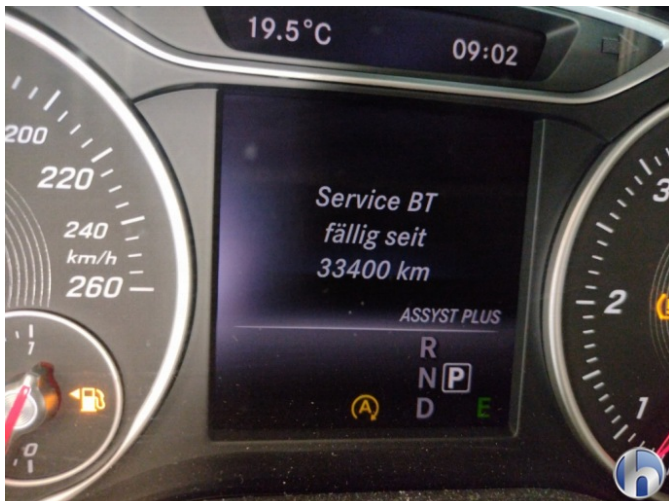
| component | Damage | Rep kind |
|---|---|---|
| 4. maintenance | Due | Replace |

4. maintenance

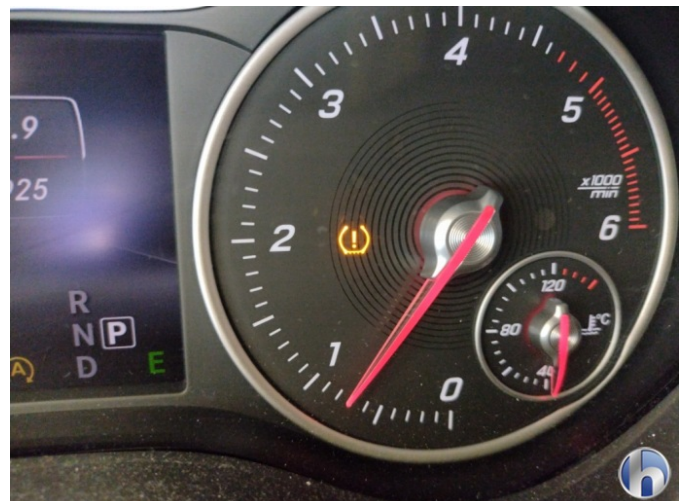
| component | Damage | Rep kind |
|---|---|---|
| 5. Reifendruckkontrollleuchte | Error message | Carry out a fault diagnosis |

5. Reifendruckkontrollleuchte

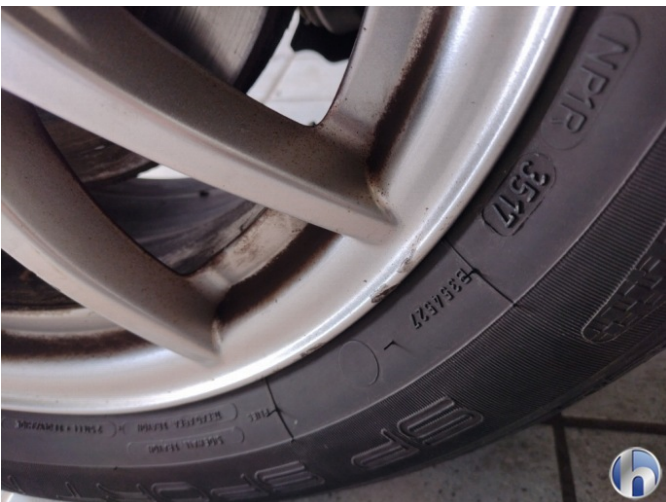
| component | Damage | Rep kind |
|---|---|---|
| 6. Rim rear - right | Scratch(es) | Paint |

6. Rim rear - right

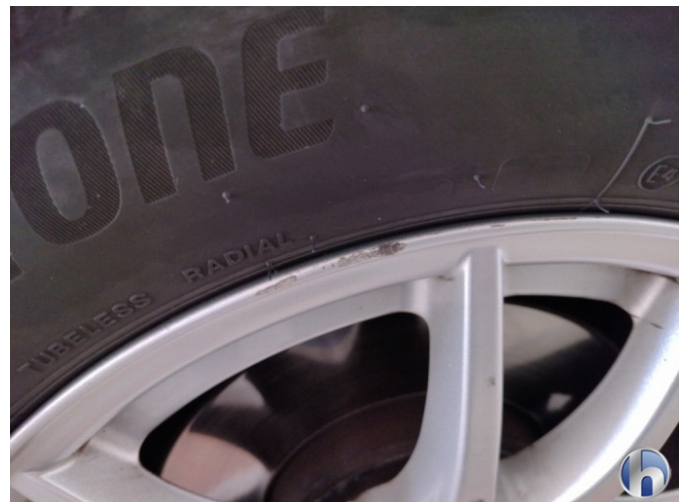
| component | Damage | Rep kind |
|---|---|---|
| 7. Rim front - right | Scratch(es) | Smart repair |

7. Rim front - right

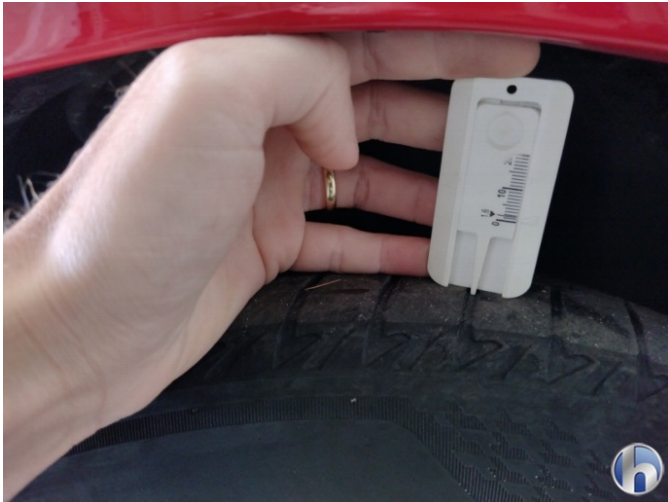
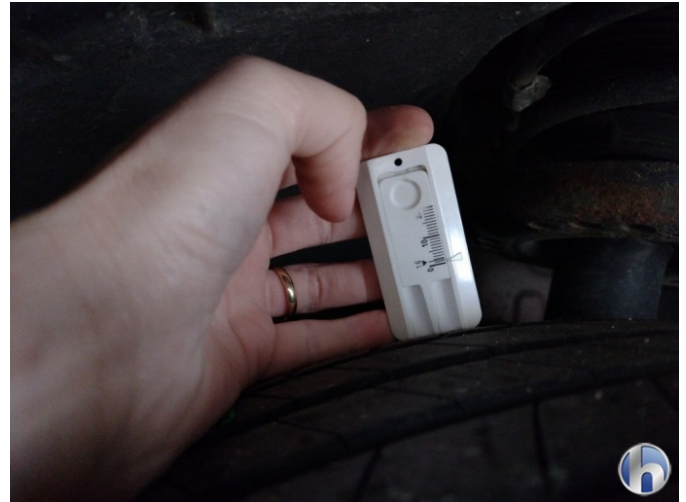
| General examination | |
|---|---|
| <b>Note Road Safe:</b> | Beide Reifen Vorne Verschlissen |

| component | Damage | Rep kind |
|---|---|---|
| 8. Beide Reifen Vorne | Worn | Replace |

8. Beide Reifen Vorne

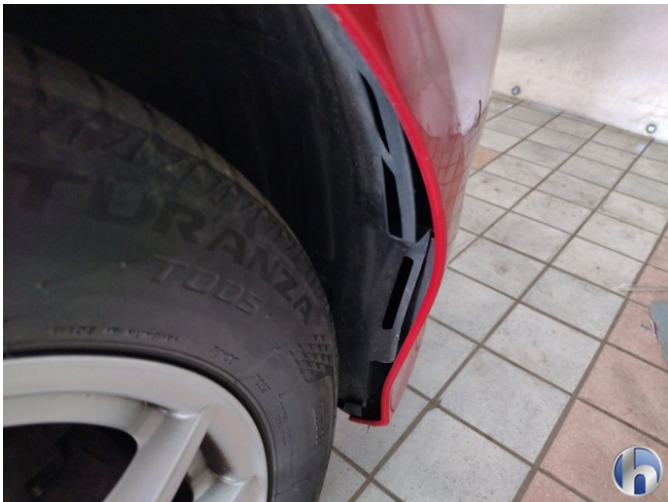
| component | Damage | Rep kind |
|---|---|---|
| 9. Front right wheel housing liner | Damaged | Replace |

9. Front right wheel housing liner

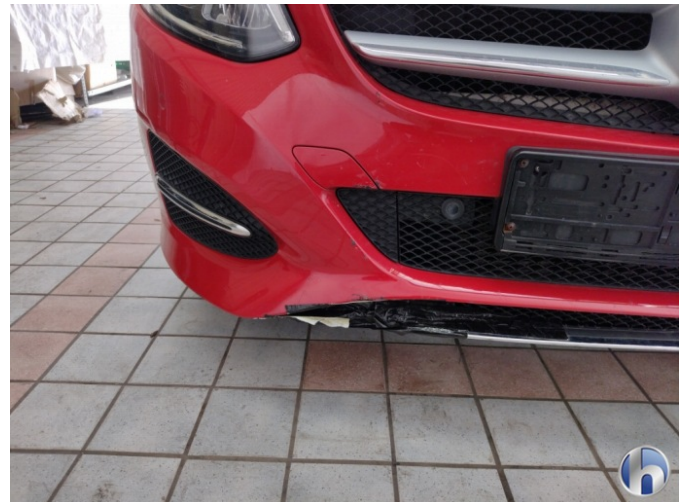
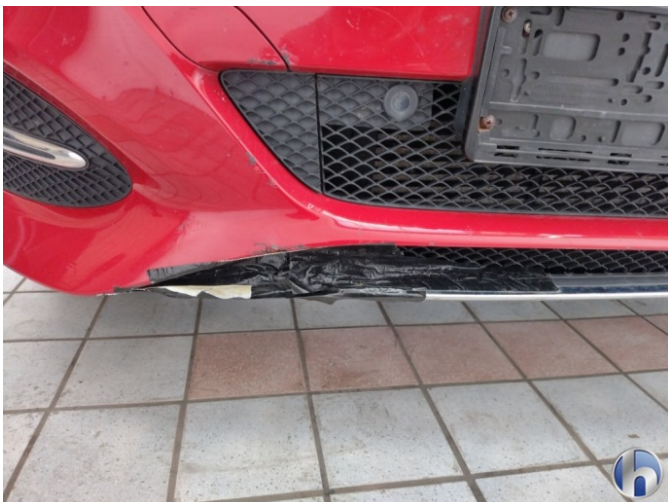
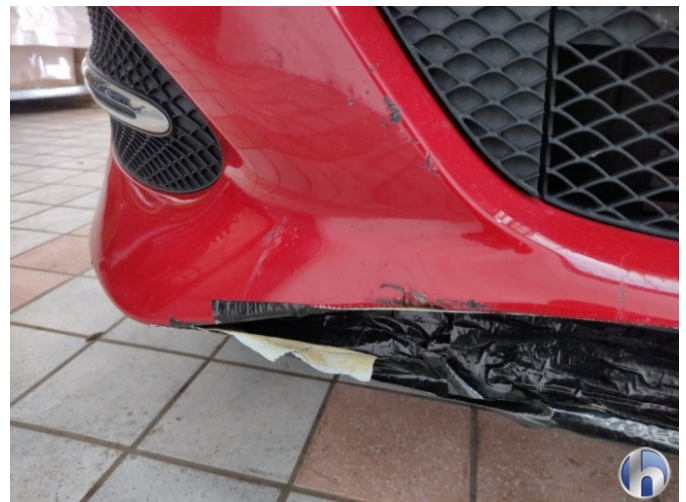
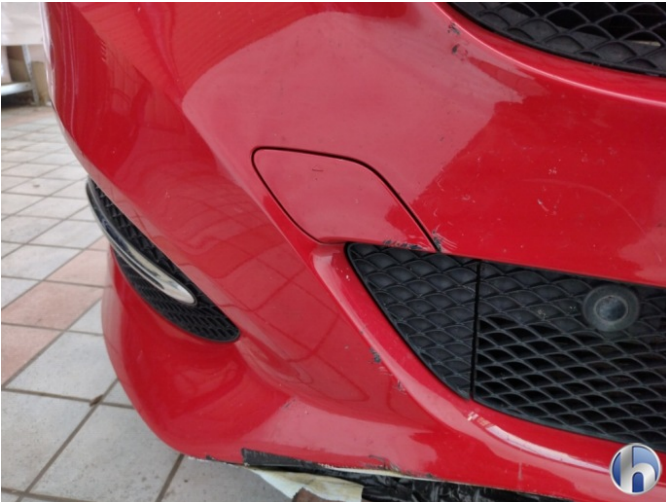
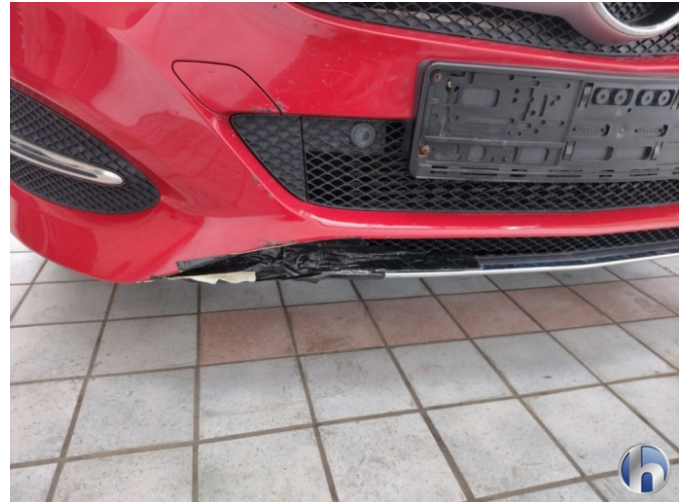
| Accident injury assessment | |
|---|---|
| <b>reference:</b> | Fahrzeug mit bestehenden Unfallschaden, zur Schadensermittlung wurden keine |

Demontagearbeiten durchgeführt, verborgen gebliebene Schäden können nicht ausgeschlossen werden. Unfallschaden Kosten wurden überschlägig Kalkuliert, Kostenerweiterung möglich.

| component | Damage | Rep kind |
|---|---|---|
| 10. Unfallschaden Vorne,<br>Schadenserweiterung möglich | Accident damage | Replace |

10. Unfallschaden Vorne, Schadenserweiterung möglich

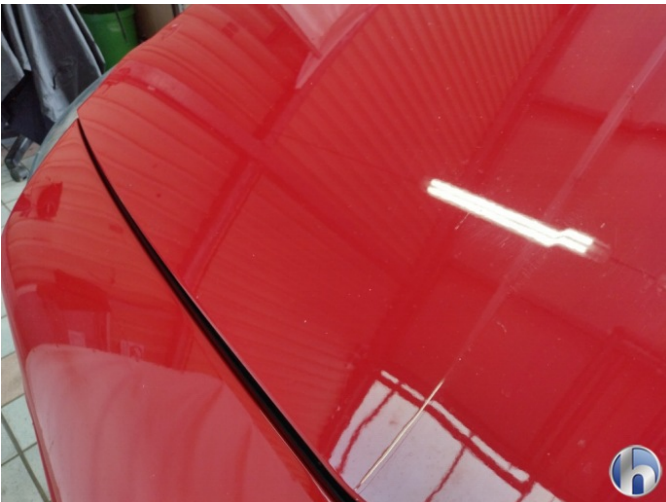
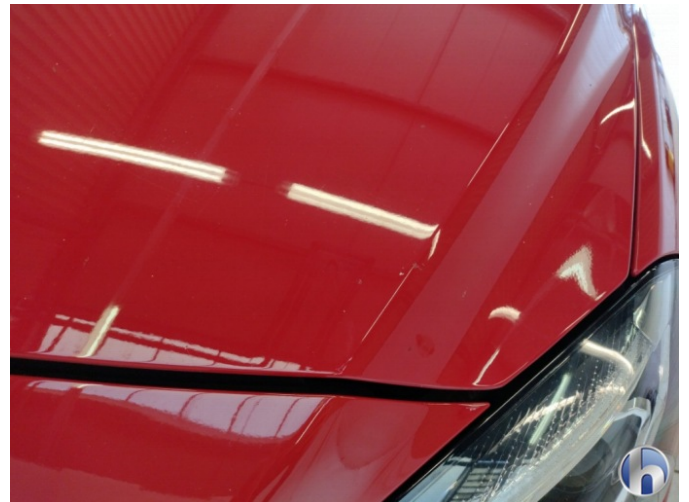
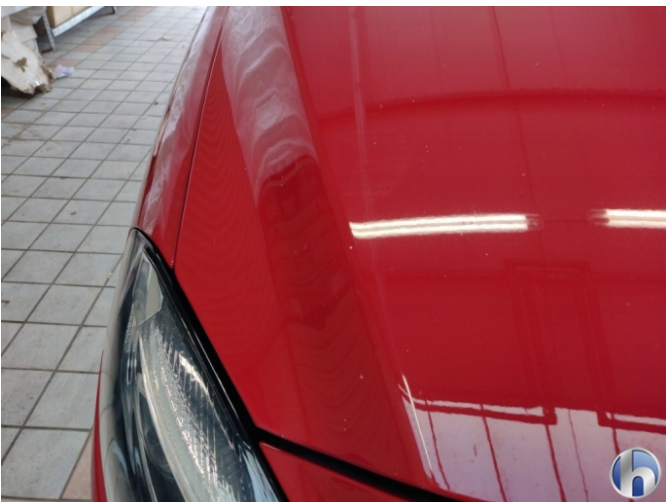
| component | Damage | Rep kind |
|---|---|---|
| 11. hood | Wear and tear | acceptable |

11. hood

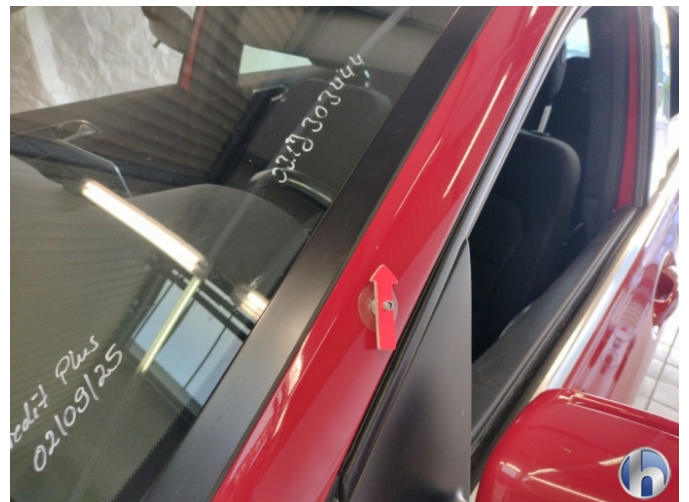
| component | Damage | Rep kind |
|---|---|---|
| 12. A-pillar Front - Left | Wear and tear | acceptable |

12. A-pillar Front - Left

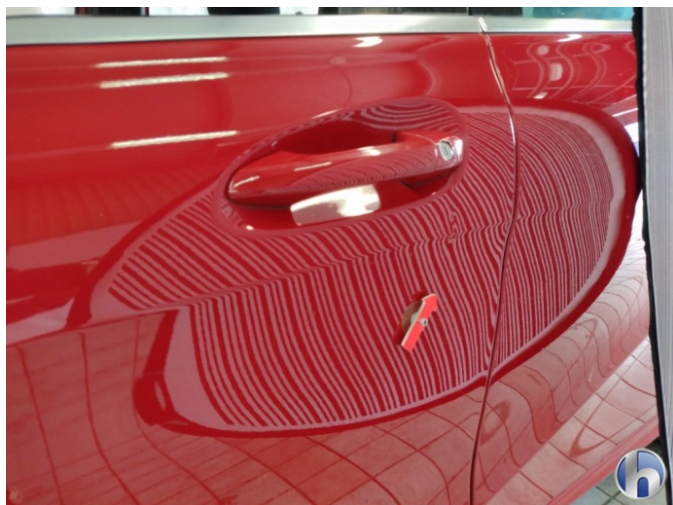
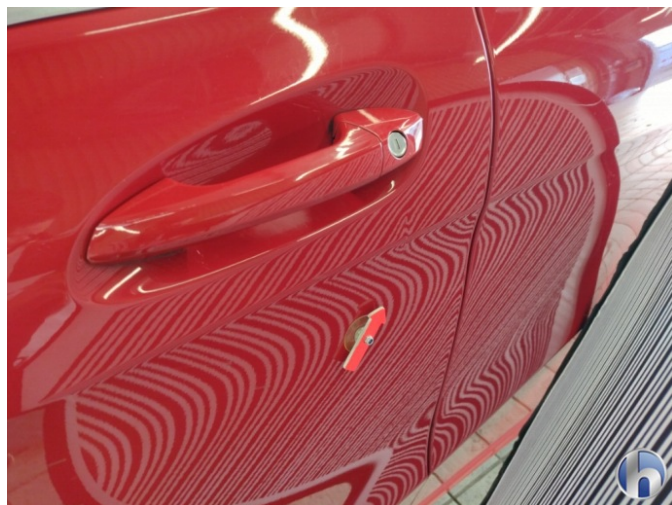
| component | Damage | Rep kind |
|---|---|---|
| 13. Front door - left | Deformed | Refurbish and paint |

13. Front door - left

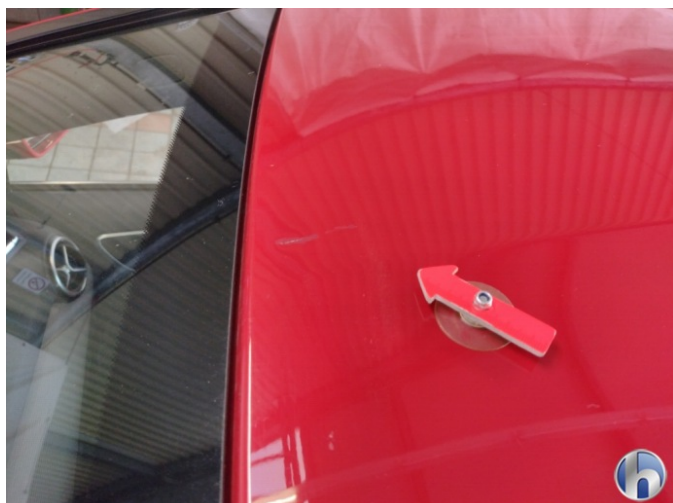
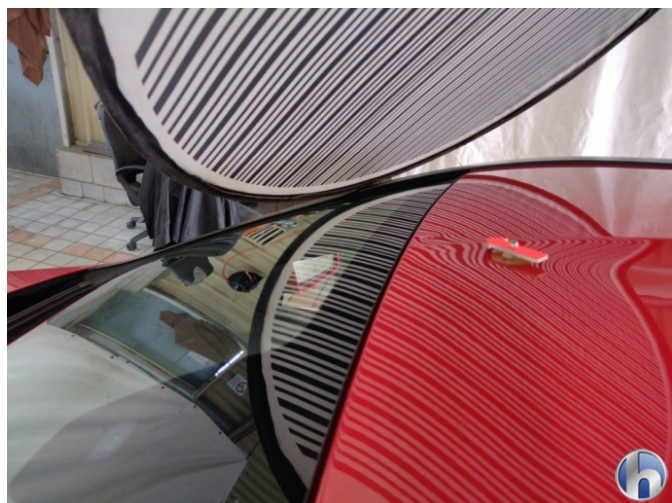
| component | Damage | Rep kind |
|---|---|---|
| 14. roof | Damaged | Refurbish and paint |

14. roof

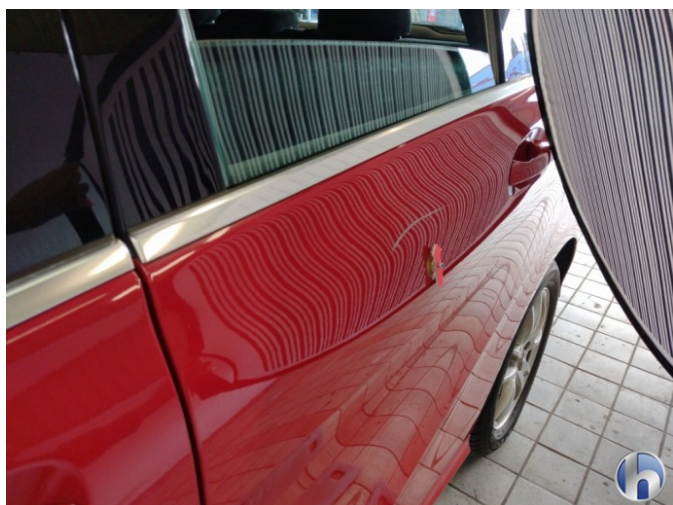
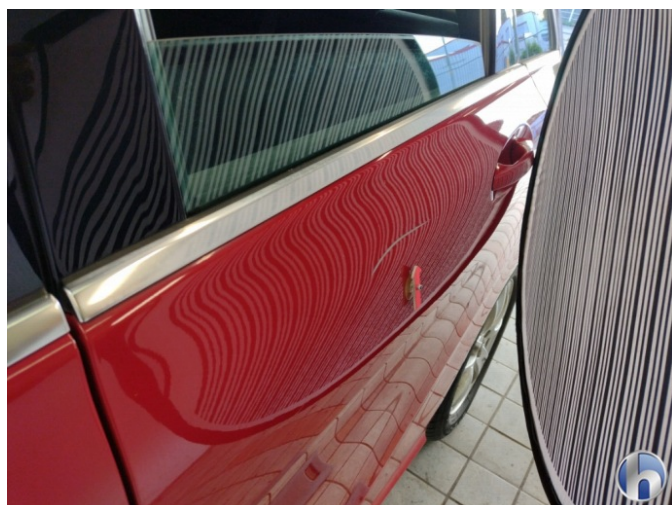
| component | Damage | Rep kind |
|---|---|---|
| 15. Rear door - left | Deformed | Refurbish and paint |

15. Rear door - left

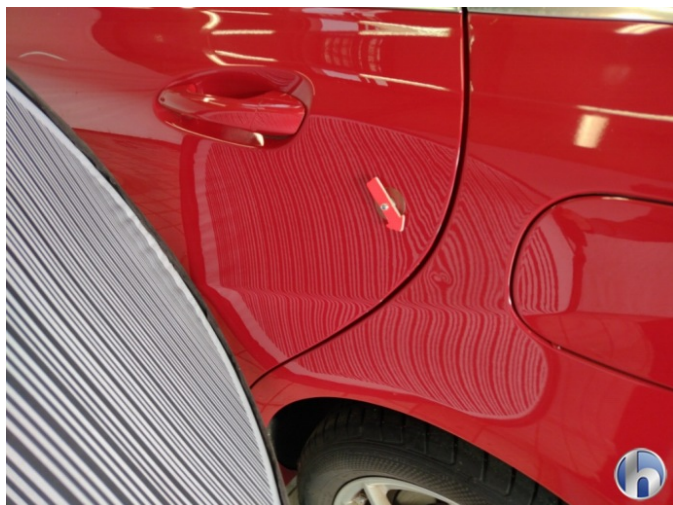
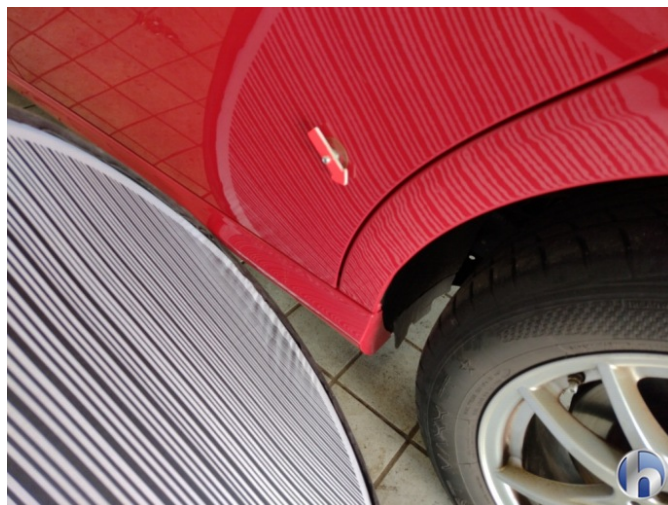
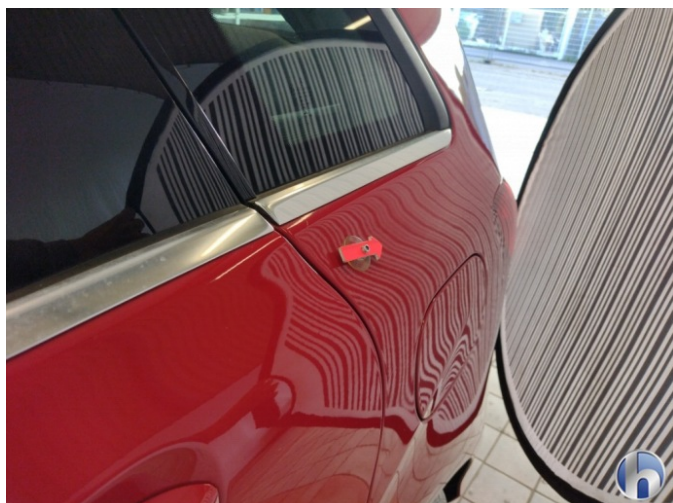
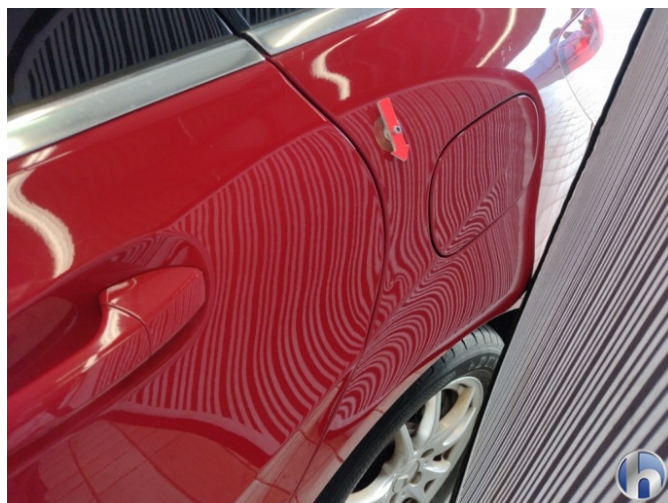
| component | Damage | Rep kind |
|---|---|---|
| 16. Sidewall - Rear - Left | Deformed | Refurbish and paint |

16. Sidewall - Rear - Left

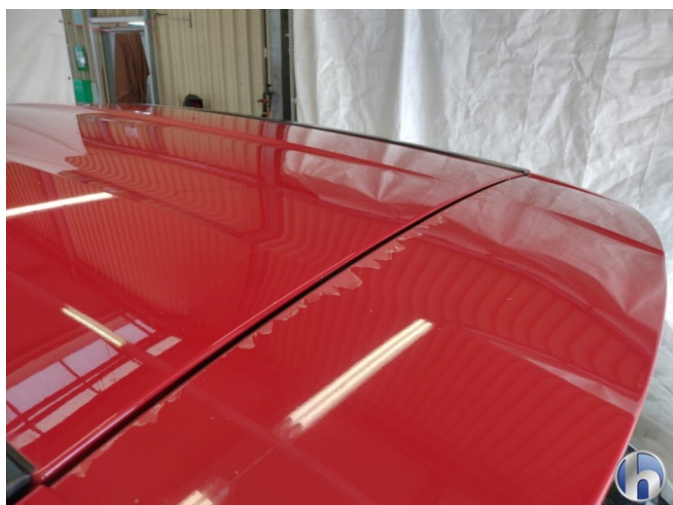
| component | Damage | Rep kind |
|---|---|---|
| 17. Heckklappe Spoiler | chipped paint | Paint |

17. Heckklappe Spoiler

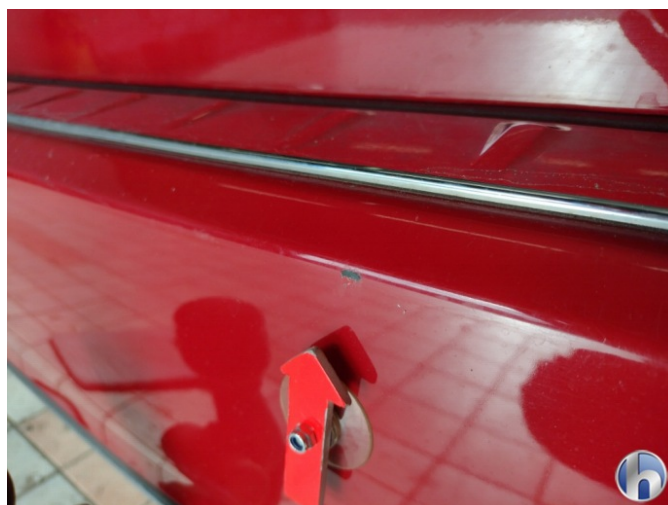
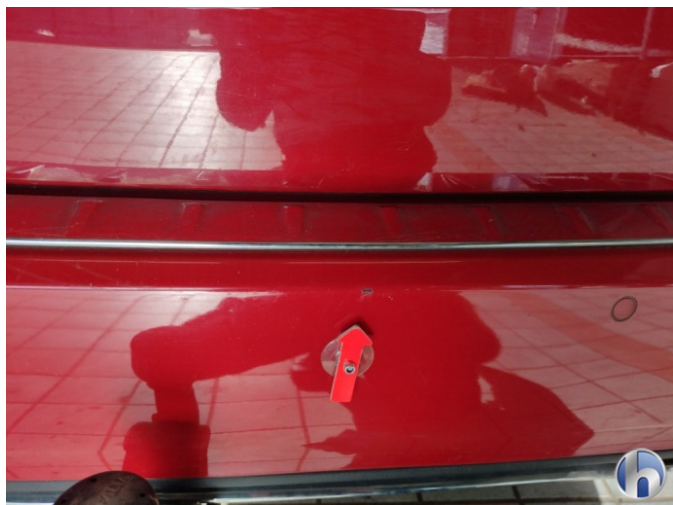
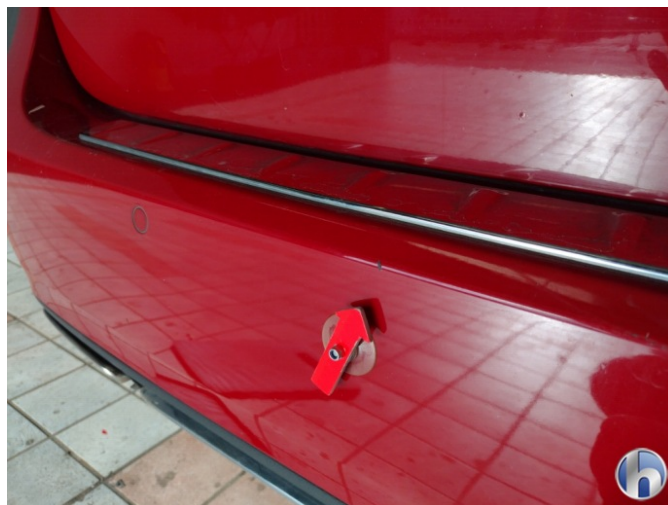
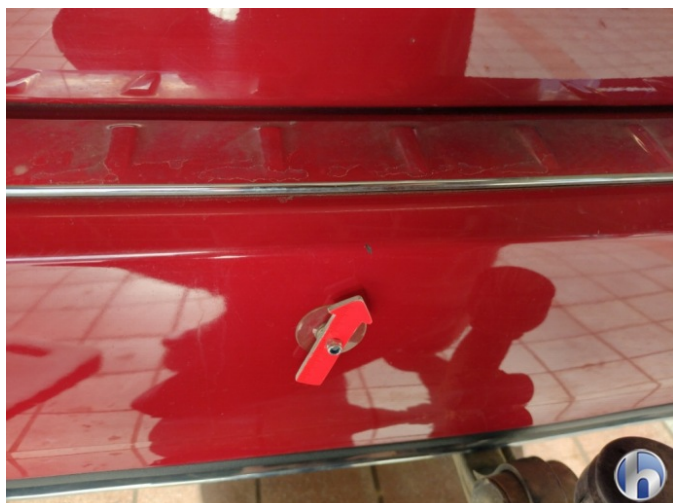
| component | Damage | Rep kind |
|---|---|---|
| 18. Rear bumper | Scratch(es) | Paint |

18. Rear bumper

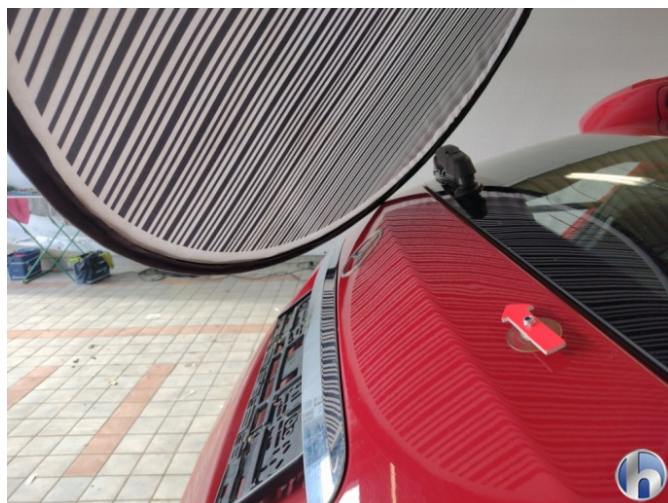
| component | Damage | Rep kind |
|---|---|---|
| 19. tailgate | Delle | Smart repair |

19. tailgate

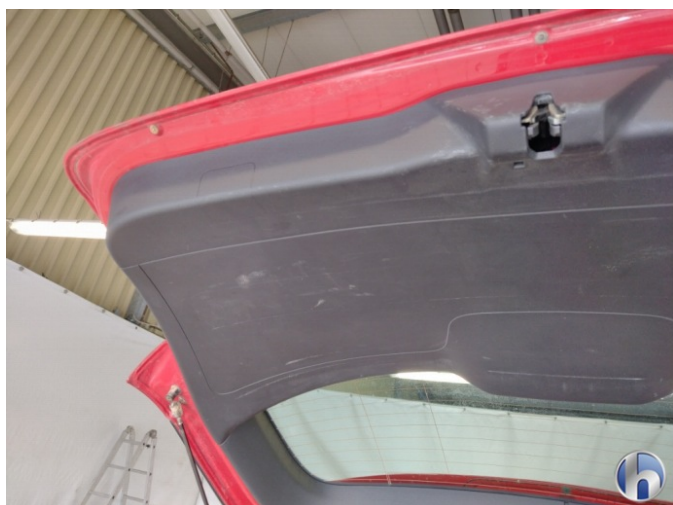
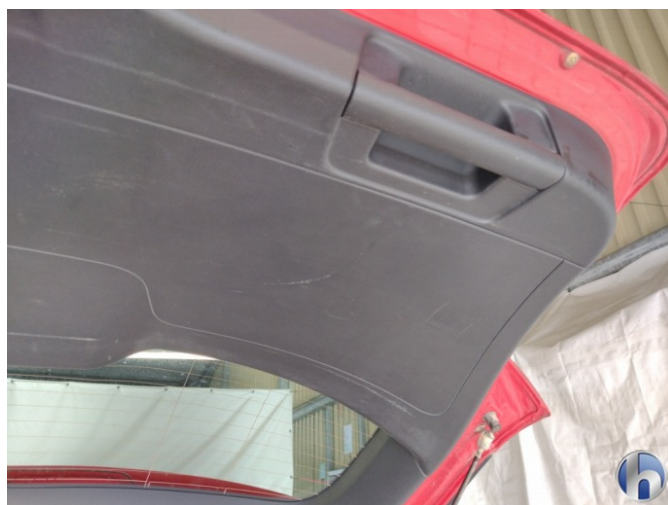
| component | Damage | Rep kind |
|---|---|---|
| 20. tailgate trim | Wear and tear | acceptable |

20. tailgate trim

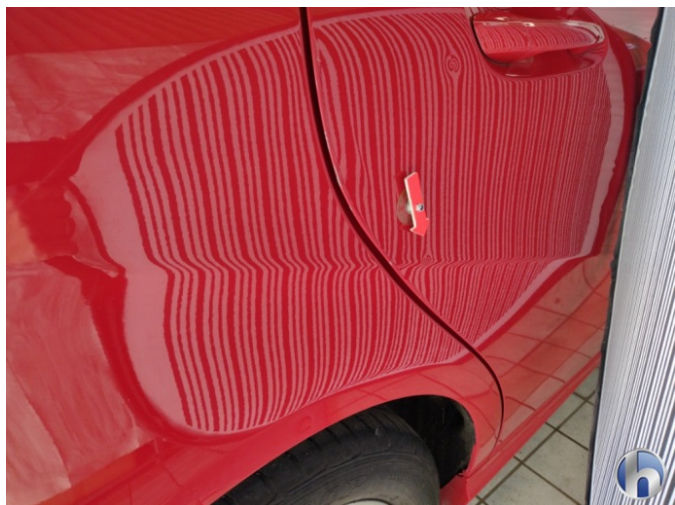
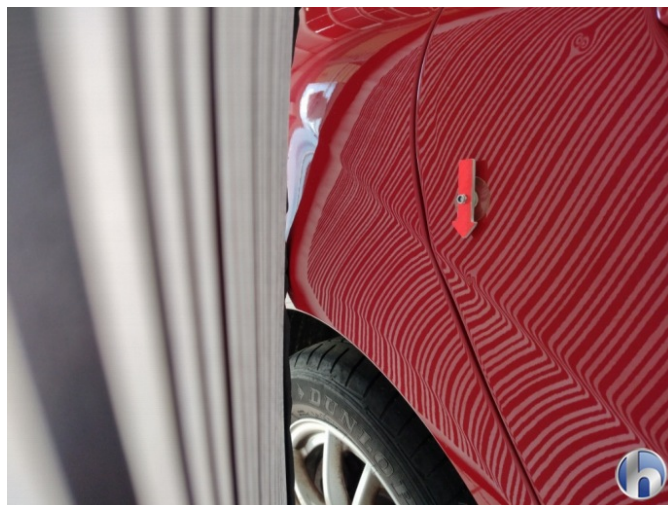
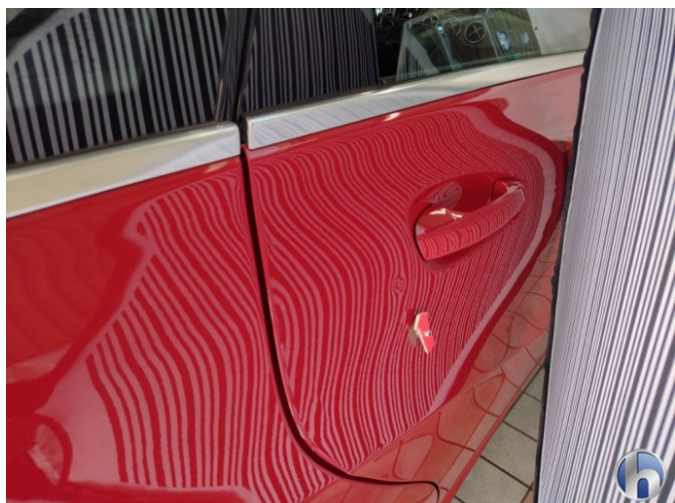
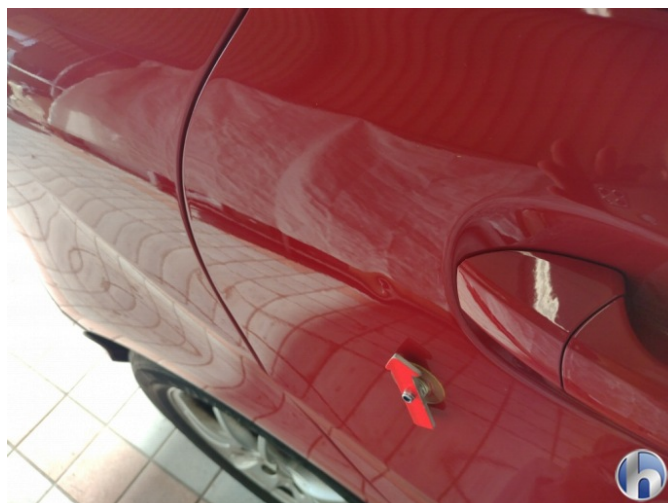
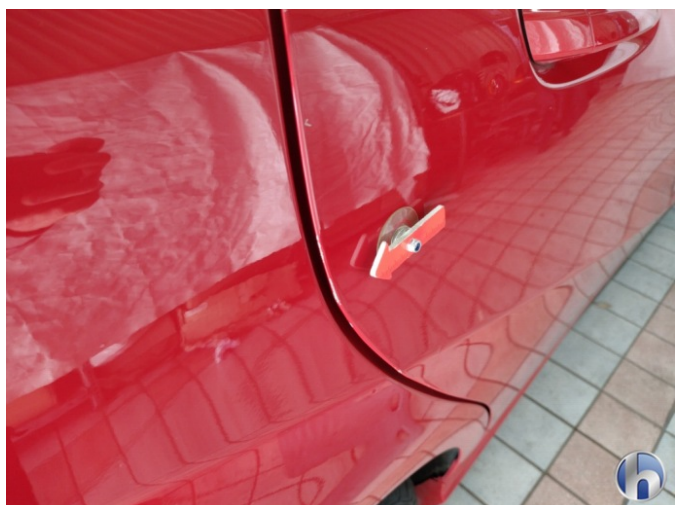
| component | Damage | Rep kind |
|---|---|---|
| 21. Door Rear - right | Deformed | Refurbish and paint |

21. Door Rear - right

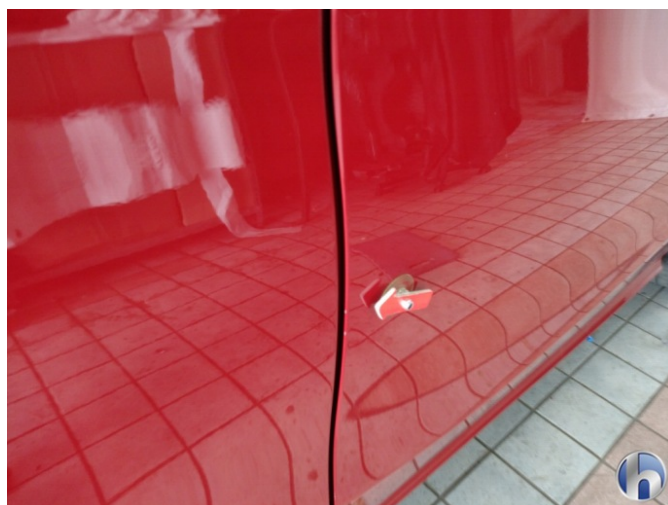
| component | Damage | Rep kind |
|---|---|---|
| 22. Front door - right | Wear and tear | acceptable |

22. Front door - right

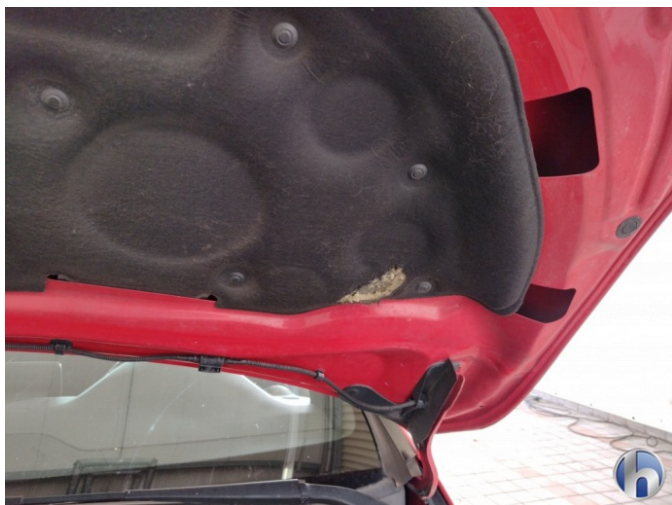
| component | Damage | Rep kind |
|---|---|---|
| 23. motor insulation | Damaged | Replace |

23. motor insulation

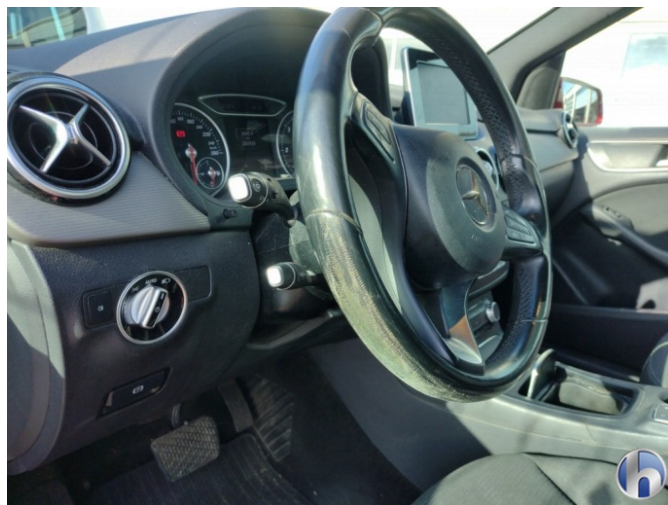
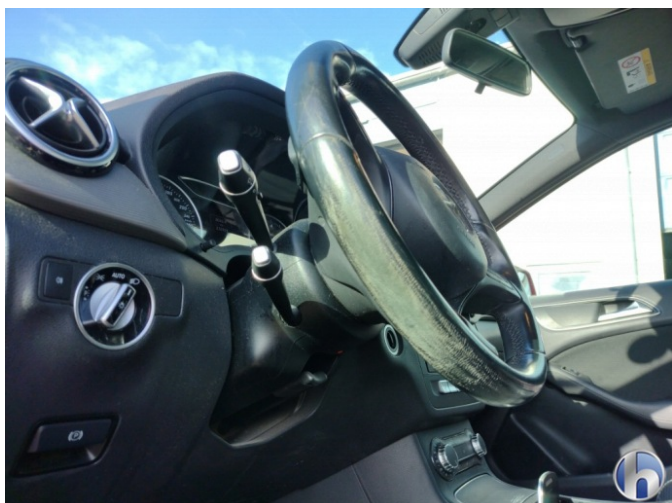
| component | Damage | Rep kind |
|---|---|---|
| 25. steering wheel | Damaged | Smart repair |

25. steering wheel
