Expertise

Protocol number: 41716547  
Order number / reference: 25226594  
Inspection date: 26 Sept 2025

| Manufacturer: Mercedes-Benz | Model: Vito 111 CDI Lang |

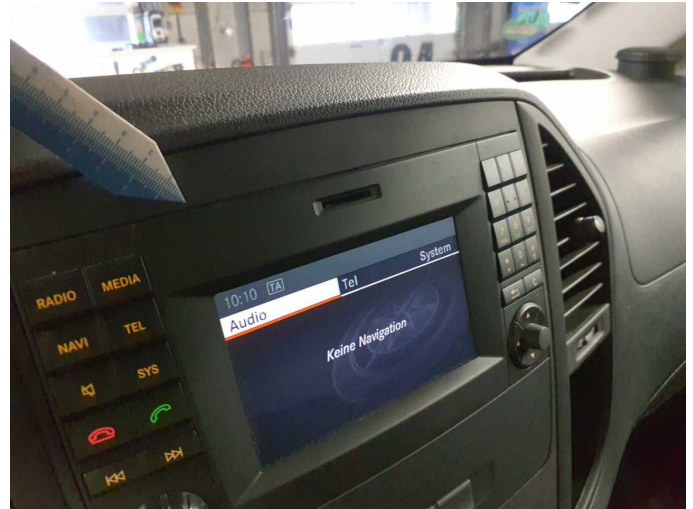
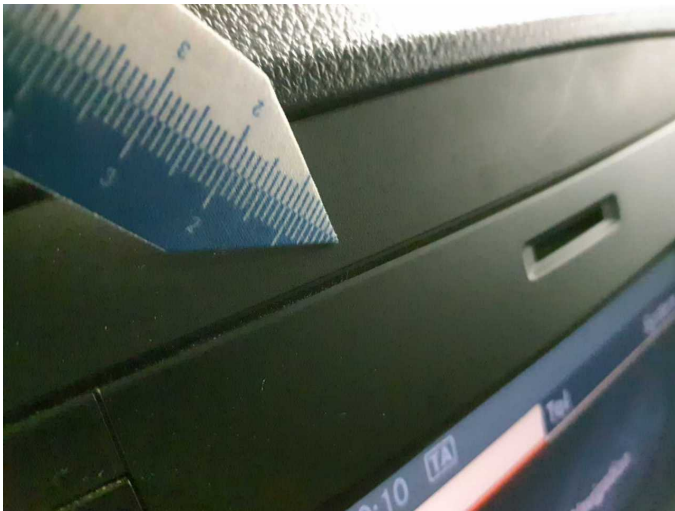
| No. | Component group | Description |
|---|---|---|
| 1 | Multimedia system | Radio (Mehrkosten möglich) - Malposition - Perform diagnosis |

**Damage 1:** Multimedia system: Radio (Mehrkosten möglich) - Malposition  
- Perform diagnosis

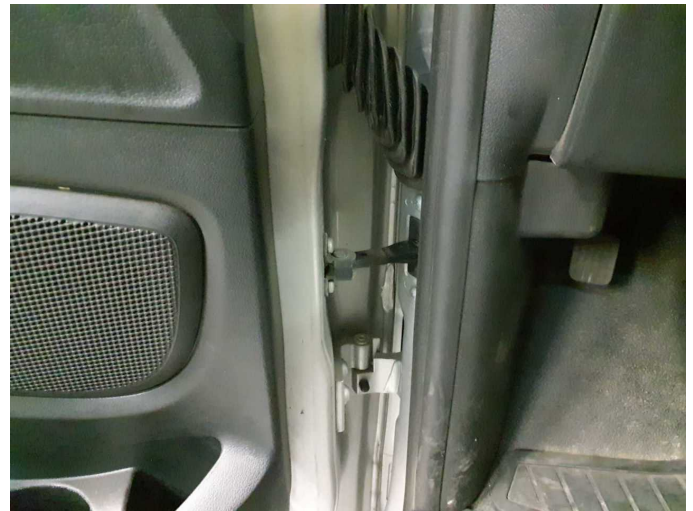
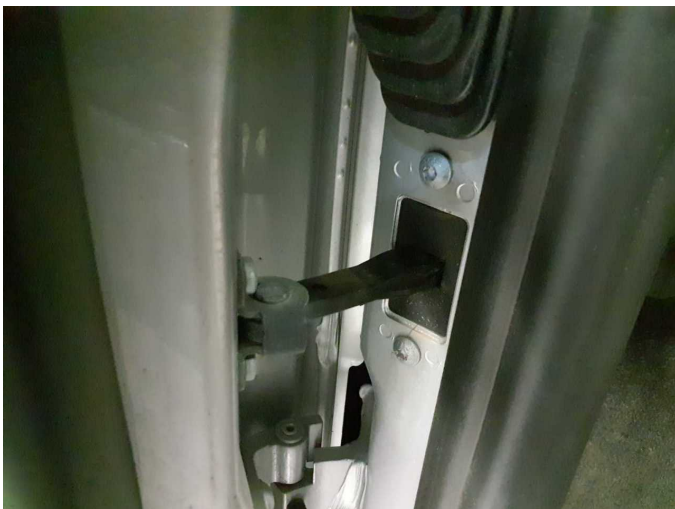
| No. | Component group | Description |
|---|---|---|
| 2 | Door - front left side | Door (FESTSTELLER TÜR V L) - Defective - Replace |

**Damage 2:** Door - front left side: Door (FESTSTELLER TUER V L) -  
Defective - Replace

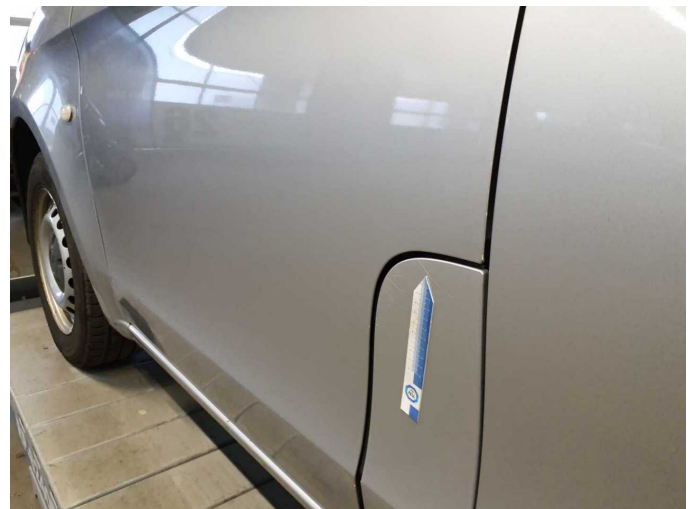
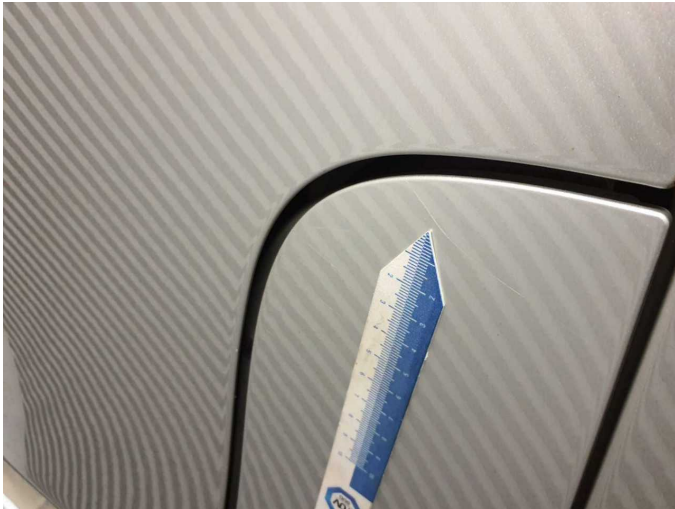
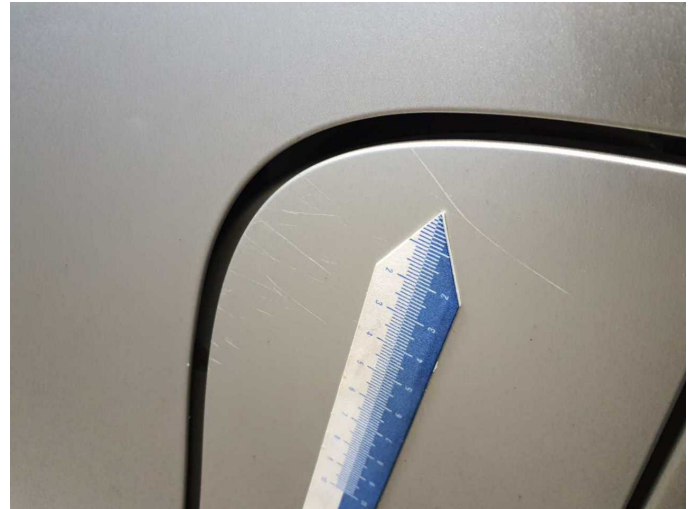
| No. | Component group | Description |
|---|---|---|
| 3 | Fuel system | Tank cap - Scratched - Smart repair |

**Damage 3:** Fuel system: Tank cap - Scratched - Smart repair

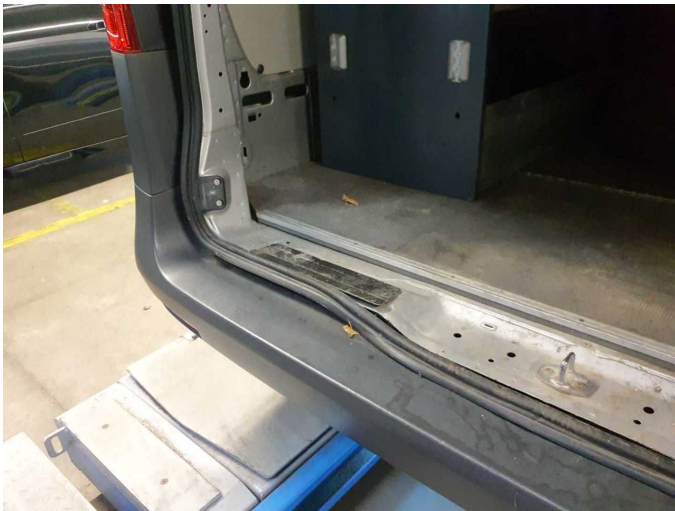
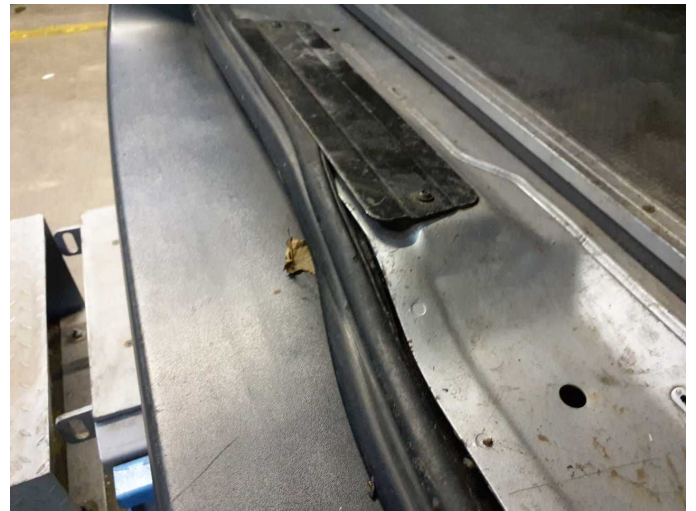
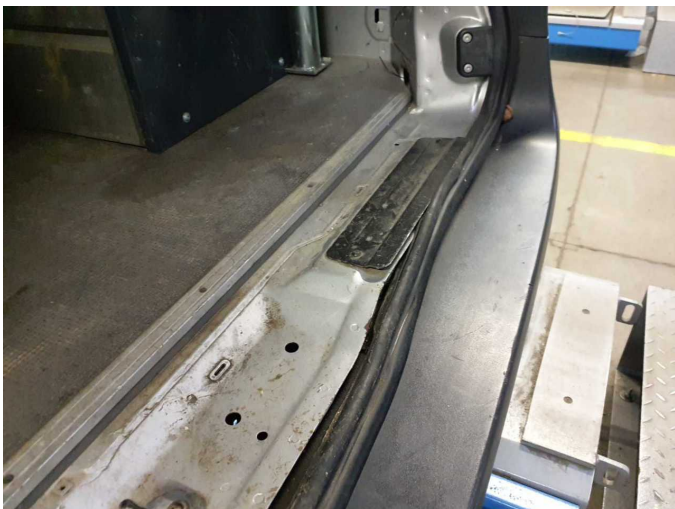
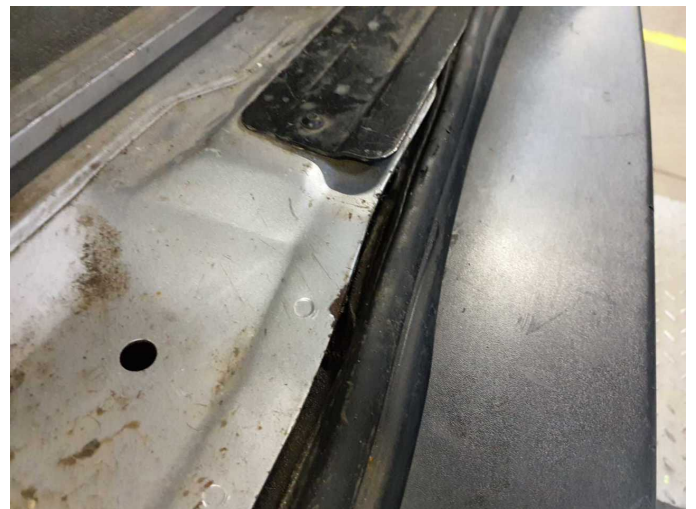
| No. | Component group | Description |
|---|---|---|
| 4 | Boot lid / rear door | Seal - Malposition - Repair |

**Damage 4:** Boot lid / rear door: Seal - Malposition - Repair

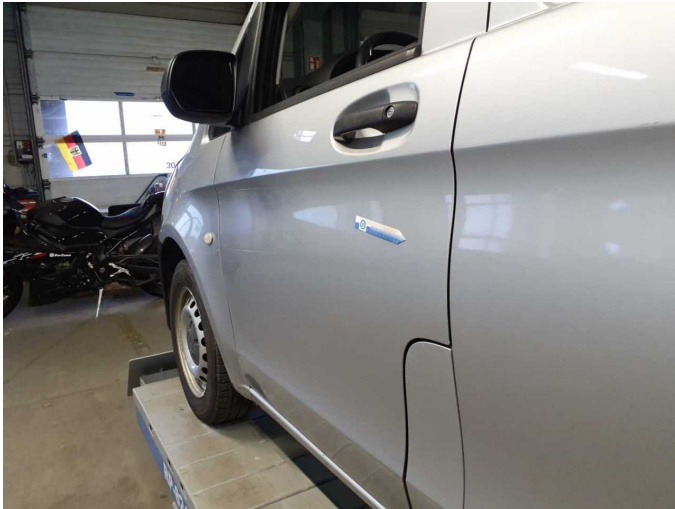
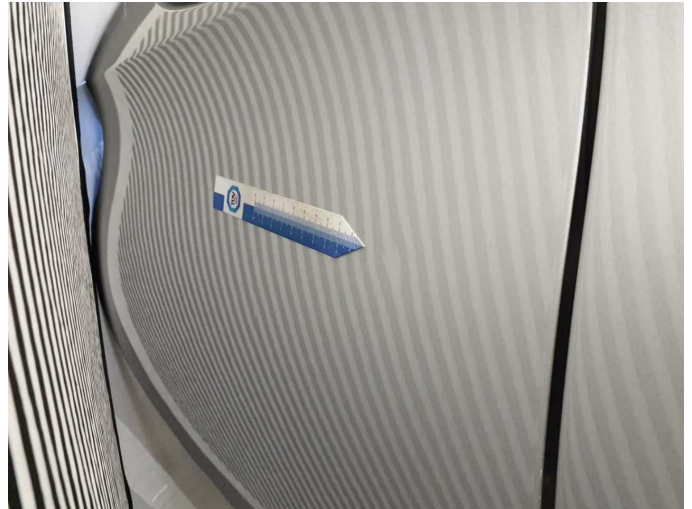
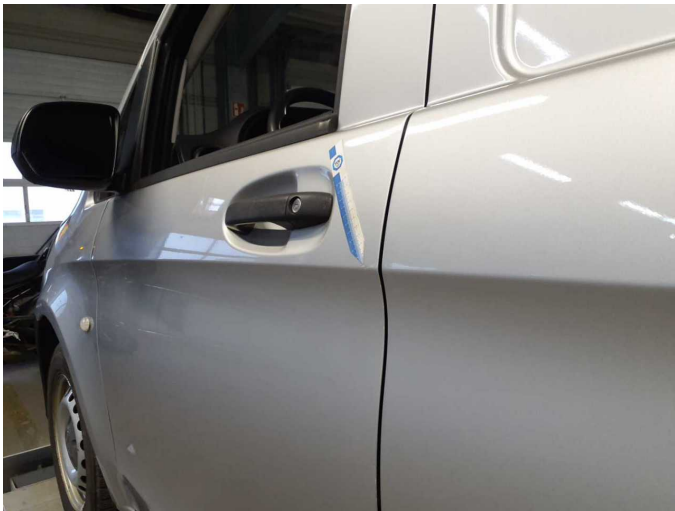
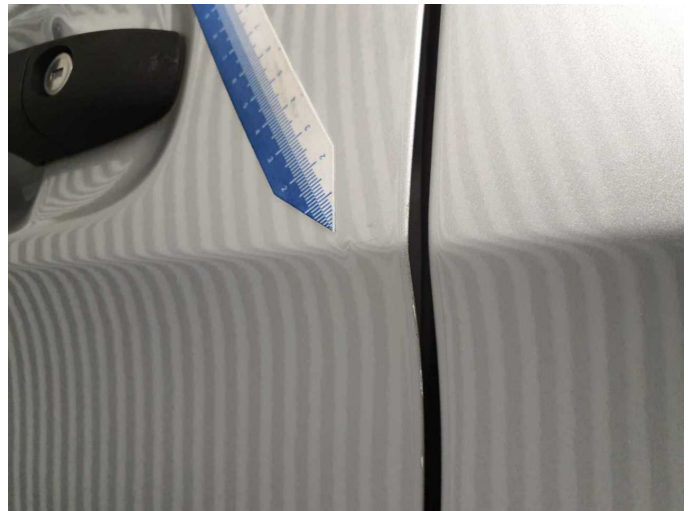
| No. | Component group | Description |
|---|---|---|
| 5 | Door - front left side | Door - Dent / paintcoat damage - Smart repair |

**Damage 5:** Door - front left side: Door - Dent / paintcoat damage - Smart repair

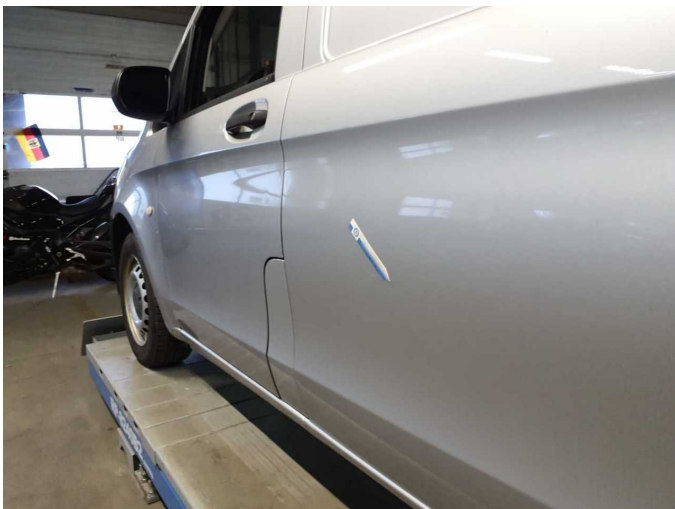
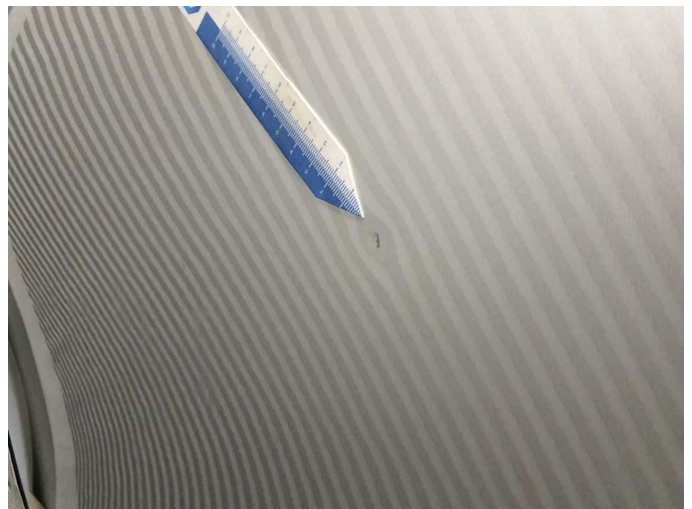
| No. | Component group | Description |
|---|---|---|
| 6 | Side panel - rear left side | Side panel - Scratched - Smart repair |

**Damage 6:** Side panel - rear left side: Side panel - Scratched - Smart repair

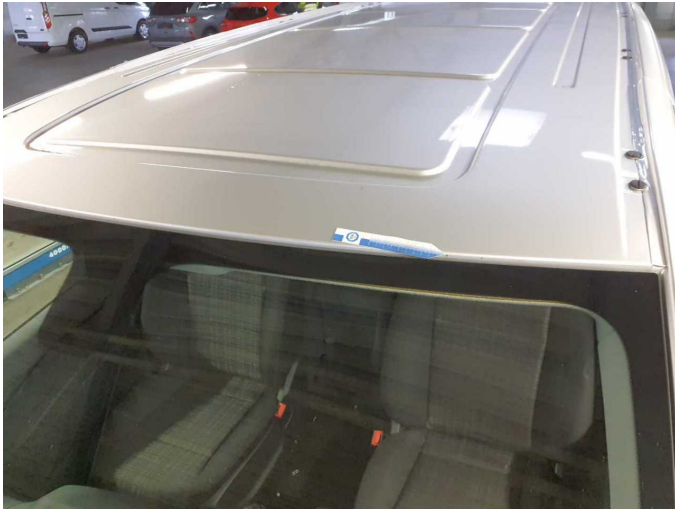
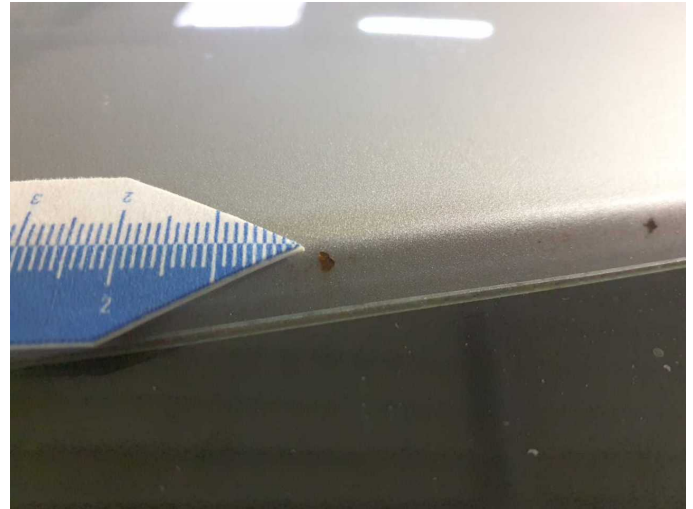
| No. | Component group | Description |
|---|---|---|
| 7 | Roof | Roof - Corrosion - Smart repair |

**Damage 7:** Roof: Roof - Corrosion - Smart repair

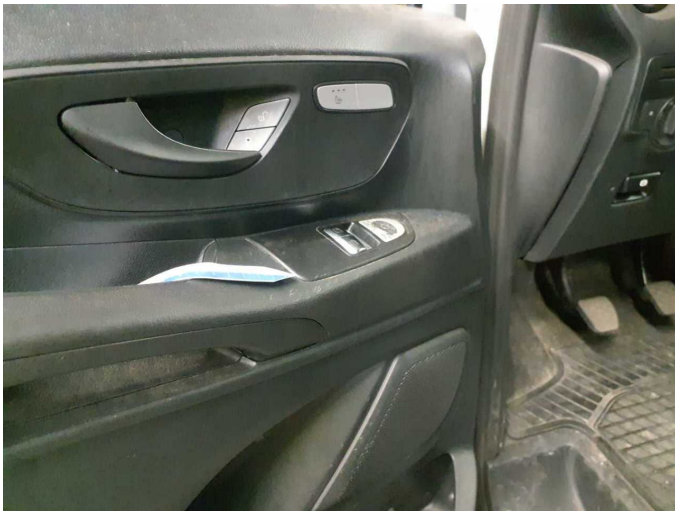
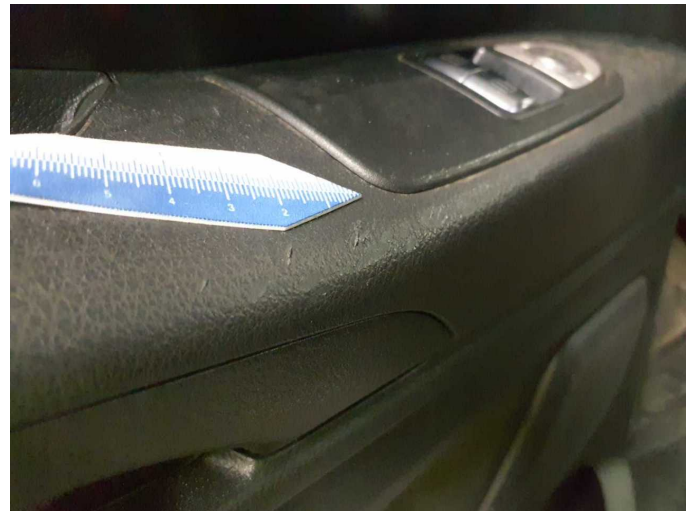
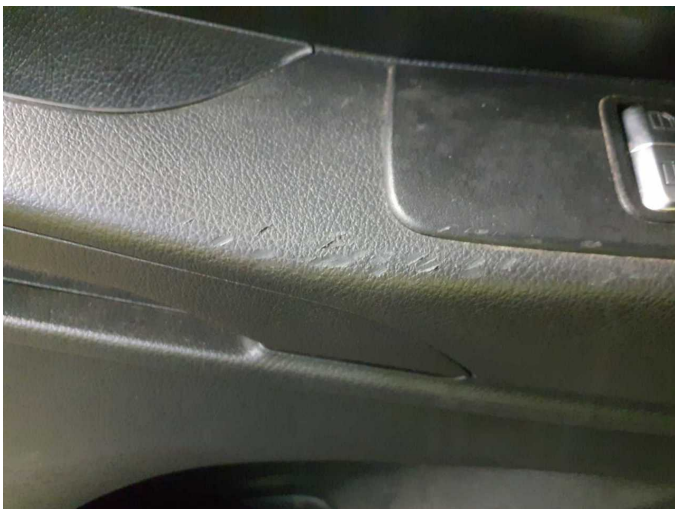
| No. | Component group | Description |
|---|---|---|
| 8 | Trim / covers | Door trim - front left side - Scratched - Replace |

**Damage 8:** Trim / covers: Door trim - front left side - Scratched - Replace

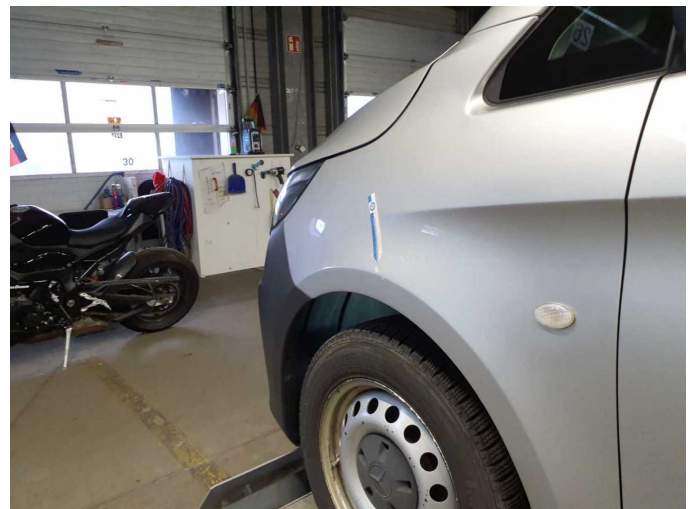
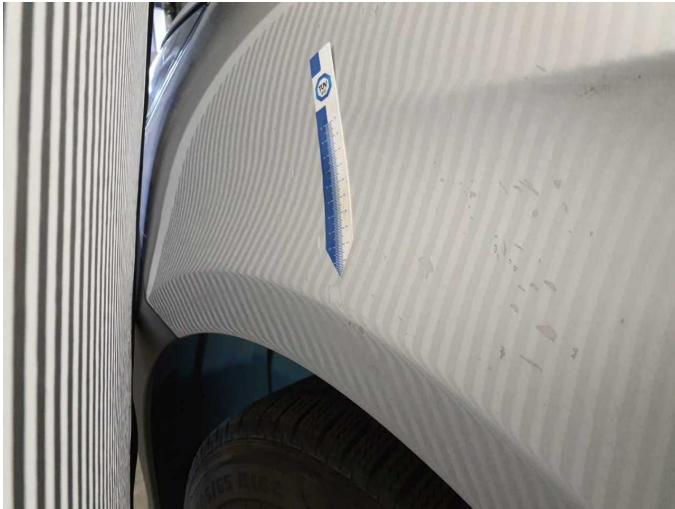
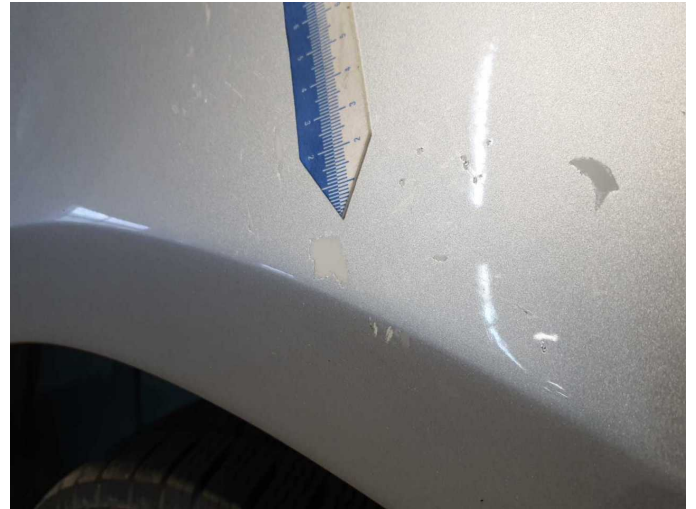
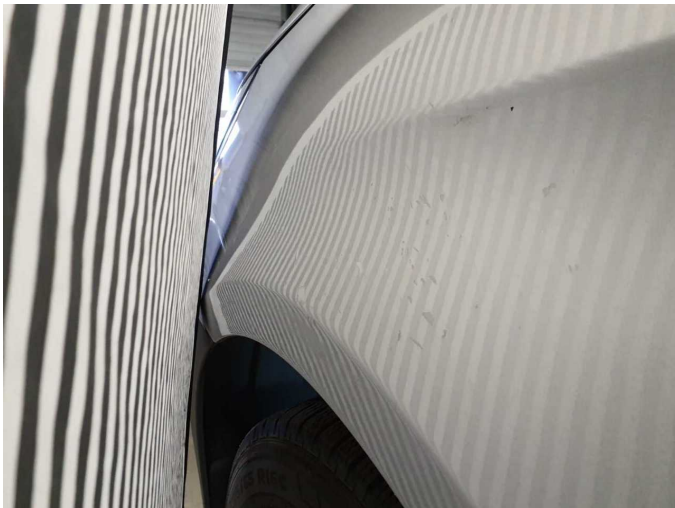
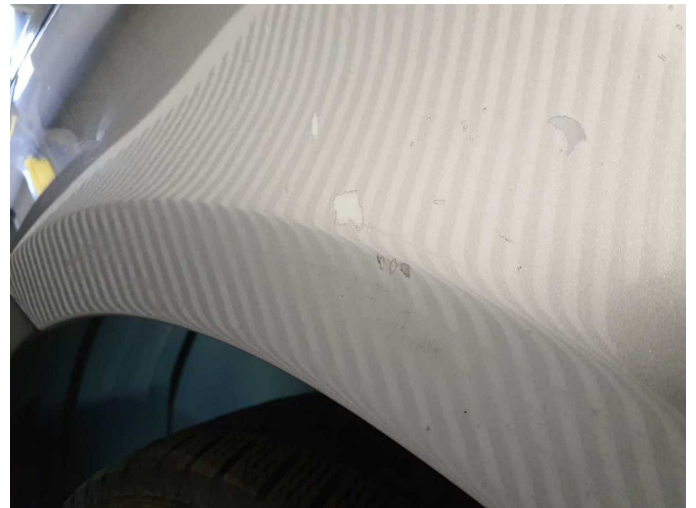
| No. | Component group | Description |
|---|---|---|
| 9 | Mudguard - left side | Mudguard - left side - Scratched - Paint |

**Damage 9:** Mudguard - left side: Mudguard - left side - Scratched - Paint

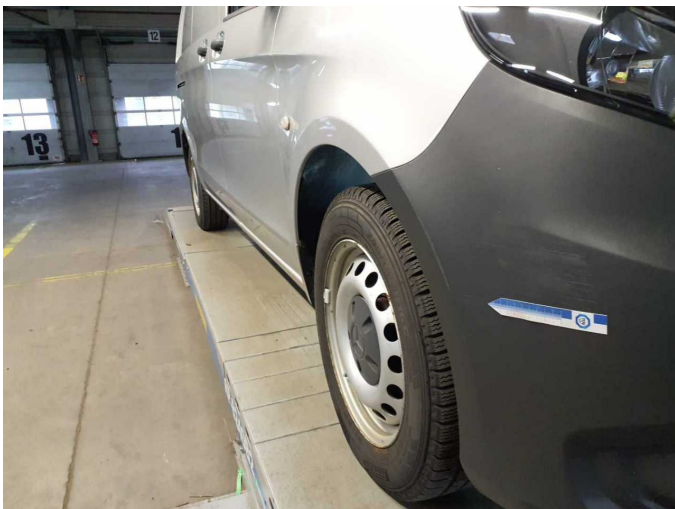
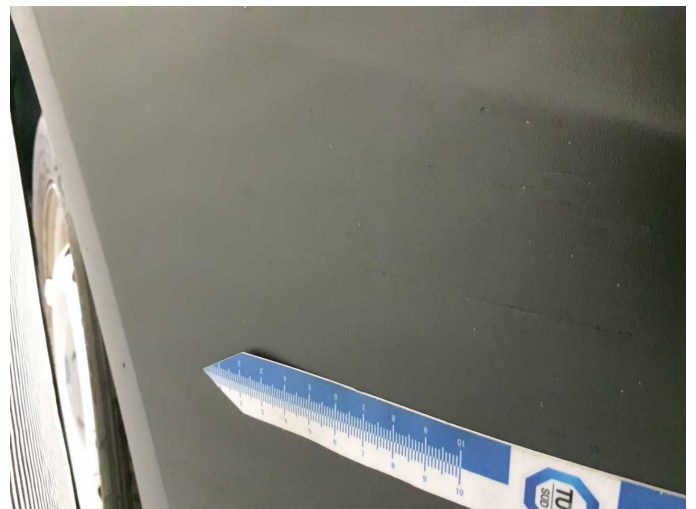
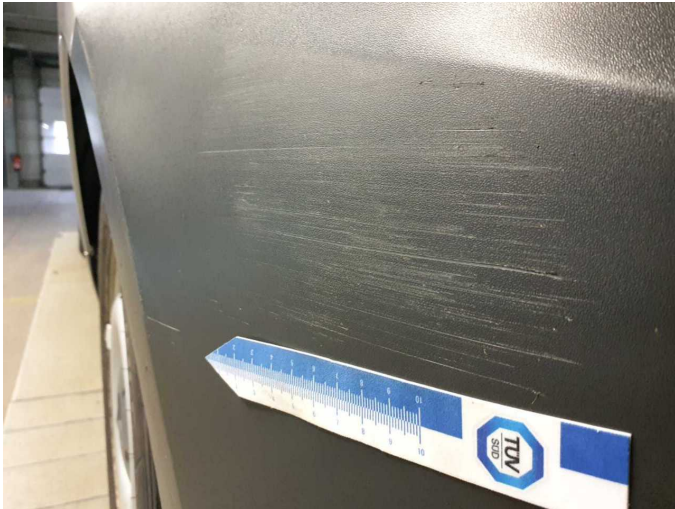
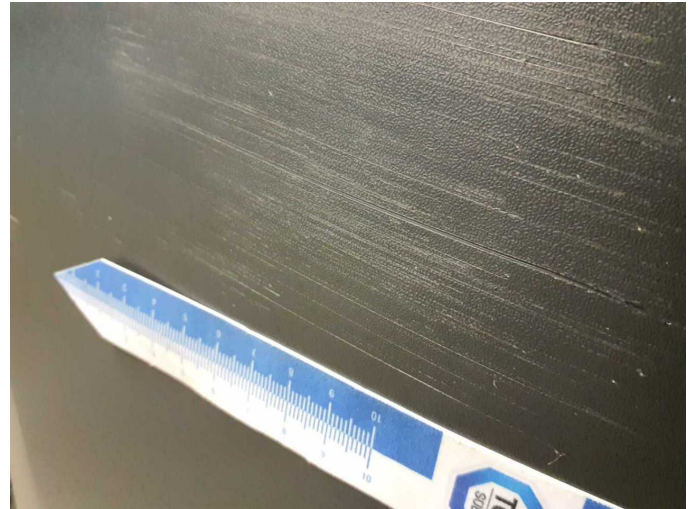
| No. | Component group | Description |
|---|---|---|
| 10 | Front bumper | Front bumper - Scratched - Replace |

**Damage 10:** Front bumper: Front bumper - Scratched - Replace

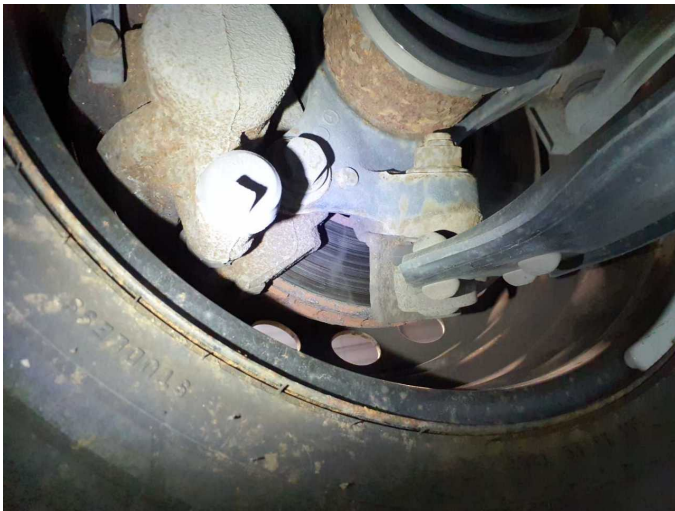
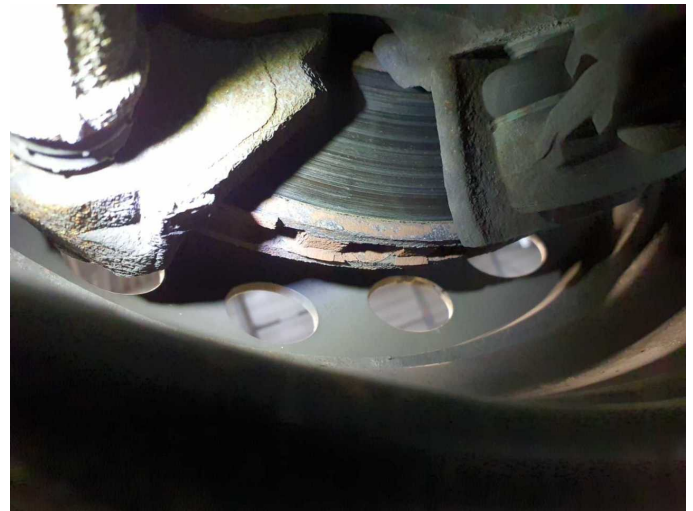
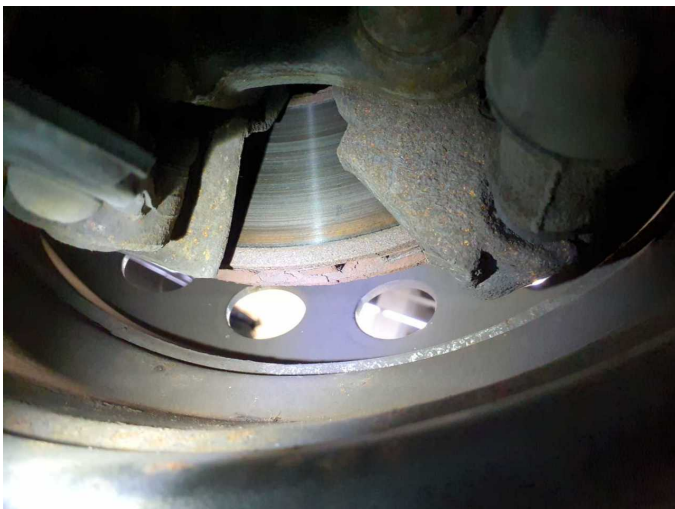
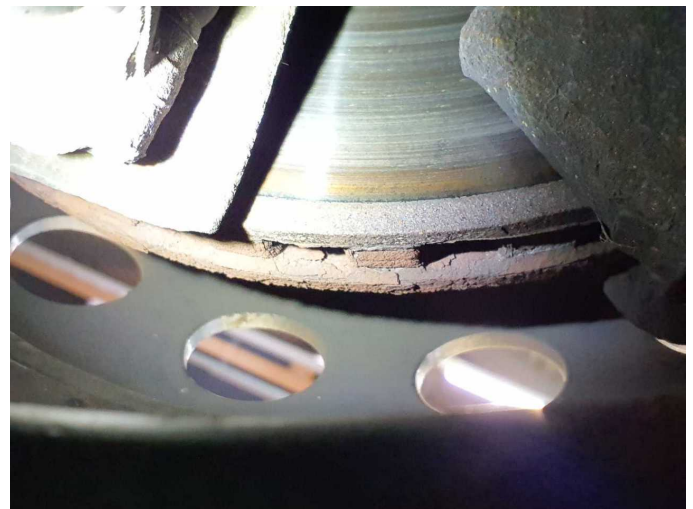
| No. | Component group | Description |
|---|---|---|
| 11 | Braking system | Brake discs - front (Tragbild mangelhaft) - Corrosion - Replace |

**Damage 11:** Braking system: Brake discs - front (Tragbild mangelhaft) - Corrosion - Replace

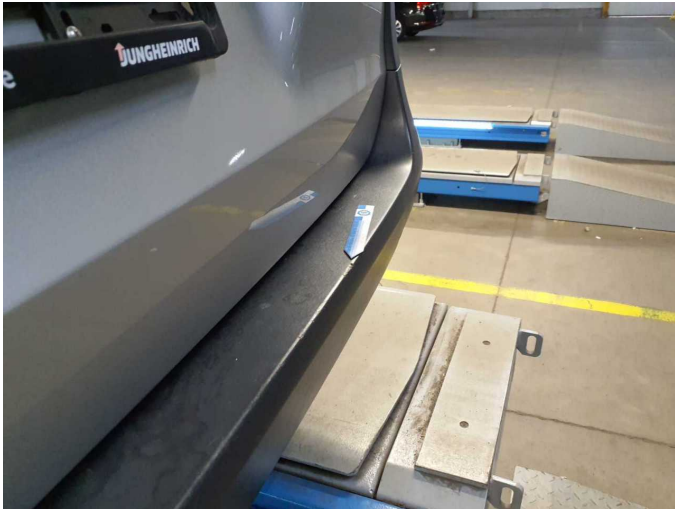
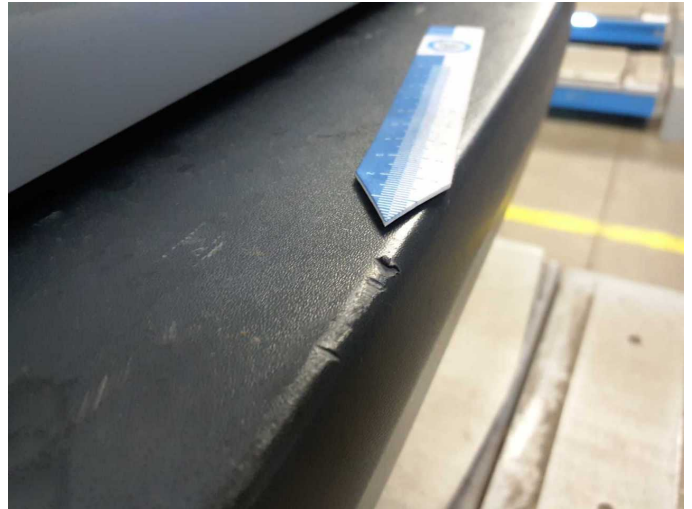
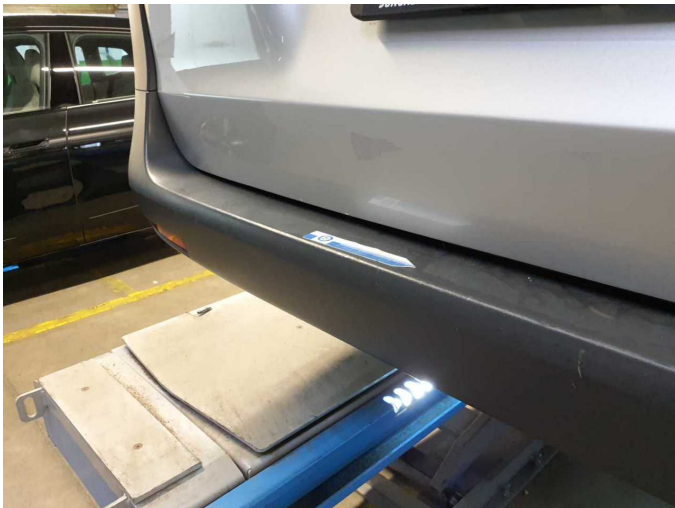
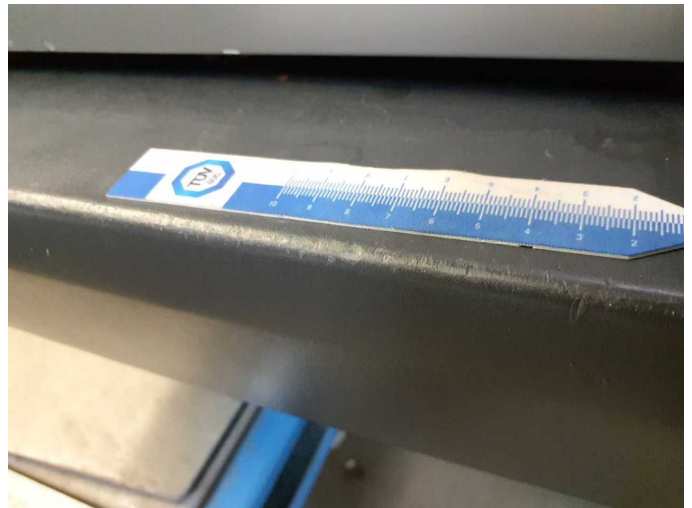
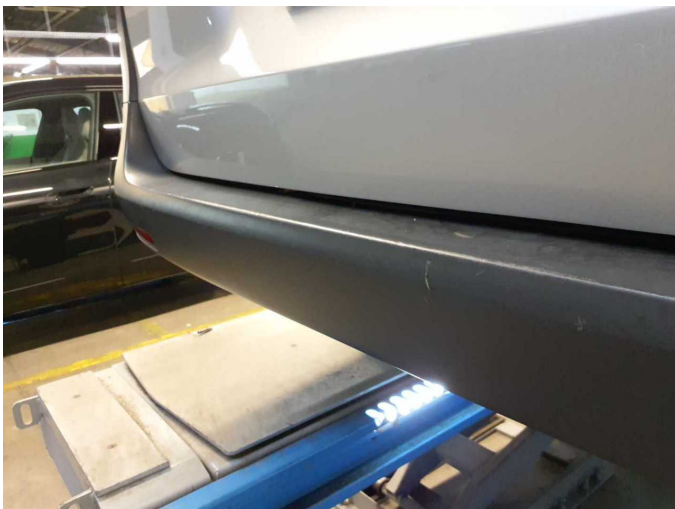
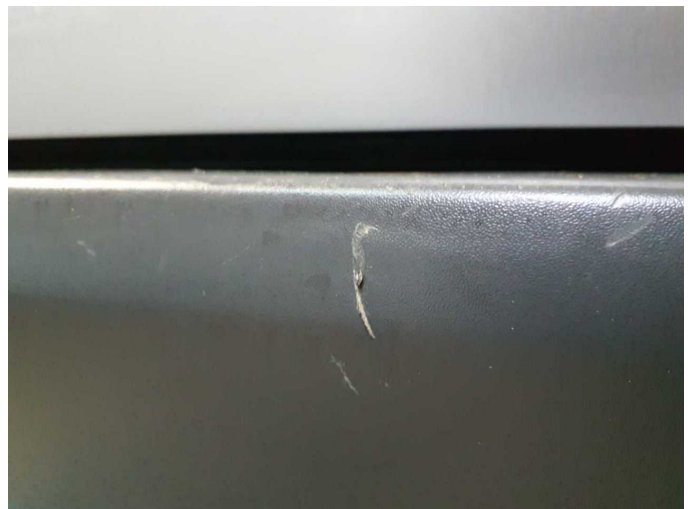
| No. | Component group | Description |
|---|---|---|
| 12 | Rear bumper | Rear bumper - Scratched - Replace |

**Damage 12:** Rear bumper: Rear bumper - Scratched - Replace

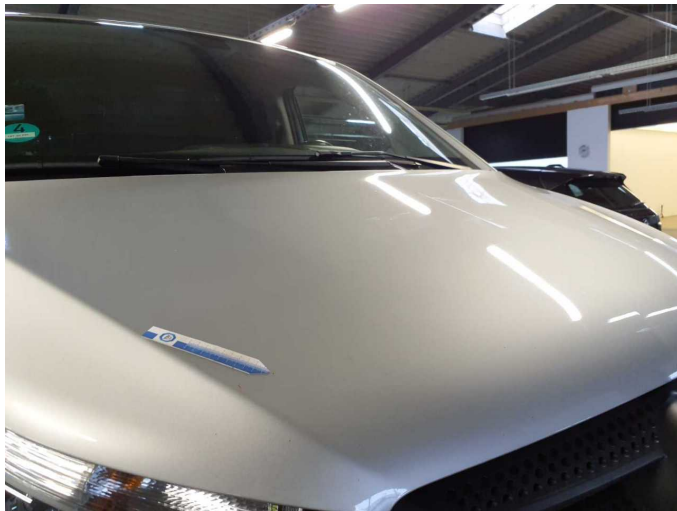
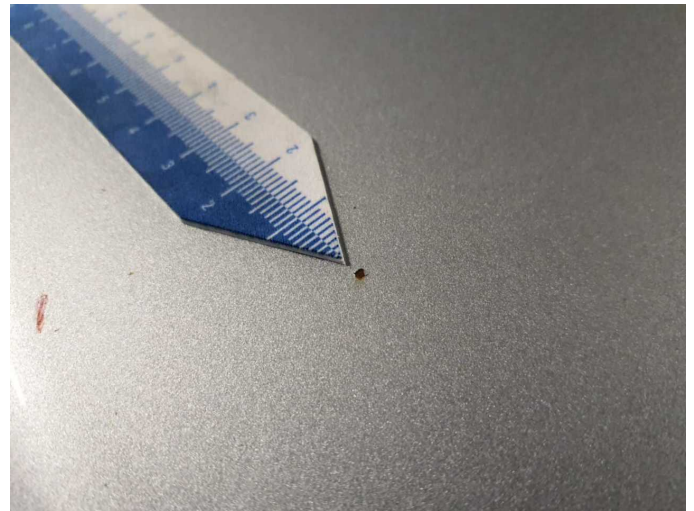
| No. | Component group | Description |
|---|---|---|
| 13 | Bonnet | Bonnet (Steinschlag) - Corrosion - Repair and paint |

**Damage 13:** Bonnet: Bonnet (Steinschlag) - Corrosion - Repair and paint

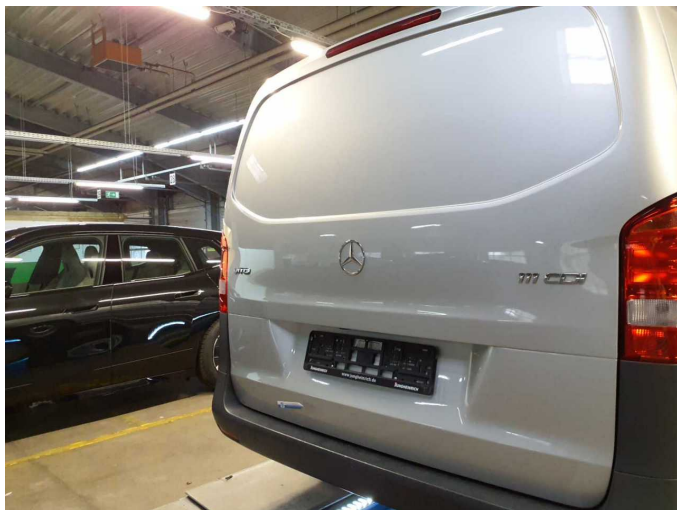
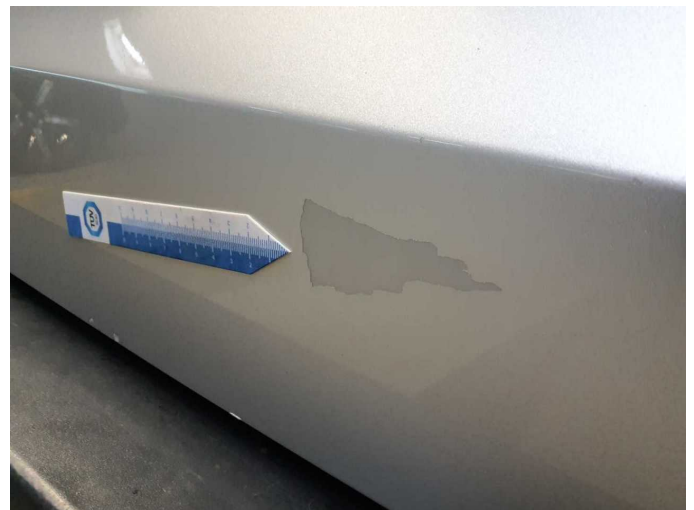
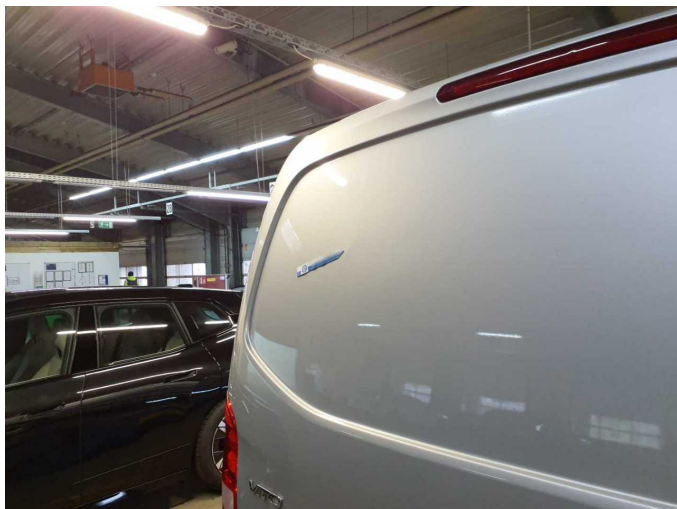
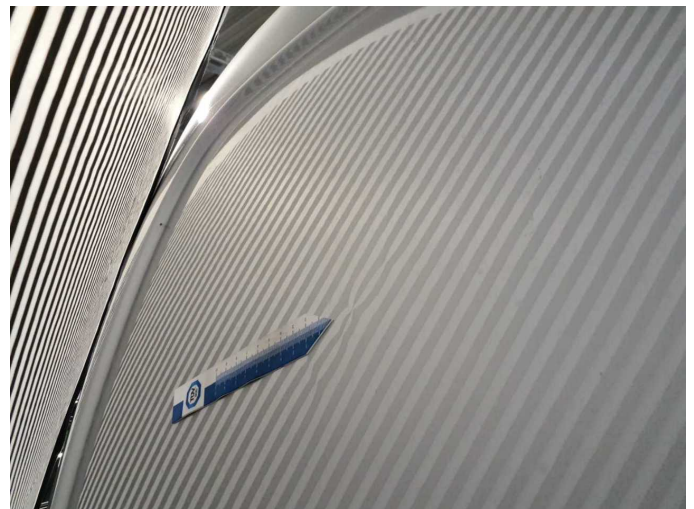
| No. | Component group | Description |
|---|---|---|
| 14 | Boot lid / rear door | Boot lid (Dellen) - Scratched - Repair and paint |

**Damage 14:** Boot lid / rear door: Boot lid (Dellen) - Scratched - Repair and paint

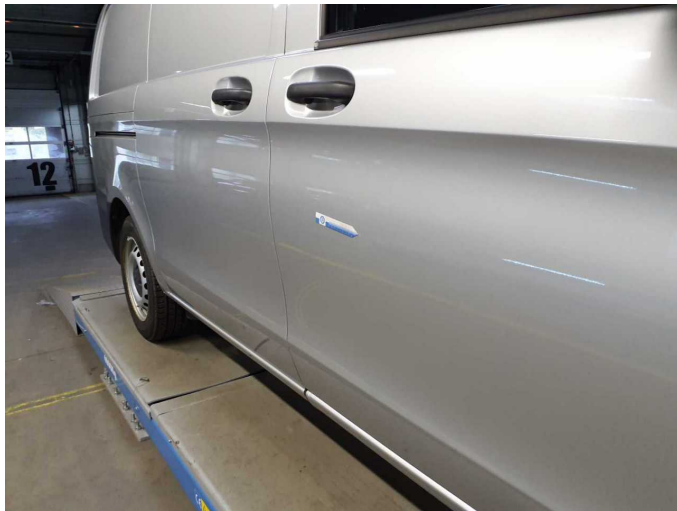
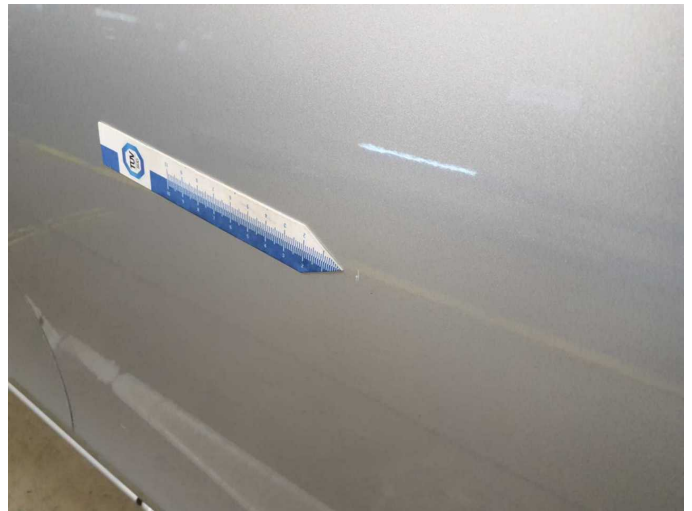
| No. | Component group | Description |
|---|---|---|
| 5 | Door - front right side | Door - Scratched - No deduction |

**Wear and tear 5:** Door - front right side: Door - Scratched - No deduction

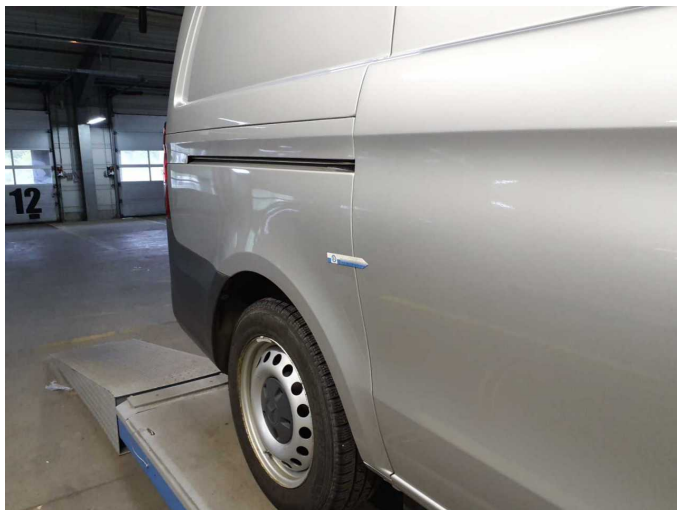
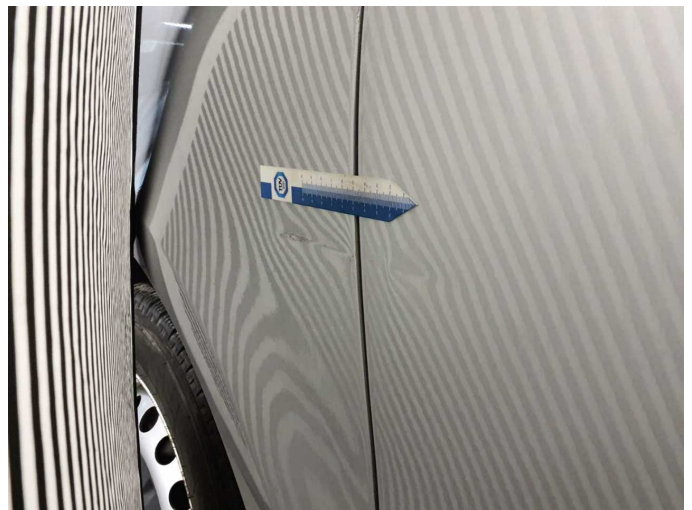
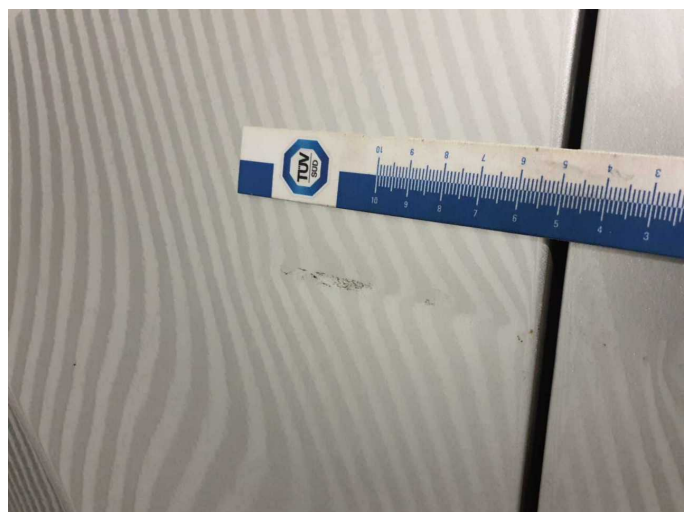
| No. | Accident |
|---|---|
| 1 | Side right |

**Accident 1:** Side right
